## HAZARDOUS MATERIALS SURVEY REPORT & MANAGEMENT PLAN

17-21 University Avenue,  
Canberra ACT 2601

Survey Completion Date: 9 August 2024

Job reference: LDJ3334

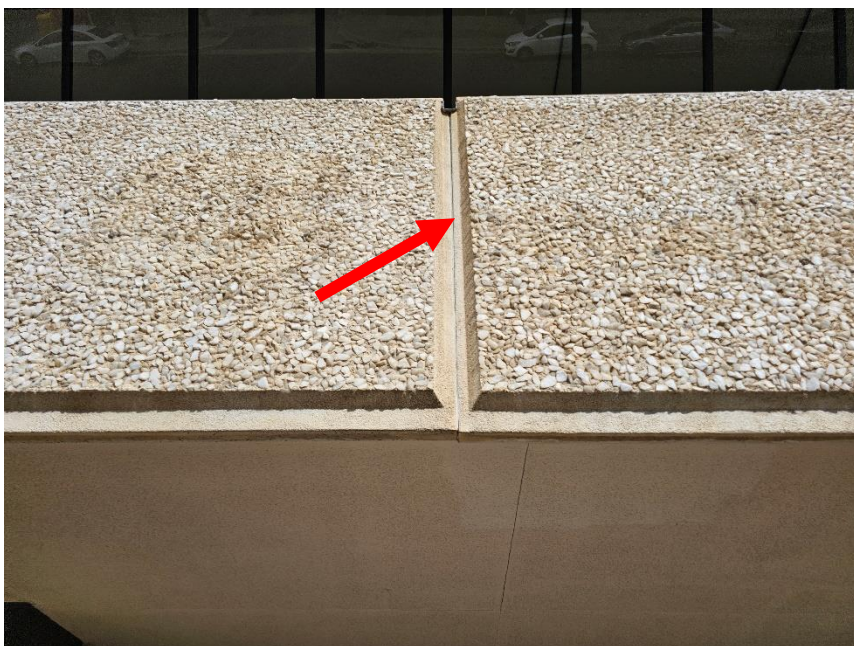
**Photo Number:** ACM1

**Location description:** Exterior - Sealant to joints in concrete panels

**Material:** Mastic

The asbestos mastic to the joints between the exterior concrete panels is cracking and weathered in several locations. Weathered sections should be sealed in order to prevent further deterioration.

| ITEM NO. | LEVEL | LOCATION DESCRIPTION | MATERIAL DESCRIPTION | PHOTO NO | SAMPLE NO. | ASBESTOS FIBRE CONTENT | ACM TYPE | MATERIAL CONDITION | LIKELIHOOD OF DISTURBANCE | RISK RATING | MINIMUM RECOMMENDED ACTION |
|---|---|---|---|---|---|---|---|---|---|---|---|
| LDJ03334 - 1 | All | Exterior - Sealant to joints in concrete panels | Mastic | ACM1 | Refer to 85722 | CHR | NF | Fair | L | VL | Seal cracked sections |

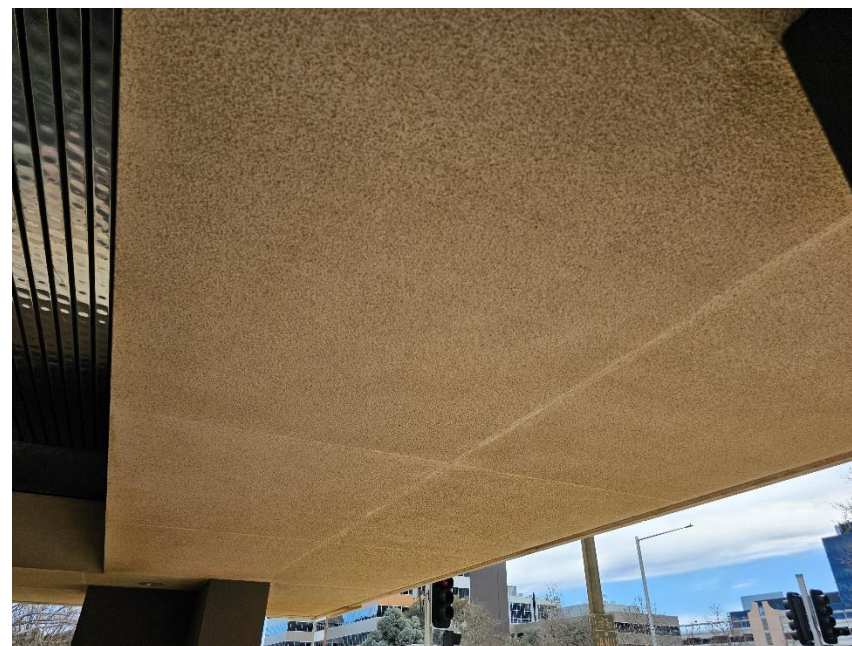
**Photo Number:** ACM2

**Material:** Fibre Cement

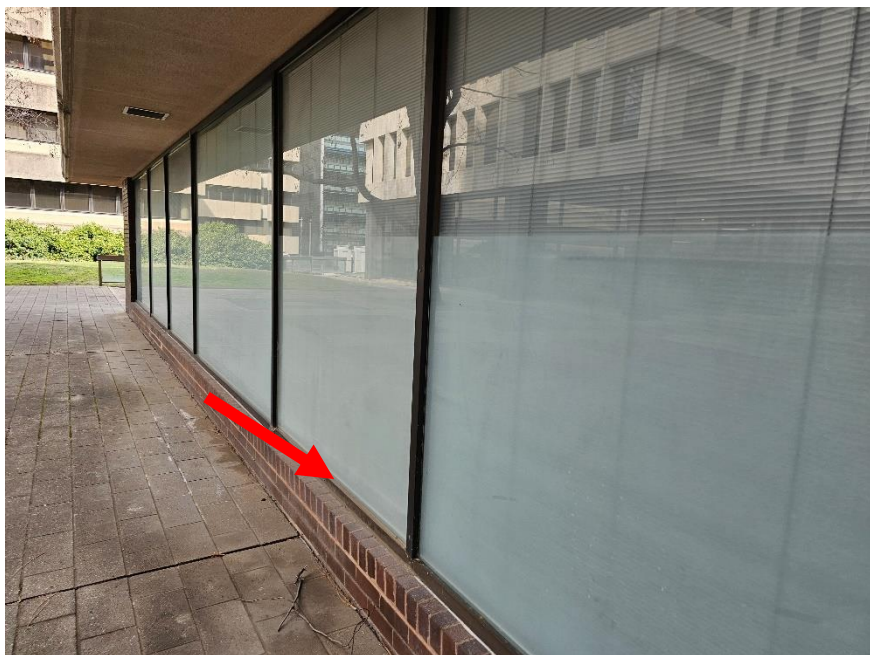
**Photo Number:** ACM3

**Location description:** Exterior - Sealant to window aluminium window on southeast façade

**Material:** Caulking

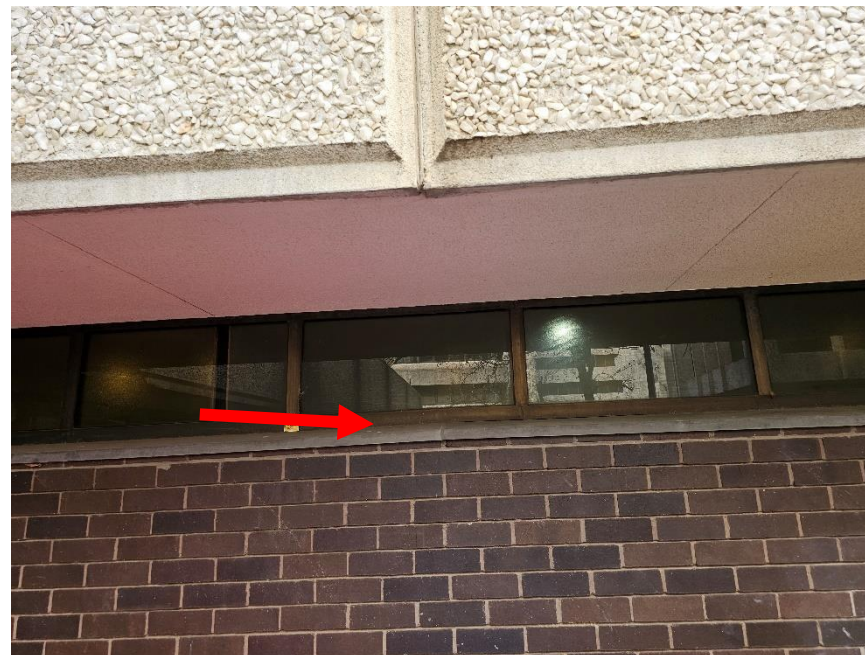
**Photo Number:** ACM4

**Material:** Caulking

| ITEM NO. | LEVEL | LOCATION DESCRIPTION | MATERIAL DESCRIPTION | PHOTO NO | SAMPLE NO. | ASBESTOS FIBRE CONTENT | ACM TYPE | MATERIAL CONDITION | LIKELIHOOD OF DISTURBANCE | RISK RATING | MINIMUM RECOMMENDED ACTION |
|---|---|---|---|---|---|---|---|---|---|---|---|
| LDJ03334 - 4 | G | Exterior - Sealant to frosted glass window on south facade | Putty | ACM4 | C108379/A02 | CHR | NF | Good | L | VL | Label and maintain |

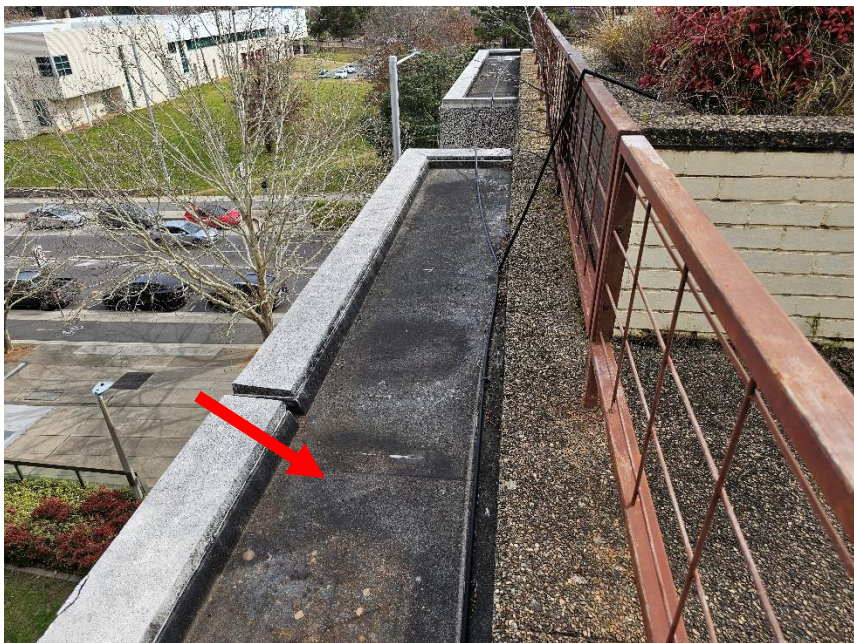
**Photo Number:** ACM5

**Location description:** Exterior - Waterproofing to parapet under sloped windows and rooftop garden

**Material:** Membrane

The waterproofing membrane to the Level 3 Roof Top Garden and the exterior parapets is weathered in several locations. Weathered sections should be sealed in order to prevent further deterioration.

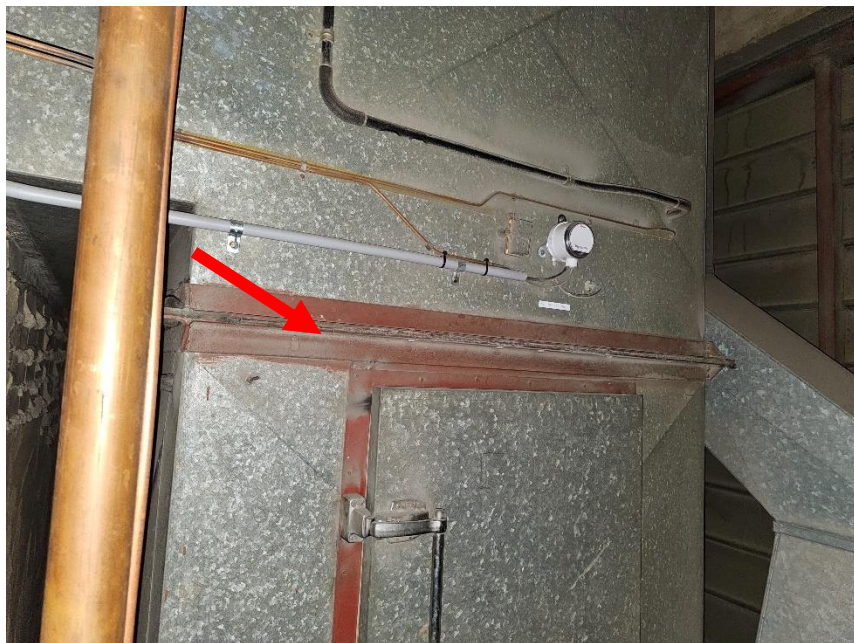
**Photo Number:** ACM7

**Location description:** Risers and Ceiling Spaces – Sealant to ductwork flange joints

**Material:** Mastic

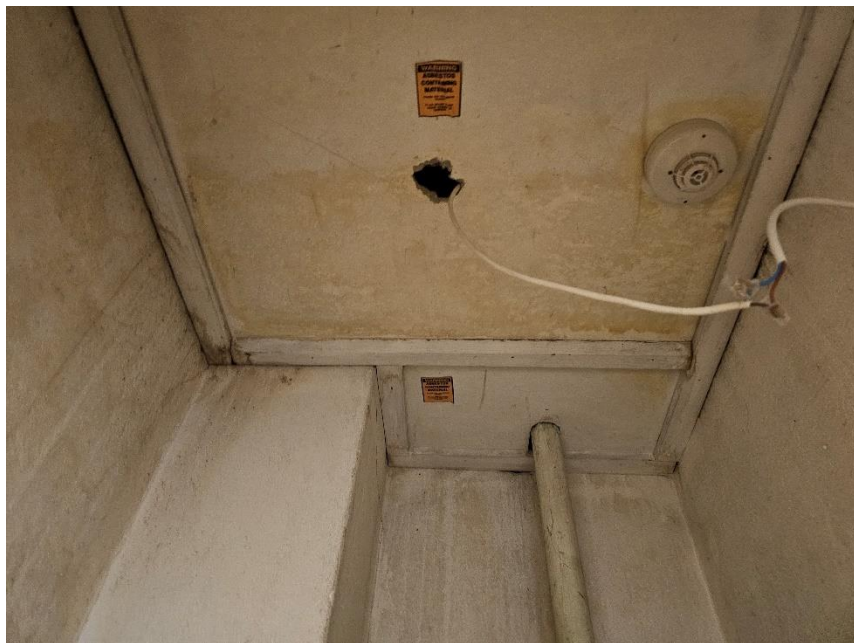
**Photo Number:** ACM9

**Location description:** Gas Valve Cupboard - Ceiling

**Material:** Fibre cement

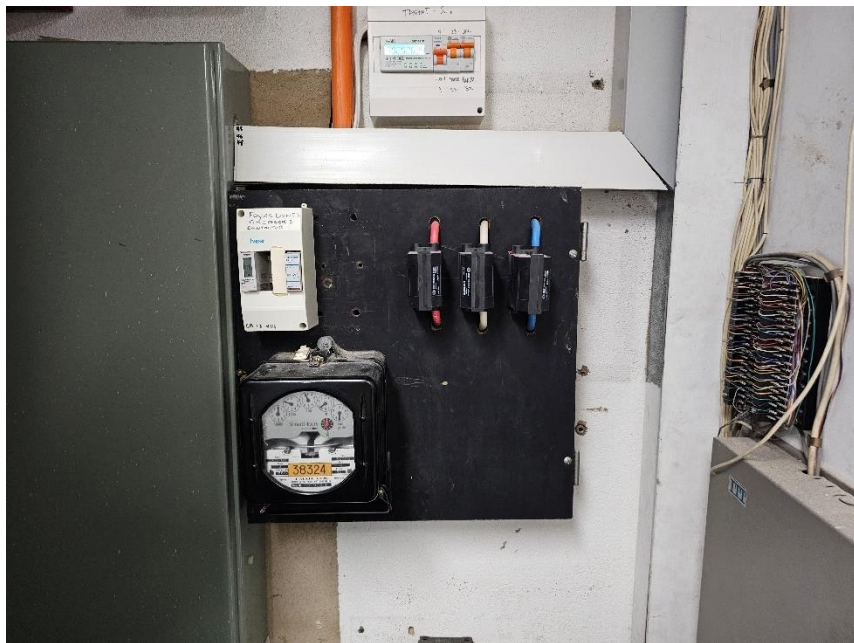
**Photo Number:** ACM11

**Location description:** Electrical Switchboard & Metering Cupboards-  
Electrical switchboard backing

**Material:** Tar board

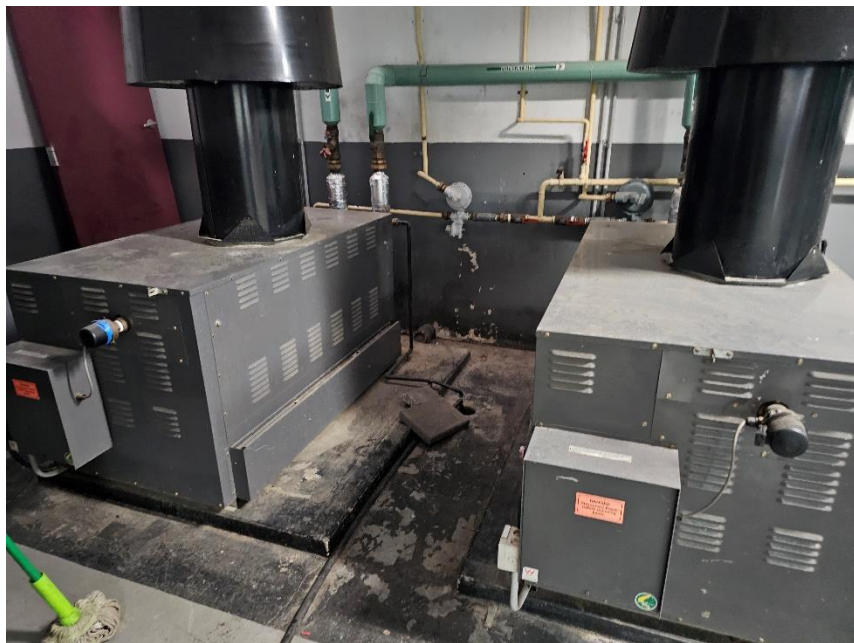
**Photo Number:** ACM13

**Location description:** Plant Room – To Boilers 1 and 2

**Material:** Rope gasket, seals and Insulation

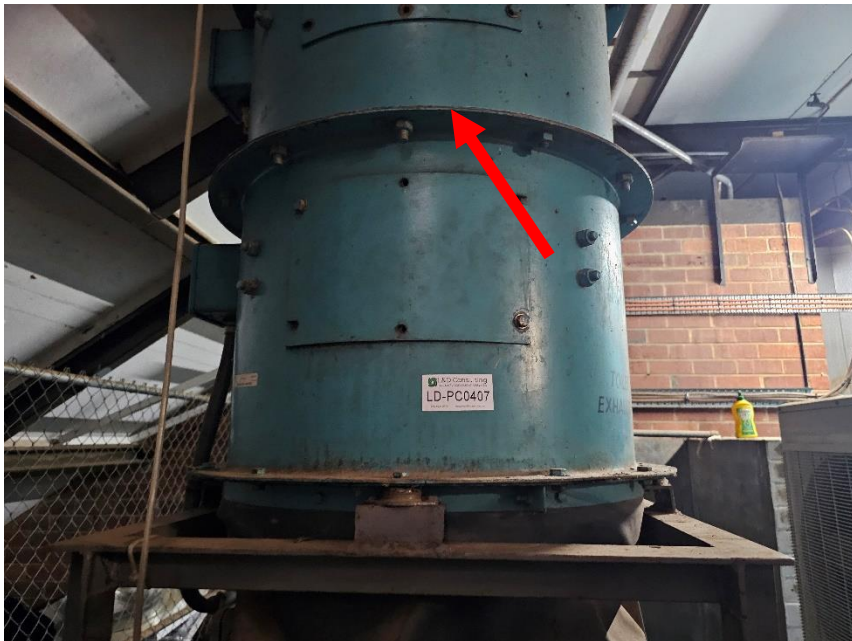
**Photo Number:** ACM15

**Location description:** Plant Room - Sealant to exhaust fan duct flange joint

**Material:** Mastic

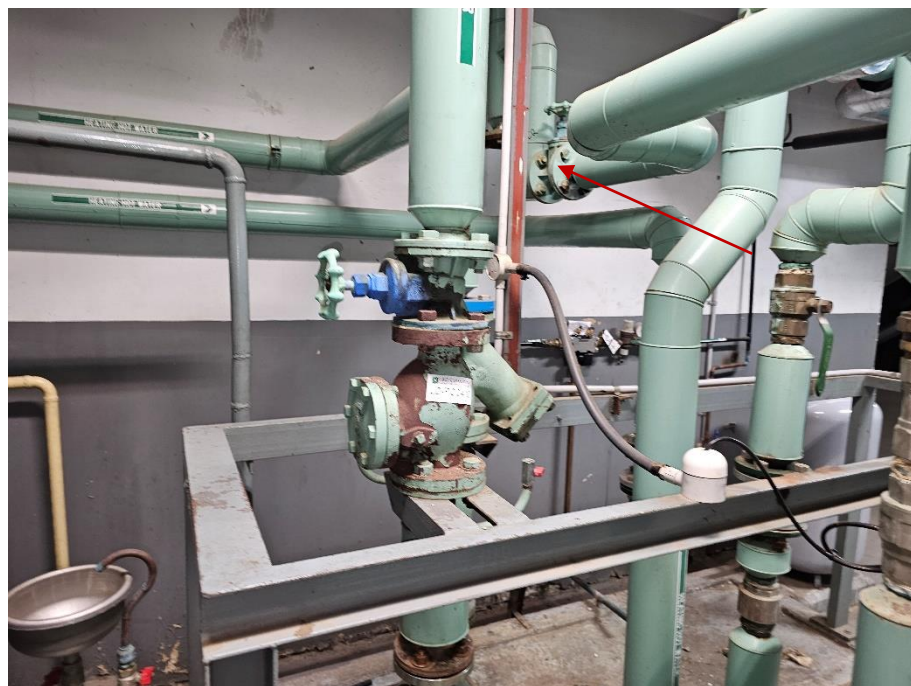
**Photo Number:** LP1

**Location description:** Plant Room – Pipework

**Paint colour:** Light green

All other identified lead paints were found to be in poor condition with flaking and chipping present. The paints should be stabilised via overpainting with a lead free alternative in order to minimise the lead exposure risk.

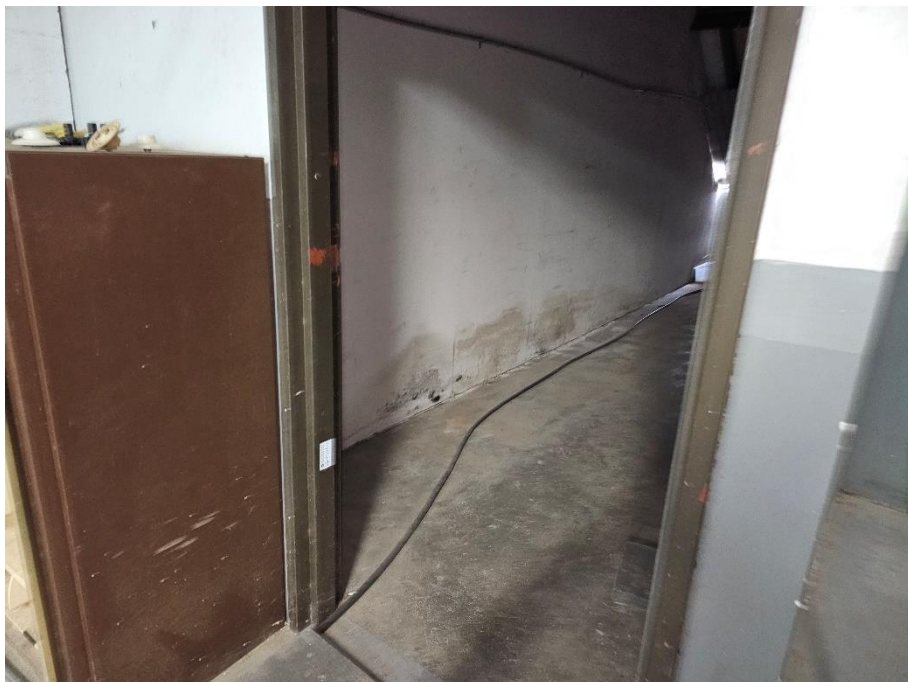
**Photo Number:** LP3

**Location description:** Plant Room – Metal door frame

**Paint colour:** Brown over red

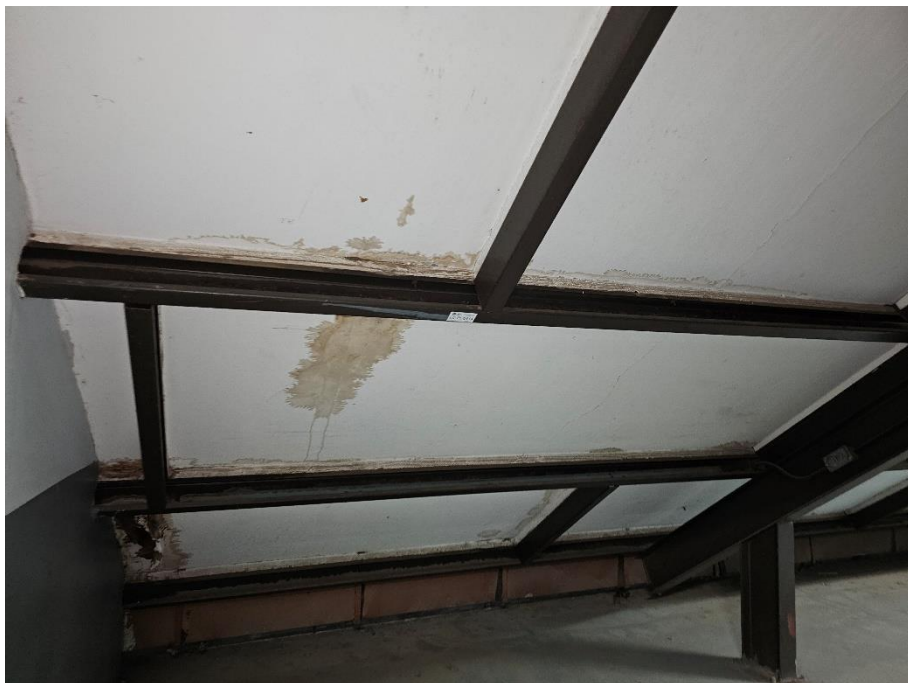
**Photo Number:** LP5

| ITEM NO | SAMPLE NO | LOCATIONS | COLOUR | LEAD CONTENT (%) | PHOTO NO. | CONDITION | COMMENTS |
|---|---|---|---|---|---|---|---|
| LDJ03334-LP5 | LD-PC0414 | Level 8 – Plant Room – Metal frame to roof | Brown | 0.62 | LP5 | Stable | Maintain in good condition |

**Location description:** Plant Room – Metal frame to roof

**Paint colour:** Brown

The brown lead paint to the metal roof supports was found to be sound condition and should be maintained as such.

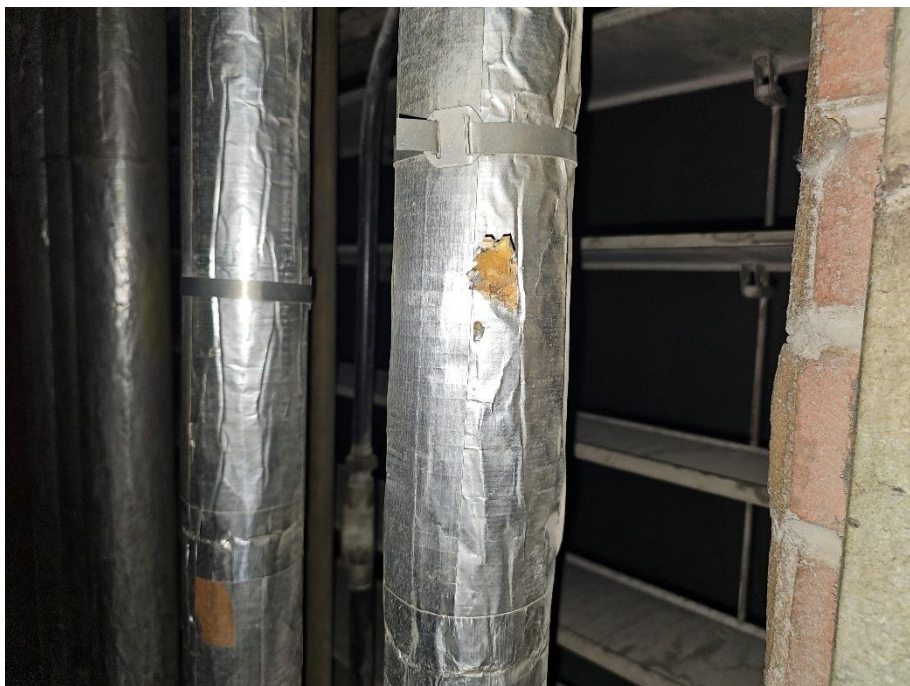
**Photo Number:** SMF1

**Location description:** Foil backed insulation to pipework

**Material description:** Fibreglass

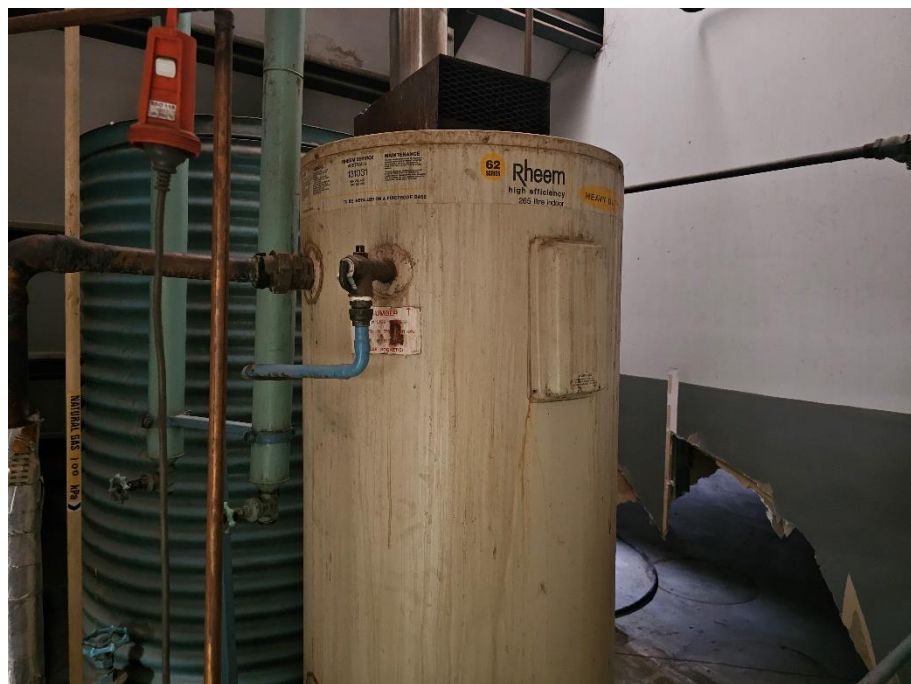
**Photo Number:** SMF3

**Location description:** Plant Room – Insulation to interior of Rheem Hot Water Unit

**Material description:** Fibreglass

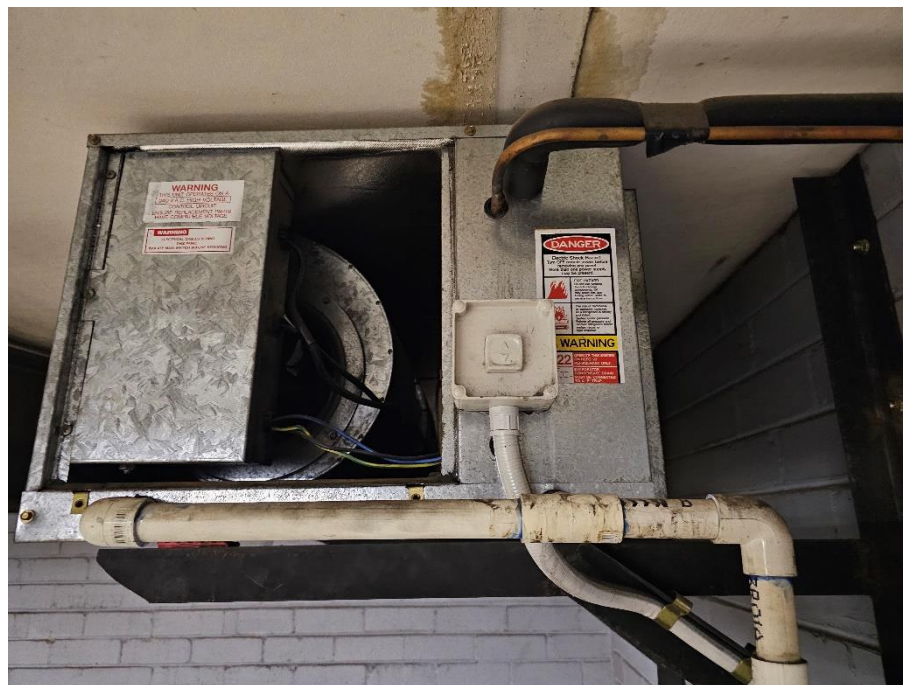
**Photo Number:** ODS1

| ITEM NUMBER | LEVEL | UNIT DESCRIPTION | REFRIGERANT NUMBER | ODS? (Y/N) | PHOTO NO. | RECOMMENDED ACTION |
|---|---|---|---|---|---|---|
| LDJ03334-ODS1 | 8 | Lift Motor Room – AC unit | R410A | Yes | ODS 1 | <b>Degas prior to disposal<br/>Maintain in good condition</b> |
