## HAZARDOUS MATERIALS SURVEY REPORT & MANAGEMENT PLAN

24 Marcus Clarke Street,  
Canberra  
ACT 2601

Survey Completion Date: 31 July 2024

Job reference: LDJ03333

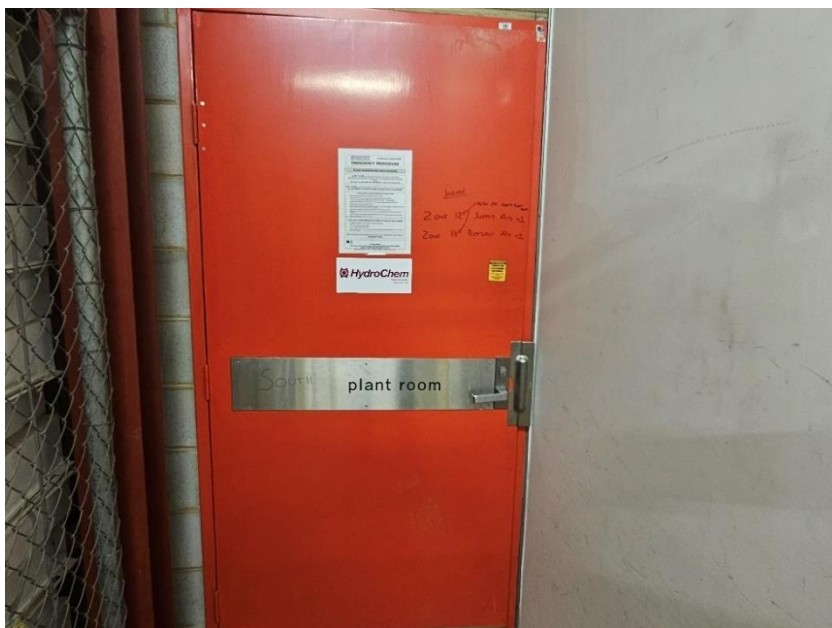
**Photo Number:** ACM1

**Location description:** Main Plantroom - Doors to North and South Plantrooms

**Material:** Fire door core

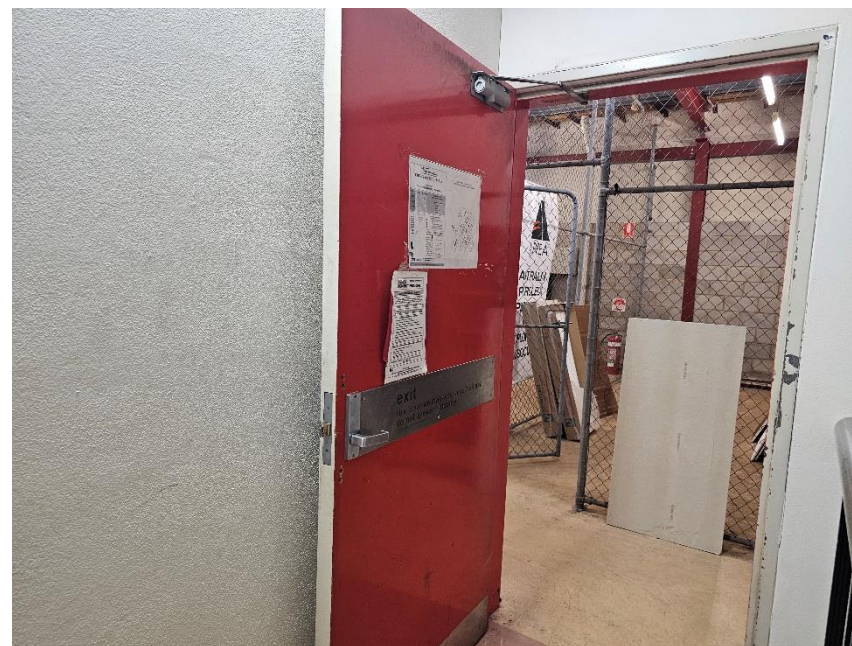
**Photo Number:** ACM2

**Material:** Fire door core

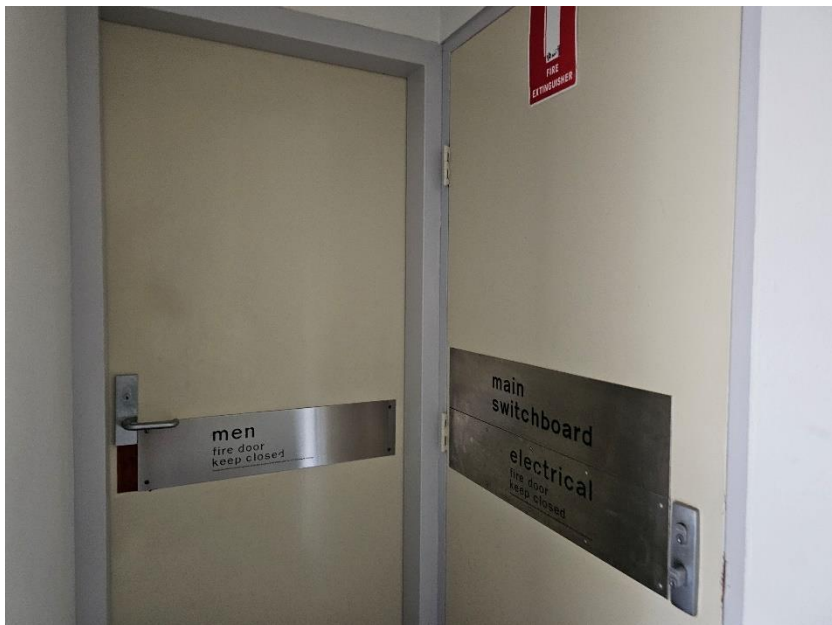
**Photo Number:** ACM3

**Location description:** Stairwell - Doors to toilets, shower and switchboard.

**Material:** Fire door core

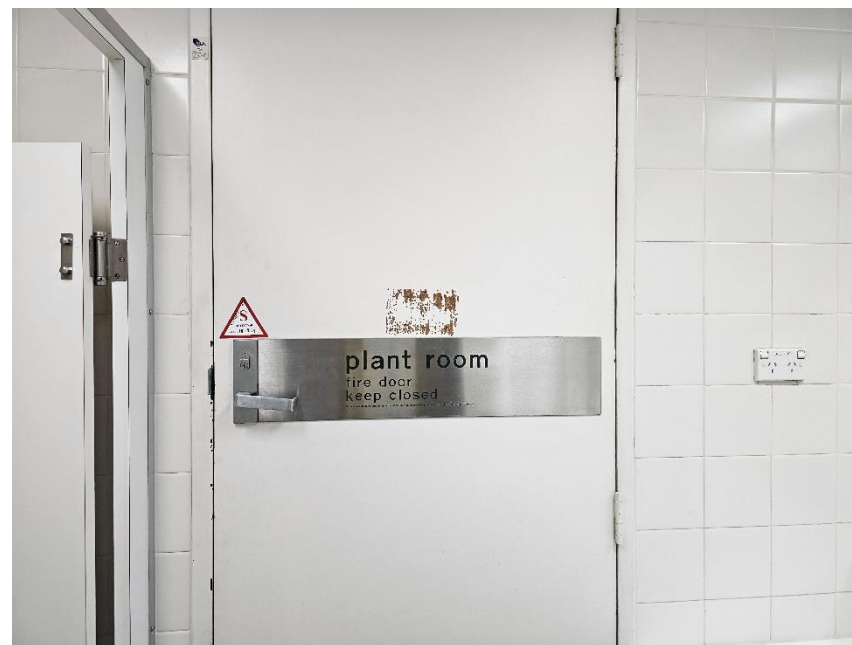
**Photo Number:** ACM4

**Material:** Fire door core

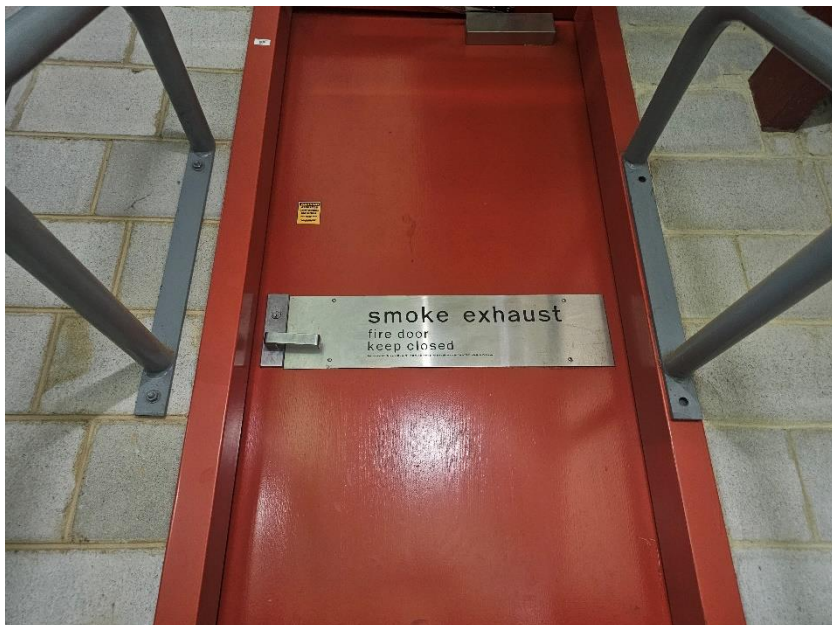
**Photo Number:** ACM5

**Location description:** South Plantroom - Door to smoke exchange

**Material:** Fire door core

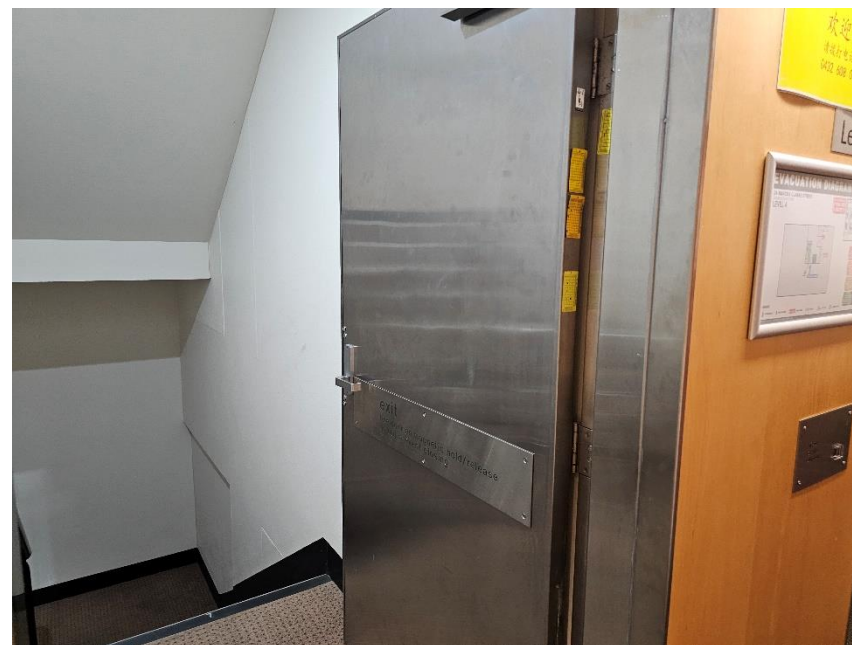
**Photo Number:** ACM6

**Material:** Fire door core

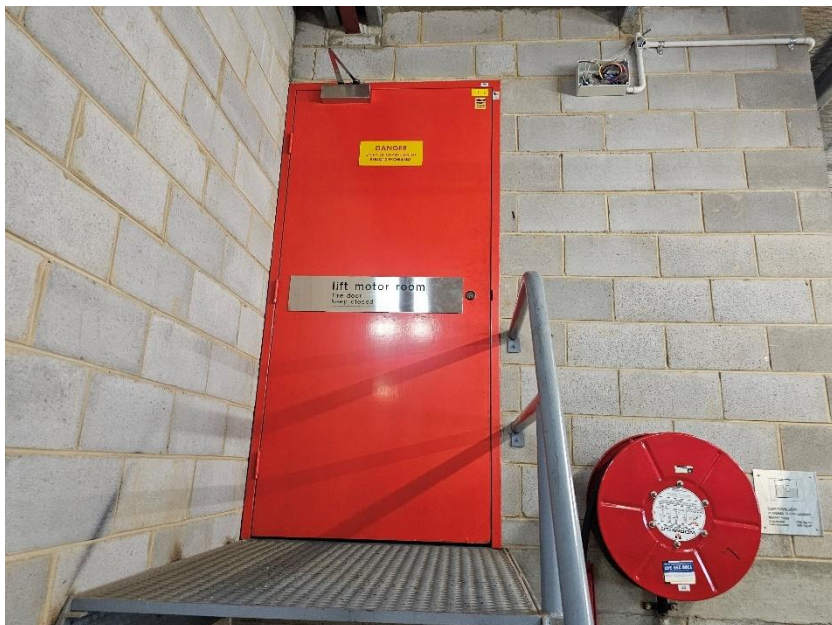
**Photo Number:** ACM7

**Location description:** Main Plantroom - Door to Lift Motor Room

**Material:** Fire door core

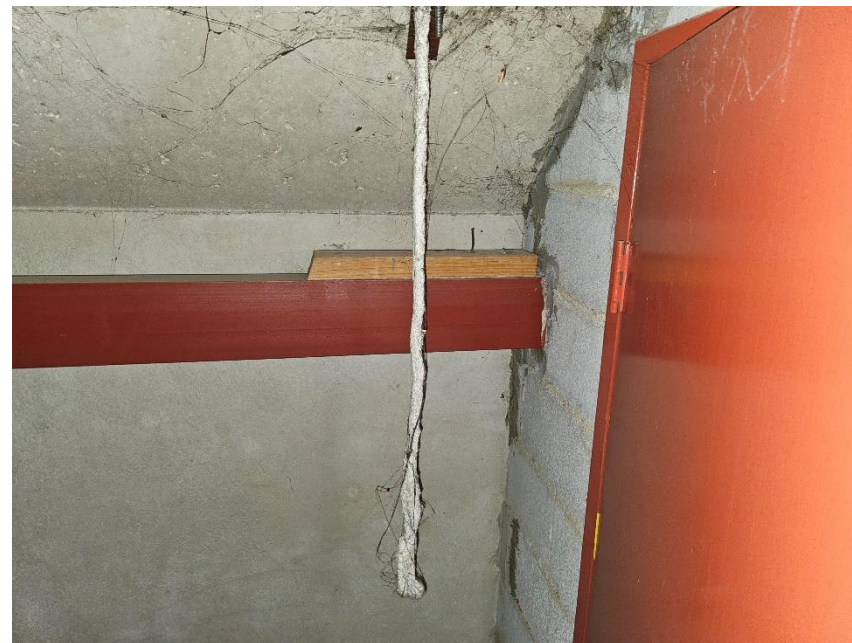
**Photo Number:** ACM8

**Material:** Rope

Friable asbestos rope material identified within the Smoke Exchange room was in poor condition at the time of assessment. The hanging asbestos material should be removed and any rope packing remaining in situ should be encapsulated to prevent further damage. Access to the smoke exchange should be restricted until these works are completed. Asbestos was also detected in rope packing to masonry walls in the Main Rooftop Plantroom and the Telecoms and Electrical Cupboards on Levels 1 to 4. This material should be encapsulated to prevent asbestos fibre release. Asbestos rope should be considered to be present in similar applications in inaccessible areas throughout the building.

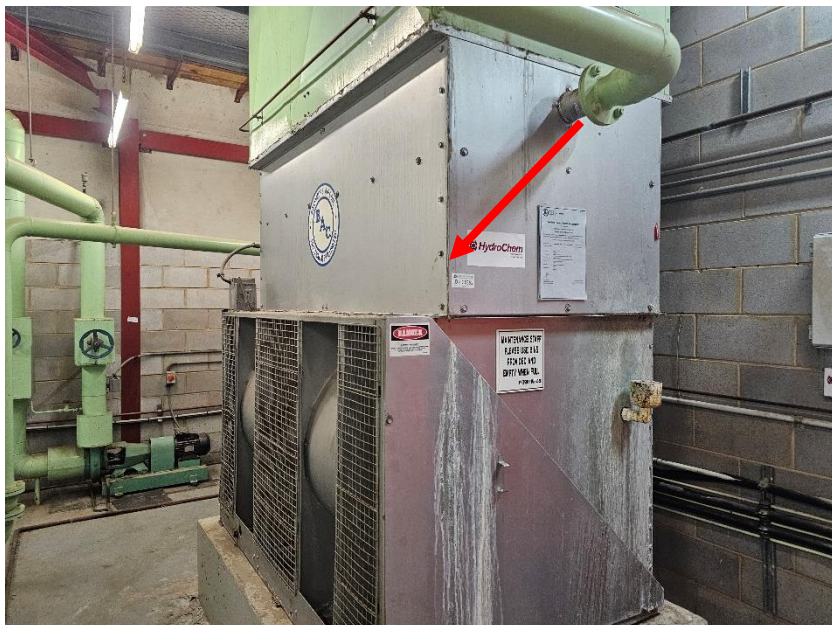
**Photo Number:** ACM9

**Location description:** South Plantroom – Sealant to joints in Baltimore Air Coil

**Material:** Mastic

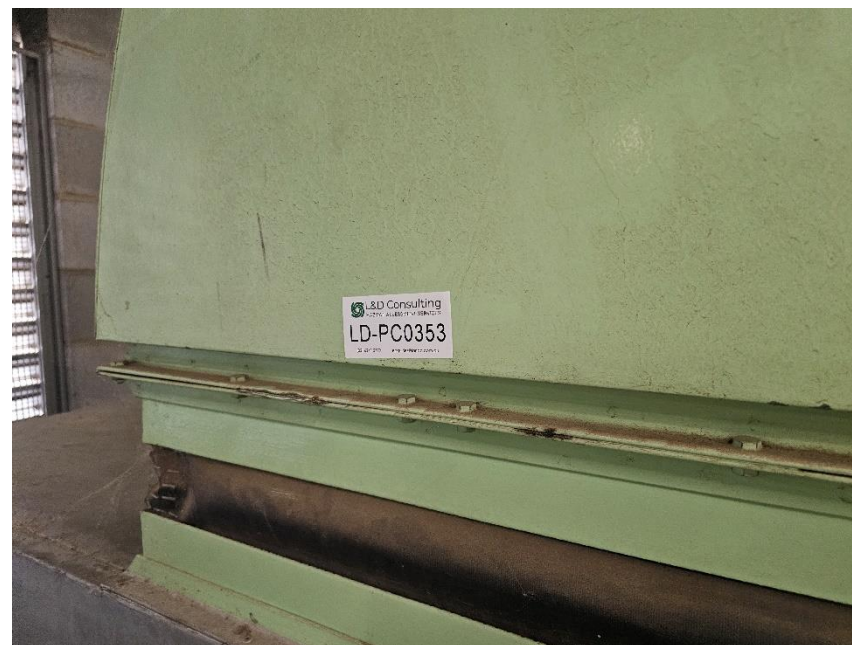
**Photo Number:** ACM10

**Material:** Mastic

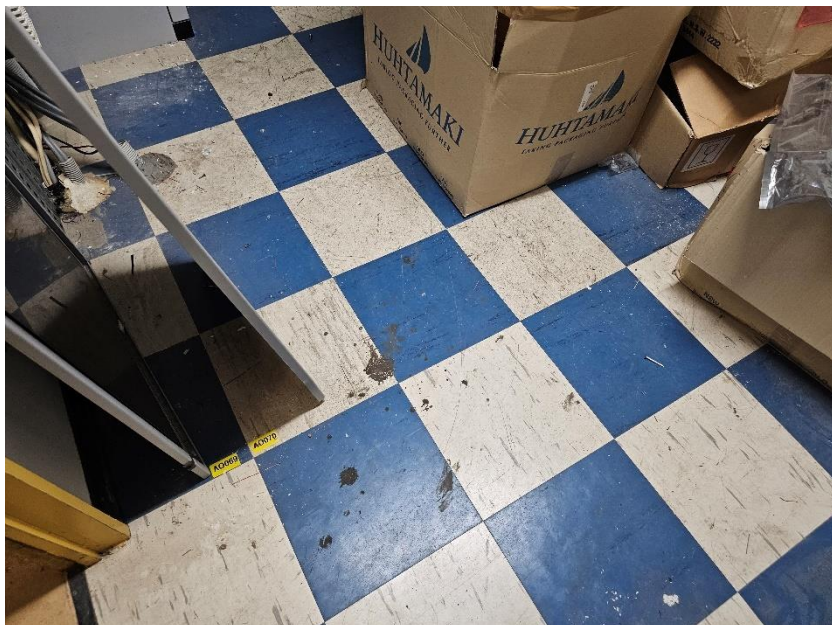
**Photo Number:** ACM11

**Location description:** Eastern Switch Room – Blue and White vinyl floor tiles

**Material:** Vinyl floor tiles

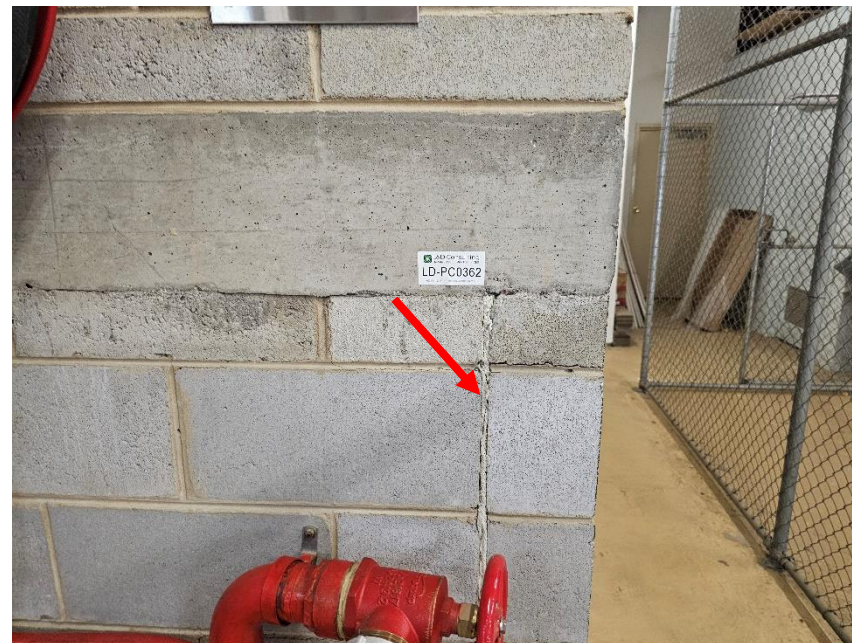
**Photo Number:** ACM12

**Material:** Rope

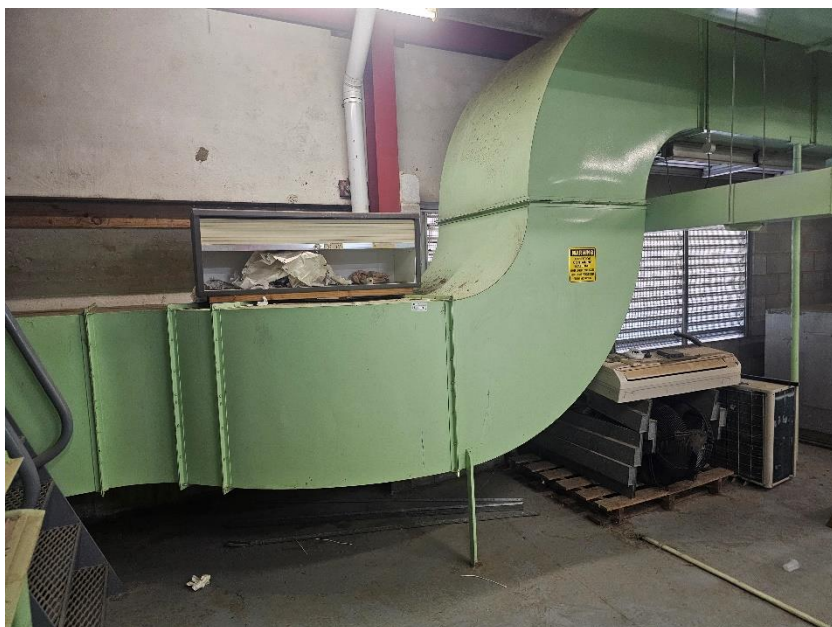
**Photo Number:** LP1

| ITEM NO | SAMPLE NO | LOCATIONS | COLOUR | LEAD CONTENT (%) | PHOTO NO. | CONDITION | COMMENTS |
|---|---|---|---|---|---|---|---|
| LDJ03333-LP1 | LD-PC0343 | Roof – South Plantroom -Ductwork | Light Green | 0.46 | LP1 | Sound | Maintain in good condition |

**Location description:** South Plantroom -Ductwork

**Paint colour:** Light Green

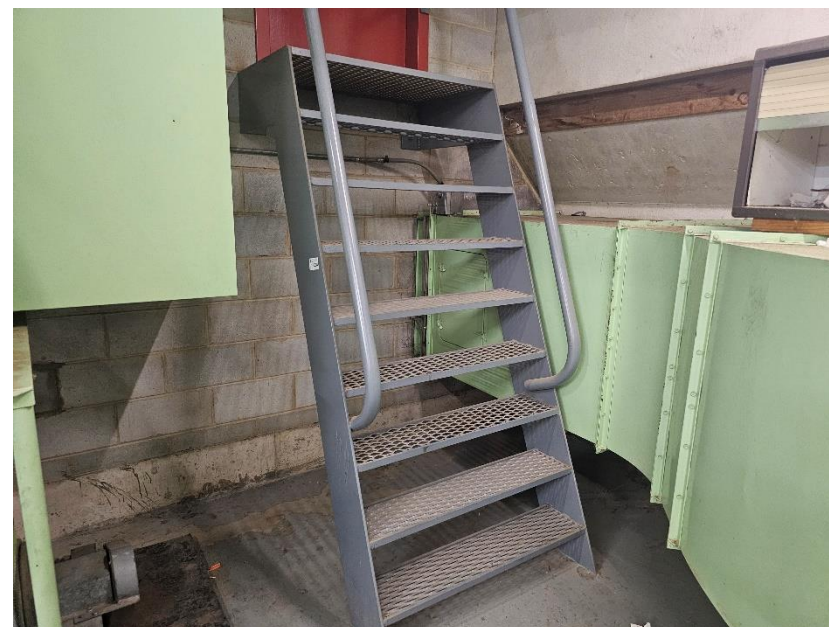
**Photo Number:** LP2

| ITEM NO | SAMPLE NO | LOCATIONS | COLOUR | LEAD CONTENT (%) | PHOTO NO. | CONDITION | COMMENTS |
|---|---|---|---|---|---|---|---|
| LDJ03333-LP2 | LD-PC0344 | Roof – South Plantroom - Stairs and handrails | Grey | 0.45 | LP2 | Sound | Maintain in good condition |

**Paint colour:** Grey

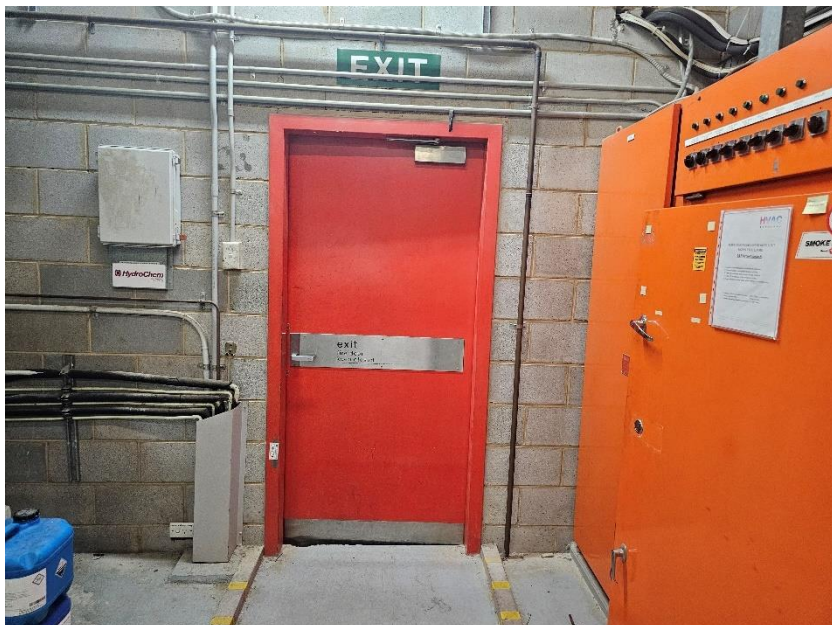
**Photo Number:** LP3

**Location description:** South Plantroom - Fire doors and frames

**Paint colour:** Red

The red paint to the South Plantroom fire door and frame, the cream paint the Luke Chiller in the South Plantroom and the grey paint the Main Plantroom door frame in the Fire stairs were all found to in poor condition with flaking and chipping present. These paints should be stabilised via overpainting with a lead-free alternative. If damage to the paint continues then the paint or the lead-painted items should be removed in order to control the potential lead exposure risk.

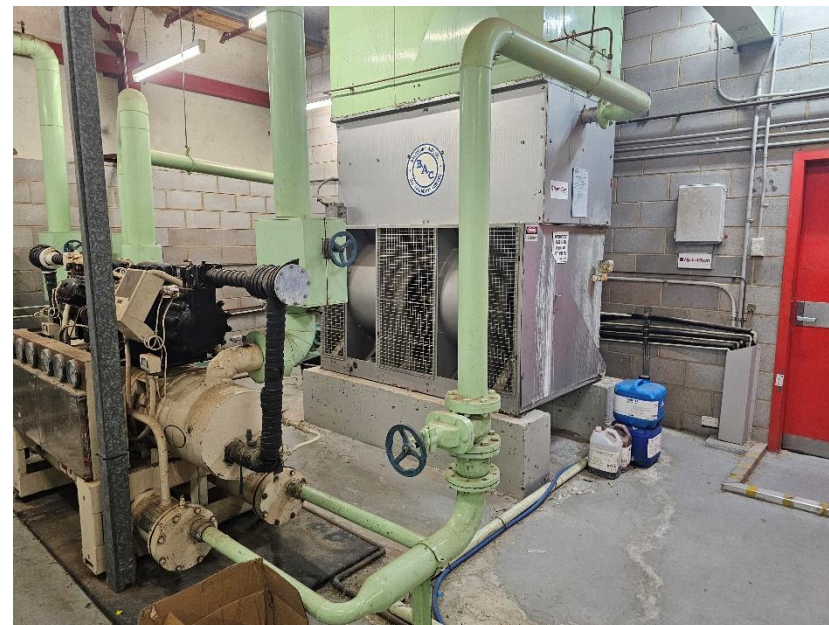
**Photo Number:** LP4

| ITEM NO | SAMPLE NO | LOCATIONS | COLOUR | LEAD CONTENT (%) | PHOTO NO. | CONDITION | COMMENTS |
|---|---|---|---|---|---|---|---|
| LDJ03333-LP4 | LD-PC0348 | Roof – South Plantroom – Pipework | Light Green | 0.30 | LP4 | Sound | Maintain in good condition |

**Paint colour:** Light green

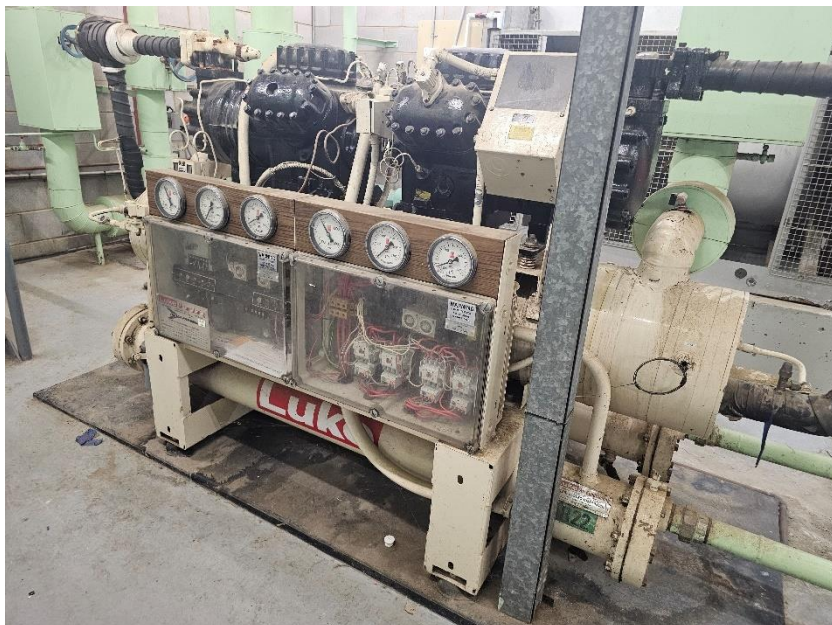
**Photo Number:** LP5

**Location description:** South Plantroom – Luke Chiller

**Paint colour:** Cream

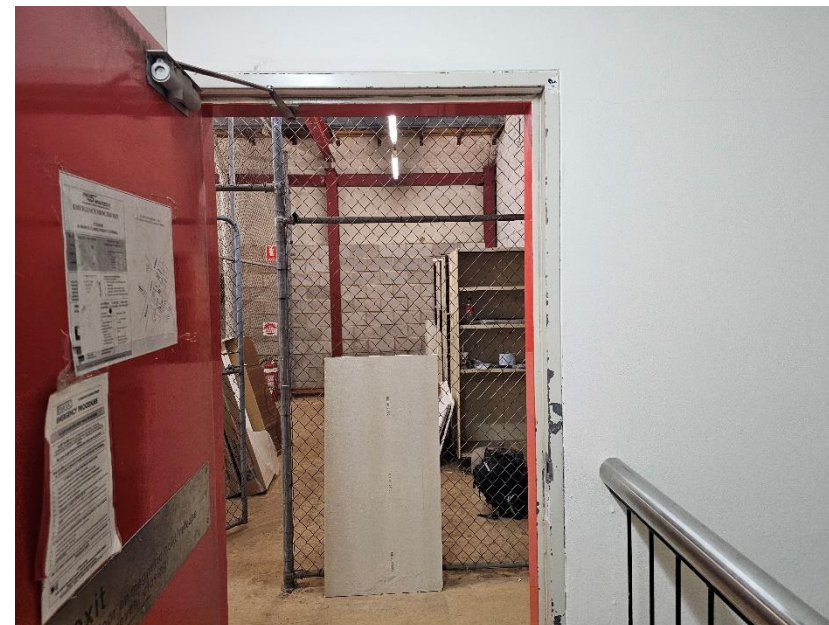
**Photo Number:** LP6

**Paint colour:** Grey

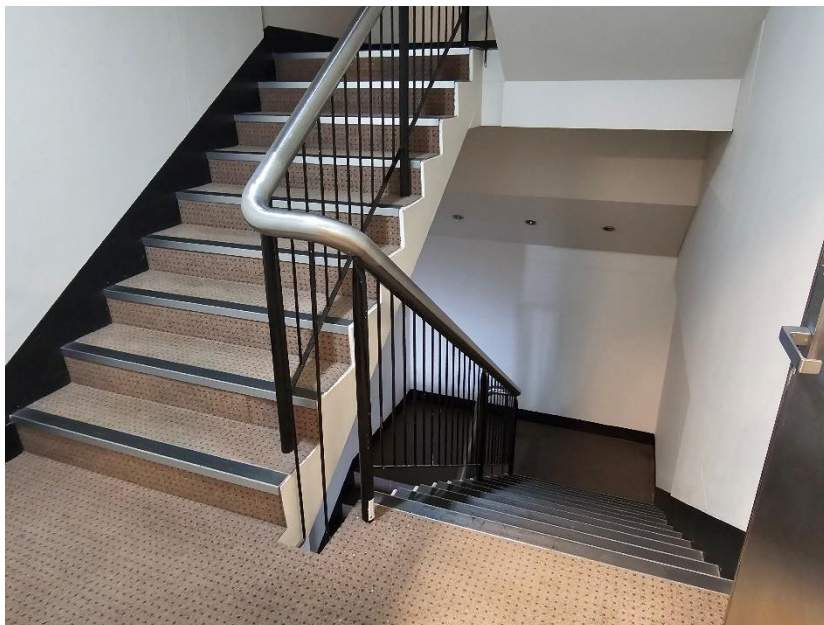
**Photo Number:** LP7

| ITEM NO | SAMPLE NO | LOCATIONS | COLOUR | LEAD CONTENT (%) | PHOTO NO. | CONDITION | COMMENTS |
|---|---|---|---|---|---|---|---|
| <b>LDJ03333-LP7</b> | <b>LD-PC0369</b> | <b>L1 to Roof – Fire Stairs - Handrail</b> | <b>Black</b> | <b>0.18</b> | <b>LP7</b> | <b>Good</b> | <b>Maintain in good condition</b> |

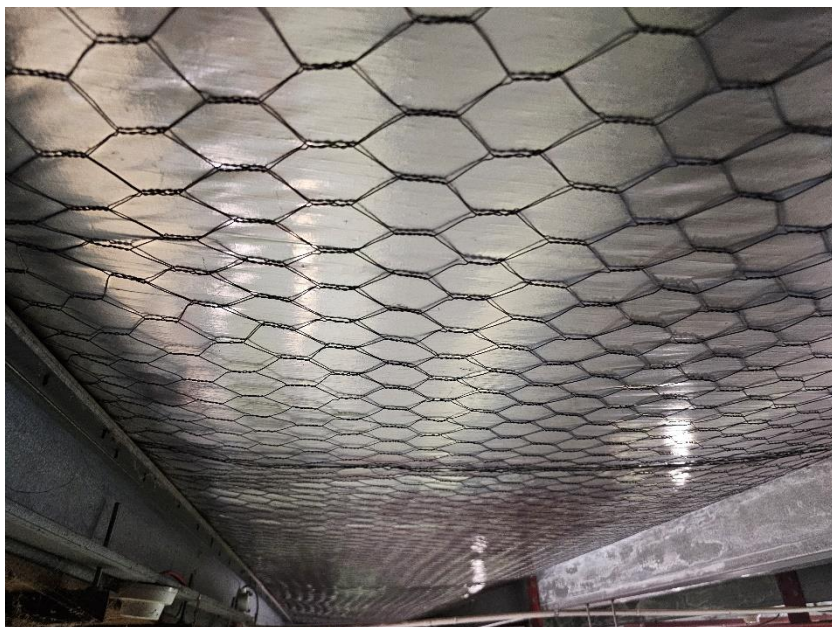
**Photo Number:** SMF1

**Location description:** Throughout – Foil backed insulation to underside of roof

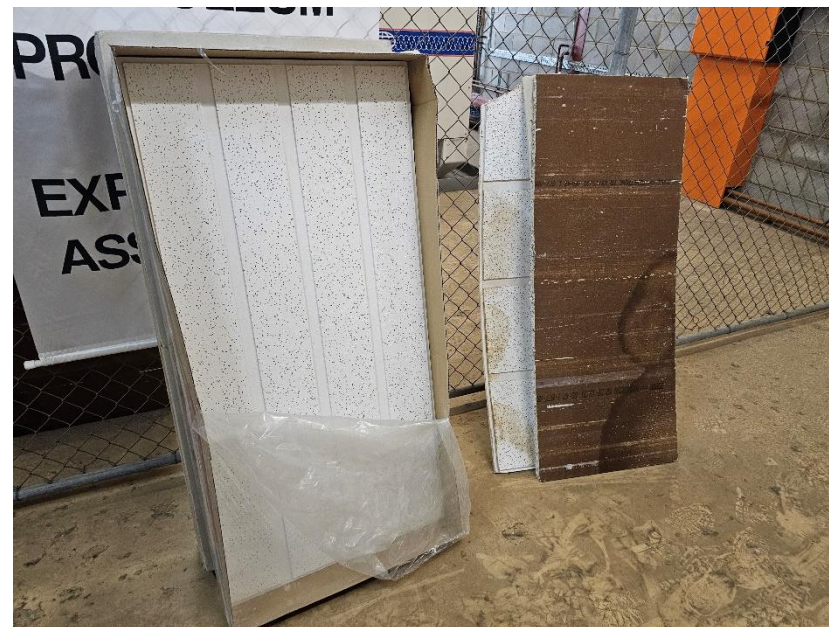
**Photo Number:** SMF2

**Location description:** Main Plant Room – Stored ceiling tiles

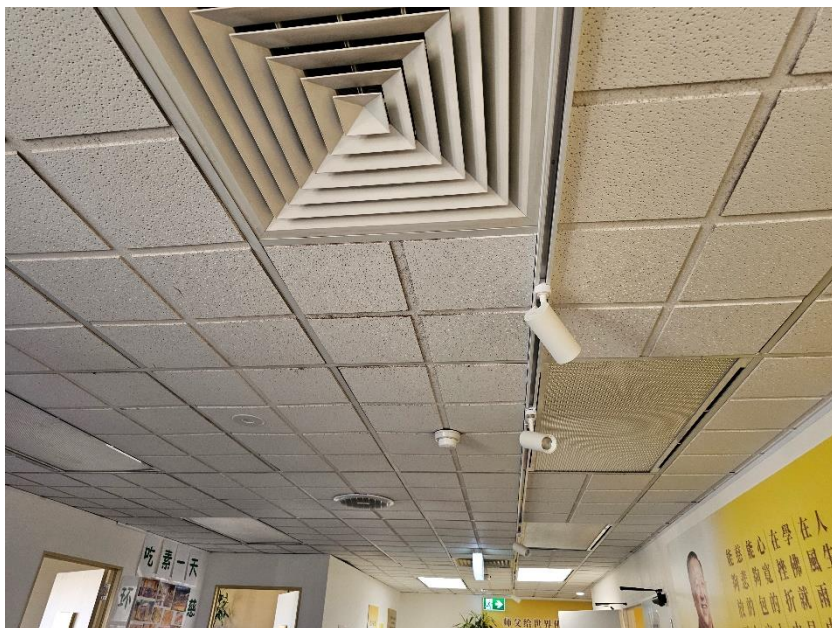
**Photo Number:** SMF3

**Location description:** Throughout – Ceiling tiles

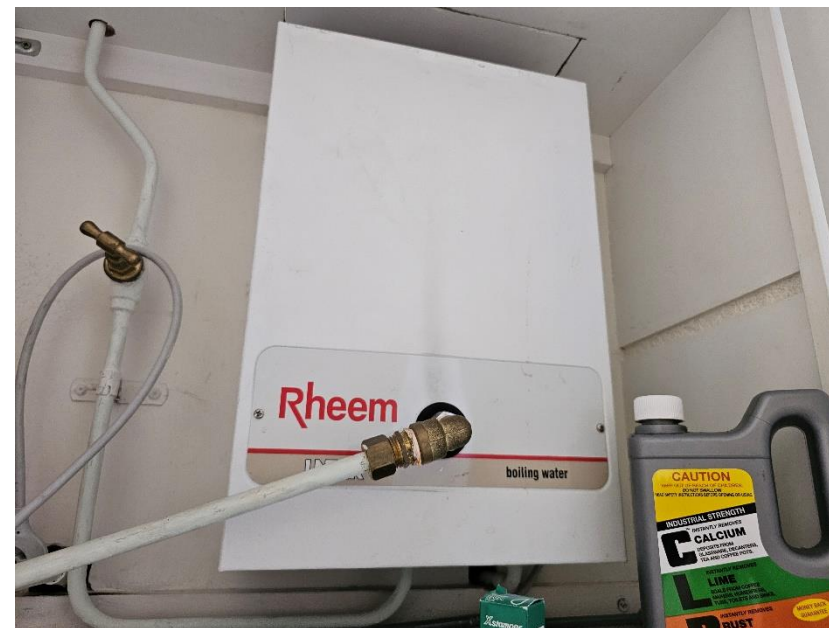
**Photo Number:** SMF4

**Location description:** Tea Room and tenancy Kitchen – Insulation to interior water boiler

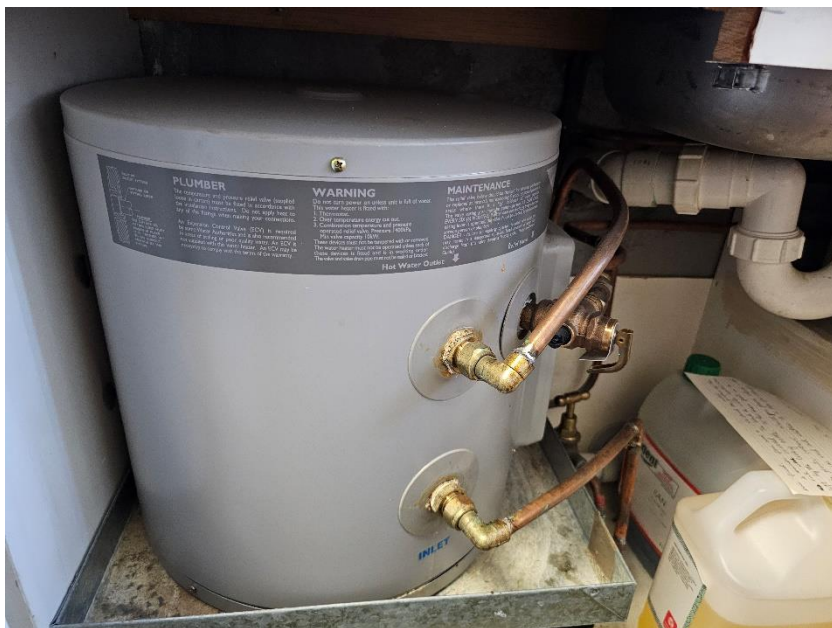
**Photo Number:** SMF5

**Location description:** Tea rooms – Insulation to interior of hot water units

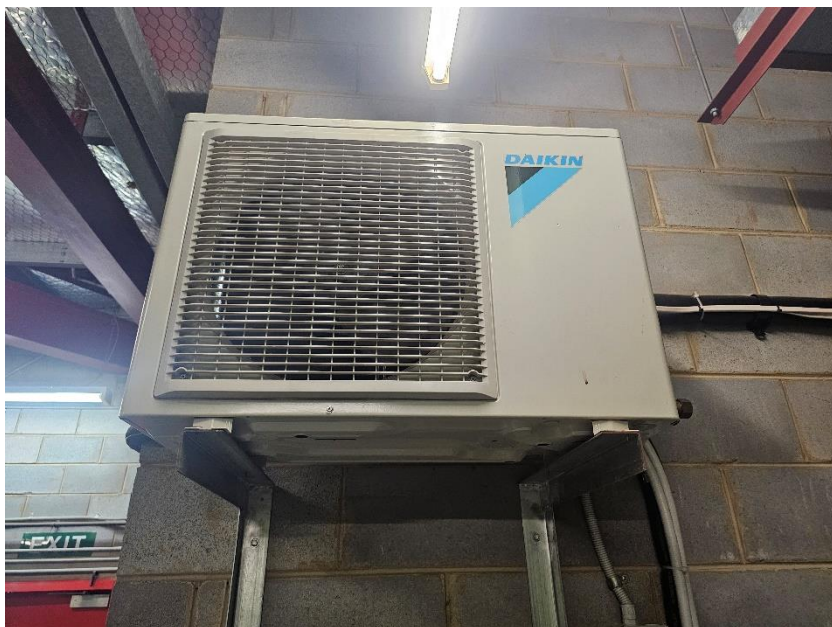
**Photo Number:** ODS1

**Location description:** South Plantroom – Daikin Air conditioner unit

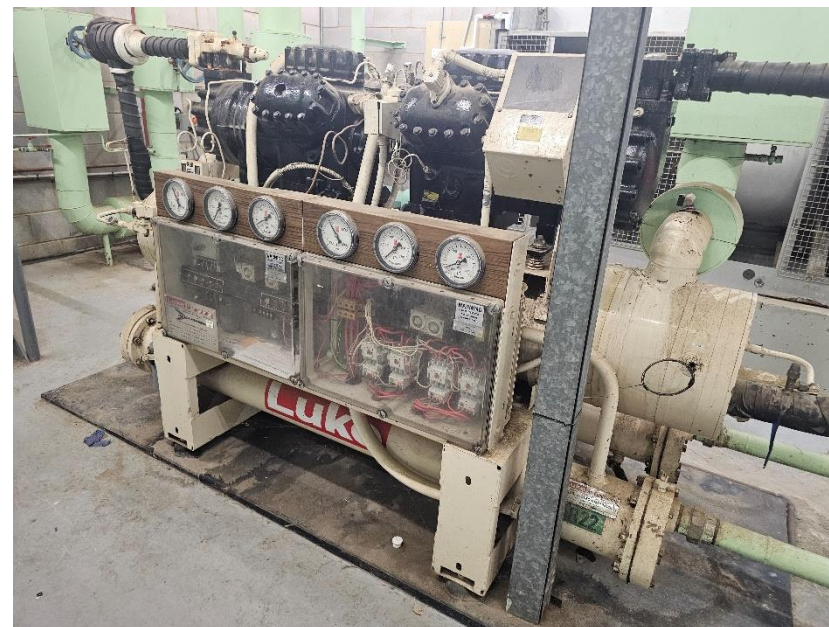
**Photo Number:** ODS2

**Location description:** South Plantroom – Luke Chiller unit

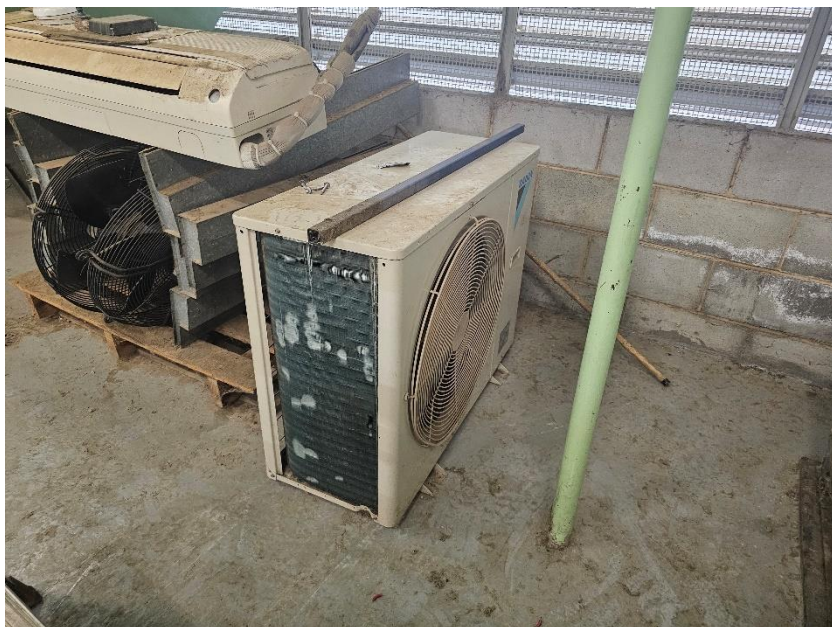
**Photo Number:** ODS3

**Location description:** South Plantroom – Redundant Daikin Air conditioner unit
