Hazardous Material Survey for the Heritage Core DA

Hazardous Materials Survey & Management Plan

Re inspection

Canberra Brickworks
Denman Street
Block 1 Section 102
Yarralumla
ACT 2600

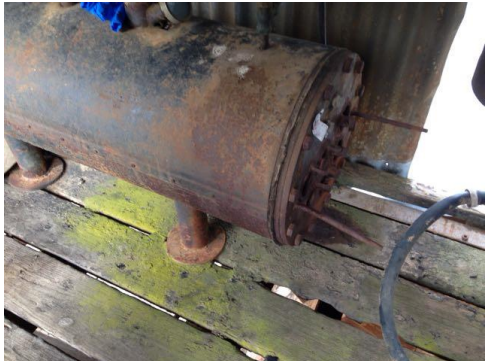
SAMPLE NO.	LOCATIONS	MATERIAL DESCRIPTION	PHOTOGRAPH
2810-40-A3	Roof space K2 walkway - heat exchange gasket	Gaskets (compressed) (Non-Friable)

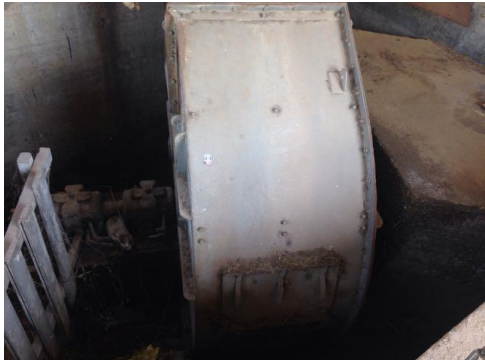
2810-40-A4	Ground floor FH2 - flange joint the ducting	Rope (Friable)

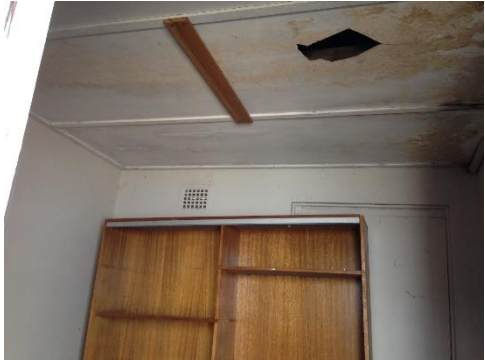
- ACM debris present in the room adjacent to the former canteen. It is recommended that the ACM be removed by a licensed Asbestos Removalist as soon as possible. Access should be restricted until a clearance certificate is given by an Asbestos Assessor.

RA 2810-40-A5	Ground floor small room adjacent former canteen - ceiling sheet & debris on floor	Sheet (Non-Friable)

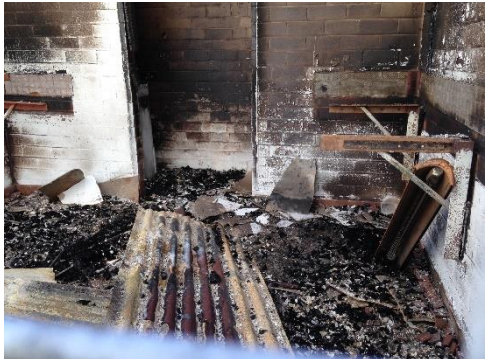
- The former canteen was found in a fire damaged condition with building debris including ACM ceiling sheet identified in the previous report found amongst the building rubble. It is recommended that access to the area be restricted and all fire related debris be removed as ACM.

2810-40-A5	Ground floor former canteen - fire damaged ceiling sheet	Debris (Non-Friable)

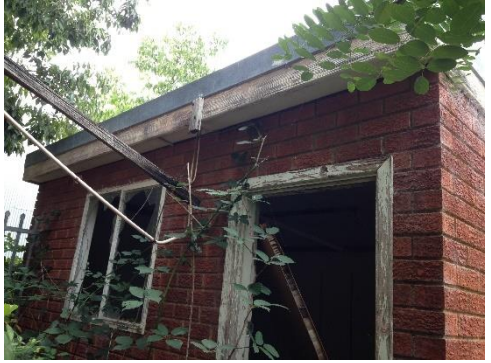
SAMPLE NO.	LOCATIONS	MATERIAL DESCRIPTION	PHOTOGRAPH
RA 2810-40-A9	Ground floor small building adjacent A4 - ceiling and narrow eave soffits surround buildings	Sheet (Non-Friable)

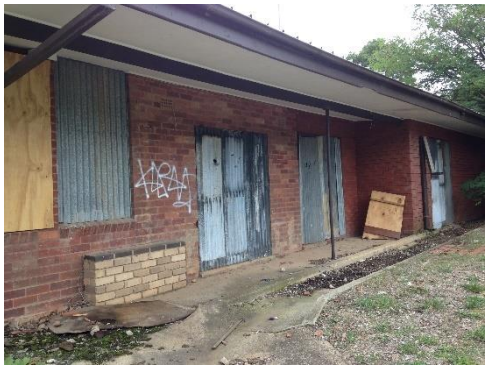
2810-40-A9	Ground floor A4 - perimeter eave and eave soffits	No Access to Sheet (Non-Friable)

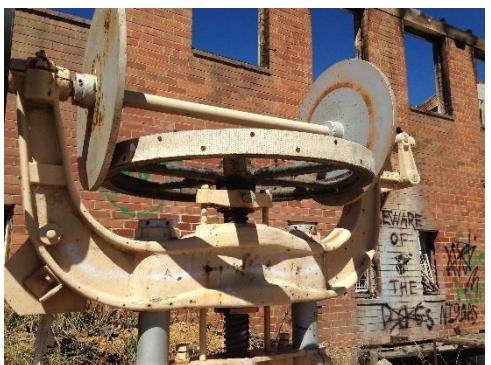
3617-103-A1	Ground floor open courtyard between K1 & K2 - old brick making machine	Rope (Non-Friable)

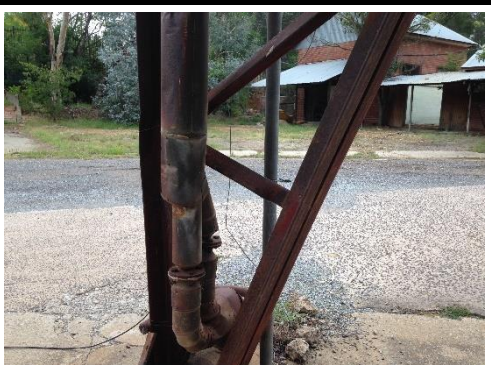
3617-103-A4	Ground floor front corner B block main kilns - gaskets adjacent downpipes	Gaskets (compressed) (Non-Friable)

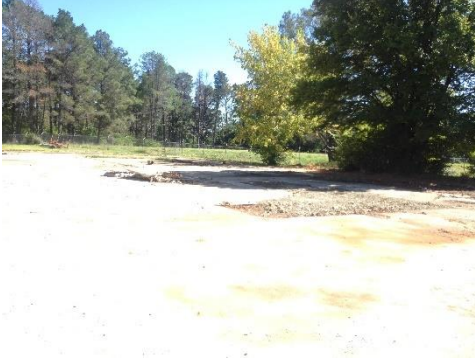
SAMPLE NO.	LOCATIONS	MATERIAL DESCRIPTION	PHOTOGRAPH
3617-103-A7	Ground floor FH2 and various areas - fragments in the soil	Debris (Non-Friable)

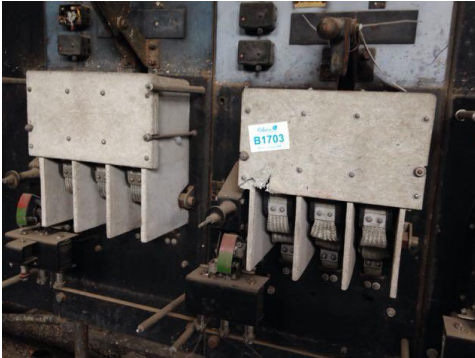
- ACM casing for earthing tapes was found throughout different areas of the site and particularly in the Electrical Switchboard Control room. It is recommended that access be restricted and the ACM removed as soon as practicable.

B1703	Ground floor Electrical control board building and throughout site - casing for earthing tapes	Sheet (Non-Friable)

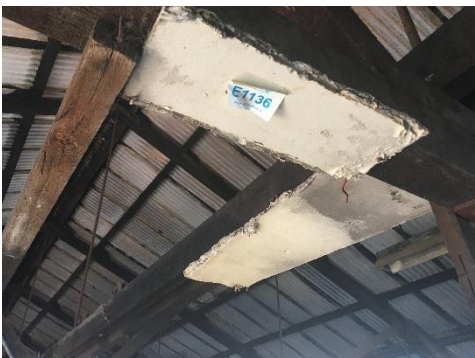
- Asbestos millboard and sheet debris is still present throughout the roof space of K3. All were found to be in an extremely poor condition and therefore access to this area must be prohibited until the area has been completely remediated and a clearance certificate has been issued.

E1136	Ground floor K3 ceiling space - above kiln	Millboard (Friable)

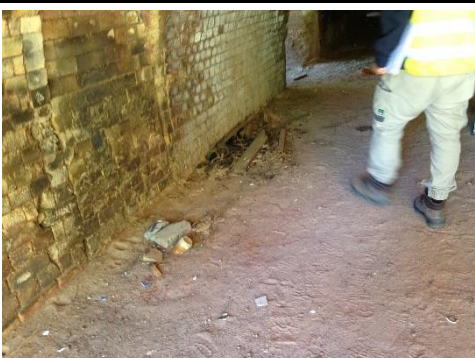
E1137	Ground floor K3 to soil - fragments	Debris (Friable)

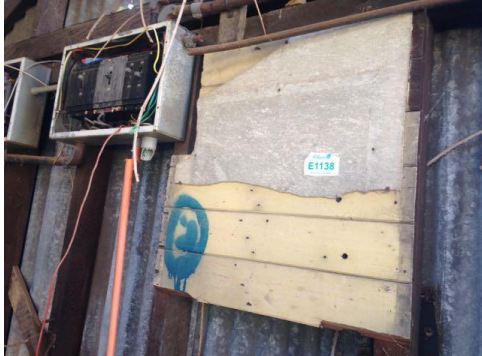
SAMPLE NO.	LOCATIONS	MATERIAL DESCRIPTION	PHOTOGRAPH
E1138	Ground floor FH1 - on wall adjacent switchboard	Sheet (Non-Friable)

- Access within FH1 should be restricted until the damaged asbestos sheet fixed to the wall has been removed.
- The asbestos ceiling sheets in SS3 should be sealed with paint where exposed surfaces are visible.

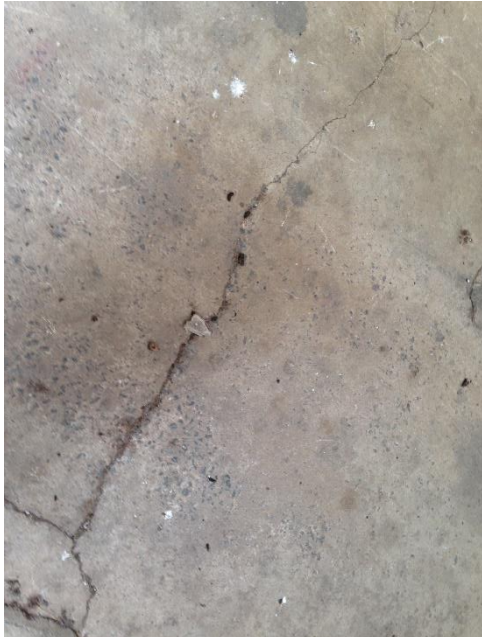
E1141	Ground floor former wood store adjacent main kilns - fragments	Debris (Non-Friable)

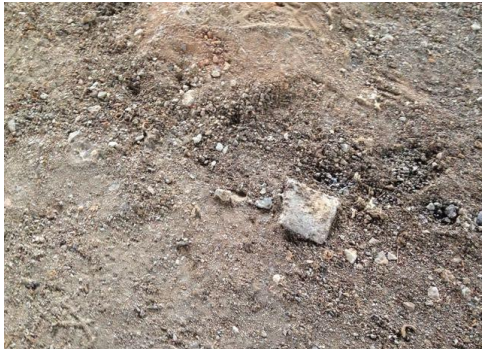
M0100	K2 top floor - debris post removal	Millboard (Friable)

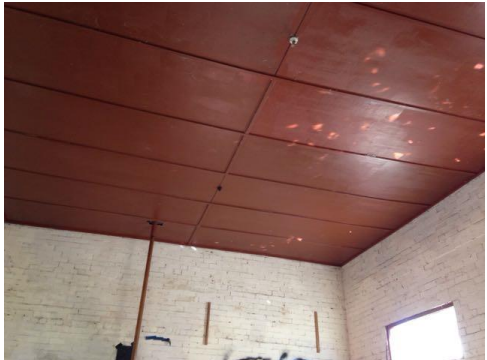
SAMPLE NO.	LOCATIONS	MATERIAL DESCRIPTION	PHOTOGRAPH
RA M0101	Ground floor BH - ceilings	Sheet (Non-Friable)

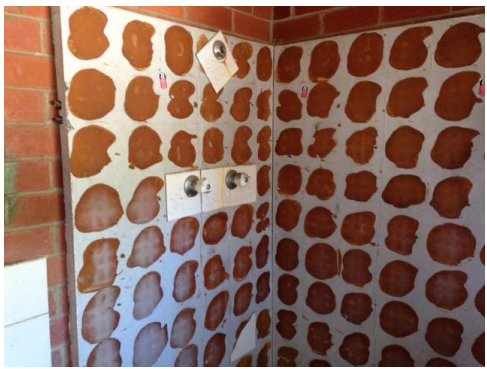
RA M0101	Ground floor SS4 - lining to previous shower area	Sheet (Non-Friable)

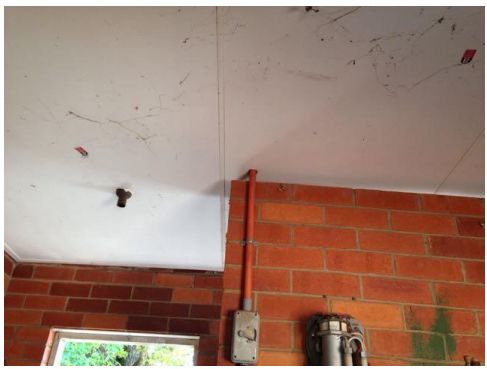
RA M0101	Ground floor SS4 - ceiling	Sheet (Non-Friable)

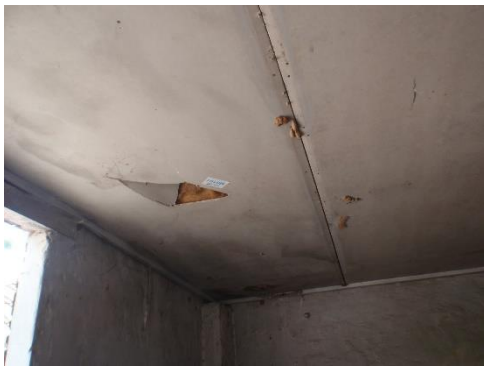
M0101	Ground floor SS3 - ceilings	Sheet (Non-Friable)

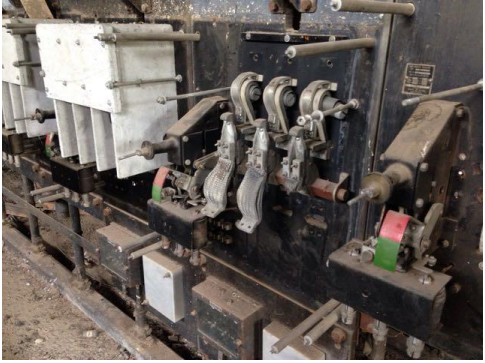
SAMPLE NO.	LOCATIONS	MATERIAL DESCRIPTION	PHOTOGRAPH
Y2048	Ground floor Electrical control board building - switchboard backing sheet	Bituminous product (Non-Friable)

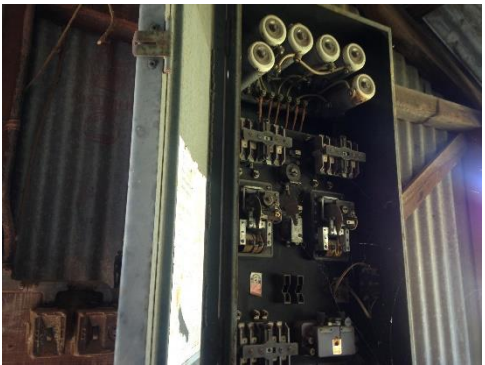
RA Y2048	In all buildings on site - electrical switchboard backing (throughout building)	Sheet (Non-Friable)

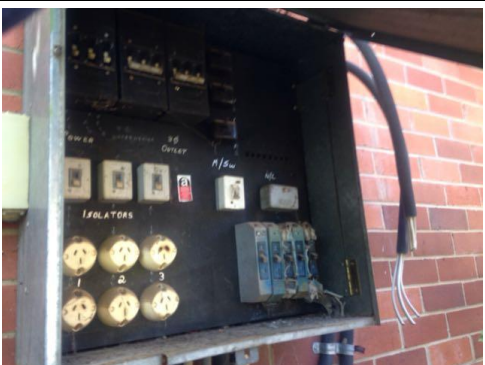
RA Y2048	Ground floor SS4 - electric switchboard backing	Sheet (Non-Friable)

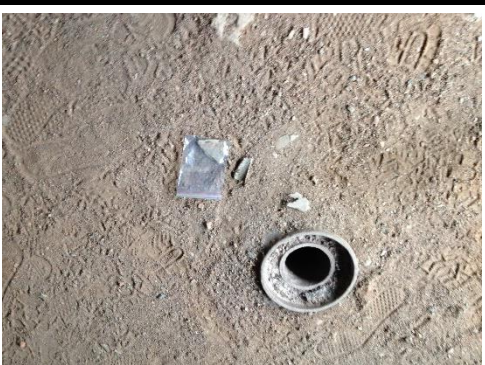
Y2050	K1 roof space - fragments on south side	Sheet debris (Non-Friable)

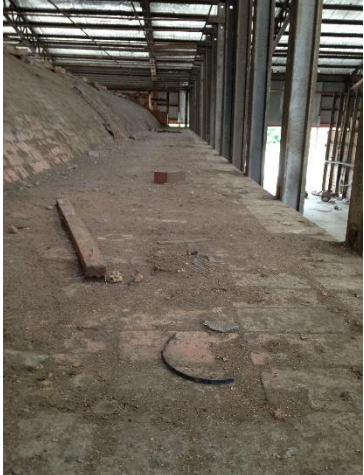
- Corrugated moulded ACM sheet debris was found on the ground within the B Building wood store area and on top of three main kilns. Based on previous reports noting that corrugated moulded ACM roof sheet was removed from this building and discussions with staff on site who reported the material, it is likely to be debris remaining from the old roof. Any further debris found should be removed, and an environmental clean undertaken in the vicinity.

SAMPLE NO.	LOCATIONS	MATERIAL DESCRIPTION	PHOTOGRAPH
RA Y2050	K1 on top of three main kilns - fragments of corrugated sheets	Sheet debris (Non-Friable)

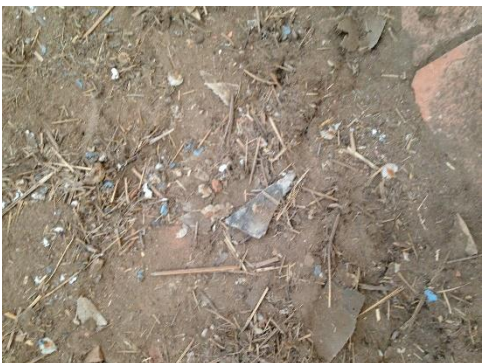
RA Y2050	Ground floor K1 - fragments	Sheet debris (Non-Friable)

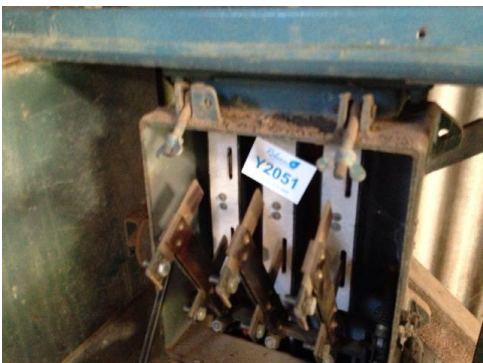
Y2051	Ground floor F south end - casing for earthing tape	Sheet (Non-Friable)

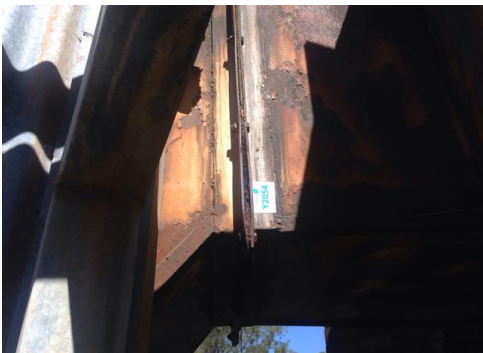
Y2054	Ground floor FH1 - flange joint the ducting	Rope (Friable)

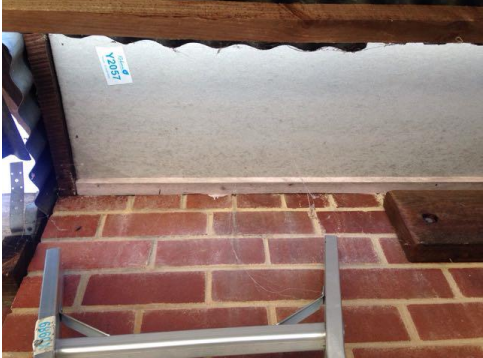
SAMPLE NO.	LOCATIONS	MATERIAL DESCRIPTION	PHOTOGRAPH
Y2057	Ground floor SS1 & SS2 - eave soffits	Sheet (Non-Friable)

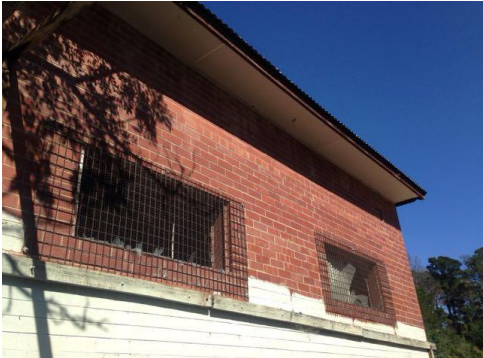
RA Y2057	Ground floor BH - eave soffits	Sheet (Non-Friable)

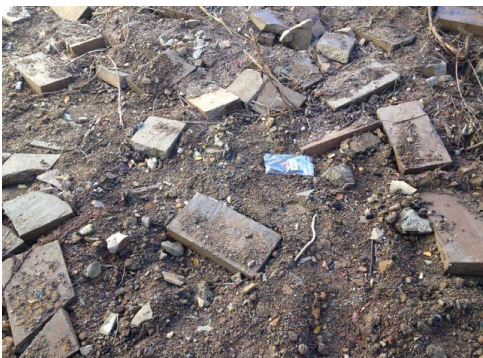
- A large amount of asbestos sheet debris was sighted in the area between BH and SS1 and in front of BH. It emerged from depth as a result of the soil disturbance during or after the field assessment which found buried ACM sheet on site. It is recommended that the debris be removed as soon as possible or be covered with soil until all ACM sheet is removed from the area.

Y2058	Ground floor between BH & SS1 - sheet fragments	Debris (Non-Friable)

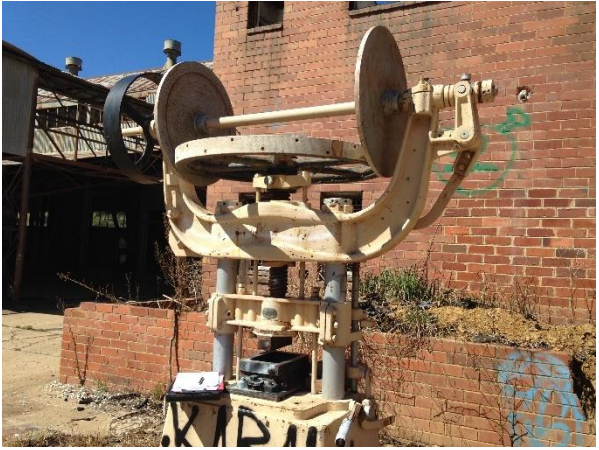
LEAD PAINT - Canberra Brickworks			
ITEM NO.	LOCATION	Lead %	PHOTOGRAPH
PB2673	Ground floor main internal yard - brick maker machine	1.3

- Lead paint were detected on the red door frame in BH and cream paint on the old brick maker machine. It is recommended that lead paint be maintained until demolition of the building. Appropriate dust control measure must apply during demolition.
- It should be assumed that all similar paint applications throughout the building would contain similar percentages of lead.
- Refer to Appendix D for further general information on lead paint.

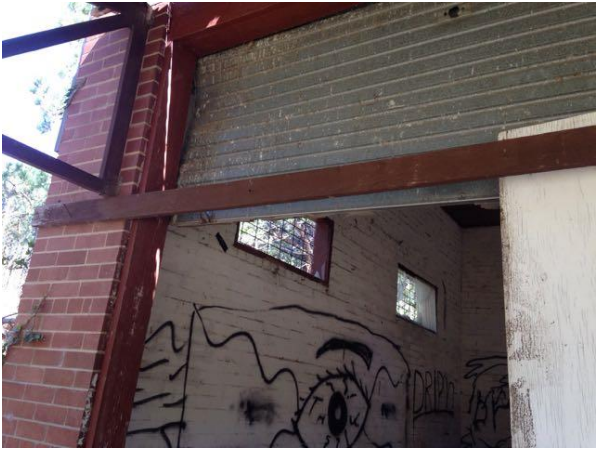
PB2675	Ground floor BH - door frame	0.17

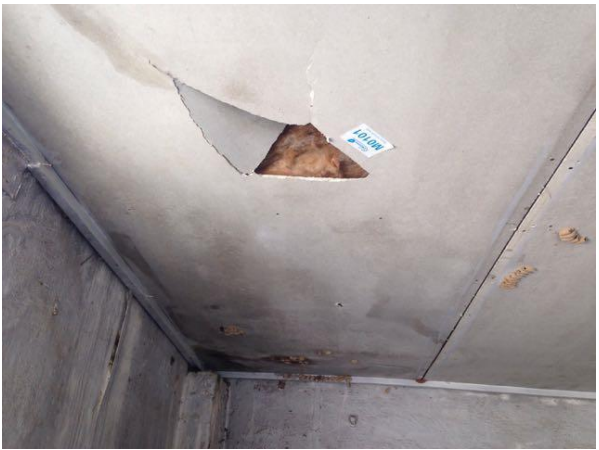
SMF - Canberra Brickworks			
ITEM NO.	LOCATION	MATERIAL TYPE	PHOTOGRAPH
SMF2229	Ground floor ceiling space throughout site	Batts

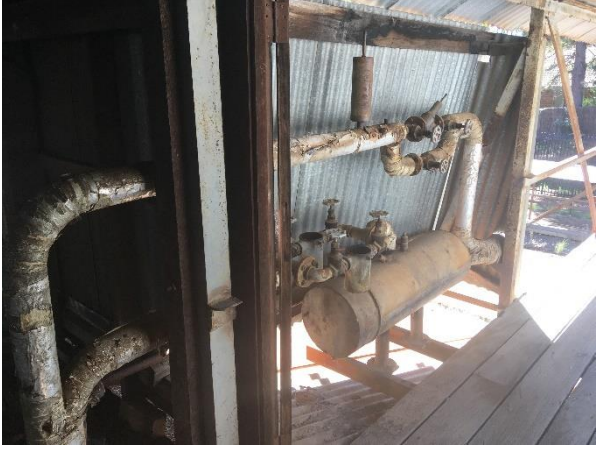
SMF2228	Ground floor pipes throughout site	Insulation

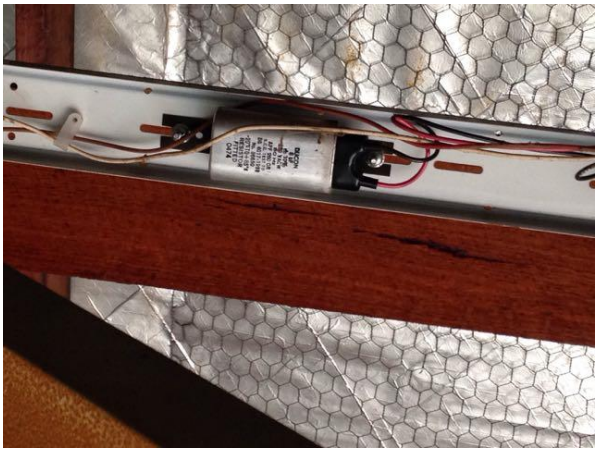
POLYCHLORINATED BIPHENYLS - Canberra Brickworks			
ITEM NO.	LOCATION	MATERIAL TYPE	PHOTOGRAPH
PCB818	Ground floor R1	Ducon metal – APF 260CR 6µF

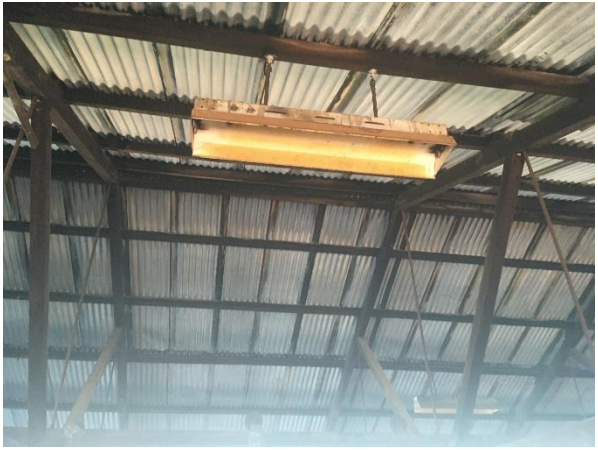
PCB819	Ground floor K1 ceiling space	Presumed
