ASBESTOS CLEARANCE CERTIFICATION

SITE OF CERTIFICATION: 23 Dumaresq Street, Dickson ACT

TIME OF CERTIFICATION: 12:15 PM, 13 October 2021

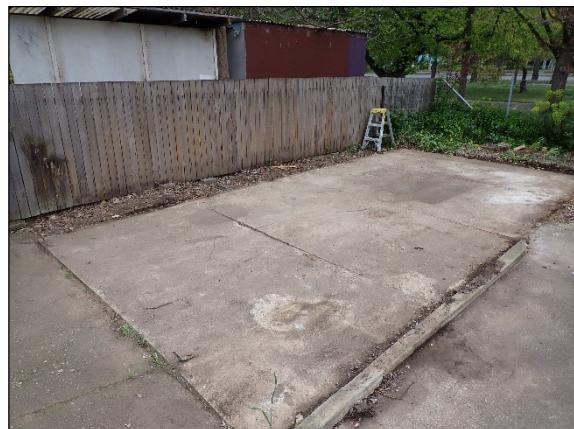
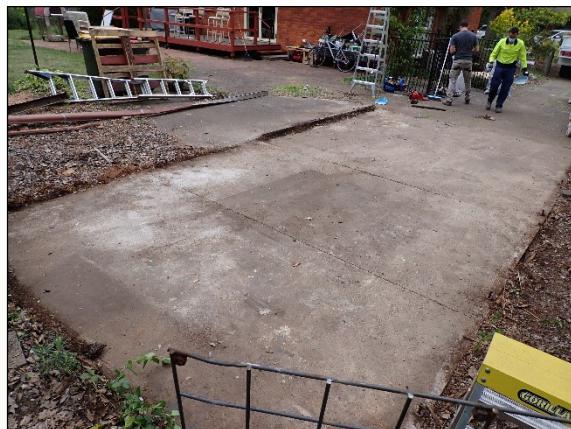
As shown below, the works involved removal of all asbestos cement roof & wall sheeting from the garage prior to its demolition.

As required under the ACT *Work Health and Safety Regulation 2011*¹ and in accordance with the ACT-approved *How to Safely Remove Asbestos Code of Practice*², visual inspection of the removal area following the removal works showed no evidence of asbestos-containing dust or debris in or around the area.
