Assessment of the Stability of the Batter Faces of the  
Former Quarry

Our ref: JM/C11596.2 v2

**CANBERRA BRICKWORKS REDEVELOPMENT - BLOCKS 1, 7, & 20, SECTION 102, YARRALUMLA  
PROPOSED DWELLINGS - LOTS a to q**

**ASSESSMENT OF THE STABILITY OF THE BATTER FACES OF THE FORMER QUARRY**

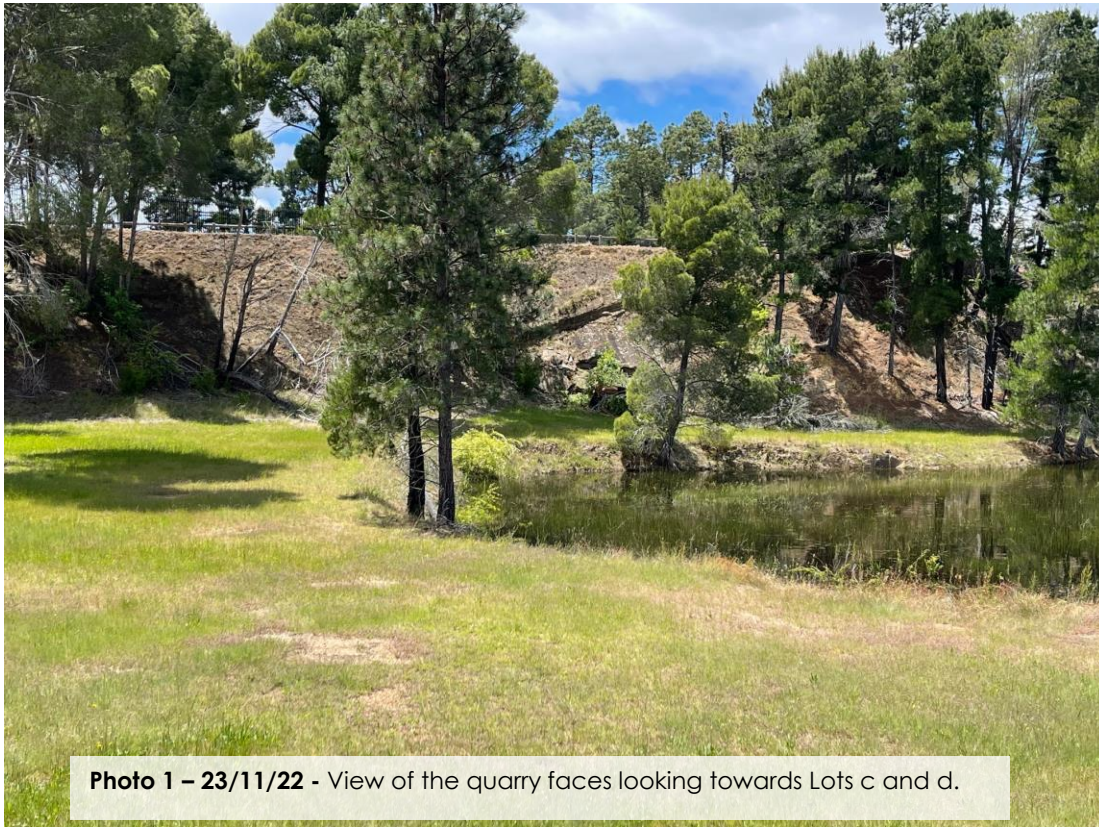
Lot c	~4m high cut	HW/MW PHYLLITE	Foliation - 50°/190° ~500mm spacing	Photo 1

**Photo 1 – 23/11/22** - View of the quarry faces looking towards Lots c and d.

It is recommended that the set backs are increased for any pools or dwellings that are not set back from the top edge of the batter at least by the same distance as the depth of the cut batter at that location. This recommendation applies to Lots k to n, and Lots c to e.

Where pools or dwellings cannot be set back, then these structures must be founded on deep bored piers that are socketed into the weathered bedrock. The depth of pier socket into the bedrock will depend on the set back to the top edge of the cut batter and the depth of the cut at that location.

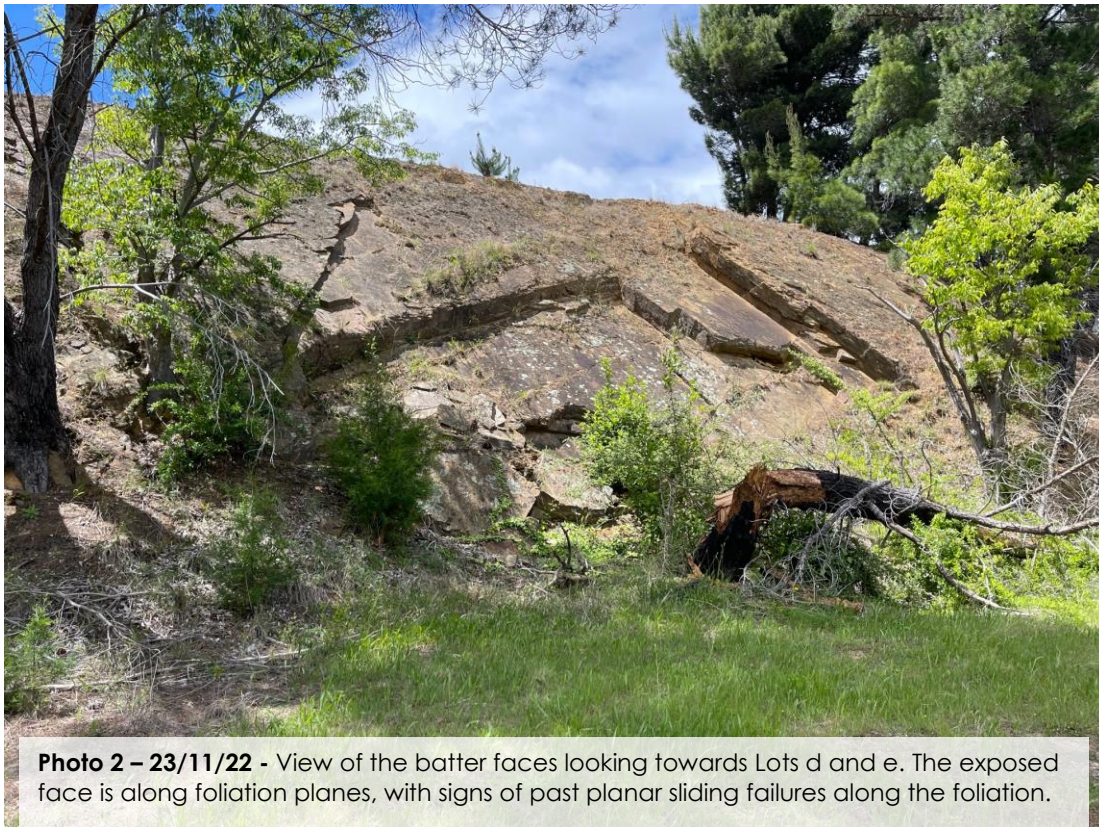
Lot j	~4m high cut	Residual soil & EW, underlain by HW/MW PHYLLITE	Disturbed and weathered face. Several large boulders on face (from quarrying or wedge failures) and signs of erosion.	Photo 4 & 5
Lot i	~4m high cut	Residual soil & EW, underlain by HW/MW PHYLLITE	Disturbed and weathered face. Several large boulders on face (from quarrying or wedge failures) and signs of erosion.	Photo 3 & 5
Lot h	~4m high cut	Residual soil & EW, underlain by HW/MW PHYLLITE	Disturbed and weathered face. Several large boulders on face (from quarrying or wedge failures) and signs of erosion.	Photo 5
Lot g	NA	NA	Dwelling set well back from the top edge of the existing quarry faces	
Lot f	NA	NA	Dwelling set well back from the top edge of the existing quarry faces	
Lot e	~4m high cut	HW/MW PHYLLITE	Foliation - 50°/185° ~500mm spacing	Photo 2
Lot d	~4m high cut	HW/MW PHYLLITE	Foliation - 50°/180° ~500mm spacing	Photo 2

**Photo 2 – 23/11/22** - View of the batter faces looking towards Lots d and e. The exposed face is along foliation planes, with signs of past planar sliding failures along the foliation.

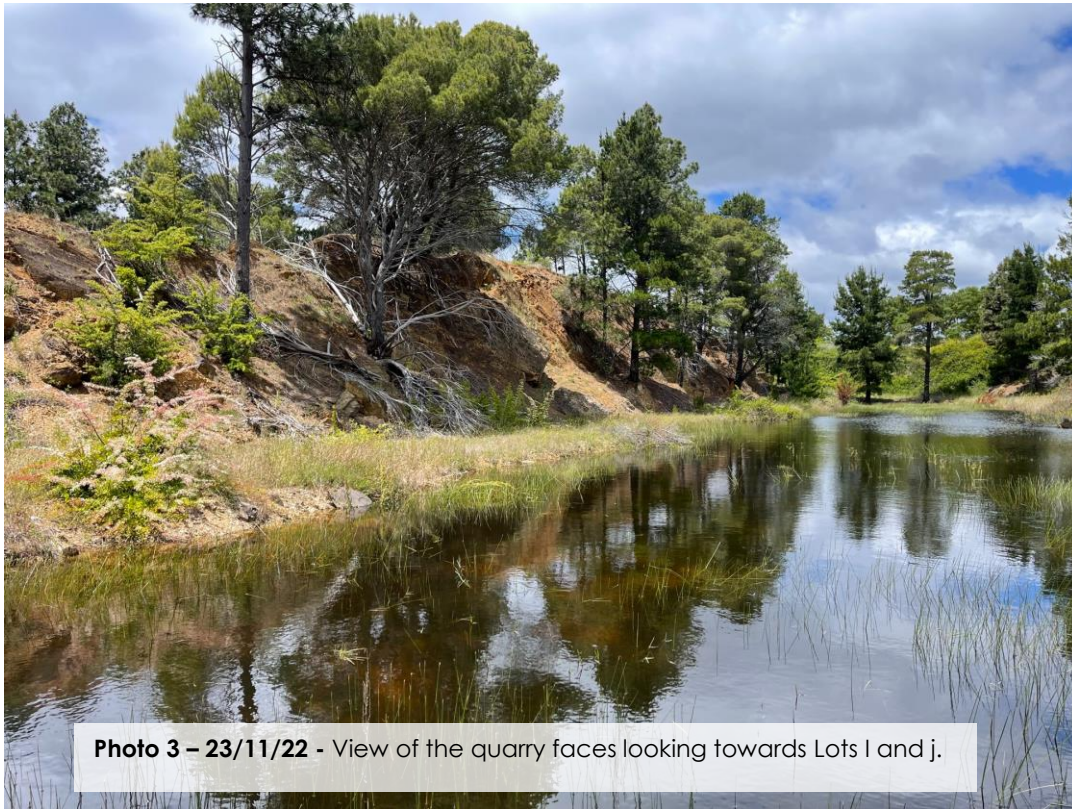
**Photo 3 – 23/11/22** - View of the quarry faces looking towards Lots I and j.

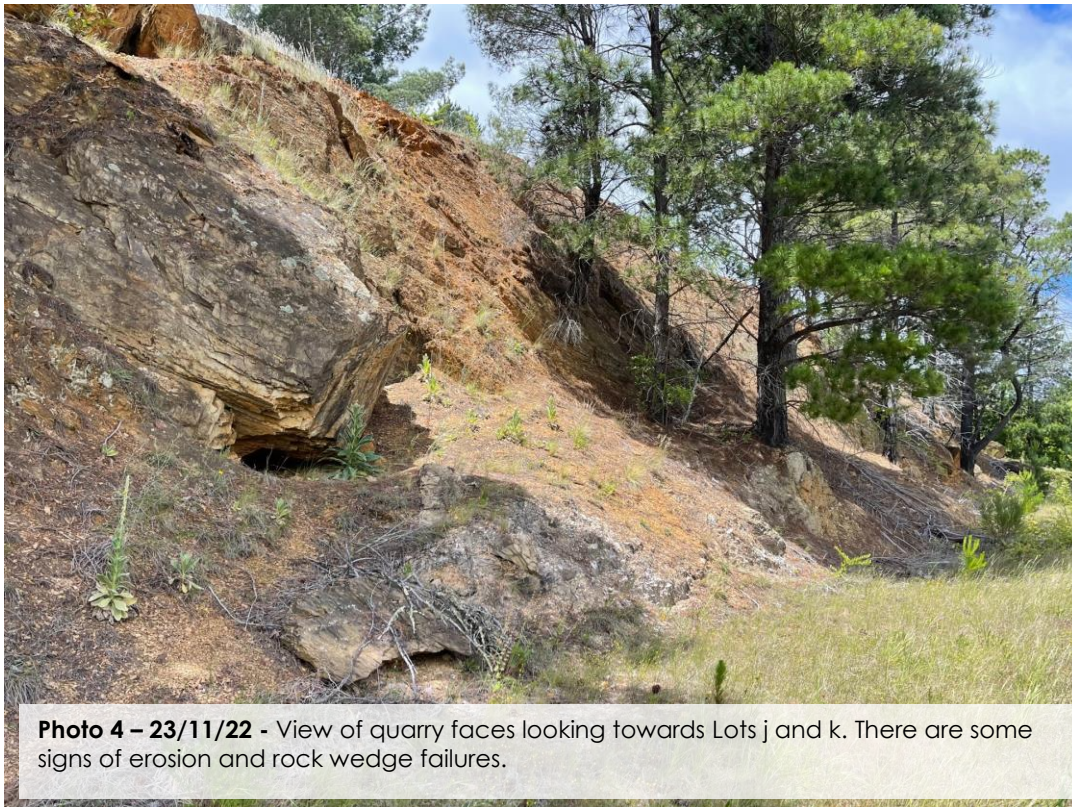
**Photo 4 – 23/11/22** - View of quarry faces looking towards Lots j and k. There are some signs of erosion and rock wedge failures.

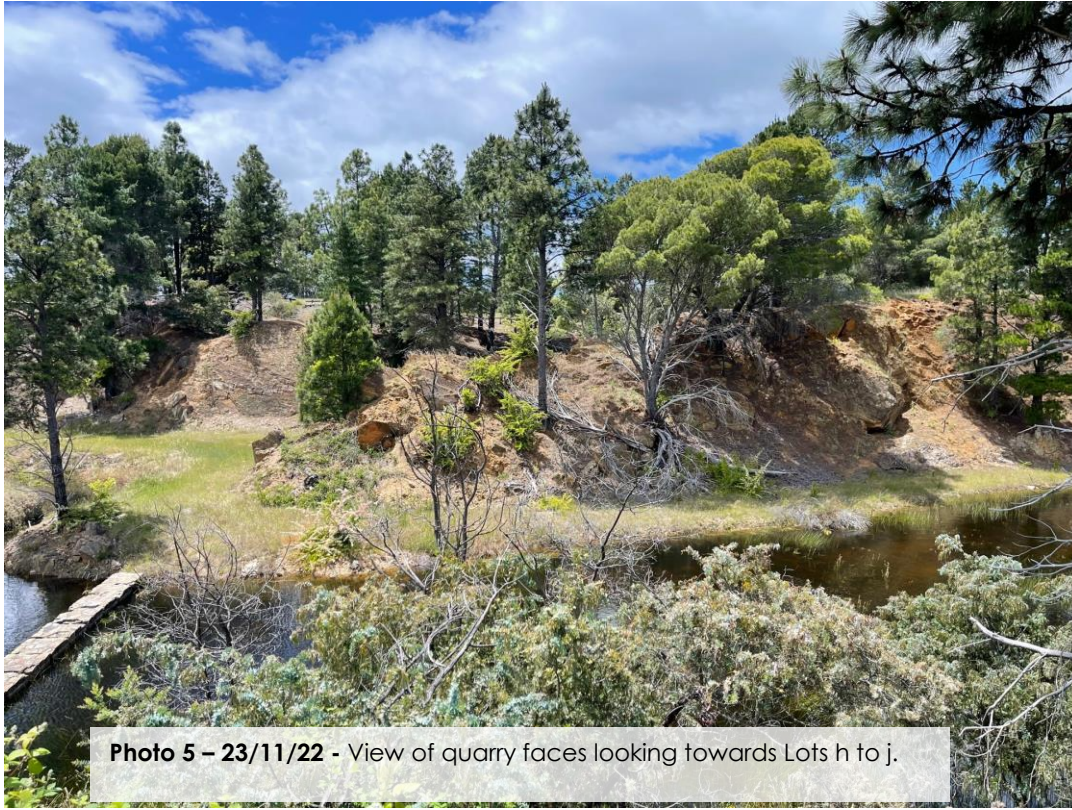
**Photo 5 – 23/11/22** - View of quarry faces looking towards Lots h to j.

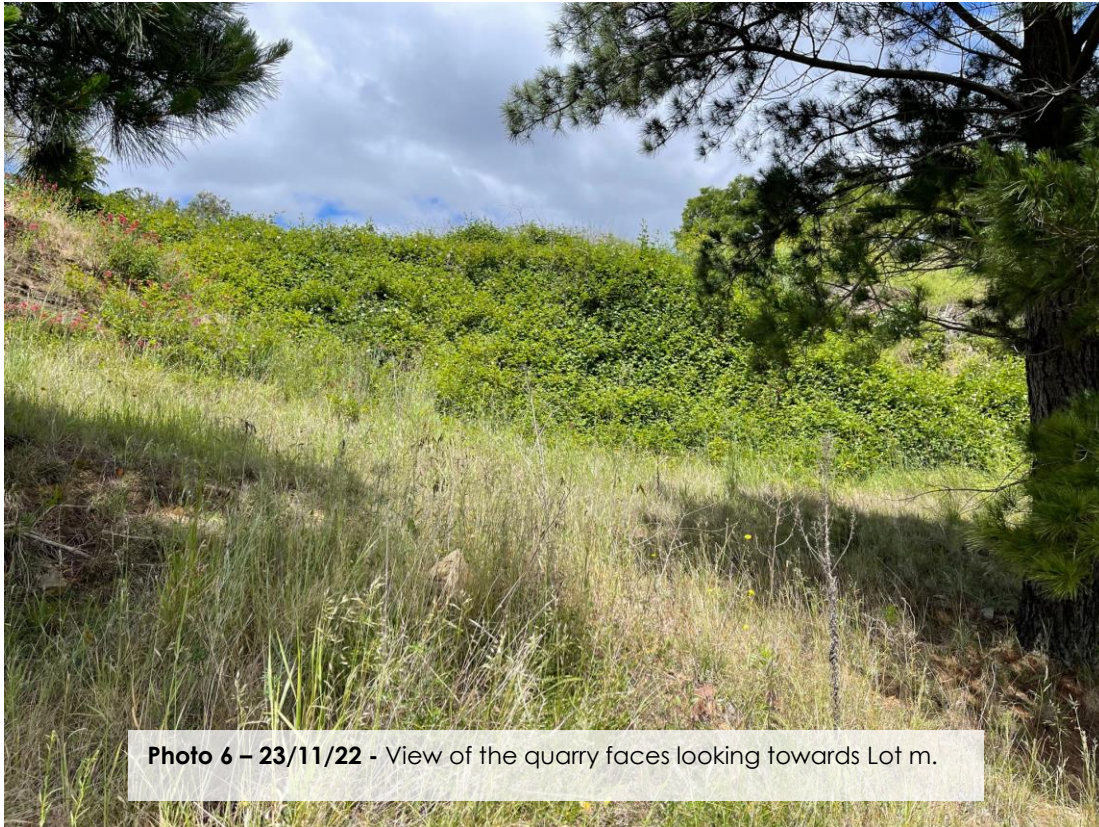
**Photo 6 – 23/11/22** - View of the quarry faces looking towards Lot m.

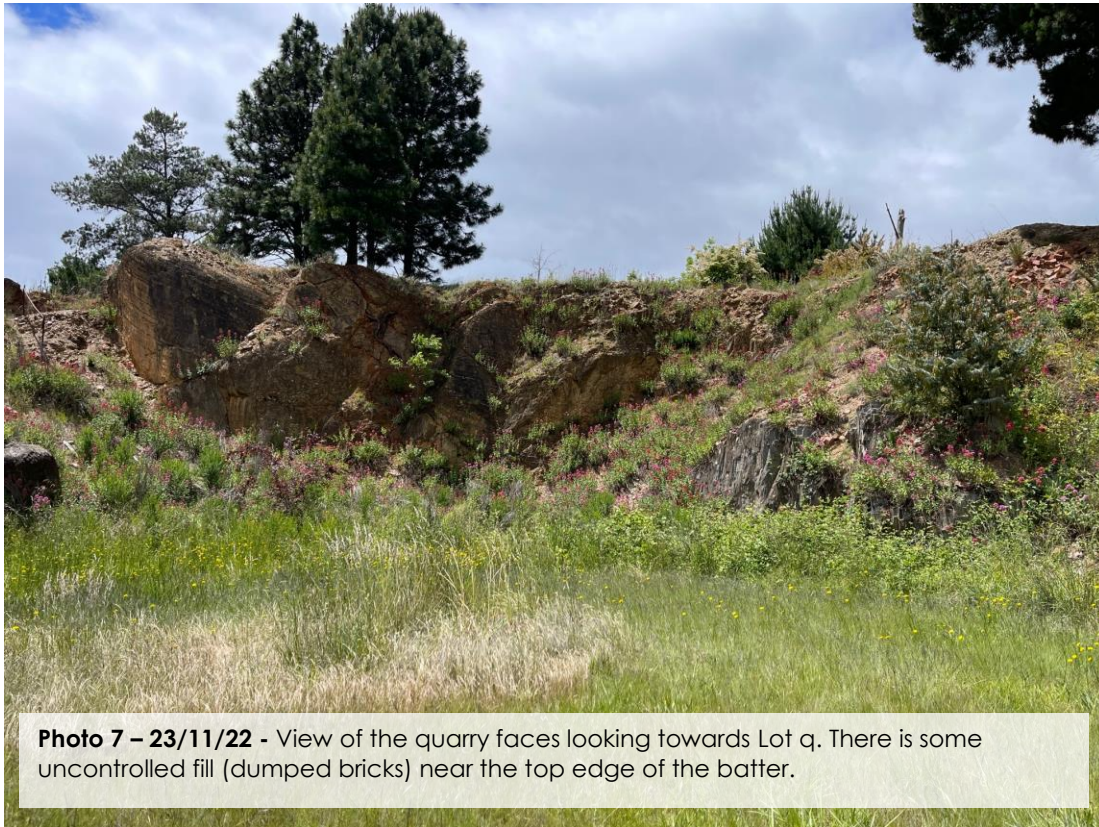
Dwelling No.	Description	Rock Profile	Defect Mapping	Photo No.
Lot q	~4m high cut	~3m of overburden fill, then MW/SW PHYLLITE	Foliation - 73°/260° 80mm to 500mm spacing Bedding- 38°/235° - 30mm to 300mm spacing	Photo 7.
Lot p	~2.5m high cut	MW/SW PHYLLITE	Foliation - 88°/260° 80mm to 500mm spacing Bedding- 39°/247° - 30mm to 300mm spacing	Photo 8.
Lot o	NA	NA	Dwelling set well back from the top edge of the existing quarry faces	
Lot n	~6m high cut	HW to HW/MW PHYLLITE	Foliation - 88°/062° 5mm to 70mm spacing Bedding- 42°/260° - 30mm to 70mm spacing Signs of rock wedge failures and erosion on both sides of the 'peninsula'.	Photos 9, 10, 11, and 12
Lot m	~3m high cut	Covered in vegetation	Covered in vegetation	Photo 6
Lot l	~4m high cut	HW/MW PHYLLITE	Foliation - 81°/102° 5mm to 70mm spacing Bedding- 42°/213° - 30mm to 70mm spacing Joints - 68°/146° - 10mm to 20mm spacing	
Lot k	~3m high cut	HW/MW PHYLLITE	Foliation of the bedrock is dipping into the excavation.

**Photo 7 – 23/11/22** - View of the quarry faces looking towards Lot q. There is some uncontrolled fill (dumped bricks) near the top edge of the batter.

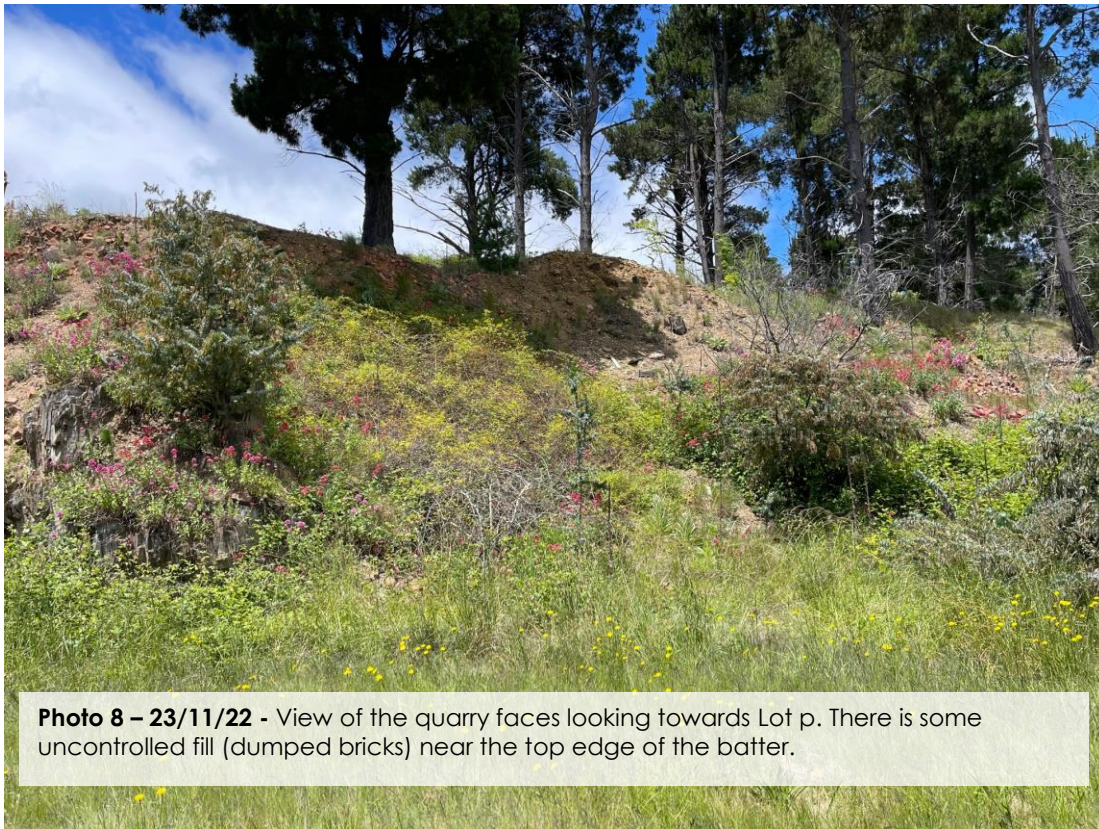
**Photo 8 – 23/11/22** - View of the quarry faces looking towards Lot p. There is some uncontrolled fill (dumped bricks) near the top edge of the batter.

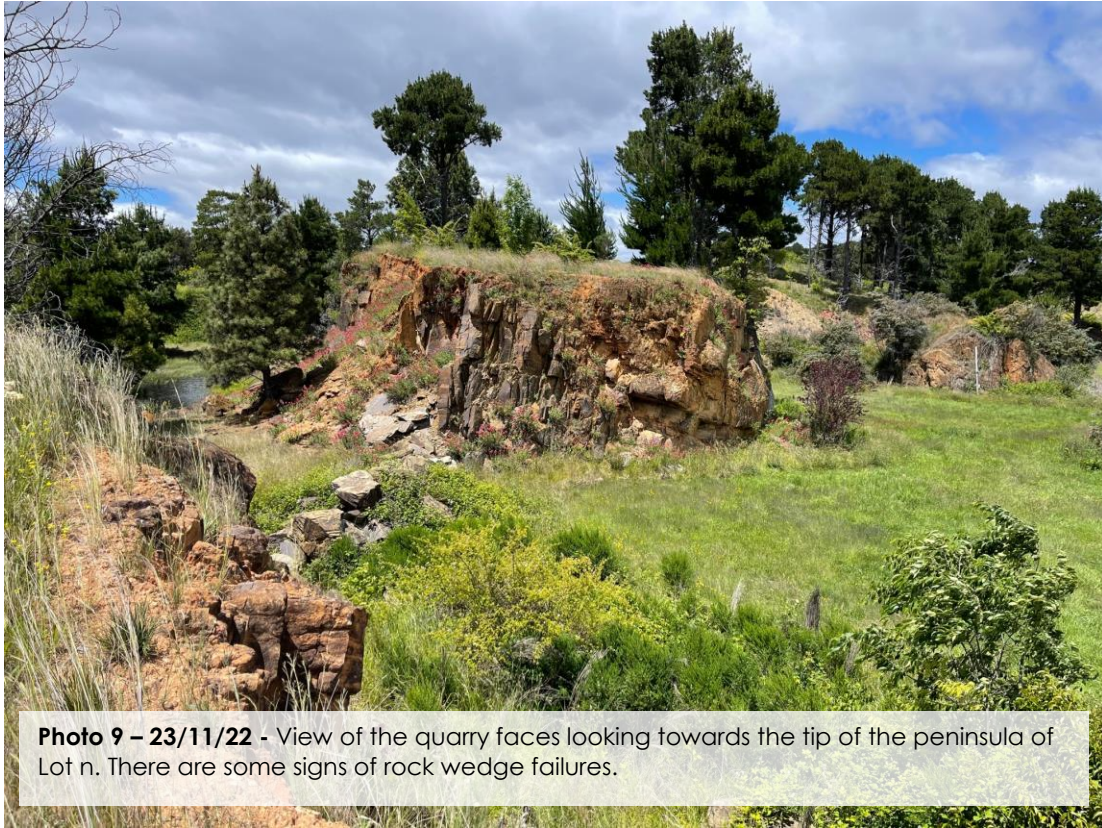
**Photo 9 – 23/11/22** - View of the quarry faces looking towards the tip of the peninsula of Lot n. There are some signs of rock wedge failures.

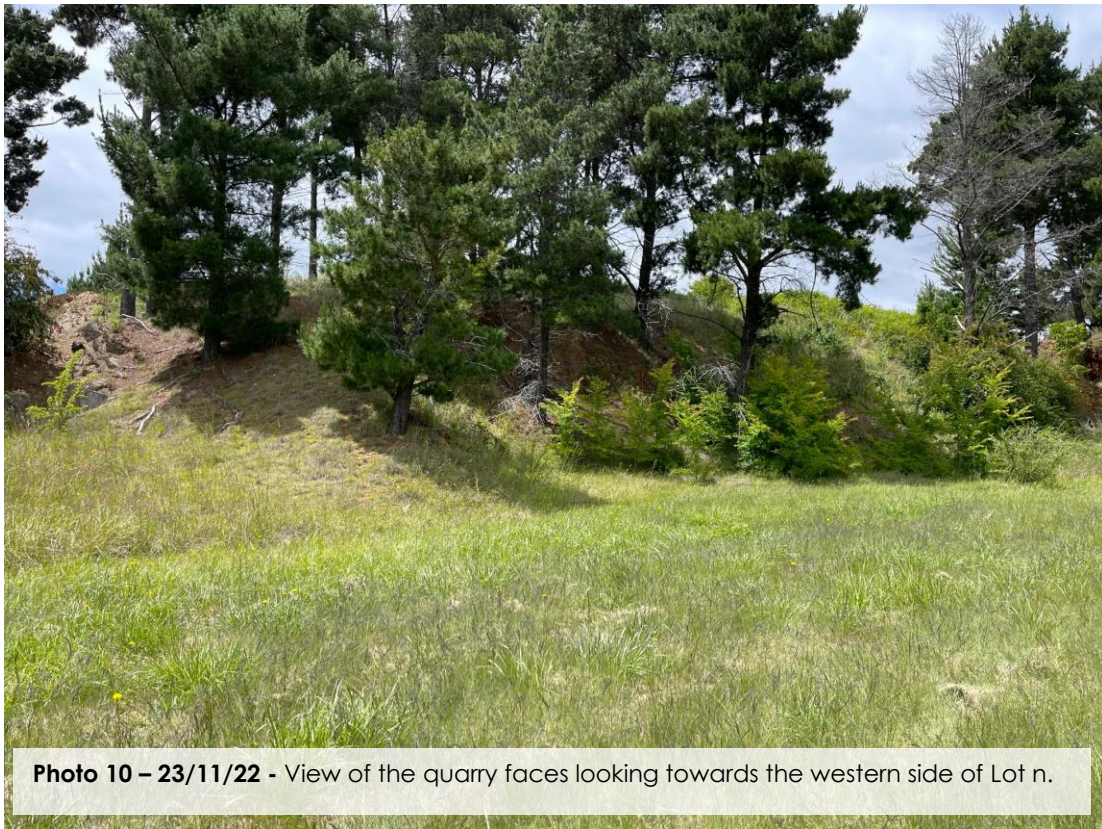
**Photo 10 – 23/11/22** - View of the quarry faces looking towards the western side of Lot n.

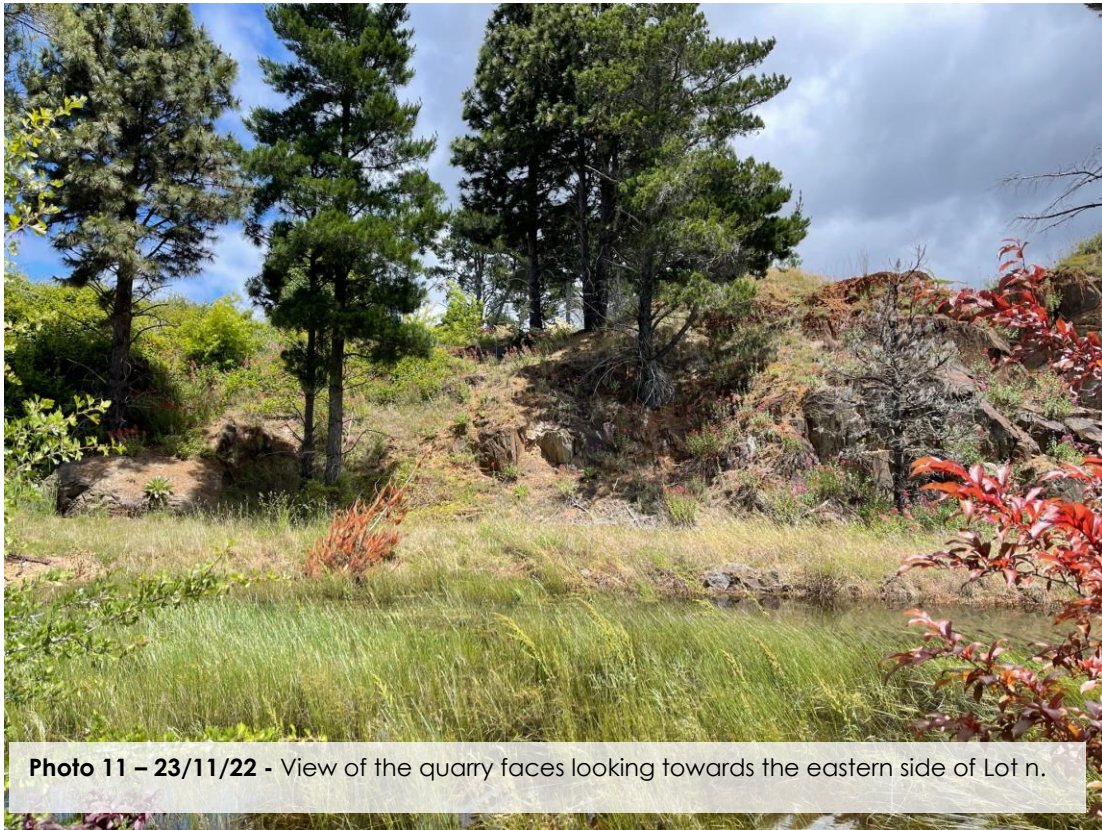
**Photo 11 – 23/11/22** - View of the quarry faces looking towards the eastern side of Lot n.

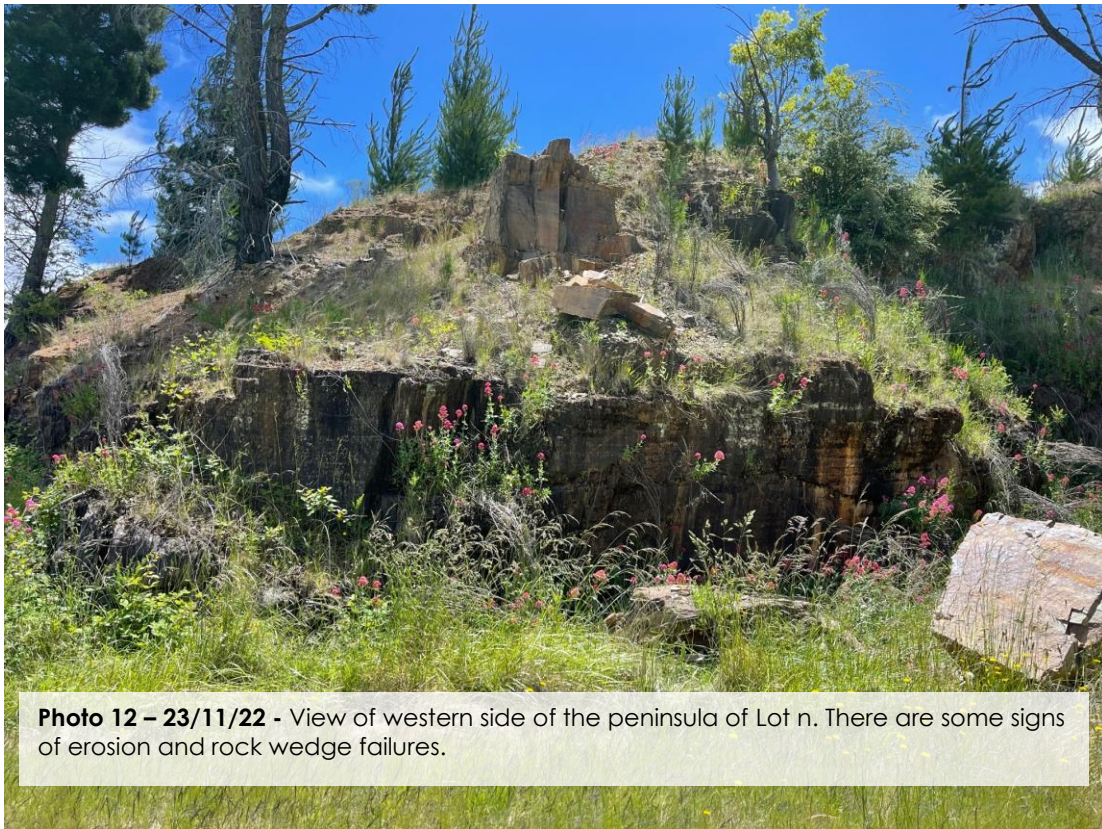
**Photo 12 – 23/11/22** - View of western side of the peninsula of Lot n. There are some signs of erosion and rock wedge failures.

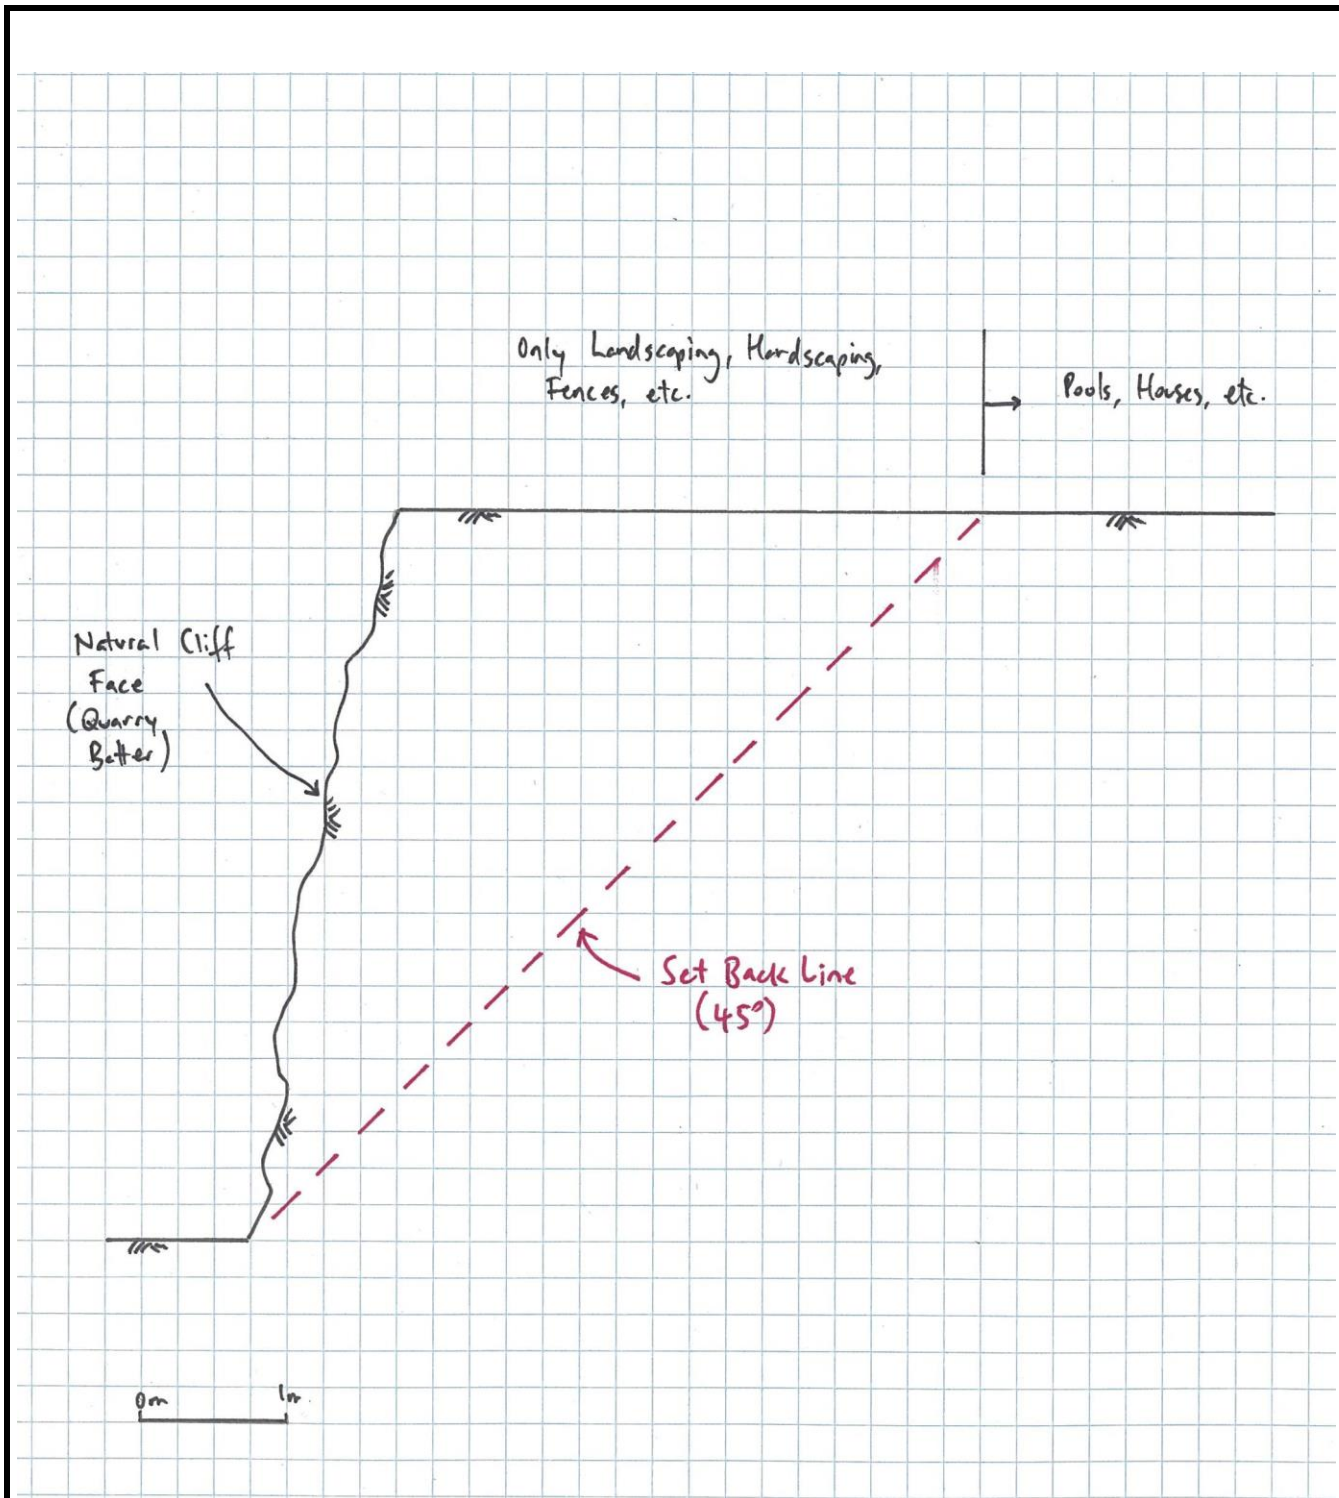
Natural Quarry Cliff Batter Faces – Set Back Line

It is assessed that structures such as houses, pools, sheds, etc. cannot be constructed in close proximity to the top edges of the quarry batters. It is assessed that any dwellings/pools that are less than 1 (H):1 (V) back from the top edge of the cut batter face is increasing the risk of instability (dwellings/pools that do not set back from the top edge of the batter at least by the same distance as the depth of the cut batter at that location). This does not apply to landscaping, hardscaping, fences, etc., which can be located in close proximity to the top edges of the quarry batters.
