# Canberra Brickworks Precinct

## Conservation Management Plan

### Volume Two—Appendices

September 2021

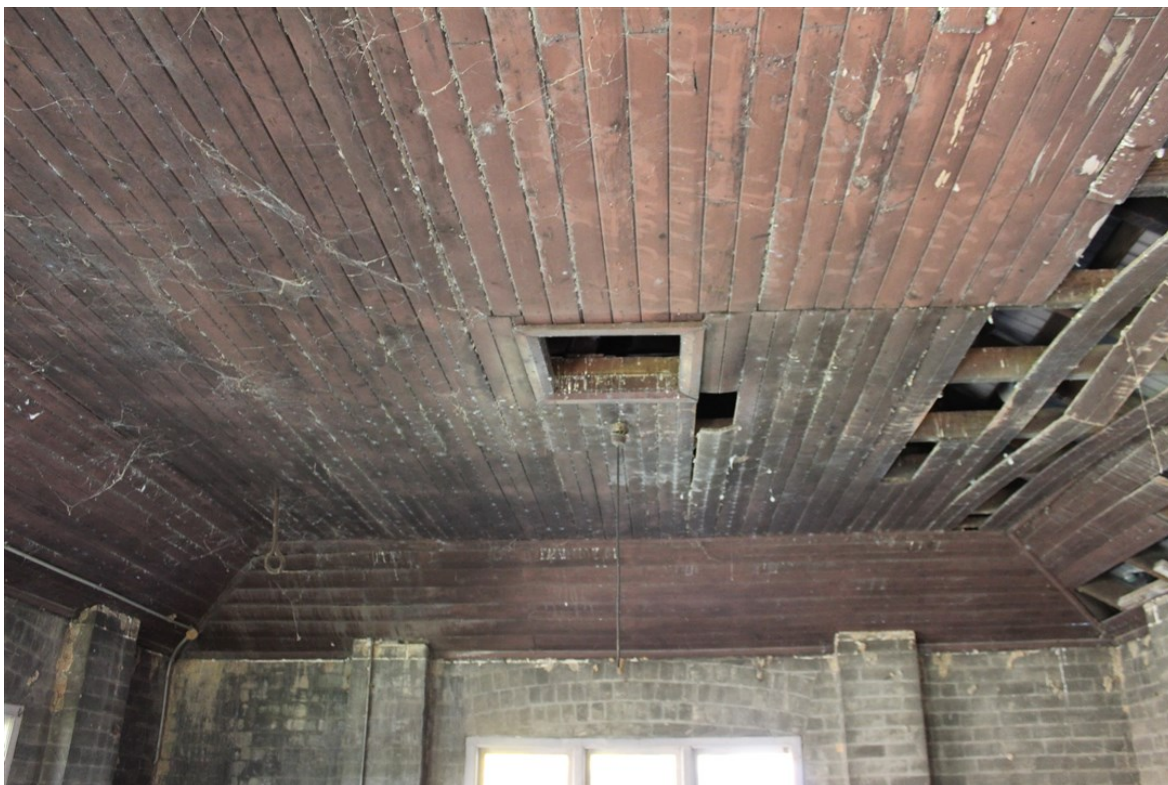
The inspection report for the building identified that the ceiling boards are in poor condition and partially collapsed and the concrete basement is filled with debris. The front doors have been removed, the windows are broken and the glass panes are missing. The internal brickwork is graffitied and heavily stained by soot. The handrails do not fully extend around the ground floor platform, with one handrail loose. There is moderate cracking of the brick lintels above the windows. The remaining fan motor is in a dilapidated state. Sinkholes have been observed around the building due to settlement of basement backfill. The brick 'oven' structure next to the chimney stack is severely cracked. Little to no mortar remains in the joints, leaving bricks loose and unstable. The rainwater goods, soffits and fascias to the roof have all been removed. The condition of the roof, joinery and interior is poor. Brickwalls are in reasonable condition, with some cracking to lintels.

**Figure 4** Interior of the Fan House, showing poor condition ceiling boards. (Source: GML, 2017)

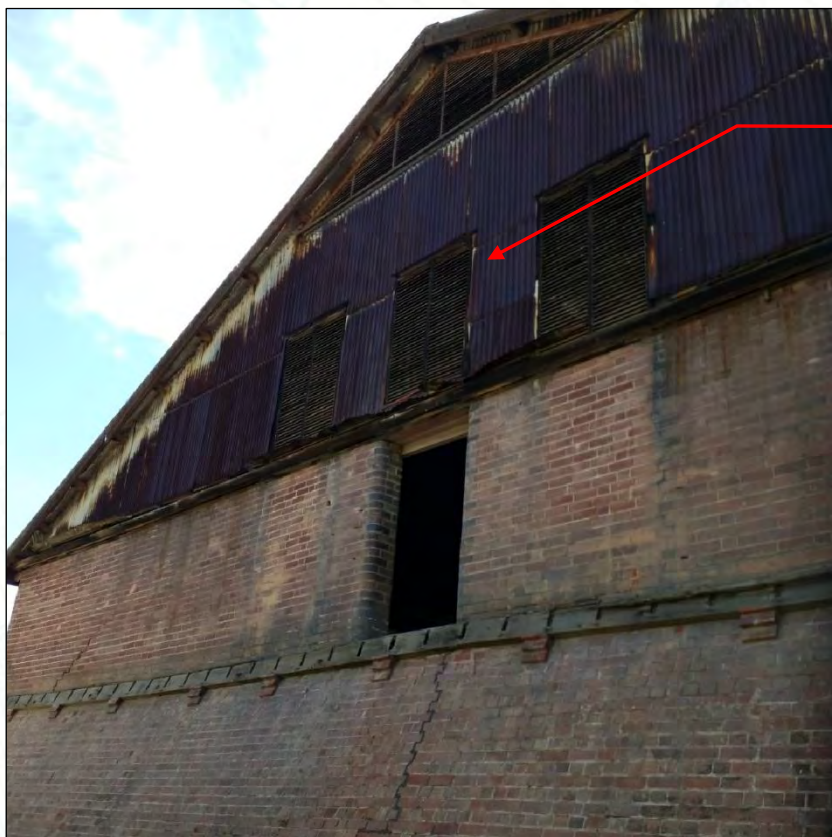
Deteriorated wall sheeting

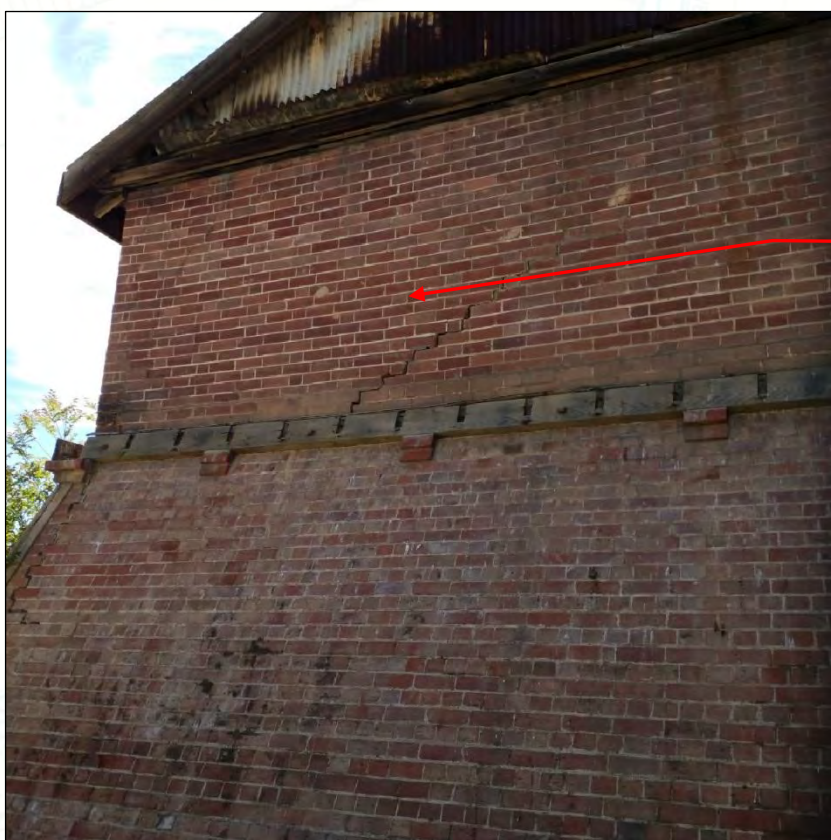
Stepped cracking to brick veneer wall

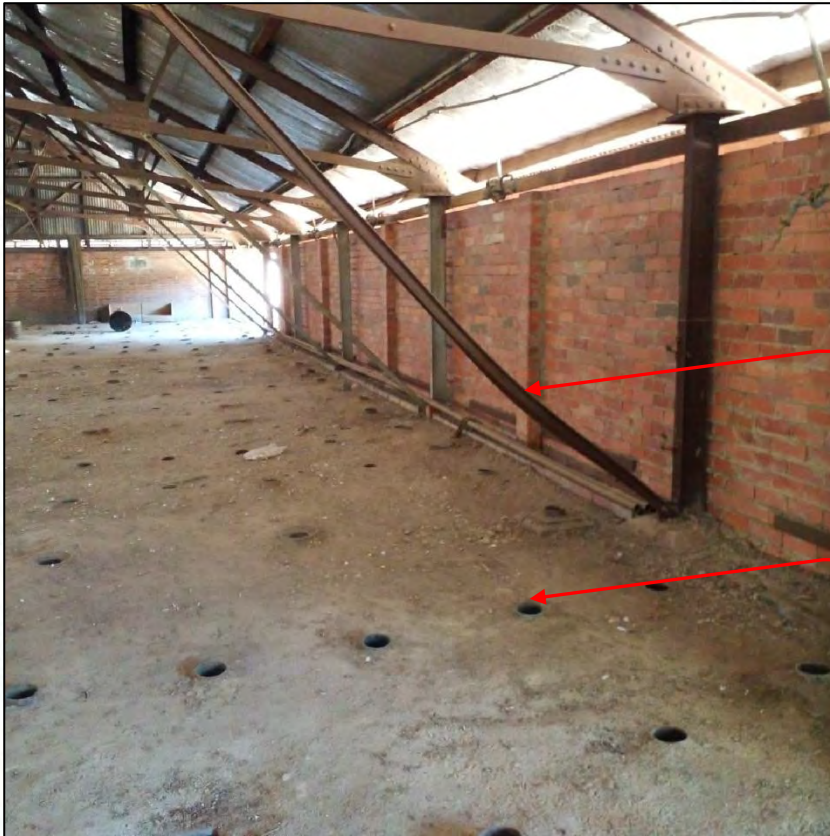
Buckled roof brace

Firing holes

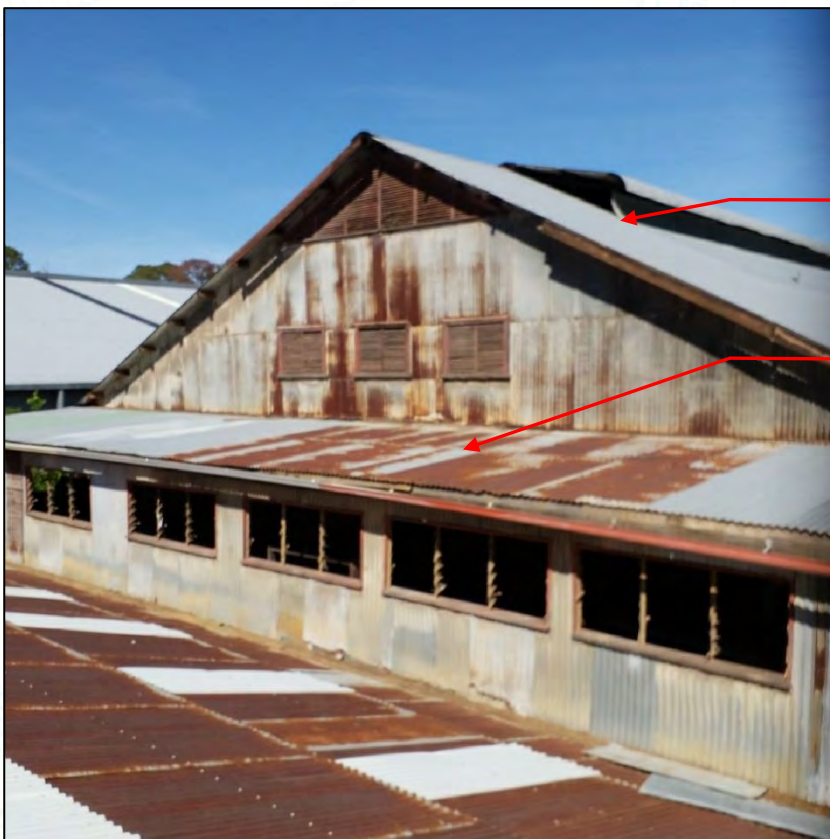
Newer roof sheeting

Deteriorated roof sheeting  
(lean-to roof)

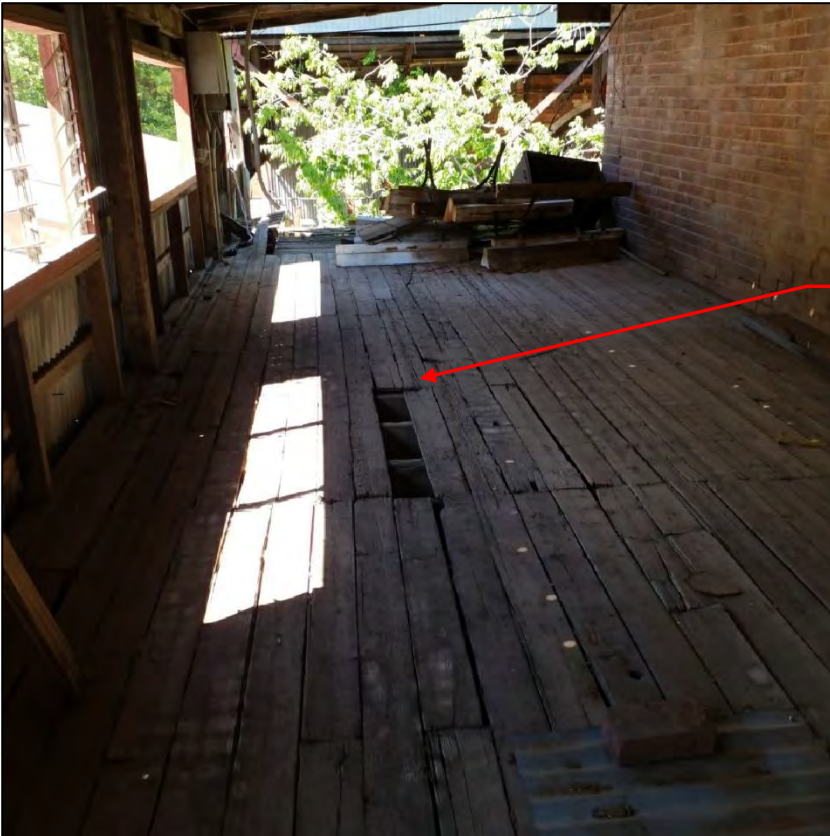
Weathered flooring

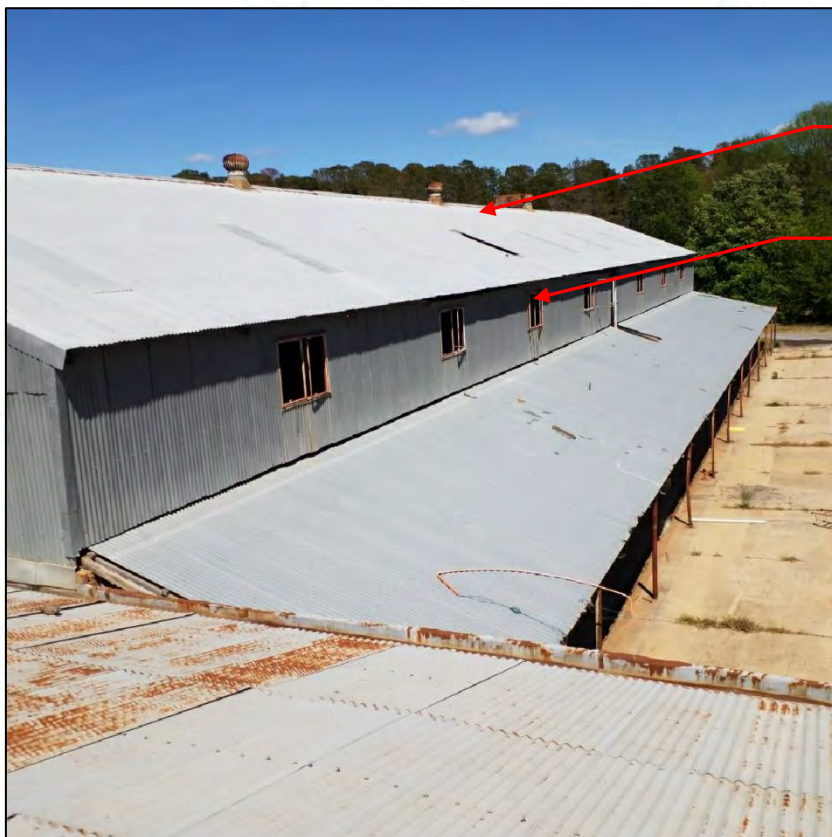
Hole in roof

Broken windows

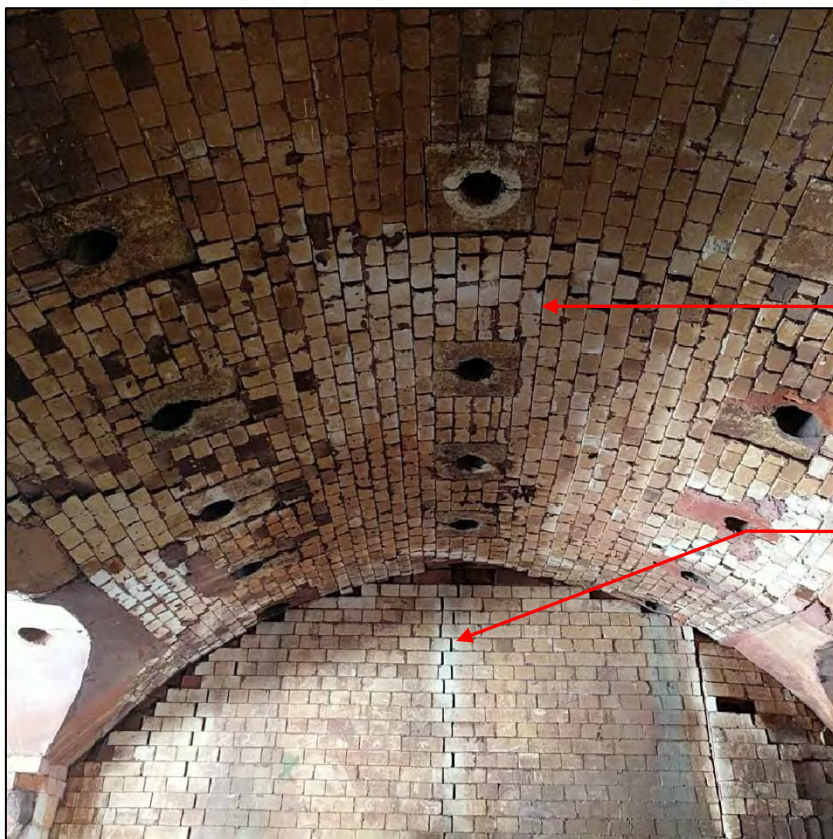
Loose bricks throughout

Cracking to brick wall

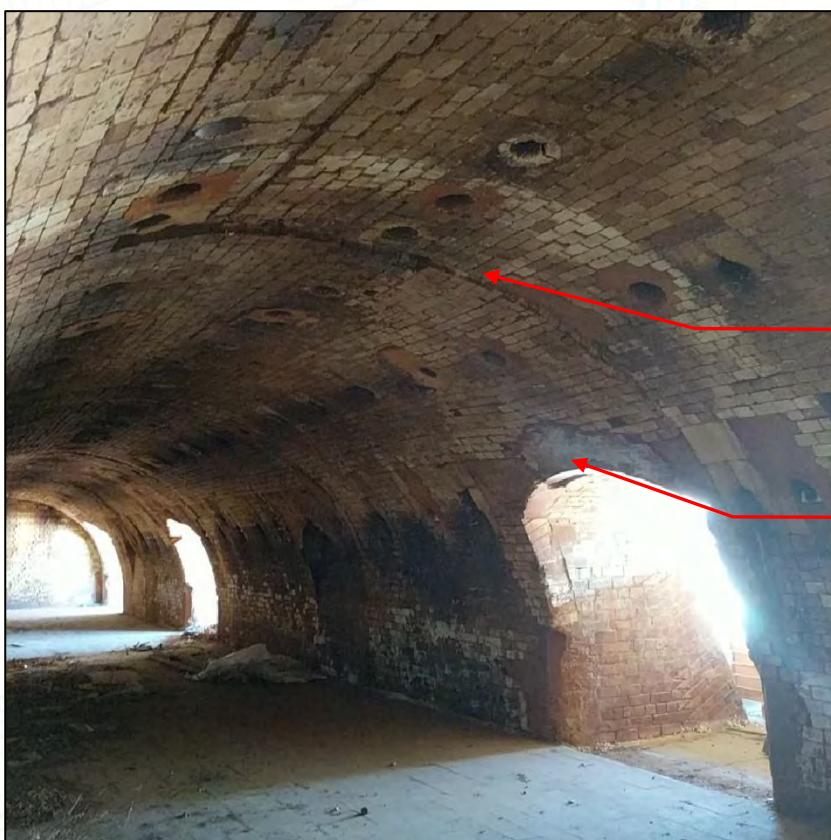
Internal structural generally sound overall, loose bricks noted

Displacing entry arch

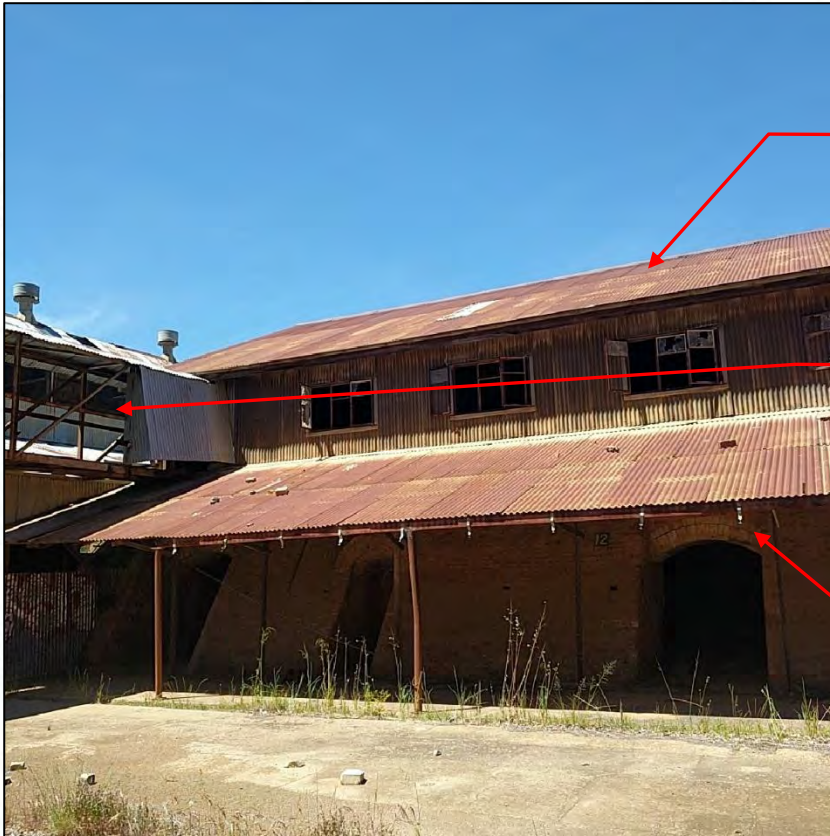
Weathered roof sheeting

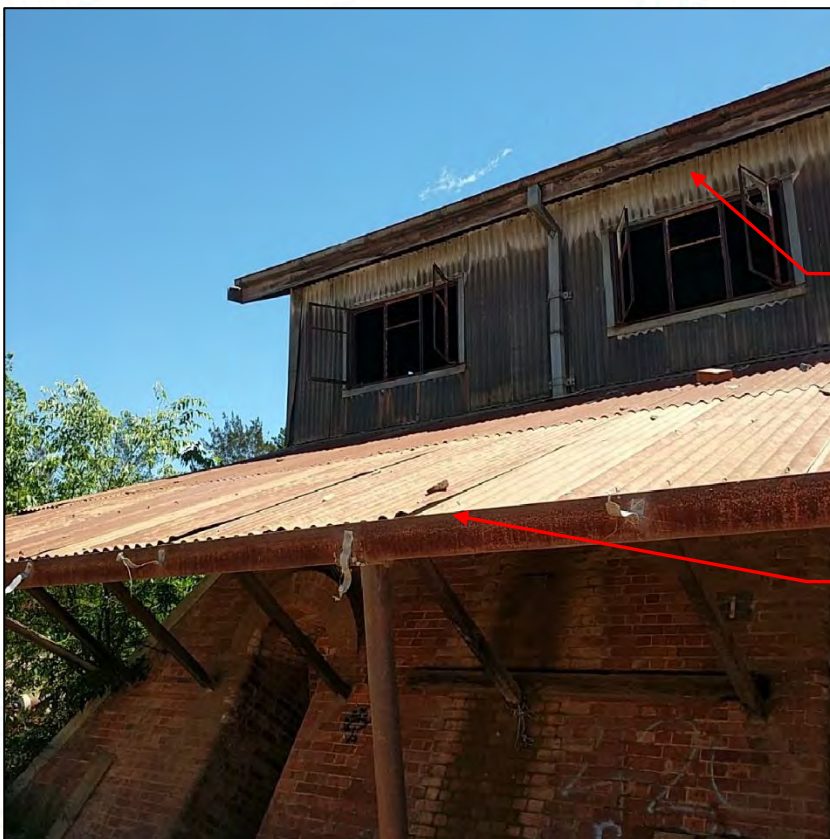
Deteriorated fascia

Sheet fixings loose

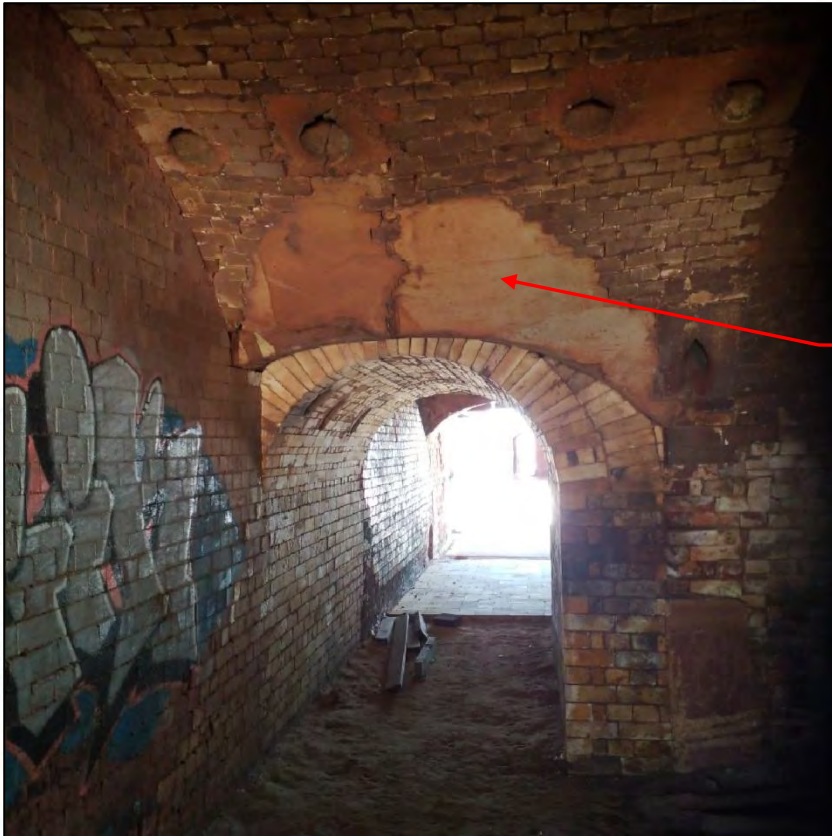
Displaced arch

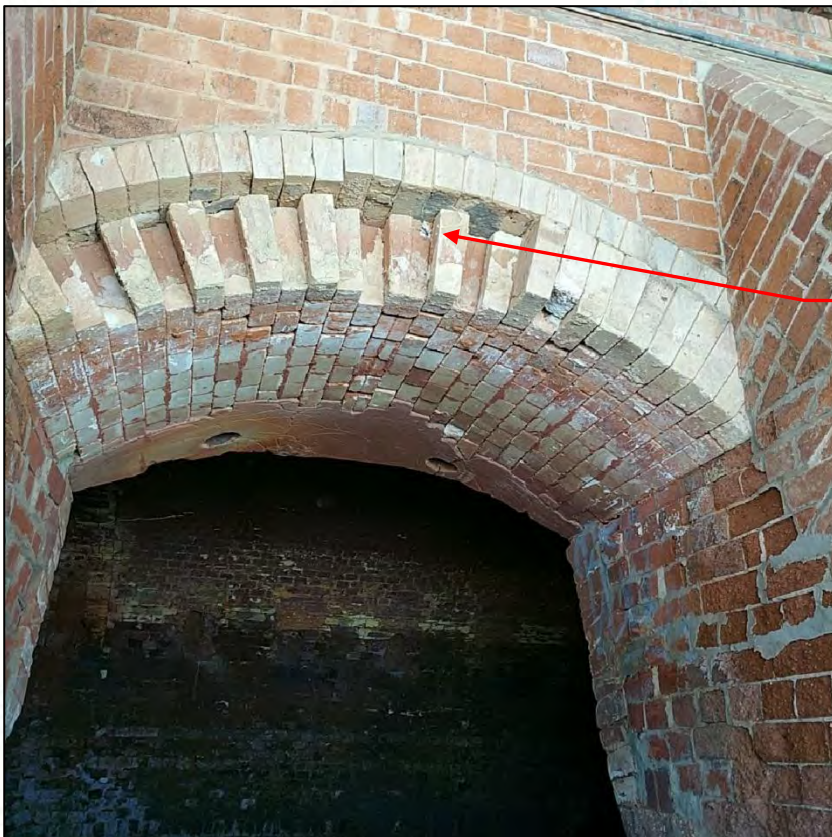
Loose bricks to arch

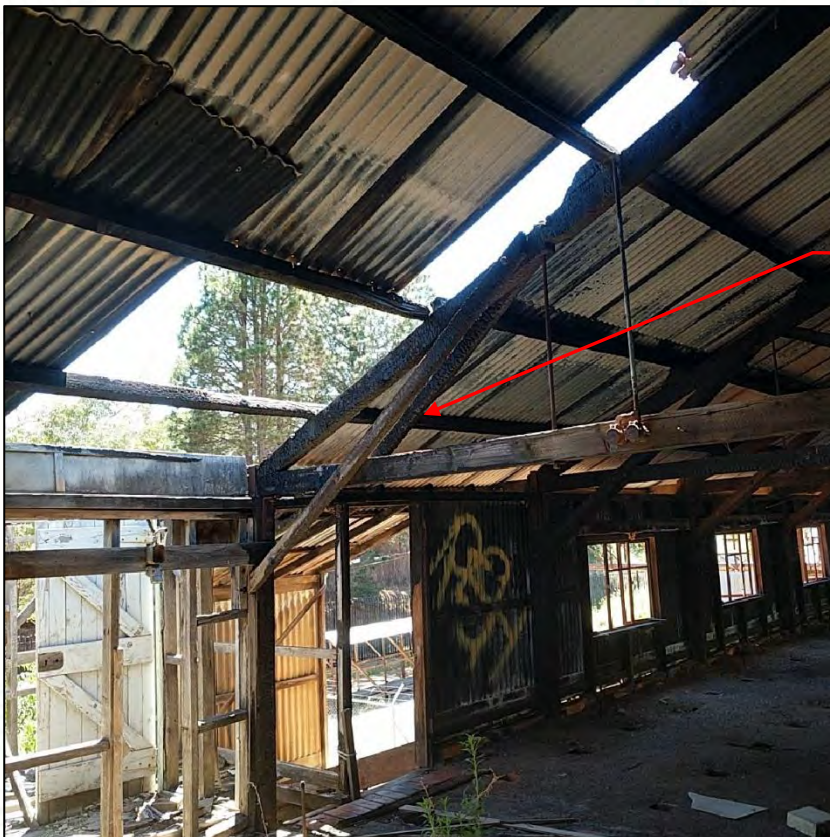
Fire damage

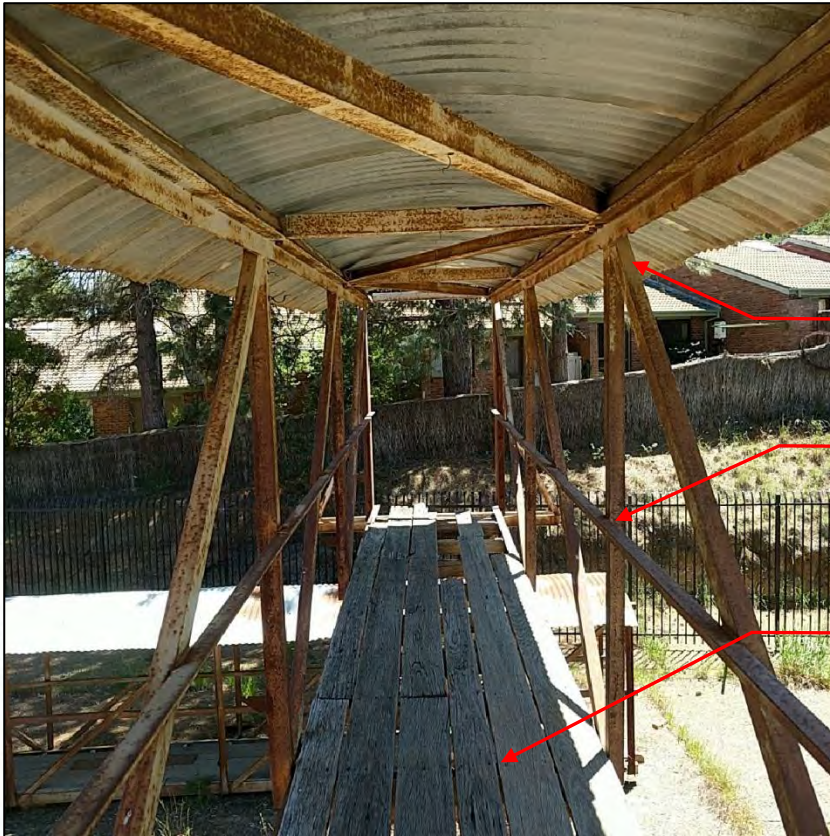
Surface rust to steelwork  
Steelwork may be reused

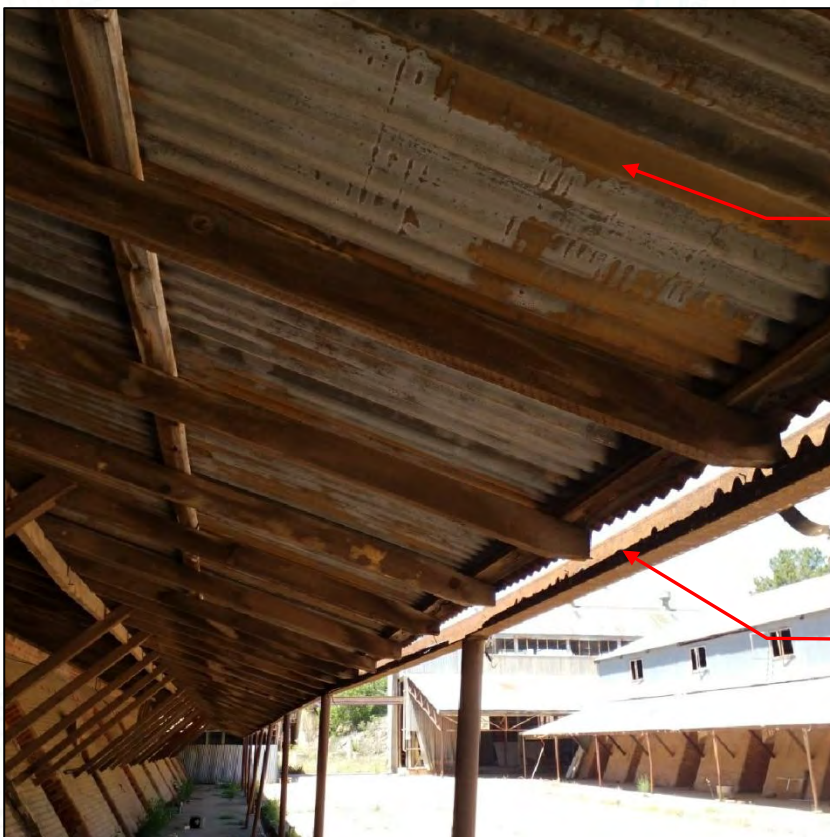
Deteriorated sheeting

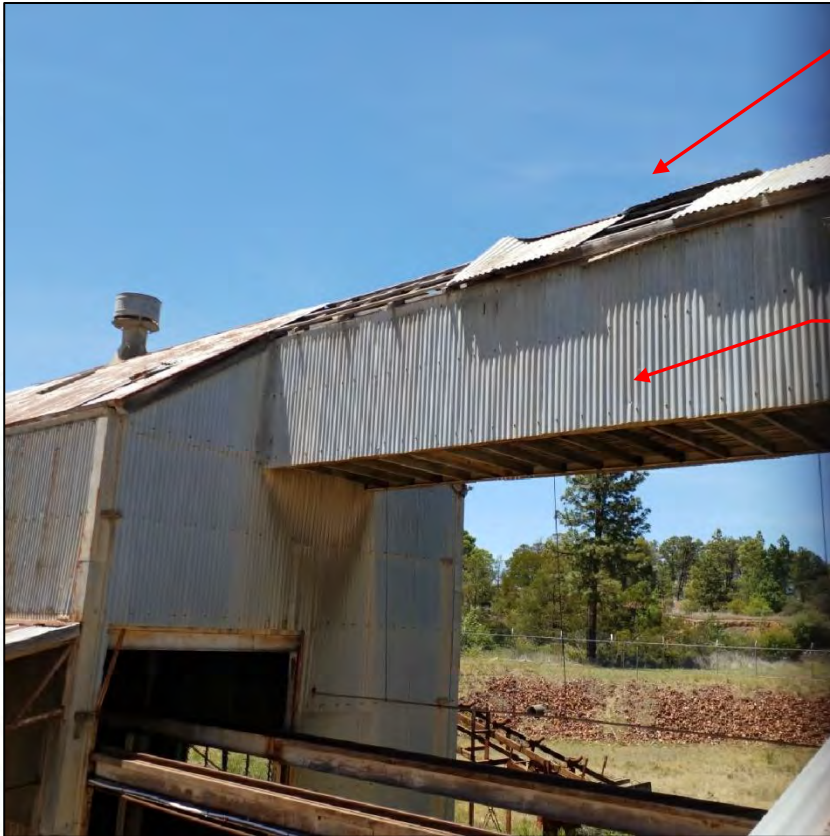
Loose and missing roof sheets

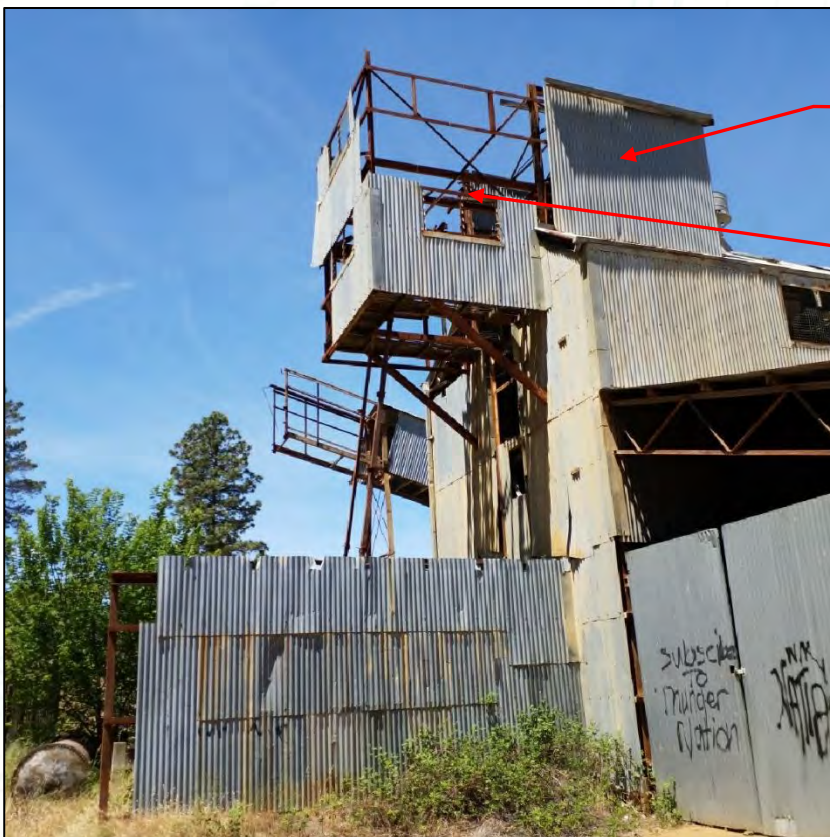
Loose and missing sheeting

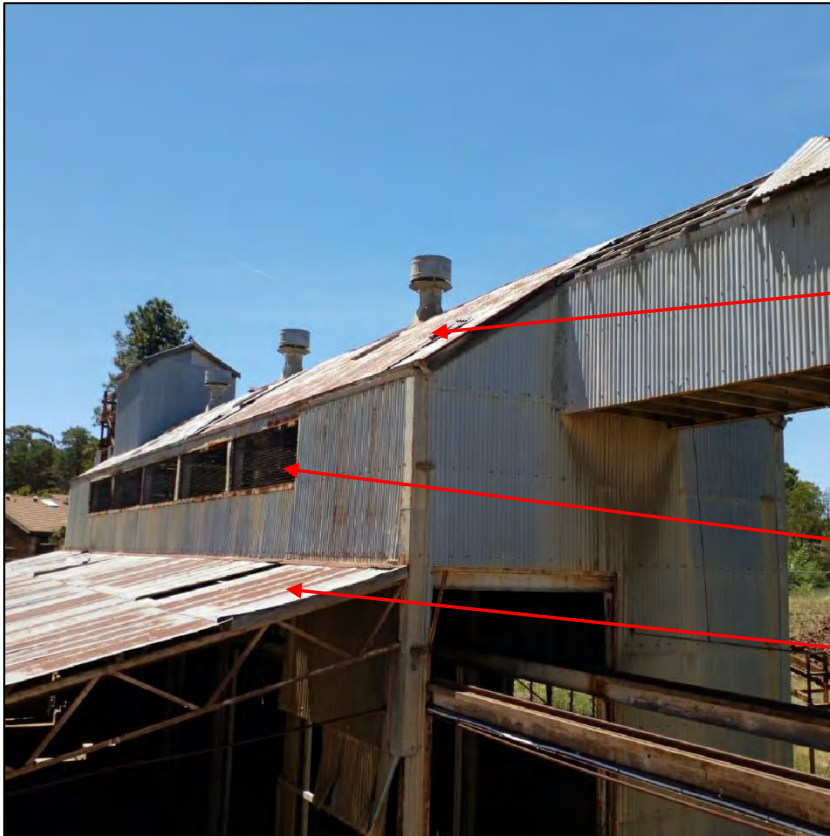
Loose and missing sheeting

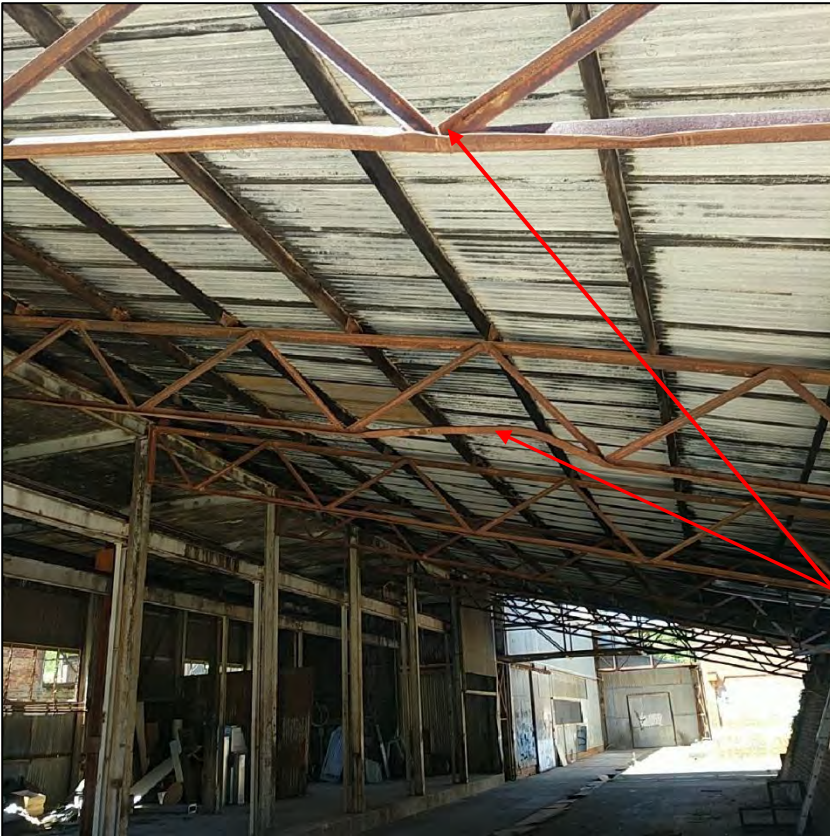
Damaged bottom chords

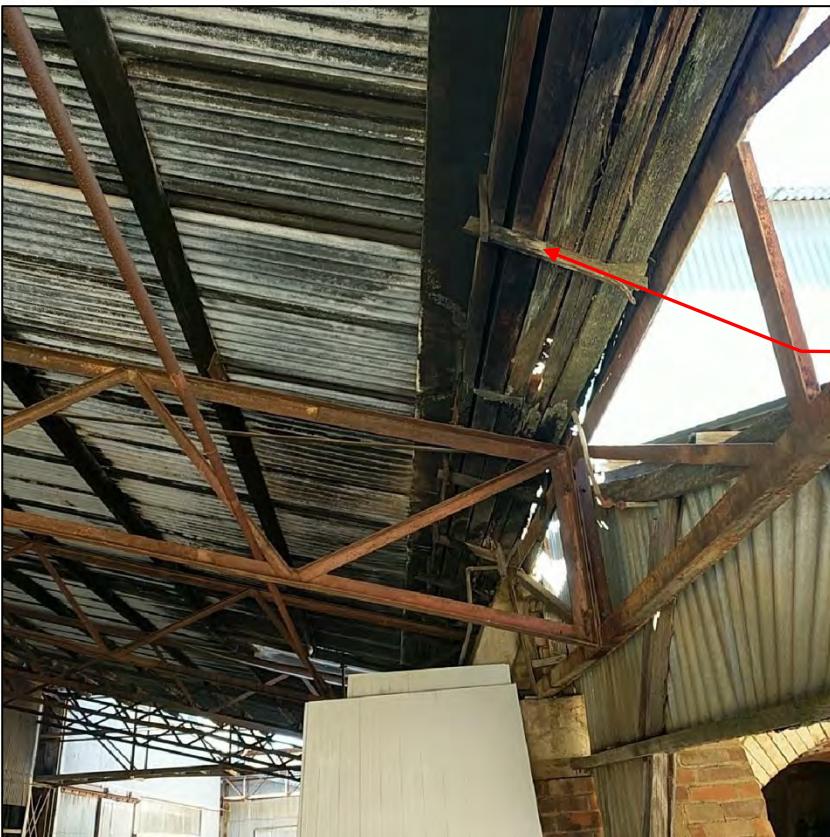
Deteriorated box gutter timber framing

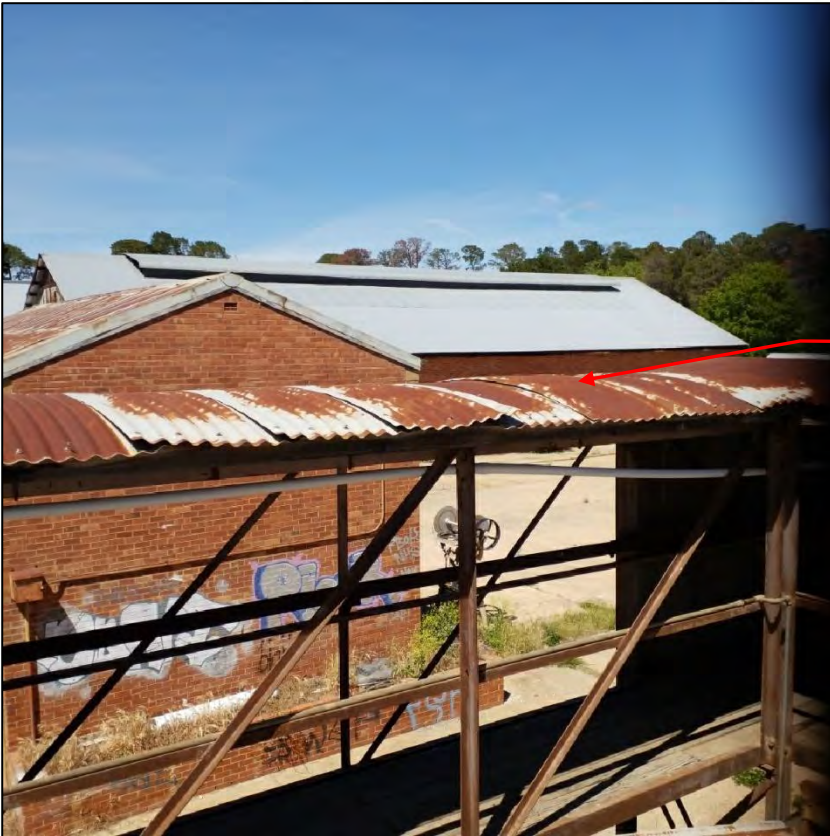
Weathered and loose  
sheeting

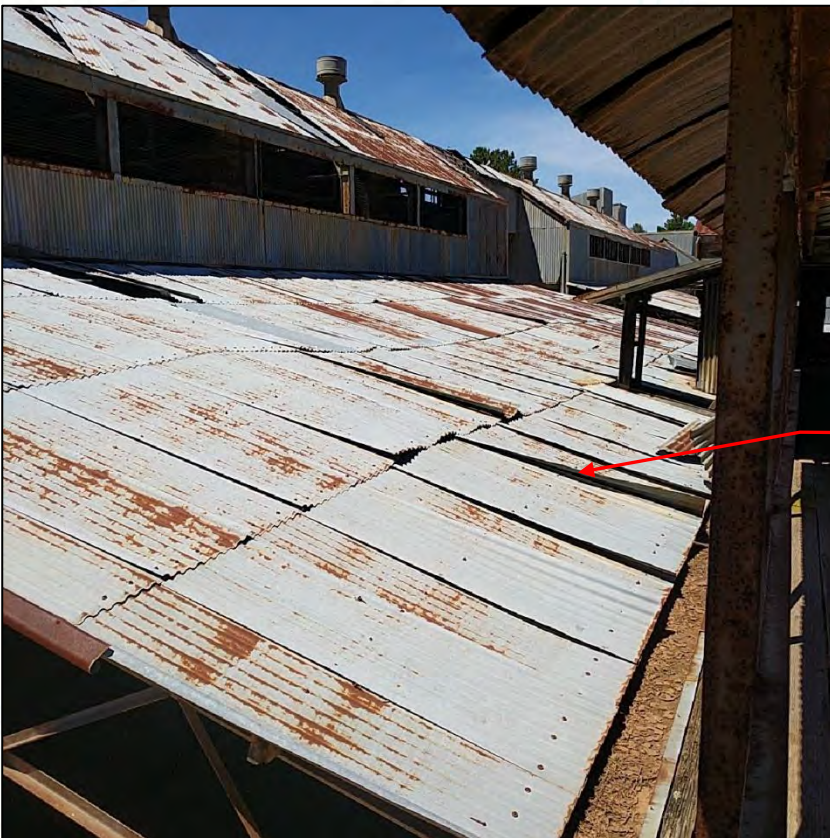
Loose and missing  
sheeting

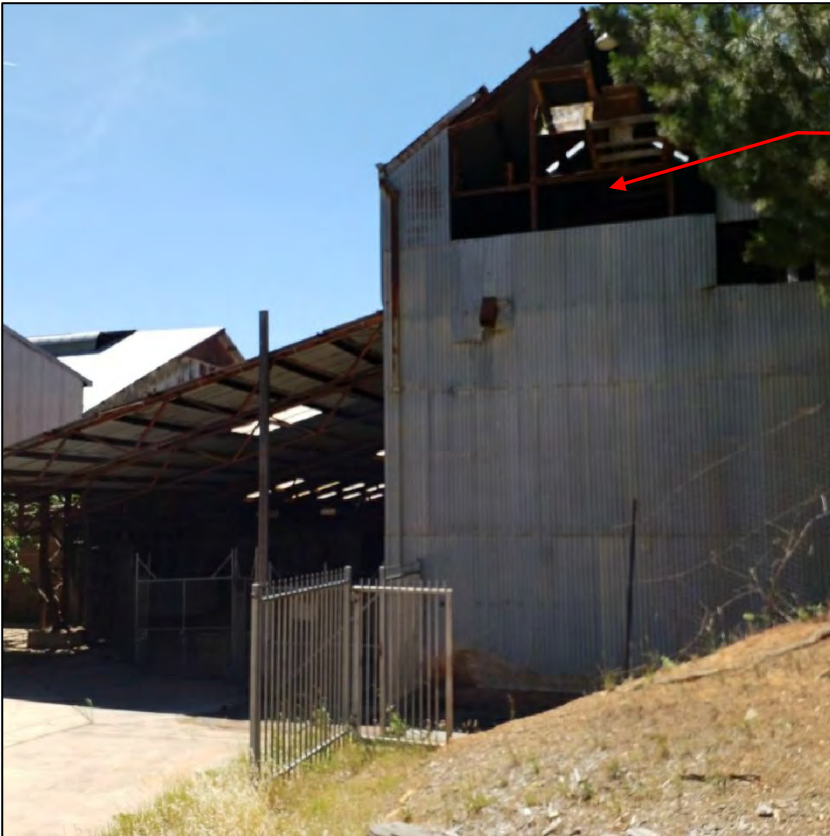
Wall sheets loose  
and missing

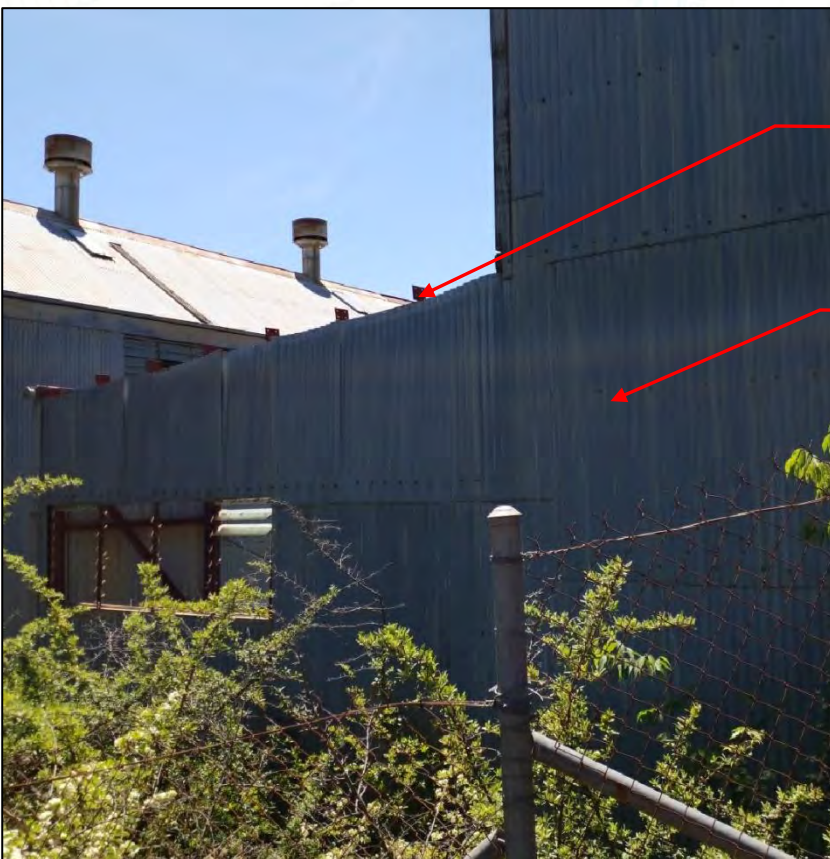
Roof framing has been  
removed

Loose sheets

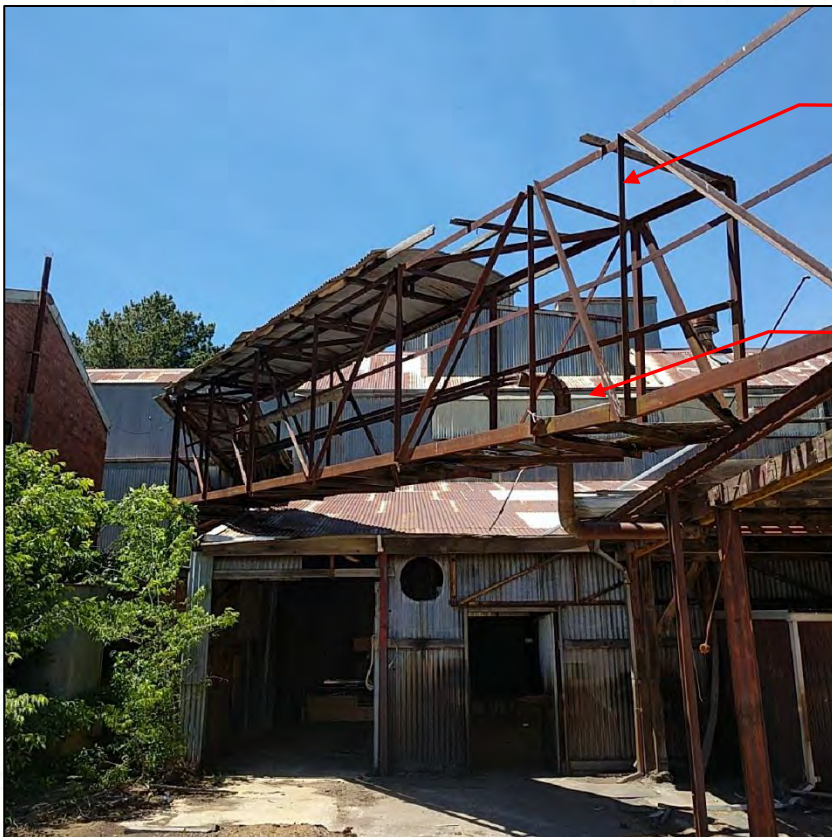
Roof sheets missing

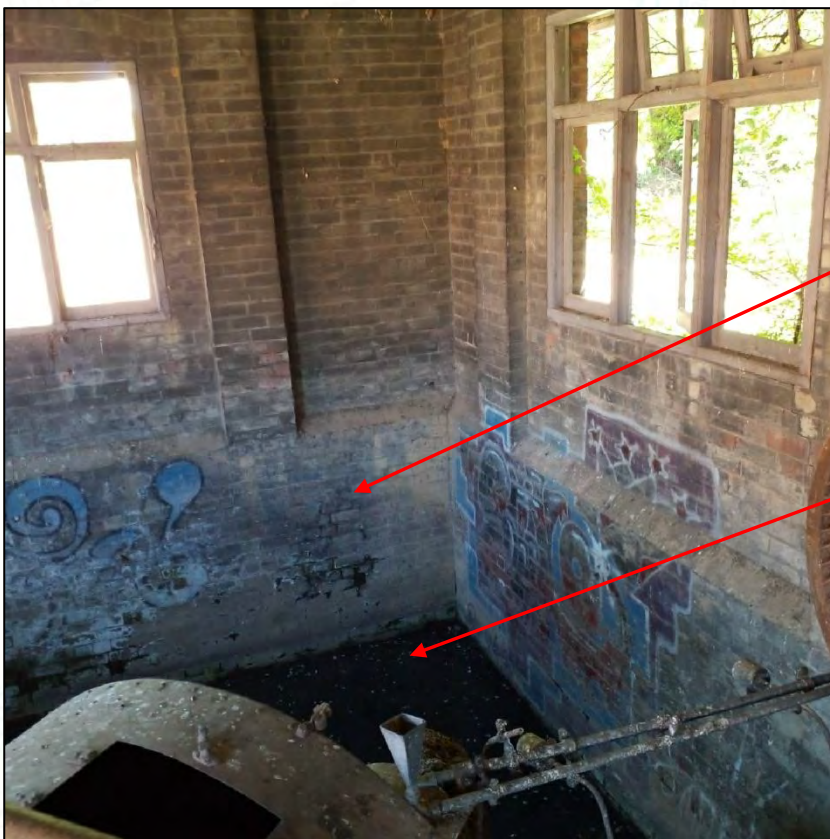
Debris and murky water

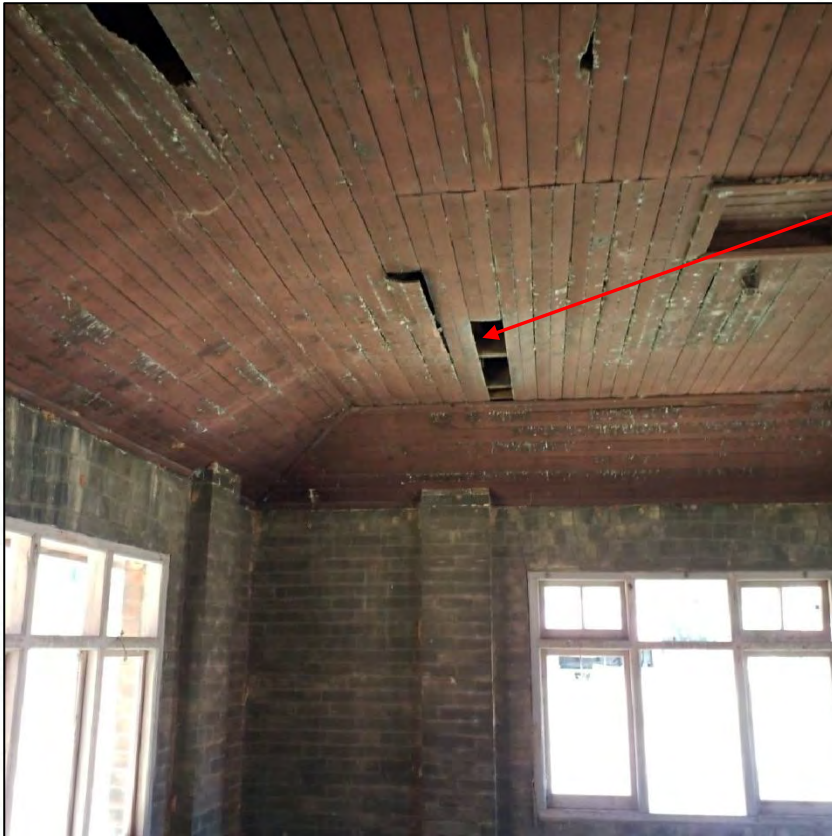
Deteriorated ceiling boards  
Partially collapsed

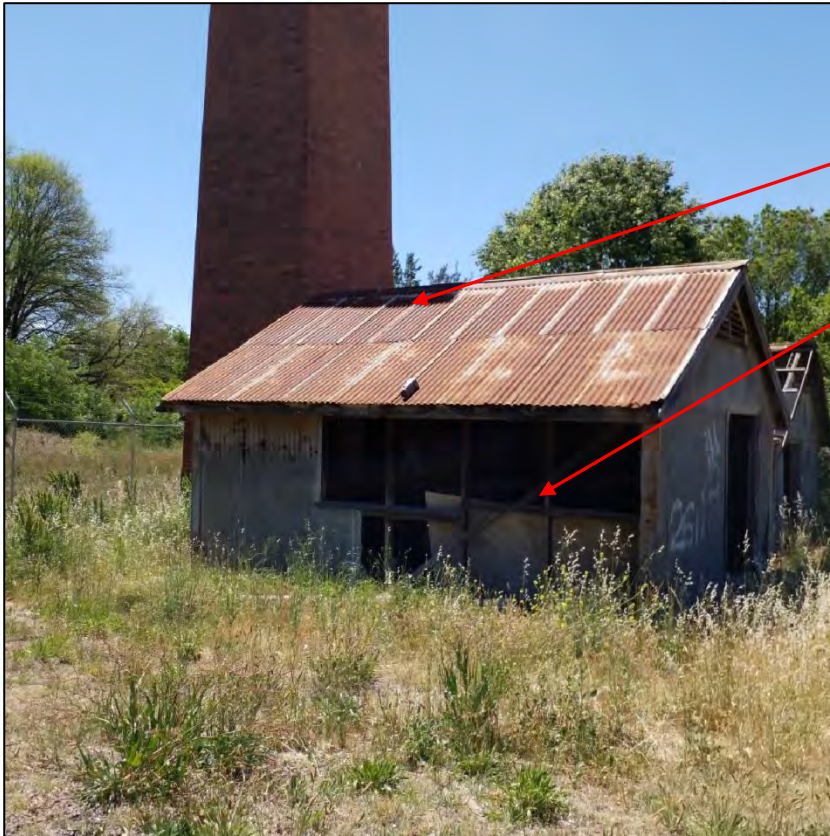
Weathered sheeting  
Loose fixings

Missing wall sheets

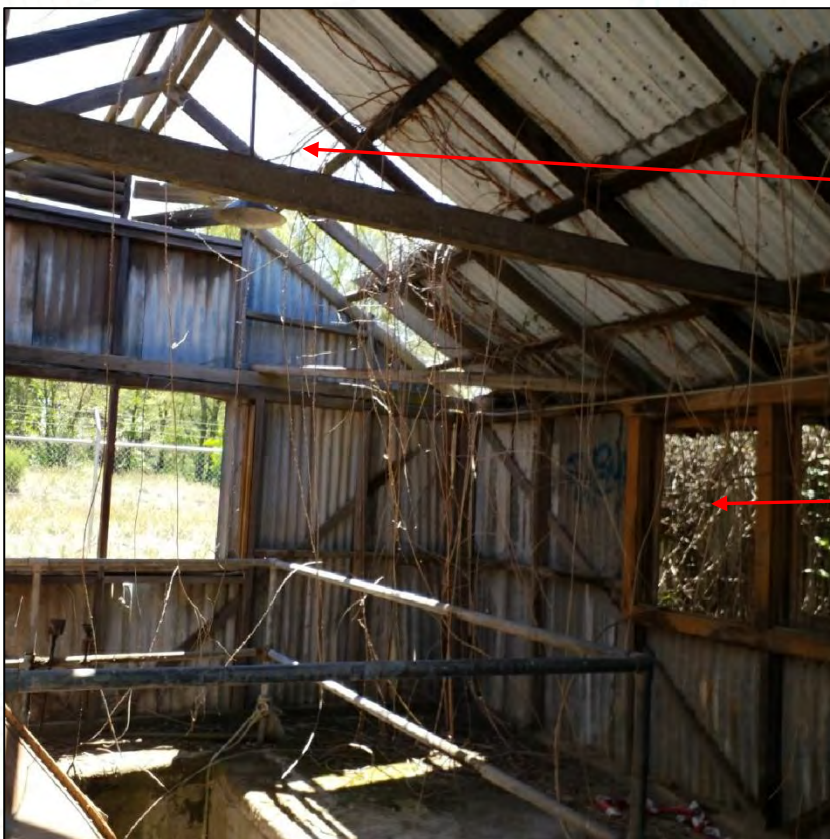
Missing roof sheets

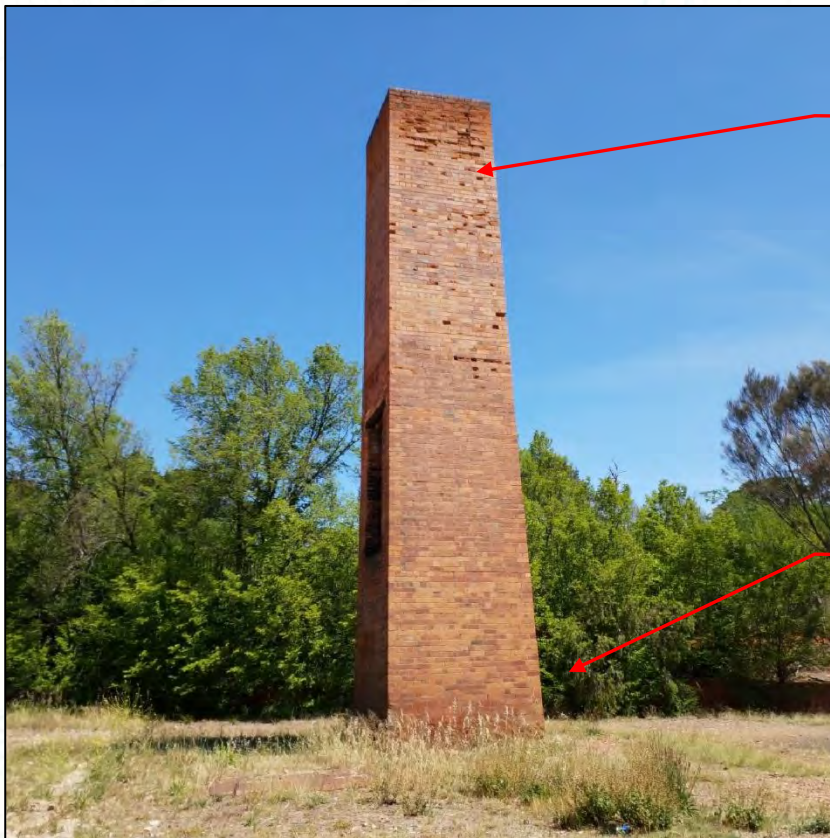
Loose and deteriorated bricks to upper area
