Canberra Brickworks Precinct

Archaeological Excavation Report and Statement of Heritage Effects

Volume 1—Report

Prepared for
Doma Group
April 2022

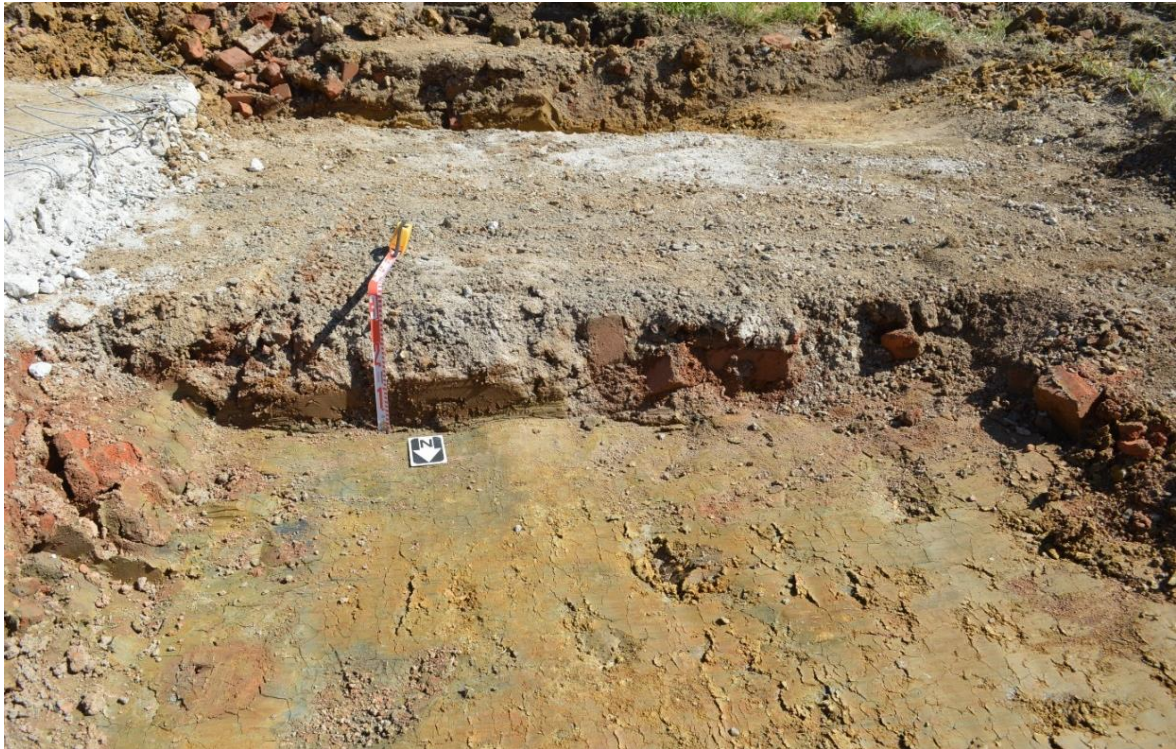
Figure 4.115 TT4, oil-stained natural beneath the levelling gravel deposit (27) and clay with brick rubble (26), aspect south.

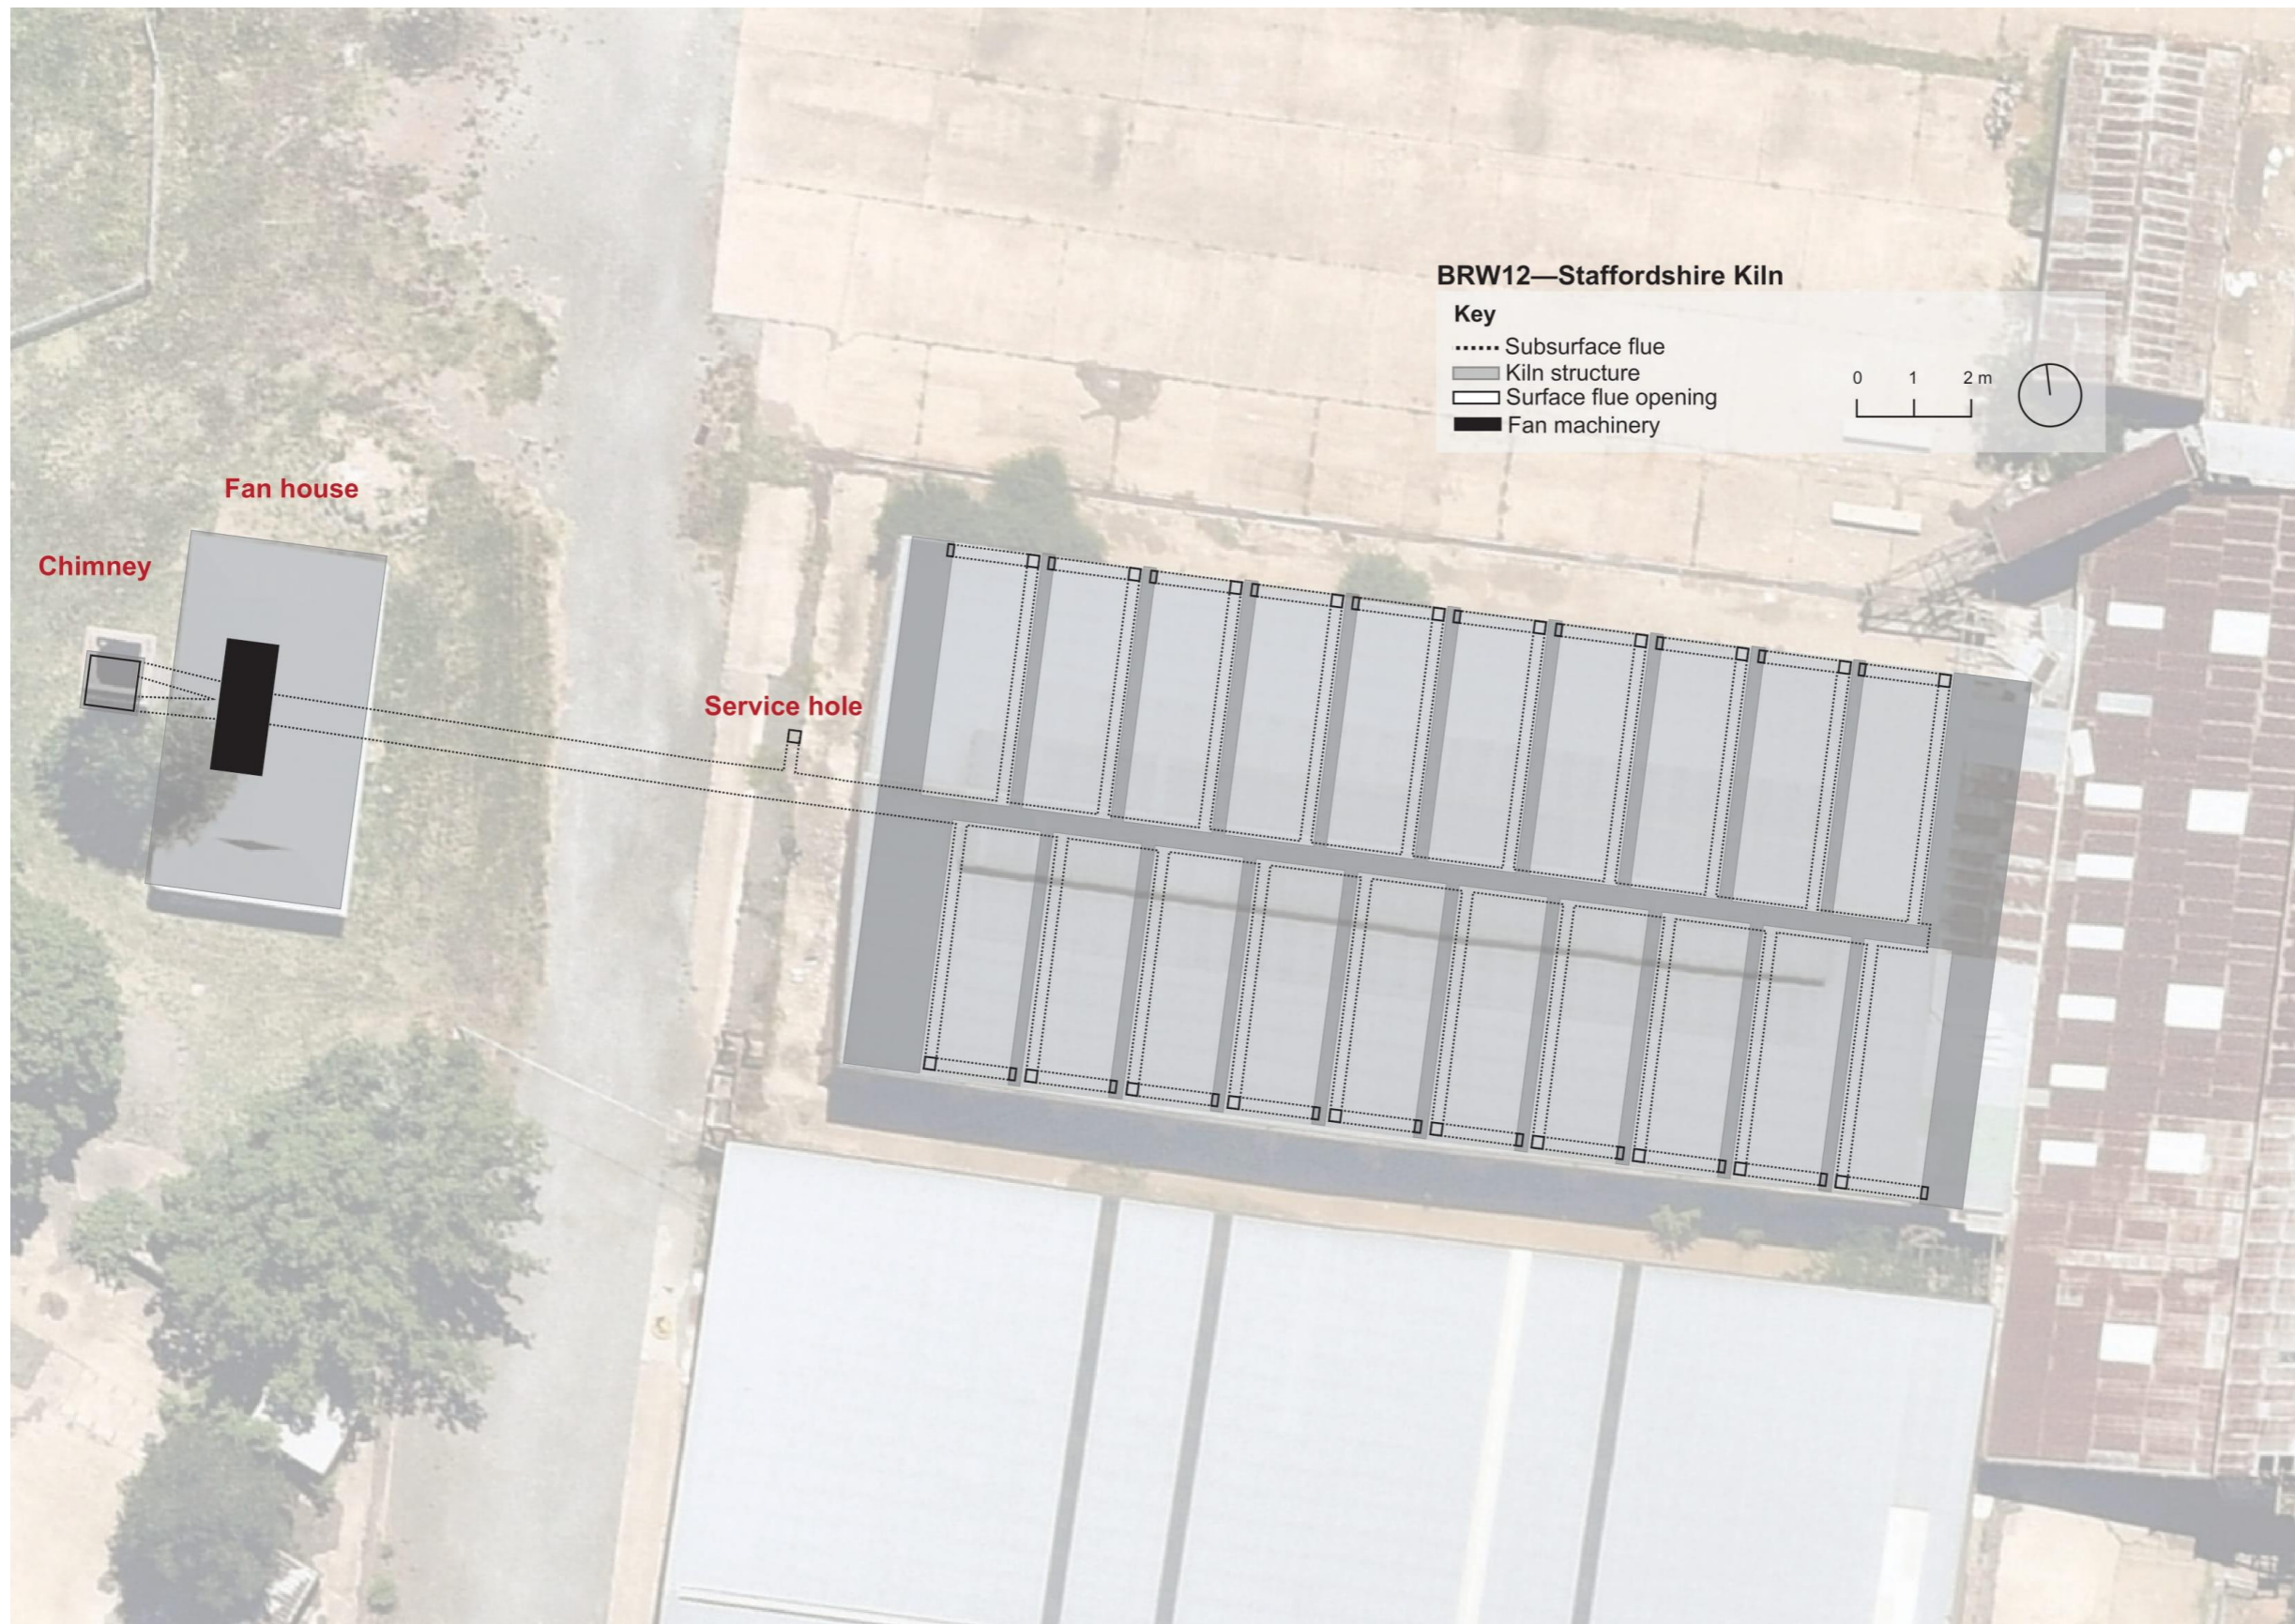
Figure 4.124 The subsurface flues for the Staffordshire Kiln.

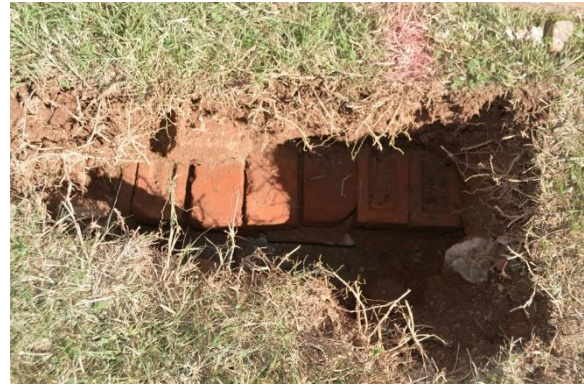
Figure 4.127 Part of a damaged remnant brick flue.

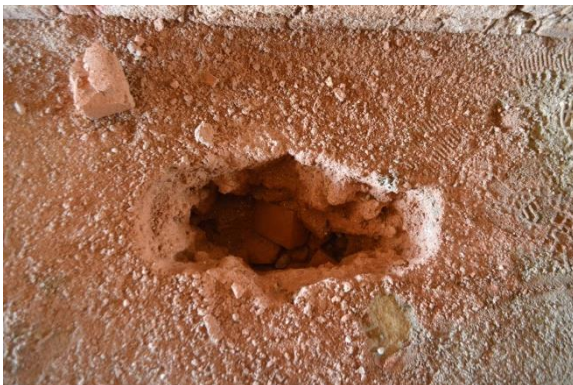
Figure 4.128 Brick rubble embedded beneath the floor surface in the western passage between the two kiln chambers.

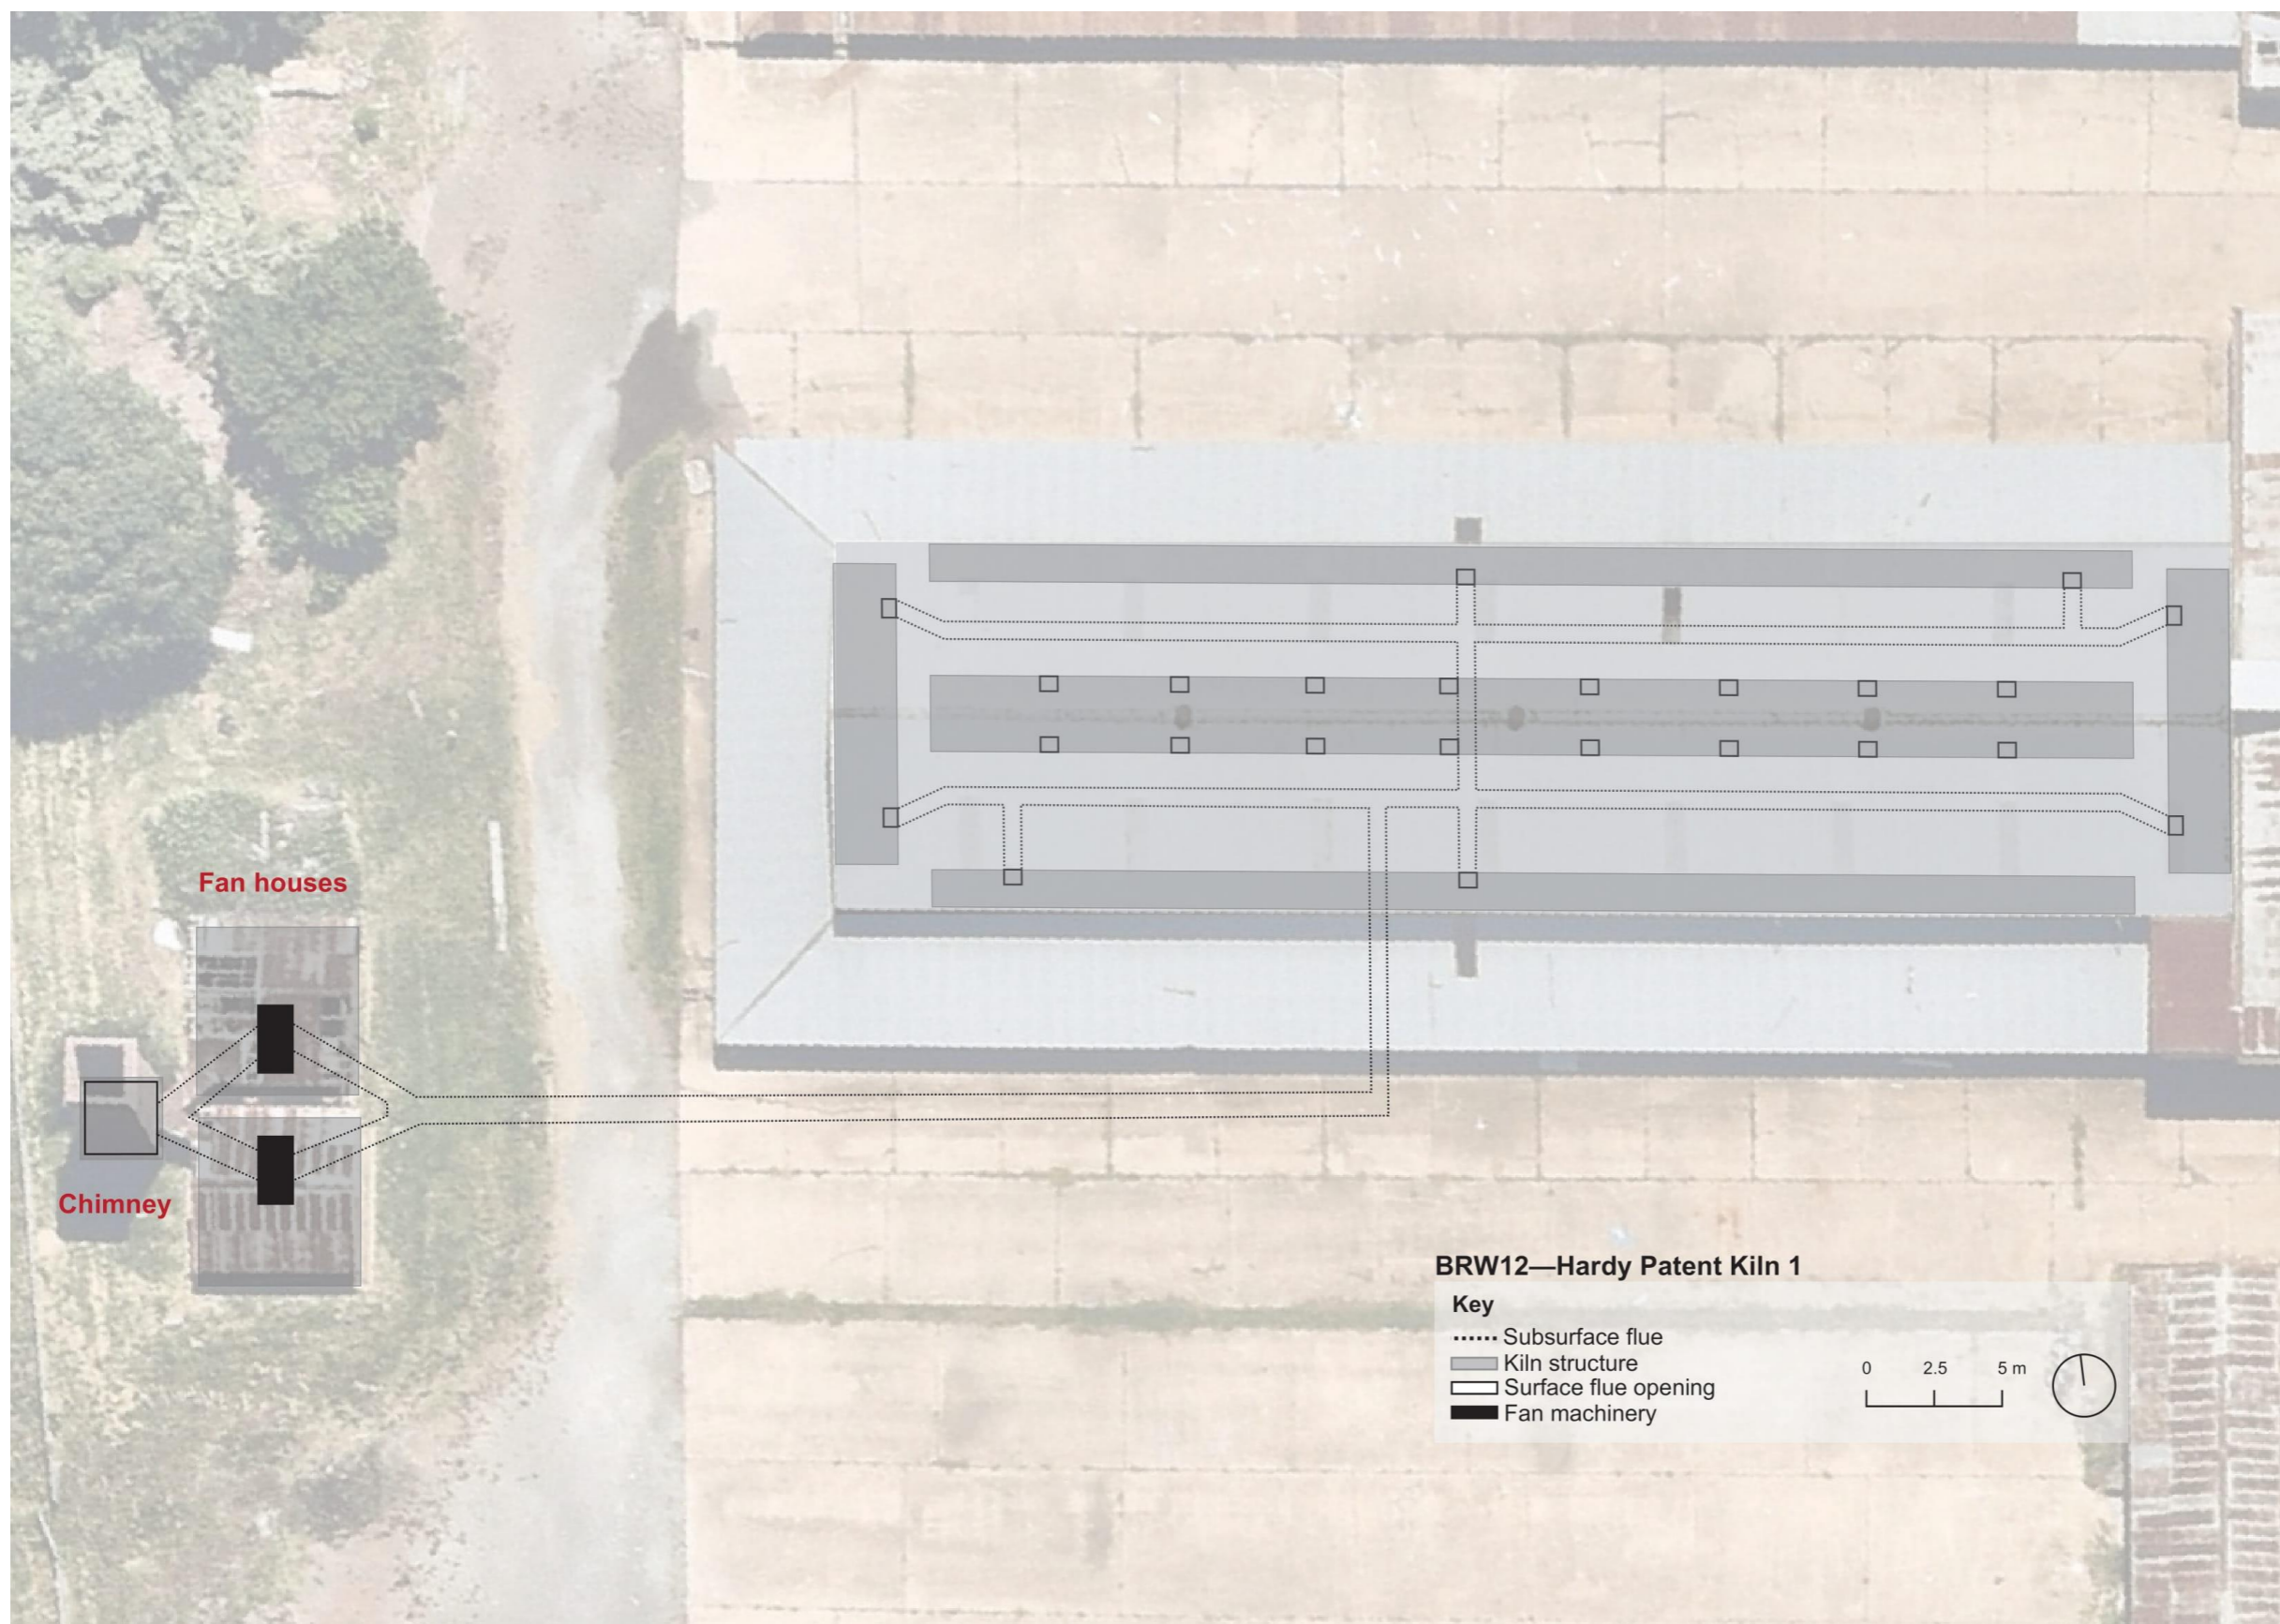
Figure 4.130 The subsurface flues for the Hardy Patent Kiln 1.

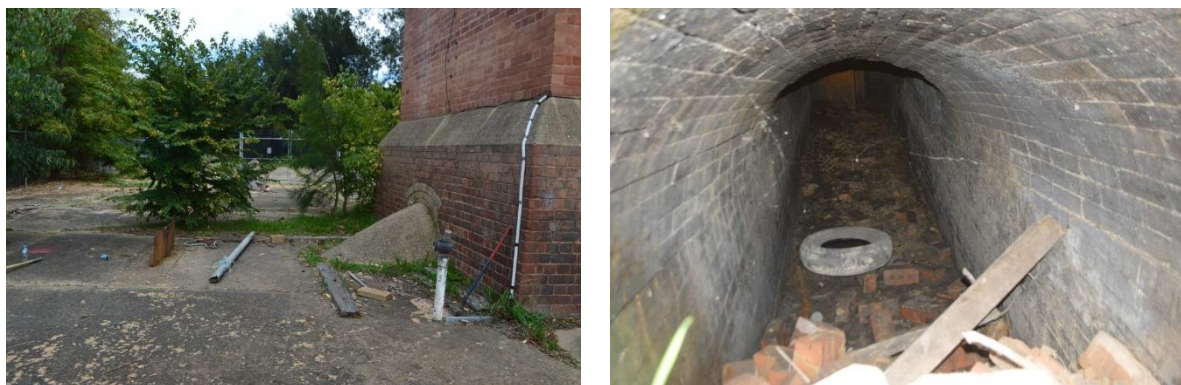
Figure 4.131 Steel dampeners blocked the flue tunnels from the chimney (left) and adjacent tunnel (right).

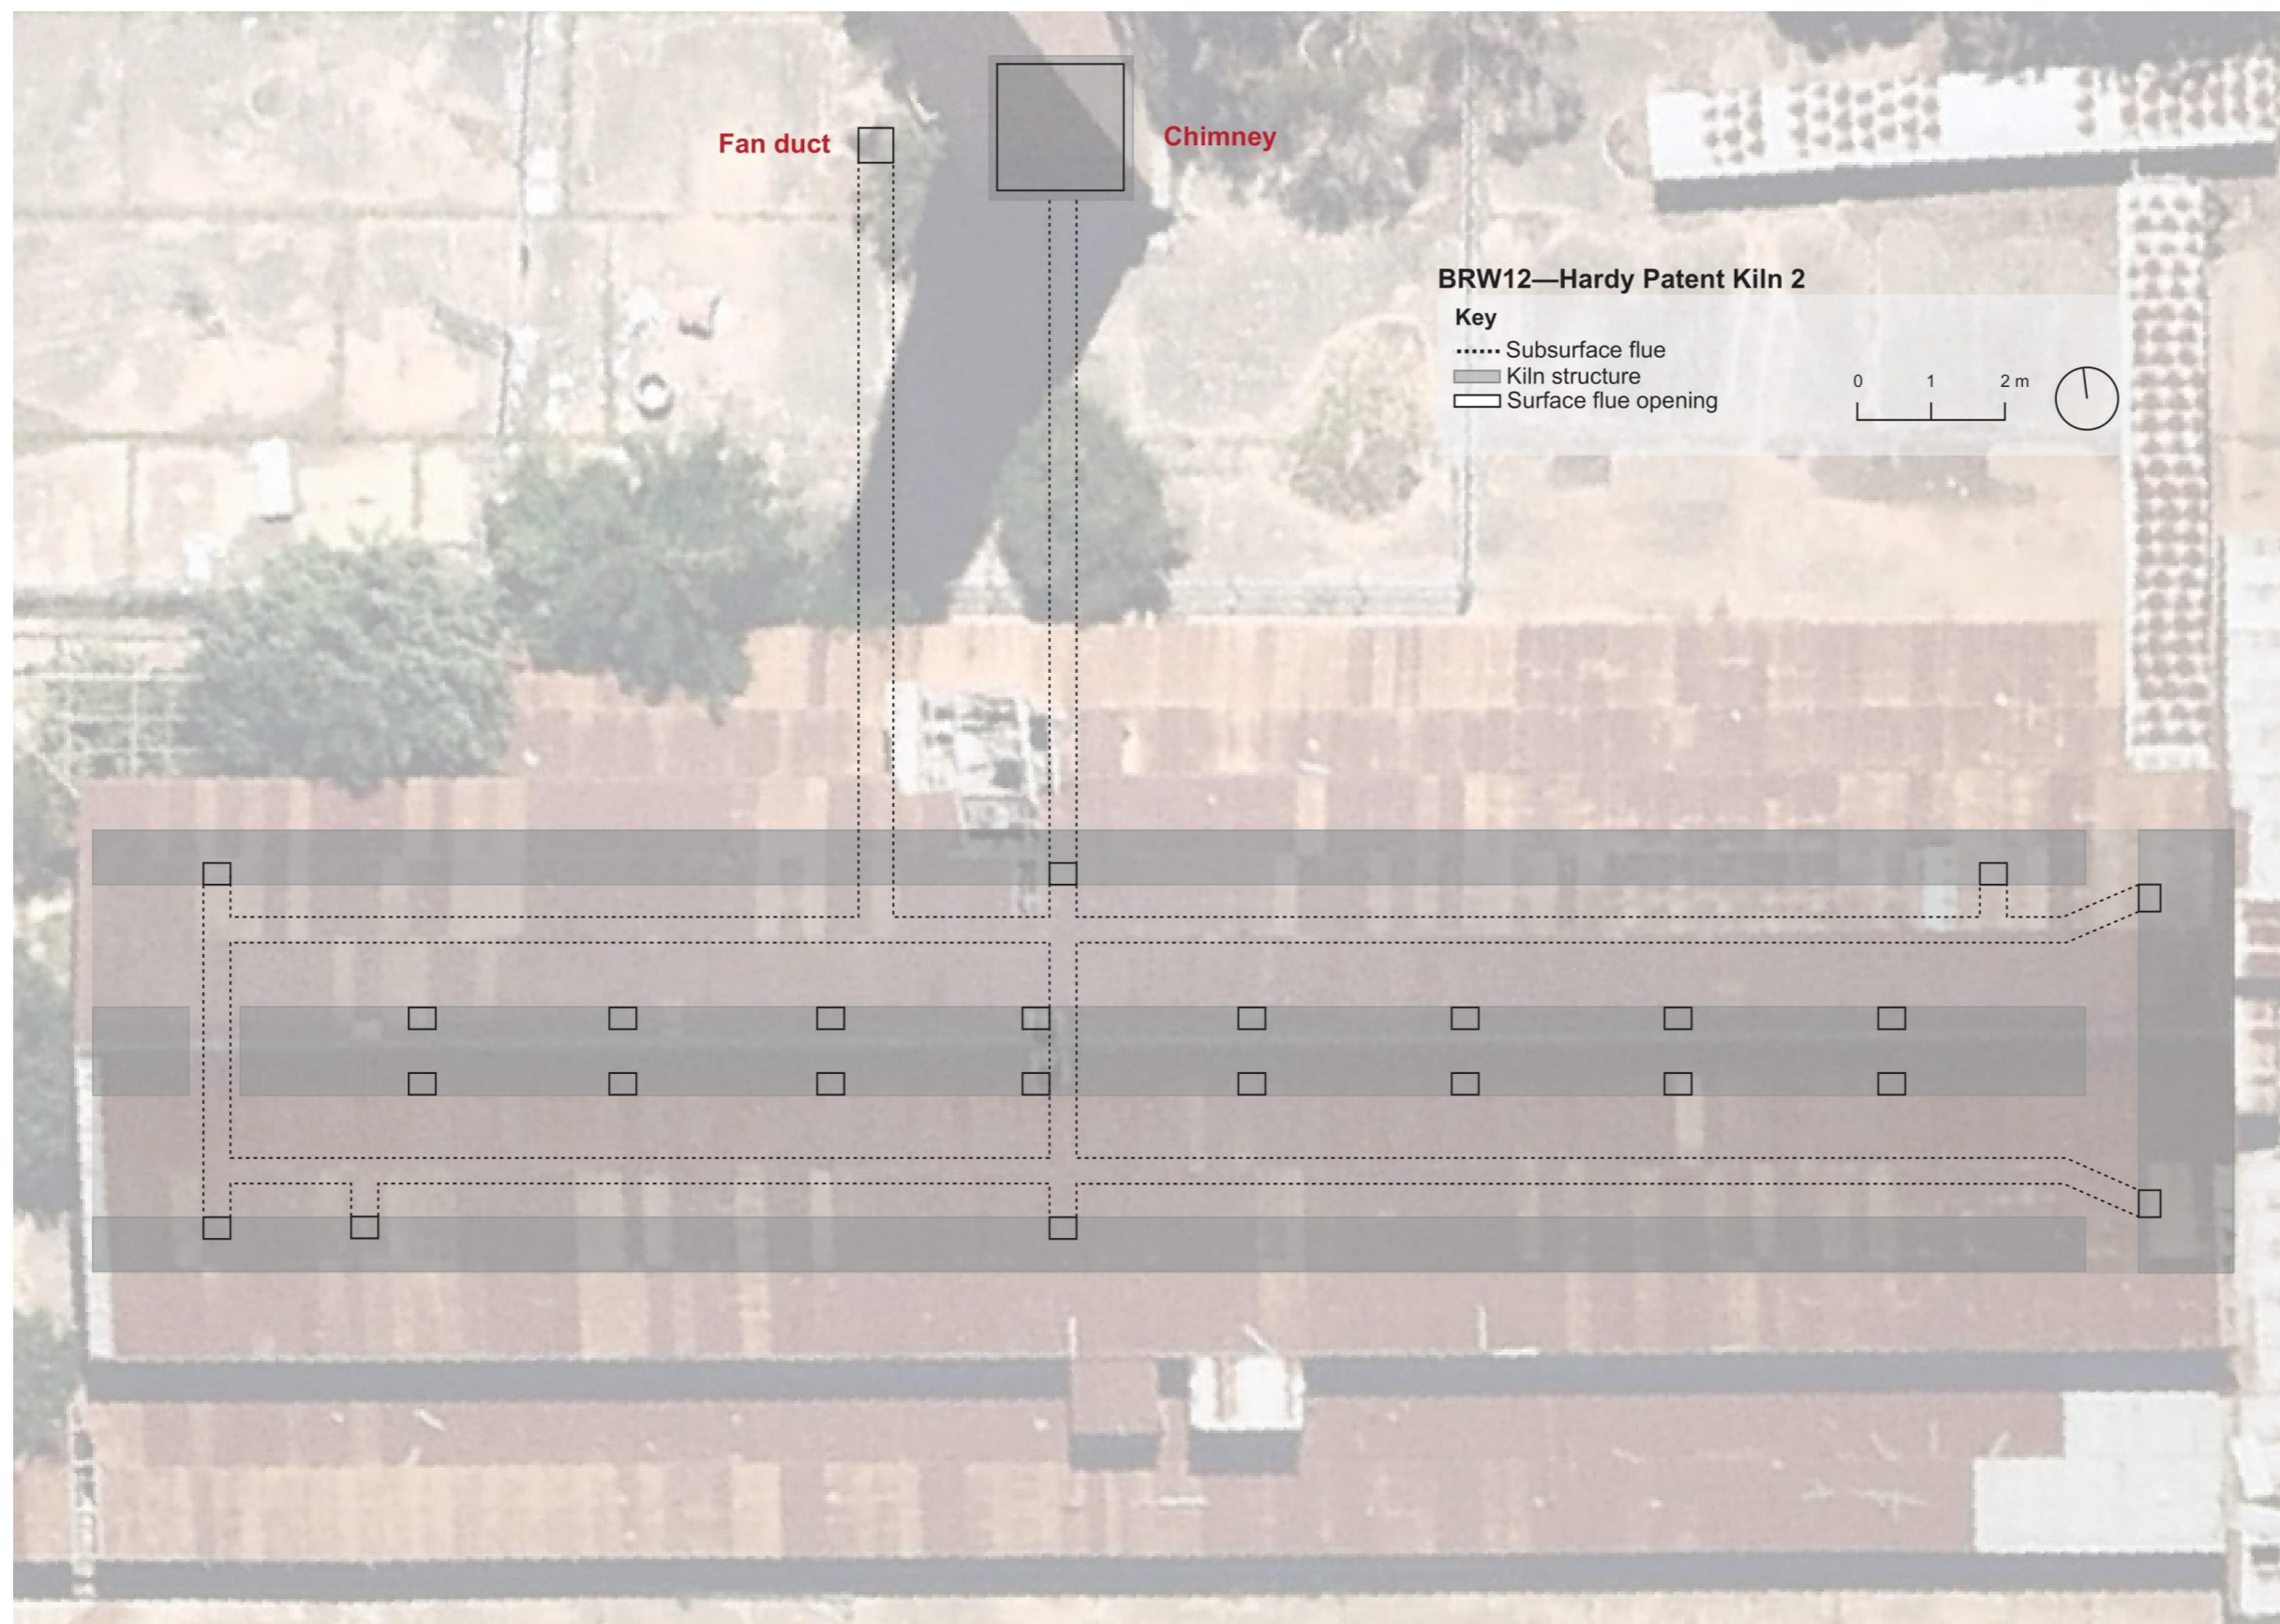
Figure 4.135 The subsurface flues for the Hardy Patent Kiln 2.

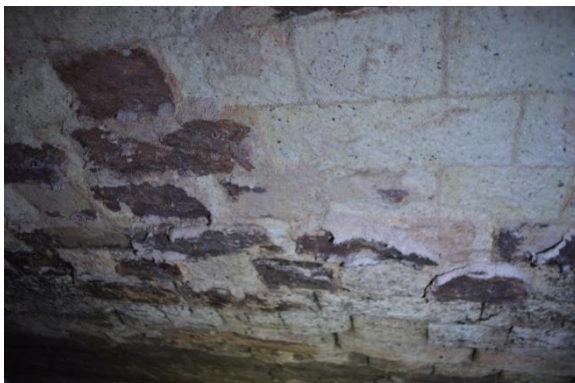
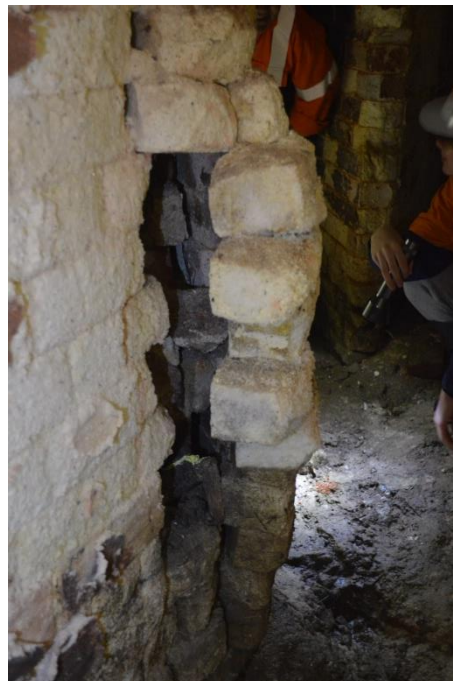
Figure 4.141 Damp conditions have resulted in extensive salt damage and cracking in the brickwork (see also Figure 4.136).

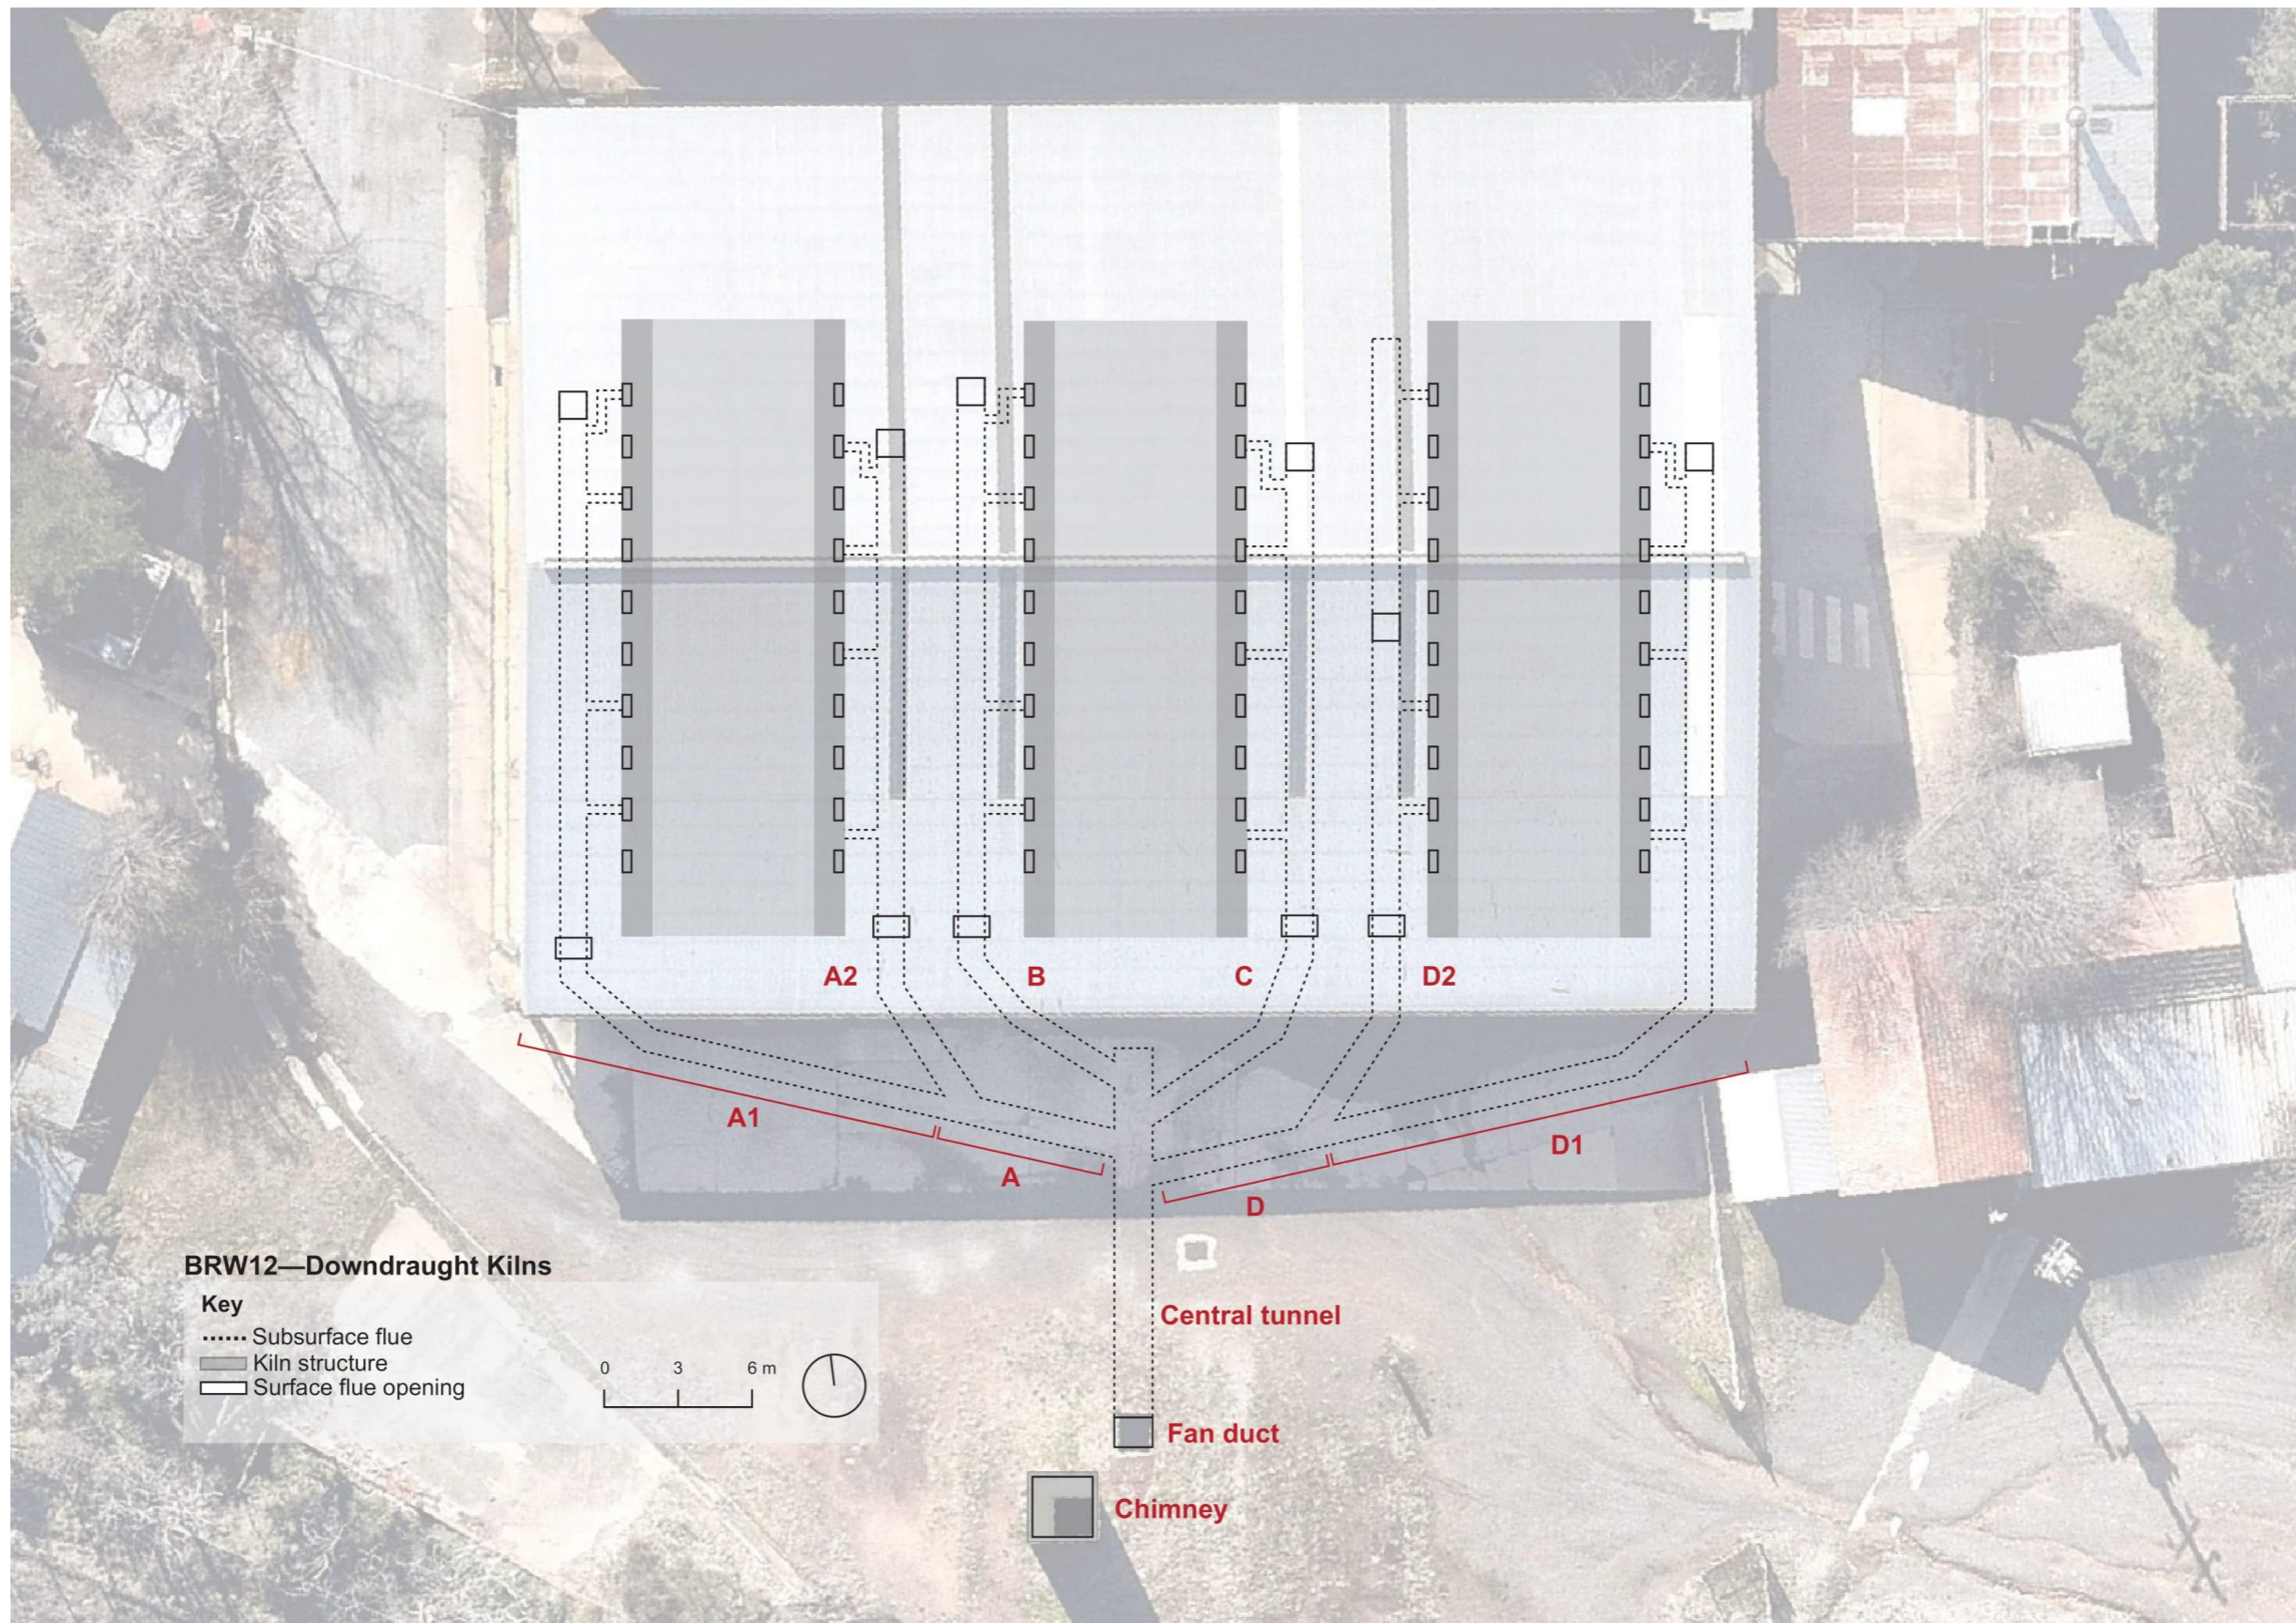
Figure 4.142 The subsurface flues for the Downdraught Kilns.
