Yarralumla Brickworks Precinct Tree Assessment Update

Tree Assessment Update and Historical Tree
Assessment Package

Prepared by dsb Landscape Architects
5 March 2023

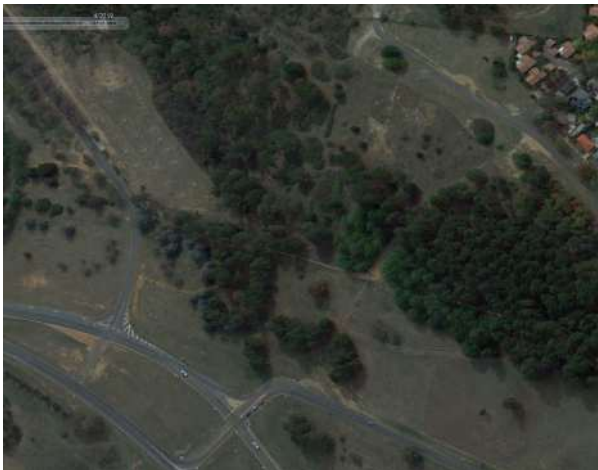
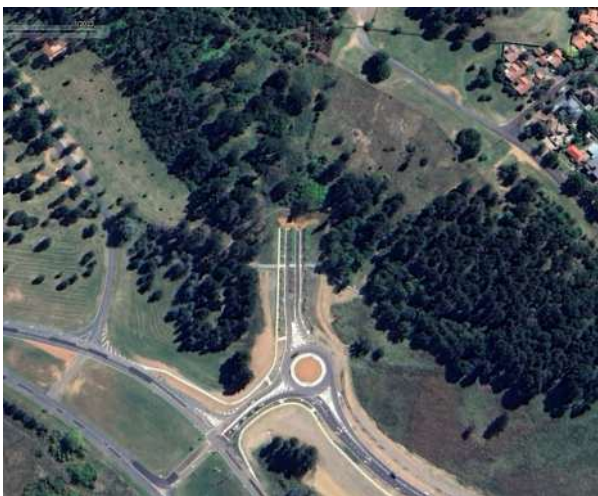
The other change is the loss of trees within the southern extent of Block 7. The construction of the Dudley Street roundabout and the access road into Block 7 has resulted in the loss of pine trees and reduction in the extent of the *Quercus cerris* plantation.

Dudley Street roundabout and access road construction are in place. *Quercus cerris* plantation is approximately 50% of previous. Management thinning and maintenance of this plantation is outstanding.
