CANBERRA
BRICKWORKS

**CONSERVATION
DEVELOPMENT
STRATEGY**

February 2015

STAGE 1
PUBLIC AND PEDESTRIAN ACCESS
BUILDING WORKS

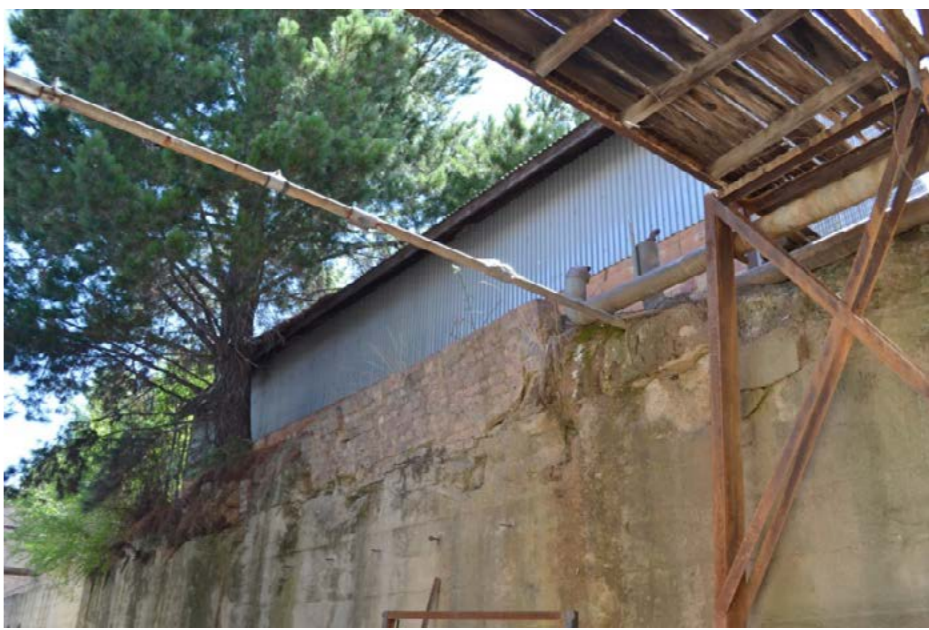
Building #	Building Name	Significance as identified in the 2010 CMP review	Make Safe - architectural	Make Safe - structural	Photo
01	Quarry	Core space	Ensure fencing to perimeter is secure and all existing holes and missing wires made good.		
02	Concrete retaining wall	Core element	Remove all vegetation.	Collapsed brickwork on the upper section of the retaining wall and retained soil should be removed. The tree should also be removed before it becomes too large and collapsed. Earth should be battered at 45 degrees

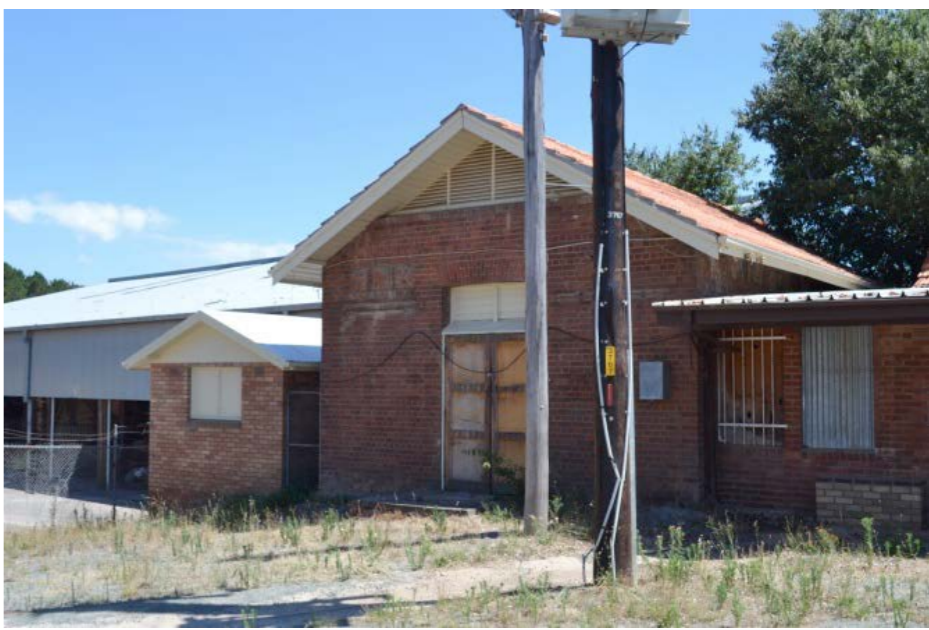
03	Power House	Core element	Investigate rainwater goods and make operational ensuring connection to storm water system. Secure openings.	Seal all windows to protect internal elements. Demolish retaining wall. This may also require underpinning of footings or demolition of adjacent small room. Further investigation required once wall has been demolished.

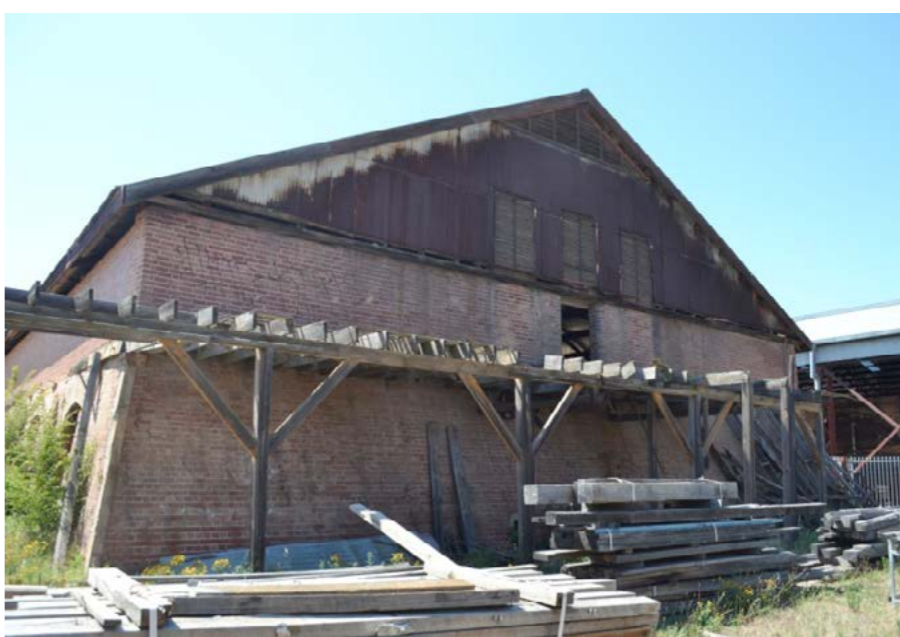
Building #	Building Name	Significance as identified in the 2010 CMP review	Make Safe - architectural	Make Safe - structural	Photo
04	Staffordshire Kiln (Kiln 1)	Core element	<p>Remove non-original skillion roof at west end of building.</p> <p>Rebuild fascias and install new eaves gutter and downpipes to upper level roof on north side. Connect to surface storm water drain system.</p> <p>Large capacity eaves gutters on south side abutting Building 22 discharges into galvanised down pipes. These are bent and distorted at base. Rectify damage to ensure direct discharge into open storm water drain.</p> <p>Remove vegetation and debris from open storm water drain to perimeter and ensure operational including discharge to and from pits.</p> <p>Secure all openings with CGI sheet or marine grade plywood to timber frame.</p> <p>Provide temporary covers to the vent pits located in the floors of the kilns to exclude vermin.</p> <p>Provide compliant stair access at west end.</p>	<p>Walls and roof should be waterproofed to prevent damage to the upper timber and steel structure by the elements. This includes completing brick veneer walls on upper floor and sealing west wall louvres.</p> <p>Masonry entry and archway should be reinforced to allow public access (20 off).</p> <p>All loose debris should be removed as necessary. All other members should be re-secured as required.</p> <p>Reinstate buckled steel angle brace.</p> <p>Seal holes from first floor. Ensure flat to remove trip hazard.</p>

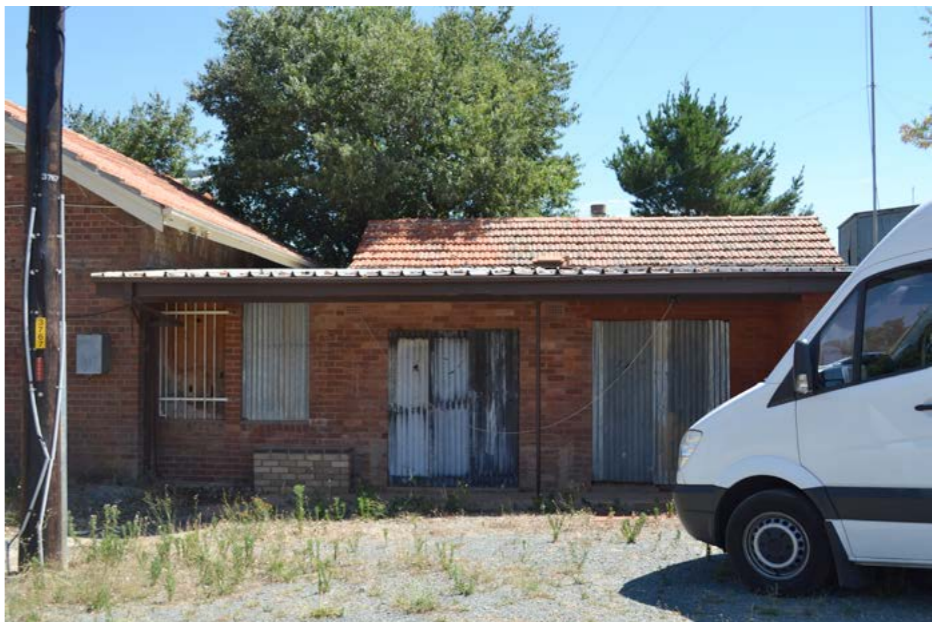
Building #	Building Name	Significance as identified in the 2010 CMP review	Make Safe - architectural	Make Safe - structural	Photo
07	Offices	Core element	Investigate rainwater goods and make operational ensuring connection to storm water system. Secure openings. Refix slipped tiles.

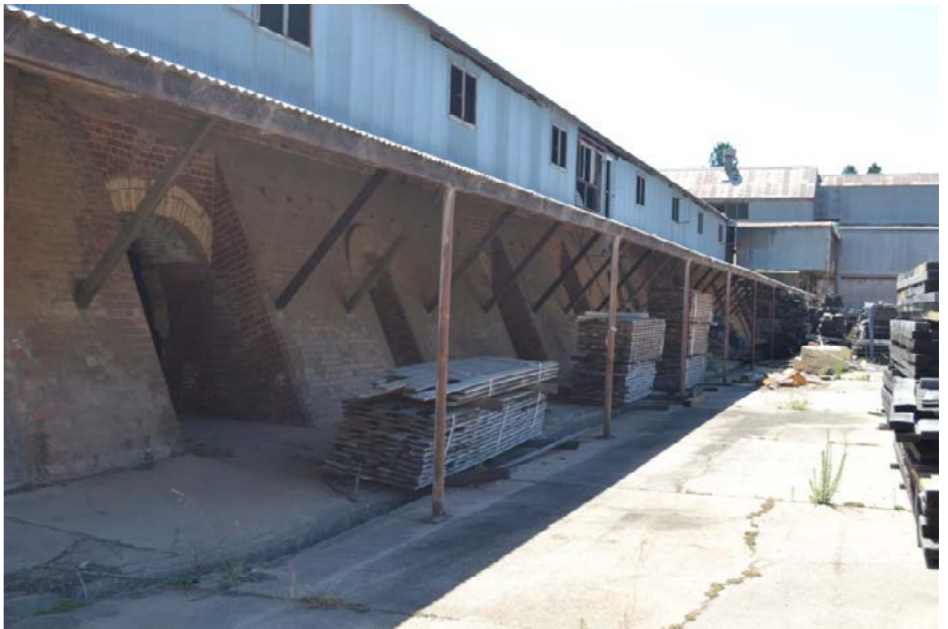
Building #	Building Name	Significance as identified in the 2010 CMP review	Make Safe - architectural	Make Safe - structural	Photo
08	Hardy patent Kiln (Kiln 2)	Core element	<p>Refix rusted and loose CGI roof sheeting. Reinststate fascias, eaves gutters and down pipes to both roof levels and connect to surface storm water drainage system.</p> <p>Remove vegetation and debris from open storm water drain to perimeter and ensure operational including discharge to pits and from pits.</p> <p>Secure all openings both levels with CGI sheeting or marine grade plywood or similar. Secure entry point /ladder access on south side of building</p>	<p>Walls and roof should be waterproofed to prevent damage to the upper timber and steel structure by the elements.</p> <p>Masonry and entry archways should be reinforced to allow public access (16 off).</p> <p>Masonry archways to kilns at ground floor should be strengthened to allow public access (2 off).</p> <p>Steel roof to timber lean-to (north and south) should be reinstated where panels are missing and rotted timbers replaced.</p> <p>Ceiling battens on first floor should be resecured or removed in their entirety.</p> <p>Seal chimney holes from first floor. Ensure flat to remove trip hazard.</p> <p>All timber members to timber walkway between building 4 and 7 should be replaced with new treated timber.</p> <p>Provide new compliant stair access to first floor.</p>

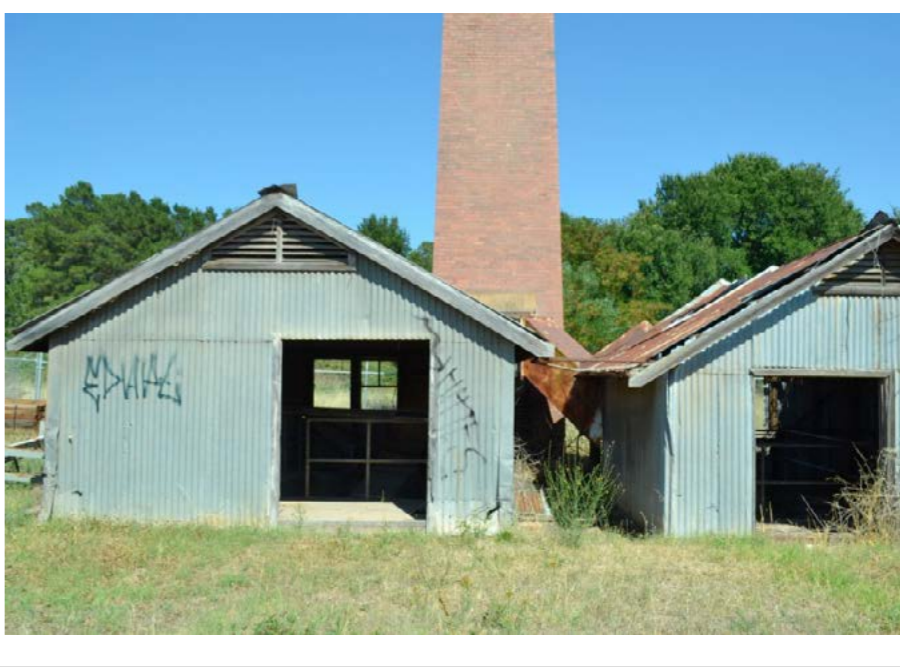
Building #	Building Name	Significance as identified in the 2010 CMP review	Make Safe - architectural	Make Safe - structural	Photo
09	Fan House for Kiln 2	Core element	<p>Refix rusted and loose CGI sheeting to walls. Allow to replace sections of rotted timber framing.</p> <p>Install new eaves gutters and down pipes, connect to storm water system on site.</p> <p>Replace CGI roof sheeting to full extent. Allow to install new battens to full extent.</p> <p>Secure all openings with CGI or marine grade ply.</p> <p>Remove invasive vegetation.</p>	<p>Replace collar ties to each line of rafters.</p> <p>Seal all windows and doors from the elements.</p> <p>Provide secure handrails around the internal pit.</p> <p>Fill sinkholes with suitable fill.</p>

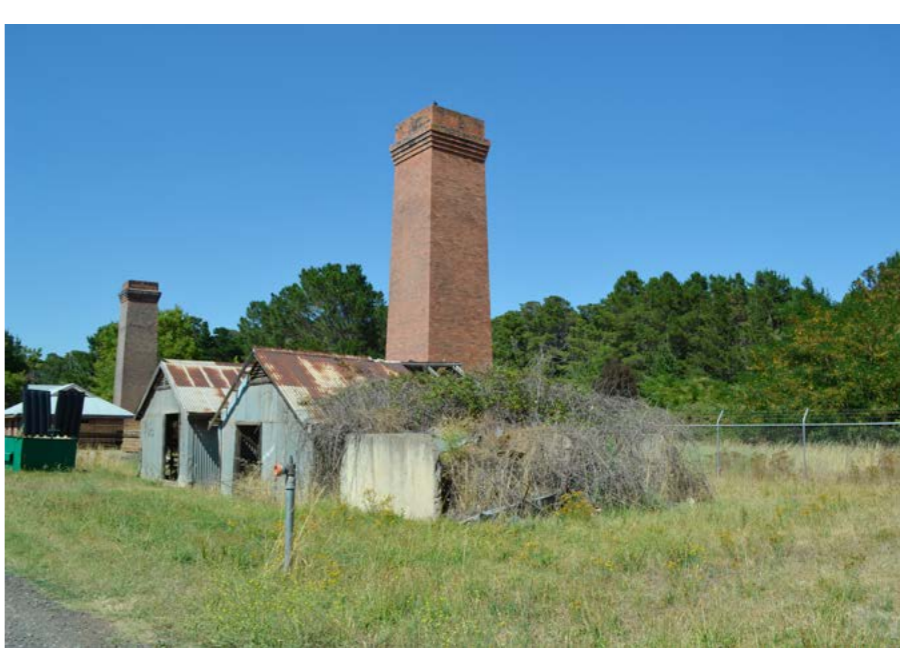
10	Chimney stack for Kiln 2	Core element	<p>Cap to make weather tight</p> <p>Brick growth to top course, refer Structural Engineer recommendations.</p> <p>Check lightning protection and rectify/replace if required.</p>	<p>Provide steel straps around top of chimney stack.</p>

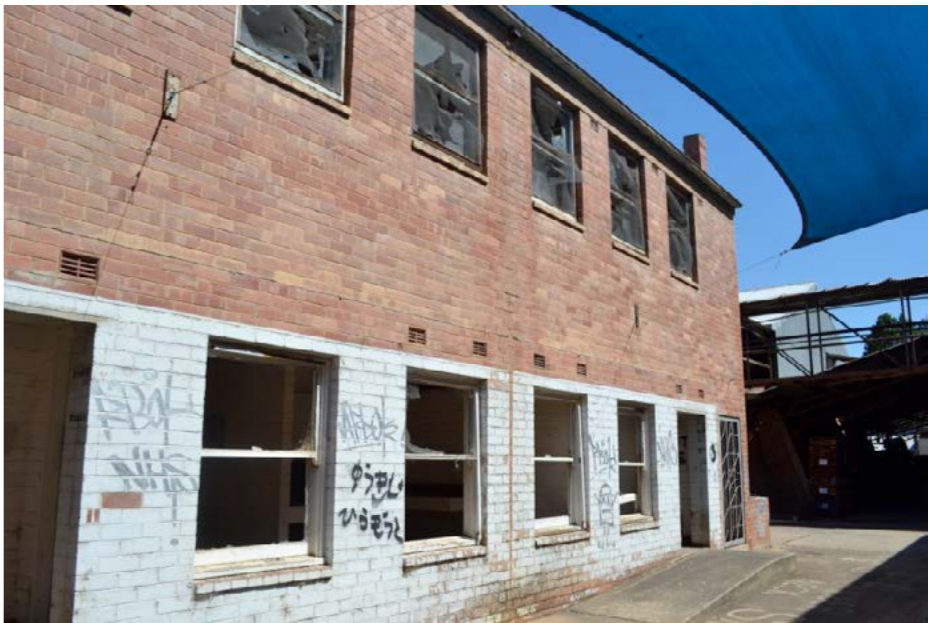
Building #	Building Name	Significance as identified in the 2010 CMP review	Make Safe - architectural	Make Safe - structural	Photo
11	Amenities Block	Supporting element	<p>Remove all damaged internal linings (assumed to be asbestos cement sheet).</p> <p>Remove all pigeon debris from interior (hazardous substance).</p> <p>Secure all openings with CGI sheeting or marine grade ply (note most window sashes glazing is broken or lost).</p> <p>Install new eaves gutters and fascias and downpipes and connect to storm water system.</p>	Seal all windows and doors to prevent further damage from elements.

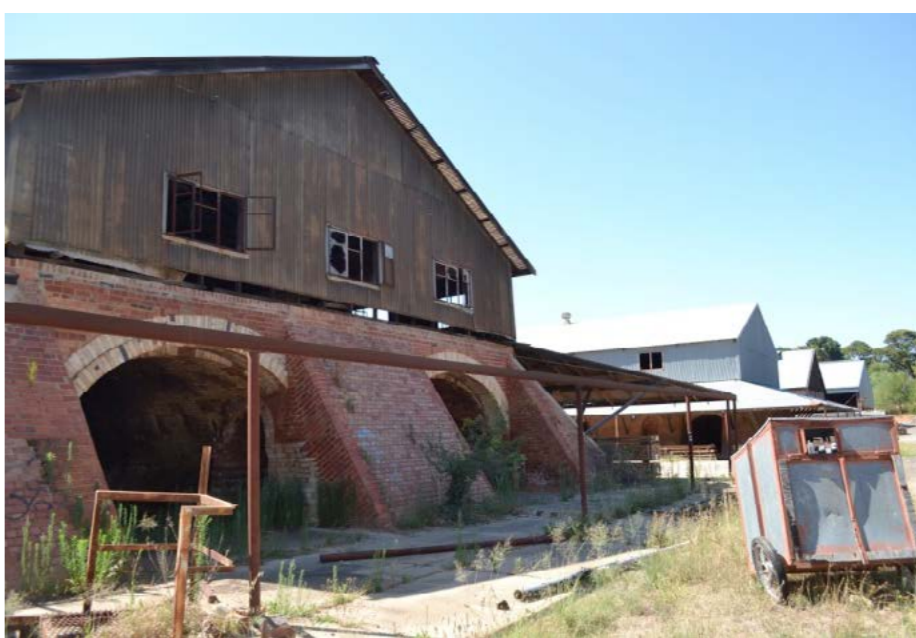
Building #	Building Name	Significance as identified in the 2010 CMP review	Make Safe - architectural	Make Safe - structural	Photo
12	Hardy Patent Kiln (Kiln 3)	Supporting element	<p>Eaves gutters generally in poor condition, install new eaves gutters and downpipes. Allow new fascias throughout. Direct DPs into open storm water drain around perimeter.</p> <p>Rectify all loose CGI sheeting to roof and replace cover flashings to barge ends to gable roofs.</p> <p>Timber skillion at ground level largely dismantled, roof sheeting removed and eaves gutters removed. Record (photography/measured drawings) and continue dismantling to make safe.</p> <p>Secure all openings both levels with CGI sheeting or marine grade plywood or similar to external face.</p> <p>Provide compliant stair on south side in existing location.</p> <p>Remove loose stone debris from roof.</p> <p>Remove vegetation from open storm water drain to perimeter and ensure operational including discharge to pits and from pits.</p>	<p>Walls and roof should be waterproofed to prevent damage to the upper timber and steel structure by the elements. Broken windows should be sealed as required.</p> <p>Masonry archways to kilns should be reinforced. Entry archways should be reinforced (16 off).</p> <p>Masonry archways should be strengthened to south west main entry (1 off).</p> <p>Sheet roof to timber lean-to should be reinstated where panels are missing and rotted rafters replaced.</p> <p>Replace roof truss where fire damaged (approx 20 m span)</p> <p>Seal holes from first floor.</p> <p>Fence and prevent access to timber walkway to north east.</p> <p>Provide new stair access to first floor.</p>

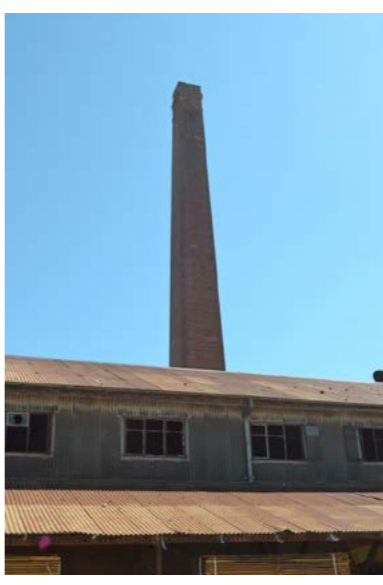
13	Chimney stack for Kiln 3	Core element	<p>Cap to make weather tight.</p> <p>Check lightning protection and rectify/replace if required.</p> <p>Openings already secured with steel mesh, make secure.</p>	<p>Provide steel plate strap around top of structure to secure brickwork (5 off).</p>

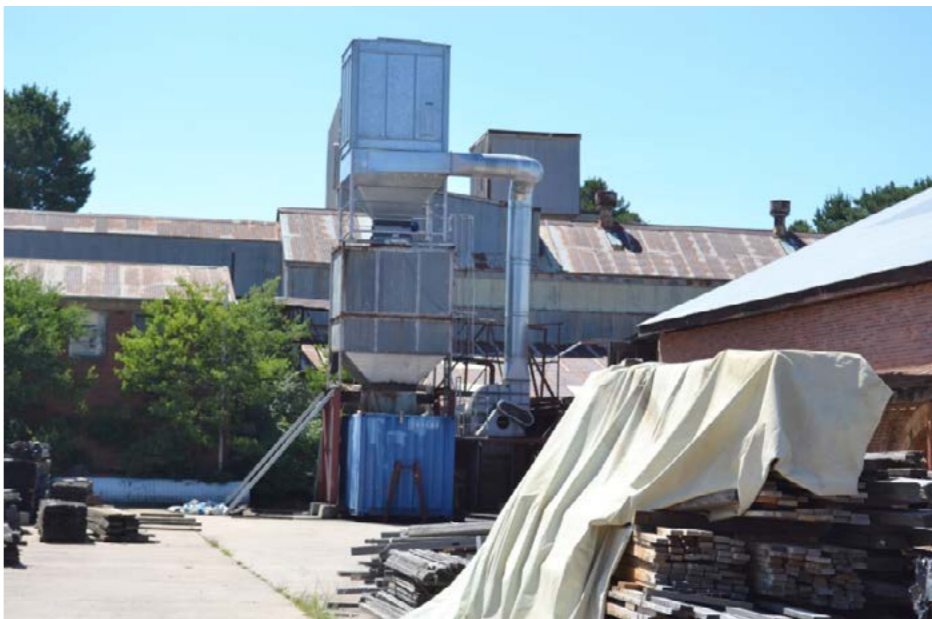
Building #	Building Name	Significance as identified in the 2010 CMP review	Make Safe - architectural	Make Safe - structural	Photo
14	Machine bay I for Kiln 1	Supporting element	<p>Eaves gutters generally in poor condition, install new eaves gutters and downpipes. Allow new fascias throughout. Direct DPs into open storm water drain around perimeter.</p> <p>Remove vegetation and debris from open storm water drain to perimeter and ensure operational including discharge to pits and from pits.</p>	<p>Removed wall braces should be replaced where they have been removed (4 off). Handrails should be provided to first floor penetrations.</p> <p>Reinstate wall framing and lining to south elevation first floor.</p> <p>Restrict public access to raised walkway above first floor.</p>

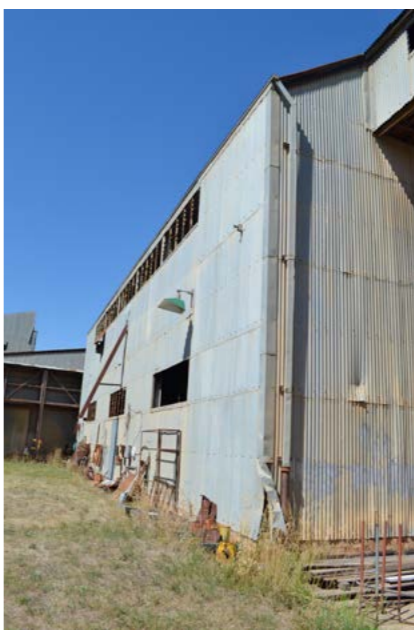
15	Machine bay II for Kiln 2	Supporting element	<p>Retain existing box and eaves gutters. Replace missing down pipes and direct into open storm water drain. Check the box gutters are fully lined and flashed – inspection was not possible from roof level.</p> <p>Secure all openings at ground level including rectification of semi-secured CGI lined gates/panels.</p> <p>Secure all window openings with CGI sheeting or marine grade plywood sheeting or similar. Note all louvre windows glazing smashed/removed.</p> <p>Cover openings in floor of upper levels.</p> <p>Remove vegetation and debris from open storm water drain to perimeter and ensure operational including discharge to pits</p>

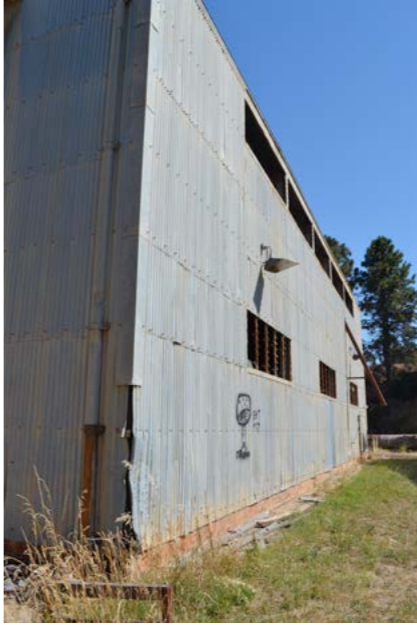
Building #	Building Name	Significance as identified in the 2010 CMP review	Make Safe - architectural	Make Safe - structural	Photo
16	Machine bay III for Kiln 3	Supporting element	<p>Retain existing box and eaves gutters. Replace missing down pipes and direct into open storm water drain. Check the box gutters are fully lined and flashed.</p> <p>Secure all openings at ground level including rectification of semi-secured CGI lined gates/panels.</p> <p>Secure openings with CGI sheeting or marine grade plywood sheeting or similar. Note all louvre windows glazing smashed/removed.</p> <p>Cover and secure openings in floor of upper levels.</p> <p>Remove invasive vegetation and debris from open storm water drain to perimeter and ensure operational including discharge to and from pits.</p>	<p>Repair trusses (2 off).</p> <p>Restrict access to public to timber deck above first floor.</p> <p>New stairway access should be provided to the first floor slab through the existing stairway voids (2 off). Handrails should be installed around the other first floor penetrations.</p> <p>Walls and roof should be waterproofed to prevent damage to the upper timber and steel structure by the elements. Broken windows should be sealed as required.</p> <p>Before waterproofing rotted timber purlins should be replaced with new where damaged.</p> <p>Reinstate wall framing to north elevation and lining to north elevations. Demolish timber deck and remove access to north upper deck.</p> <p>Replace missing wall braces as required (2 off).</p> <p>Treat spalled concrete and reinforcement to underside of floor slab.</p>

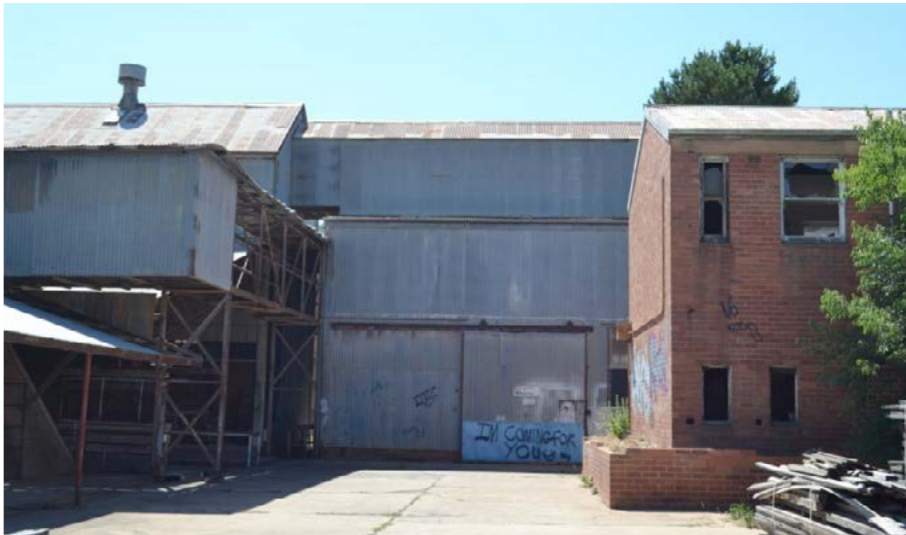
17	Workshop	Supporting element	<p>Install new fascias, eaves gutters and down pipes. Connect to storm water system.</p> <p>Secure openings with CGI sheeting or marine grade plywood sheeting or similar. Note all louvre windows glazing smashed/removed to east side.</p> <p>Remove invasive vegetation and debris from open storm water drain to perimeter and ensure operational including discharge to and from pits</p>	<p>Seal windows to prevent further damage.</p> <p>Restrict access to timber walkway.</p>

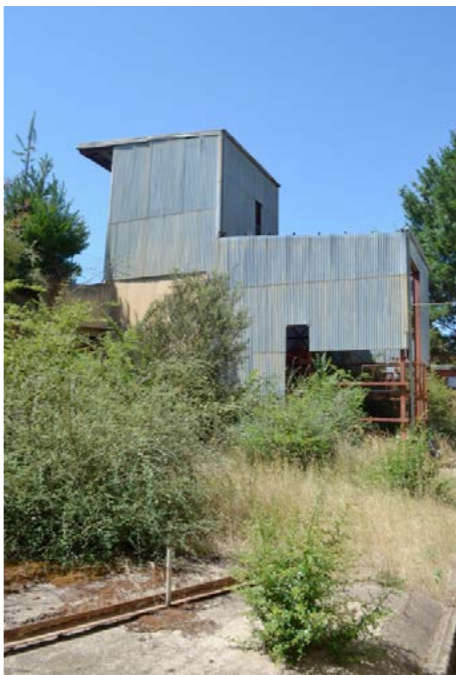
Building #	Building Name	Significance as identified in the 2010 CMP review	Make Safe - architectural	Make Safe - structural	Photo
18	Small crusher house (Crusher House I)	Supporting element	<p>This building is unroofed to lower section. No change.</p> <p>Upper section that is roofed retain and ensure connection of existing eaves gutters via down pipes to storm water system</p> <p>Remove all invasive vegetation.</p> <p>Remove vegetation and debris from open storm water drain to perimeter and ensure operational including discharge to and from pits.</p> <p>Remove all equipment and debris that is not associated with the brickworks.</p>	<p>Remove loose and damaged timber elements.</p> <p>Restrict access to public.</p>

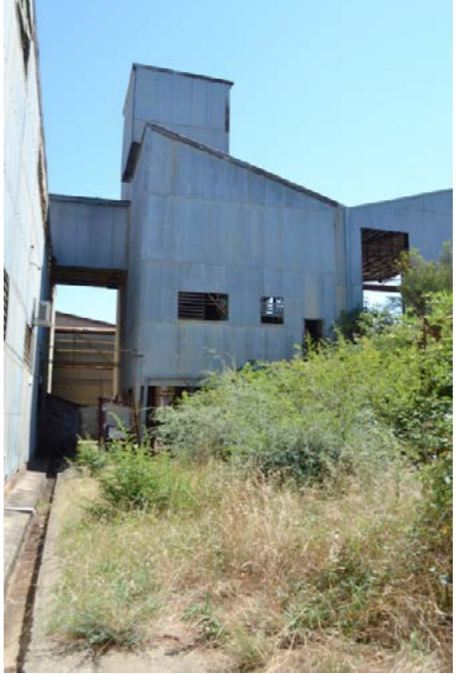
19	Large Crusher House (White pan room/ Crusher House II)	Supporting element	<p>Remove all equipment and debris that is not associated with the brickworks.</p> <p>Retain existing roof, allow refixing loose CGI sheeting and ensuring connection of existing eaves gutters via down pipes to storm water system.</p> <p>Remove invasive vegetation and debris from open storm water drain to perimeter and ensure operational including discharge to and from pits.</p> <p>Remove invasive vegetation.</p> <p>Fence off all levels of building to perimeter to restrict access/entry.</p>	<p>Wall braces should be replaced where they have been removed (3 off).</p> <p>Remove debris from floor and higher levels.</p> <p>Reinstate damaged and removed CGI wall and roof sheeting.</p> <p>Provide fencing around the base of the building to prevent public access.</p>

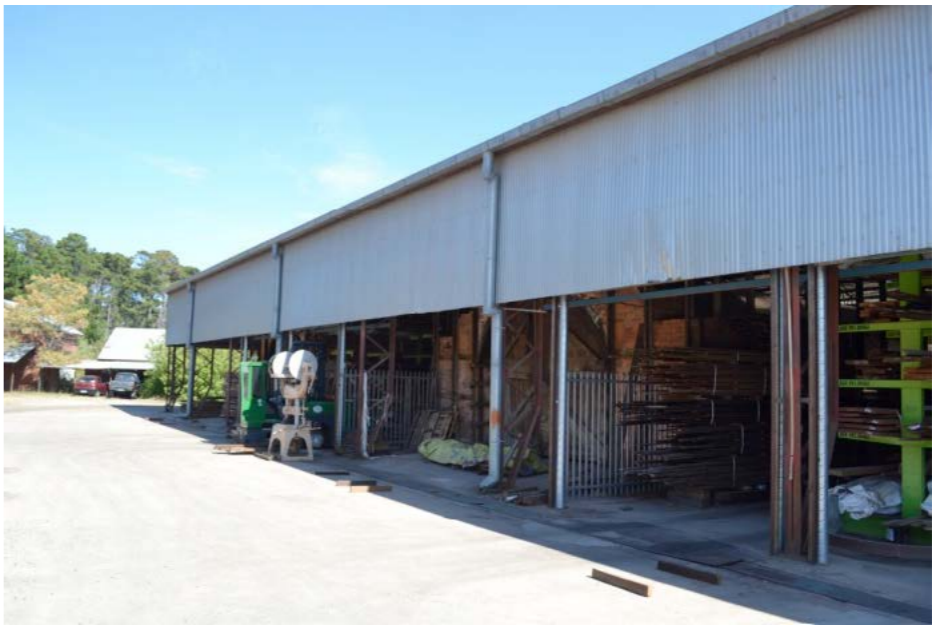
Building #	Building Name	Significance as identified in the 2010 CMP review	Make Safe - architectural	Make Safe - structural	Photo
22	Downdraft Kilns (Kiln 4-5)	Supporting element	<p>Remove loose stone debris from roof. Rectify damaged galvanised down pipes at base where damaged by traffic to north and south. Remove invasive vegetation from open storm water drain to perimeter and ensure operational including discharge to pits.</p>	<p>Reinstate welds/connections where they have been damaged. Install mesh over brickwork where currently loose to prevent falling debris. Reinstate missing wall braces to match existing. Damaged portal columns should be straightened to original condition.</p>

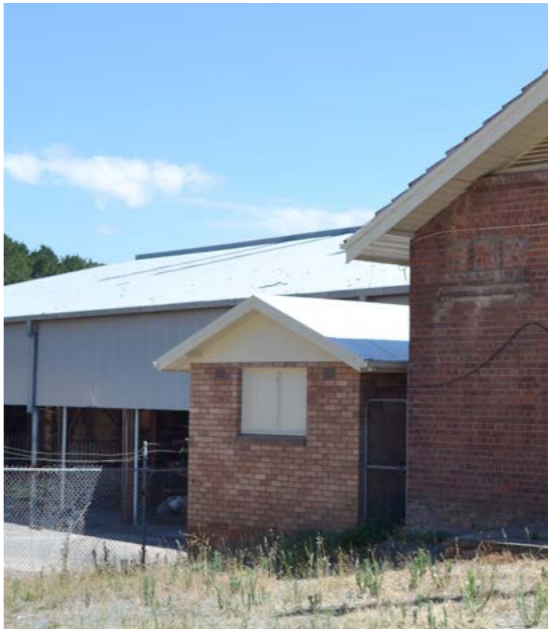
23	Downdraft kiln control room	Supporting element	<p>Remove/poison grub out all invasive vegetation (blackberry). Rebuild retaining wall to west side – Refer notes retaining wall in Building #03 Confirm existing storm water system is operational. Secure all openings with CGI steel sheet or marine grade plywood.</p>

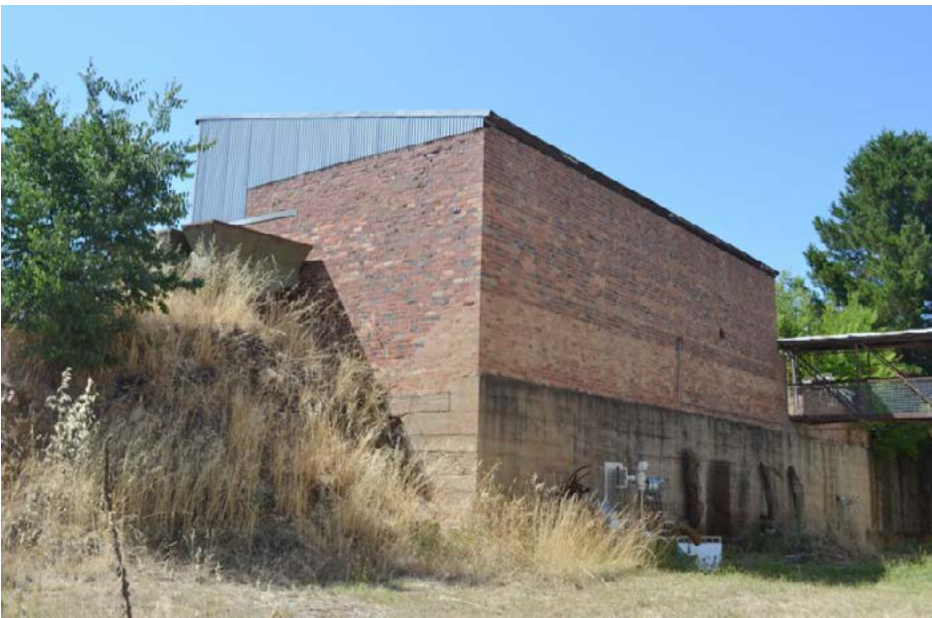
Building #	Building Name	Significance as identified in the 2010 CMP review	Make Safe - architectural	Make Safe - structural	Photo
33	Model railway workshop	Incidental element	<p>Install new eaves gutters (allow replacement of fascias) and new downpipes. Connect into storm water system.</p> <p>Secure all openings with CGI sheet or marine grade plywood.</p>	<p>Possible underpinning may be required due to the demolition of the adjacent retaining wall.</p> <p>Collapsed brickwork on the upper section of the retaining wall and retained soil should be removed. The tree should also be removed before it collapses. Earth should be battered at 45 degrees away from the top of the wall.</p> <p>The adjacent buildings (33 and 34) should be monitored during the demolition.</p> <p>Building 33 should be underpinned during the wall removal.</p>
