# Kingston Arts Precinct

1D: PRECINCT CONCEPT DESIGN REPORT

VOLUME 2 - APPENDICES

Stormwater & Sewer Hydraulics Investigation

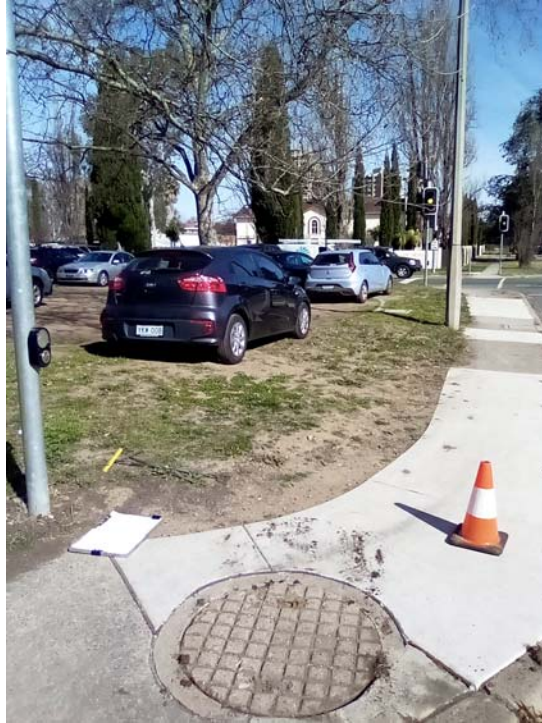
| PIT ID: | P6 |

| STRUCTURE: | SMH (Silted) |
