30 September 2022

Arboricultural Impact Assessment and Tree Management Plan

350 Antill Street Watson ACT

Report Reference No. 9840

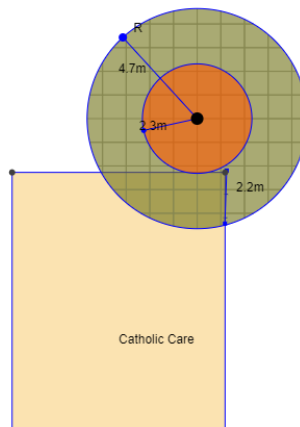
Tree 1

TPZ radius = 4.7m
TPZ area = 68.0m²
SRZ radius = 2.3m (R)
Catholic Care
Encroachment: 14.2
Encroachment area: 9.6 m²

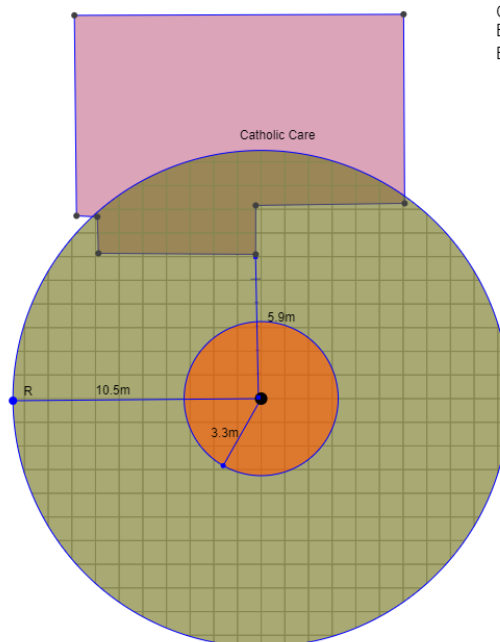
Tree 38

The encroachment on tree 86 is so minimal that it is unlikely to have an effect on the tree. Considering the age, health, and condition of tree 38 and the existing offset to the south of the tree, the impact of this encroachment will be reduced.

TPZ radius = 10.5m
TPZ area = 345.6m²
SRZ radius = 3.3m (R)
Catholic Care
Encroachment: 9.8
Encroachment area: 33.9 m²

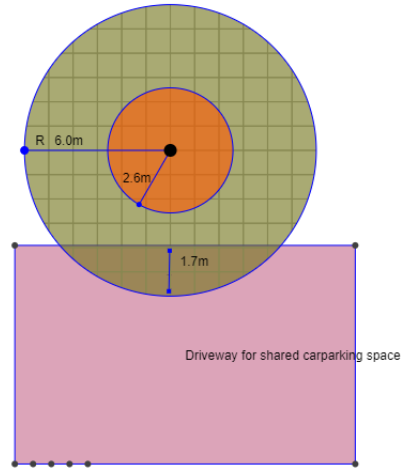
Tree 54

TPZ radius = 6.0m
 TPZ area = 113.1m²
 SRZ radius = 2.6m (R)

Driveway for shared carparking space
 Encroachment: 11.3
 Encroachment area: 12.8 m²

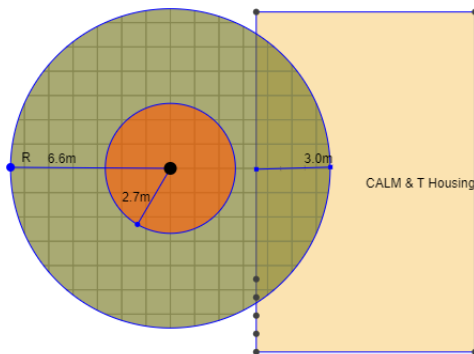
Tree 59

TPZ radius = 6.6m
 TPZ area = 135.7m²
 SRZ radius = 2.7m (R)
 CALM & T Housing
 Encroachment: 17.3
 Encroachment area: 23.4 m²

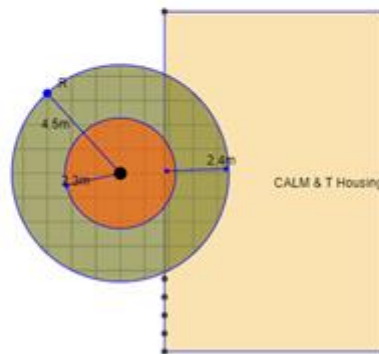
Tree 60

TPZ radius = 4.5m
 TPZ area = 62.6m²
 SRZ radius = 2.3m (R)
 CALM & T Housing
 Encroachment: 24.4
 Encroachment area: 15.3 m²

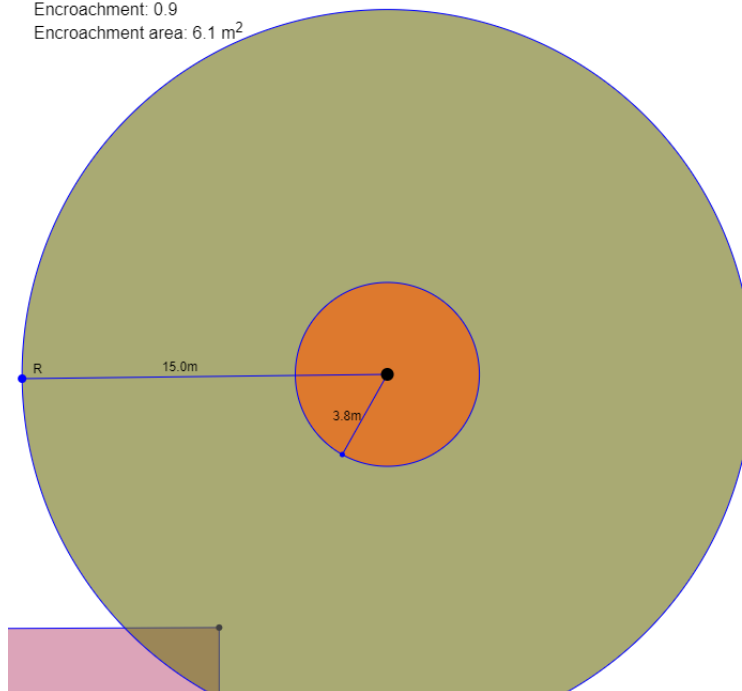
Tree 86

TPZ radius = 15.0m
 TPZ area = 708.8m²
 SRZ radius = 3.8m (R)
 S2
 Encroachment: 0.9
 Encroachment area: 6.1 m²

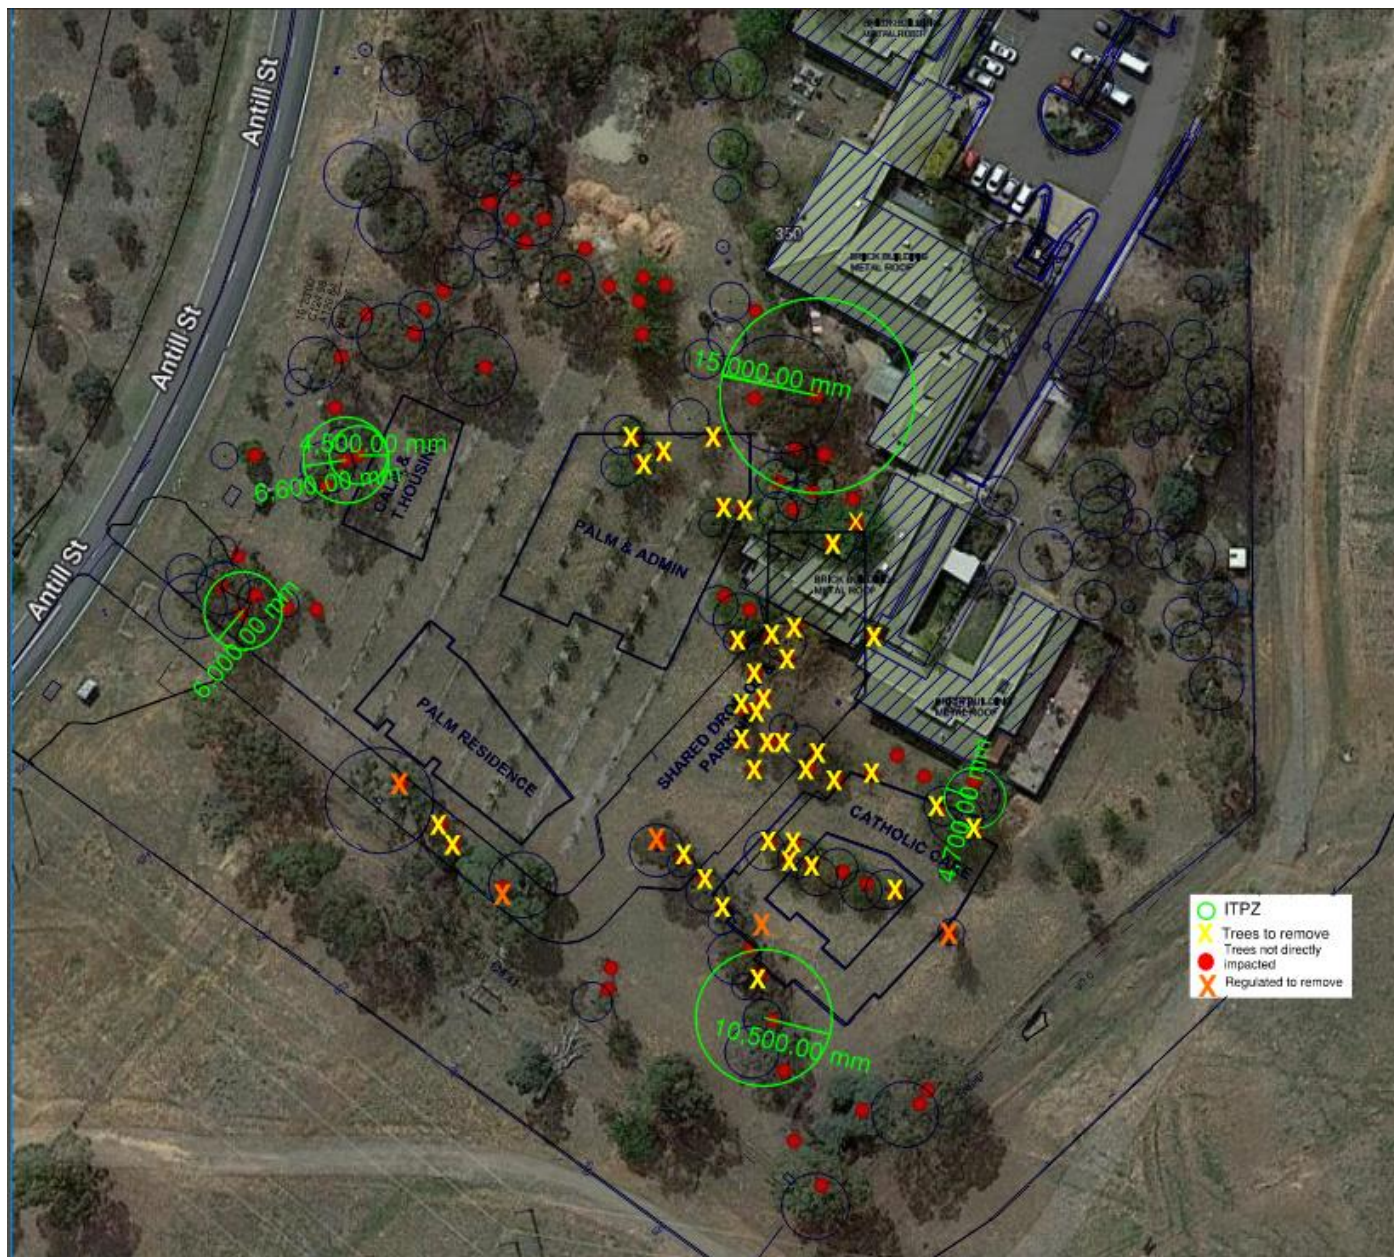
TPZ and tree removal map

If the proposed development proceeds as per supplied plans, the retention of the following trees is not possible. **Trees: 2,3, 6-21, 24, 25, 28-37, 47-50, 82-85, 91 and 95-97**, a total of 43 trees will need to be removed.

Trees: **24, 32, 36, 47 and 50** are of a regulated size and will require approval from the Tree Protection Unit for removal. All of these trees are species endemic to the area and are within the threatened woodland area.
