PRELIMINARY SITE INVESTIGATION

BLOCK 5, SECTION 46
GREENWAY, ACT

Prepared for: Construction Consultants
Date: 10 December 2023
Reference: JC1469
Version: JC1469/01

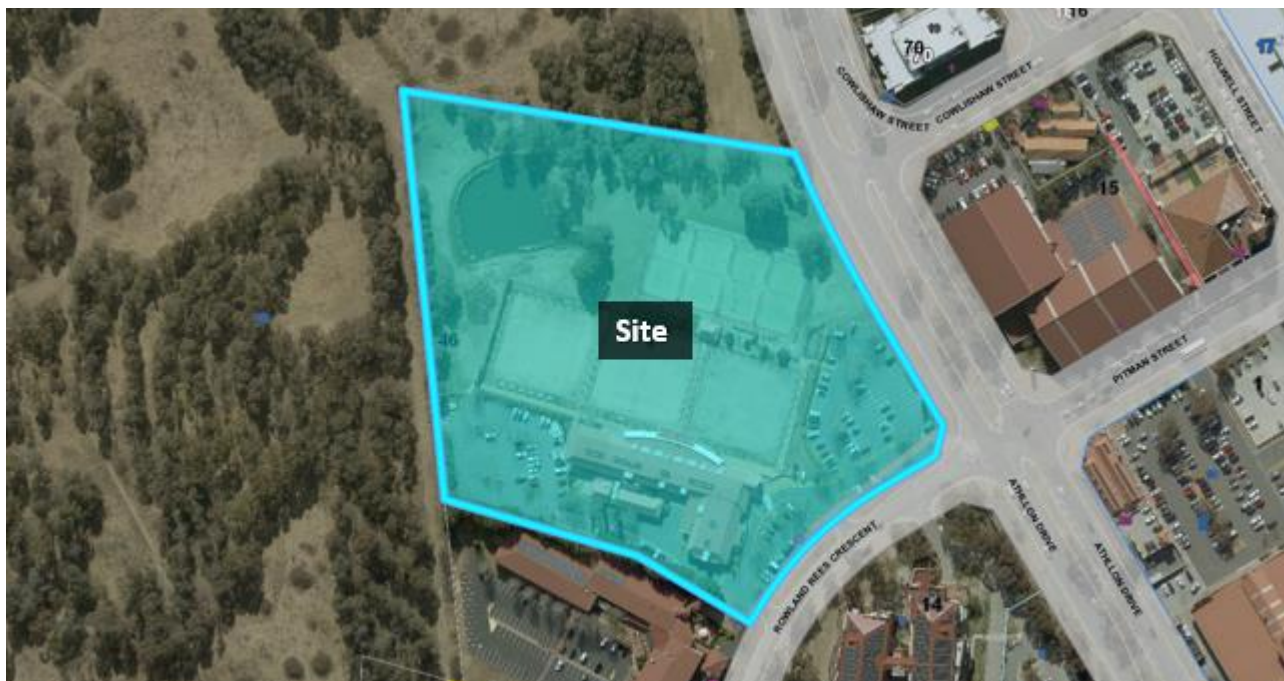
Figure 2: Site Plan

The site is situated in the division of Greenway and is bound by Athlon Drive and commercial buildings to the northeast and east, Rowland Crescent and commercial buildings to the south, and urban open space, river corridor to the west and northwest.

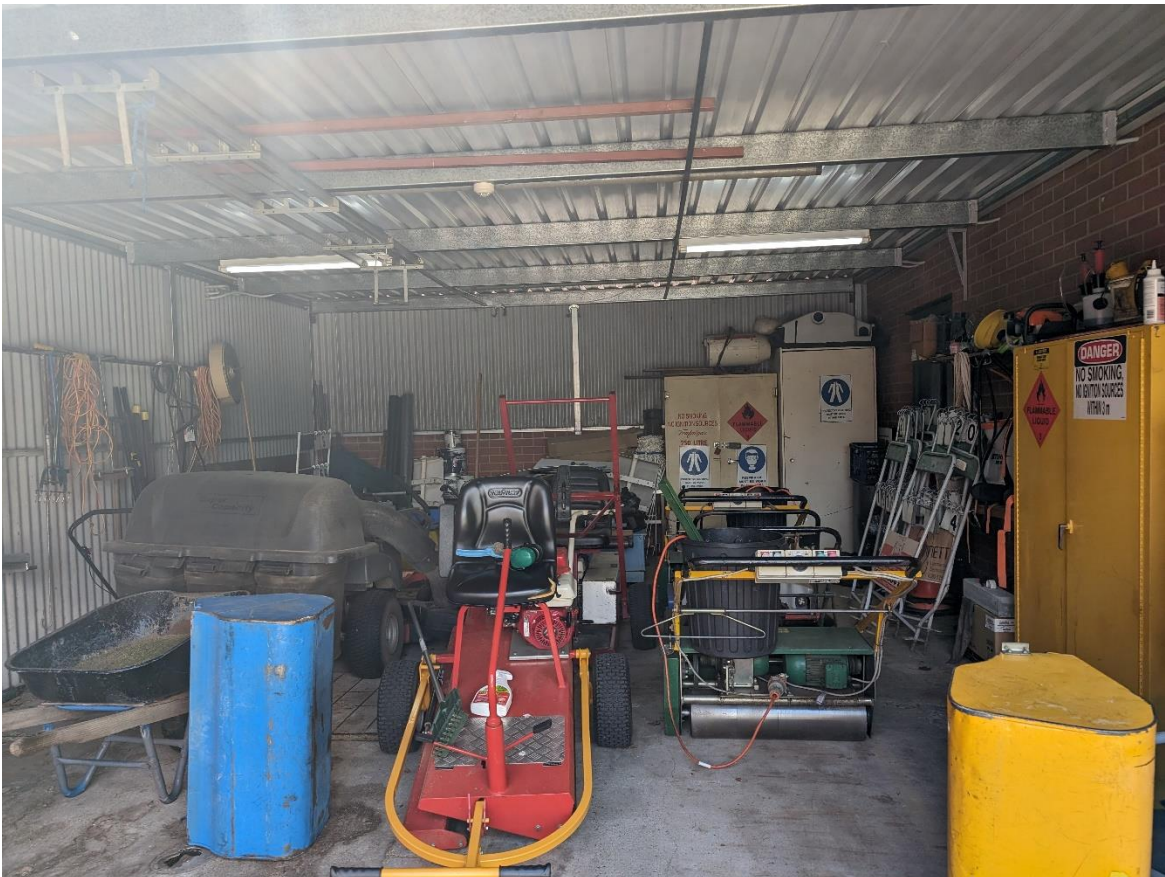
Photograph 6: Landscaping/equipment storeroom

- The southern and eastern portion of the site contain carparking with the Viking Club building, 3 bowling greens and 4 tennis courts occupying much of the central portion of the site. The northwestern portion of the site is vacant grassed open area with a small pond/dam. Refer Photographs 1-4, **Appendix A**.
- Minor amounts of topsoil and sand were stored adjacent to the southwestern carpark area, refer Photograph 5, **Appendix A**.
- Minor amounts of fuels, oils and pesticides are stored in a dedicated cabinets/shelves with the landscaping/equipment storeroom. The room itself was organised with no evidence of any spills/leaks. Refer Photographs 6-7, **Appendix A**.

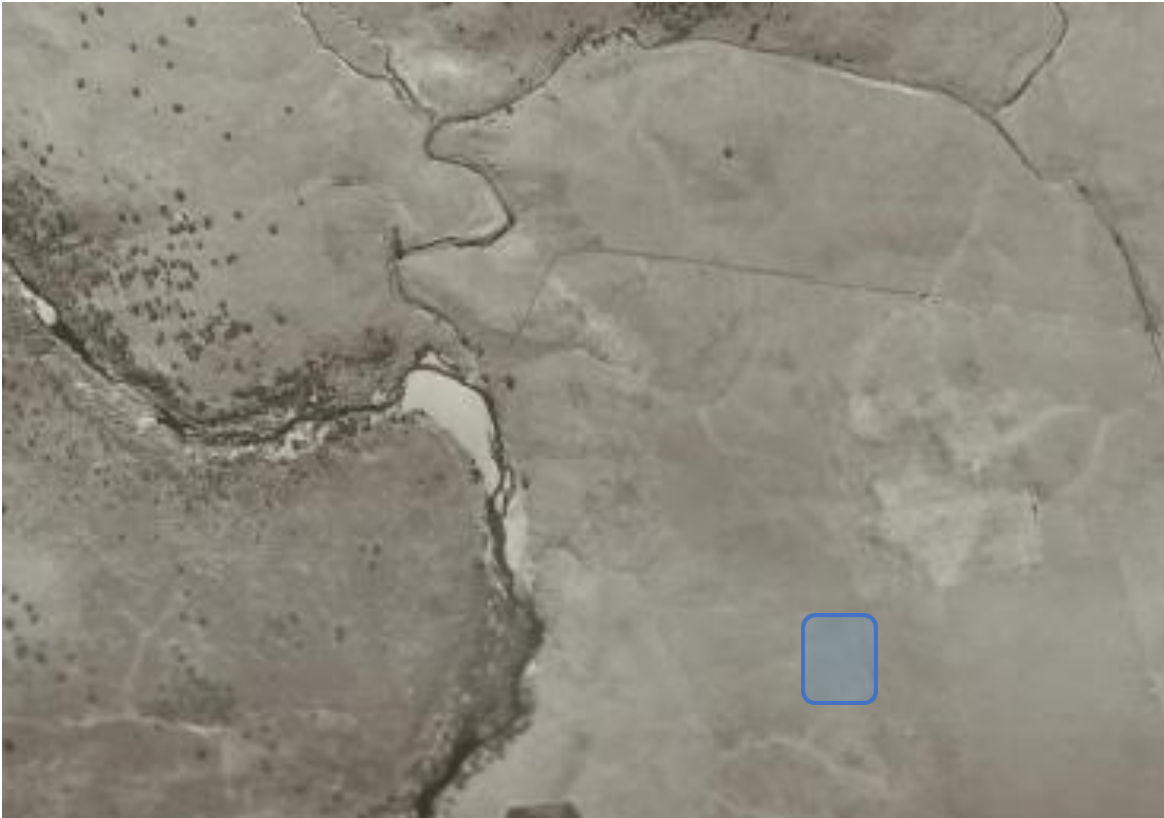
Historical Aerial Photograph 1: 1968

Year	Description
1968	Site: The site is undeveloped. Surrounds: The surrounding areas are undeveloped.
1975	Site: No change. Surrounds: No change.
1984	Site: No change. Surrounds: No change.
1987	Site: No change Surrounds: Early stages of the development of Greenway is evident.
1991	Site: No changes. Surrounds: Further development of Greenway is apparent.
1995	Site: A building, car park and sporting facilities (lawn bowls, tennis courts) have been built on the site Surrounds: Further development of Greenway is apparent.
2004	Site: No significant changes. Surrounds: Continued development of Greenway is evident.
2015	Site: No significant changes. Surrounds: Ongoing development of Greenway is evident, which has largely been developed to its current extent.
2021	Site: No change. Surrounds: No change.

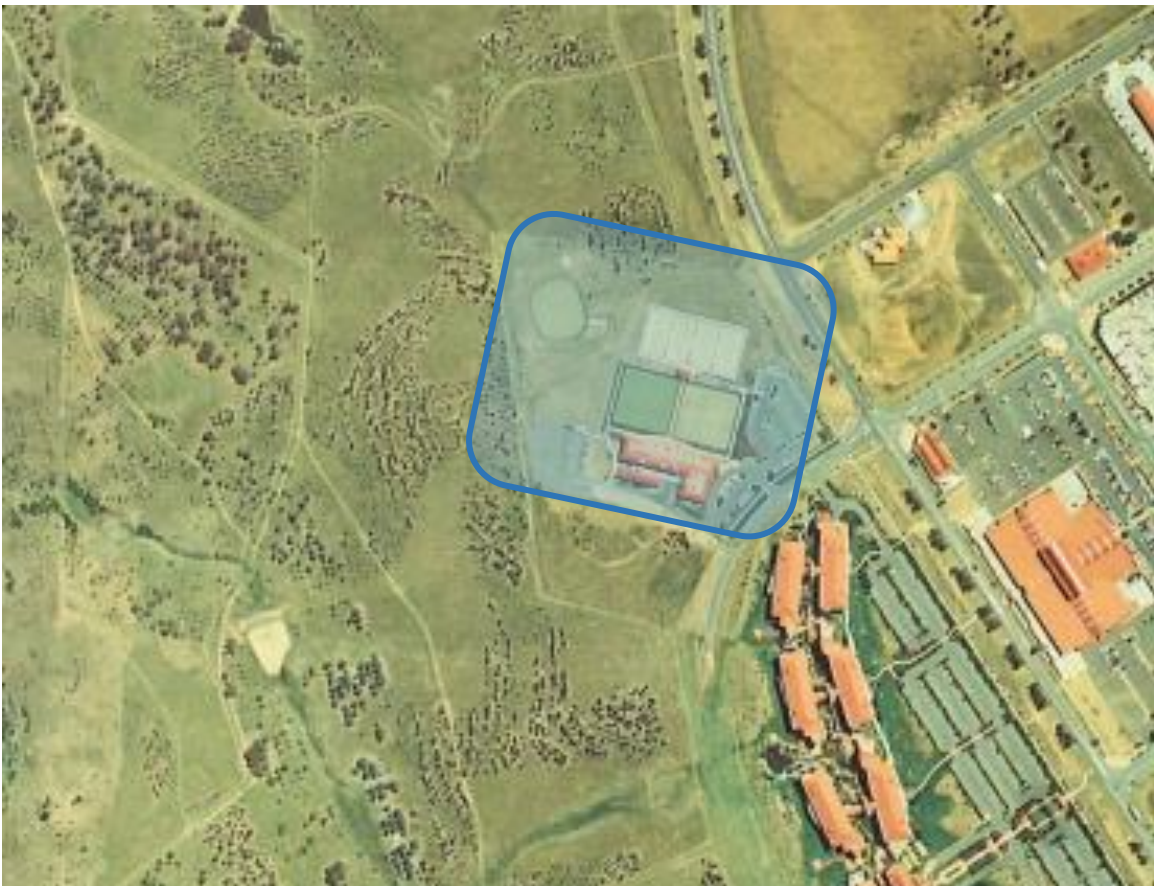
Historical Aerial Photograph 6: 1995

In summary, the site has remained vacant until the 1990s when the site was developed as the Vikings Club. The surrounding areas remained undeveloped until the 1990s, since then the surrounds were progressively developed up until the 2000s as part of Greenway.
