**Auditor Endorsement of Lanterra (2025) Site Suitability Report for Green Waste Facility, Parkwood Road Recycling Estate**

- Lanterra (2025) ‘Site Suitability Report for Green Waste Facility – Parkwood Road Recycling Estate’, dated 17 February 2025 (Revision B, document reference P24049).

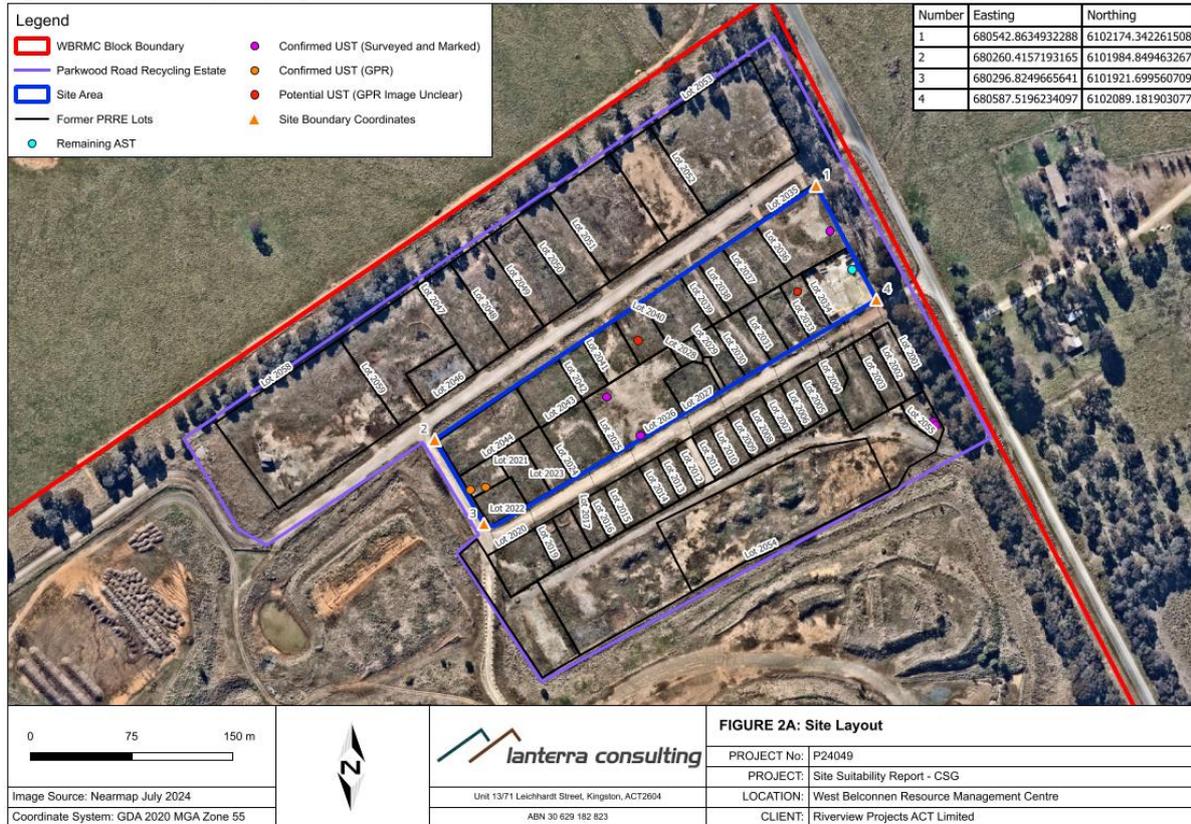
**Figure 1 Lanterra (2025) Figure 2A – Location of the sub-site within PRRE, with GPS coordinates**

(Source: Lanterra (2025). Note: Lot 2032 is not indicated in Figure 2A but its position may be inferred by the proximity of Lots with adjacent numbering.

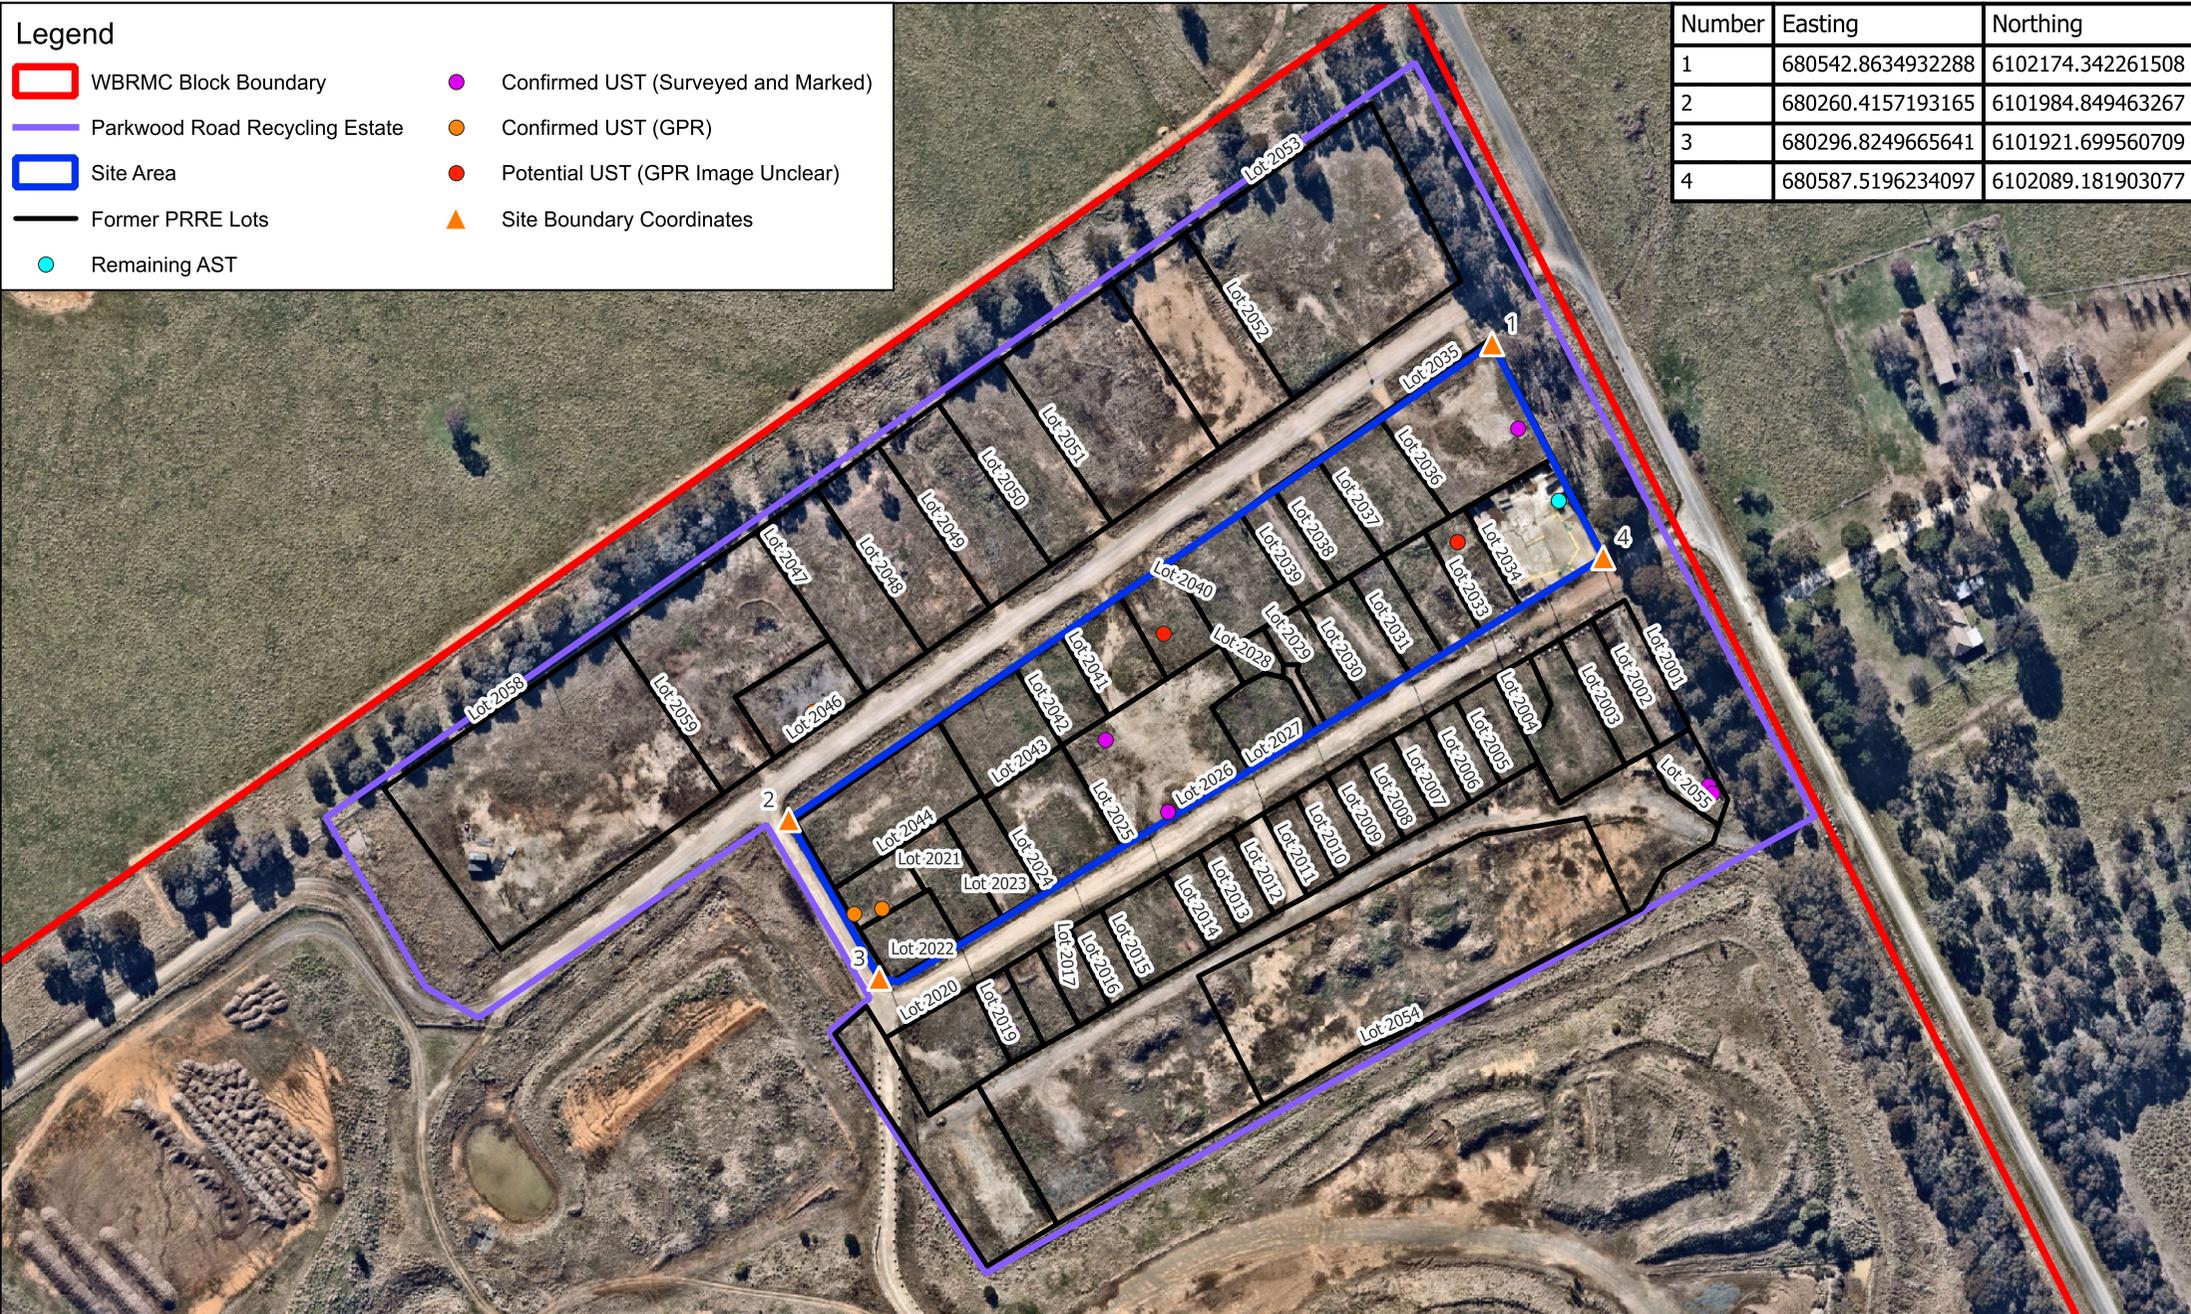
<b>FIGURE 2A: Site Layout</b>	
PROJECT No:	P24049
PROJECT:	Site Suitability Report - CSG
LOCATION:	West Belconnen Resource Management Centre
CLIENT:	Riverview Projects ACT Limited

- Six (6) USTs are located within the PRRE, which have previously been surveyed and pegged on-site during the Stage 1 surface clean-up works. Three (3) of these are located within the Site. The conditions and type of tanks are unknown (e.g. septic or fuel storage, condition and size) – see **Appendix A: Figure 2A**.

- Subsequent investigation using a Ground Penetrating Radar (GPR) identified three (3) additional USTs at the PRRE, with two (2) located within the Site. The conditions and type of tanks are unknown (e.g. septic or fuel storage, condition and size) – see **Appendix A: Figure 2A**.

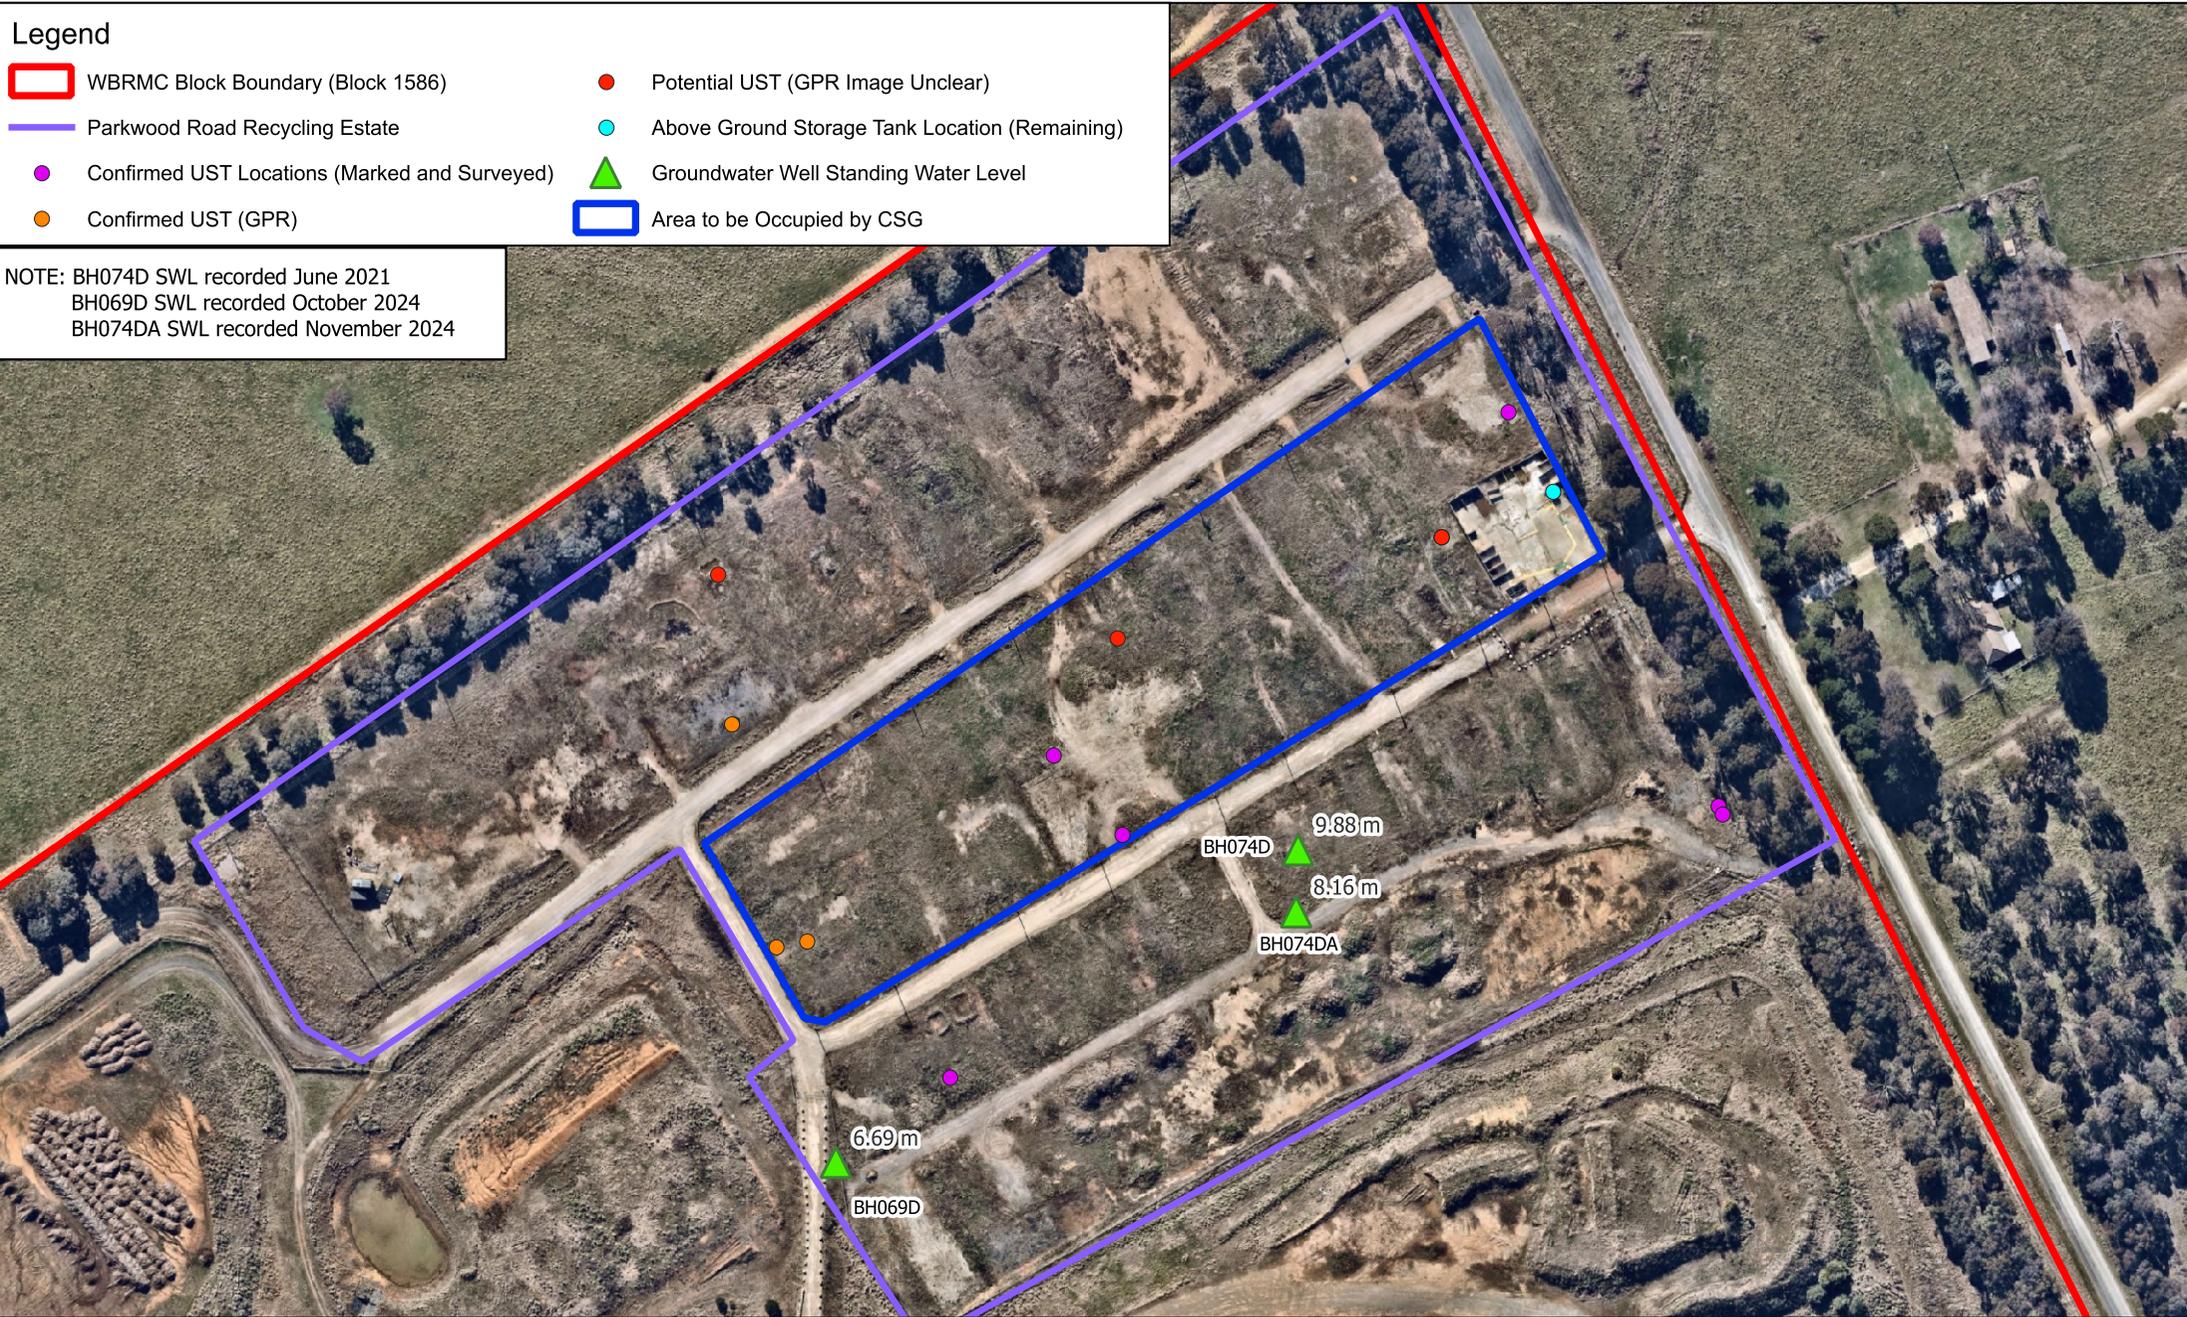
NOTE: BH074D SWL recorded June 2021  
 BH069D SWL recorded October 2024  
 BH074DA SWL recorded November 2024

- The standing water level measured in the two (2) monitoring wells within the PRRE ranged between 6.69 m below ground level (bgl) in groundwater well BH069D and 9.88 m bgl in groundwater well BH074DA<sup>3</sup>. BH074DA was installed in November 2024 to replace the former BH074D that was damaged during surface cleanup works, which was last measured in June 2021 with a standing water level of 9.88m bgl<sup>4</sup> - see **Appendix A: Figure 6**.

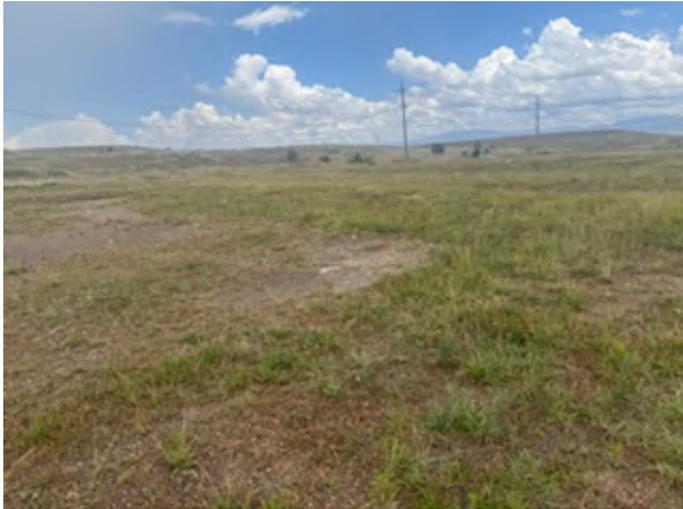
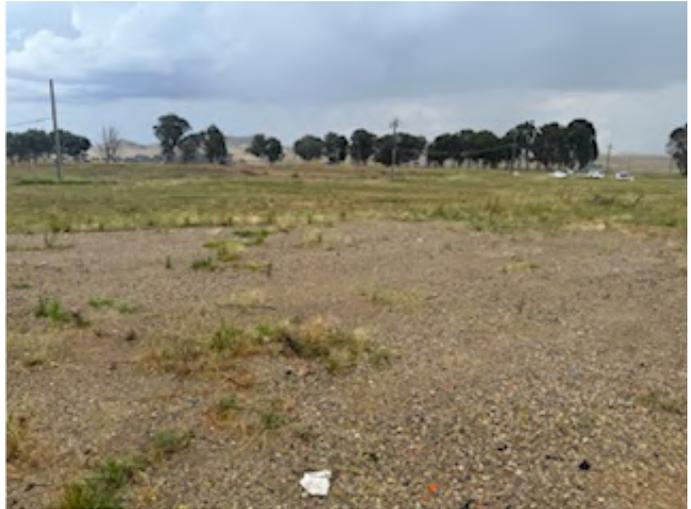
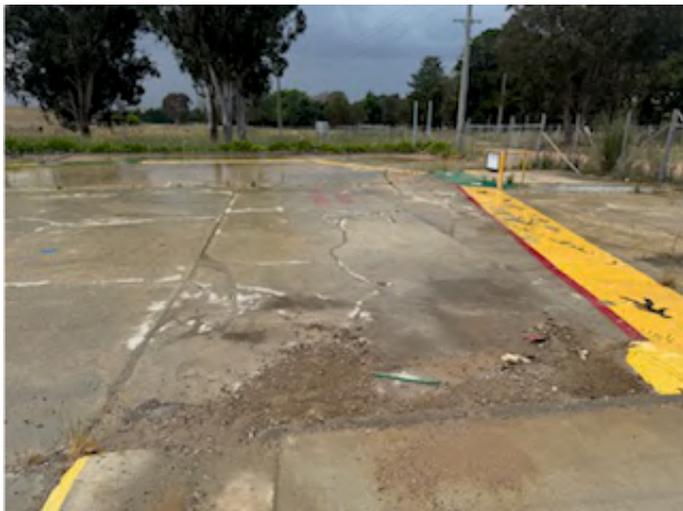
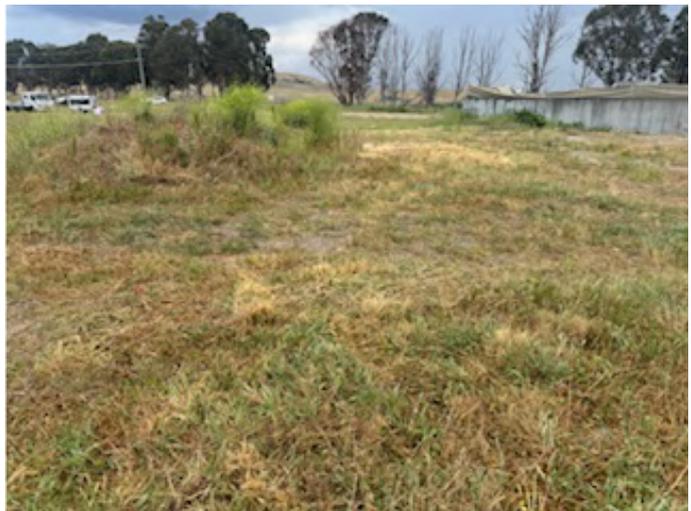
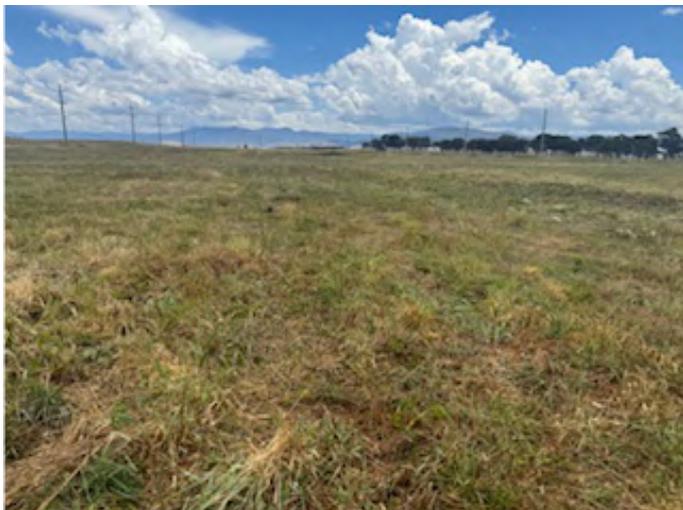
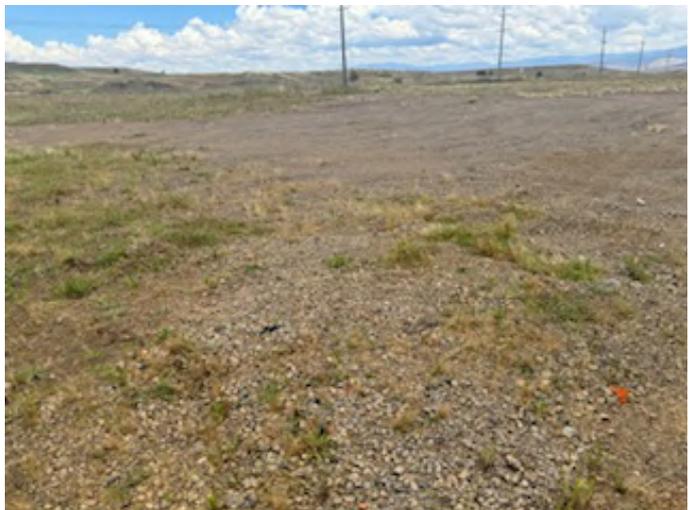
A thorough a visual inspection after completion of the above scope of works at the site location stated above and found no visible asbestos residue from asbestos removal work in the area, or in the vicinity of the area, where the work was carried out. The asbestos removal work area can now be dismantled and the area safely reoccupied. Photographs from the site inspection are attached at Appendix A. **Note: Asbestos may still be buried at depth.**

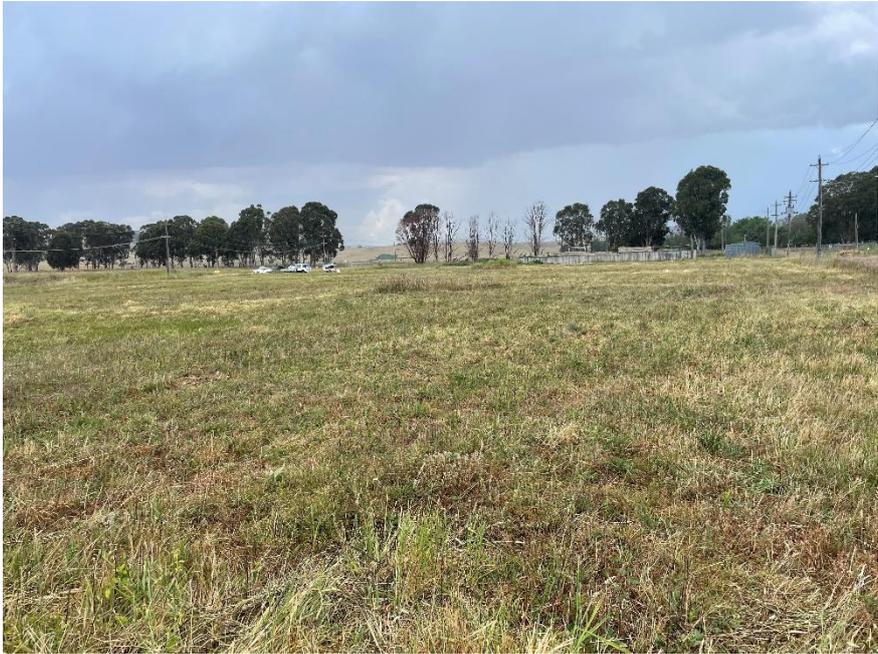
<b>Photo No.</b> 1.	<b>Date</b> 28/11/2024

<b>Description</b> View to east of site.		
<b>Photo No.</b> 2.	<b>Date</b> 28/11/2024

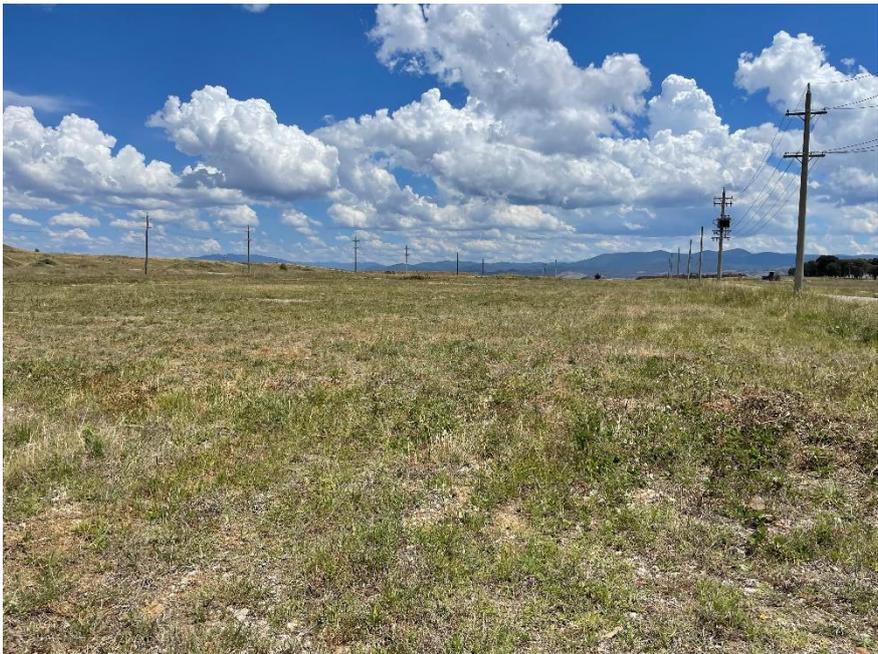
<b>Description</b> View to west of site.

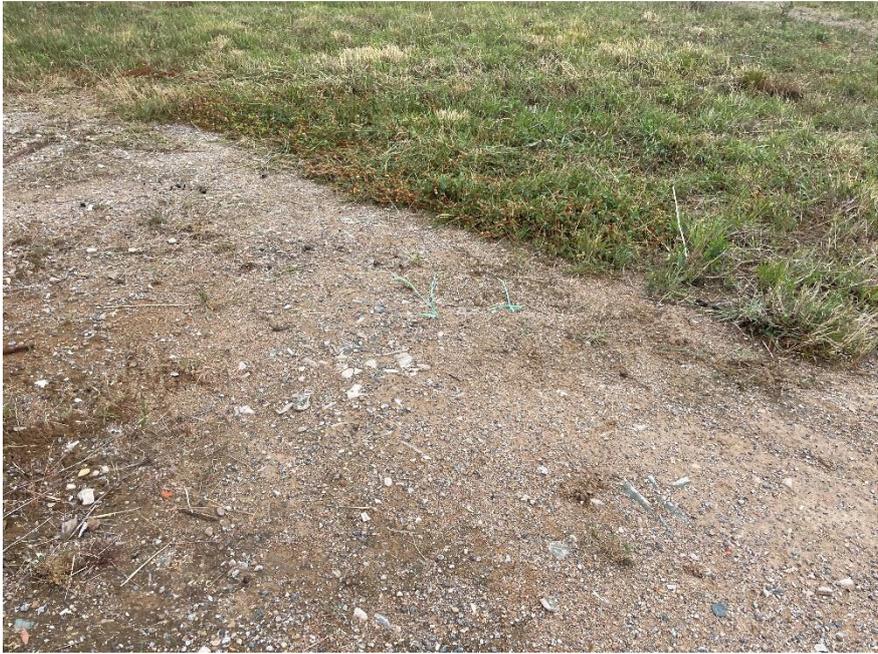
<b>Photo No.</b> 3.	<b>Date</b> 28/11/2024

<b>Description</b> View of surface with general waste and potential ACM fragments		
<b>Photo No.</b> 4.	<b>Date</b> 28/11/2024

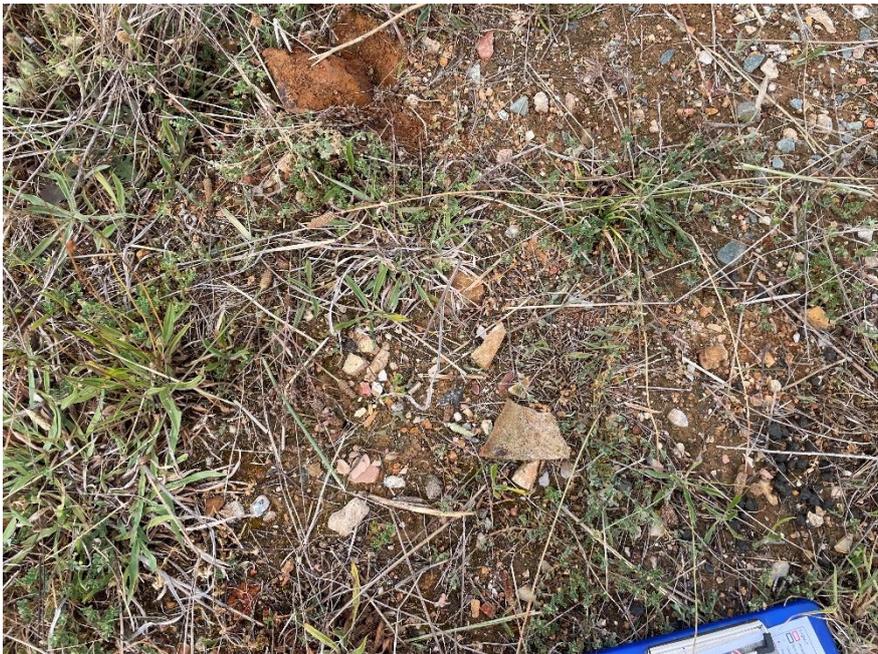
<b>Description</b> View of surface with general waste and potential ACM fragments

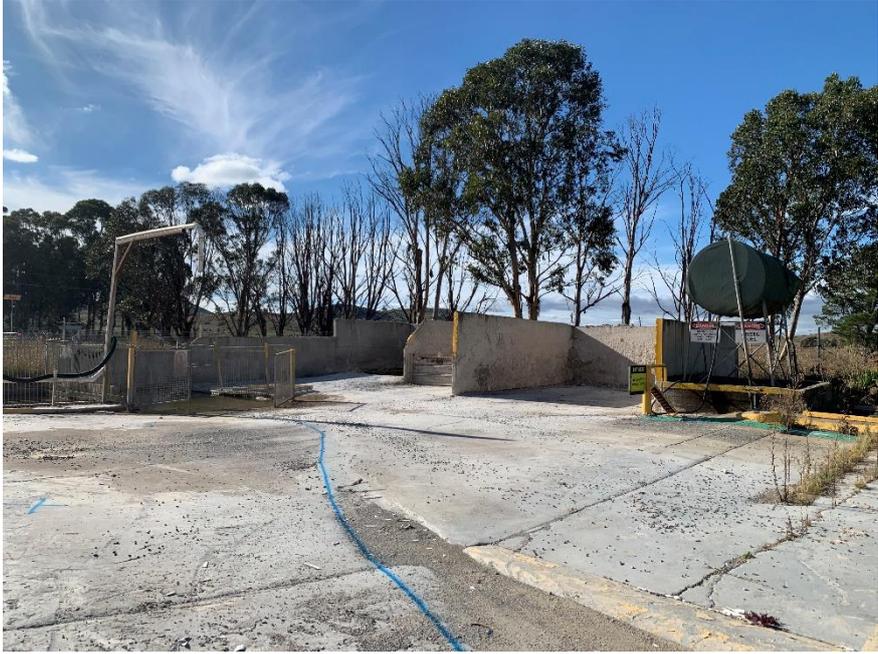
<b>Photo No.</b> 5.	<b>Date</b> 28/11/2024

<b>Description</b> View of above ground storage tank and bays in former Concreate plant lot. Photo facing north-east.		
<b>Photo No.</b> 6.	<b>Date</b> 28/11/2024

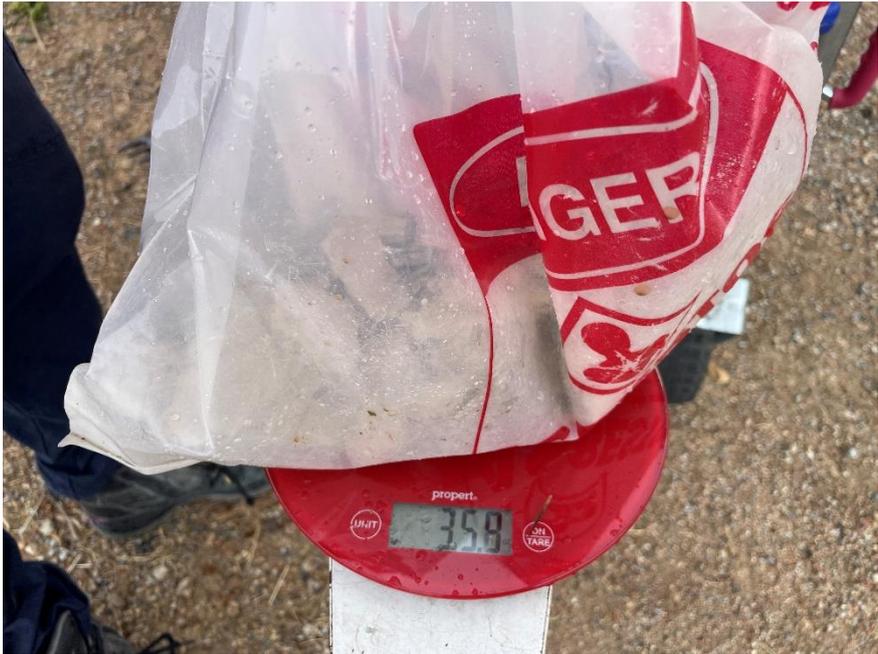
<b>Description</b> View of weighed potential ACM finds (1 out of 6 bags).
