# CX11266 – Cotter Pumping Station Improvements

## Environmental Significance Opinion

Version 1.0, 14 February 2022

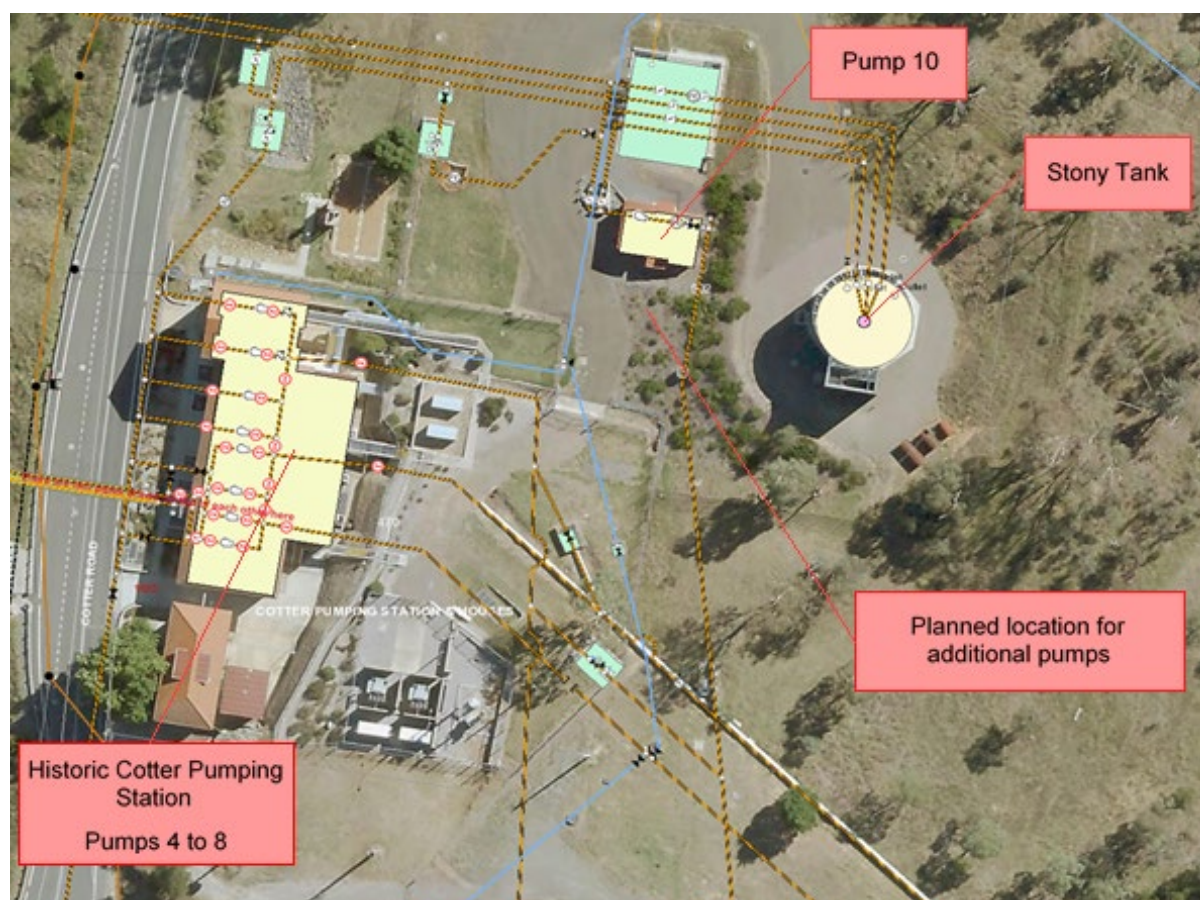
**Figure 1: CPS Site Location**

Figure 1 below shows the existing CPS and associated infrastructure.

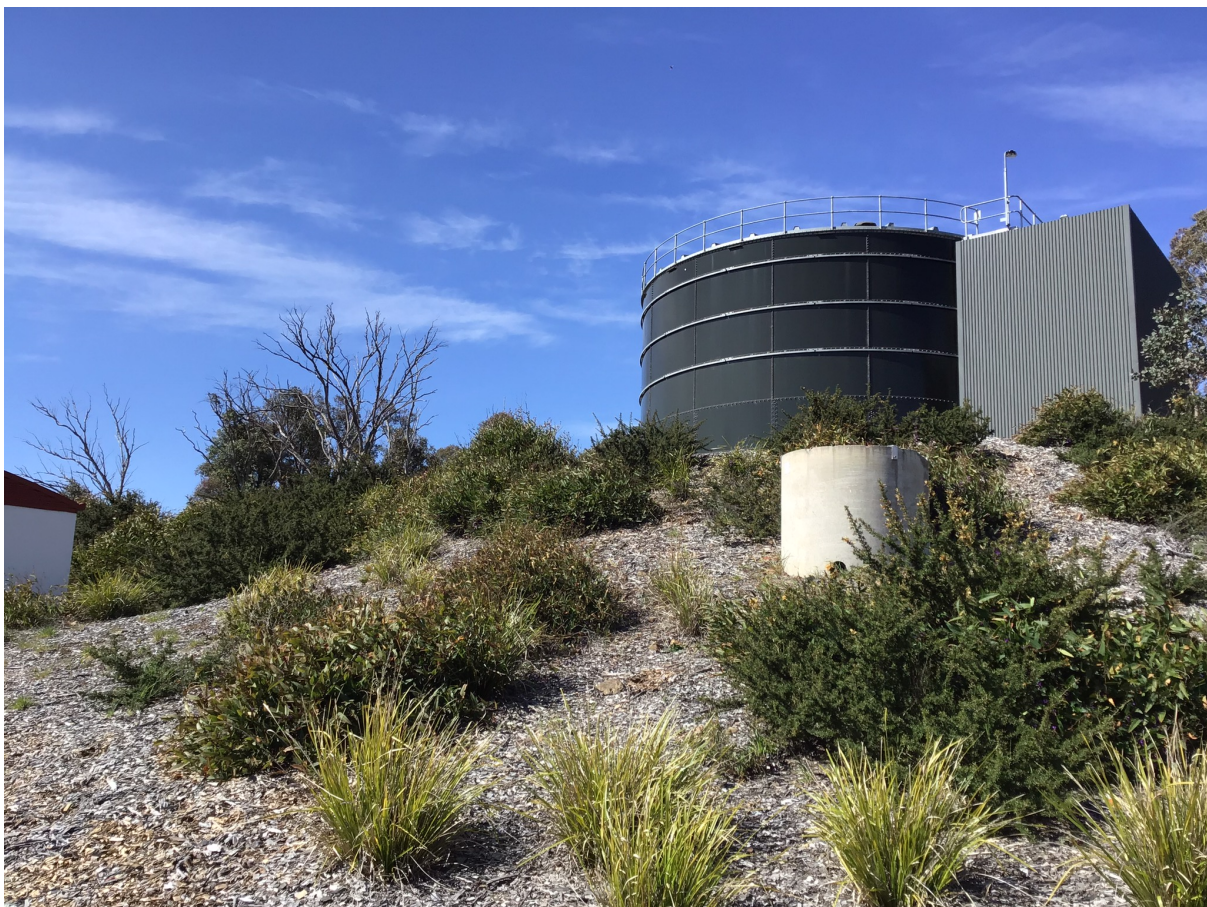
**Figure 3: Ornamental plantings to be removed**

There will be no tree removal and minimal vegetation disturbance as part of these works. Established garden beds featuring *Grevilleas*, *Hardenbergias*, and native planted sedges will be removed to make way for the new pump station building and surrounding hardstand (Figure 3).

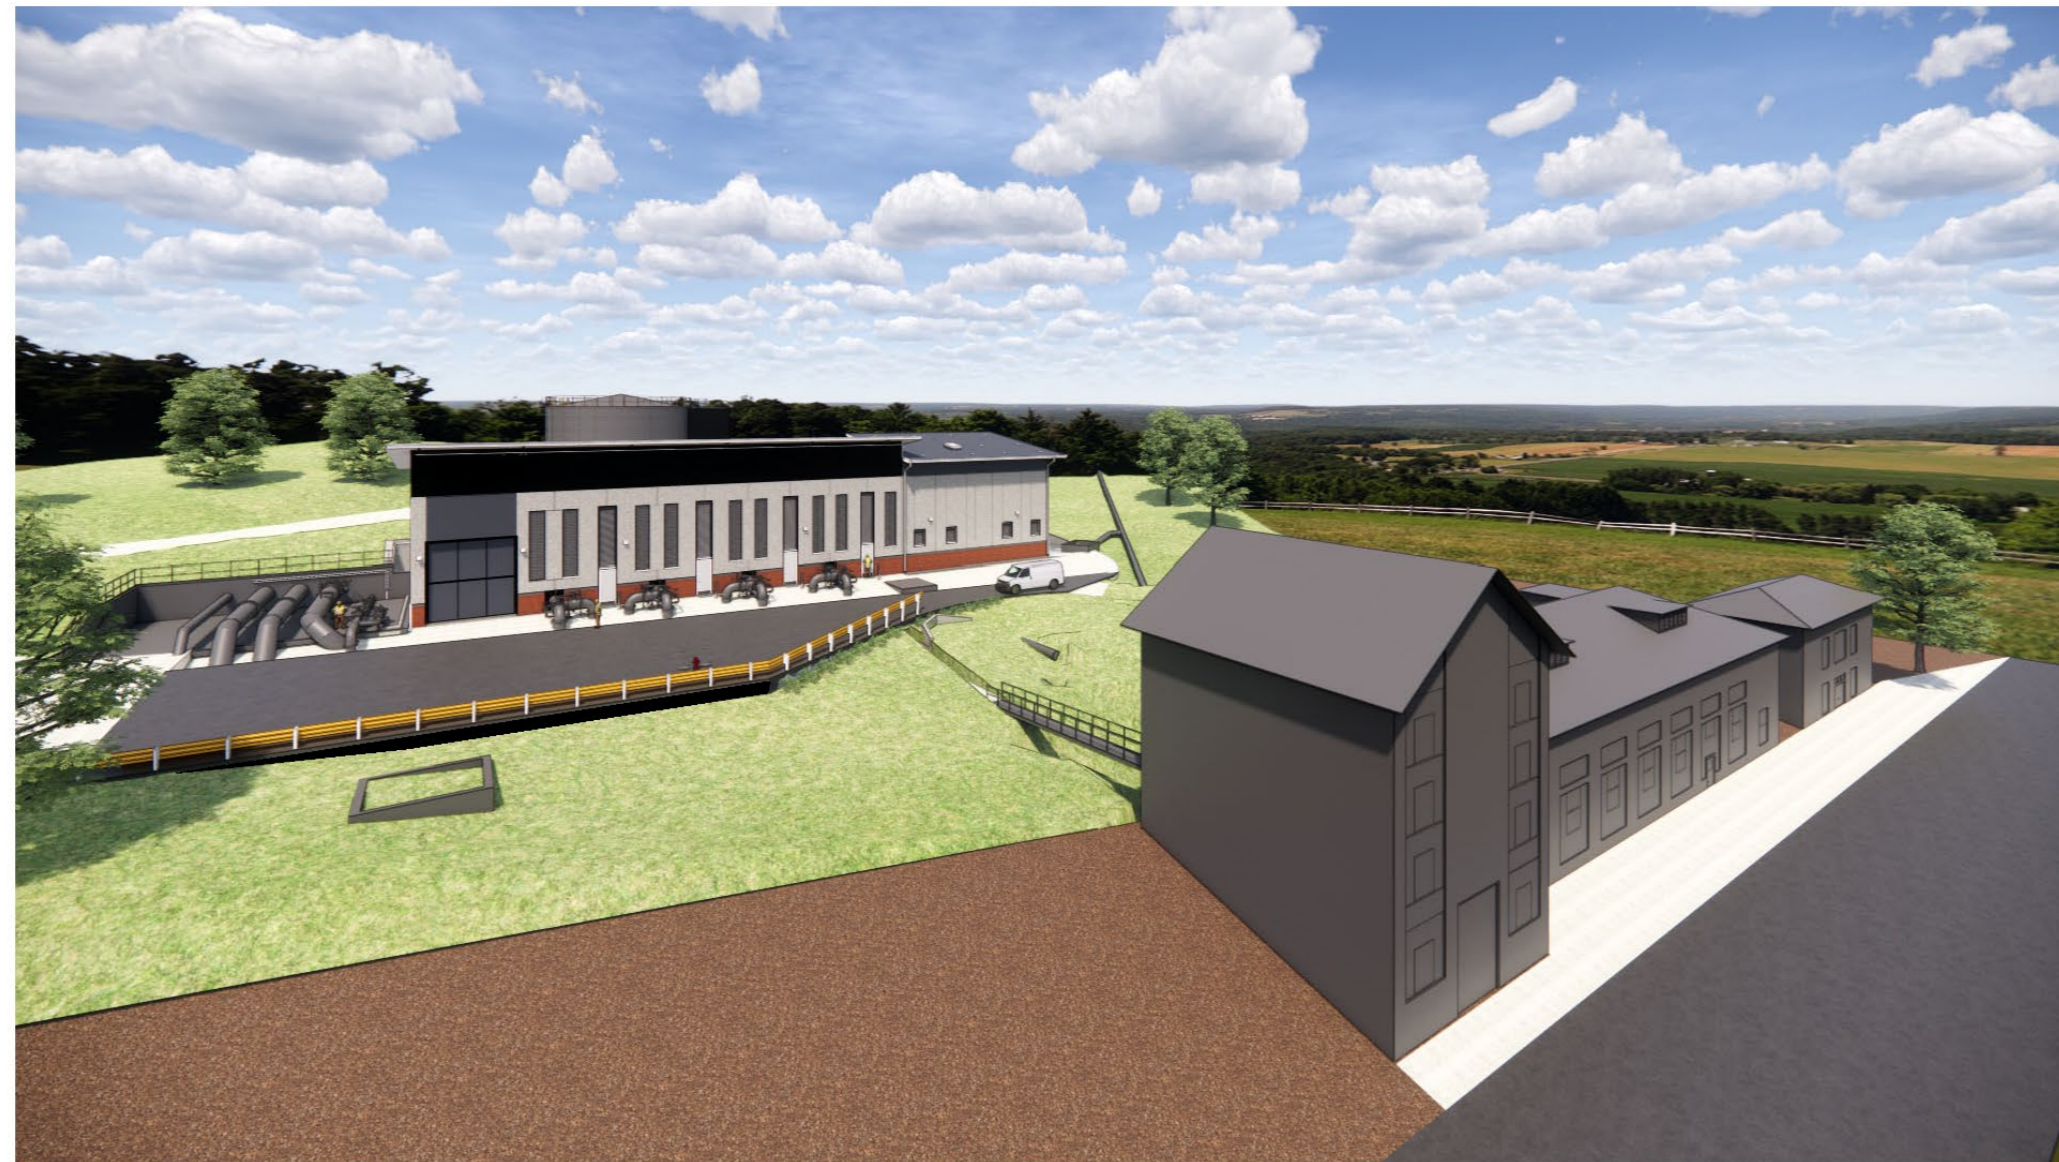
**PERSPECTIVE VIEW - EXISTING COTTER PUMP STATION 1 AND NEW COTTER PUMP STATION 2**

assessment has been undertaken to assess the impact of the new infrastructure to the surrounding vista (Appendix A).

The design of the new pump station building is sympathetic to the character of the original pump station below, within the confines of not compromising efficiency and sustainability afforded by advances in architecture.

- The proposed structure will have a sympathetic aesthetic to the existing heritage values, but will be clearly identifiable as new elements. The building will be set further back within the Precinct, behind the heritage listed Cotter WPS 1, therefore being visually separated from key heritage elements.
- No changes to the Cotter WPS 1 (Pump House) and Transformer House are included within the proposed works, and the existing heritage fabric will not be impacted. Impacts to the rising main are to later modifications only, are minor and are not inconsistent with CMP policies.
