Preliminary (Environmental) Site Investigation

Canberra Brickworks

**18 February 2014**

<b>Project Name:</b>	Preliminary (Environmental) Site Investigation, Canberra Brickworks
<b>Project Number:</b>	3002369
<b>Report for:</b>	Land Development Agency

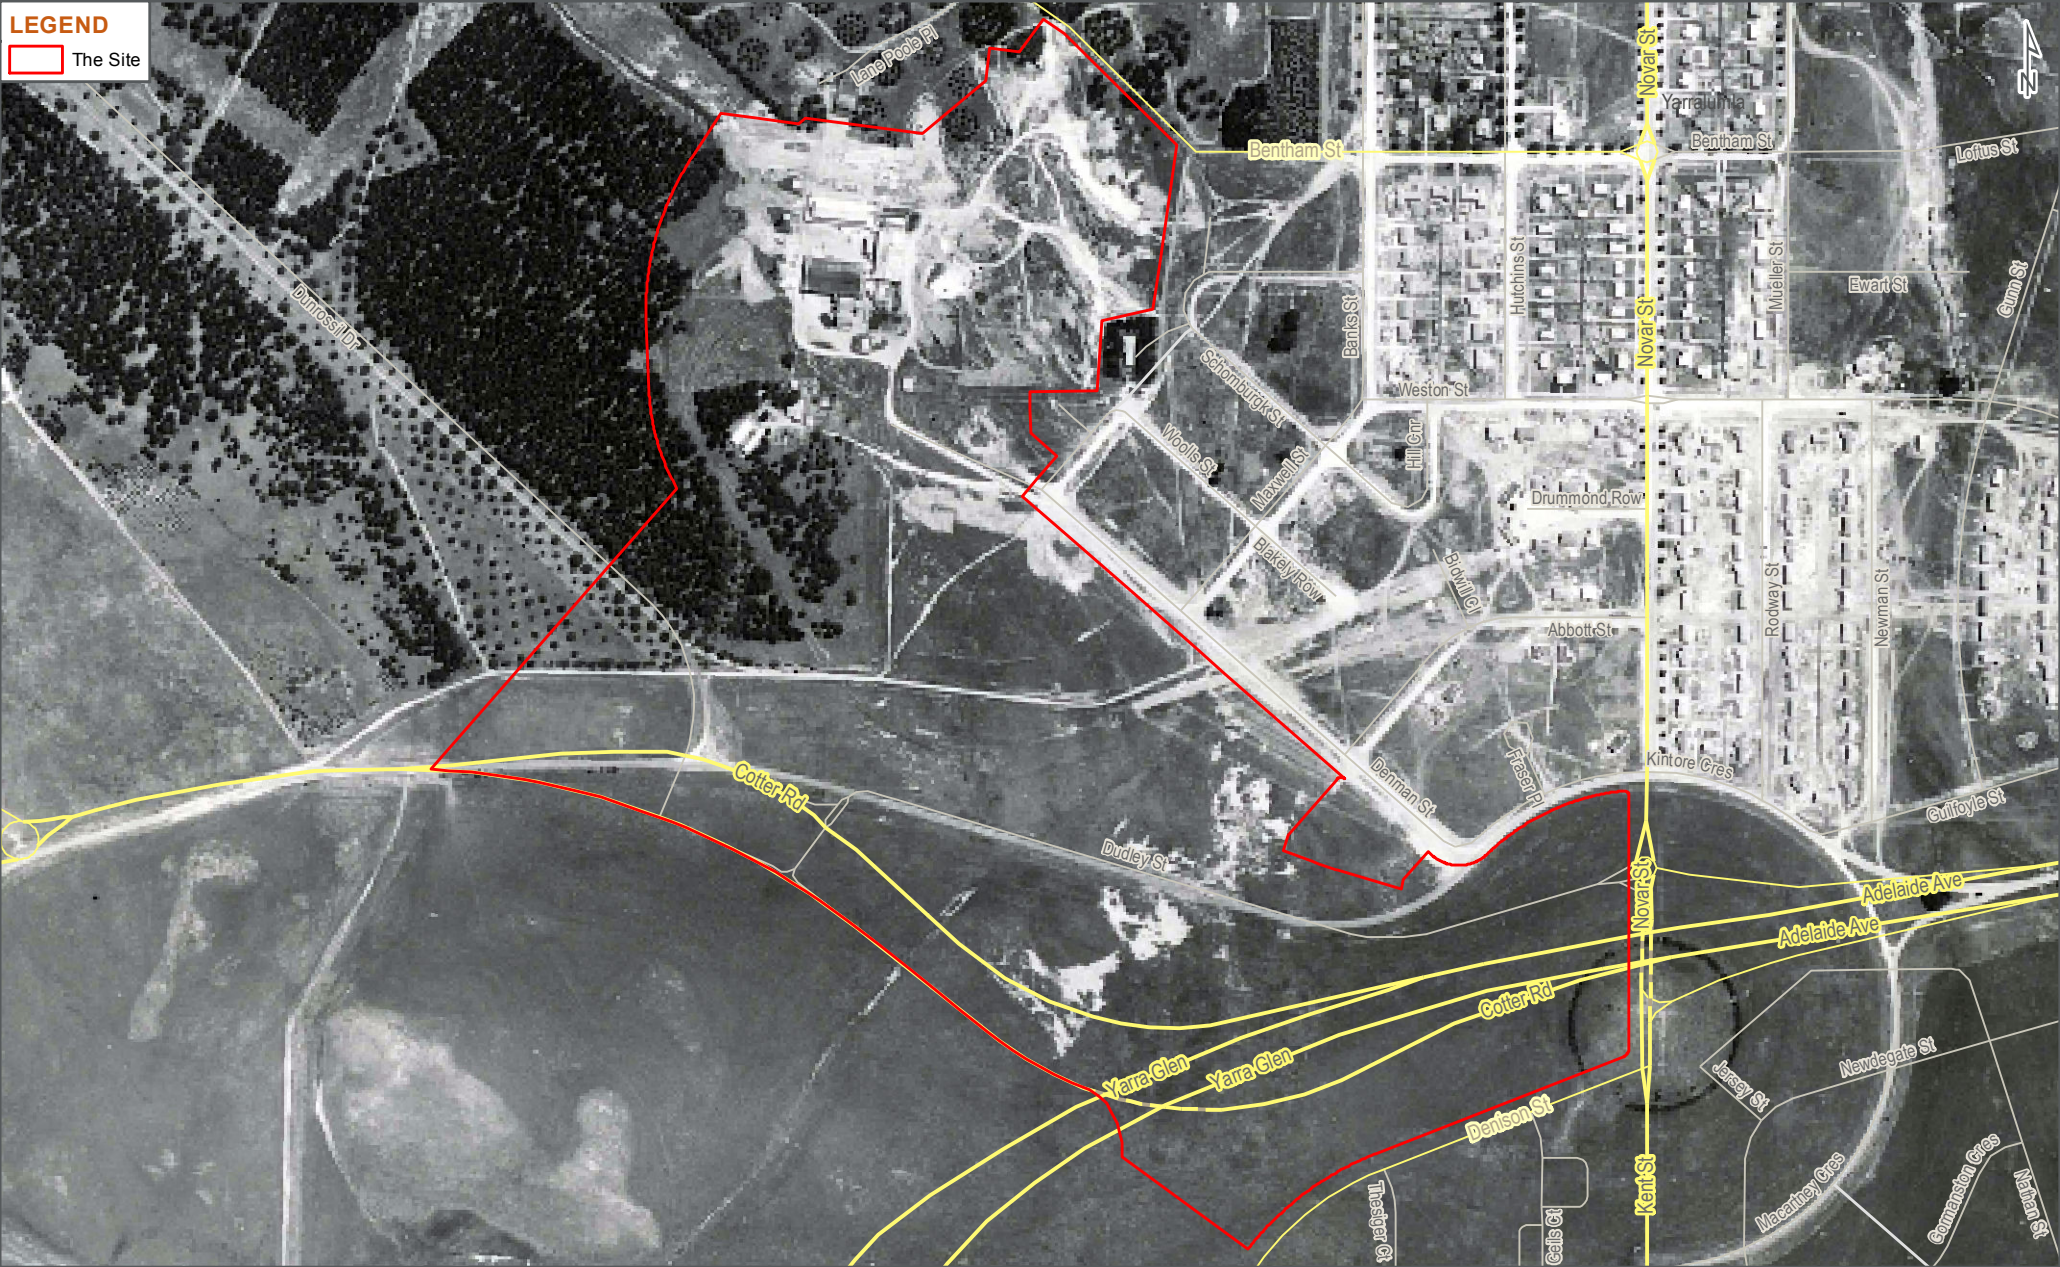
Historical aerial photographs indicate activities in this have been undertaken since the 1950's. Given the long and undocumented historical use of the area further investigation is recommended.

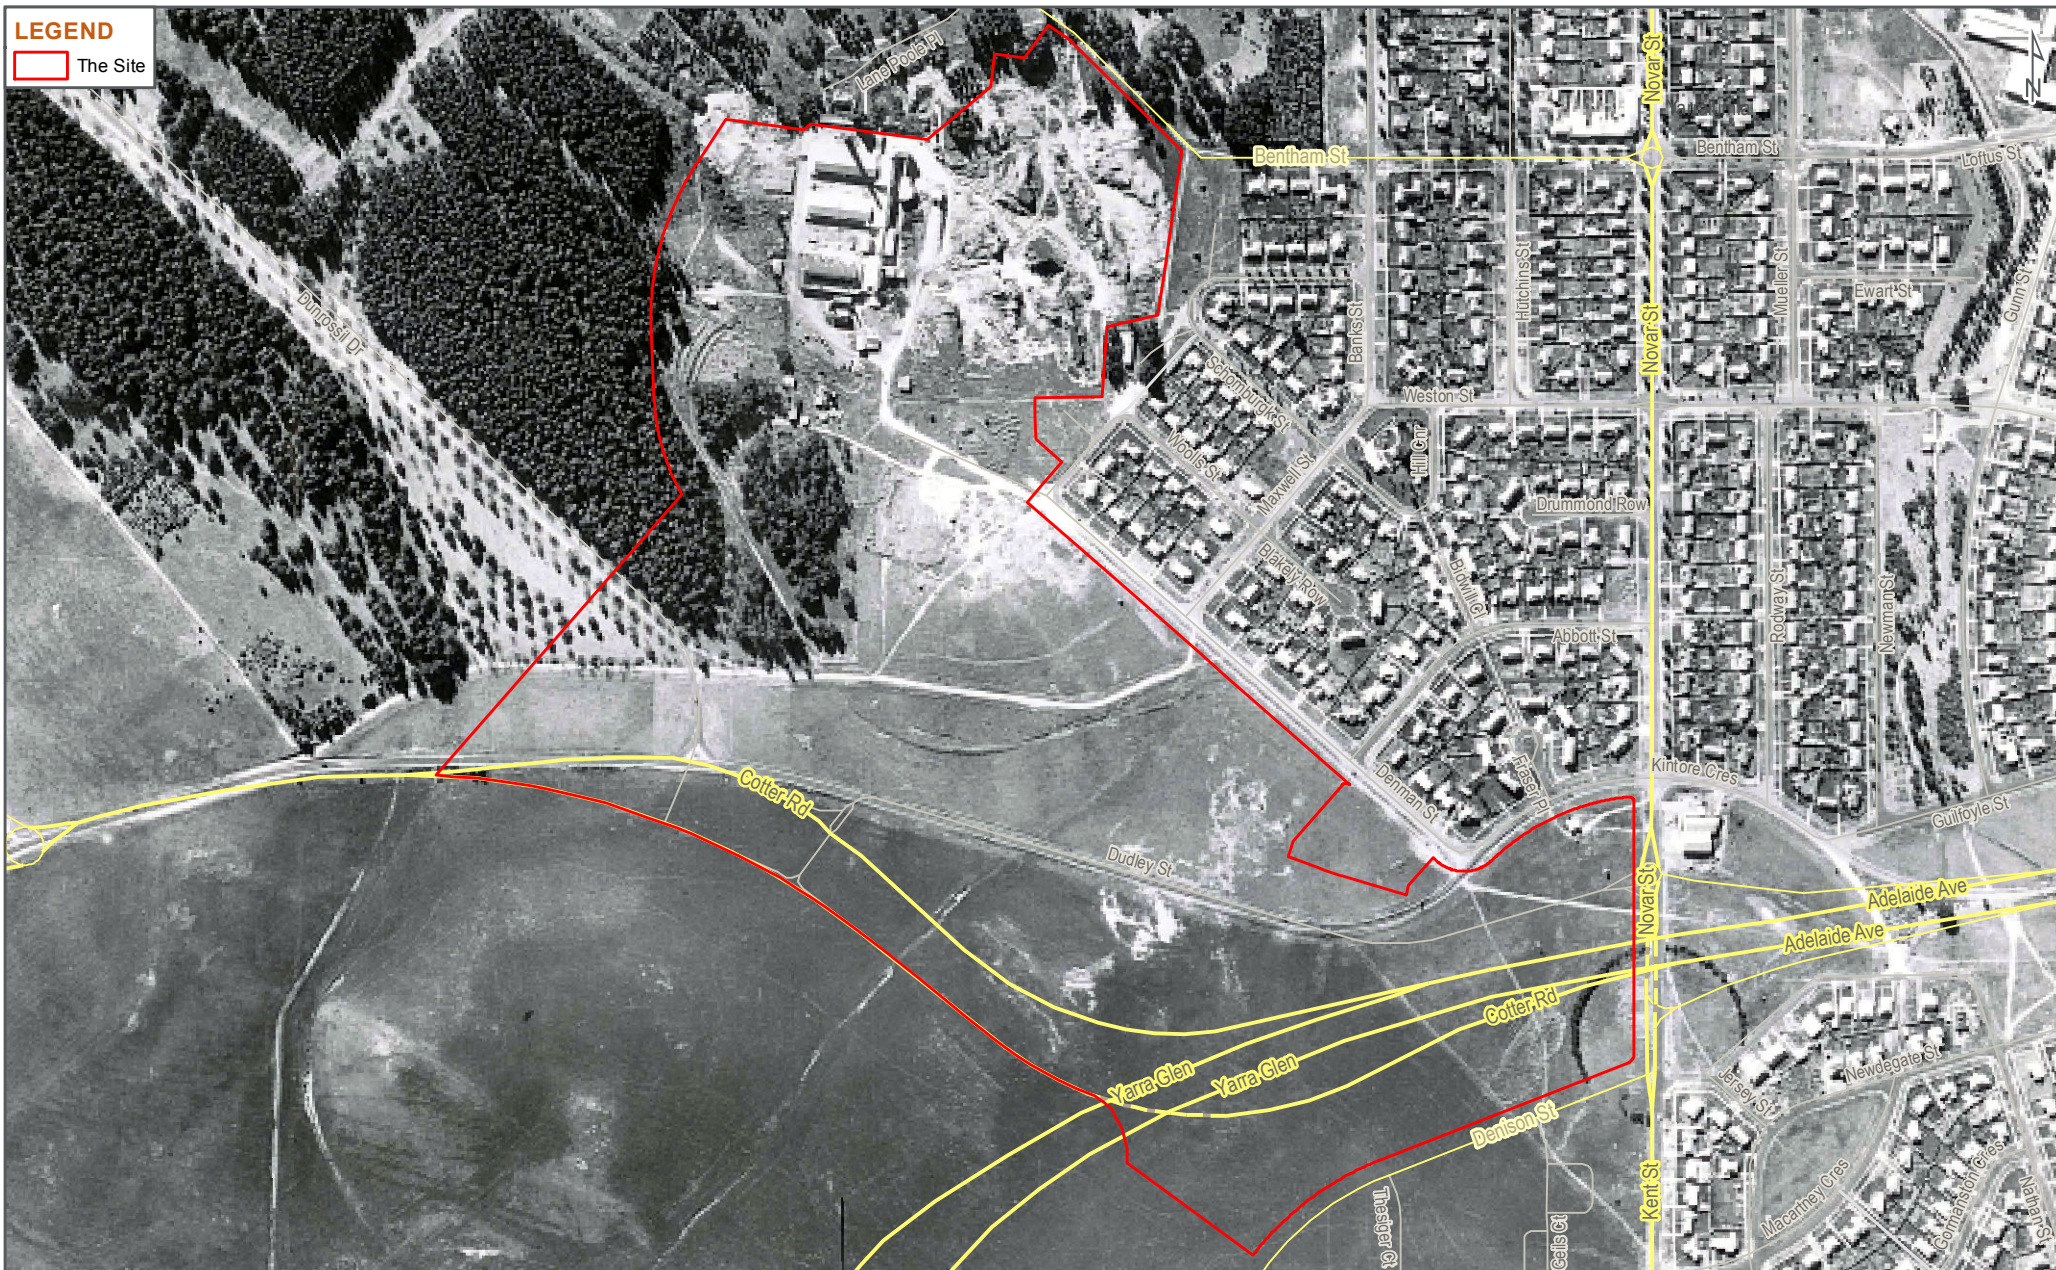
**FIG NO.**  
3b

**FIGURE TITLE**  
Historical Aerial Photograph - 1958

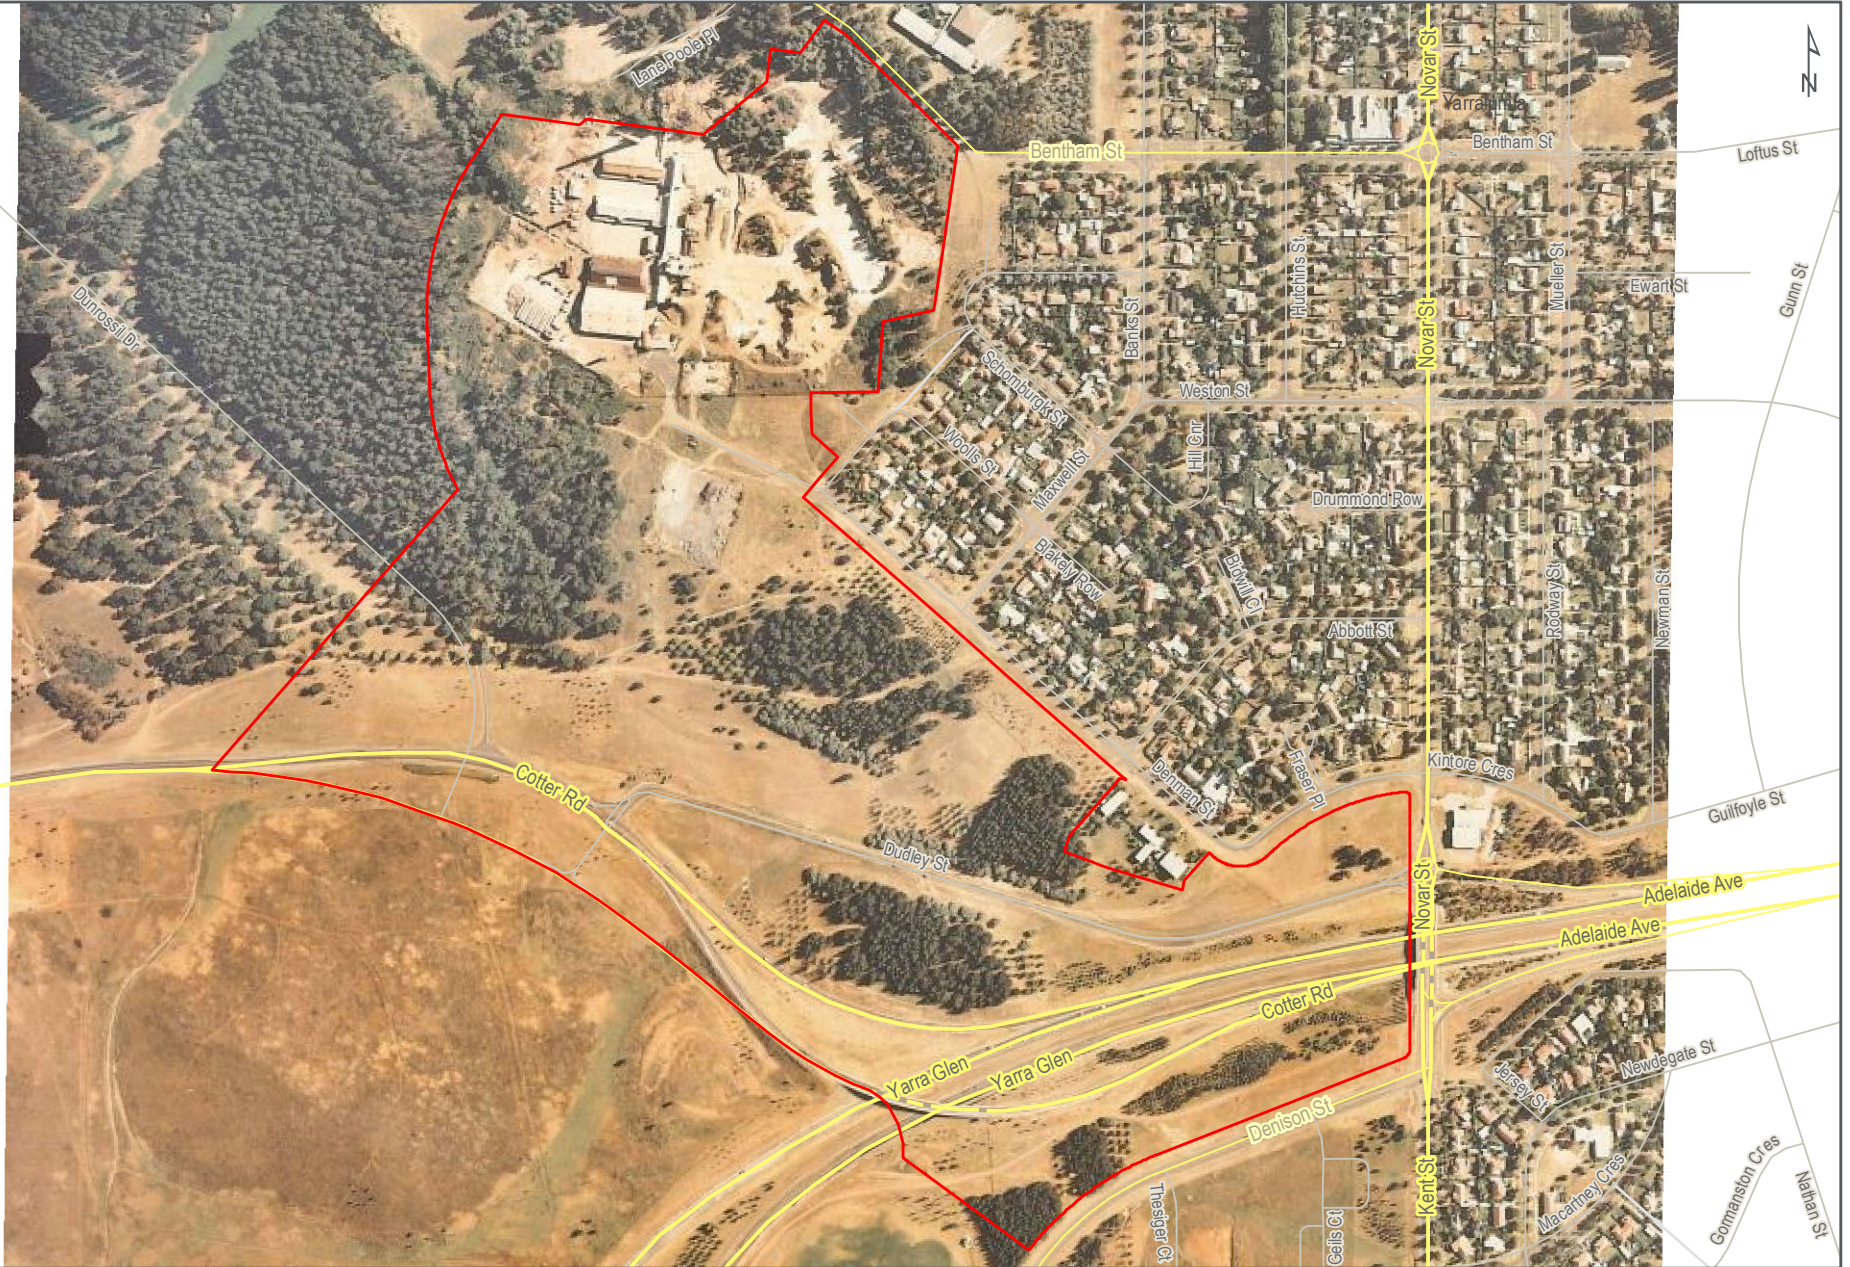
**FIG NO.**  
3d

**FIGURE TITLE**  
Historical Aerial Photograph - 1978

Figure 3d 1978 Run 15 Print 49	<p>The Site: removal of clay storage shed, workers accommodation buildings, forklift shed and several other buildings. The quarry appears to have been also been filled. Extrusion plant has been constructed. Disturbed soils observed in the north western portion of the Site, this is the location of the current asbestos dump. Cleared area south east of brickworks (noted 1958 and 1968) appears to be used for stockpiling. The vegetation around the former railway corridor and brickworks workers accommodation increased. The railway corridor is barely visible in the image.</p> <p>The Surrounding Area: Consistent with 1968. Cotter Road and Yarra Glen overpass construction completed. CSIRO School of Forestry established (NE of the site).</p>
Figure 3e 1988 Run 15 Print 6251	<p>The Site: roofing material of the kilns and workshops has been upgraded. Tracks observed in the quarry, the carpark (formerly the carpenter's workshop) is disused and overgrown with grass. Former workers accommodation and railway corridor completed overgrown with vegetation.</p> <p>The Surrounding Area: No significant changes, housing constructed to the northern and eastern boundary of the Site</p>

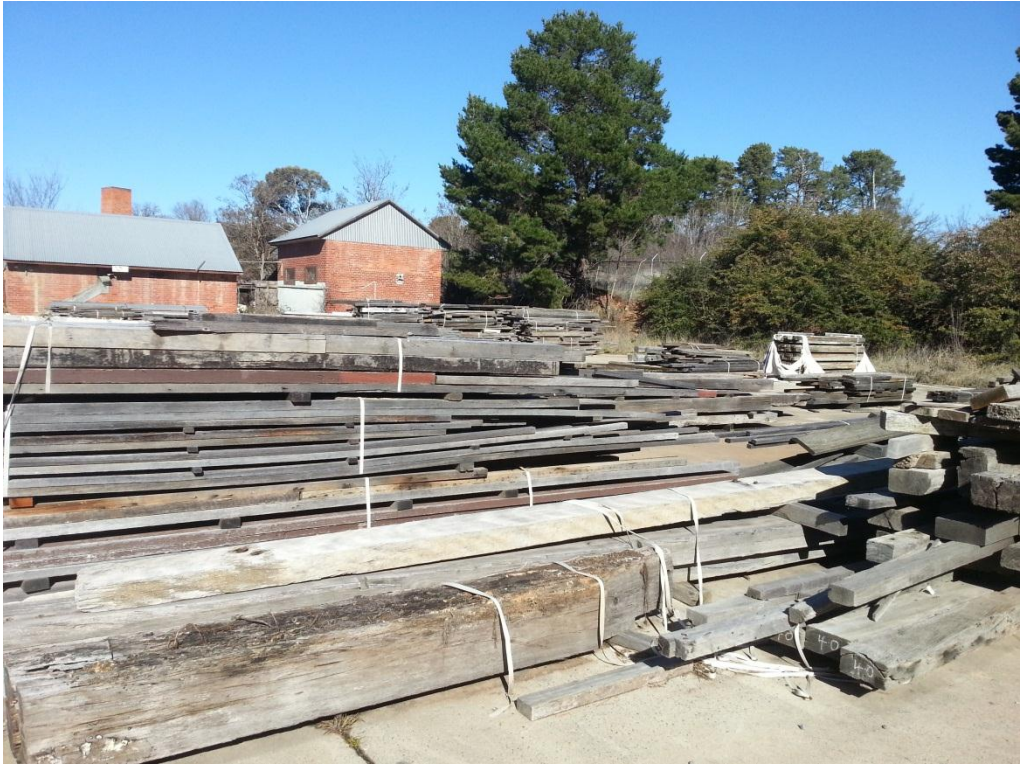
PHOTO ID: 1	CANBERRA BRICKWORKS
<p><b>DATE:</b> 2/10/13</p> <p><b>DESCRIPTION:</b></p> <p>The brickworks are currently used by Thor's Hammer for the storage of recycled wood</p>

Large portions of the brickworks were occupied by Thor's Hammer a wood recycling business (Photo 1, **Appendix H**) and were used for the storage of bulk wood supplies, it is understood that artists also utilise some workshop spaces at the brickworks. Thor's Hammer and the artists were observed to be operating in Machine Bay 1 and the Workshop (Figure 2a, **Appendix A**), other areas of the brickworks (both sealed and unsealed) were used for wood storage as shown in Figure 2b, **Appendix A**.

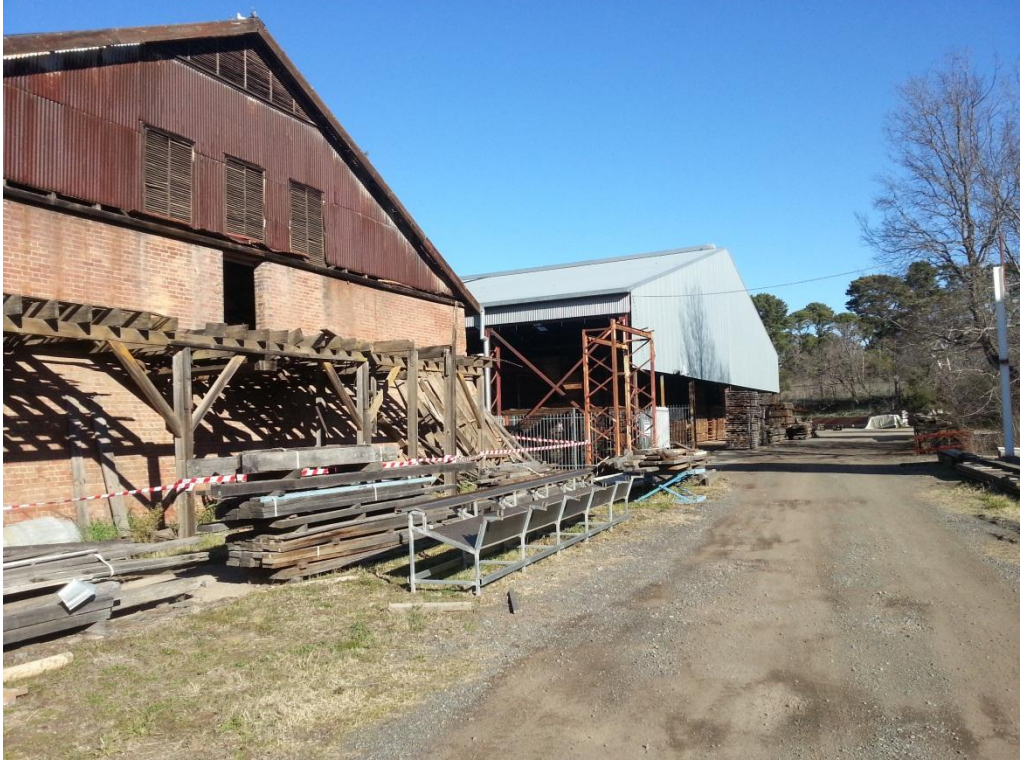
PHOTO ID: 2	
<p><b>DATE:</b> 2/10/13</p> <p><b>DESCRIPTION:</b></p> <p>Remnant brick buildings, some showing signs of disrepair.</p>

Remnant buildings associated with the operation of the brickworks were observed to be in various conditions ranging from good to some buildings showing signs of disrepair. (Photo 2, **Appendix H**).

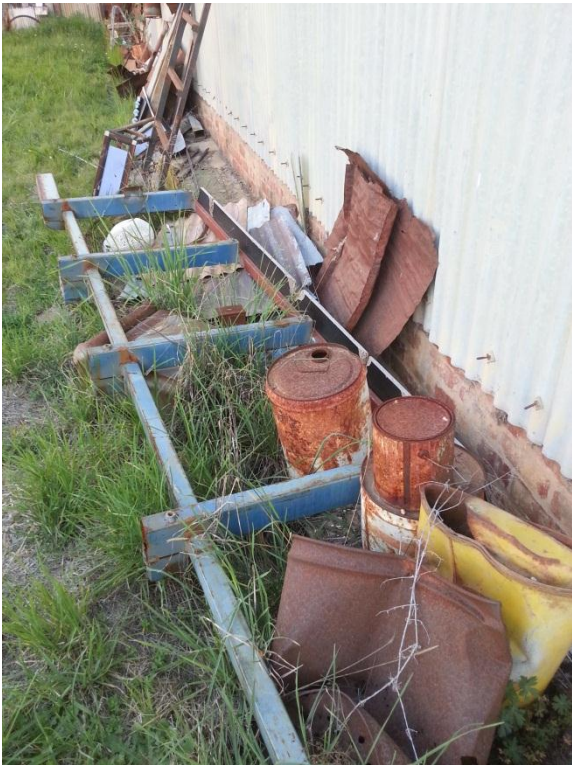
PHOTO ID: 5	CANBERRA BRICKWORKS
<p><b>DATE:</b> 2/10/2013</p> <p><b>DESCRIPTION:</b></p> <p>General areas around the machinery sheds were littered with empty drums, scrap metal and other waste materials</p>

General areas around the machinery sheds were littered with empty drums, scrap metal and other waste materials (Photo 5, **Appendix H**). No obvious signs of ACM, staining and/or odours were noted during the inspection.

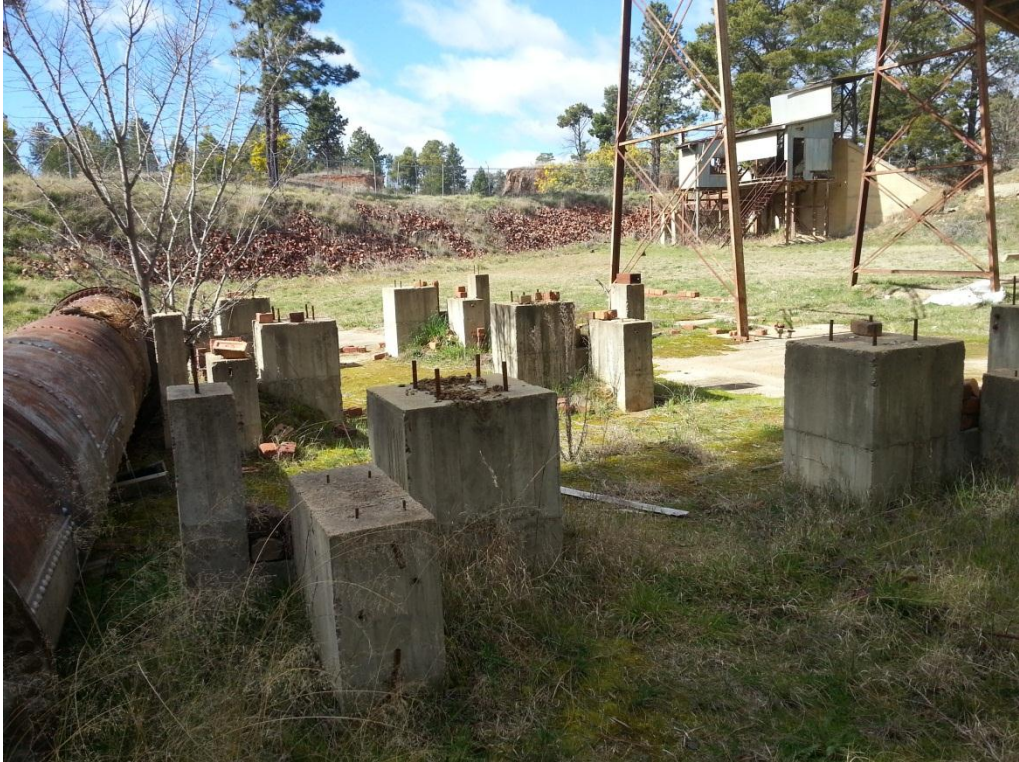
PHOTO ID: 6	
<p><b>DATE:</b> 20/8/2013</p> <p><b>DESCRIPTION:</b></p> <p>Remnant concrete footing of machinery used in the crushing and transporting of raw materials to the machinery shed.</p> <p>The disused oil pressure/storage tank located left of the footings.</p> <p>Crusher House 3 is located in the background.</p>

A disused oil pressure/storage tank was identified at the rear of Machine Shed 3 (Photo 6, **Appendix H**). It was located adjacent to the concrete footings of removed plant machinery. No odours or staining were observed however Robson (2006) identified TPH impact at nearby at location BH14.

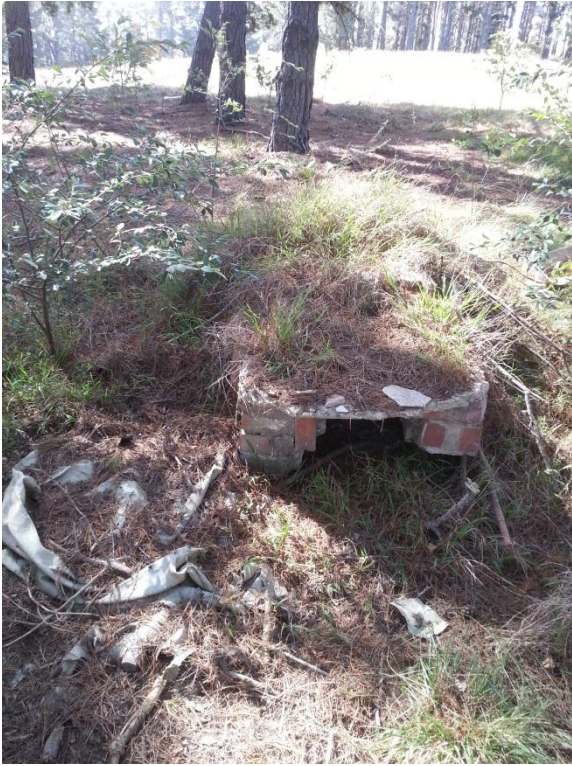
PHOTO ID: 13	CANBERRA BRICKWORKS
DATE: 2/10/2013	
<p><b>DESCRIPTION:</b></p> <p>The material comprised bricks, metal, and general waste and was approximated to be 10 m<sup>3</sup>.</p> <p>Several fragments of ACM were also observed.</p>

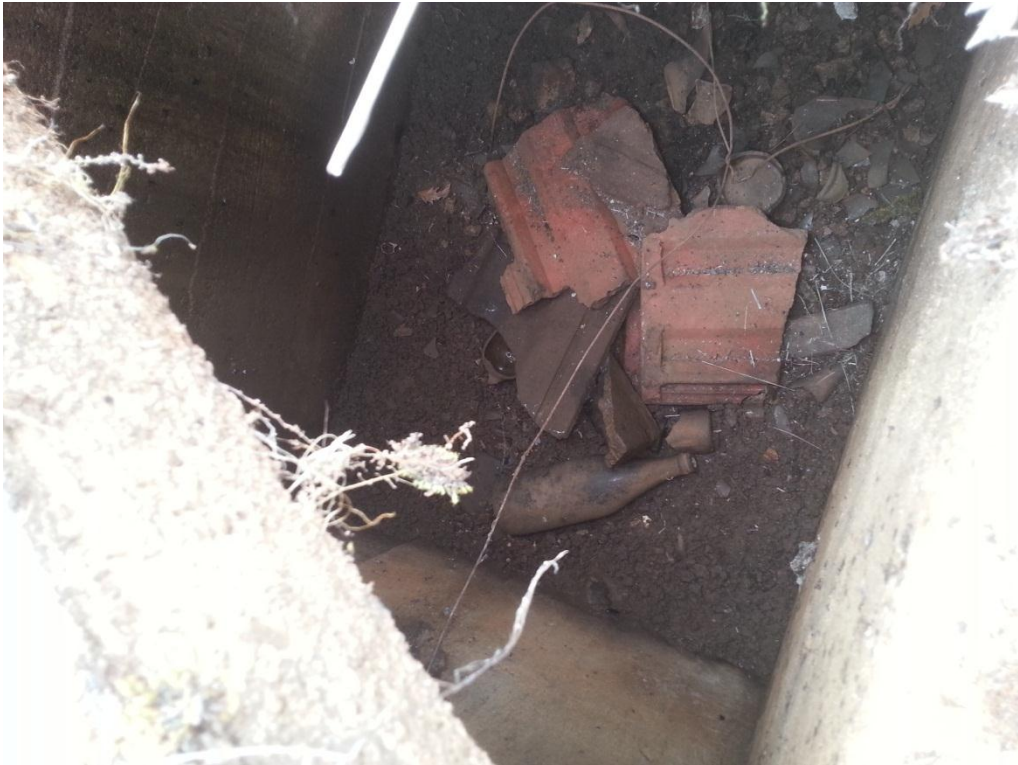
PHOTO ID: 12	
DATE: 2/10/2013	
<p><b>DESCRIPTION:</b></p> <p>The pits were empty with soil material, broken tiles and glass bottles observed at the base.</p>
