Report on
Geotechnical Investigation

Proposed Gungahlin Tennis Facility
Part Block 4 Section 109, Amaroo

Prepared for
Stantec Australia Pty Ltd

Project 220131.00
June 2023

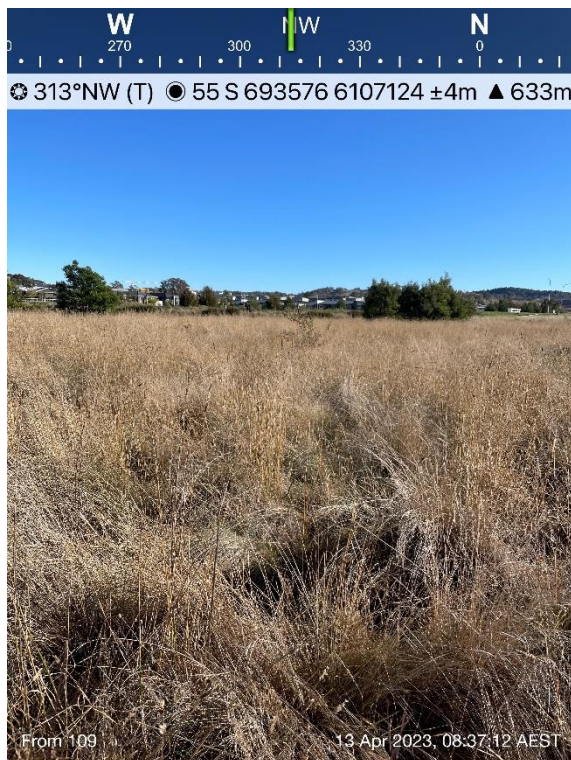
Figure 1: General view of the northern portion of the site from Pit 109 towards Jorgensen Street.

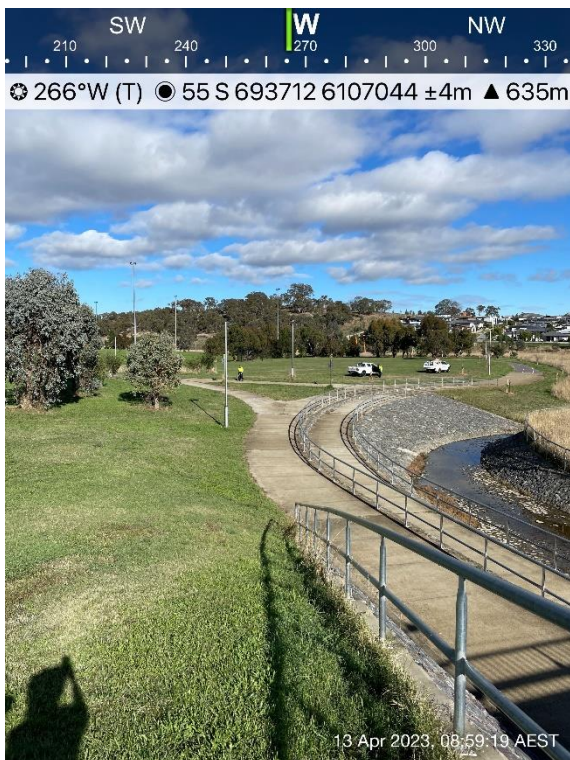
Figure 5: General view of the southern portion of the site, from the eastern end of the Bicentennial National Trail with a rock pitching drain.
