Canberra Brickworks Precinct

Archaeological Research Design

Report prepared for DOMA Group

April 2020

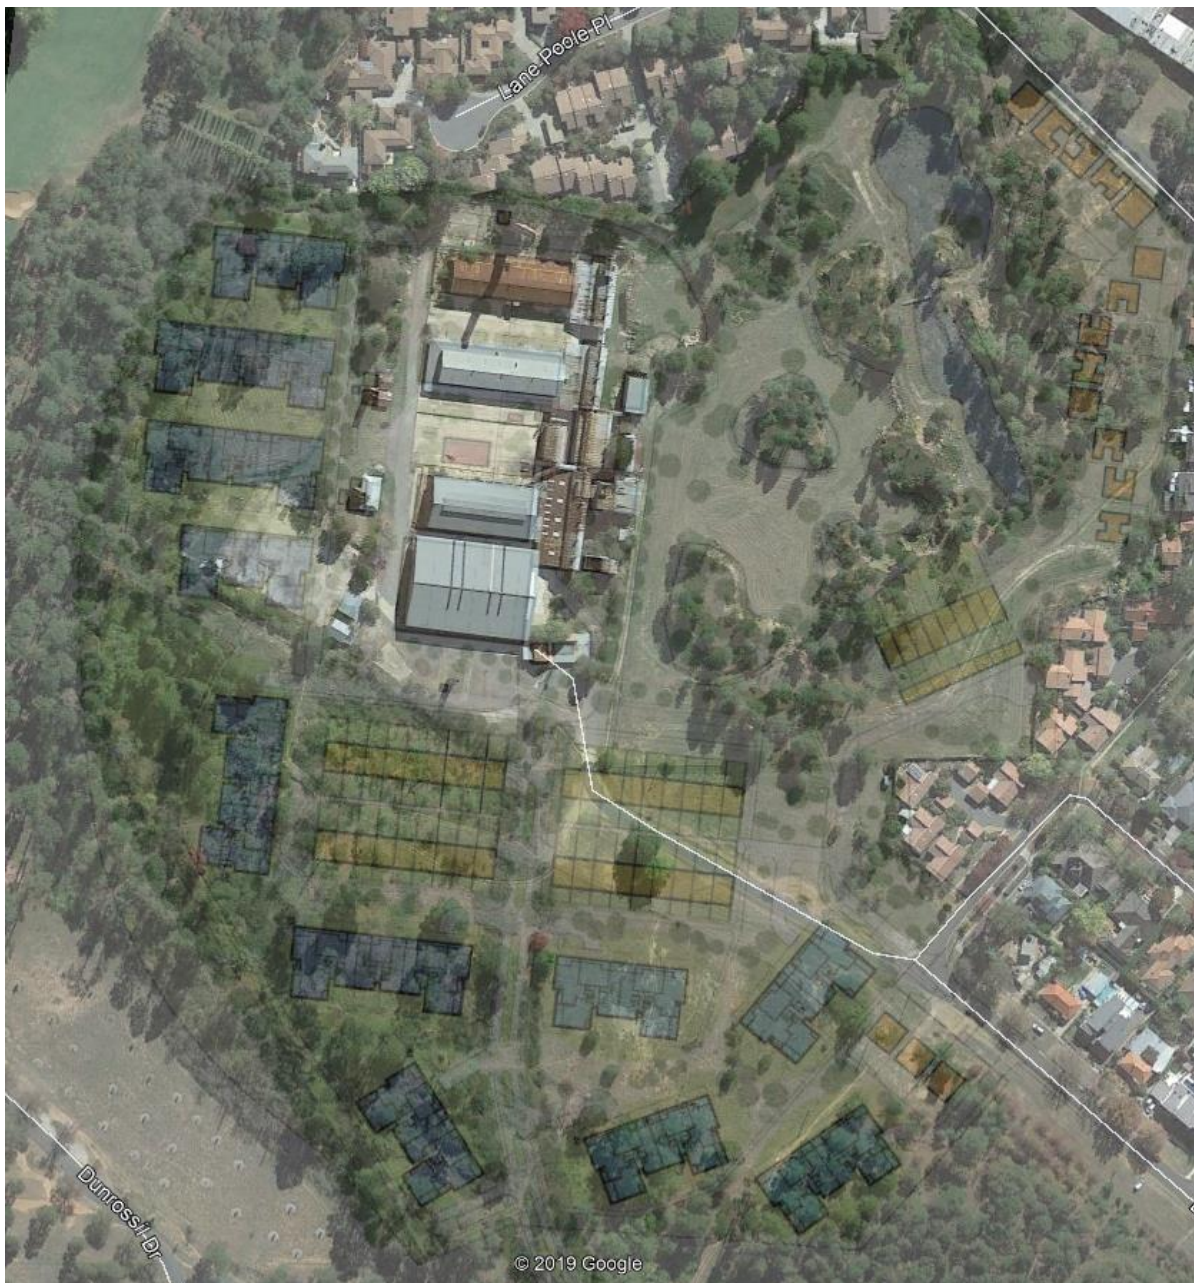
Figure 1.3 Preliminary proposed development design over a current aerial. (Source: Google Earth with GML overlay)

The proposed works involve the redevelopment of the study area into a residential area with associated infrastructure and retail and office spaces (Figure 1.1). Several of the remnant historical structures will be retained and utilised as infrastructure for the residents, and as retail and office spaces for the public. The site will be landscaped, and services and utilities will be installed. Structures are proposed to be constructed within areas found to have archaeological potential including BRW1, BRW2, BRW3, BRW4, BRW5, BRW6, BRW7, BRW8, BRW10 and BRW11. No structures are currently proposed for the BRW9 area. The quarry area will be landscaped, and a pool is proposed to be installed in the existing dam area. Several structures are proposed along the eastern boundary of the site, above the former quarry area.

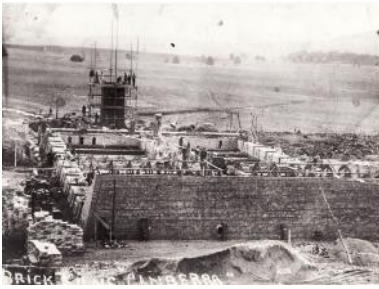
Figure 2.5 Staffordshire kiln construction at the Brickworks, c1915. (Source: Canberra District Historical Society, ID15652)

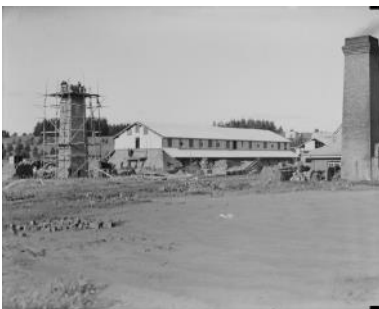
Figure 2.6 Chimney stack under construction, c1926. (Source: NAA, A3560, 2455)

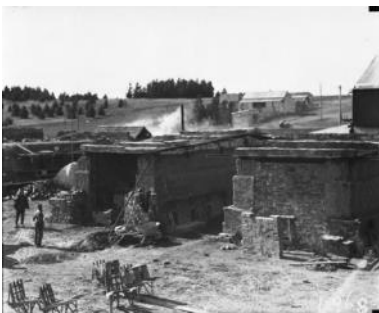
Figure 2.7 Scotch kilns were in operation at the Brickworks until the mid-1920s. (Source: NAA, A3560, 1968)

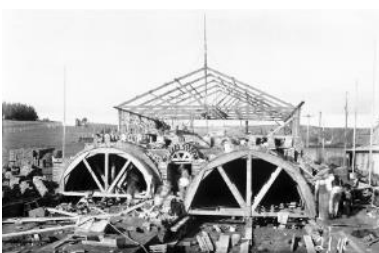
Figure 2.8 Hardy patent kiln 1 under construction, c1926. (Source: NAA, A3560, 2111)

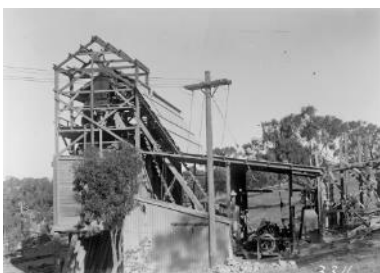
Figure 2.16 Stone crushing and screening
plant. (Source: NAA, A3560)

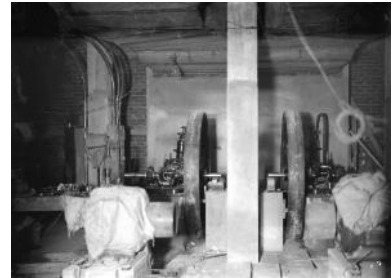
Figure 2.18 Brick pressing machinery being installed at the Brickworks, c1925. (Source: NAA, A3560, 1210)

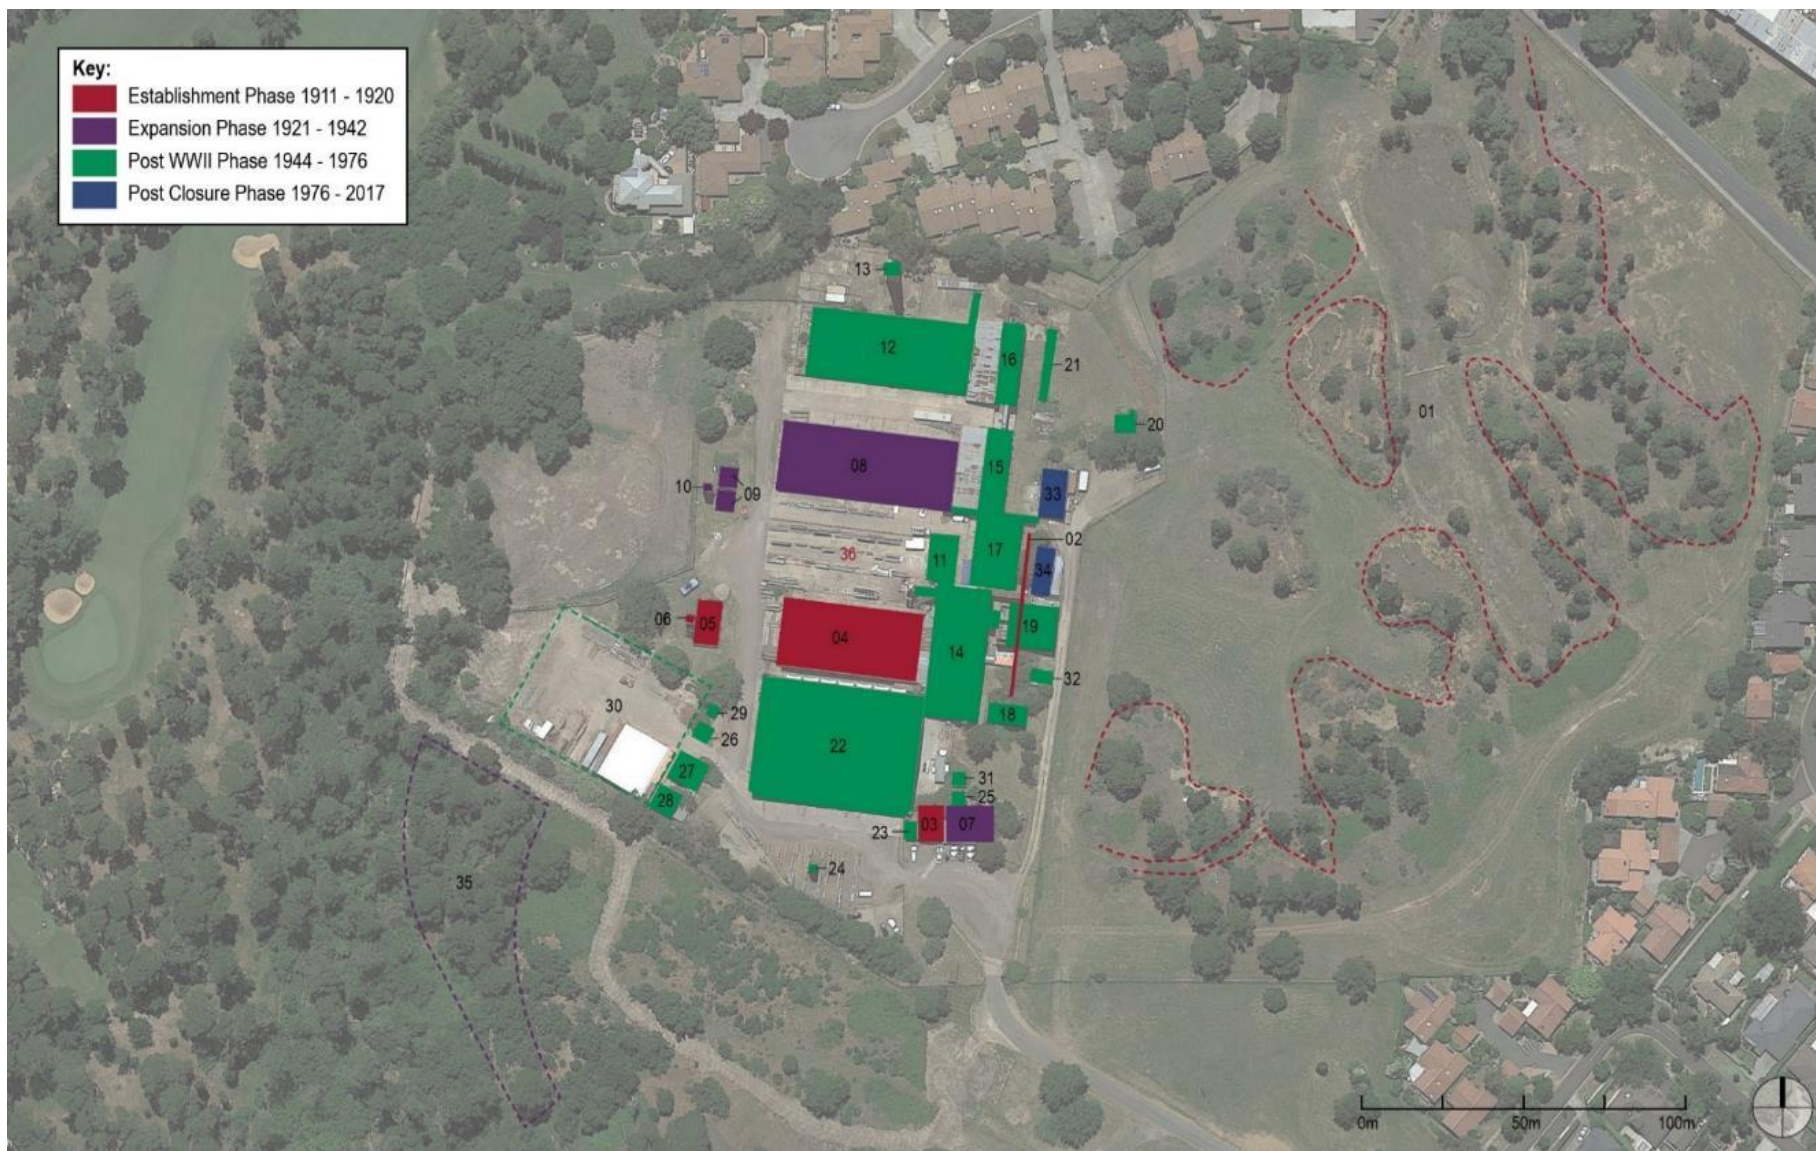
Figure 2.21 Site plan showing the location and development phase of individual elements within the Canberra Brickworks Precinct. (Source: Google Earth with GML overlay, 2017)

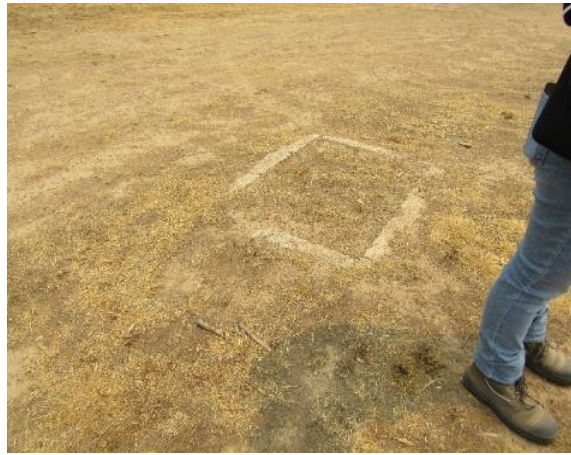
Figure 3.3 Modern services at BRW1. (Source: GML 2020)

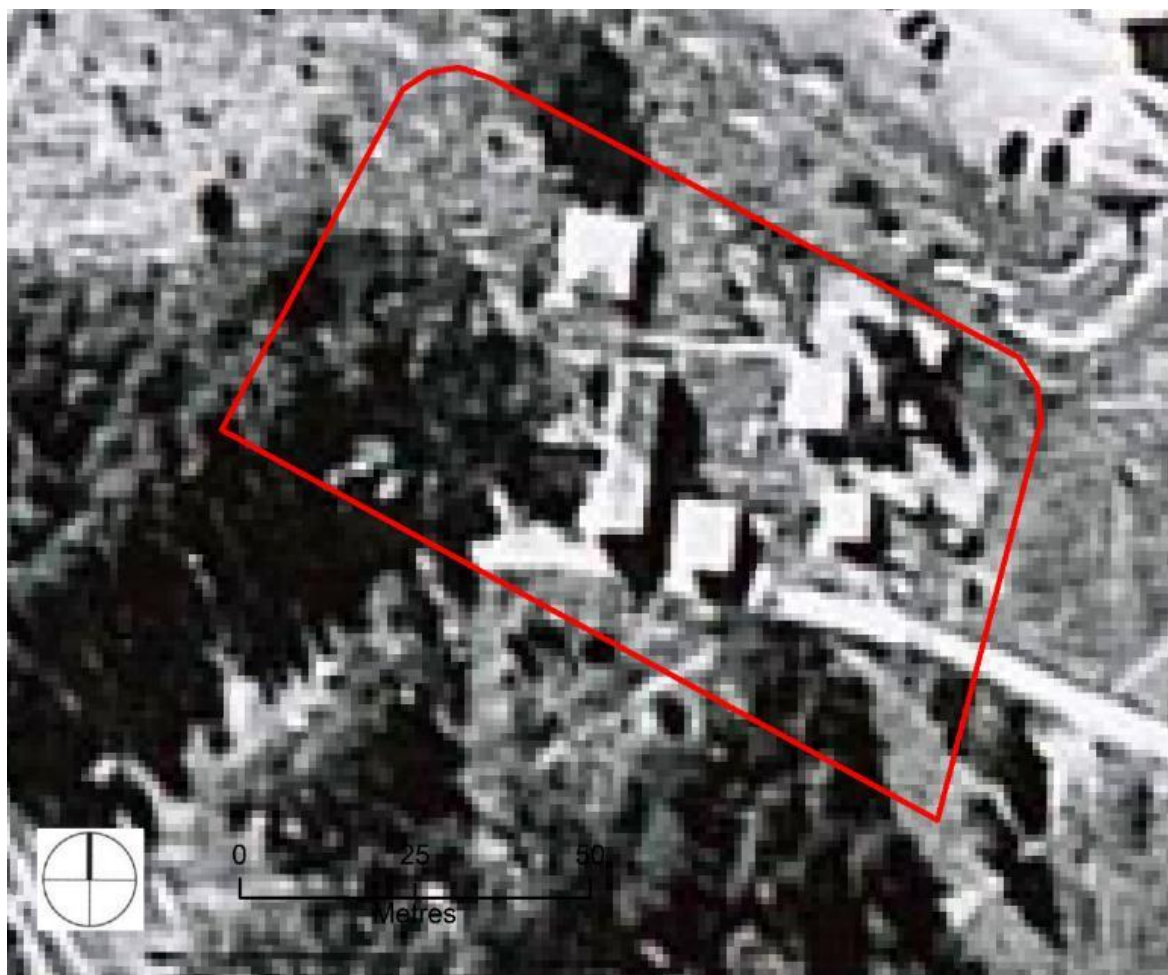
Figure 3.6 Site BRW2 overlaying a 1958 historical aerial. (Source: ACTPLA Plan Room 1958-5-21, Run 7, Print 5061)

The site inspection undertaken by GML confirmed the high potential of this area. The area is currently covered with dense grass and shrubs which limited the visibility. Archaeological deposits at this location may provide information about the nature and configuration of the structures, as well as the daily lives and living conditions of the workers who were employed at the brickworks.

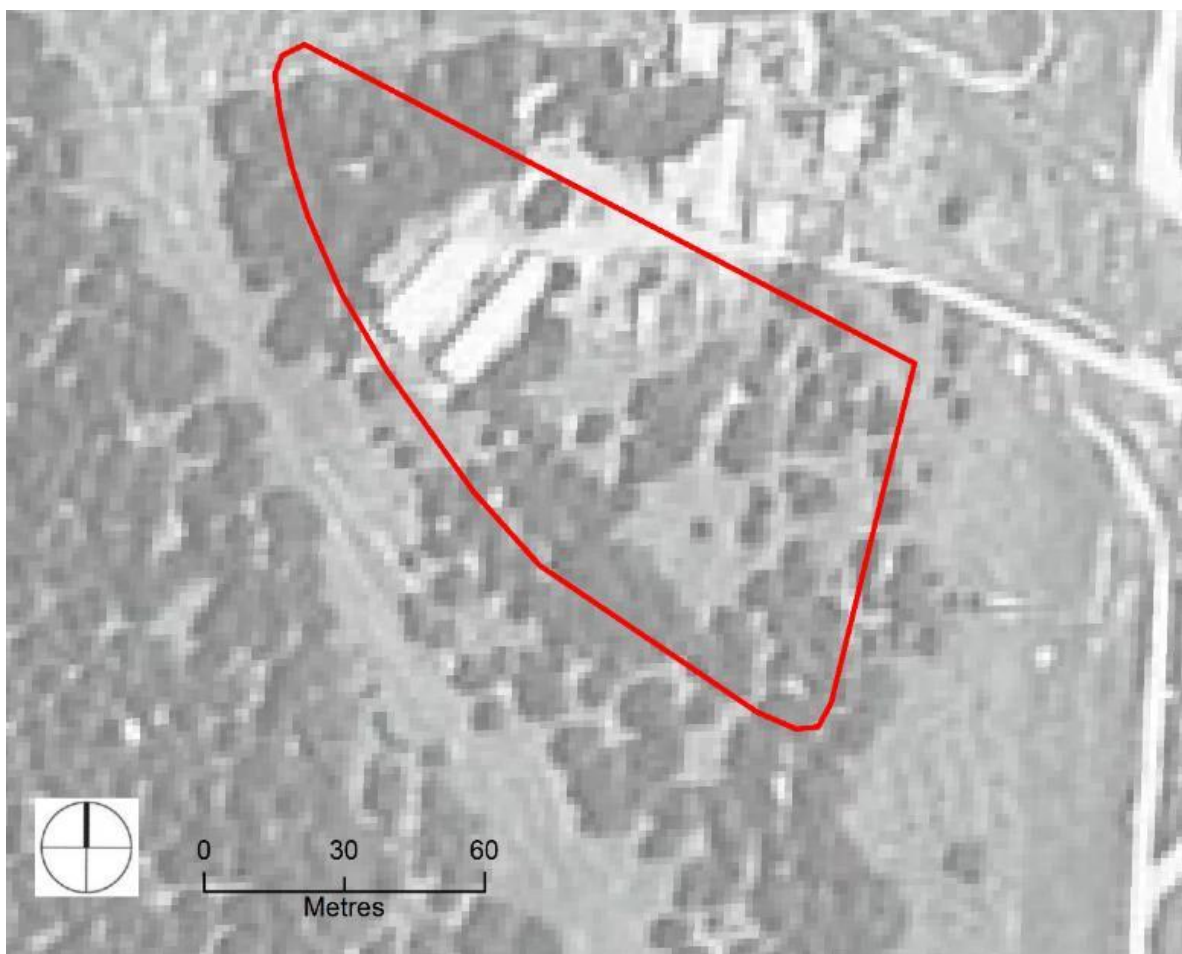
Figure 3.7 Site BRW23 overlaying a 1950 historical aerial. (Source: ACTPLA Plan Room 29-11-1950, Run 2, Print 5101)

This archaeological site consists of a complex of features relating to various structures and infrastructure to the south of BRW2. The AA describes this site as containing evidence of a modern fringe dweller's camp including a hearth made of brick and concrete which appears to be recently used. Evidence of a camp or rough shelter has also been observed here with features including planks nailed to trees, pallets used for flooring, tin sheets and nylon rope tied around trees. A circular feature defined by postholes was also identified. Early plans indicate that this area was used as an ephemeral brickworks camp. Other features found here include brick and concrete spoil mounds, a rectangular clearing, a drainage line and a slab timber fence or yard post.

The site inspection undertaken by GML confirmed the high potential of this area. Archaeological deposits at this location may provide information about the nature and extent of any structural features in this area, the nature of the various postholes, along with the daily lives and living conditions of the workers who were employed at the brickworks.

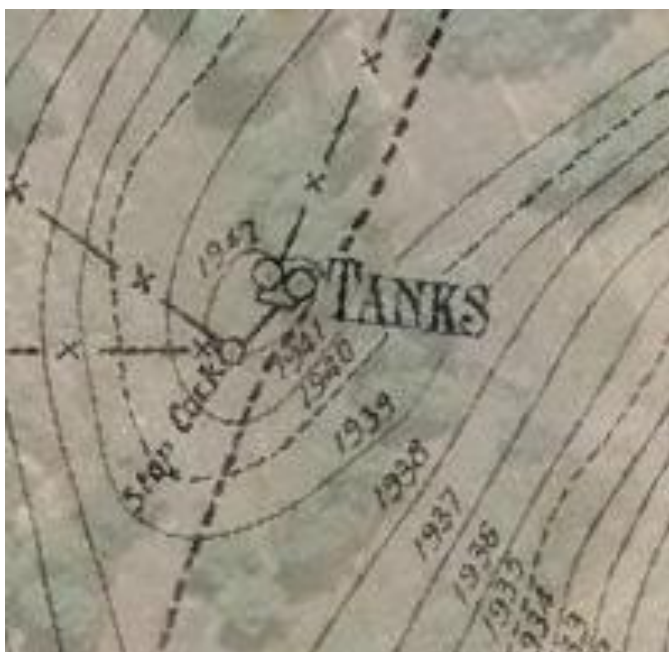
Figure 3.11 Detail of the 1916 site plan showing the former tanks at the quarry. (Source: NAA: A6664, L165A, 1916)

The AA identified two specific features at the southern end of the quarry—a bricked-over water tank (Figures 3.11–3.13) and a series of circular depressions. While the bricked-over water tank was found during the site inspection, there was no clear evidence of the circular depressions. In addition to those features, GML observed a small rise in the centre of the quarry area which may represent a structure visible in 1972 historical aerials (Figure 3.14).

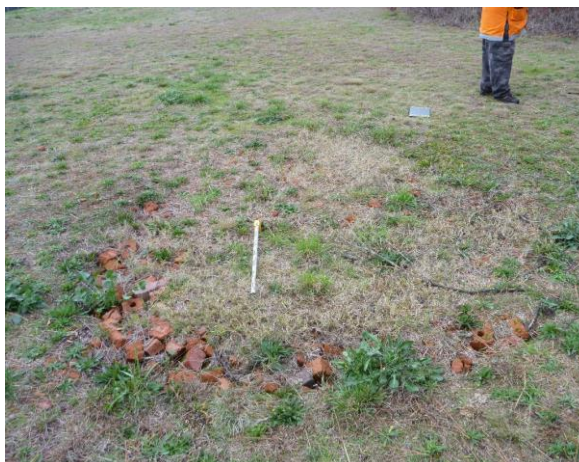
Figure 3.12 Bricked-over water tank from AA report. (Source: GML)

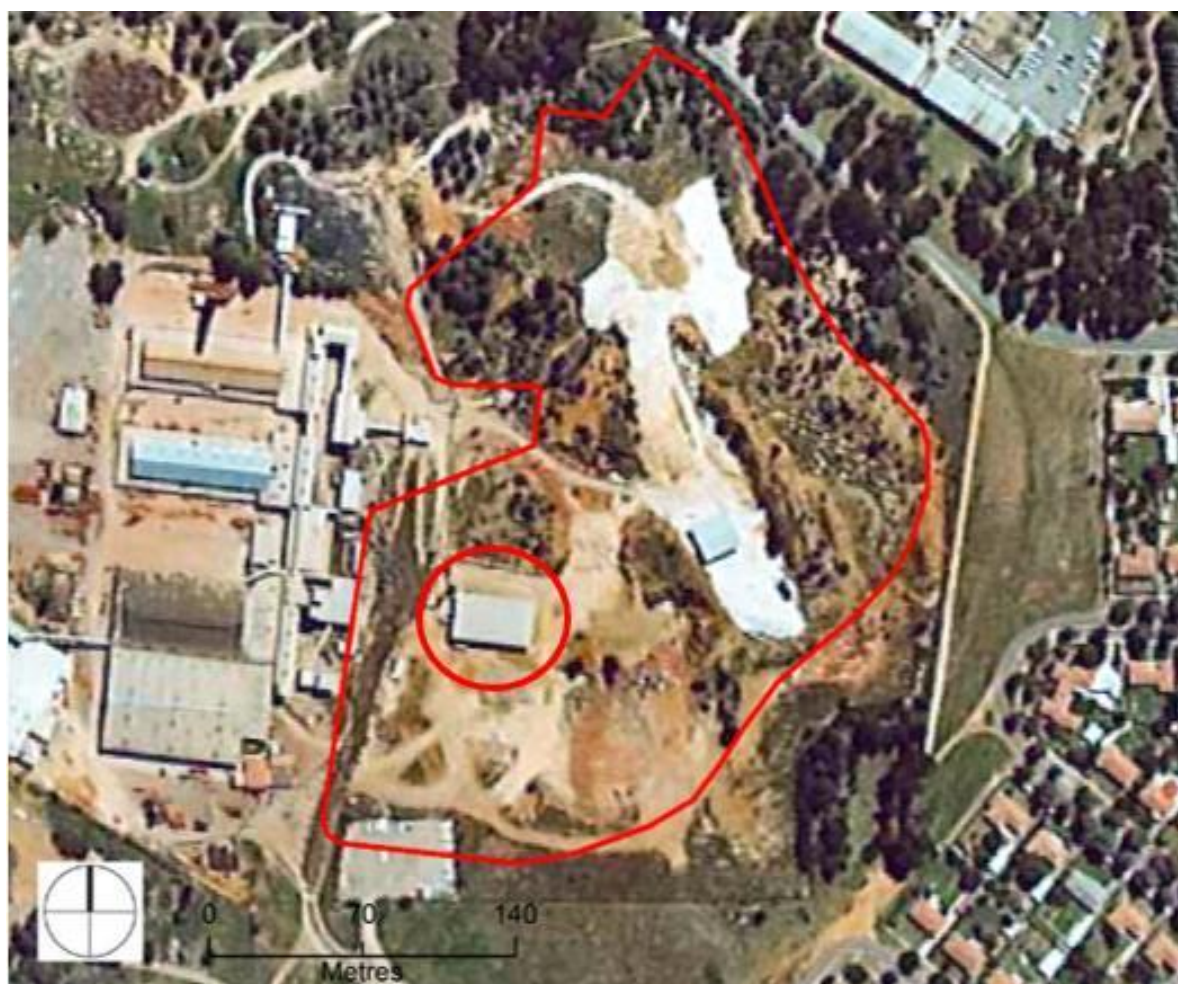
Figure 3.14 A 1972 aerial showing the location of BRW7 and the former structure. (Source: ACTPLA Plan Room 24-2-1972, Run 9, Print 047)

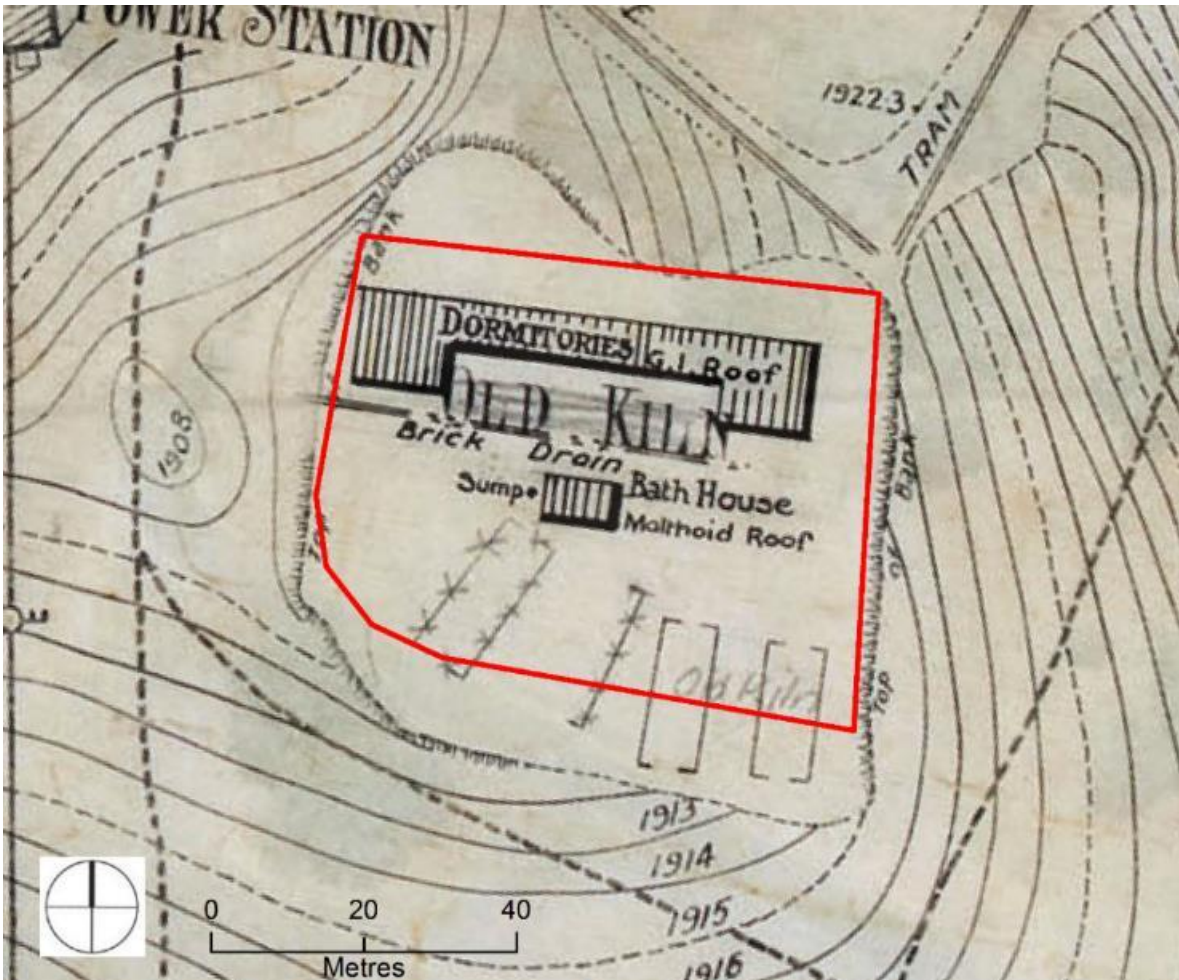
Figure 3.15 A 1916 site plan aerial showing the location of BRW8 and former structures. (Source: NAA: A6664, L165A, 1916)

GML inspected this area on 15 January 2020 and confirmed that disturbances had occurred to the BRW8 site. A review of historical aerials and maps suggests that to the south of the old kiln and dormitories building was also a brick drain and bath house. While disturbance has occurred to this area, and the AA determined this area to have a low potential for archaeological remains, GML has found that, if present, archaeological features and artefacts could be of high significance. This area is therefore proposed to be tested as part of the methodology outlined in Sections 4 and 5 of this report.

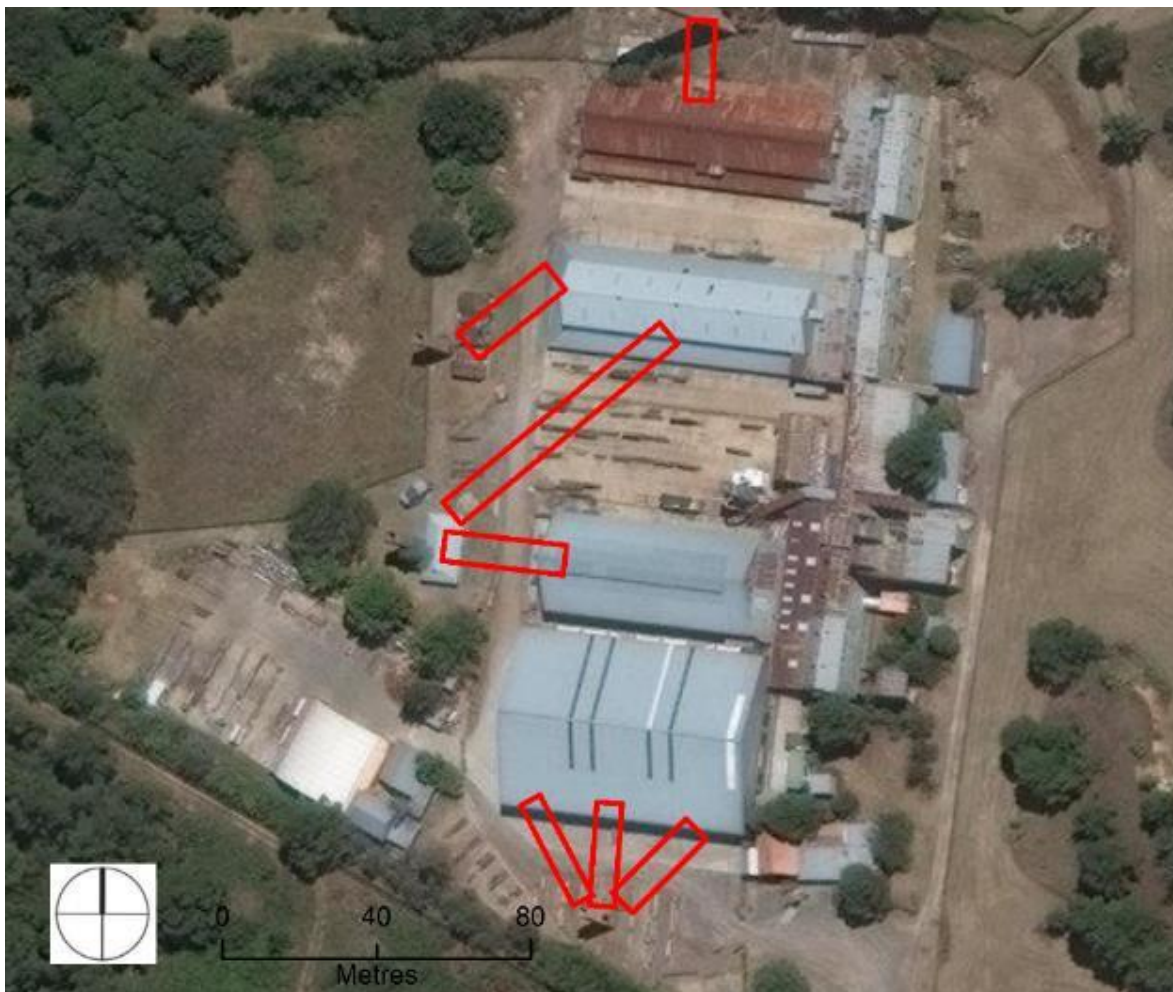
Figure 3.26 A current aerial showing the location of BRW12. (Source: ESRI Basemaps and GML Overlay)

GML observed some evidence of these features during the site inspection undertaken on 15 January 2020. Further investigation to refine the understanding of these features, their depths, extent and nature is warranted.

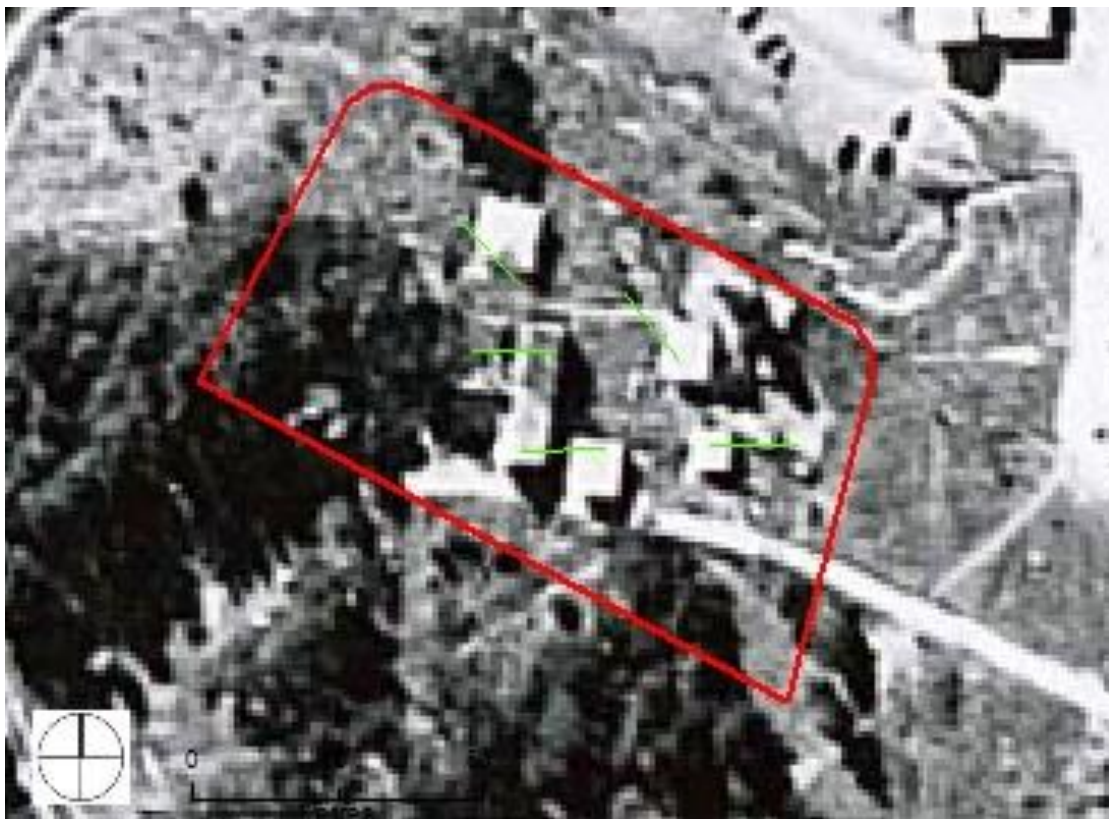
Figure 5.1 View of proposed test unit locations at BRW2 overlaid on a 1958 aerial. (Source: ACTPLA Plan Room 1958-5-21, Run 7, Print 5061)

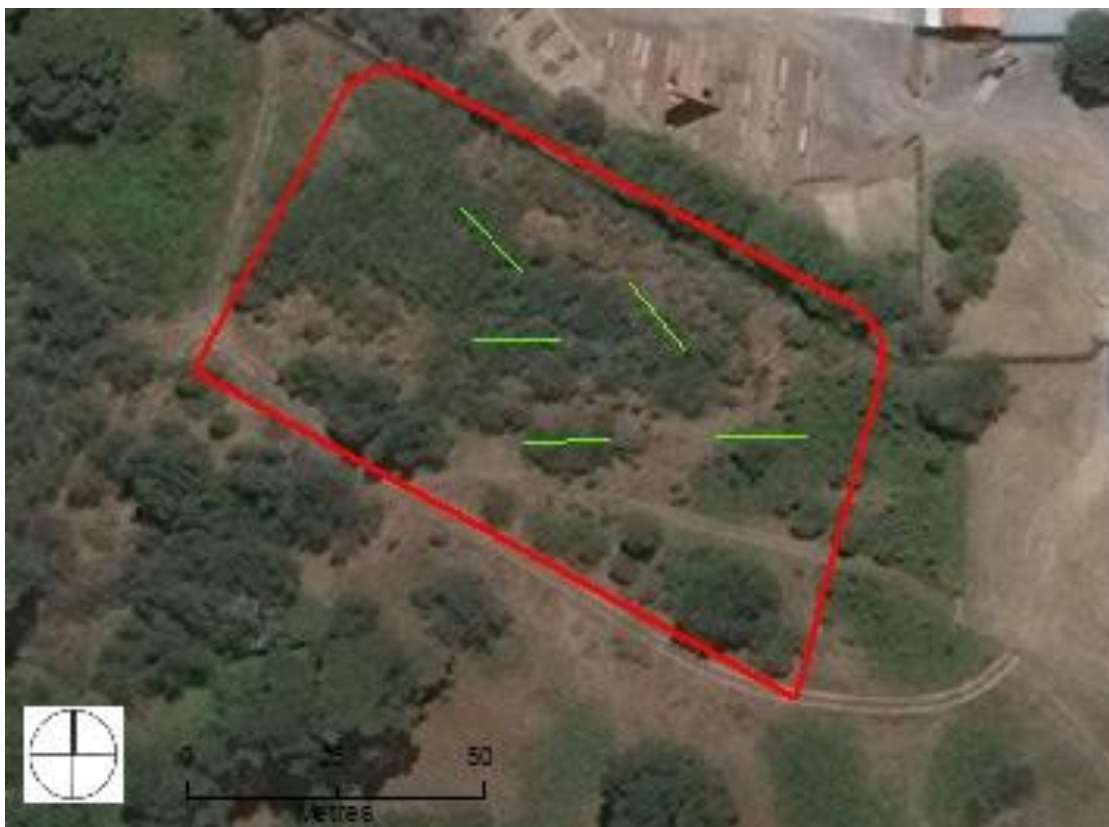
Figure 5.2 View of proposed test unit locations at BRW2 overlaid on a current aerial. (Source: ESRI Basemaps with GML Overlay)

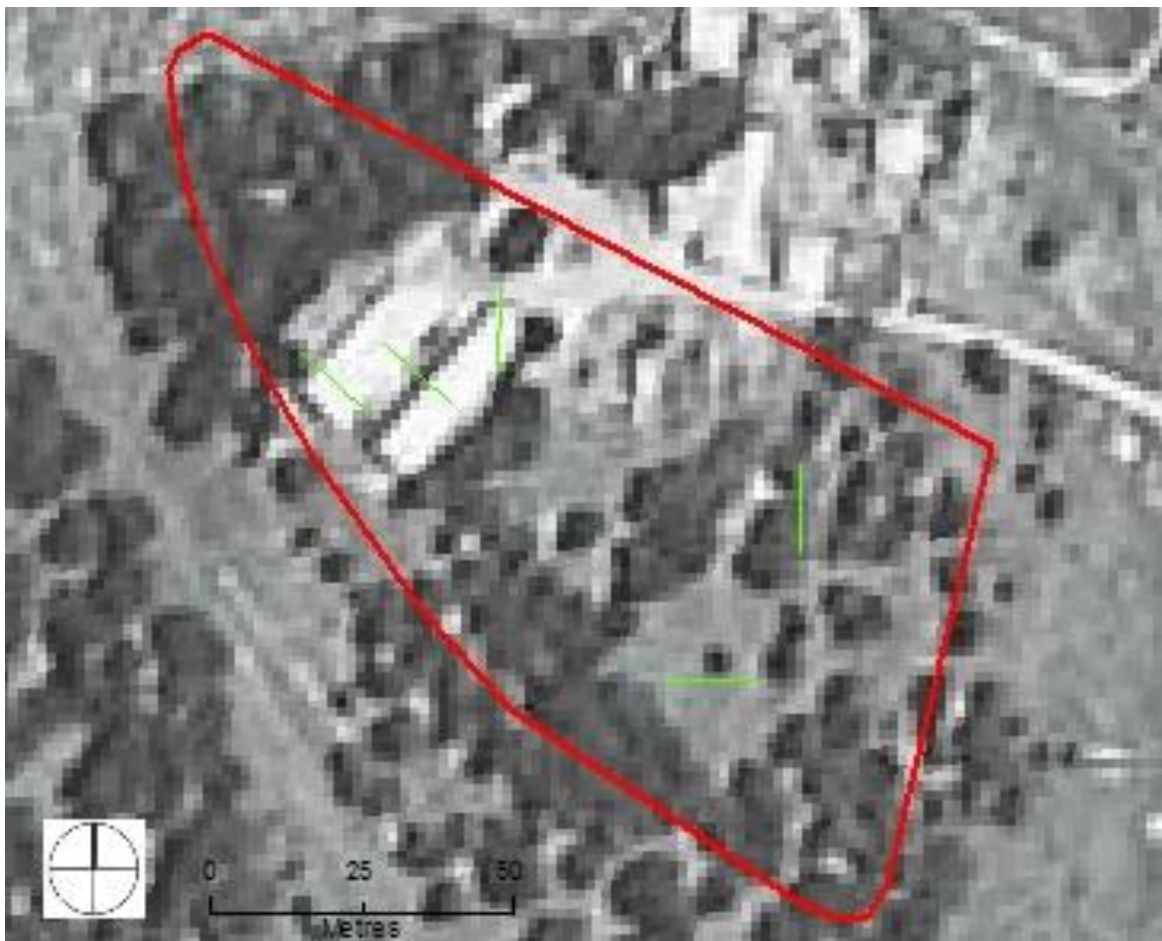
Figure 5.3 View of proposed test unit locations at BRW3 overlaid on a 1950 aerial. (Source: ACTPLA Plan Room 29-11-1950, Run 2, Print 5101)

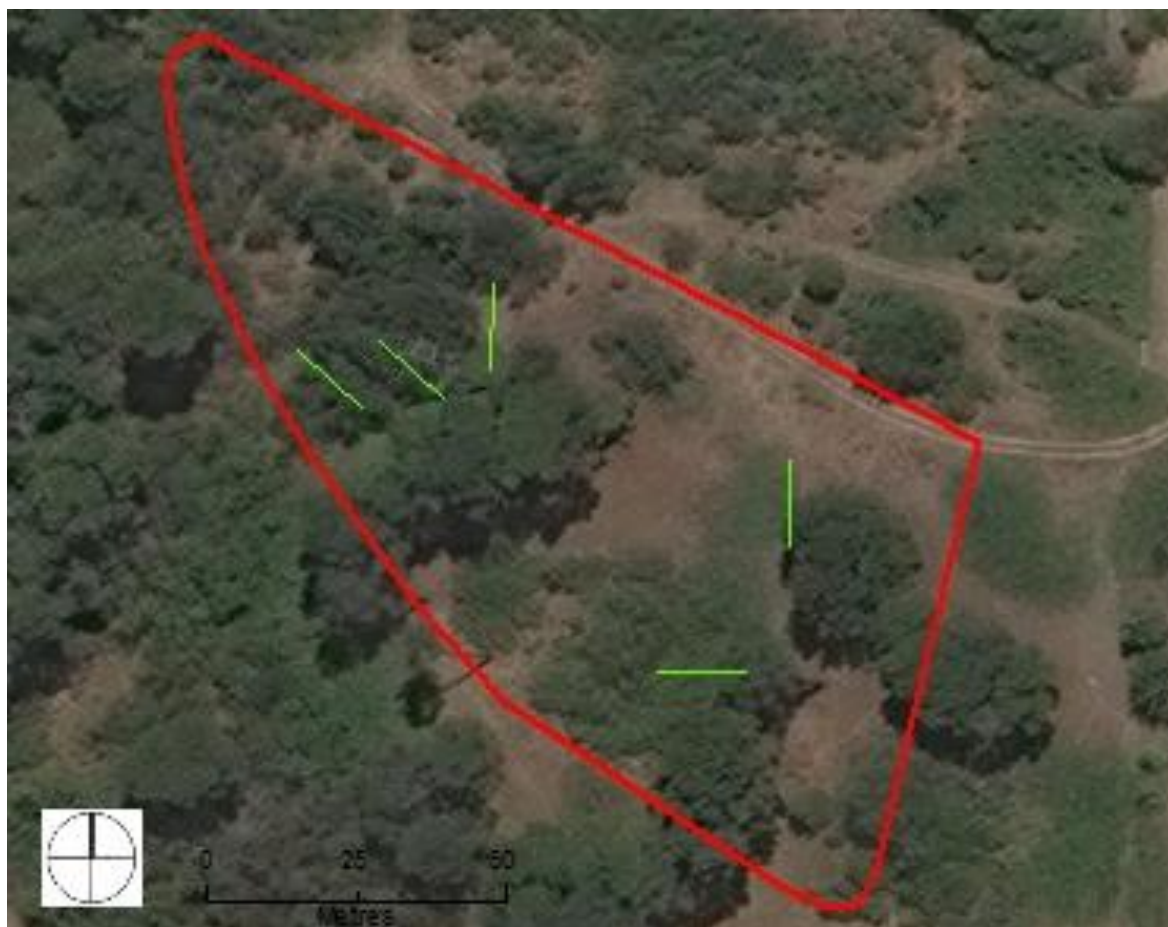
Figure 5.4 View of proposed test unit locations at BRW3 overlaid on a current aerial. (Source: ESRI Basemaps with GML Overlay)

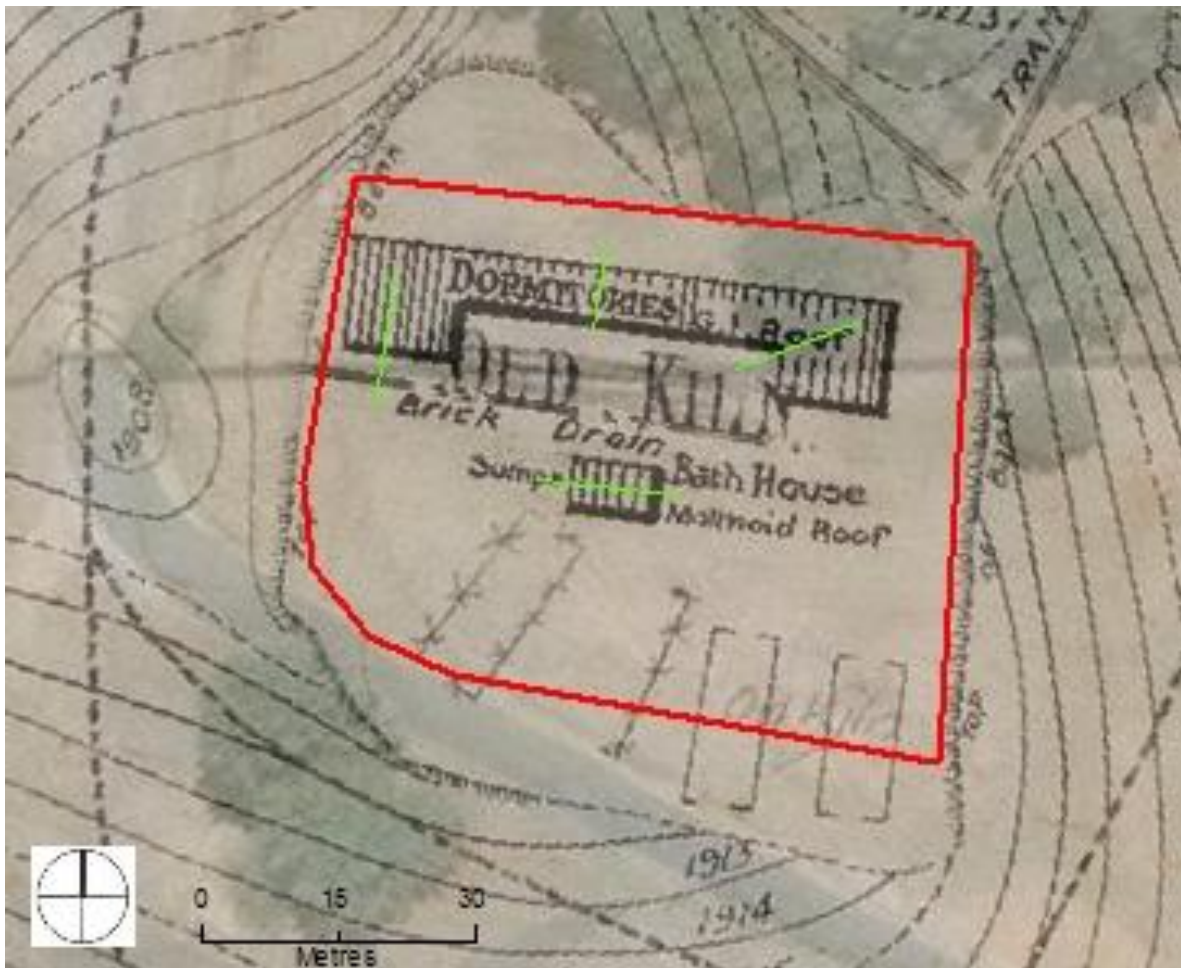
Figure 5.5 View of proposed test unit locations at BRW8. (Source: NAA: A6664, L165A, 1916)

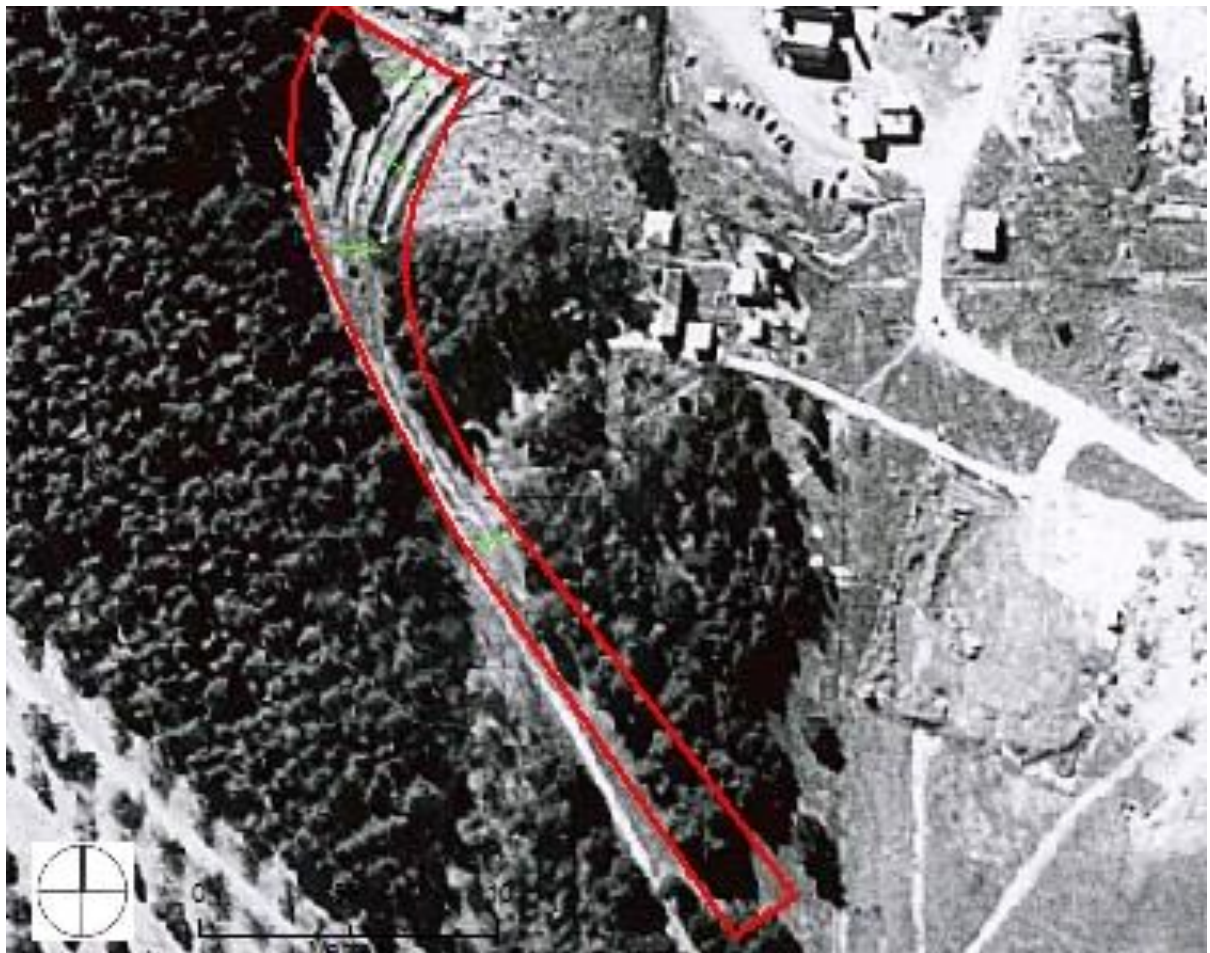
Figure 5.6 View of proposed manual test excavation locations at BRW10 overlying a 1958 aerial. (Source: ACTPLA Plan Room 1958-5-21, Run 7, Print 5061)

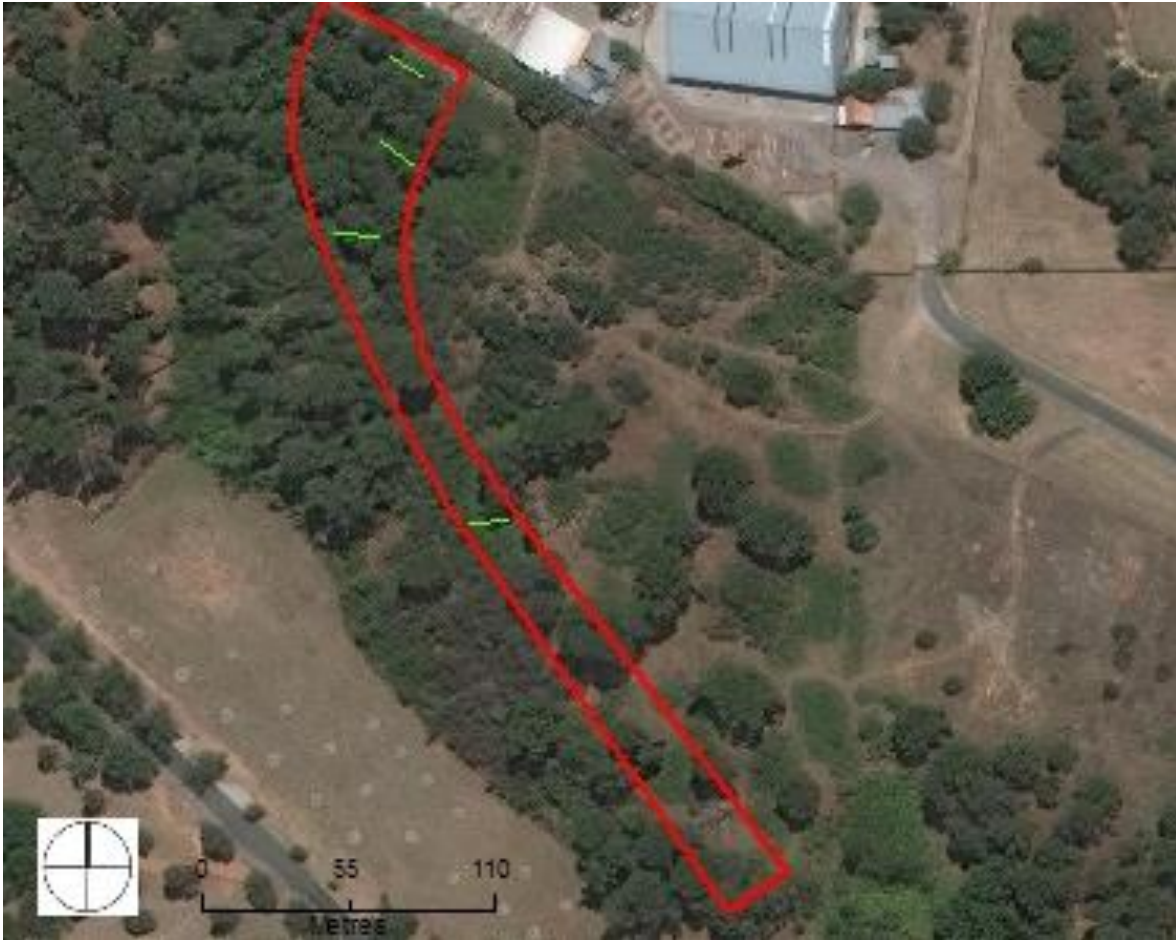
Figure 5.7 View of proposed manual test excavation locations at BRW10 overlying a current aerial. (Source: ESRI Basemaps with GML Overlay)

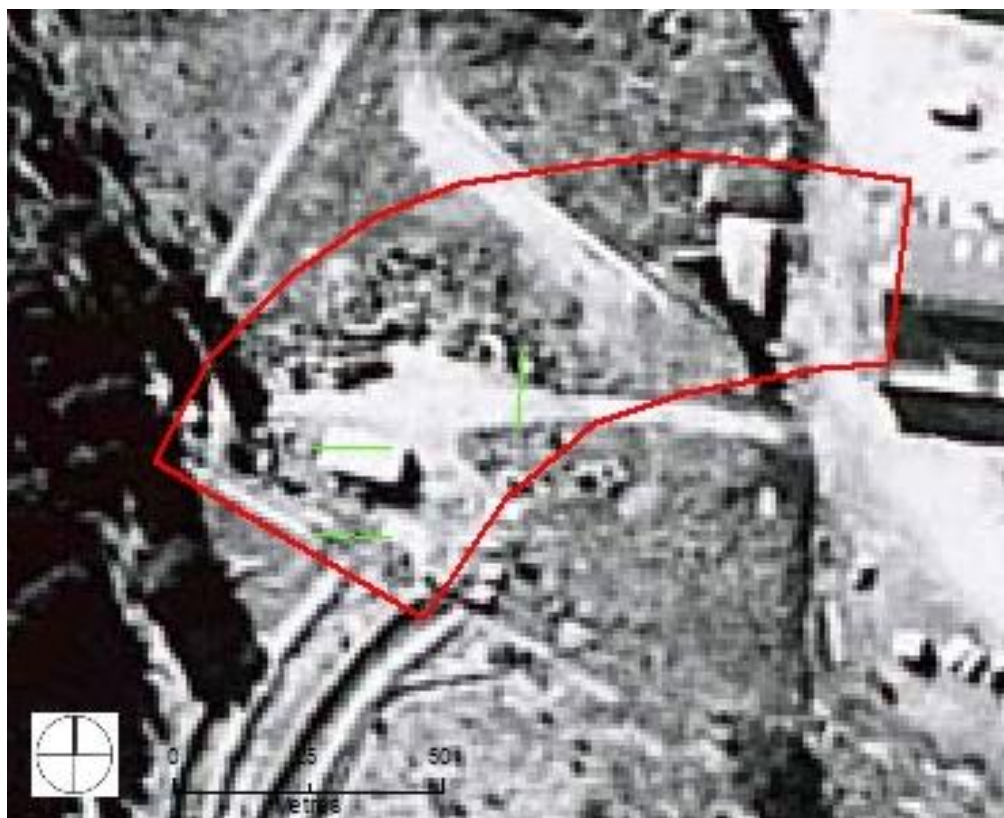
Figure 5.8 View of proposed manual test excavation locations at BRW11 overlying a 1958 aerial. (Source: ACTPLA Plan Room 1958-5-21, Run 7, Print 5061)

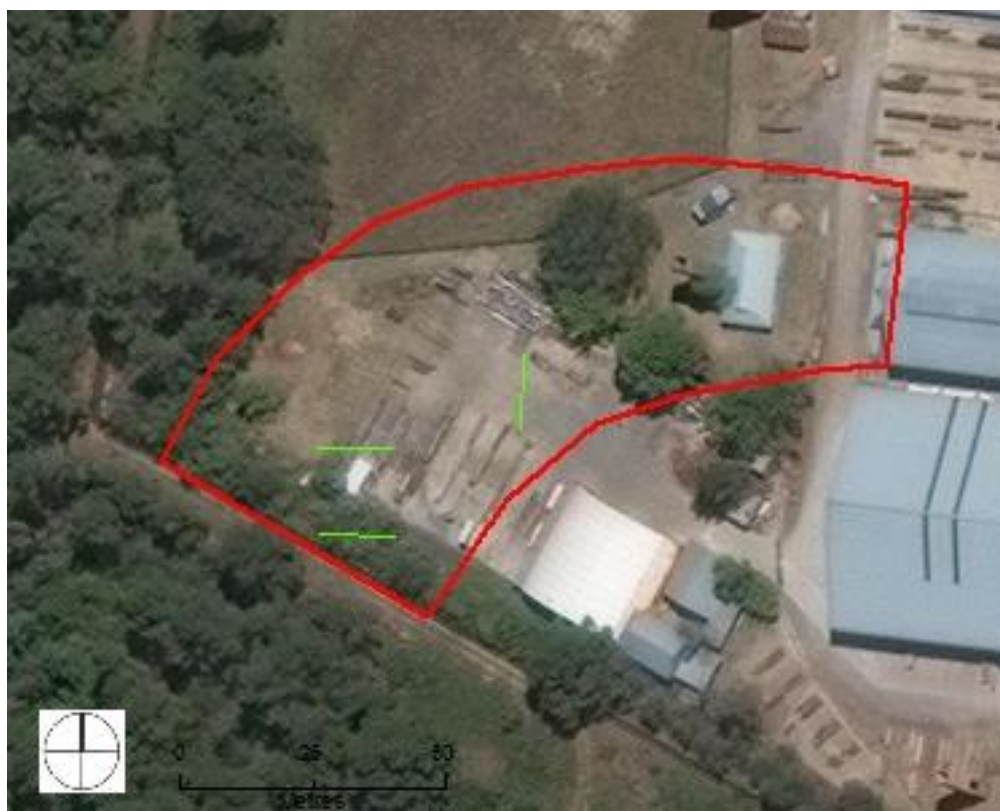
Figure 5.9 View of proposed test excavation locations at BRW11 overlying a current aerial. (Source: ESRI Basemaps with GML Overlay)

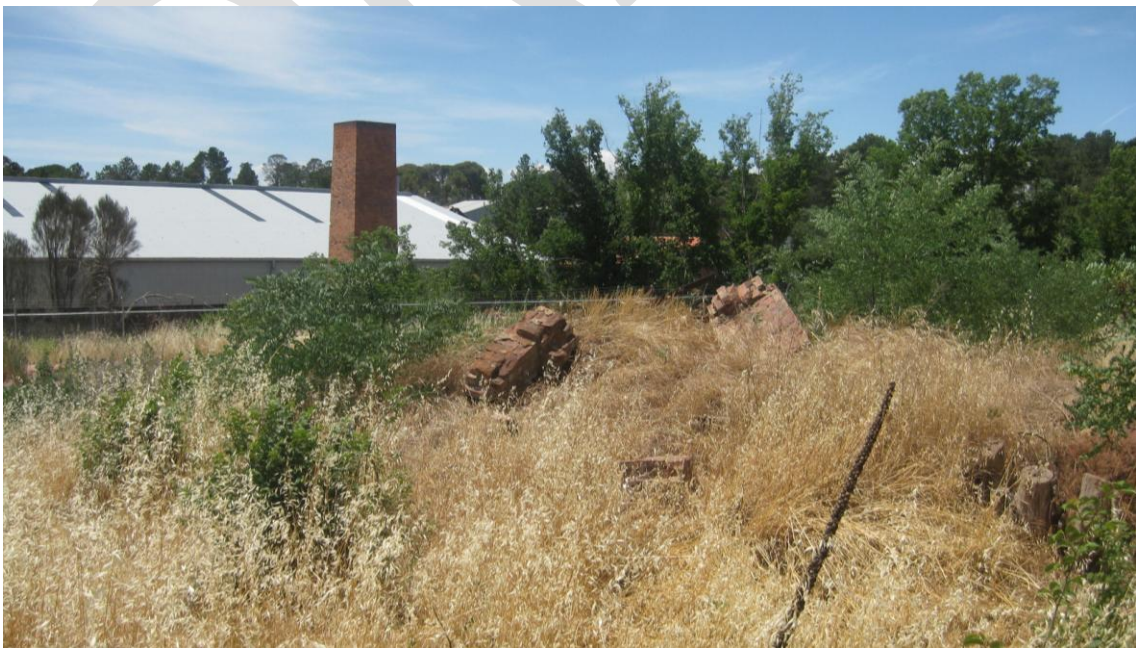
Figure 13 Walls/footings of the former Brickworks Hostel, 2010
