Canberra Brickworks Precinct

Archaeological Research Design

Report prepared for DOMA Group

April 2020

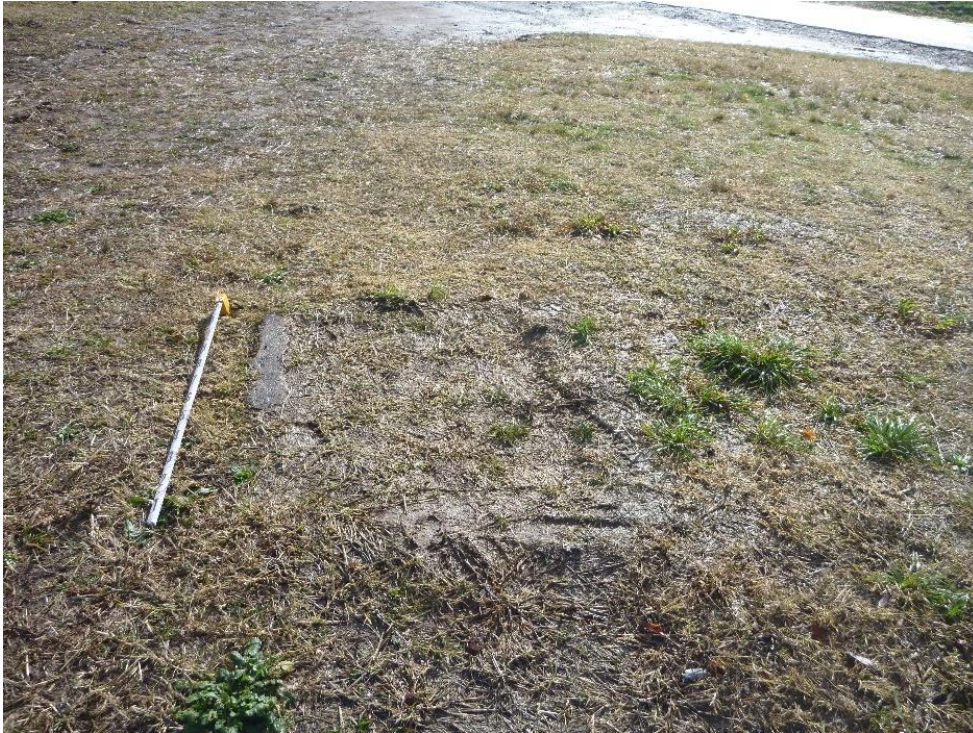
Figure 17 View of BRW1 concrete feature, looking north
Source: NOHC

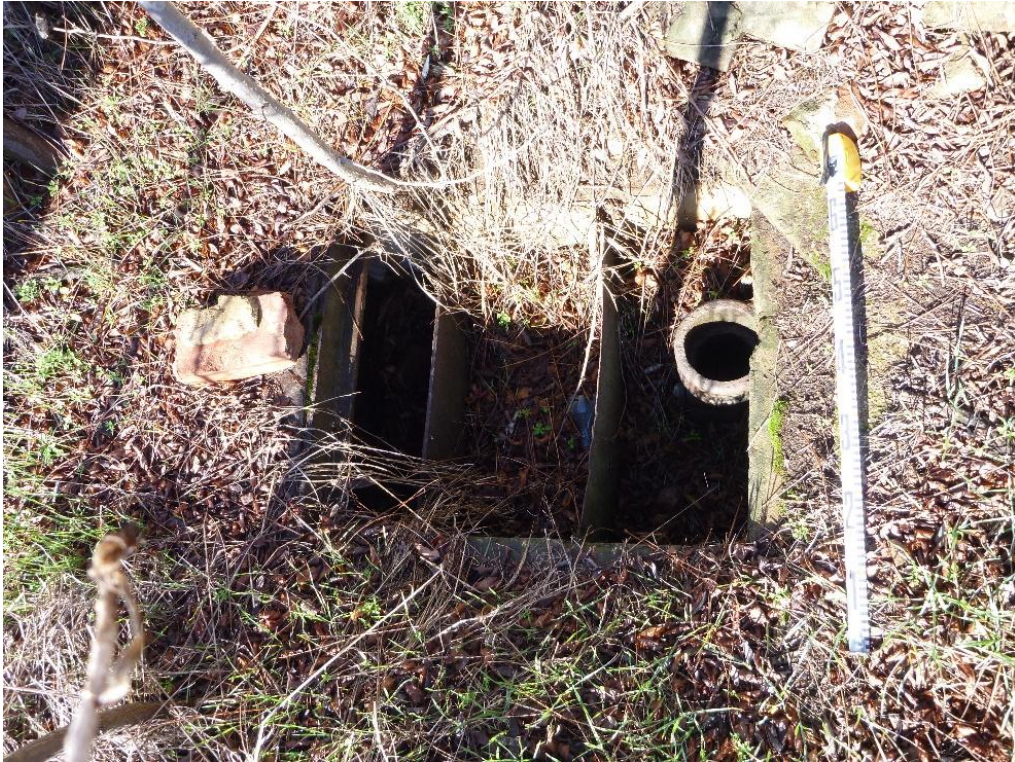
Figure 19 Detail of drain at northern end of BRW2-A
Source: NOHC

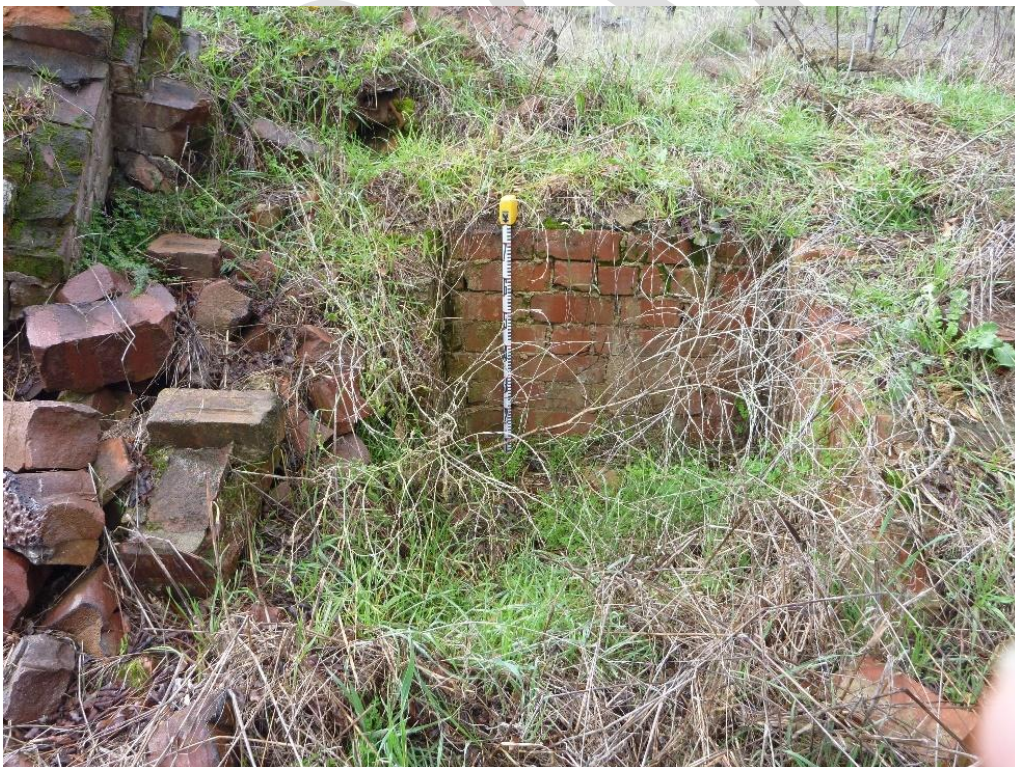
Figure 20 Detail of brick stall at BRW2-A
Source: NOHC

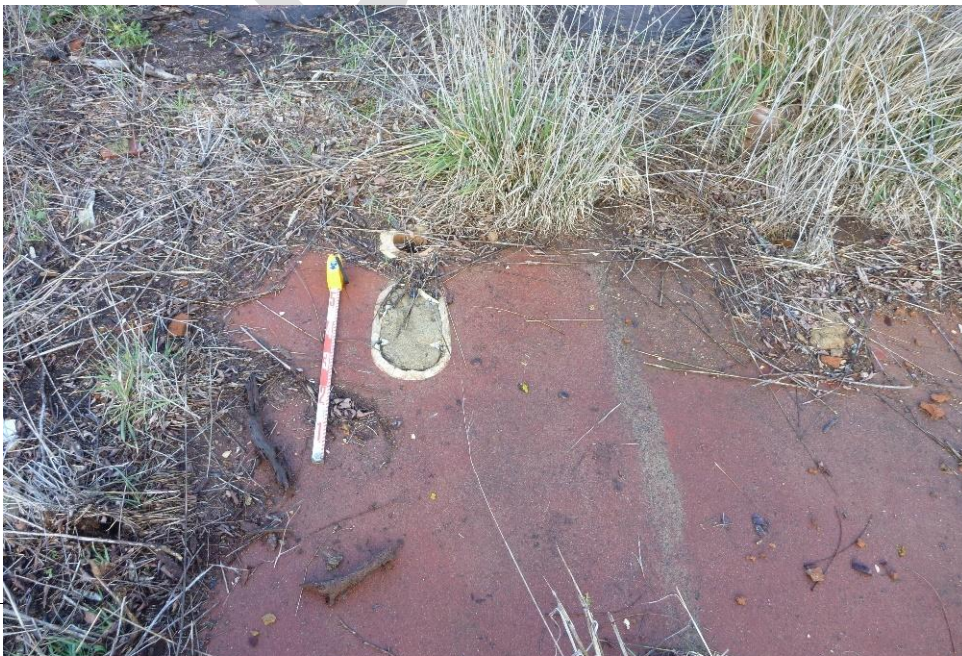
A concrete slab approximately 4m x 6m is located just south of the southern fence line of the brickworks at the western end of the site (Figure 23). The rendering is coloured red and has the remains of four toilet fittings running down the centre of the slab. The toilet bowls have been removed from the platform, although fragments of broken bowl and earthenware plumbing pipe exist around the slab (Figure 24). The alignment of the toilets suggest that the stalls were accessible from the northern side of the slab. A possible step or entrance way extends from the northern part of the slab in the centre. A stamped feature is evident in the north east corner of the slab suggesting a small closet, room or feature for what appears to be an ablutions block. The slab appears to be on the same alignment as BRW2-A, which is just further south. This structural feature appears to correspond with the brickworks ablution block which is depicted in images of this area from at least 1929. The ablution block suggests that it was more to do with the brickworks than it was to do with the accommodation of employees.

Figure 24 Remnant of one of the toilet fitting
Source: NOHC

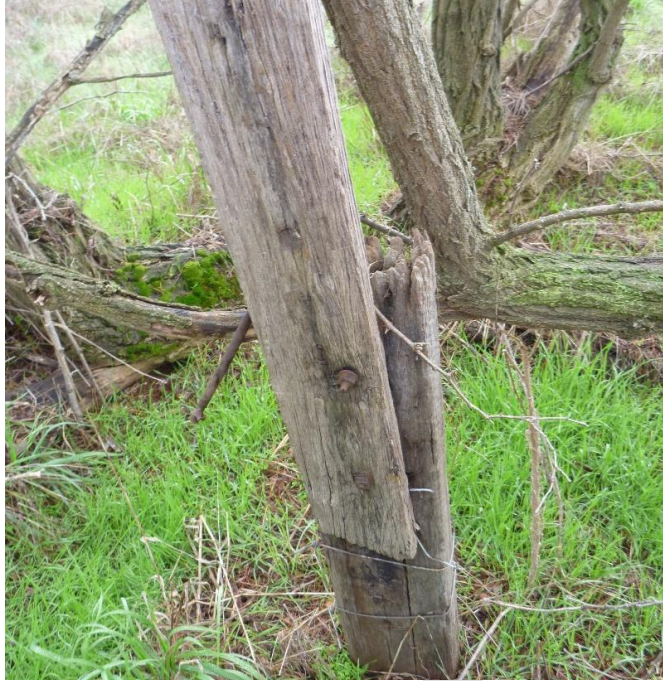
In proximity to the hearth and camp are mounds of structural spoil, consisting of brick and concrete, iron rods and metal sheeting, bottles and tin cans. To the east of the modern camp, and almost directly south from BRW2, a rectangular clearing was encountered. At the top of the slope to the south of the clearing a drainage line has been excavated, which runs approximately on an east-west alignment (Figure 27). No other structural features or remains were identified within this clearing between the drainage line and the northern border of the site. However, a slab timber fence or yard post is located at the northern end. The post itself appears to be early in origin, but has had modifications made to it by the addition of another slab bolted to the upright, and use of galvanized wire and nails, as opposed to non-galvanized iron nuts and bolts for other modifications (Figure 28). No other posts or holes were

Figure 28 Detail of slab post at BRW3
Source: NOHC

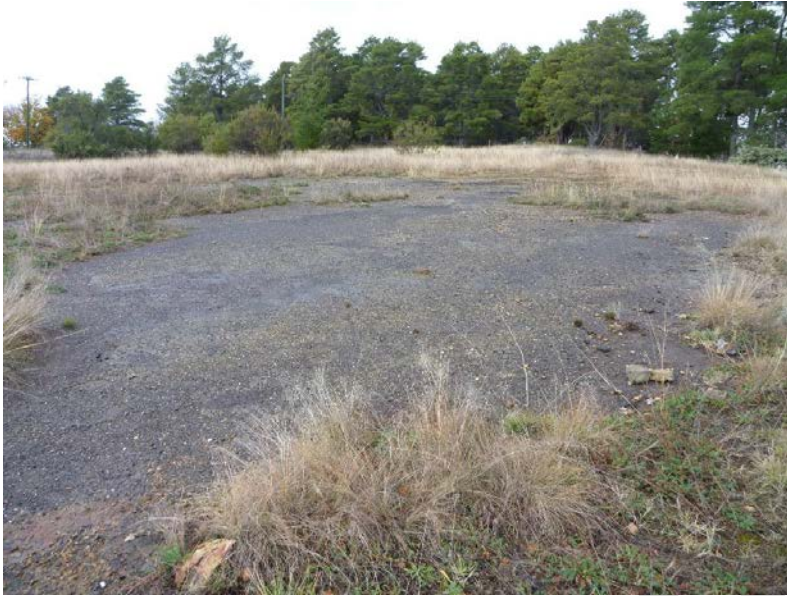
A fenced yard area measuring approximately 80m x 80m is located to the south of BRW1. Defined by a star picket fence line with wire netting along the bottom portion and barbed wire on the upper portion, the yard is accessed by gates at the northern end from Denman Street and a gate in the south-west corner. Visibility was very good as the area is relatively clear of vegetation, with the exception of a light covering of low growing grass across parts, and the occasional low growing shrub and small tree. The yard rises up a gentle slope to the south. A layer of bitumen such as that used for road surfaces covers a good portion of the site (Figure 29) and this sits directly above a layer of bedrock, with only a thin layer of topsoil present in patches throughout the yard. No structural features were identified, although fragments of window glass were found near the northern entrance to the site (Figure 30). The condition of this area is good.

Figure 29 Asphalted area at BRW4, looking east
Source: NOHC

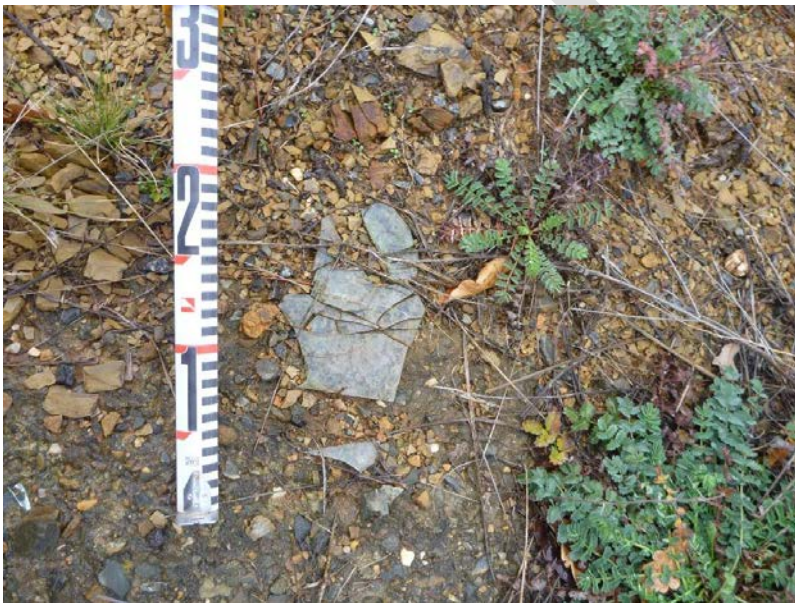
Figure 30 Window glass at BRW4
Source: NOHC

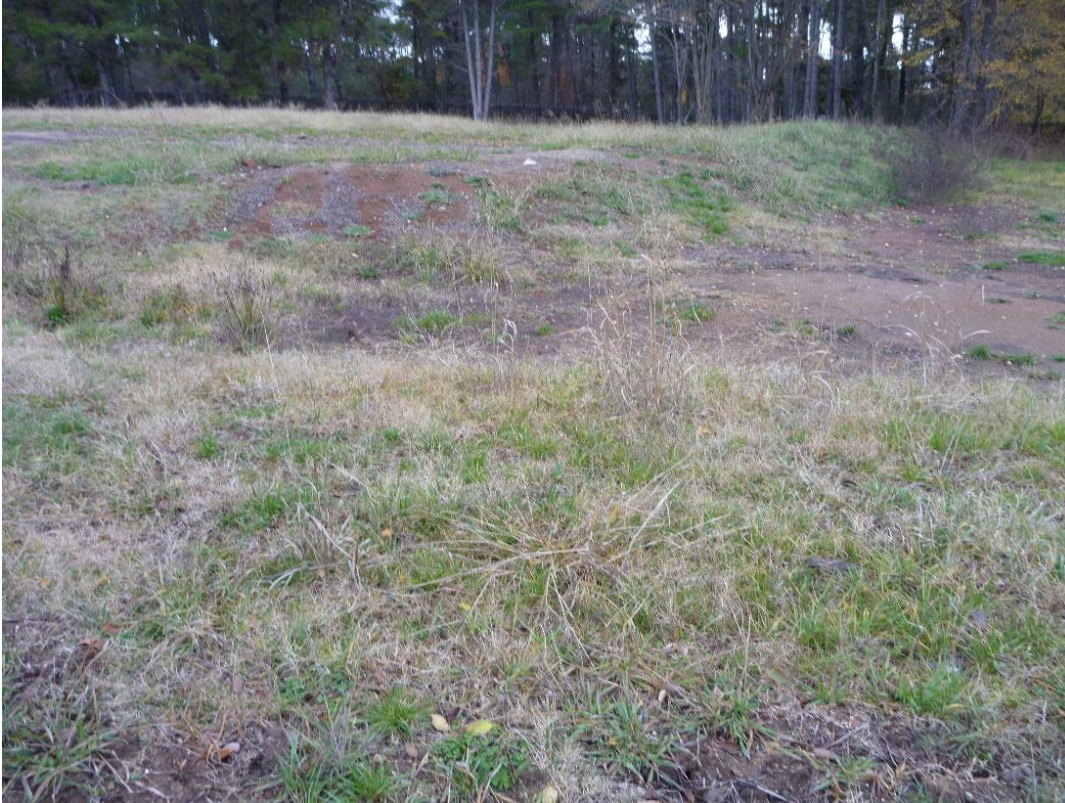
Figure 31 Clay mound feature at BRW5, looking west
Source: NOHC

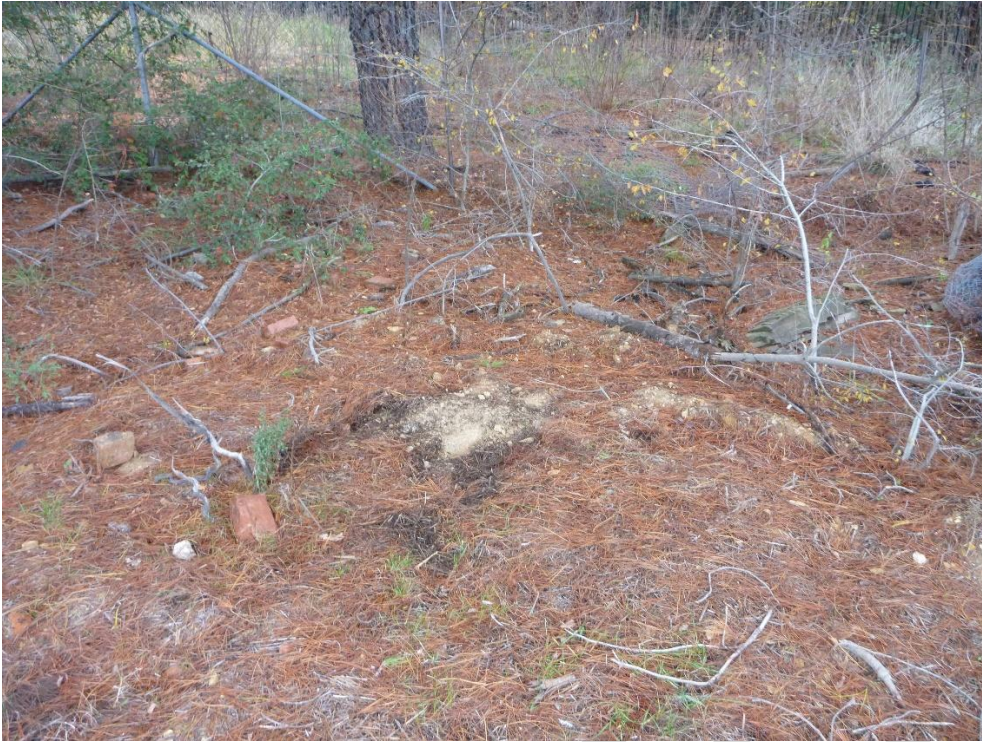
Figure 32 Rubble and depressions at BRW5
Source: NOHC

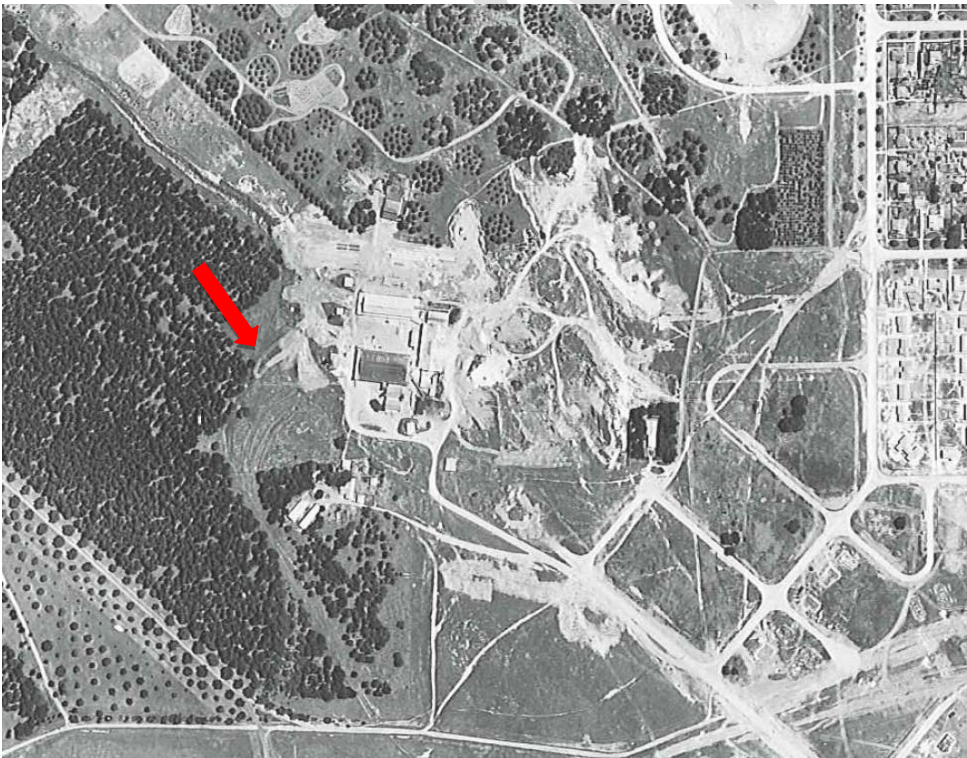
dumped from another location. An aerial image from 1950 (Figure 33) shows that a rectangular structure was once located in this vicinity. The overall condition of this element is generally fair and visibility is good.

Figure 33 Aerial photograph of the Brickworks, 1950; the rectangular feature is indicated
Source: ACTPLA

Further east and up an incline, there are a number of depressions amongst a grove of pines along the edge of the quarry cliff (Figure 35). These depressions are uniform in size, approximately 1m in diameter and appear to be in a sequence. The historic aerial dating to 1950 (Figure 33) shows a series of circular features similar to these depressions extending west to east up the slope in a double row. The function or purpose of these depressions is unknown. On the eastern side of the quarry zone to the north is an example of an in ground circular tank that has been back filled with brick rubble, approximately 3 metres in diameter (Figure 36). This tank does not resemble the depressions in the south of the quarry in scale and known purpose.

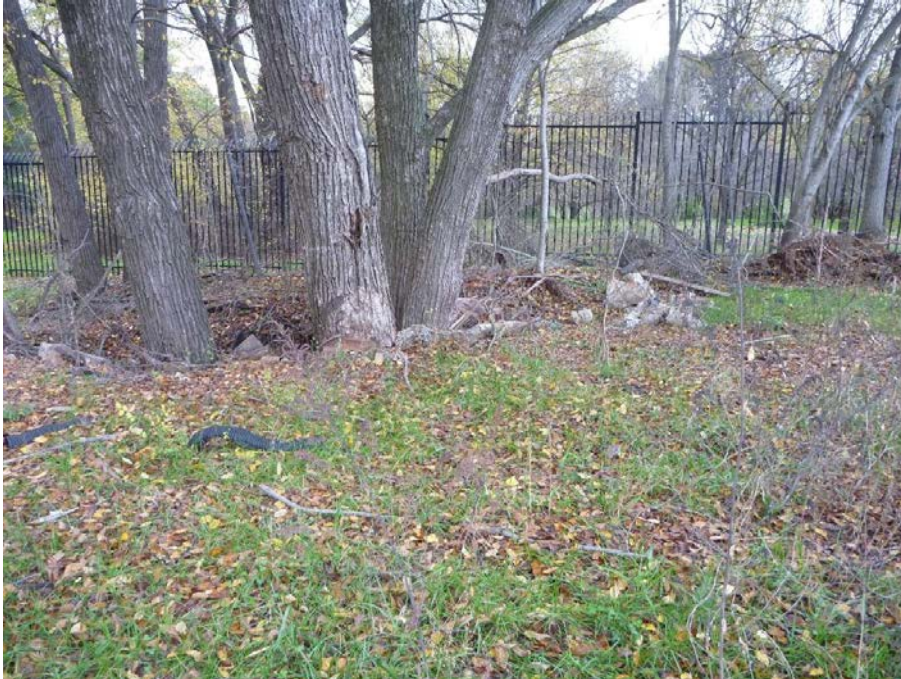
Figure 34 Brick and concrete rubble surrounding trees at BRW6, looking north
Source: NOHC

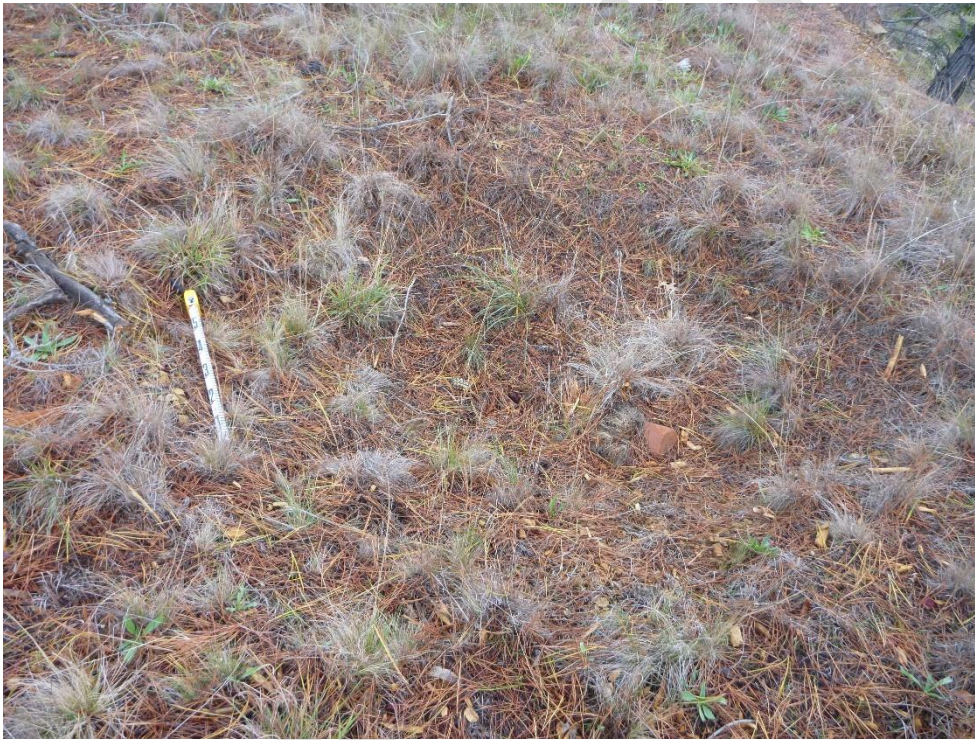
Figure 35 Depression on south side of quarry edge
Source: NOHC

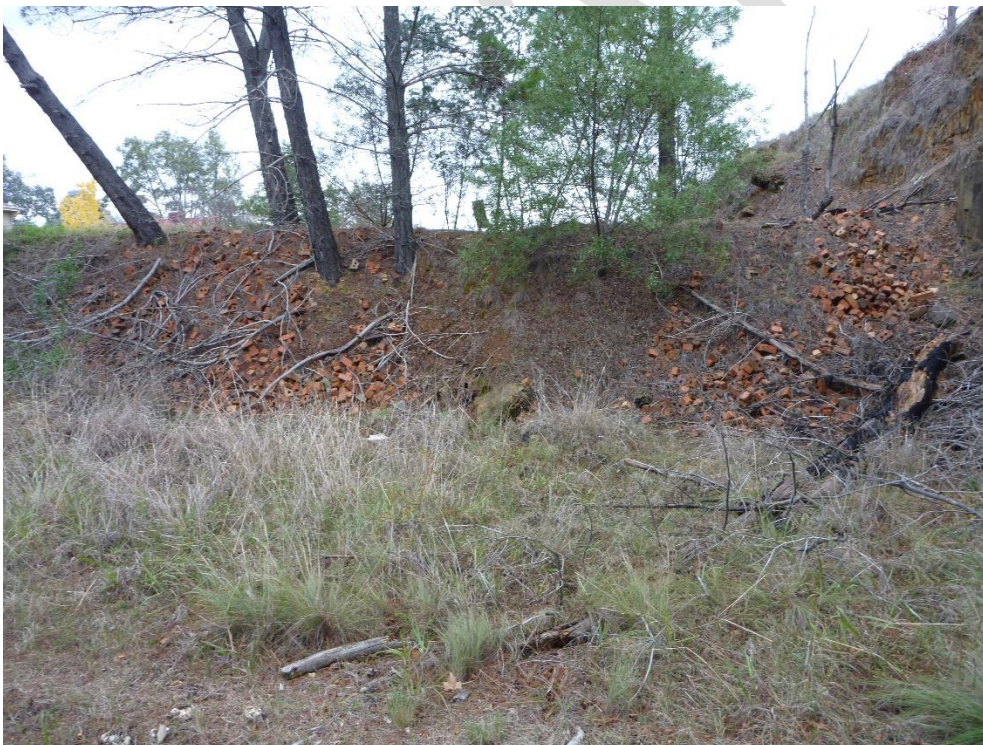
Figure 37 Rubble backfill along north-eastern edge of quarry face, looking east
Source: NOHC

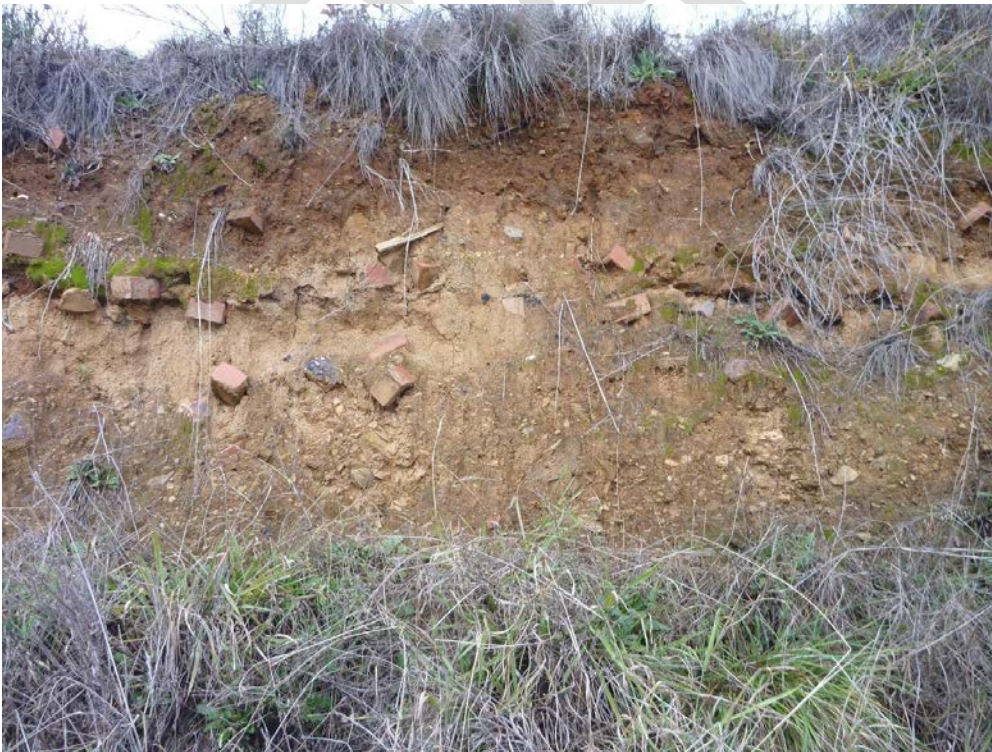
Figure 39 Quarry face showing layer of rubble and charcoal at northern end of quarry
Source: NOHC

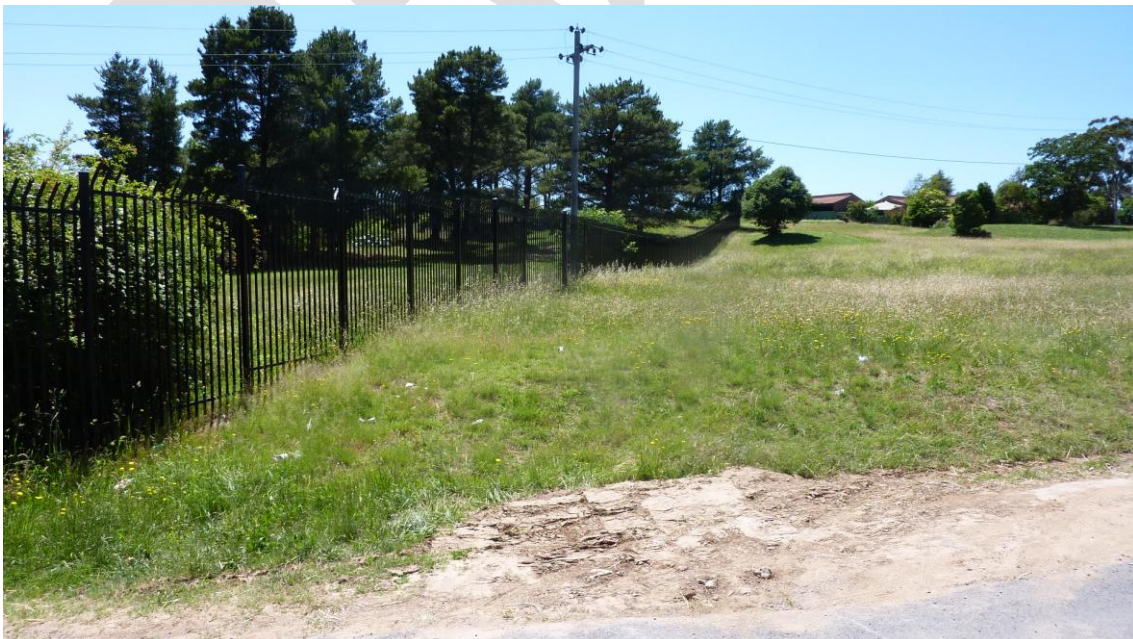
Archaeological deposits pertaining to built form from this era would be expected to comprise footings and machinery remnants. Material discard would be expected to be items of an industrial nature with the potential for some domestic material related to the dormitories (Figure 40).

Figure 40 Location of the old kiln and dormitories looking east
Source: Lovell Chen

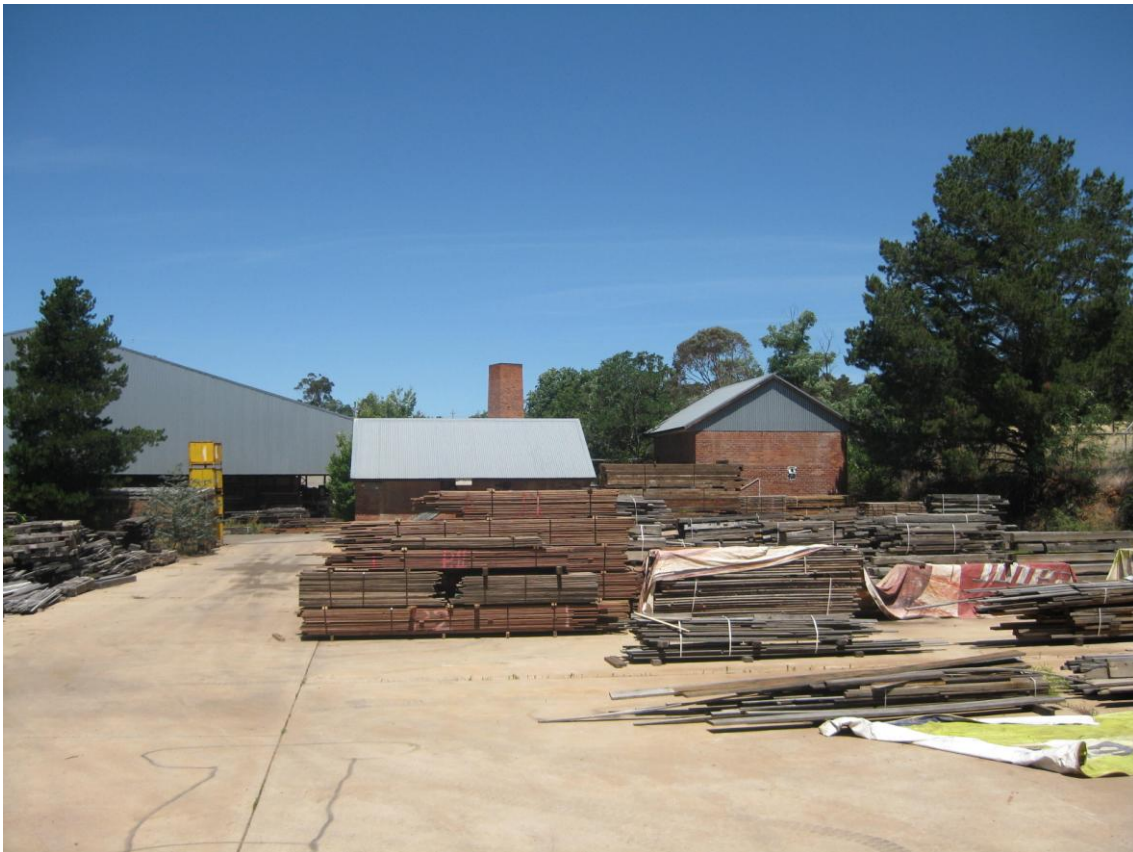
Figure 43 View looking east over the extrusion plant, part of the northern extension to the railway reserve
Source: Lovell Chen
