Conservation Management Plan (2010)

Canberra Brickworks  
Denman Street, Yarralumla, Canberra

Conservation Management Plan

Prepared for  
Land Development Agency

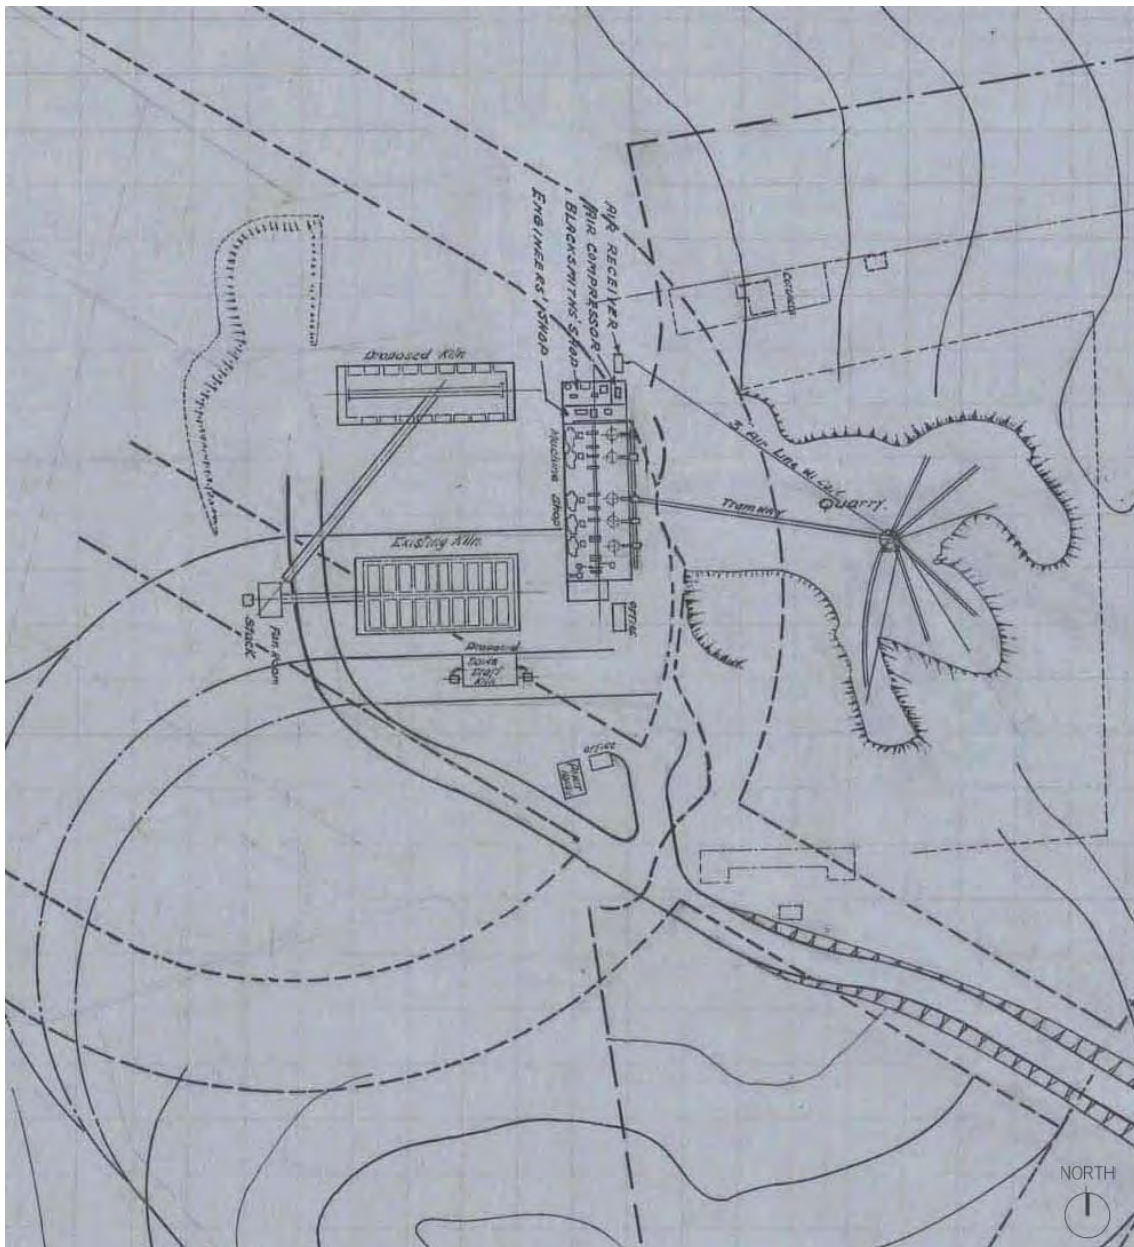
Figure 4 Site plan, 6 April 1926. On this plan, the processes occurred from east to west (right to left on this plan); the quarried material was transported via a tramway to machinery shop to be crushed, ground and pressed in the machinery shop in the centre and then to the kilns on the left. The plan shows both the existing Staffordshire Kiln and the proposed Hardy patent kiln to its north; it also shows the power house and office.

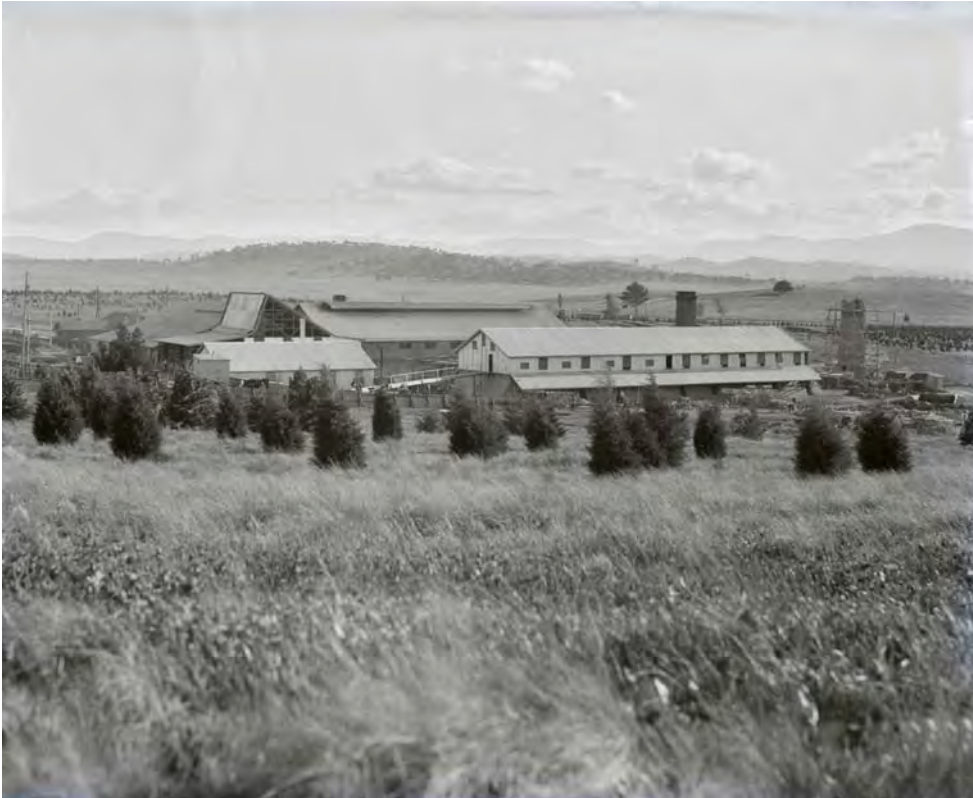
Figure 5 View from the north-east towards the brick processing buildings, c. 1927  
Source: National Library of Australia.

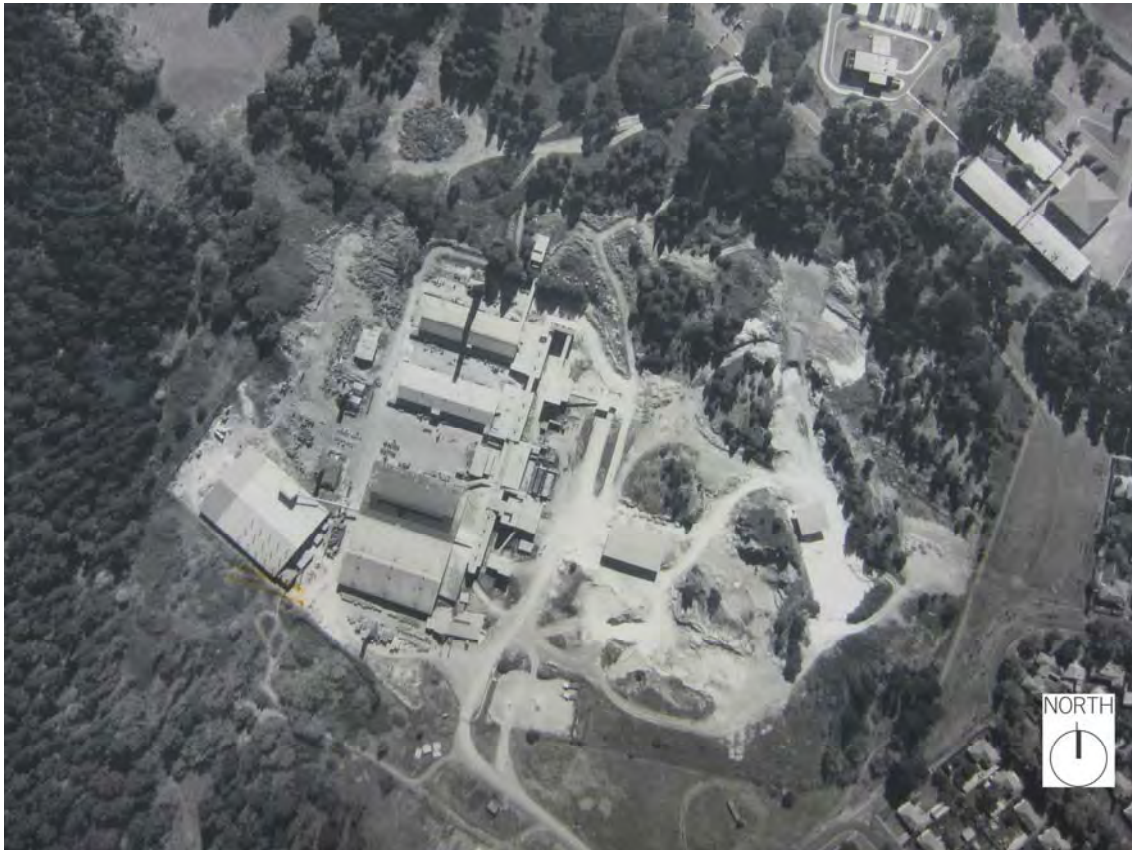
Figure 7 Aerial view, c.1976, at the time of the closure of the Canberra works. At this date, the raw materials had for many years been brought onto the site but the process continued to occur moving from east to west across the site. The 'spine' of process buildings (grinding, crushing, pressing) was located east of the kilns (between the kilns and the quarry).

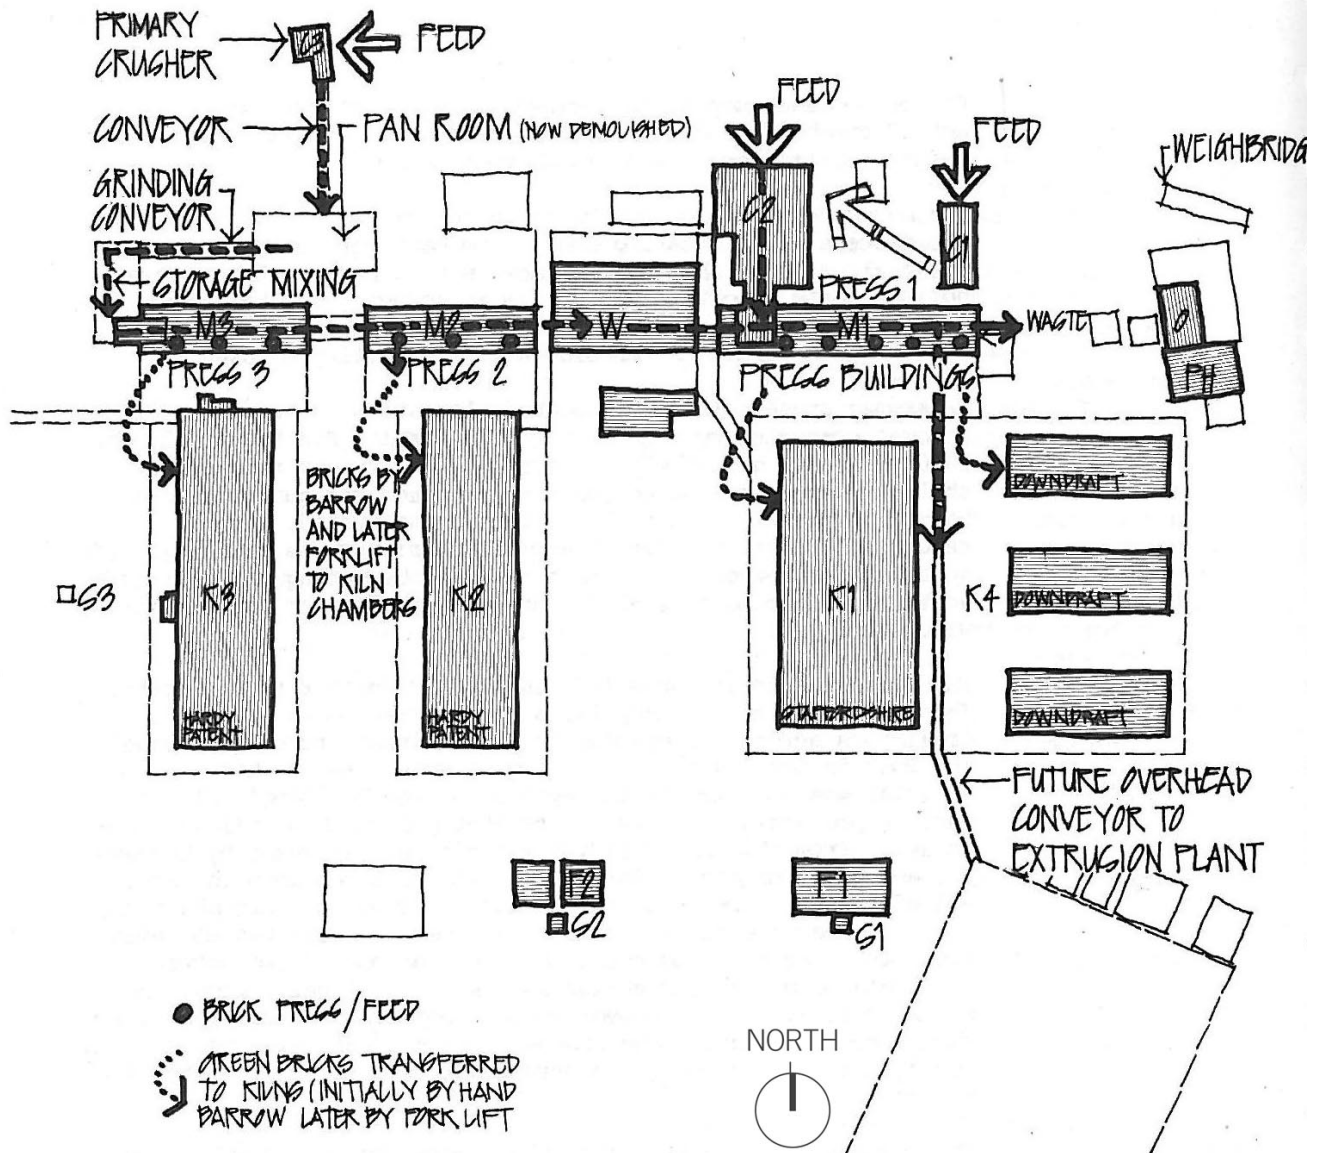
Figure 8 Sketch diagram of site operation c. 1960.  
 Source: Lester Firth Associates Pty Ltd, *Old Canberra Brickworks, Conservation Plan*, 1986, Section 2.2.1.

While the major brick kilns on the site were retained, the major expansion of the Brickworks that occurred in the 1950s saw the replacement of other early plant and buildings (see Figure 8). The early machine shop was replaced with a series of brick press buildings (machine bays) and a workshop, all of which remain today. The Brickworks was also equipped with a series of new crushers and 'pan rooms' connected to a conveyor system.

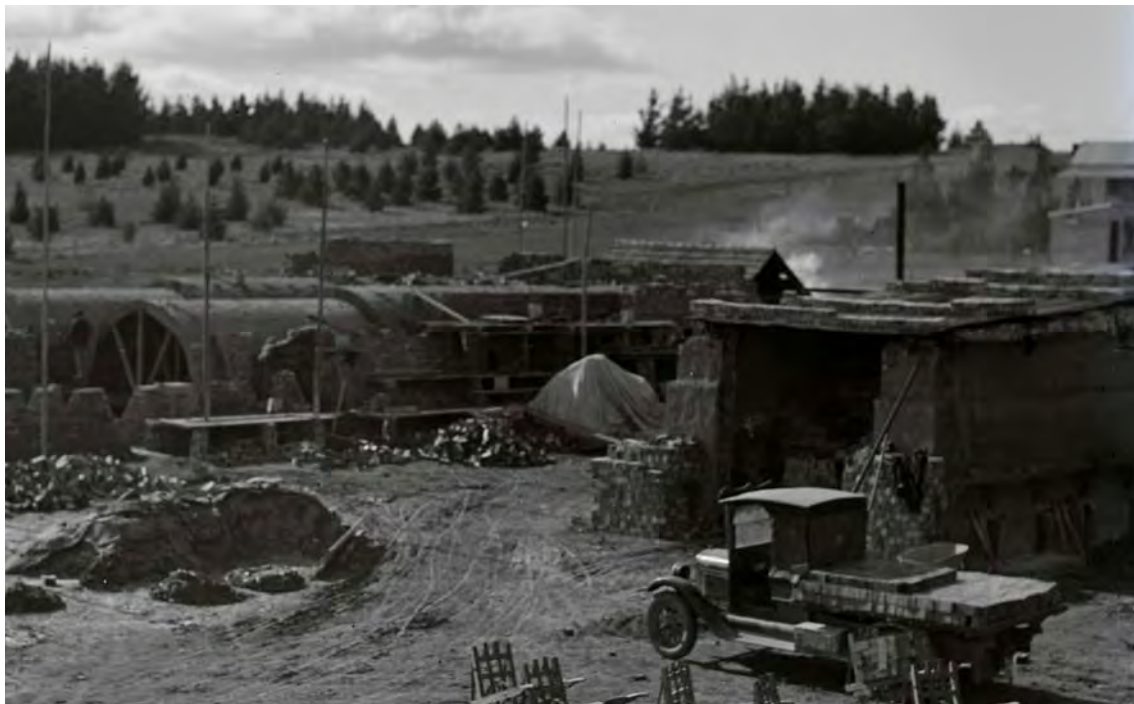
Figure 12 Scotch kiln at Canberra (right), 1926. The first Hardy patent kiln is under construction at the rear of the picture.  
Source: National Archives of Australia.

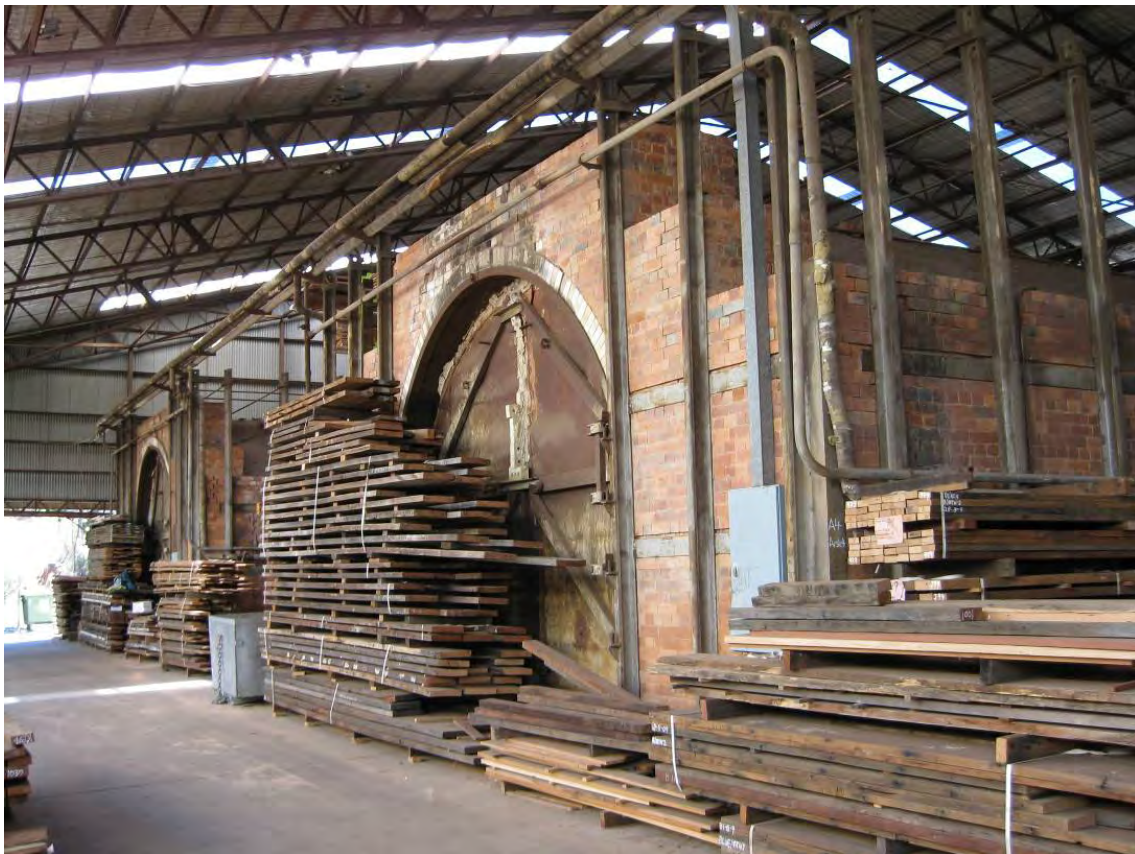
Figure 14 Downdraught kilns numbers 3 and 4 at Canberra Brickworks (Building 22).

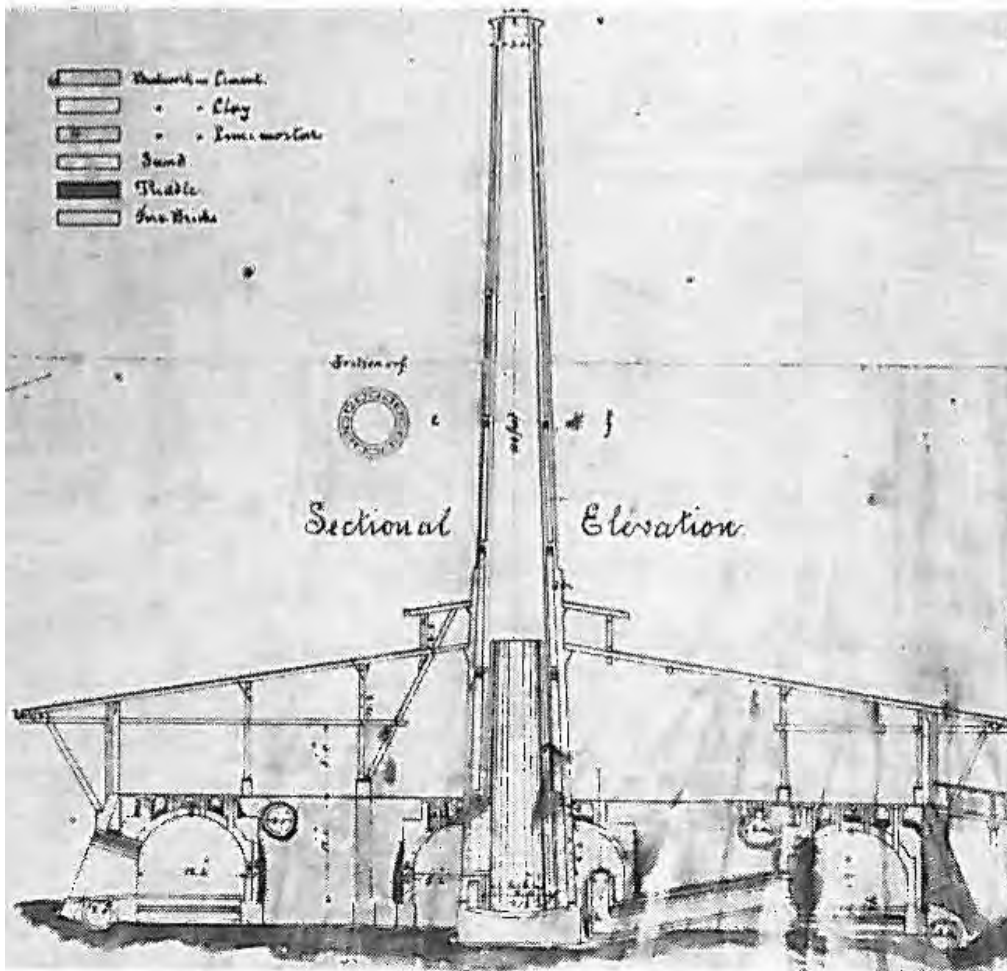
Figure 15 Section through a circular Hoffman kiln prepared by the office of Friedrich Hoffman, Berlin in 1875.  
 Source: Martin Hammond, *Bricks and Brickmaking*, p. 23.

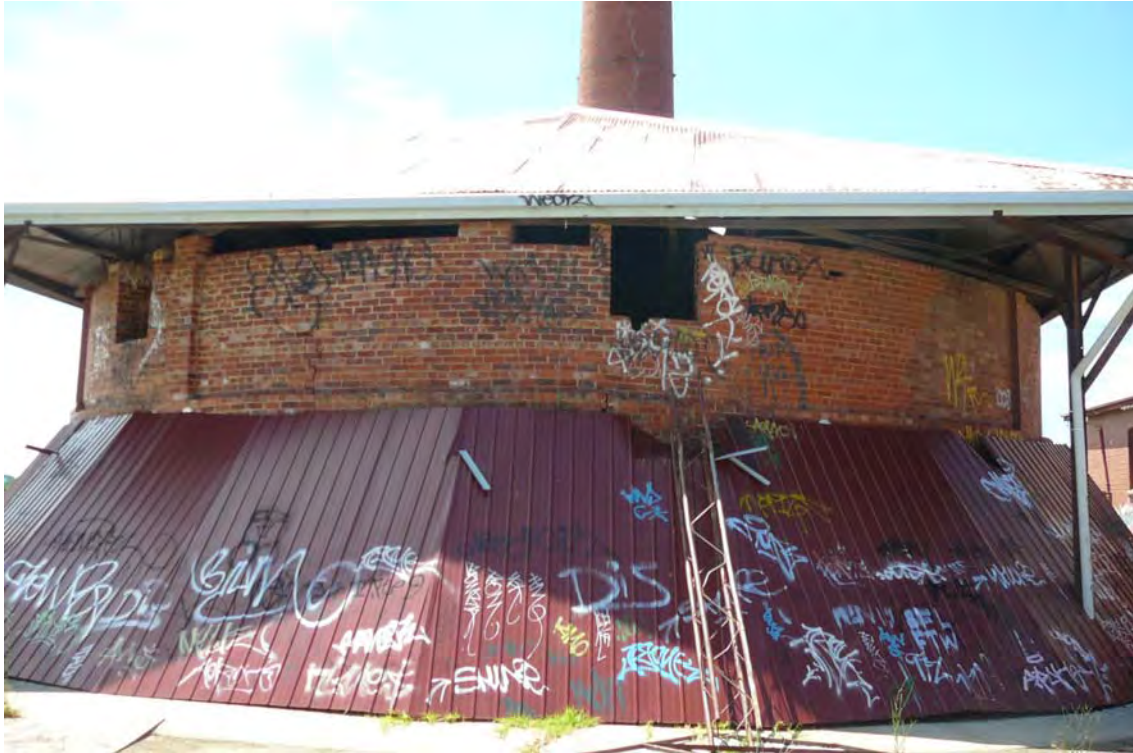
Figure 17 Hoffman kiln at the former Standard Brickworks, Box Hill (Victoria)  
Source: Lovell Chen, January 2010

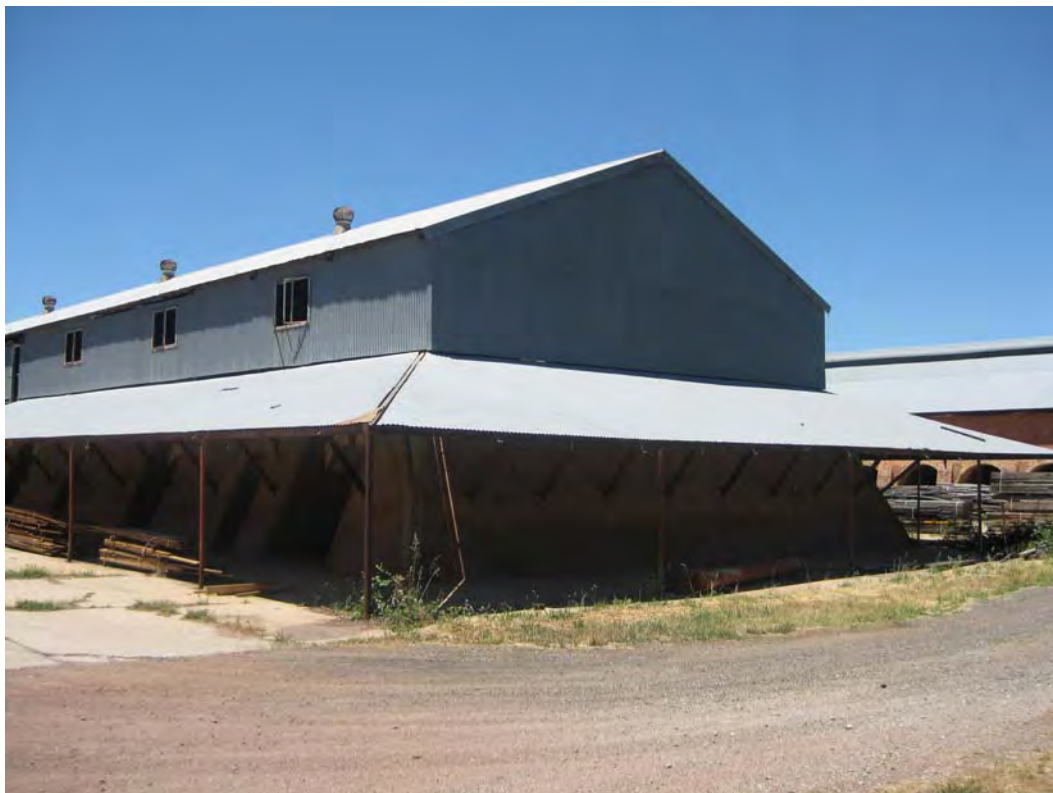
Figure 20 Hardy patent kiln, Canberra brickworks

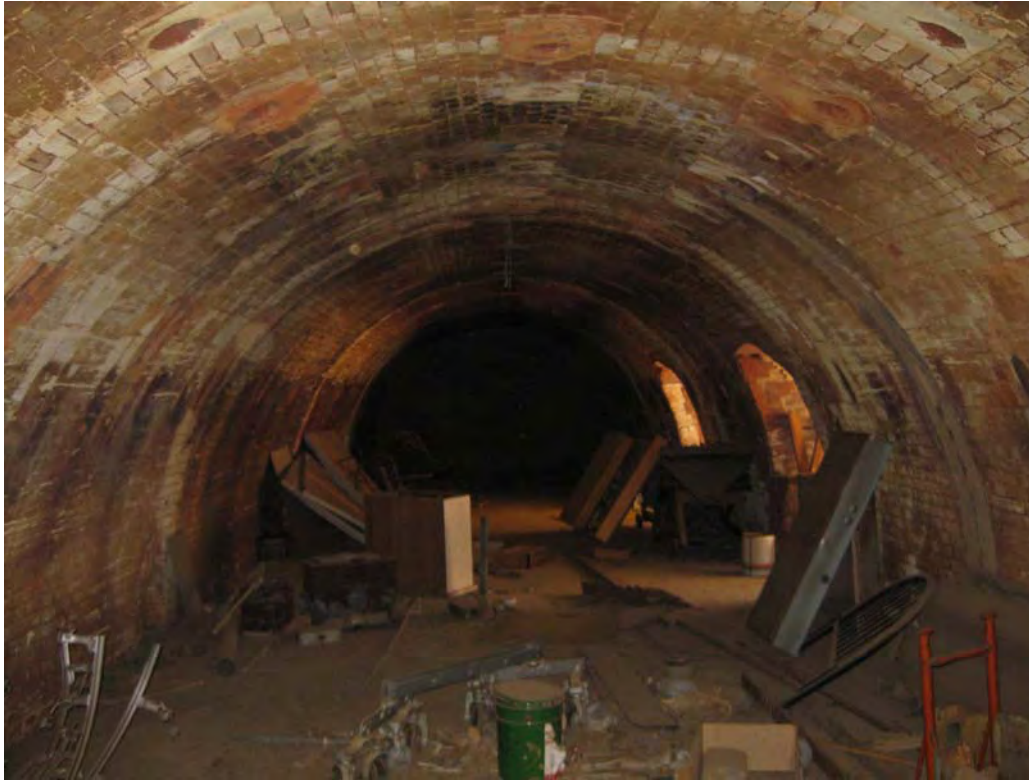
Figure 21 View into the firing chamber of one of the Hardy patent kilns at the Canberra brickworks. Note the wickets (openings) on the right from which the bricks were loaded and unloaded, and the firing holes in the ceiling/walls.

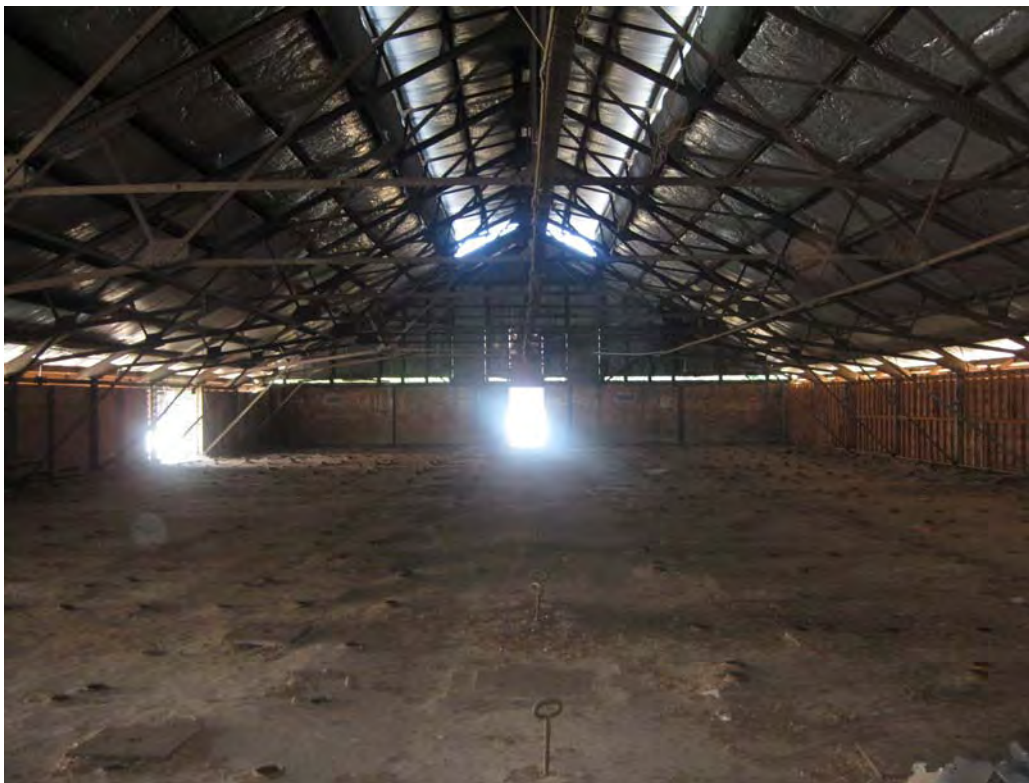
Figure 22 Interior of the firing floor to one of the Hardy patent kilns at the Canberra Brickworks

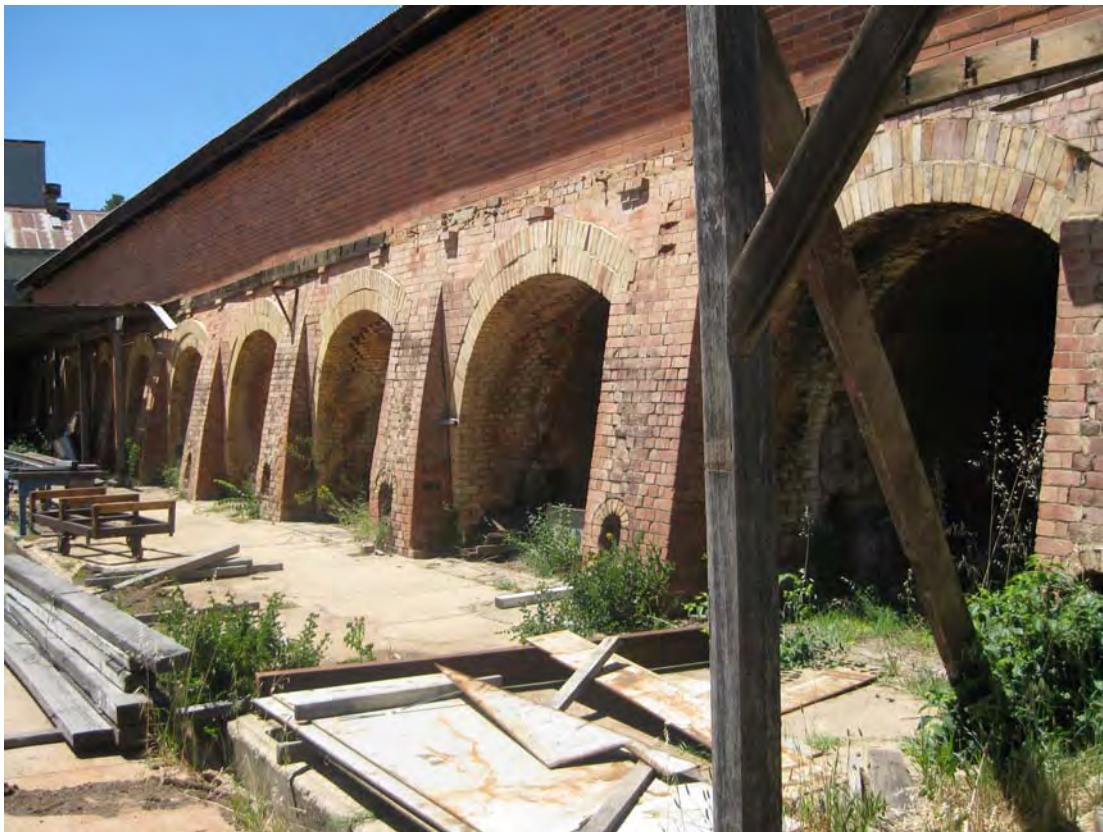
Figure 24 Staffordshire kiln at the Canberra Brickworks

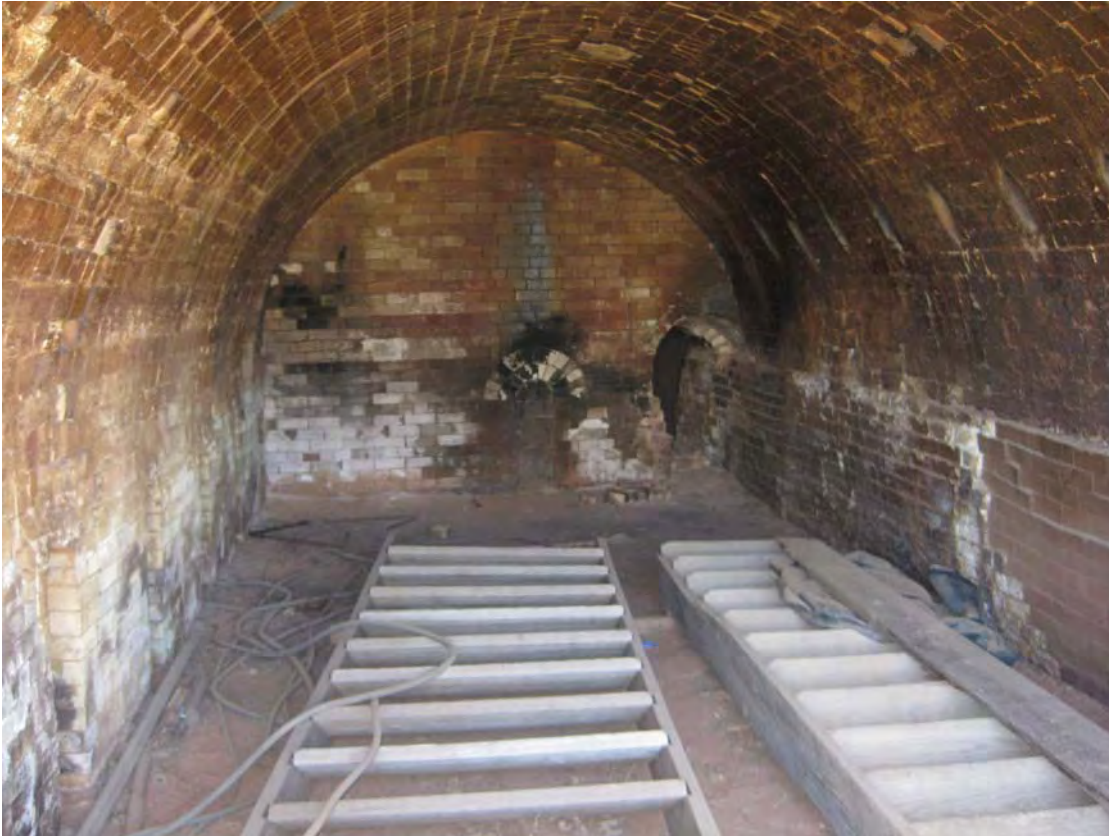
Figure 25 Interior of one of the chambers in the Staffordshire kiln.

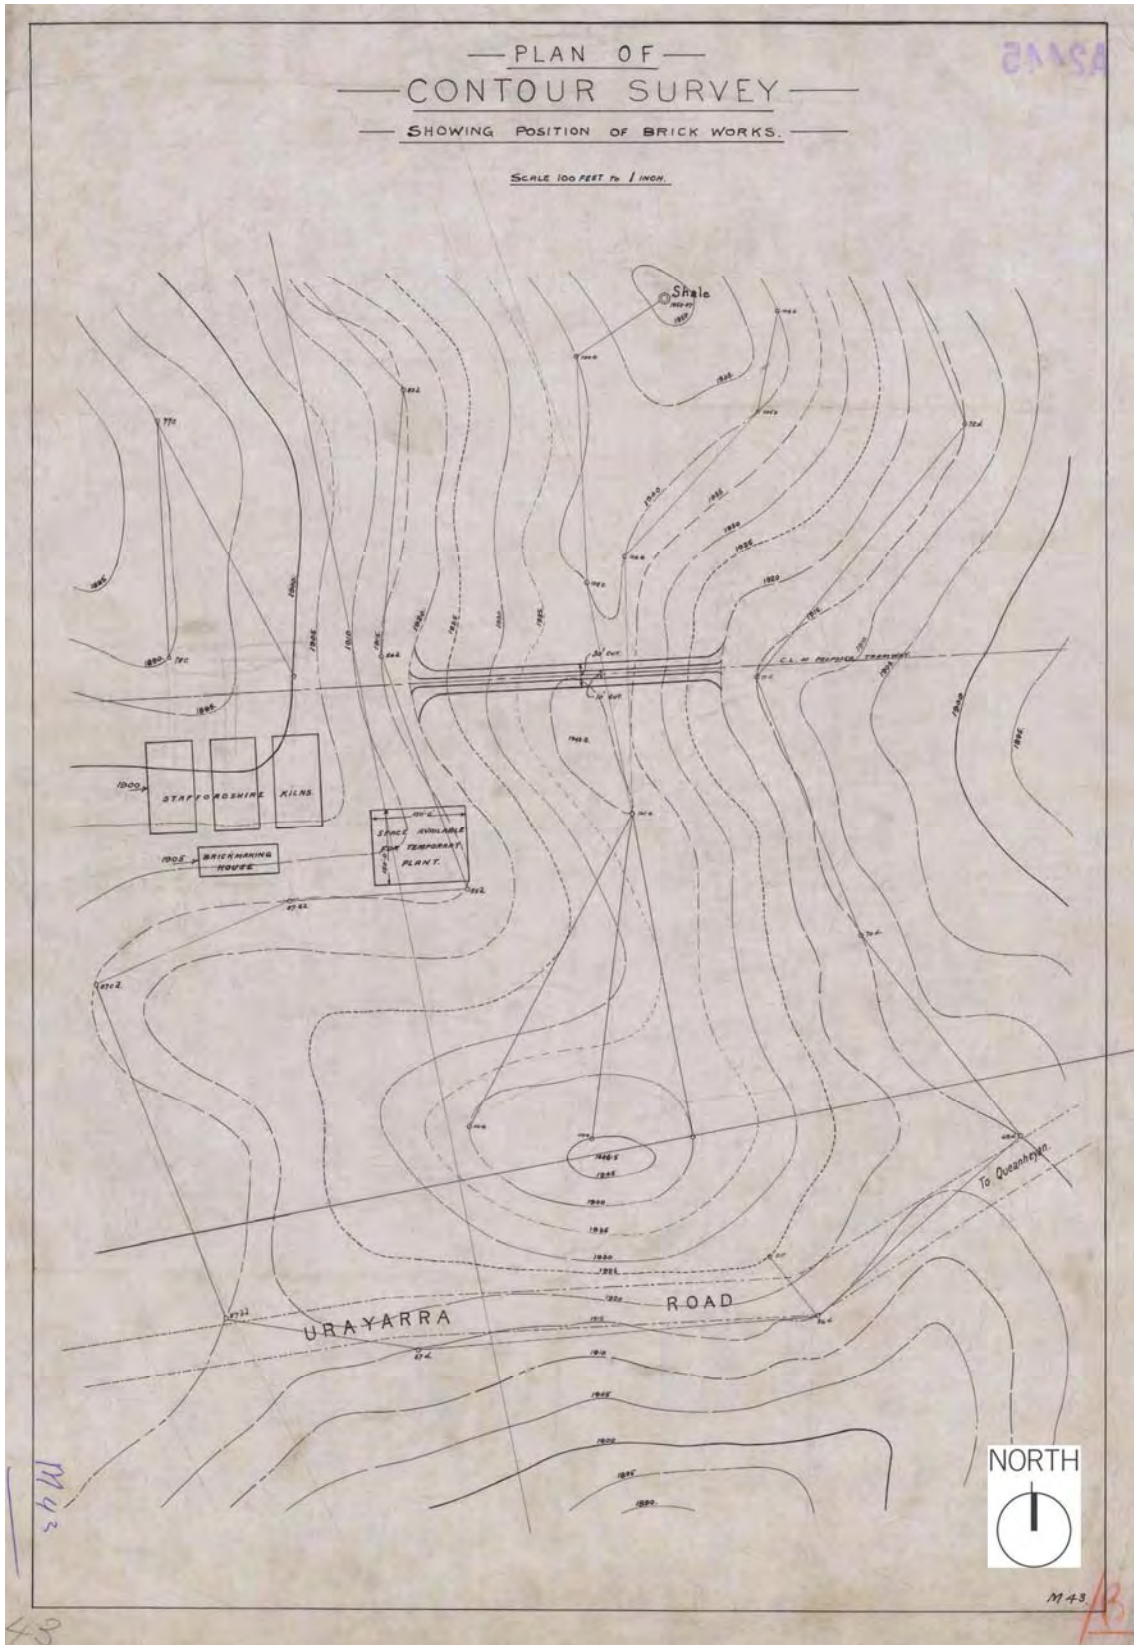
Figure 29 Contour plan with the layout of the brickworks as proposed in c. 1911, showing three Staffordshire kilns and the location of brick making plant. Source: National Archives of Australia.

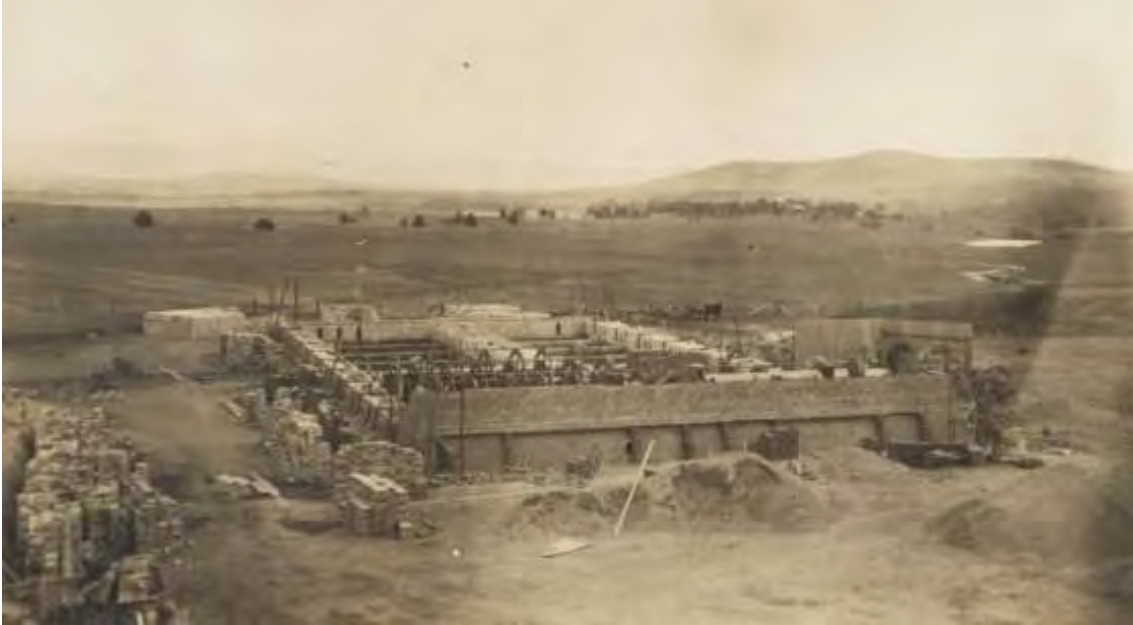
Figure 31 Staffordshire kiln under construction, c. 1915  
Source: National Library of Australia.

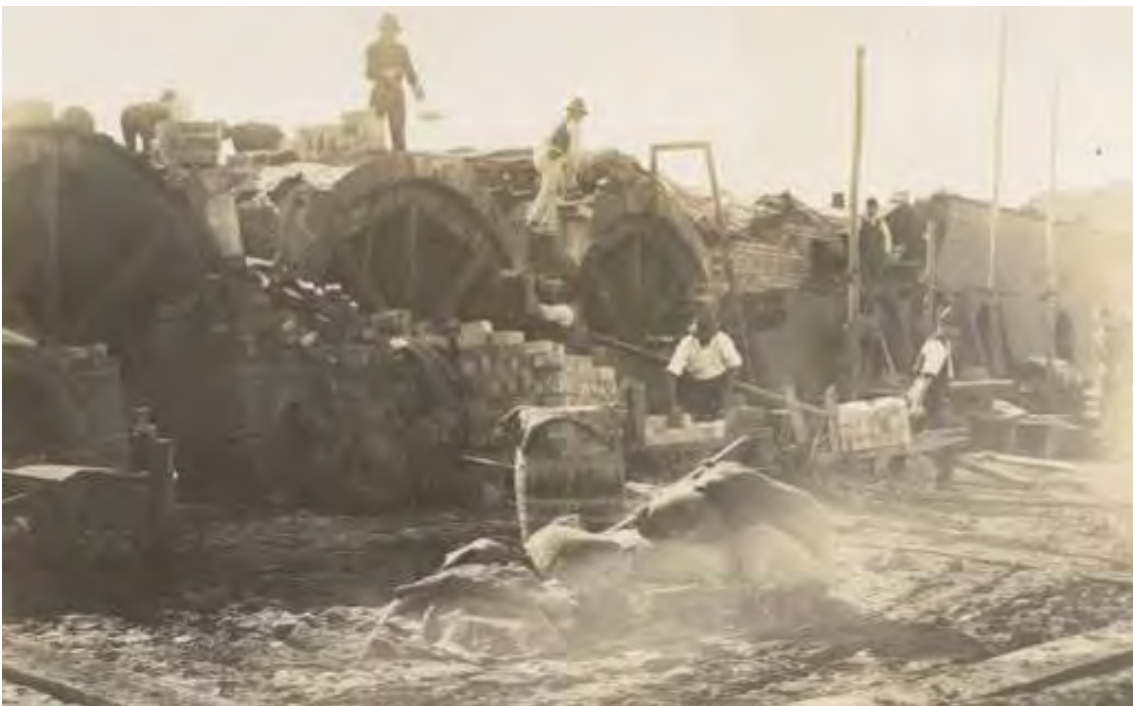
Figure 32 Constructing the transverse arches of the Staffordshire kiln, c. 1915.  
Source: National Library of Australia.

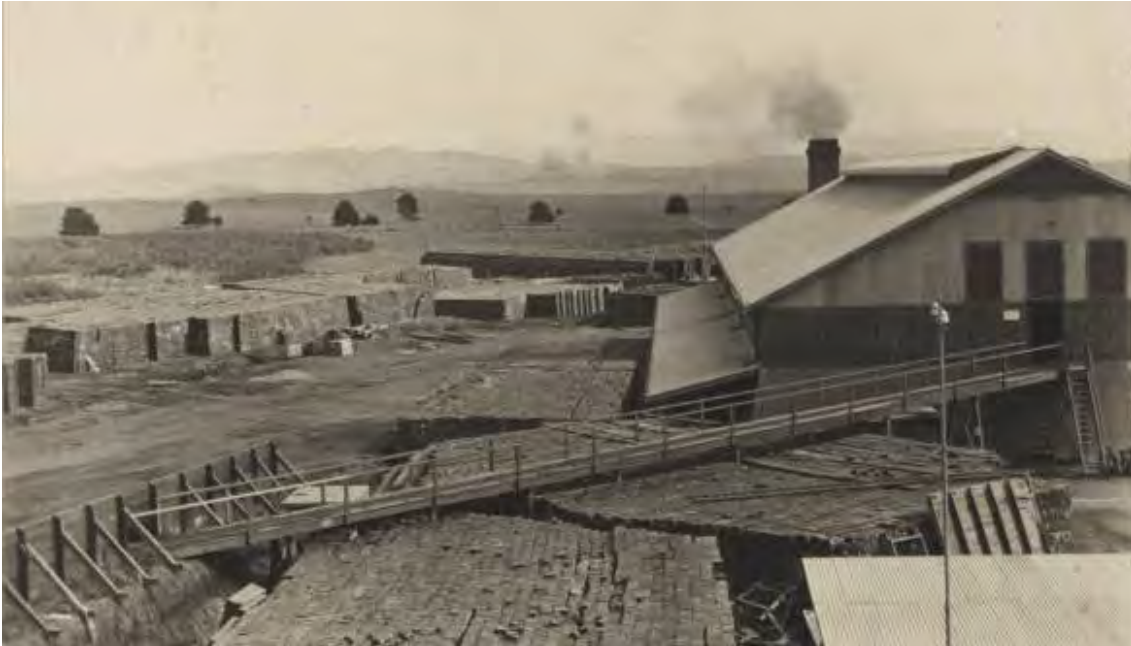
Figure 33 The Staffordshire kiln pictured in c. 1917.  
Source: National Library of Australia.

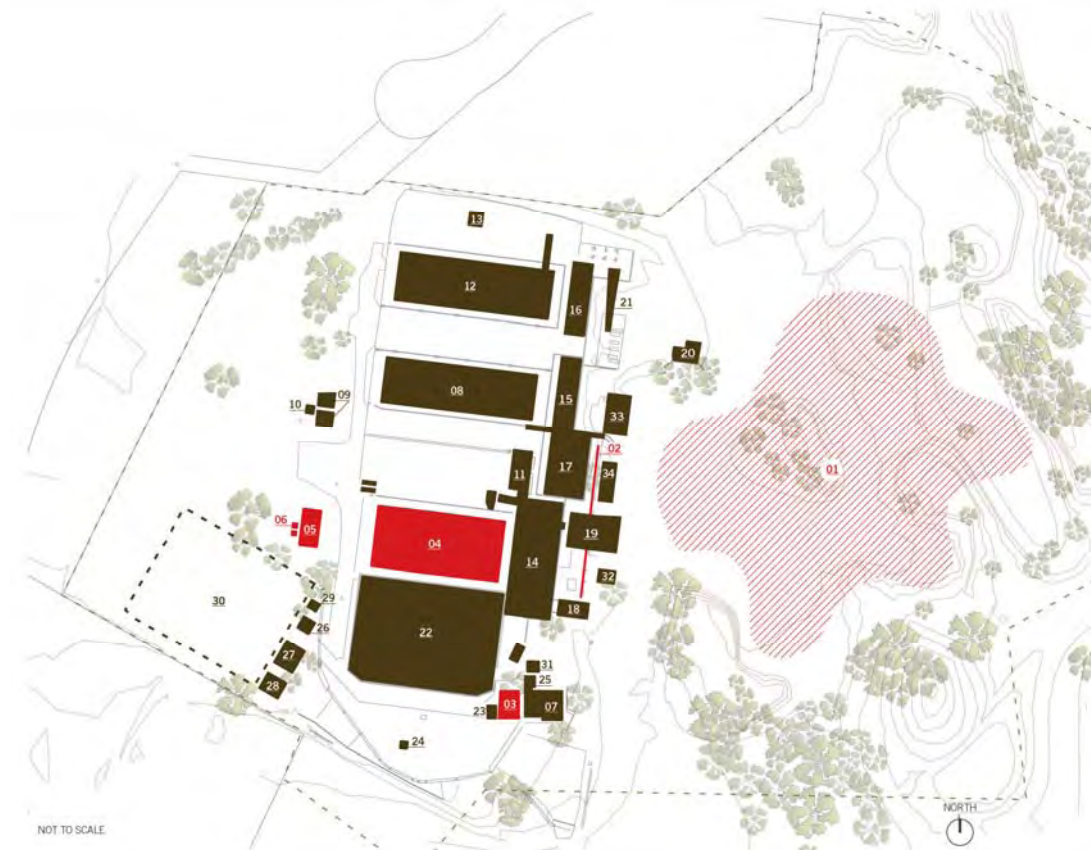
Figure 36 Location of elements surviving from the Establishment Phase. Refer to the larger scale site plan in Chapter 1 for more detail.

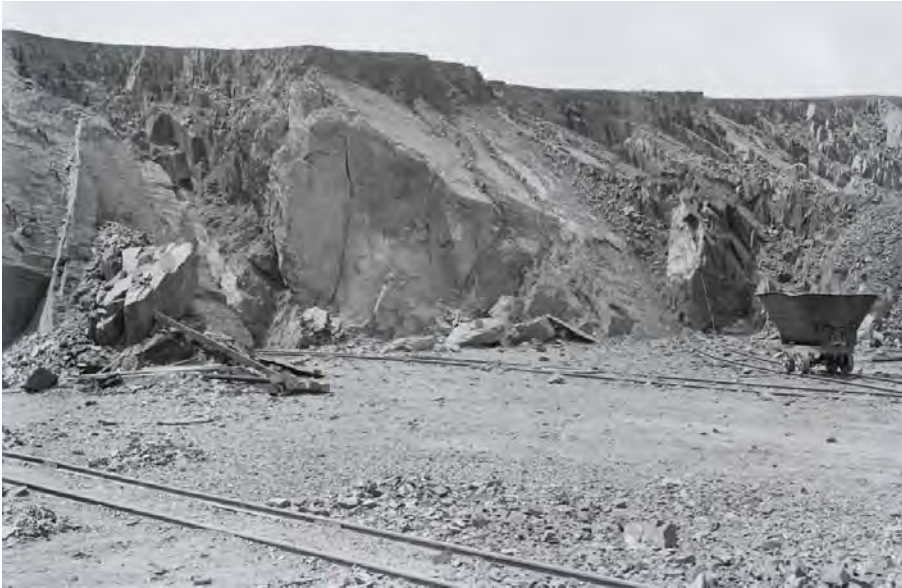
Figure 37 View of the quarry showing the narrow gauge tramway used to transport shale to the crusher, 1921.  
Source: National Archives of Australia.

quarry area using manpower. The tram lines could be relocated as the quarry face advanced (see Figure 37).

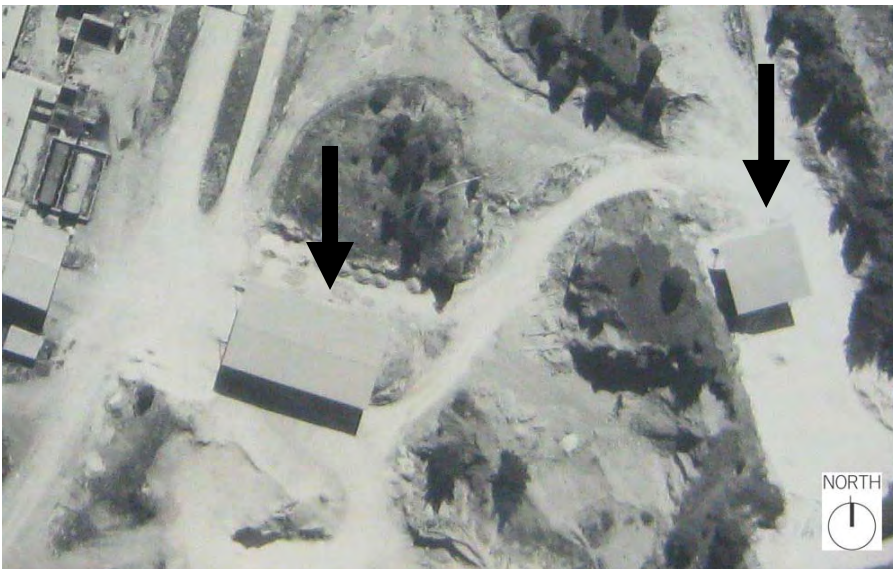
Figure 38 Detail of a 1976 aerial photograph showing the clay storage shed and an unknown smaller structure to the right (both demolished).

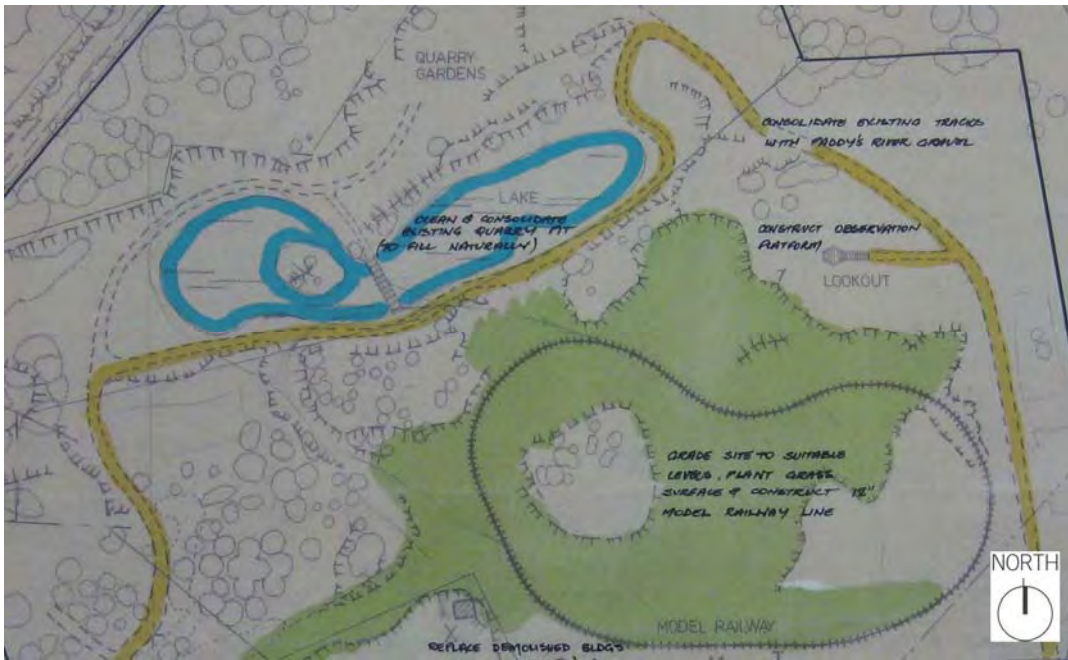
Figure 39 Detail of site landscaping plan prepared by A R Marr Pty Ltd showing the reflection pond and the location of the model railway, c. 1977.  
Source: ACT Heritage Library, Woden, ACT.

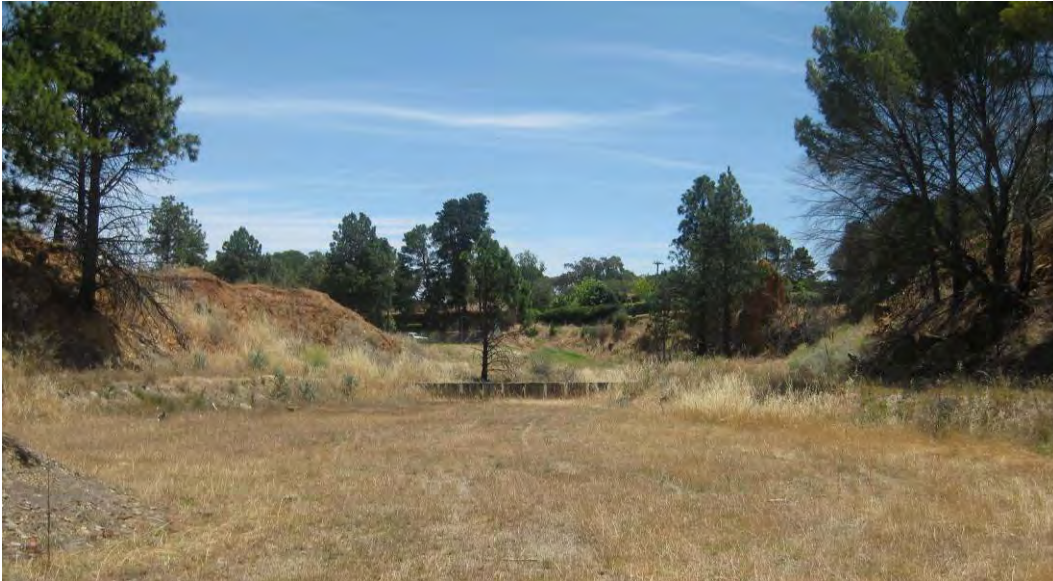
Figure 41 Looking north across the quarry floor, the site of the reflection pool, developed as part of the A R Marr Pty Ltd proposal. The dividing wall in the centre of the image marks the location of a walkway which traversed the pool.

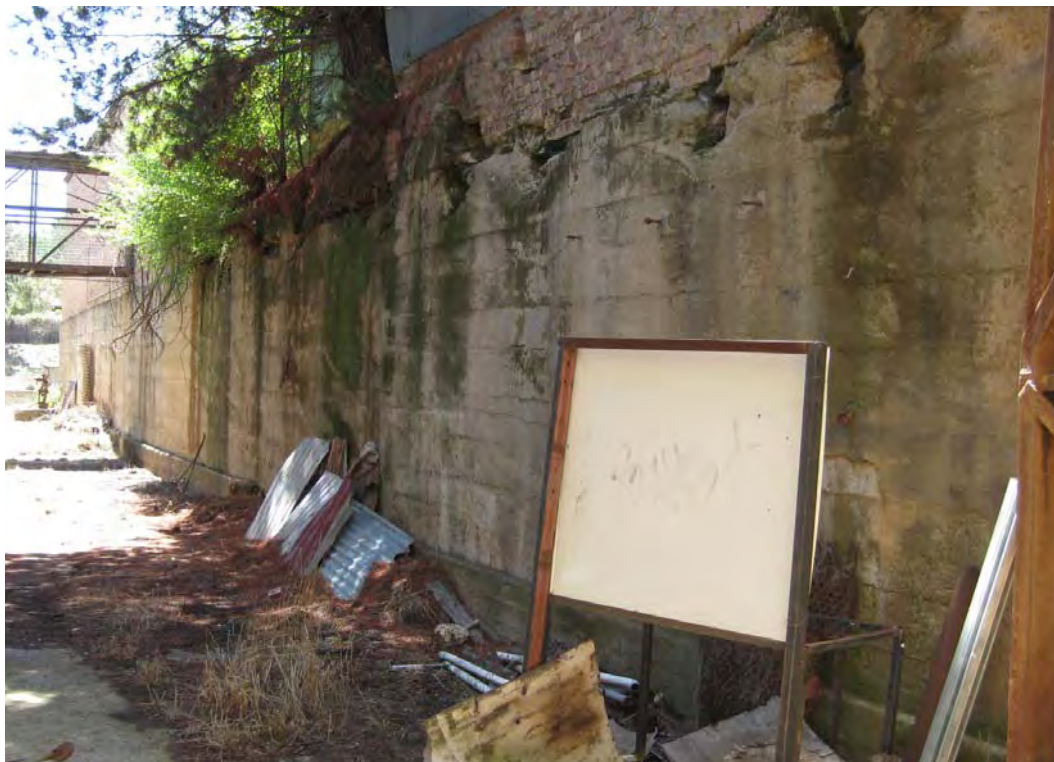
Figure 45 Retaining wall to the rear of the Workshop (Building 17).

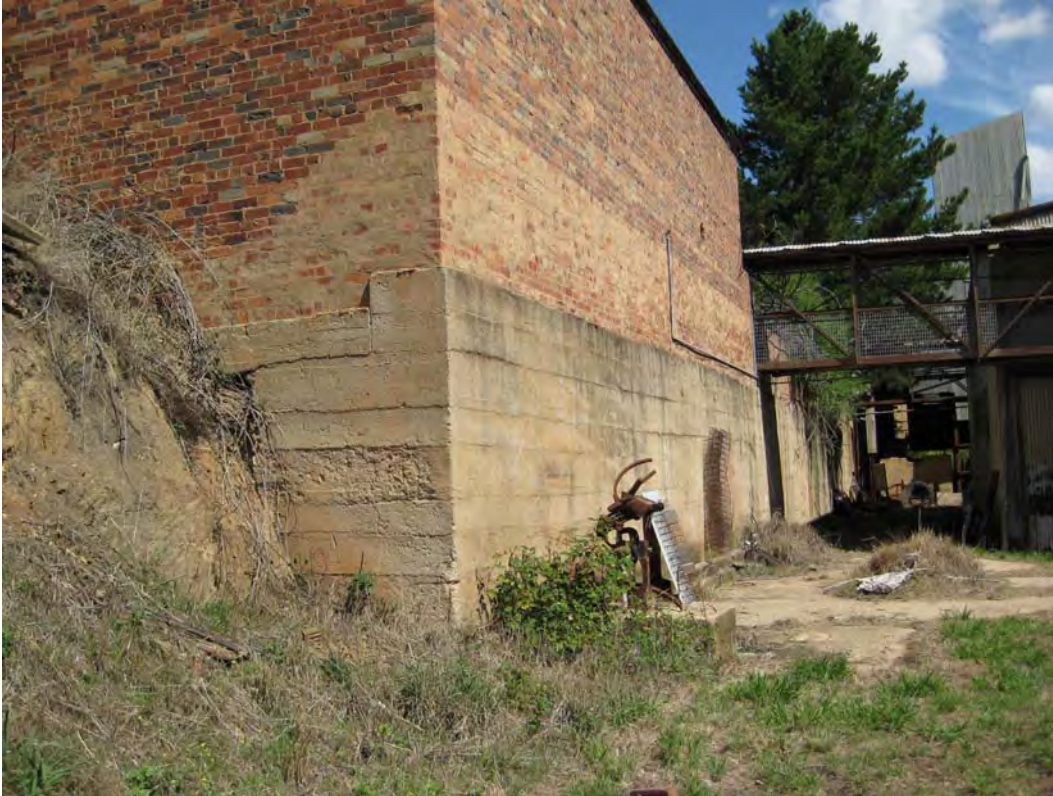
Figure 46 The north end of the concrete wall.
