Conservation Management Plan (2010)

Canberra Brickworks  
Denman Street, Yarralumla, Canberra

Conservation Management Plan

Prepared for  
Land Development Agency

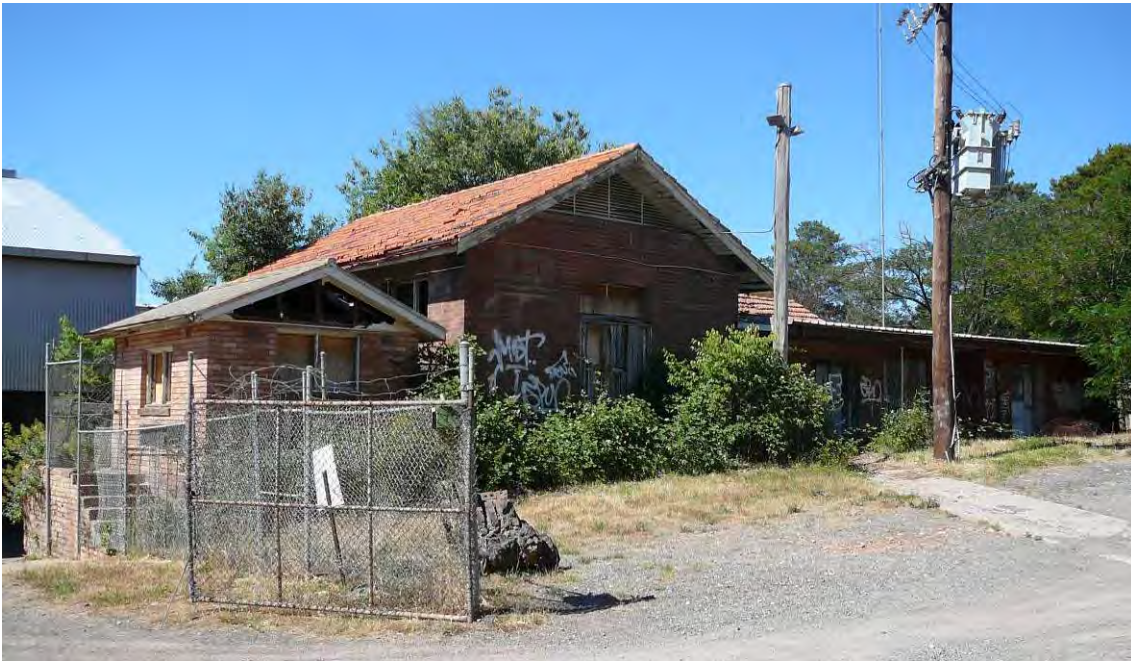
Figure 47 The Power House is the tile roofed building in the centre of the image. The office building (Building 7) adjoins it to the right and the small cream brick structure is the Downdraught kiln control room (Building 23).

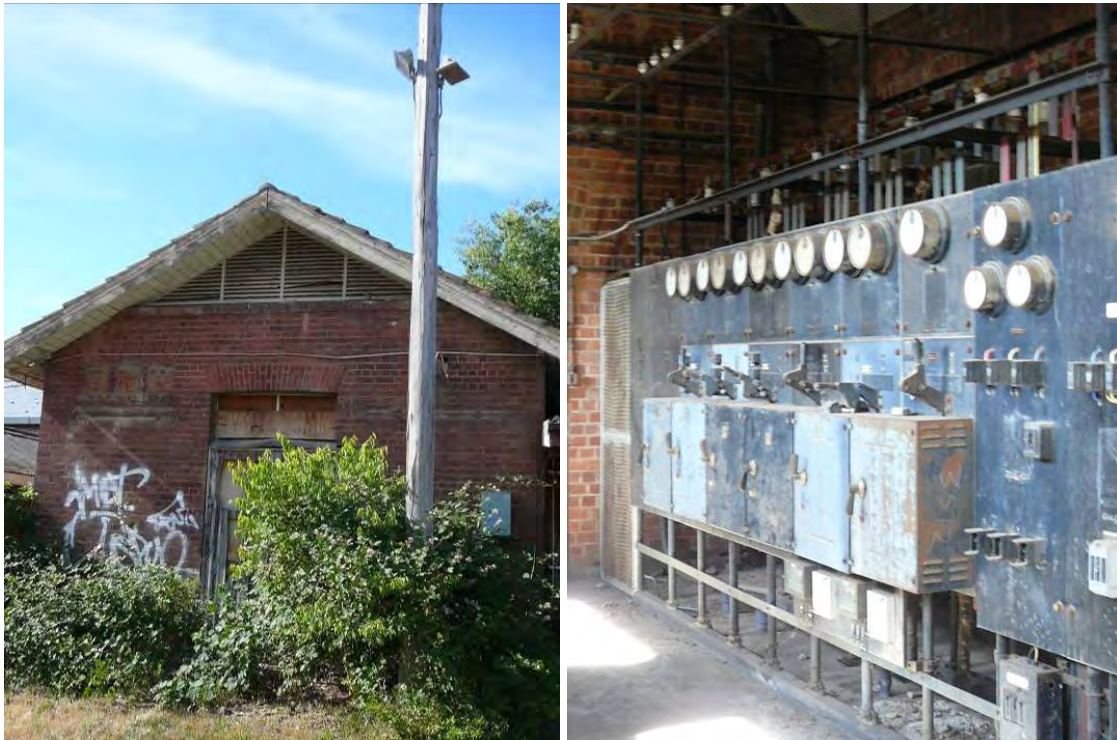
Figure 48 From left: South elevation and entry; interior showing retained plant.

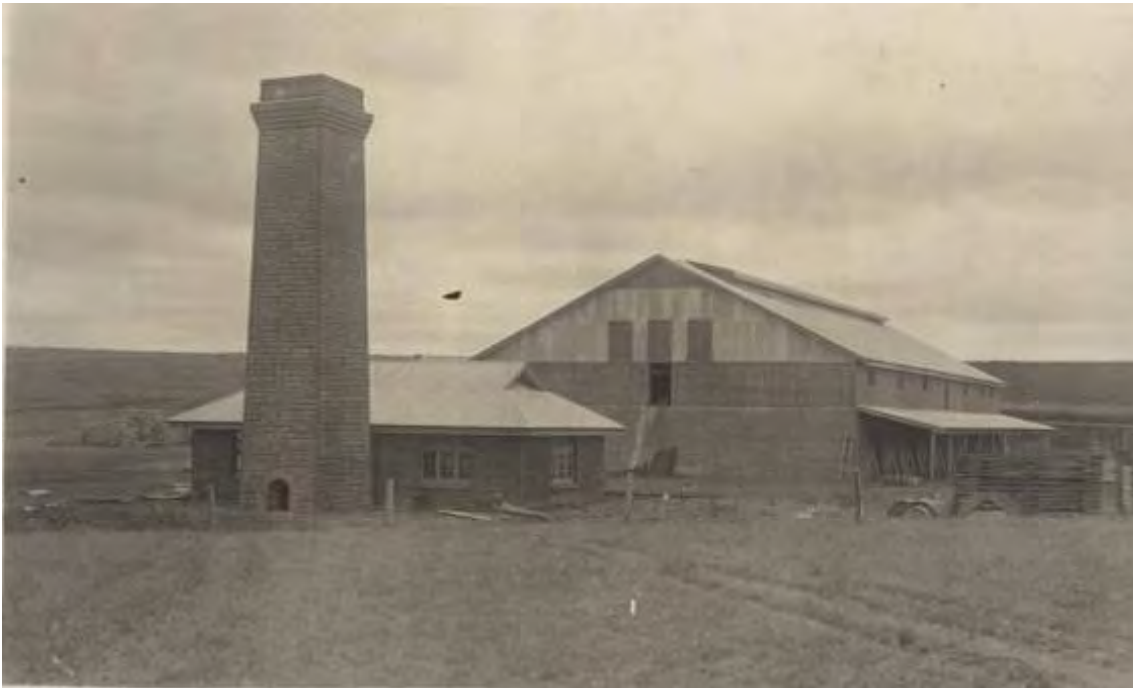
Figure 49 The Staffordshire kiln, fan house and stack, photographed in 1917 by Harry Connell. Note that in this view the kiln verandah does not extend to the west elevation.

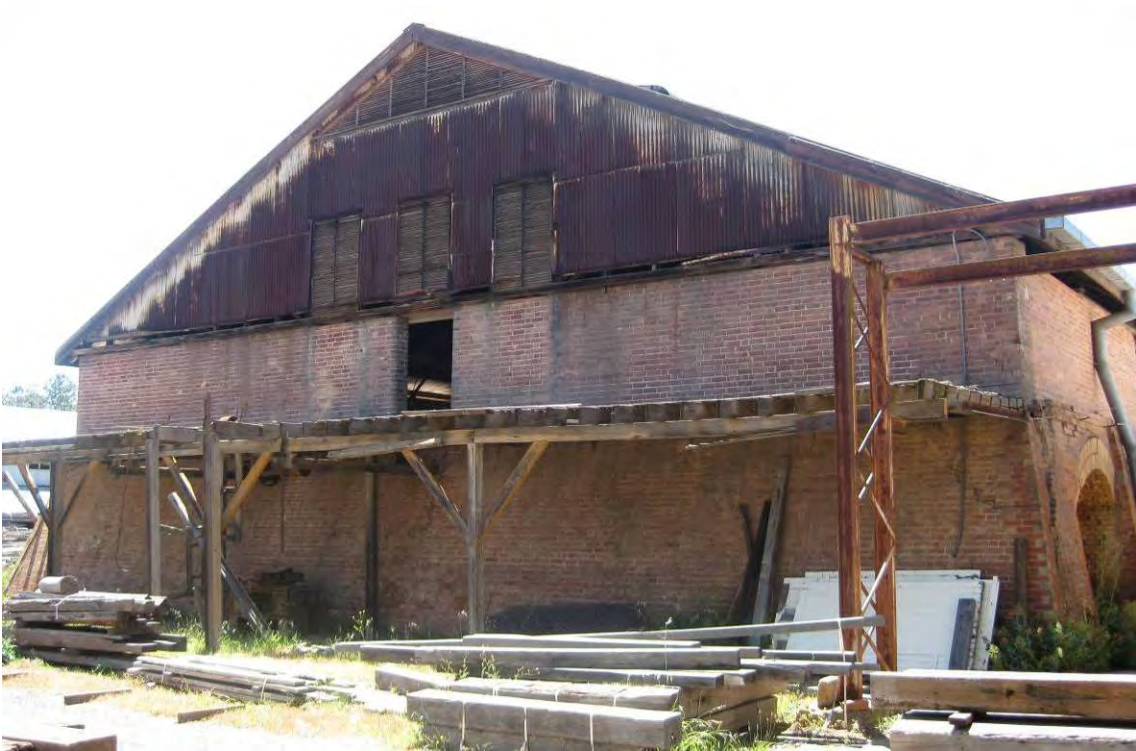
Figure 50 The west elevation today.

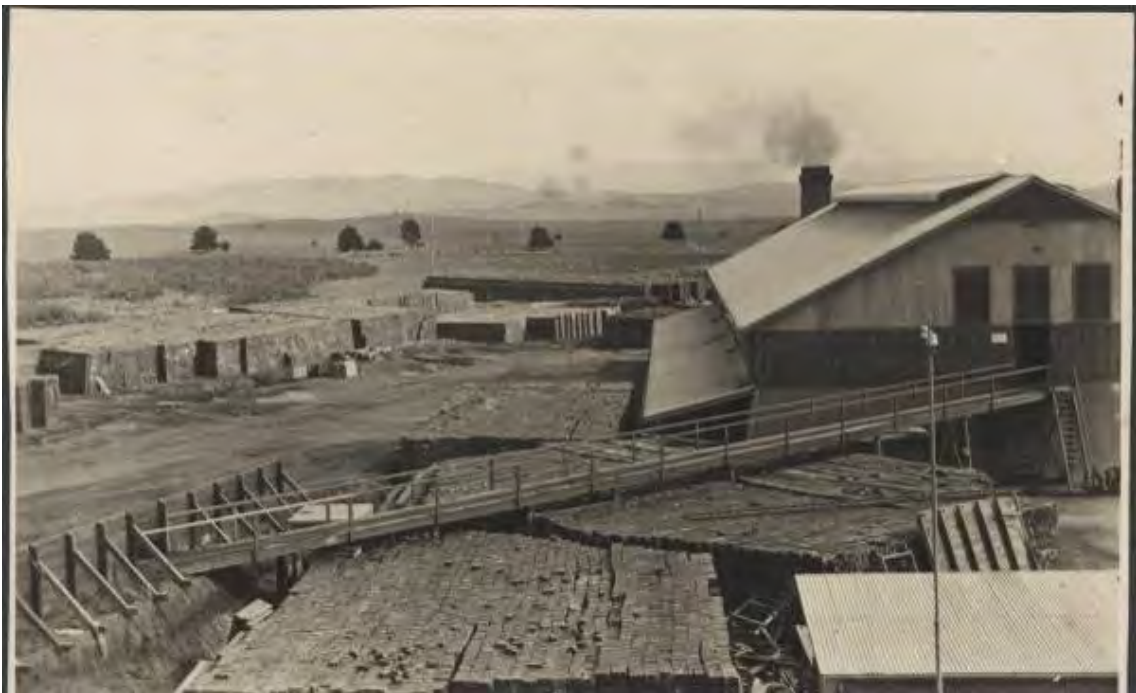
Figure 51 The east elevation, photographed by Harry Connell in 1917.  
Source: National Library of Australia.

Today the Staffordshire kiln comprises the 20 kiln chambers to the ground floor with a firing floor above, enclosed by non-original brick side walls and original brick end walls, with a gable roof form, clad in corrugated steel. The gable to the west end is infilled with corrugated steel and timber louvres, which are thought to be the original treatment. A 1917 photograph shows that the same scheme was in place at the east end, now obscured by the skillion roof structure that later enclosed the yard area between the machine bays and the kiln (see Figure 51).

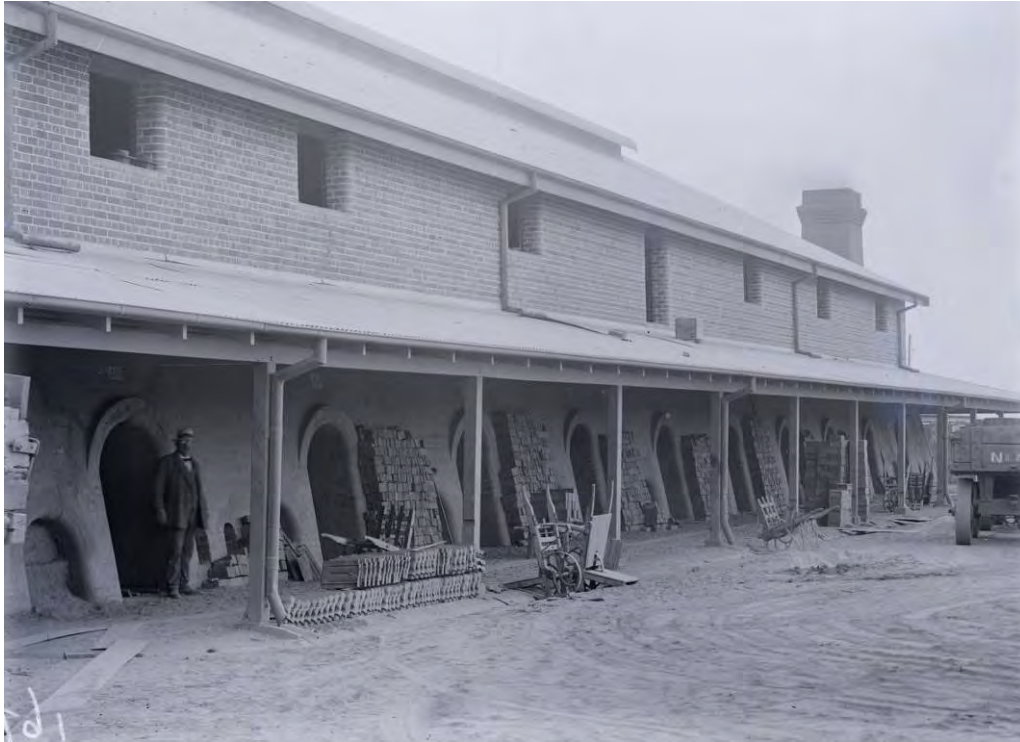
Figure 52 The north elevation, photographed prior to the rebuilding of the verandah to support a first floor enclosed verandah structure.  
Source: National Archives of Australia.

As originally constructed, the Staffordshire kiln was a two-storey structure with a brick base, brick upper walls and a galvanised steel roof. It contained 20 chambers. The internal fire bricks were imported from England, and some were apparently numbered to show construction sequence. Truss work in the loft was also imported with steel beams stamped 'Frodingham England', indicating their manufacture by the Appleby-Frodingham Steel Co. A single level verandah, supported on timber posts enclosed the north and south elevations (see Figure 51 and Figure 52). By the mid 1920s, this structure had been removed and a more robust structure enclosed the north, south and west walls at first floor level with a timber enclosed verandah structure, thought to have been open to the firing floor internally (ie the brick walls having been demolished, see Figure 53). There is some evidence that this expanded upper level to the Staffordshire kiln may have been used for the drying of tiles, presumably those produced in the tile-making plant which is understood to have been added to the site in this period (at the south end of the Machine Shed)<sup>58</sup>. A 1925 plan showing proposed alterations at the site indicates two 'tile lifts' located adjacent to the Staffordshire kiln.<sup>59</sup> According to Lester Firth Associates, the first floor level to the verandah was demolished in the A E Marr period and the brick walls at first floor level were rebuilt in their original position at this time, but without the openings as in the original (refer to Figure 52).<sup>60</sup>

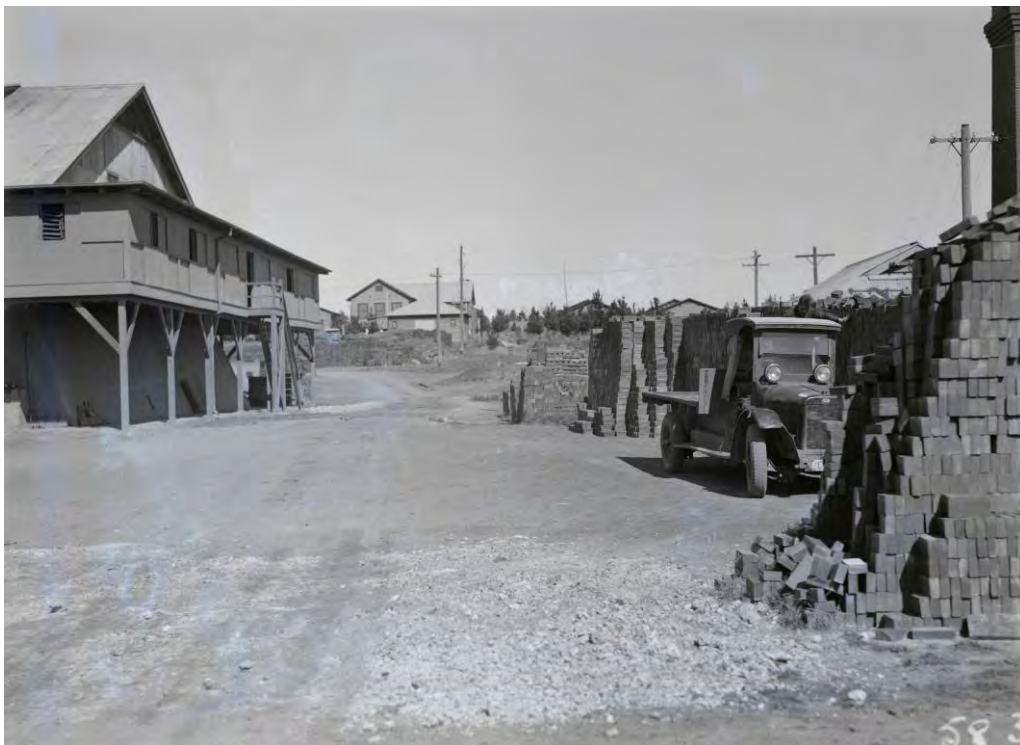
Figure 53 View of the west elevation from the 1920s showing the later two-level verandah structure.  
Source: National Archives of Australia.

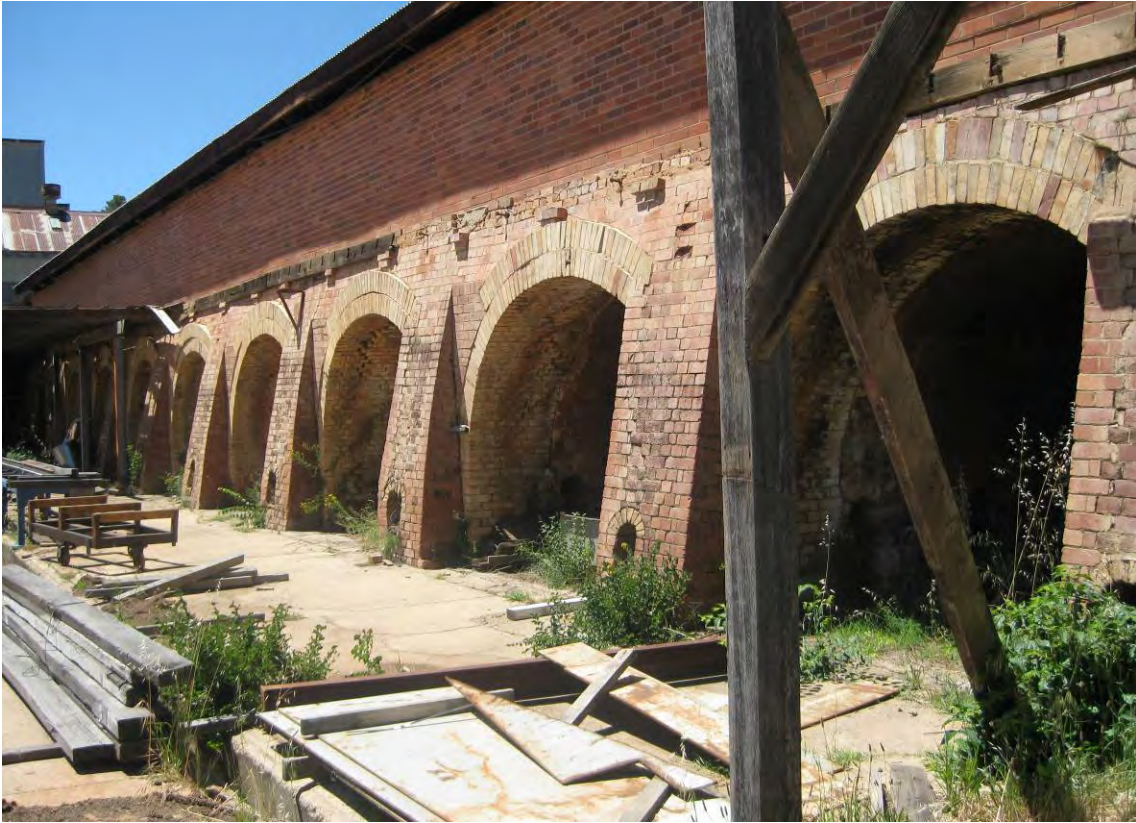
Figure 54 North elevation showing modified kiln entrances.

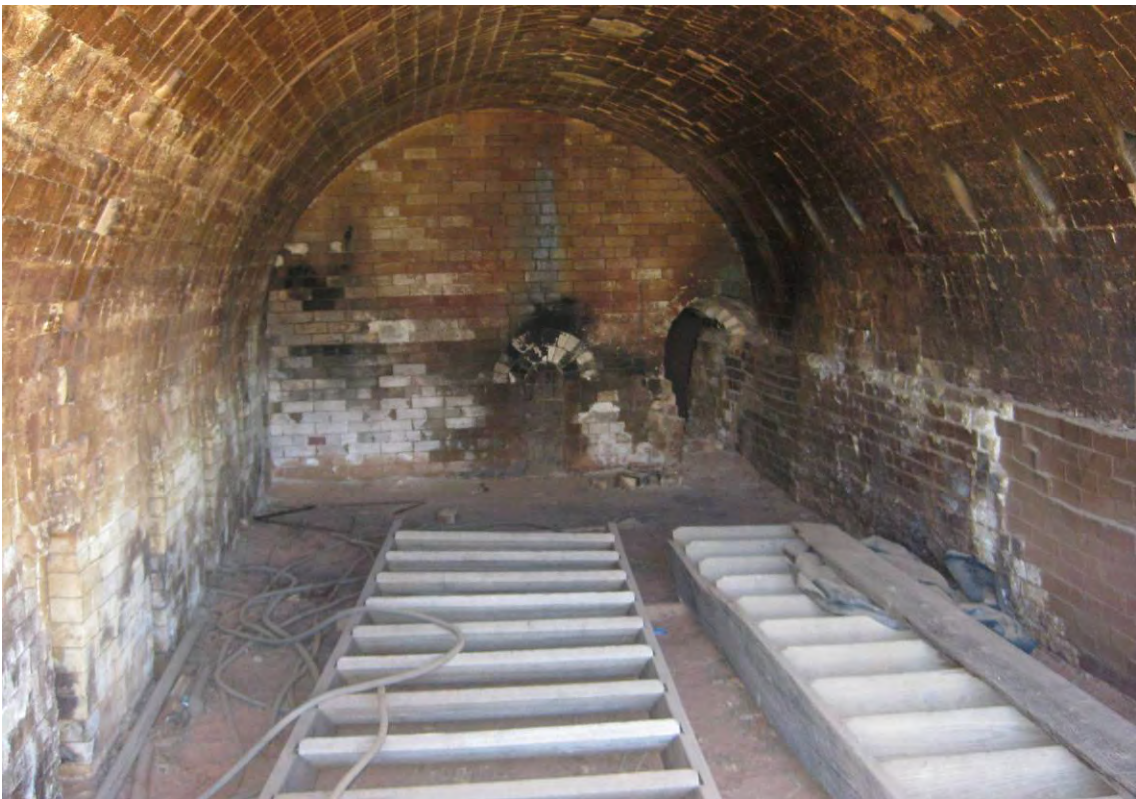
Figure 55 Kiln interior.

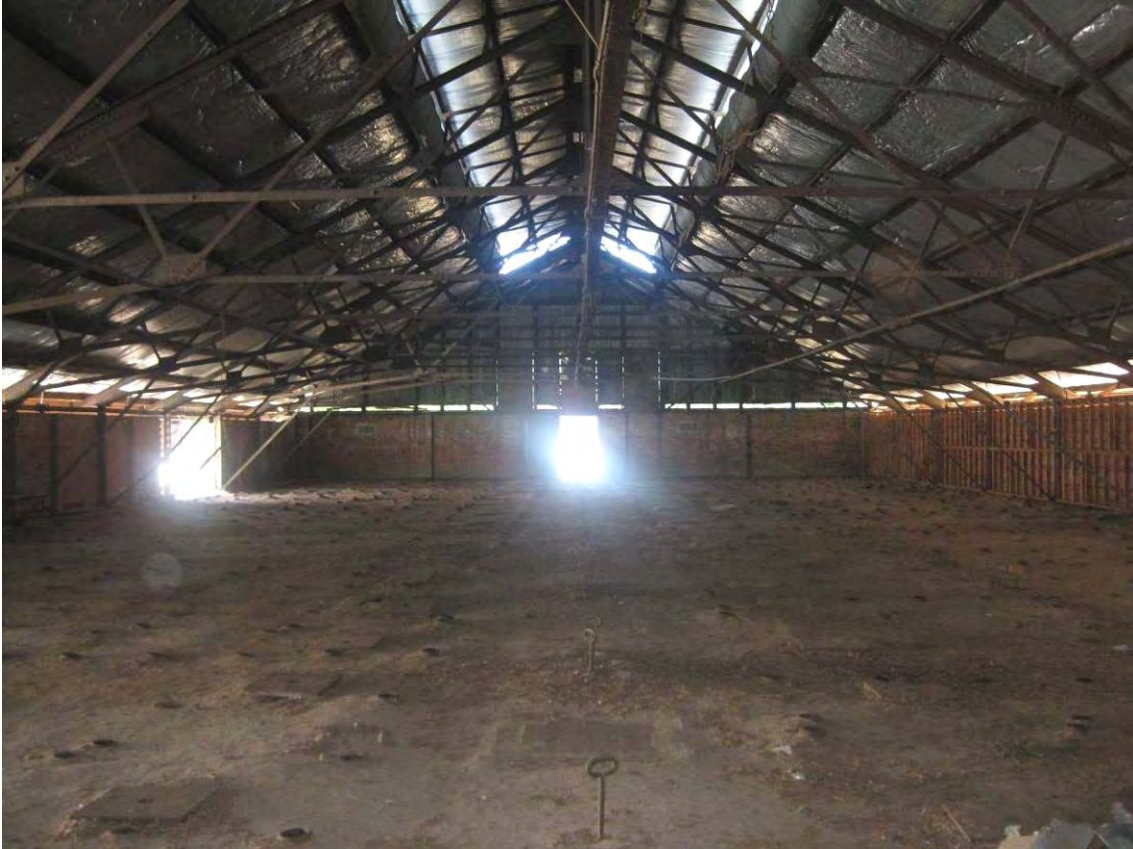
Figure 56 Interior of the upper floor of the kiln looking west across the firing floor.

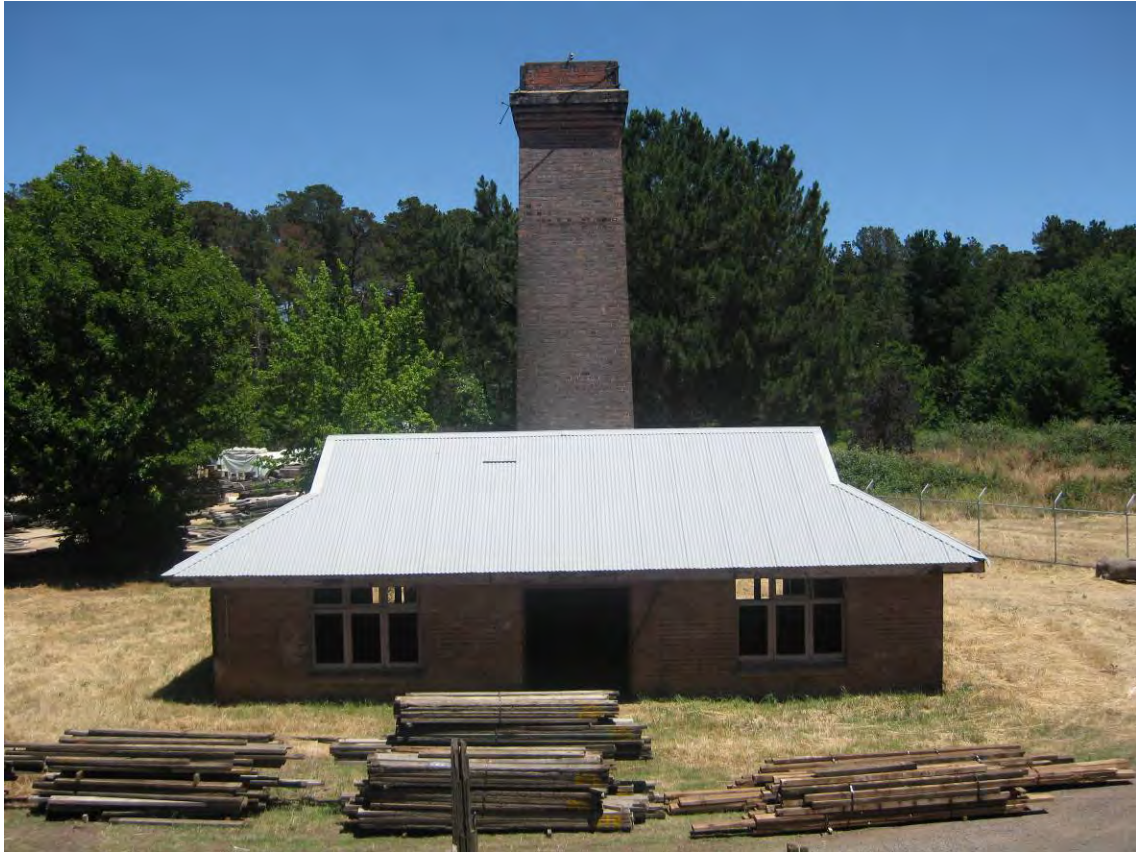
Figure 57 Fan house with stack behind.

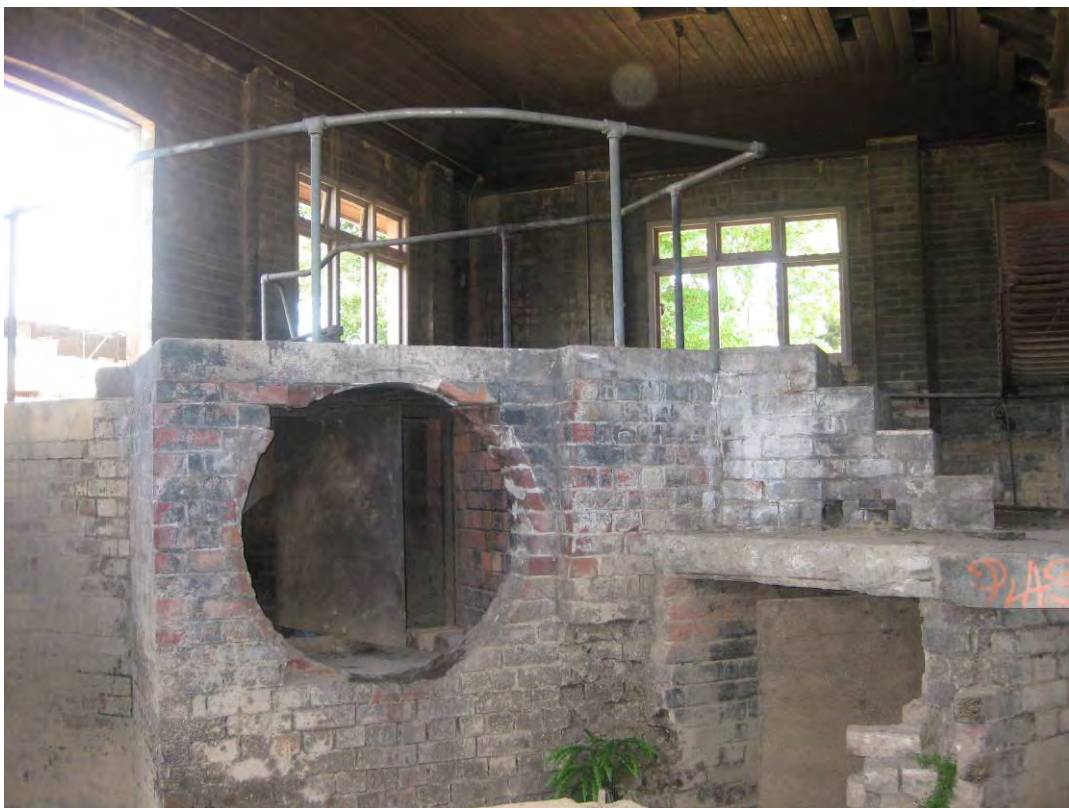
Figure 59 Another view showing the entry to the tunnel / flue connecting the fan house with the Staffordshire kiln.

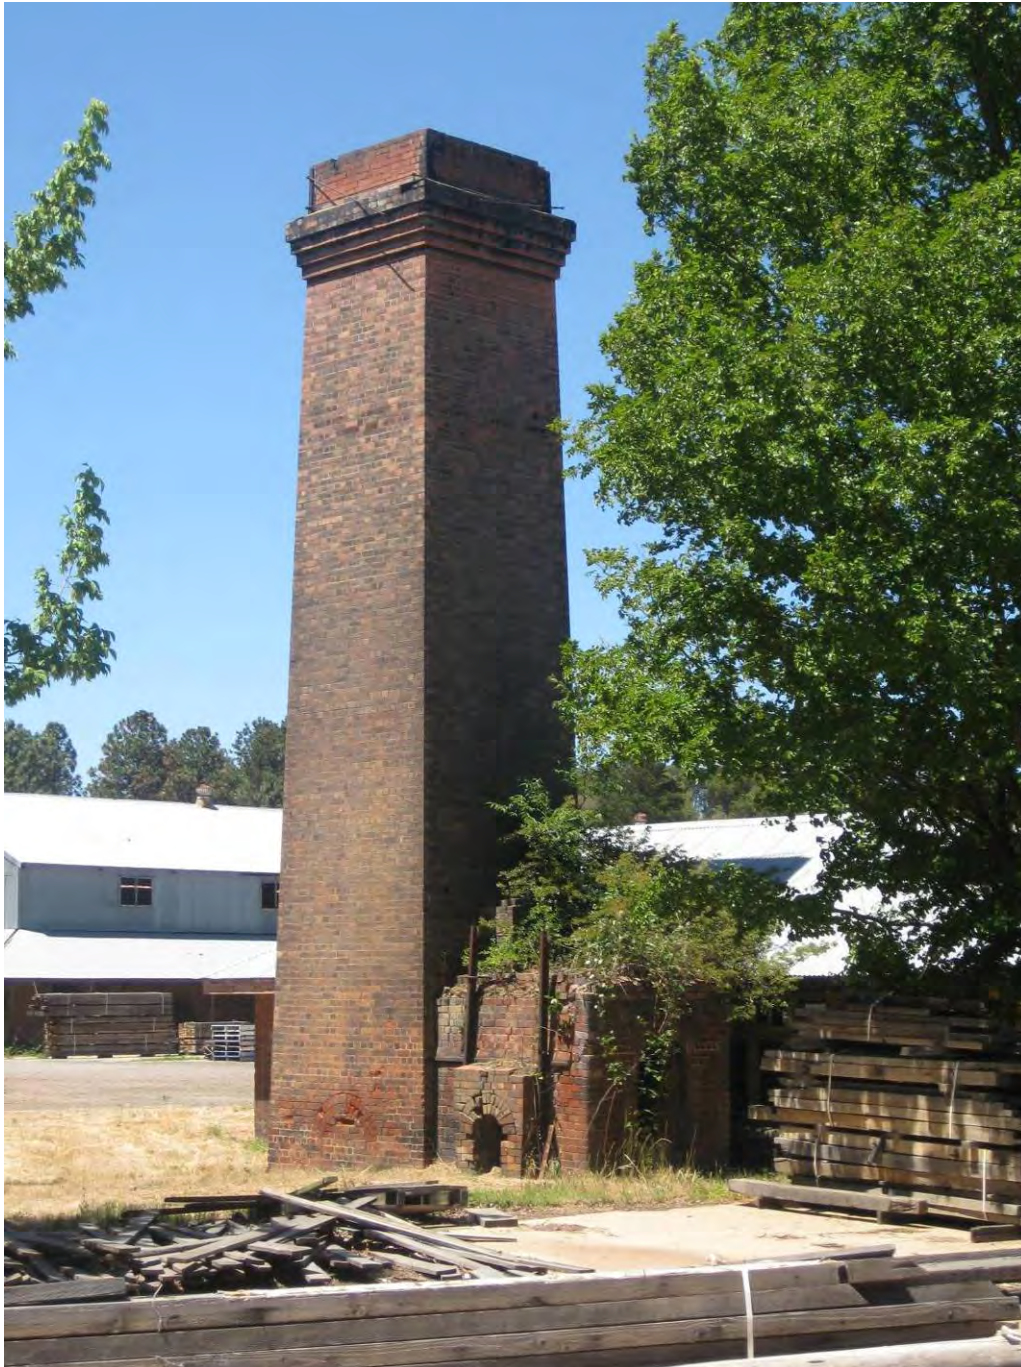
Figure 60 The full extent of the stack, with a smaller near-contemporary kiln adjoining to the right.

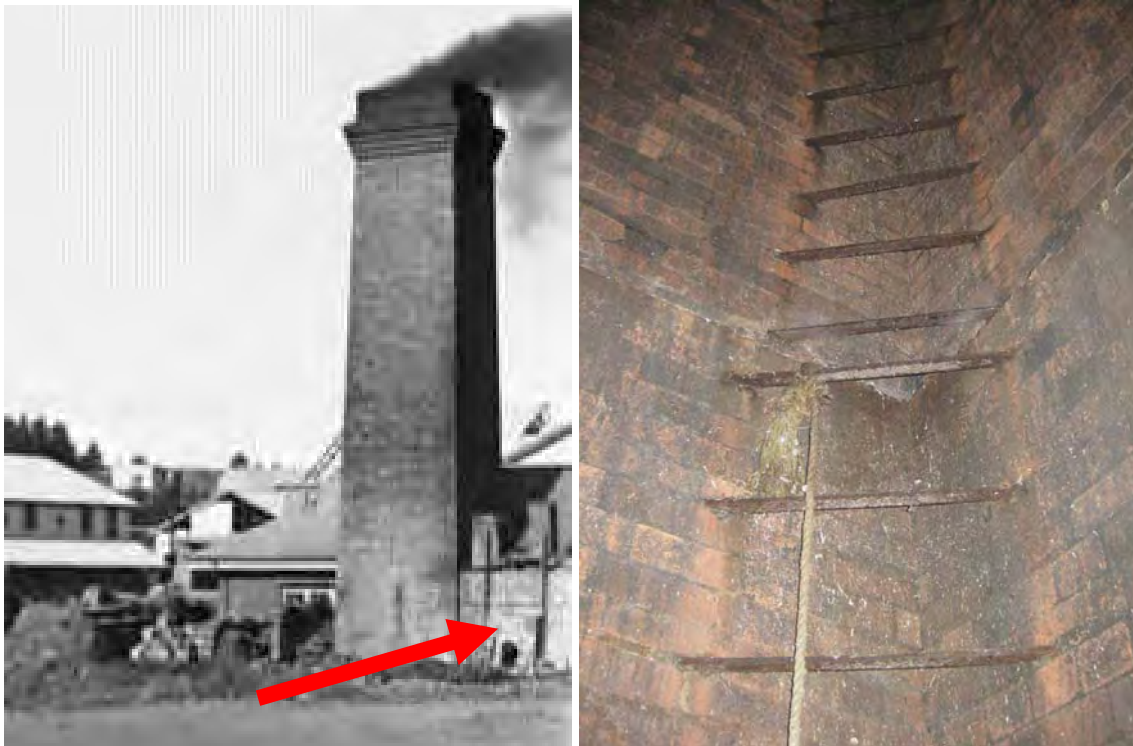
Figure 61 Left: Detail of a photograph of c.1926. The kiln abutting the stack is indicated by the arrow (Source: National Archives of Australia). Right: Interior of the chimney stack.

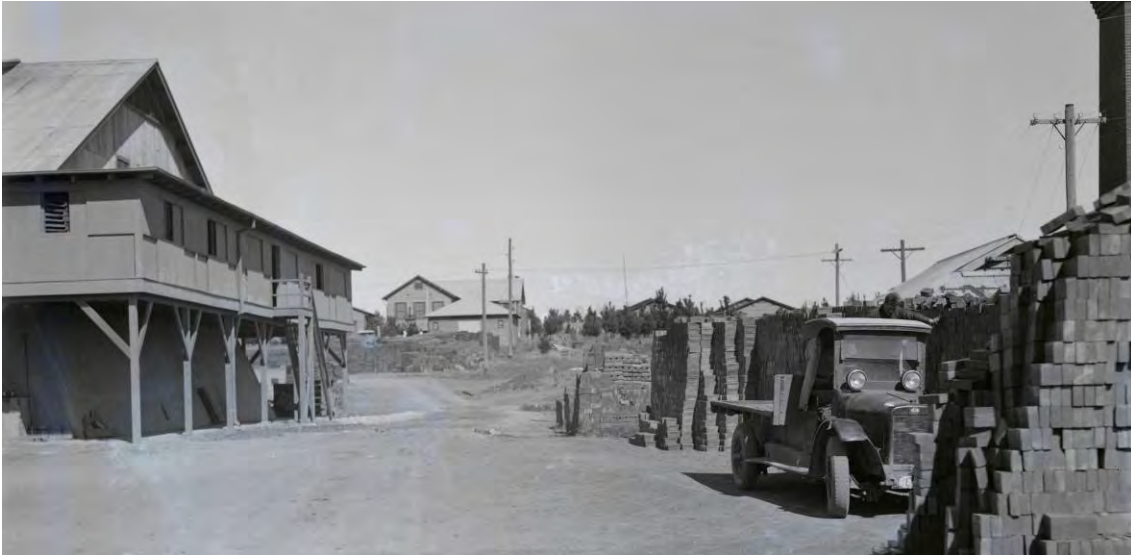
Figure 63 Looking south along the kiln 'road', the Staffordshire kiln at left, 1929. The mess hall building and the roofs of several of the sleeping quarters are visible in the background.

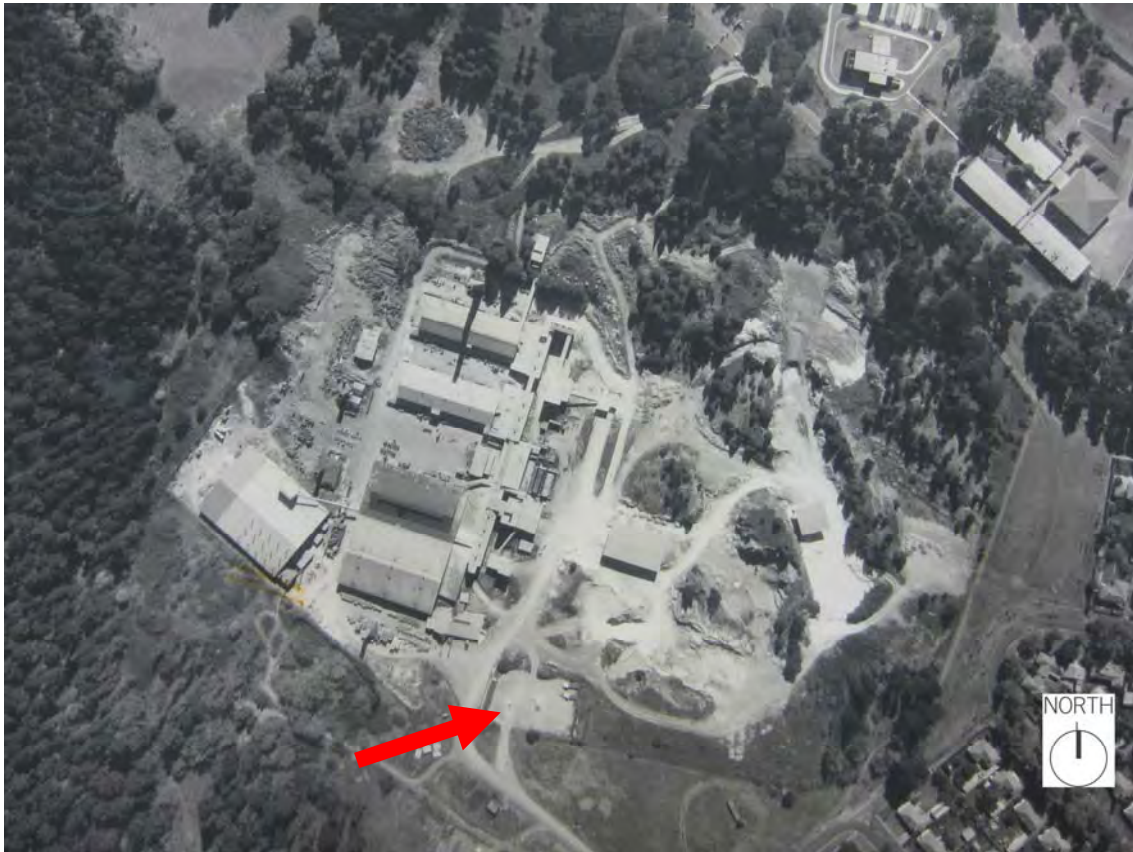
Figure 65 Detail of a 1976 aerial photograph with the then car park, thought to be the site of the former carpenter's shed indicated.  
Source: ACT Heritage Library, Woden, ACT.

This structure was located approximately 50 metres south-east of the Power House –refer to 1986 *Conservation Plan* datasheet NE8. Its date of construction is not known and it was removed during the 1960s with the site later used as a car parking area – refer to detail of the 1976 aerial photograph at Figure 65. Prior to any redevelopment of the site of the former carpenters shed, the potential for archaeological significance should be assessed.

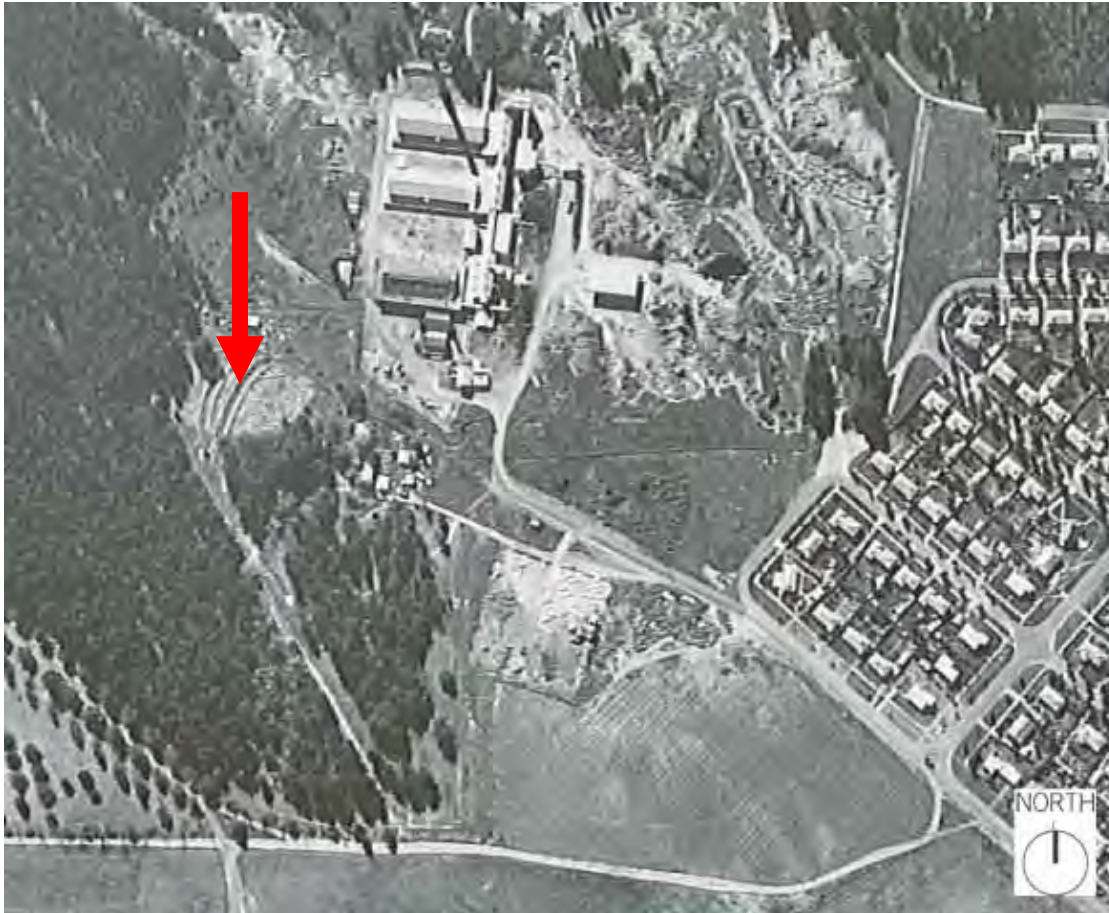
Figure 72 Aerial view of Canberra Brickworks, 1961. Note the railway cutting to the west of the site. The route of the railway east towards the city is also evident.  
Source: ACT Planning and Land Authority.

The 'branch lines' of the light railway were removed prior to the opening of the Provisional Parliament Building in May 1927 and the remaining sections of the railway were removed in 1929. From the late 1920s, bricks were transported by truck. The route of the railway is shown on a 1961 aerial view of the site (see Figure 72). It is believed that the only remaining evidence of the light rail network is the formation between Denman Street and the west side of the Brickworks.<sup>14</sup>

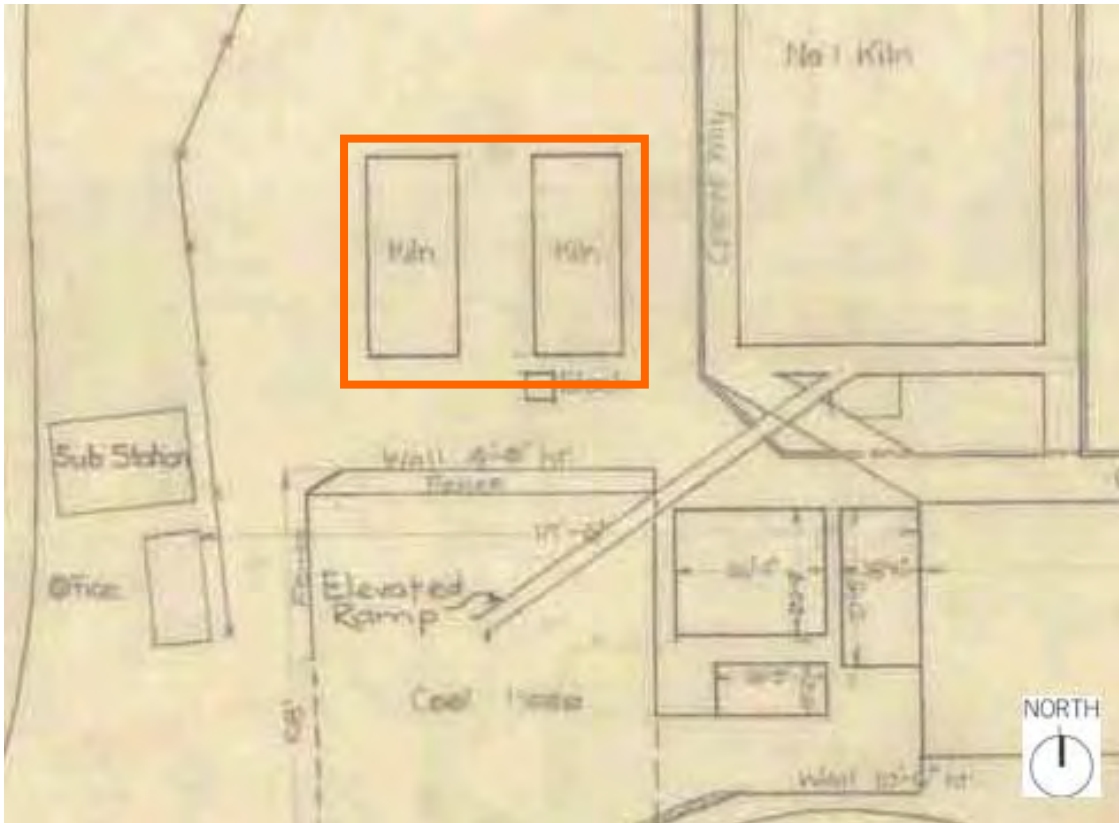
Figure 73 Detail of 1947 site plan, indicating the location of the two ‘temporary’ Downdraught kilns, to the south of the Staffordshire kiln (‘No. 1 Kiln’). . Source: National Archives of Australia.

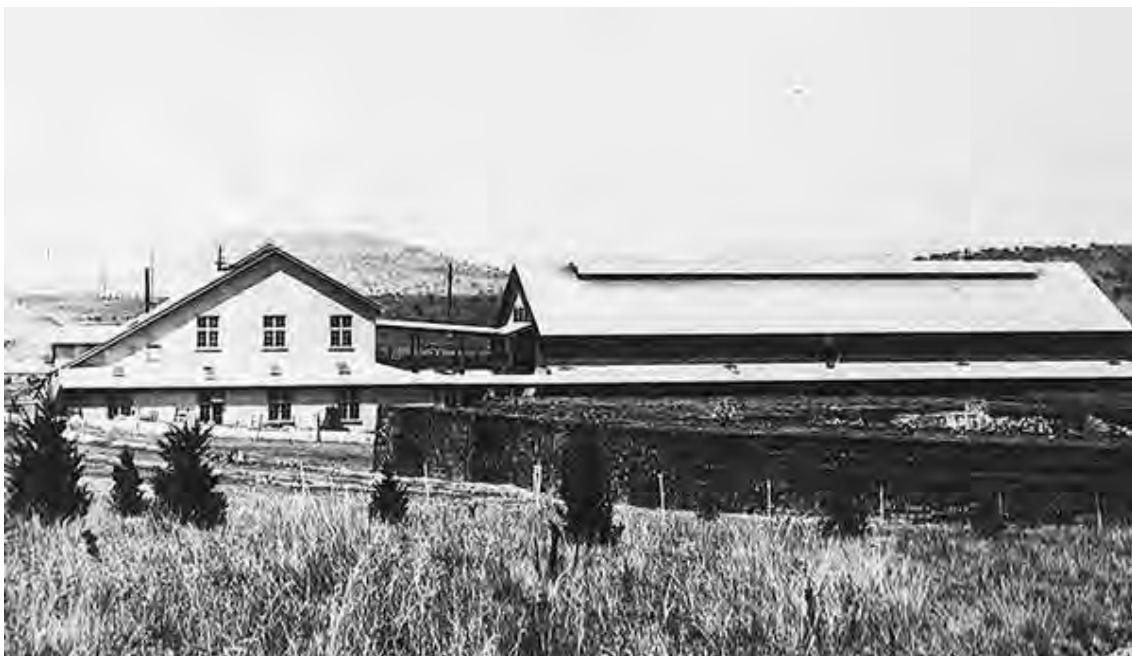
Figure 74 The Machine Shop (left), pictured mid-1920s. Source: National Library of Australia.

In 1926 the existing 'Machine Shed' (see Figure 74), was expanded by two bays for two new New Era 'Whittaker' brick machines and grinding pans. A Hardy patent kiln (a modified Hoffman-type kiln with a detached stack) was built and in use by early 1927, located to the north of and parallel to the Staffordshire kiln (see Figure 75 and Figure 76).<sup>16</sup> This kiln remains today, albeit in extensively modified form. Also during this period, a 'Scotch' kiln was in operation to the north of the Staffordshire kiln (see Figure 75), and the original section of the present office building was constructed (see Figure 78). In January 1927, the *Canberra Times* commented on the expanded capacity of the works, noting that in addition to the new Hardy patent kiln of 18 chambers (with a potential annual output of six million bricks), a new down draft tile kiln was operating with an annual output of 420,000 tiles and a new Roman tile machine had a daily output of 2,000 tiles. It also noted that three hand presses had been installed (presumably in the Machine Shed) 'for all classes of special work'.<sup>17</sup>

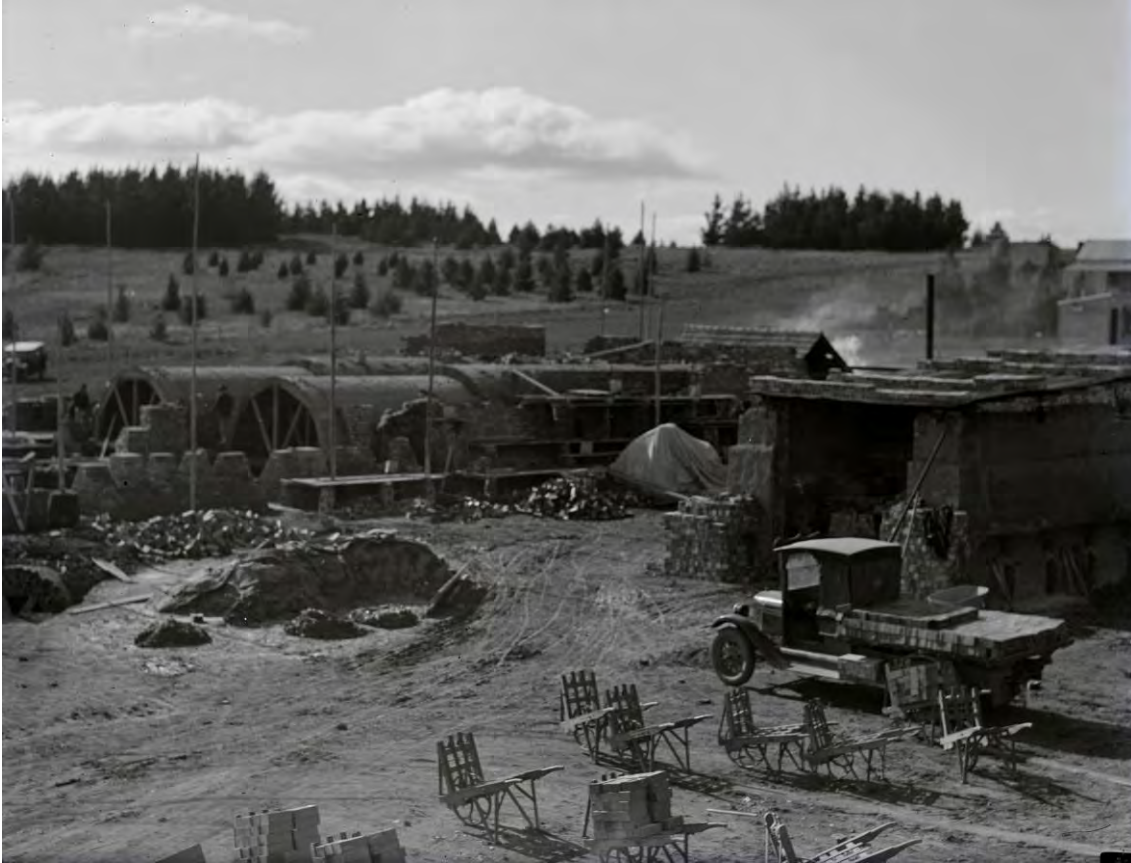
Figure 75 Hardy patent kiln under construction, 1926. Note Scotch kiln to right of picture.  
Source: National Archives of Australia.

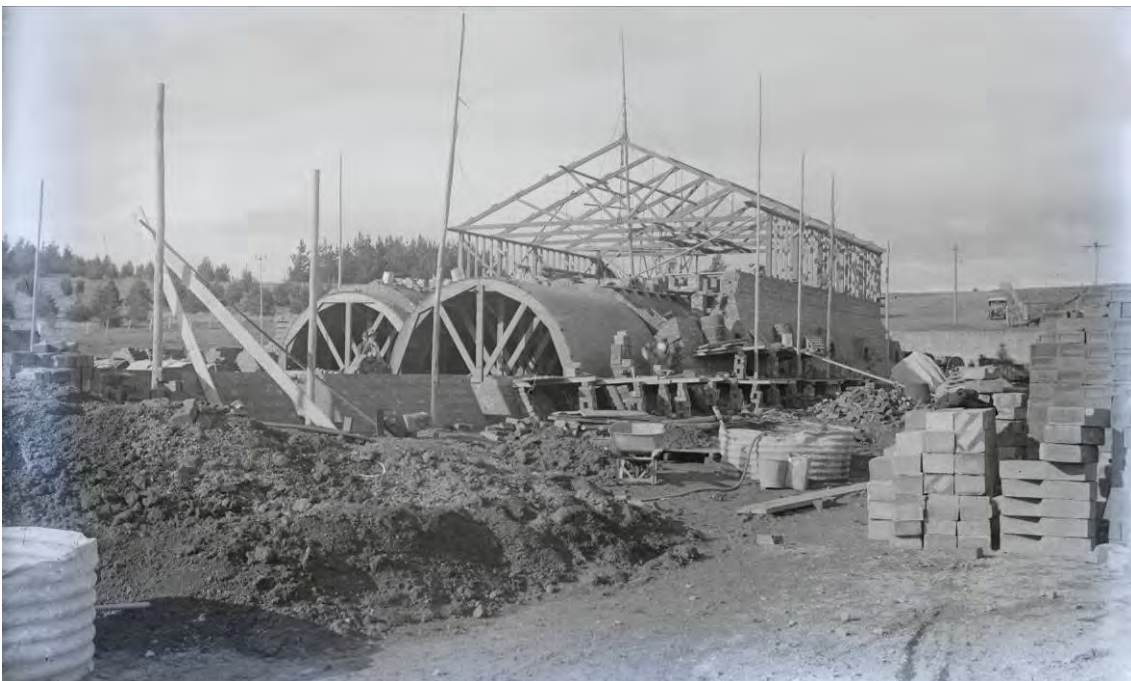
Figure 76 Hardy patent kiln under construction, c. 1926.  
Source: National Archives of Australia.

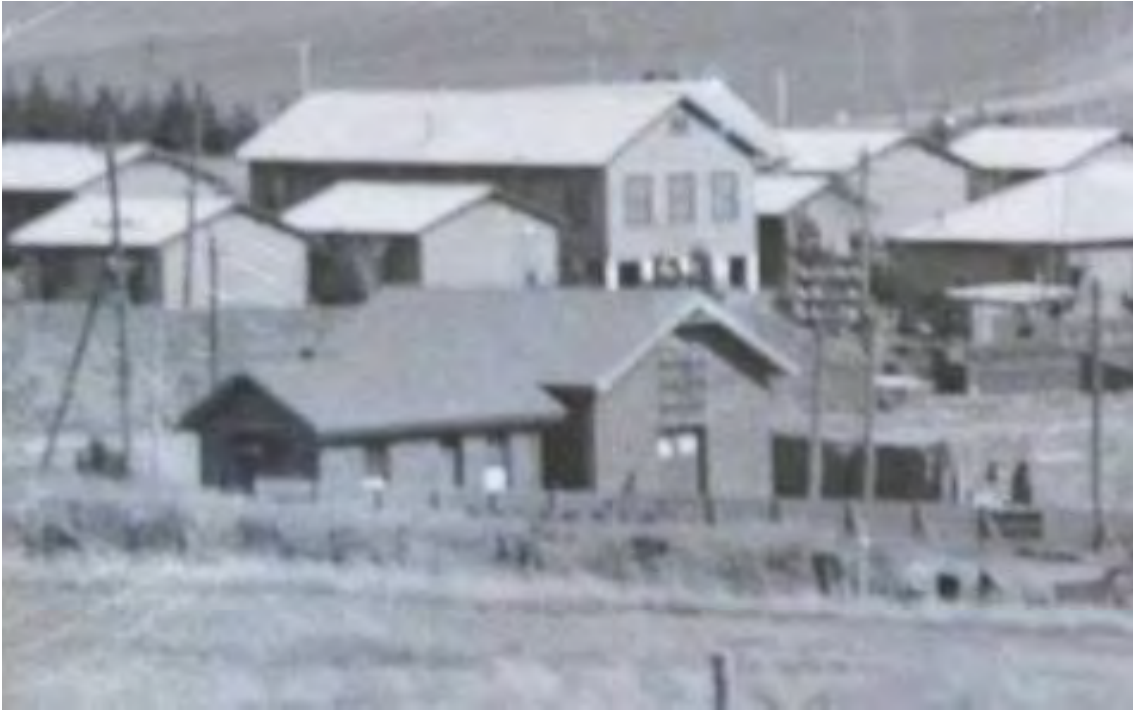
Figure 79 Detail of a photograph of the Brickworks site in 1929 taken from the quarry area, showing the original form of the office building to the east of the Power House (foreground). Note that at this date, the main entrance to the Power House is from the north. The married quarters camp is in the background. Source: National Archives of Australia.

The Survey Plan of 1916 (see Figure 30) indicates a galvanised iron 'Office' located approximately 40 metres north of the present office building. This was subsequently removed and the site developed for the original Machine Shed. The date of construction for the original portion of the present offices – consisting of two rooms – has not been established. It is not indicated on a site plan dated September 1921, but is represented in outline on a site plan of April 1926 (see Figure 78).<sup>25</sup> It appears in a 1929 photograph, shown at Figure 79.

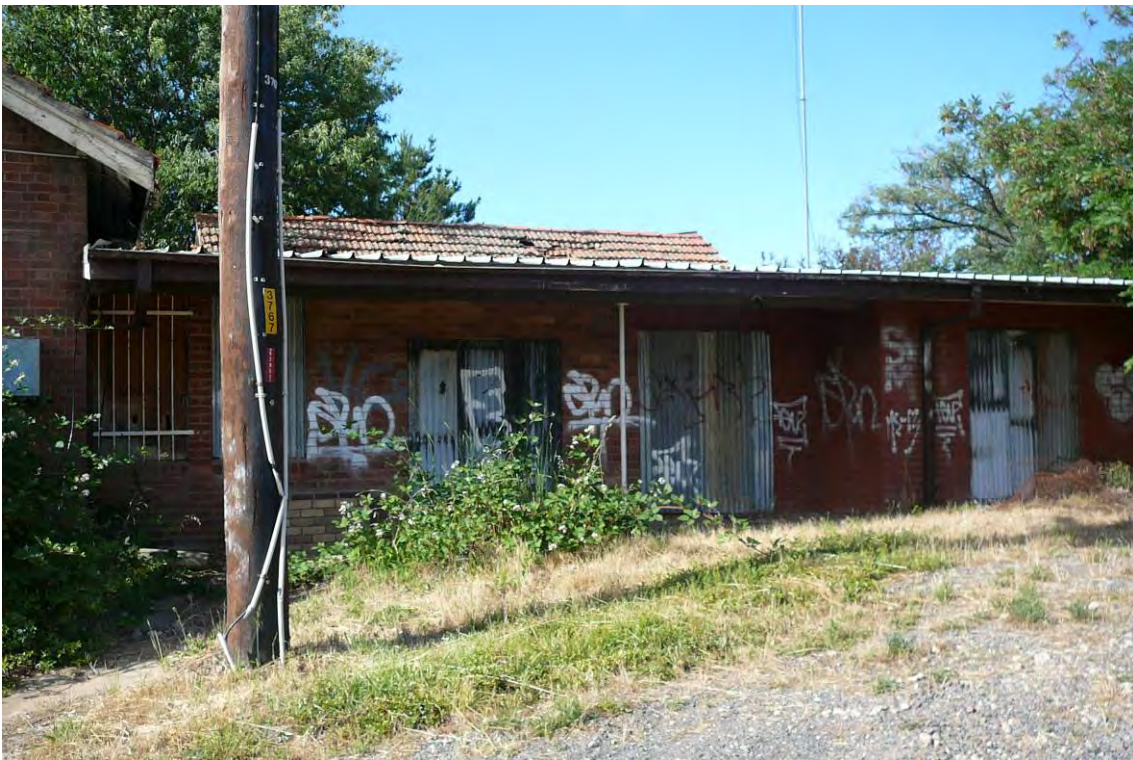
Figure 80 South elevation. Part of the Power House (Building 3) is visible at left.

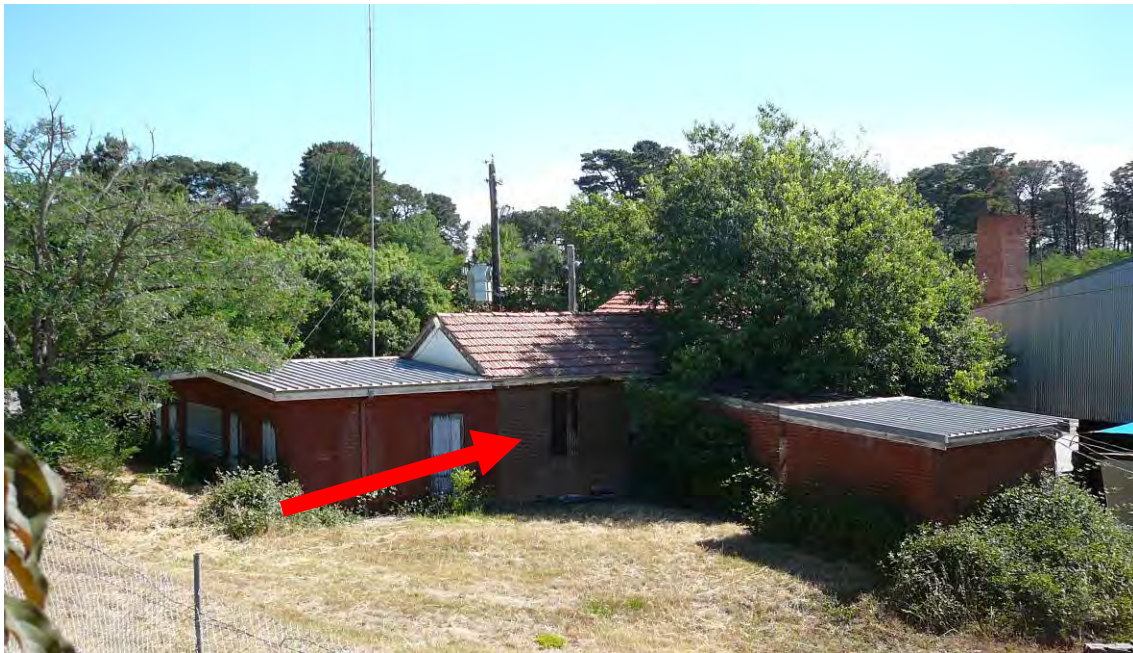
Figure 81 East and north elevations, showing the extent of the additions. The only portion of the original two-roomed structure, not enclosed by additions is indicated by the arrow.
