Conservation Management Plan (2010)

Canberra Brickworks  
Denman Street, Yarralumla, Canberra

Conservation Management Plan

Prepared for  
Land Development Agency

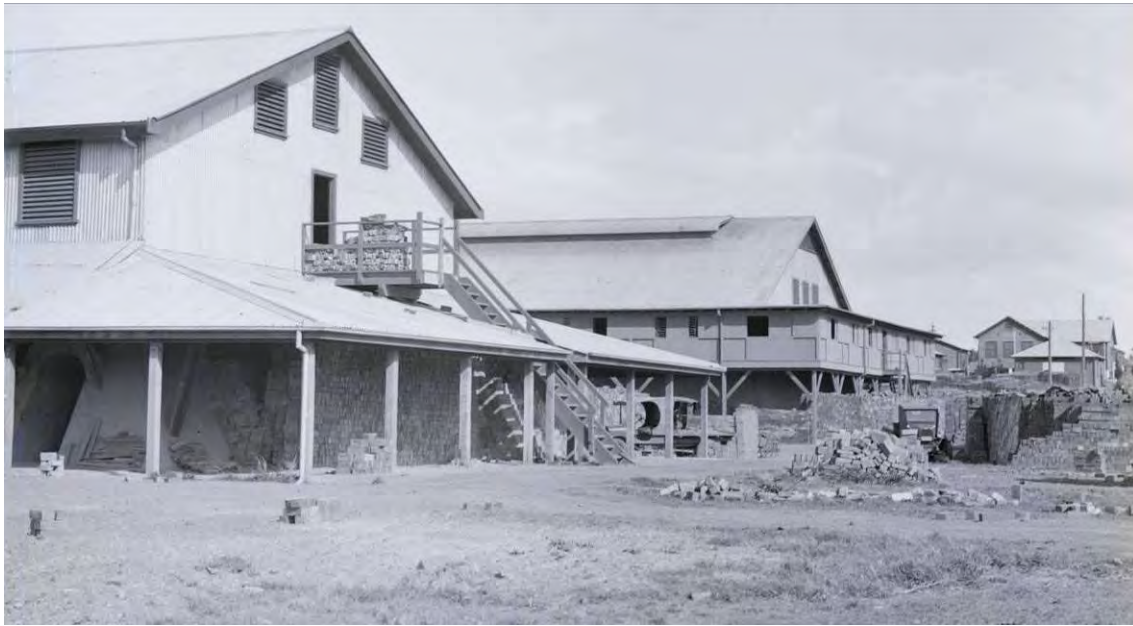
Figure 83 The first Hardy patent kiln (left) and the Staffordshire kiln in 1928.  
Source: National Archives of Australia.

Originally, access to the west end of the firing floor was via a timber stair, which rose through the verandah to this elevation (see Figure 83). Today the re-cladding of the end wall and the present verandah form has removed any evidence of this access point. The east end has been modified with a walkway at first floor level extending from the south elevation and connecting the firing floor with the adjoining machine bay behind (the latter dating to the mid-1950s). Access to the firing floor is now through a single leaf ledged and braced timber door in the east wall.

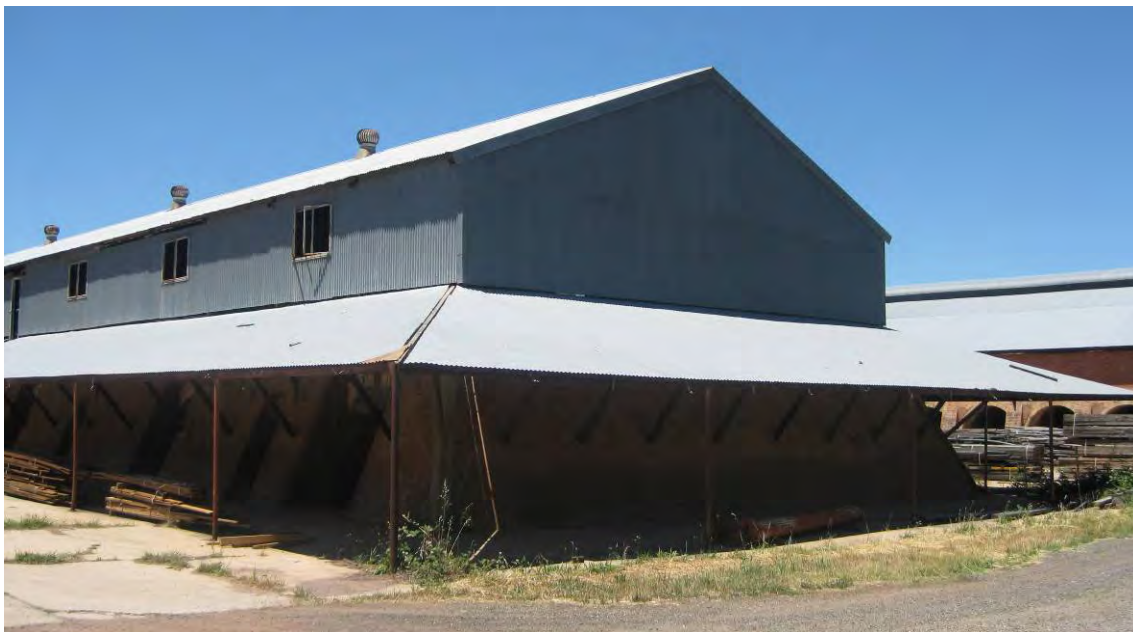
Figure 84 The Hardy patent kiln showing the west and part of the north elevation.

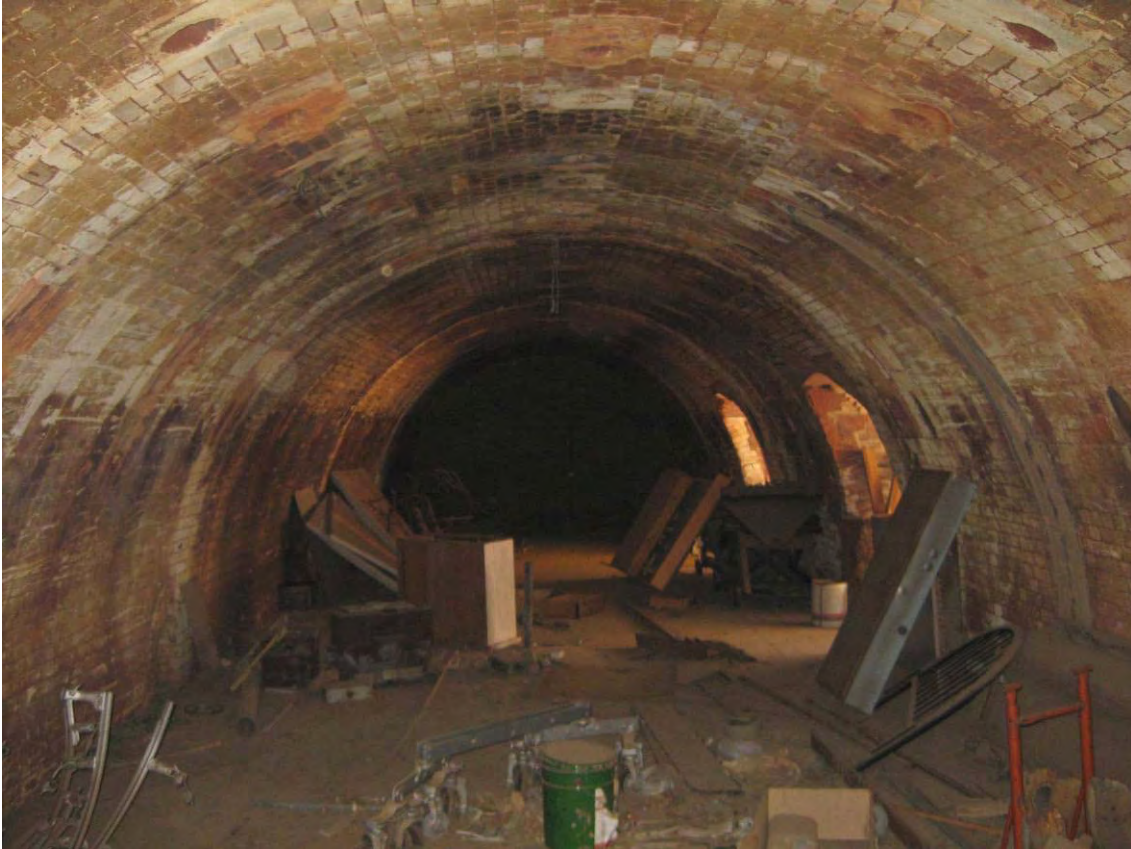
Figure 85 Interior of the Hardy patent kiln. The kiln is divided in two by a non-original brick wall.

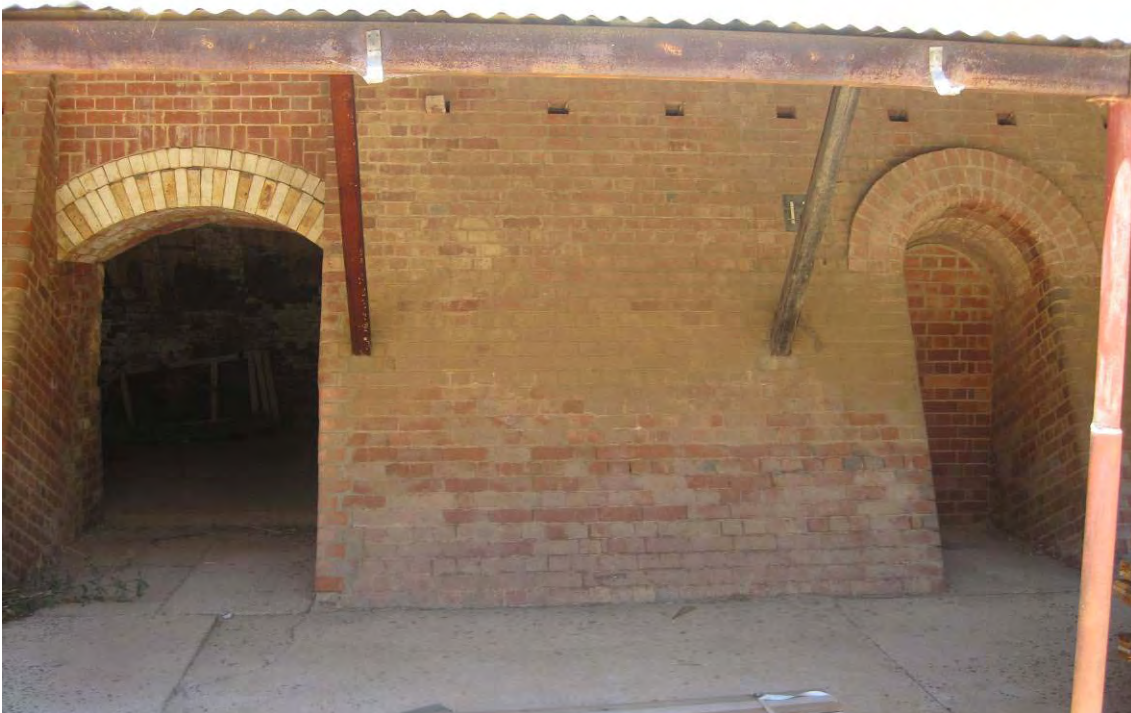
Figure 86 Kiln wickets – the opening at left has been altered to enable forklift access and the bricked-up the opening at right is as originally built.

<sup>97</sup> The recommendation for wide wickets was not carried through. As built, the wickets of the Hardy patent kiln were only a metre wide. See drawing, 'Canberra Brickworks layout of firing holes for No. 3 Kiln for Dept. of the Interior, n.d. M8759B,' National Archives of Australia.

During the 1960s, oil replaced coal as the fuel for firing the kilns, and modifications were made to the entrances of the three continuous kilns (the Staffordshire and two Hardy-patents) for the use of forklift trucks to set and remove bricks.<sup>105</sup>

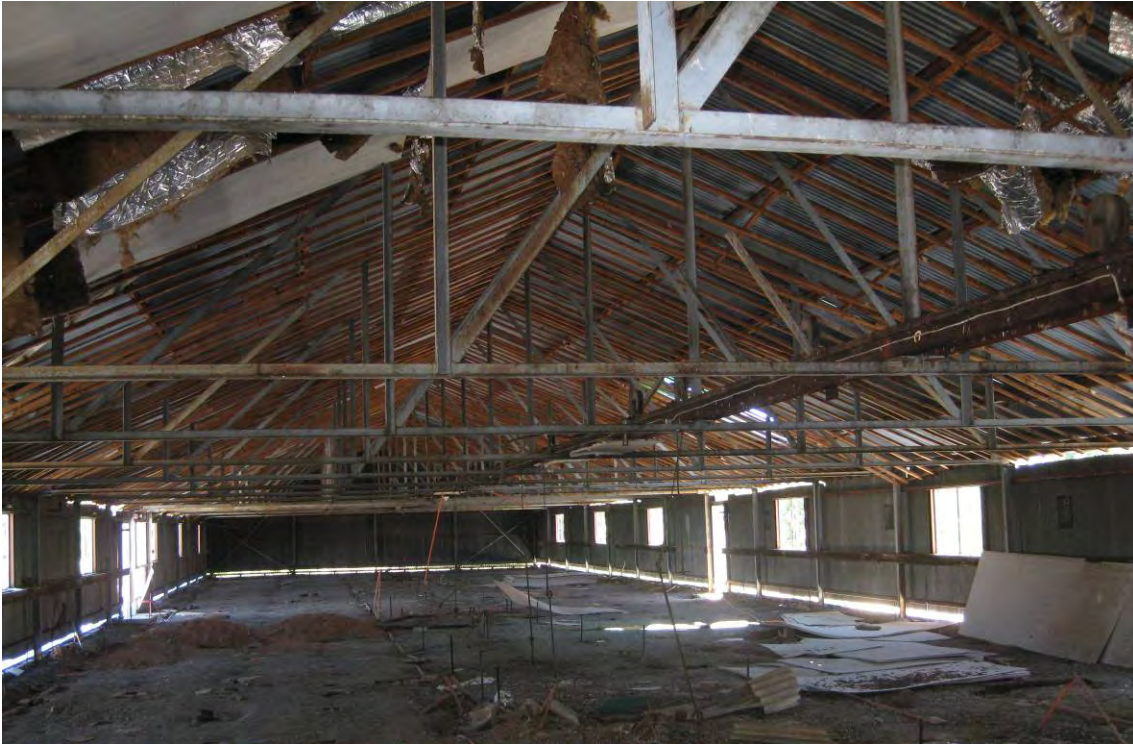
Figure 87 Interior of the firing floor, showing remnants of a commercial fitout dating from the late 1970s.

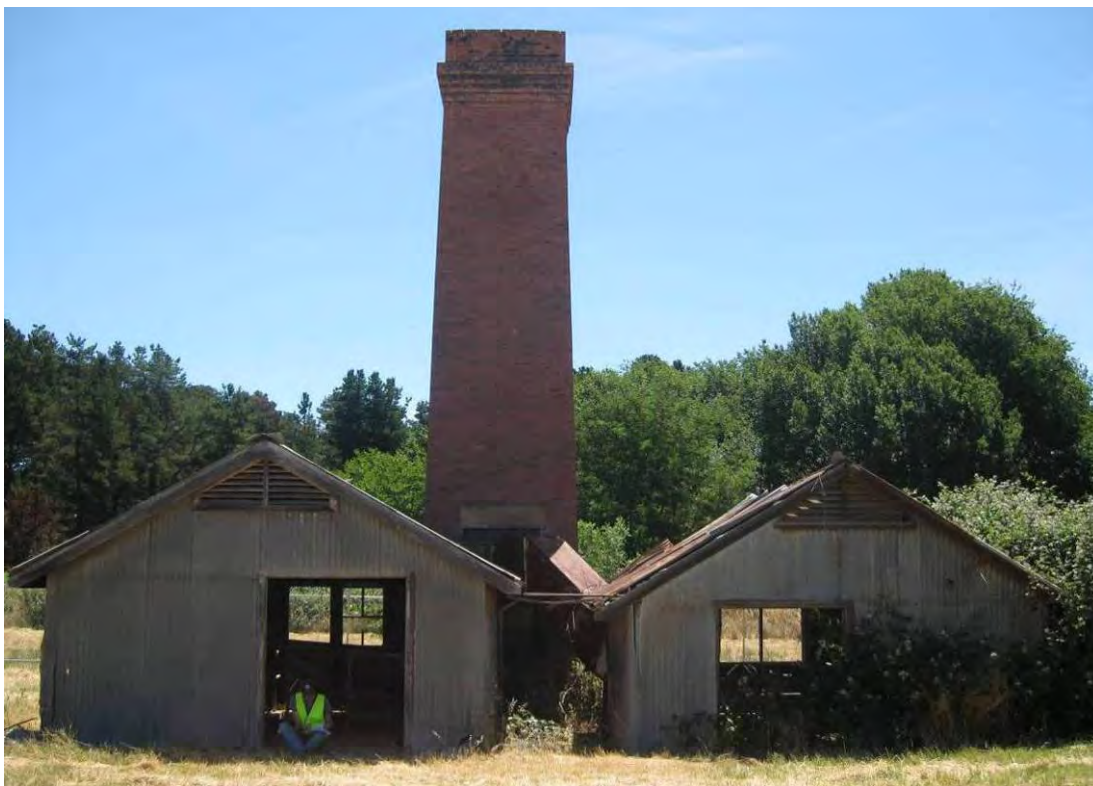
Figure 89 The fan house at right is the earlier of the two (1927). The fan house on the left was added in 1955.

The fan house comprises two timber-framed sheds, with gabled roofs, clad and roofed in corrugated steel. There is an entry to the east elevation and windows in the rear and outer walls. Part of the wall cladding has been removed, and the glazing has also been broken and many of the glazing bars are missing. The entry doors have also been removed.

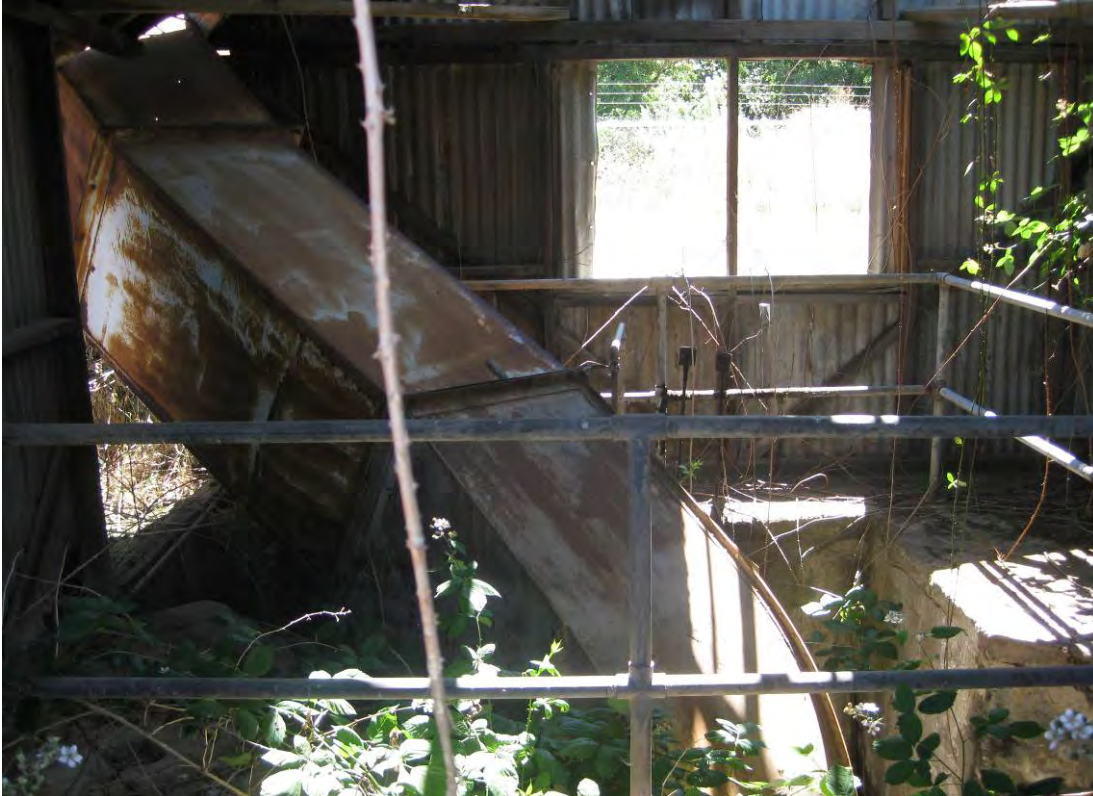
Figure 90 Interior of the 1927 fan house.

Internally, similar to the Staffordshire kiln fan house, the floor is below ground level and there is an entry apron with metal handrail. Evidence remains of the now removed fan machinery, the location of which is discernible by the pedestal mount of the fan machinery. The ducts connecting the fan house with the stack are *in-situ*, and unlike the Staffordshire kiln fan house, these are visible rising out of the rear wall of the fan houses and connecting to the east elevation of the stack at a height of approximately two metres (Figure 91).

The fan house is in an advanced state of disrepair and the c. 1926 structure is severely impacted upon by unchecked growth of blackberries.

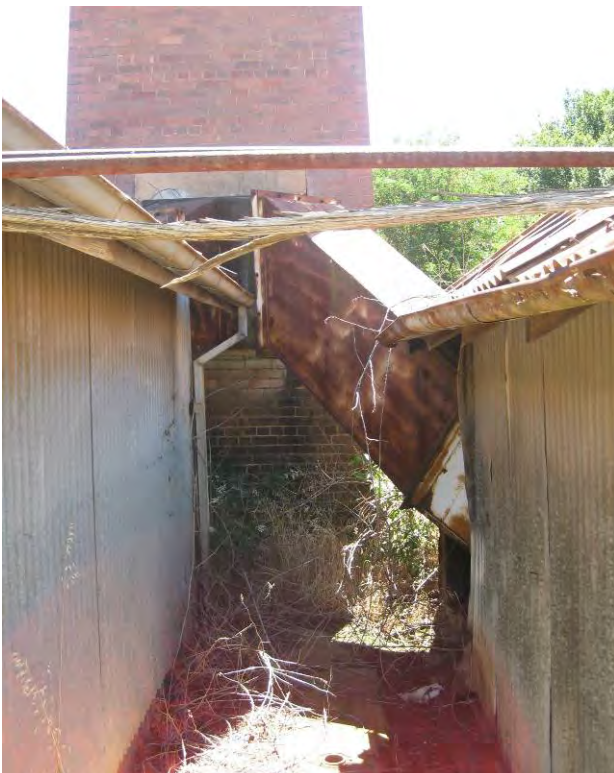
Figure 91 Ducts connect through to the chimney stack.

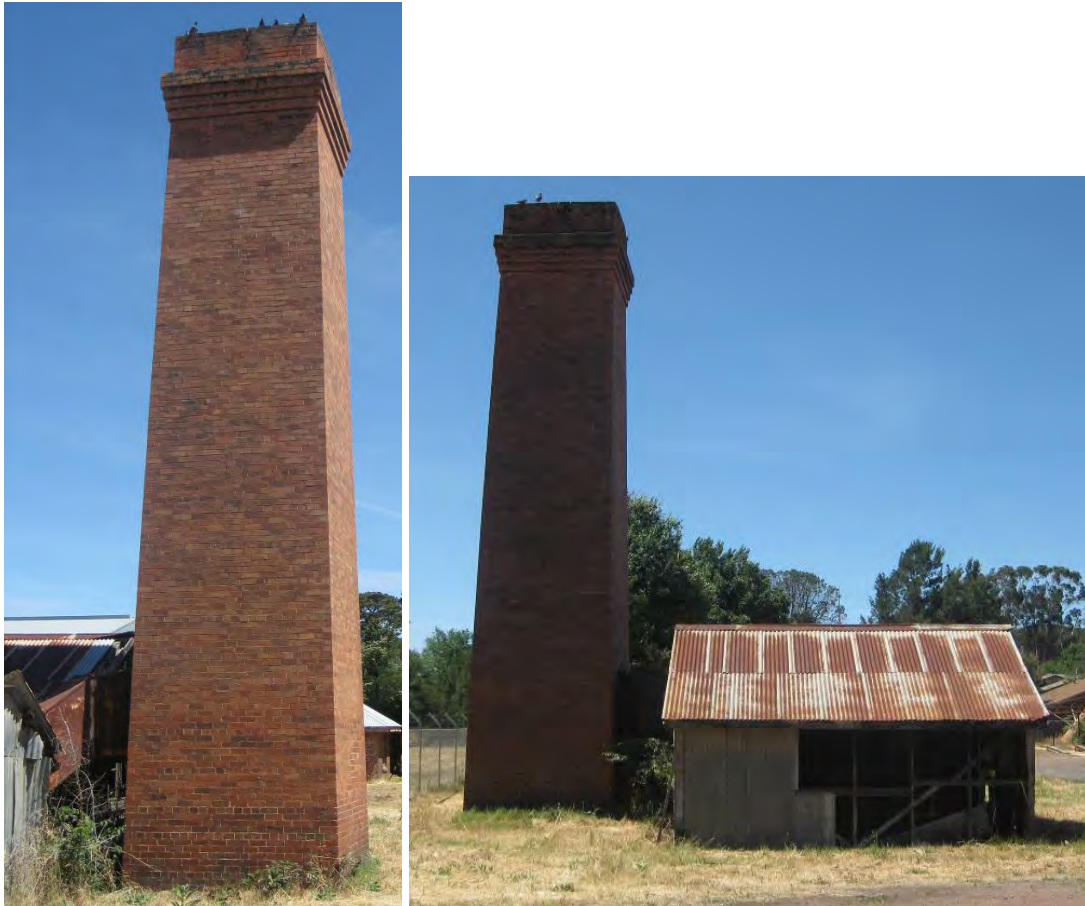
Figure 92 Left: North elevation. Right: South elevation with the 1955 fan house adjoining.

The chimney stack, constructed of face red brick, is adjacent to the fan house and located approximately 30 metres west of the kiln building. A gravelled roadway separates the kiln from the stack and fan house. The stack is capped with several courses of corbelled brickwork and surmounted by nine rows of brickwork. There is a significant crack in the north elevation of the brickwork above the stepped courses. There is an arched opening in the south face of the stack, infilled with brickwork.

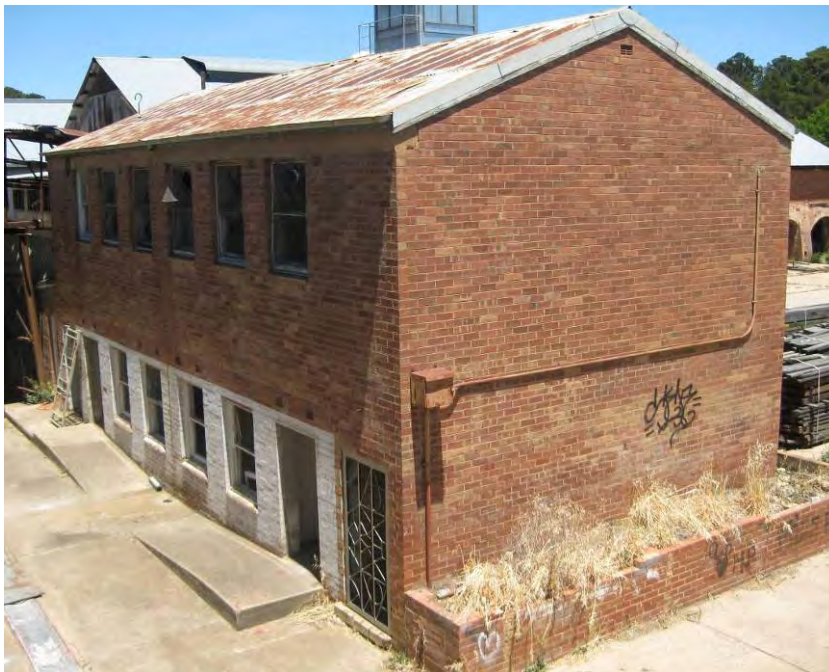
Figure 101 The Amenities Block viewed from the west.

The building is in a badly vandalized state with only a few toilets and basins intact and operable. Most of the glazing has been broken and the exterior of the building spray-painted with graffiti. Access to the first floor space was not obtained with one of the stairs secured by a metal grille and the door off the stair landing to the south end nailed shut internally.

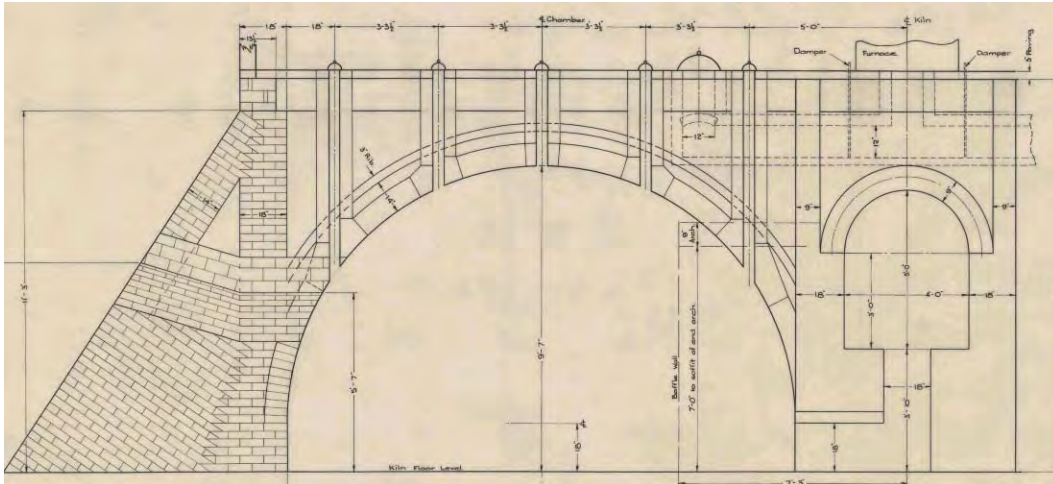
Figure 102 Section through wicket chamber and flue of the second Hardy patent kiln, 1953. Source: National Archives of Australia.

A tunnel kiln was planned and partially built at Canberra after World War II, before being abandoned in 1952. The foundations were incorporated into the second Hardy patent kiln completed in 1953 (Building 12).<sup>19</sup>

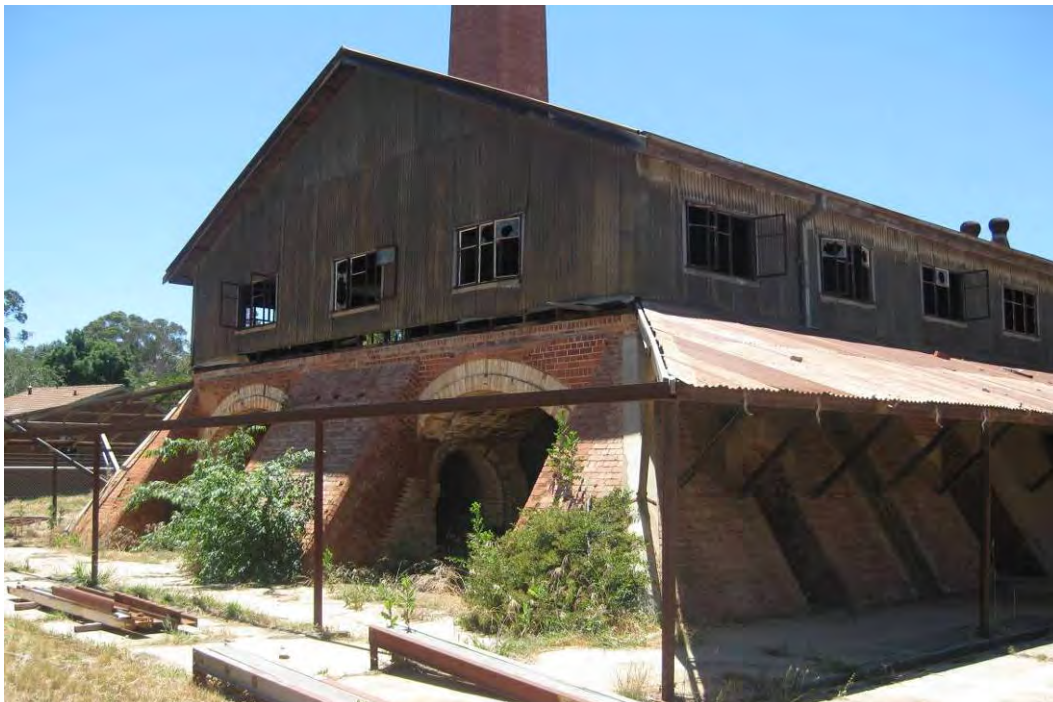
Figure 103 The Hardy patent kiln, showing the west end and part of the south elevation. Note the verandah cladding has been removed and the kiln wall part removed, presumably for improved access to the kiln interior.

A verandah roofed in corrugated steel extends around the all sides of the building, apart from the west where only the metal posts and support framing are intact. The removal of the verandah cladding may have occurred prior to the part removal of the brick end wall, where the two kilns are revealed in cross section –see Figure 103. To the east the verandah abuts the skillion roof that bridges the space between the corrugated steel machine bay to its east (Machine Bay 3, Building 16). The verandah structure here is of steel, extended at 45 degrees from the brickwork, supported on steel props as well as by a series of painted steel posts.

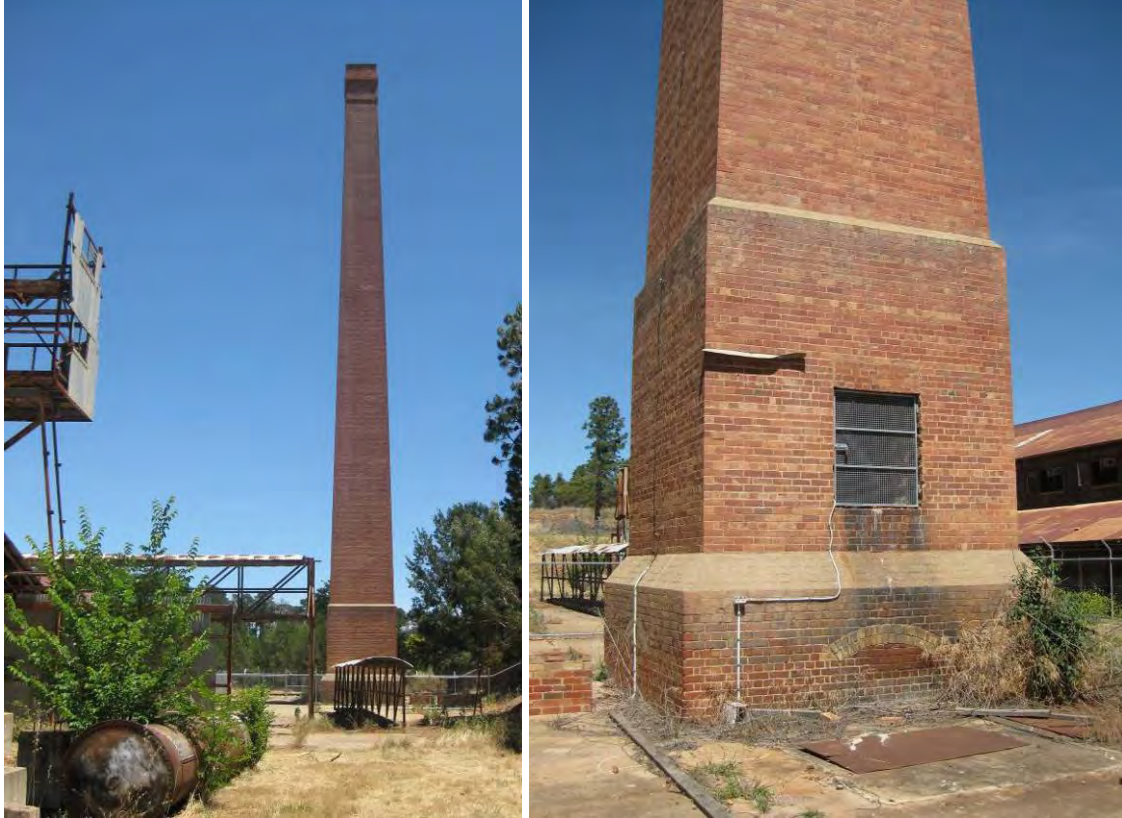
Figure 104 Left: view from east. Right: West elevation, base of stack.

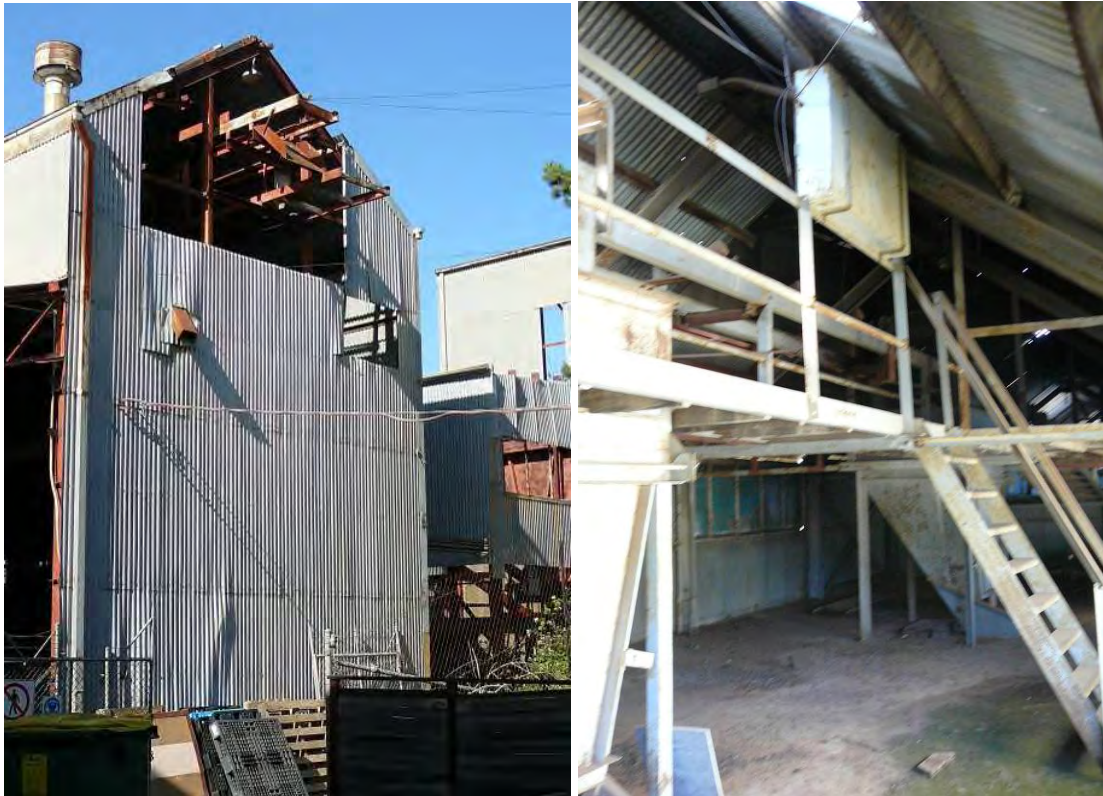
Figure 107 From left: the truncated south end of Machine Bay 1, showing location of former headgear housing; interior of the loft space.

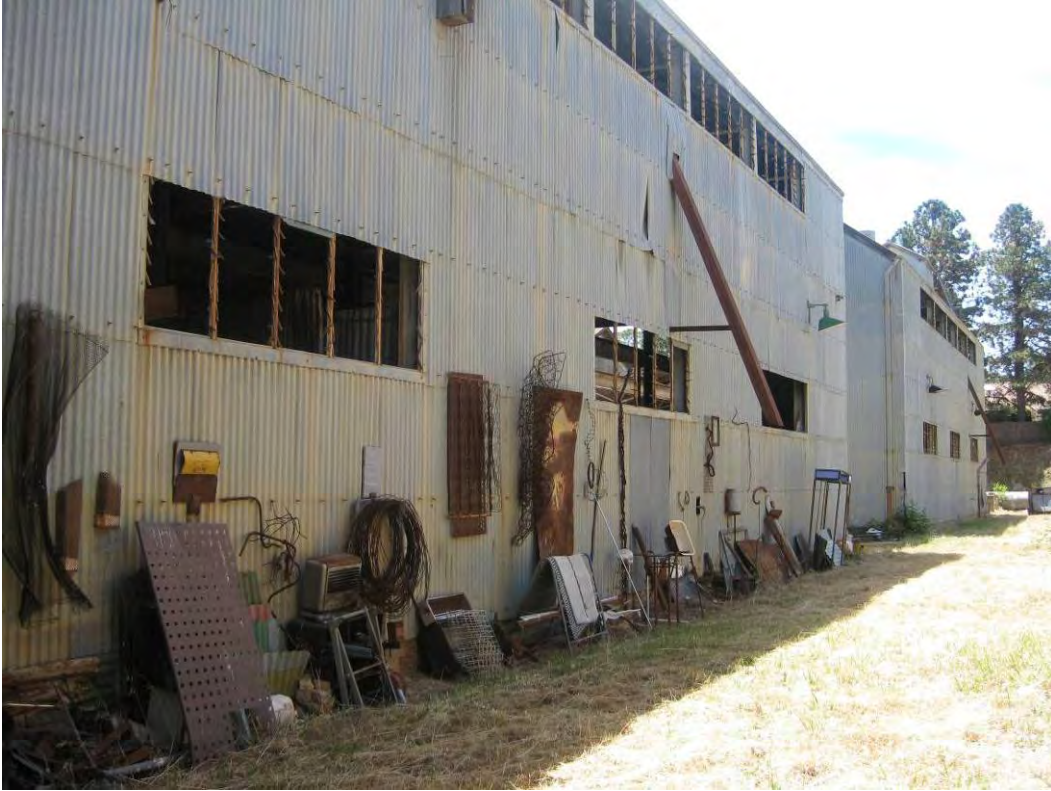
Figure 110 The rear (east) wall of Machine Bay II. The adjoining building (to the north) is Machine Bay III.

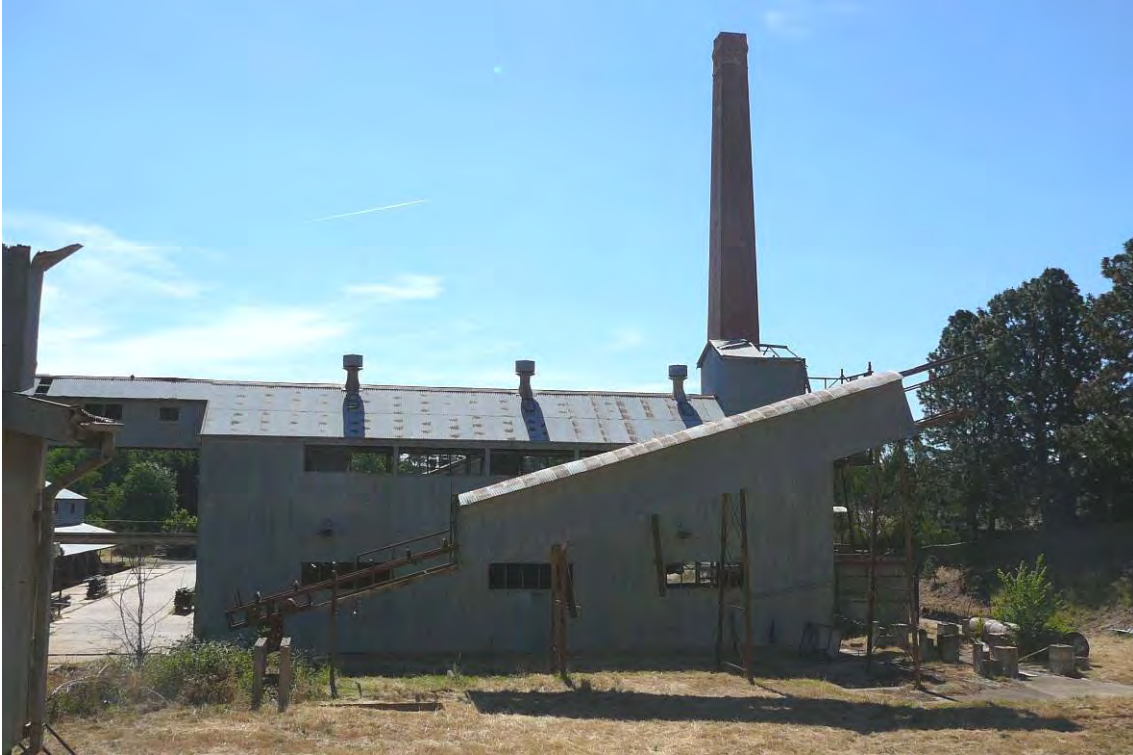
Figure 115 Machine Bay III, east elevation, with the remains of the conveyor in the foreground.

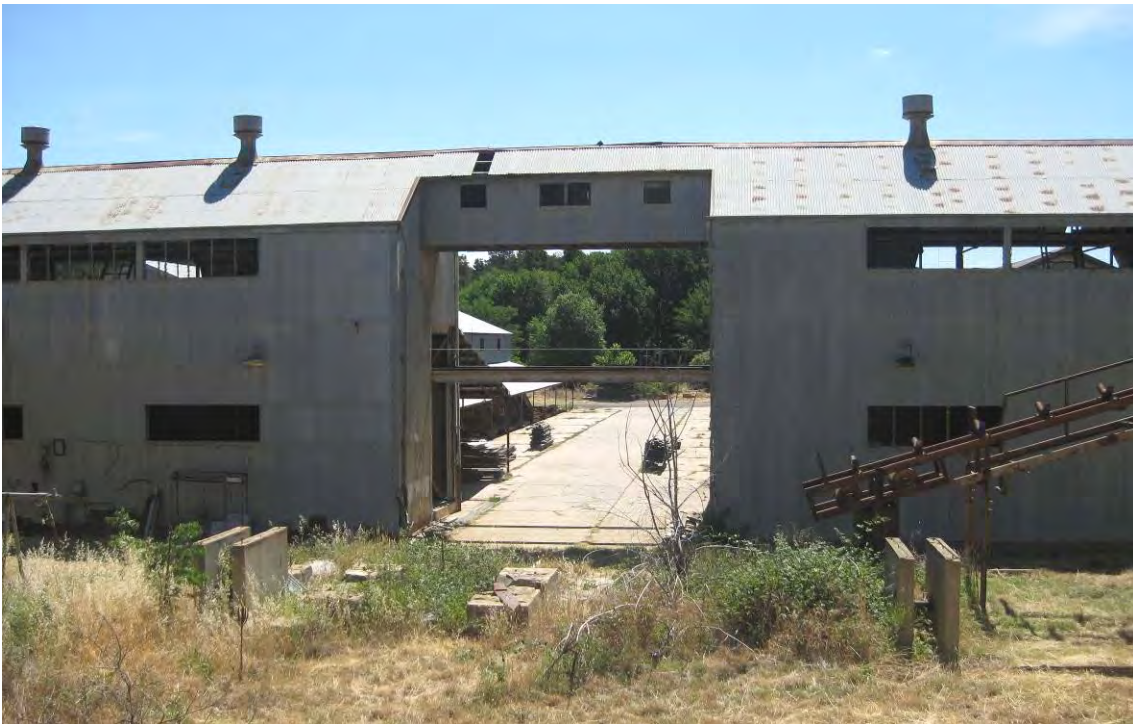
Figure 116 Machine Bays II (left) and III (right), looking west, showing the conveyor 'bridge' and open walkway between the two structures.

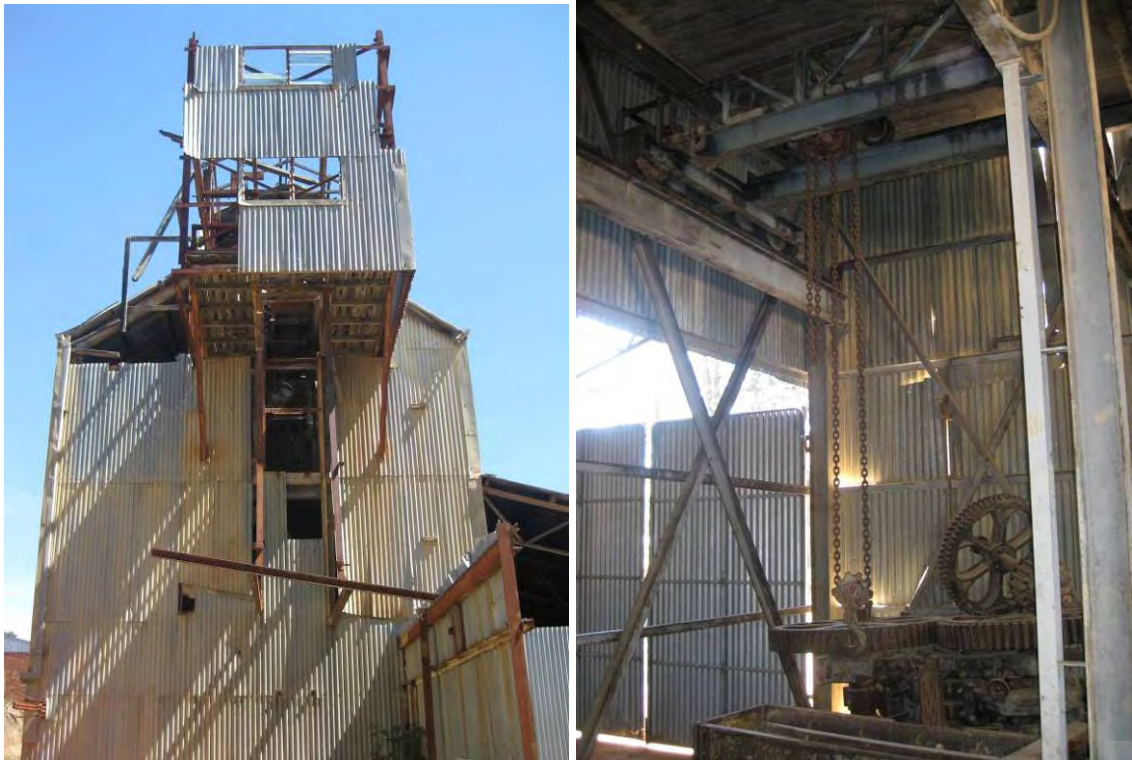
Figure 117 From left: north end Machine Bay III showing remains of headgear housing for the loft conveyor; interior with remnants of the Anderson brick machinery at north end.

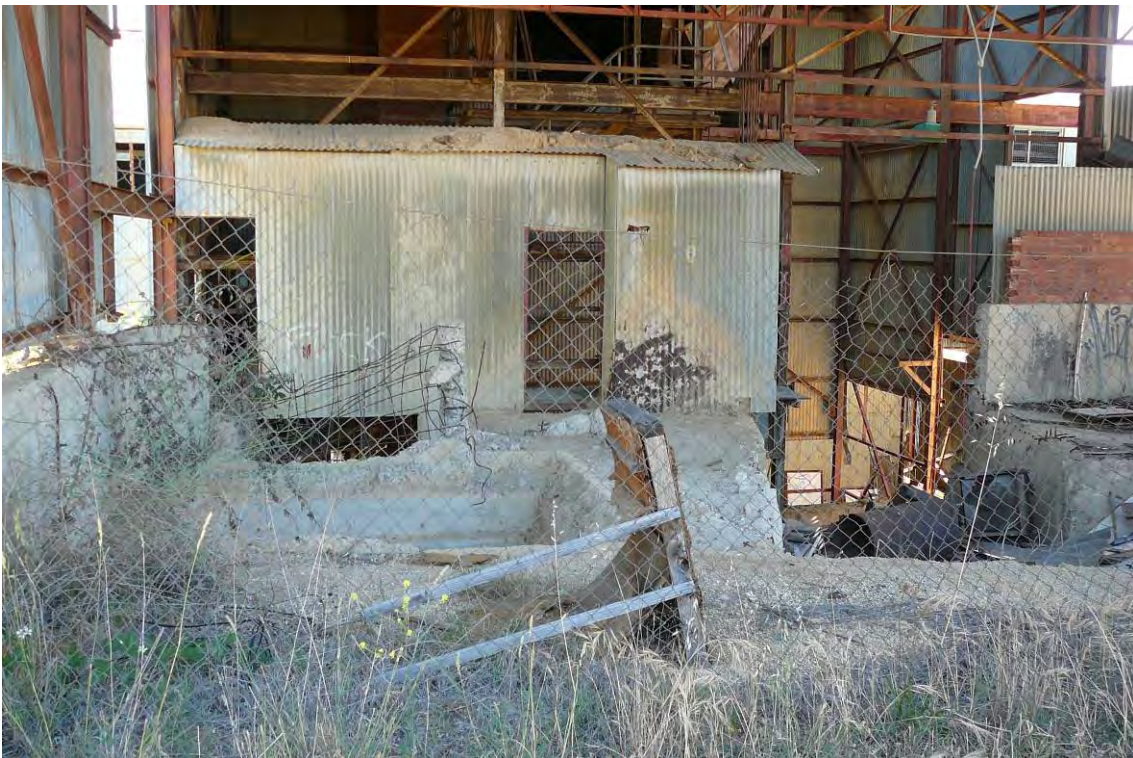
Figure 127 Interior of the White Pan Room looking west. The site of the now-removed hoppers is in the foreground.

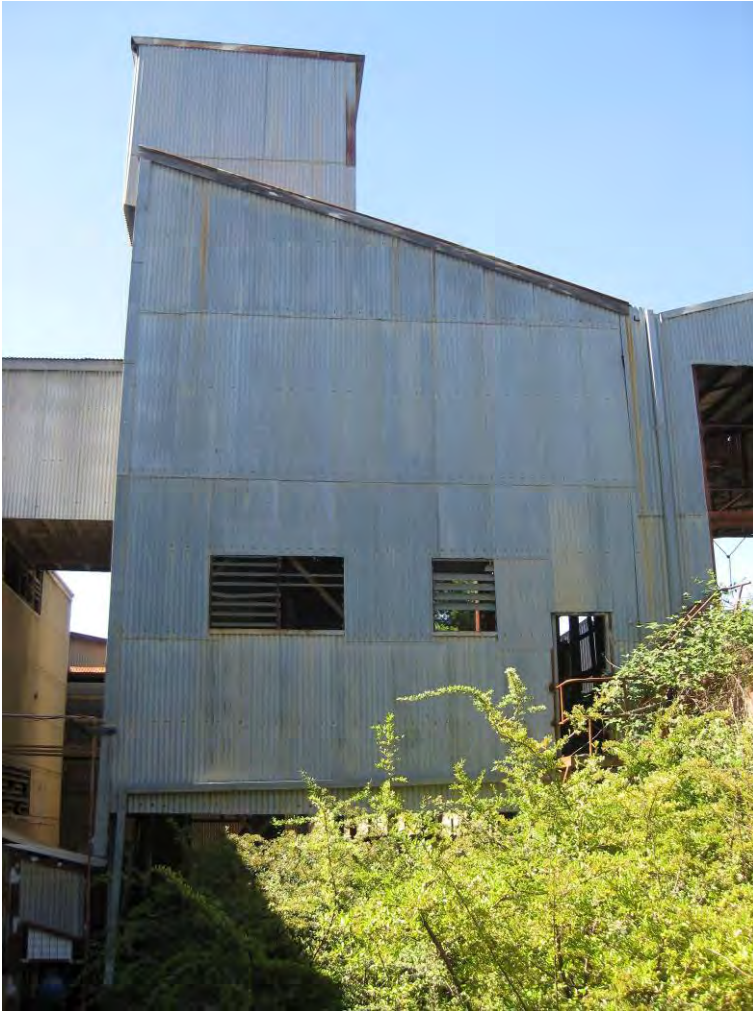
Figure 128 South elevation showing the high-level connection to Machine Bay I, which is shown at left.

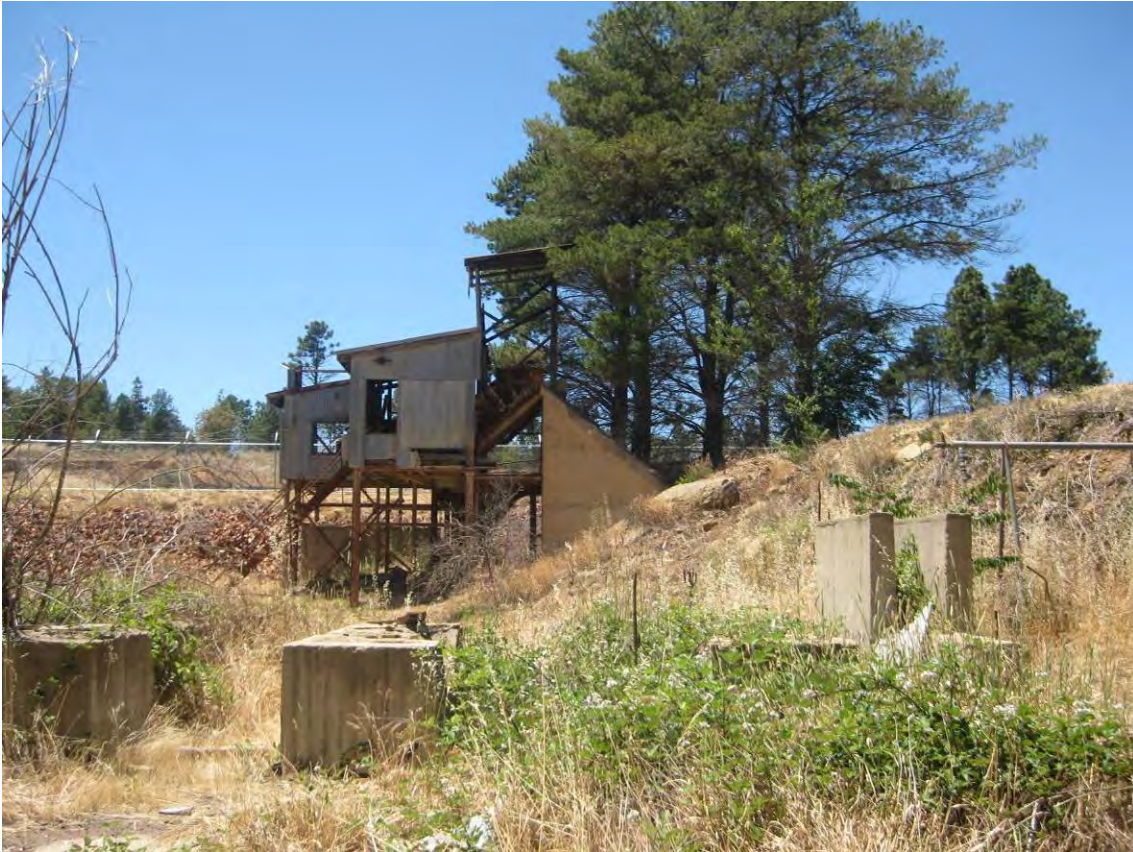
Figure 130 The Primary Crusher House viewed from the west. The concrete footings in the foreground supported the now demolished conveyor which transported crushed material to the Red Pan Room (also demolished) for further refining.

The primary crusher house (Building 20) was located further to the north. This building had two hoppers, a Ross feeder and a 'grissly feeder,' with rail bars across the opening to allow manual crushing. A Jacques swing jaw crusher was located under the Ross feeder. Material was then fed by conveyor to a 'Pan Building' for further processing. Only the foundations of this building remain today. From this Pan building material was elevated by conveyor (partially demolished, Building 21) and could be stored in massive bins or taken into the northern end of the brick press buildings for distribution throughout the plant. The material was conveyed along the length of the press buildings on conveyors and could be manually diverted into hoppers directly above the brick presses. The conveyor system, hoppers, control panels and chutes remain today. The southern brick press building was subsequently extended by two structural bays to service the 1970s extrusion plant.

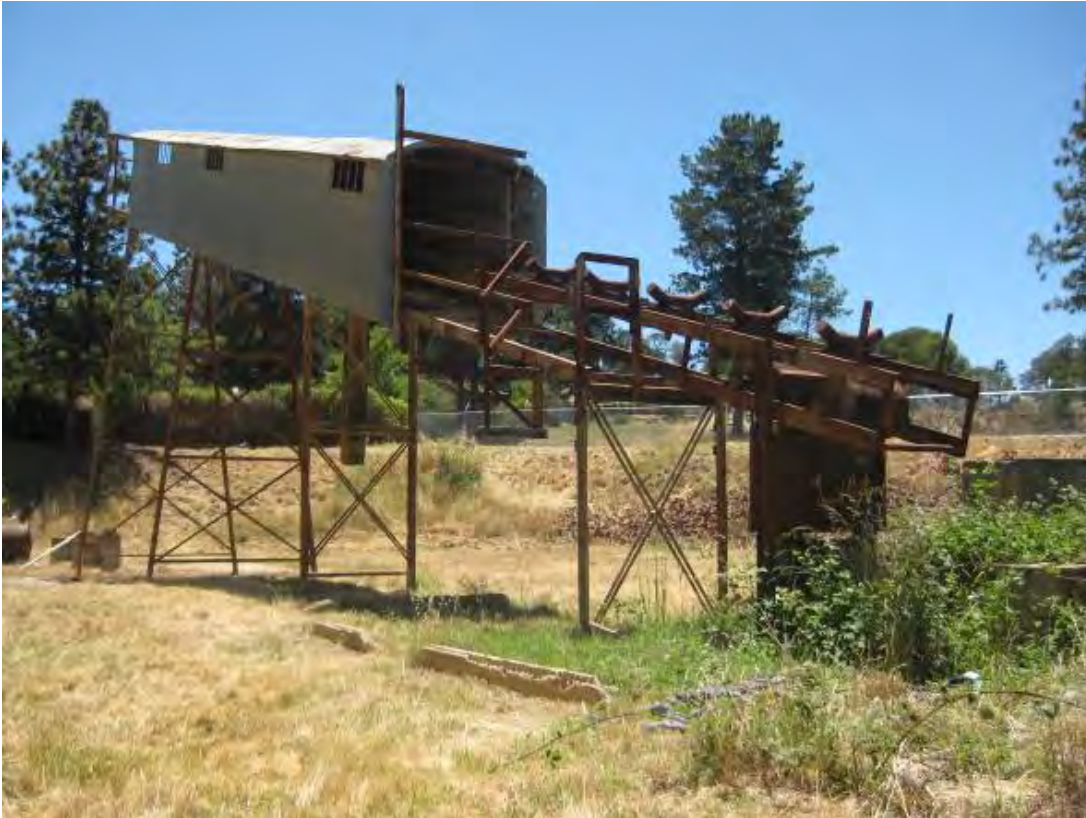
Figure 132 Extant section of the elevator/conveyor looking north-east.

The Conveyor is in poor condition. The section linking the demolished pan house to the distribution hopper is only partly intact and the section linking the pan house to the crusher has been demolished. The adjoining distribution hopper structure has also been demolished.

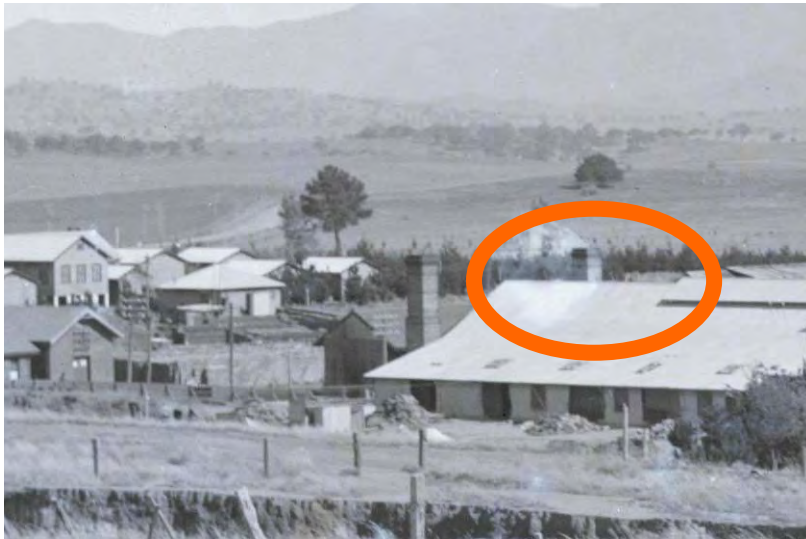
Figure 134 Detail from a 1929 photograph of the brickworks, with the chimney of the temporary downdraught kilns highlighted.  
Source: National Archives of Australia.

The kilns were constructed close to the site of two 'temporary' downdraught kilns with a brick stack (see Figure 134), which had been built in 1925 to cope with the increasing demands for Canberra's growth after the decision of the Hughes government to pursue the construction of the National Capital after World War I. These temporary kilns were demolished around in c. 1958.

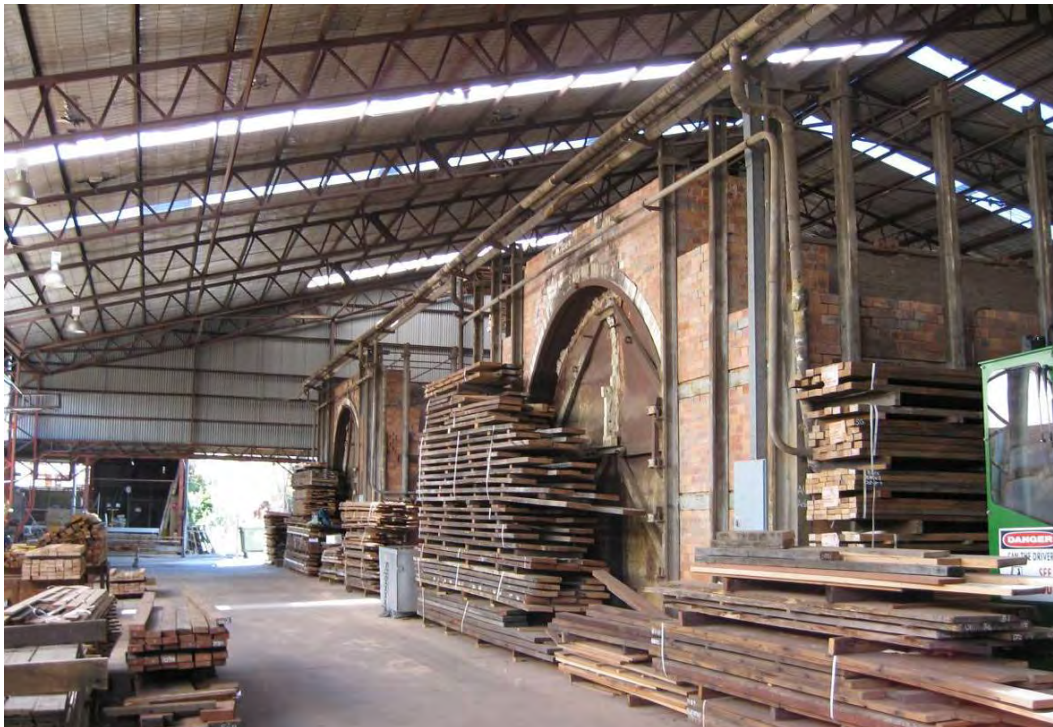
Figure 135 Interior of enclosure showing the north elevation of two of the three kilns.

Internally, the kilns are designed to be accessed via metal doors to either end. None of the three kilns are accessible from the north end. With the exception of Kiln 1, the doors to the south end comprise metal cladding to the exterior face and a wall of firebricks, held in place to the surface of the metal door by a heavy duty metal mesh. These are in reasonable condition albeit some of the brick is friable and deteriorating. The doors to Kiln 1 are of metal without the firebrick lining. The doors are fitted with easy clean hinges, enabling them to be folded fully back flat against the kiln wall to permit access to the interior. Internally the north doors are either bricked over or, as for Kiln 1, a false stud wall with plaster has been installed.

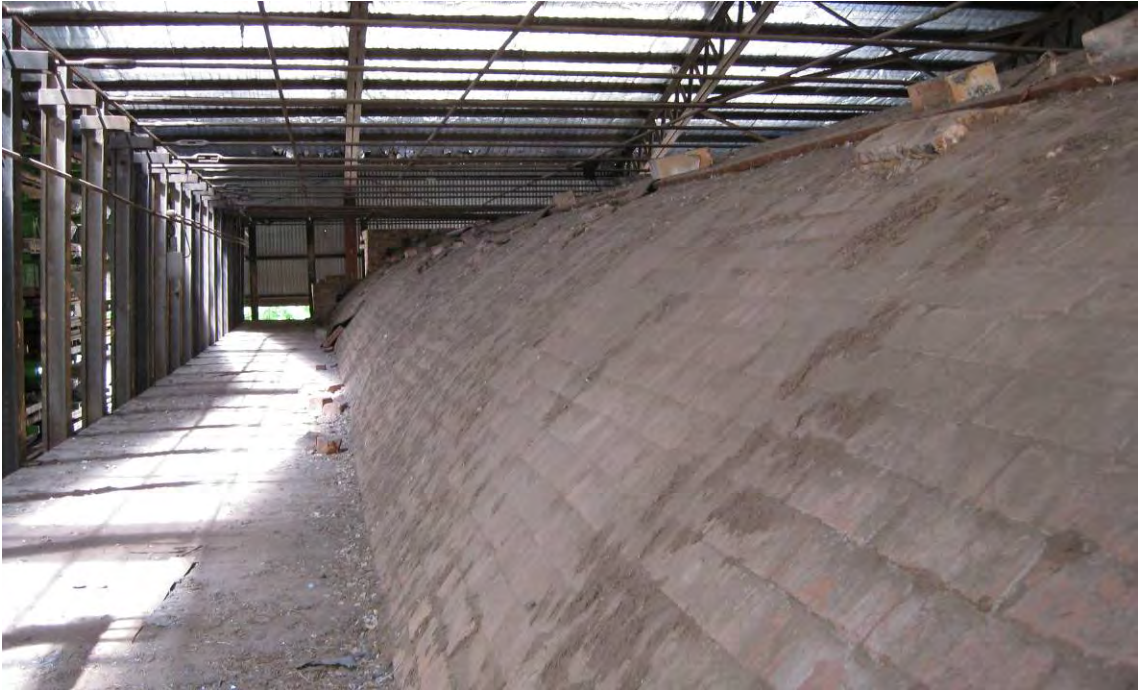
Figure 136 Kiln roof with brick walkway to sides.

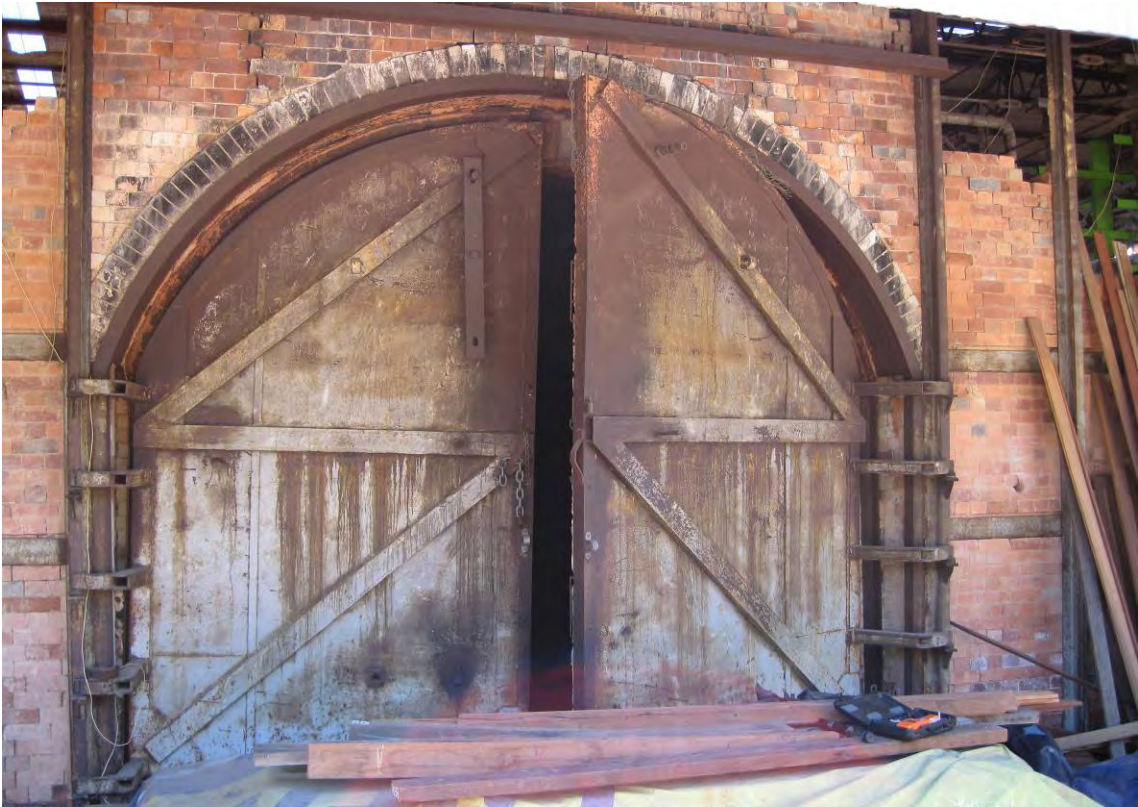
Figure 137 Kiln entry showing stepped side wall.
