Conservation Management Plan (2010)

Canberra Brickworks  
Denman Street, Yarralumla, Canberra

Conservation Management Plan

Prepared for  
Land Development Agency

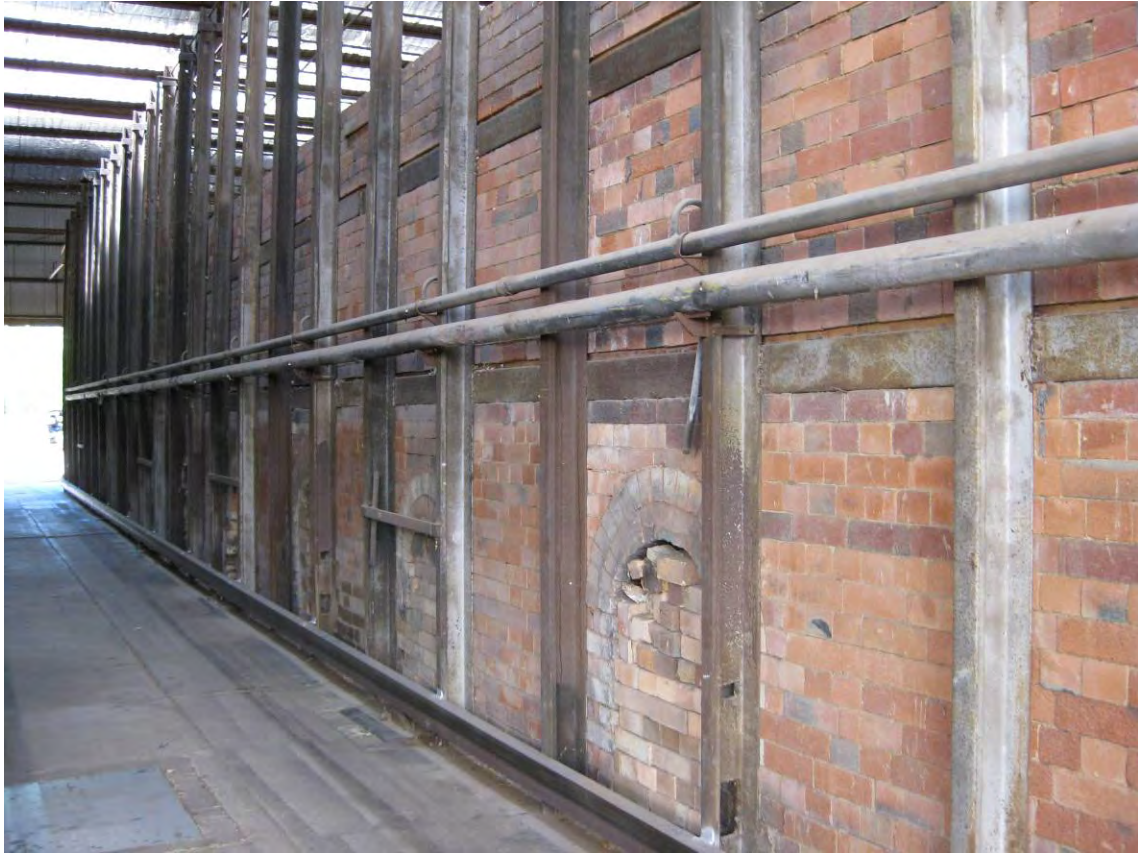
Figure 138 Side elevation showing steel framing and fireholes.

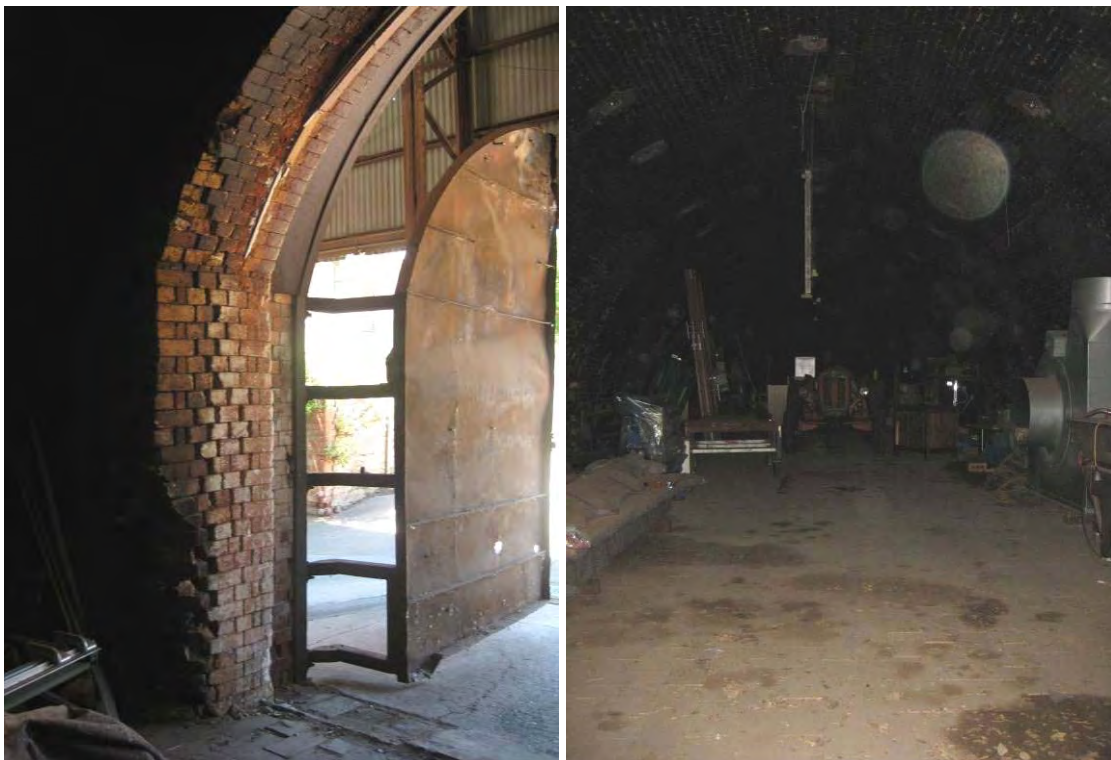
Figure 139 From left: interior of kiln showing entry and deteriorating fire bricks; interior of kiln showing later cement paving.

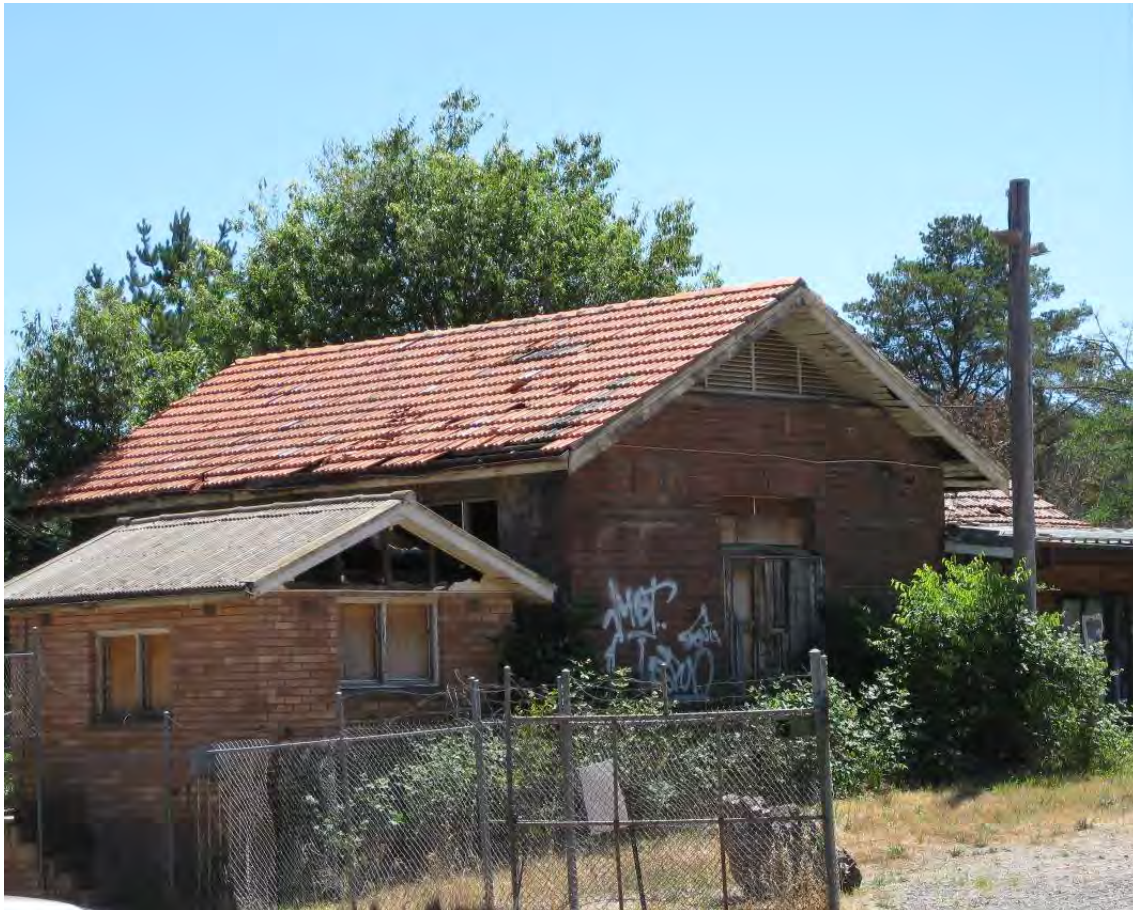
Figure 140 The downdraught kiln control room is the cream brick building adjoining the larger terracotta-tiled Power House (Building 3).

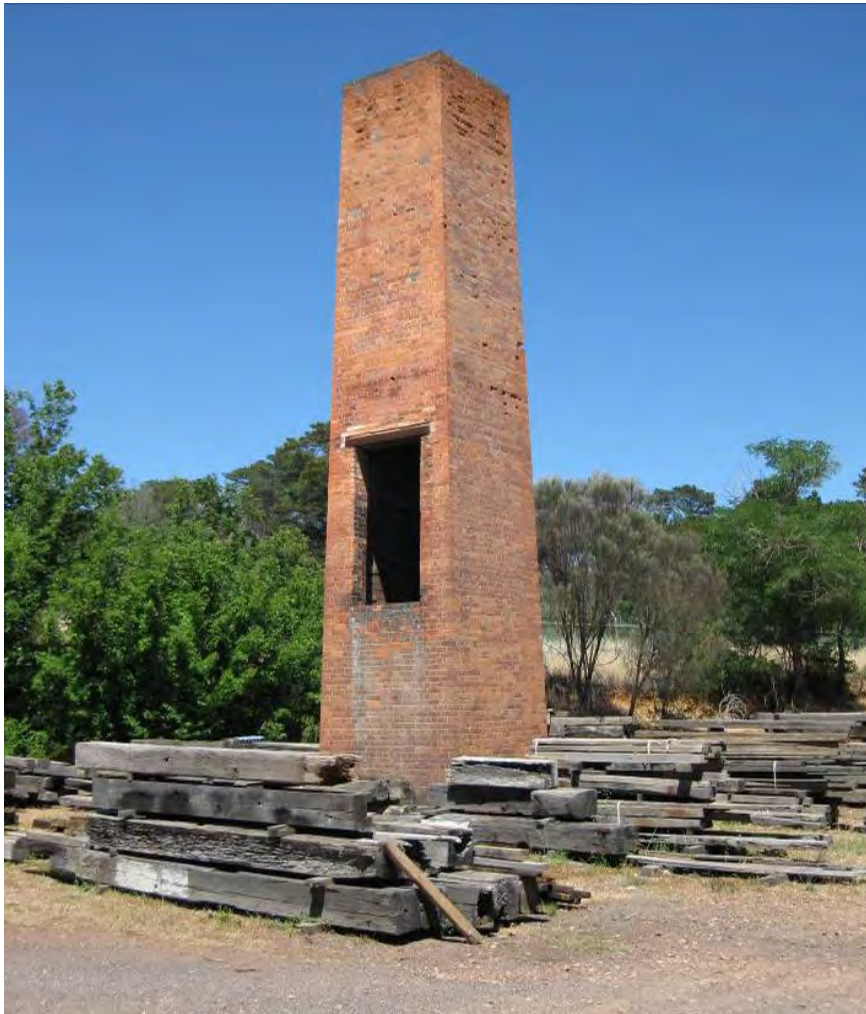
Figure 141 Chimney stack viewed from the north-west.

There is evidence of brickwork spalling, particularly to the west and north faces. There is a large oblong opening approximately three metres above the ground in the north face, indicating where a duct channelled spent fuel and heat to the stack for dispersal. There is an opening at low level in the south face, set within a steel door surround – the door is missing.

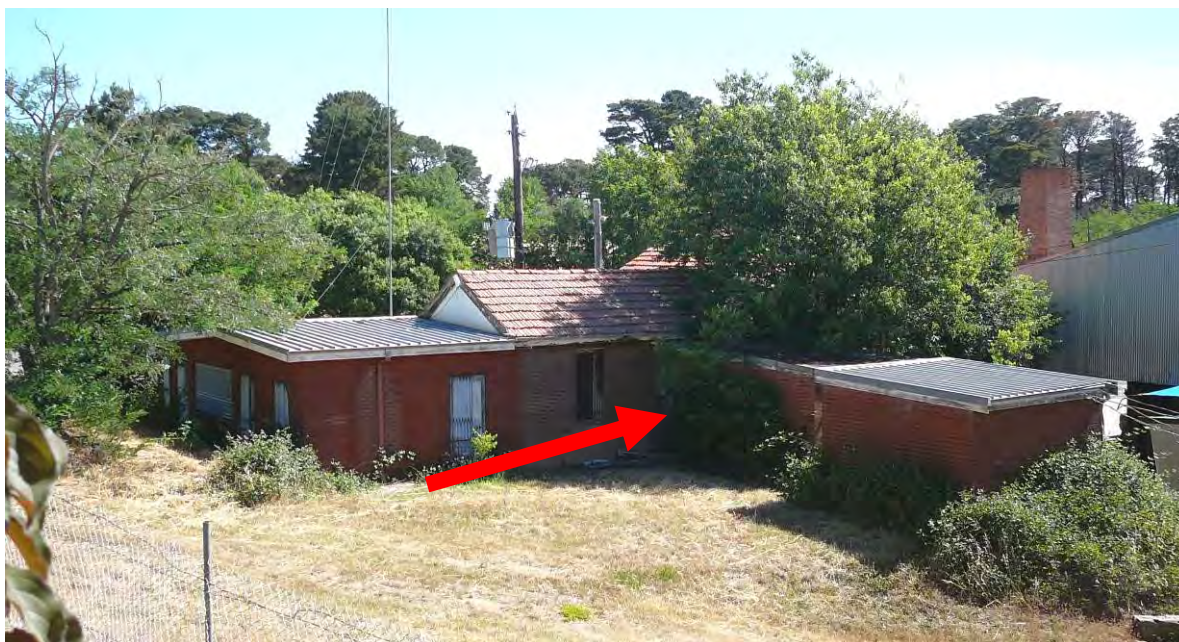
Figure 142 The toilet facility is indicated by the arrow.

The building is in poor condition.

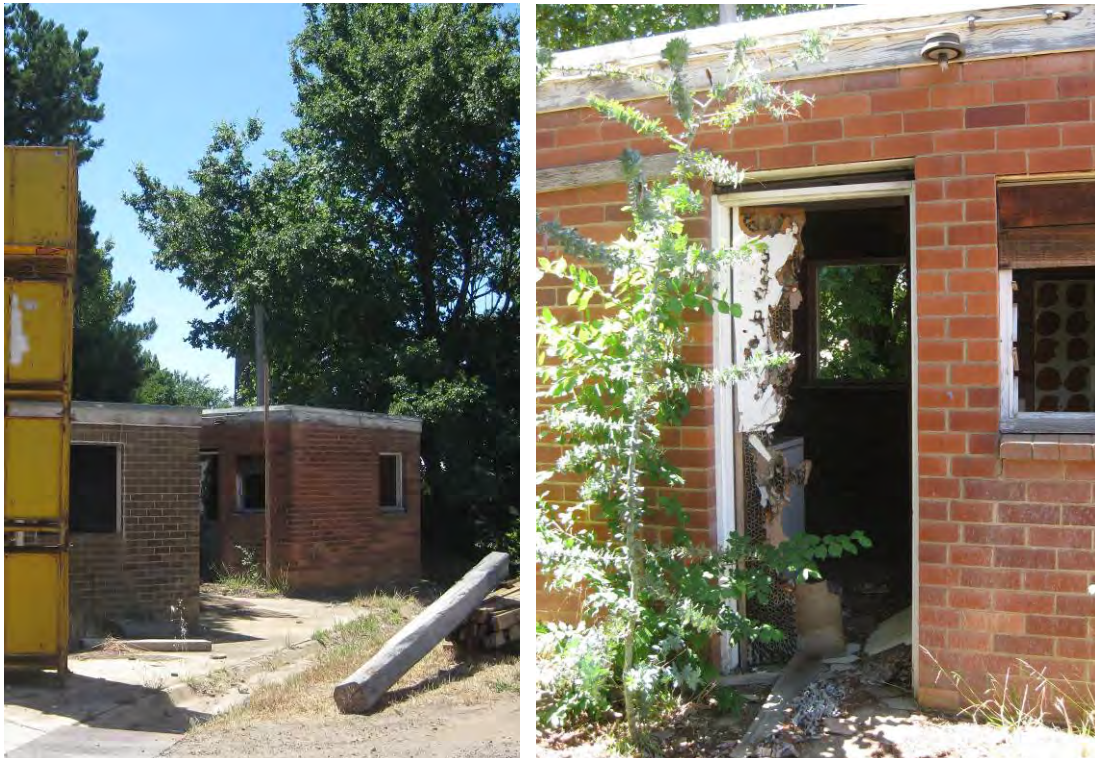
Figure 143 From left: the amenities block is the small red brick building at right; entry.

The amenities block is of vari-coloured brickwork, and has a skillion roof of metal roof decking. Internally it has a concrete floor and there are window openings to the north, east and south. The entry is from the south. The interior has been heavily vandalised with all fittings and finishes in poor condition.

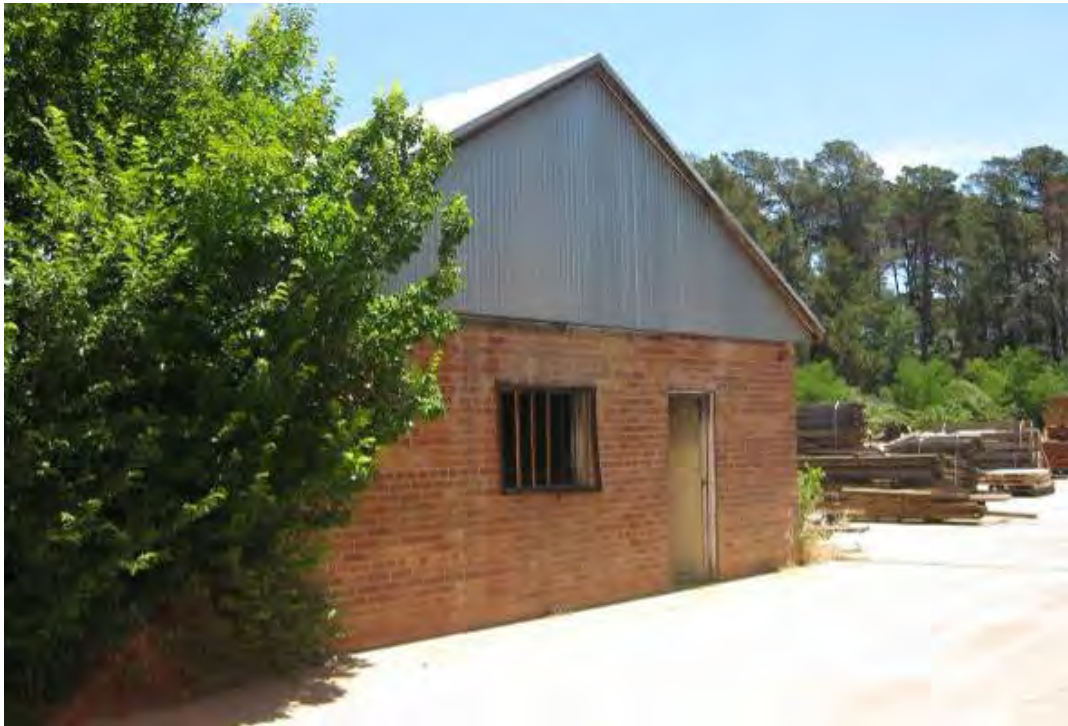
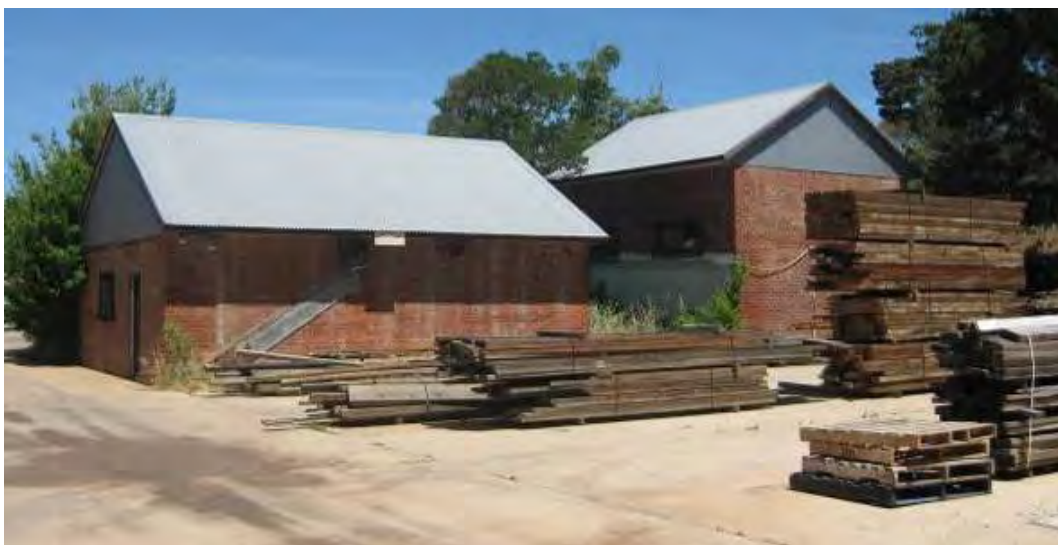
Figure 144 Substation/control room building, showing north elevation.

Figure 145 The former boiler house and adjoining substation/control room, photographed from the site of the former extrusion plant. The substation building is at left.

The building is of painted brickwork internally, has a concrete floor and painted concrete ceiling. The space is largely stripped out, and at the time of inspection a number of rusted metal brick barrows were *in-situ*.

The building is in fair condition, apart from the impacts of minor vandalism, including the breaking of windows, painted graffiti and smoke damage. The corrugated galvanised steel roofing is in very good condition.

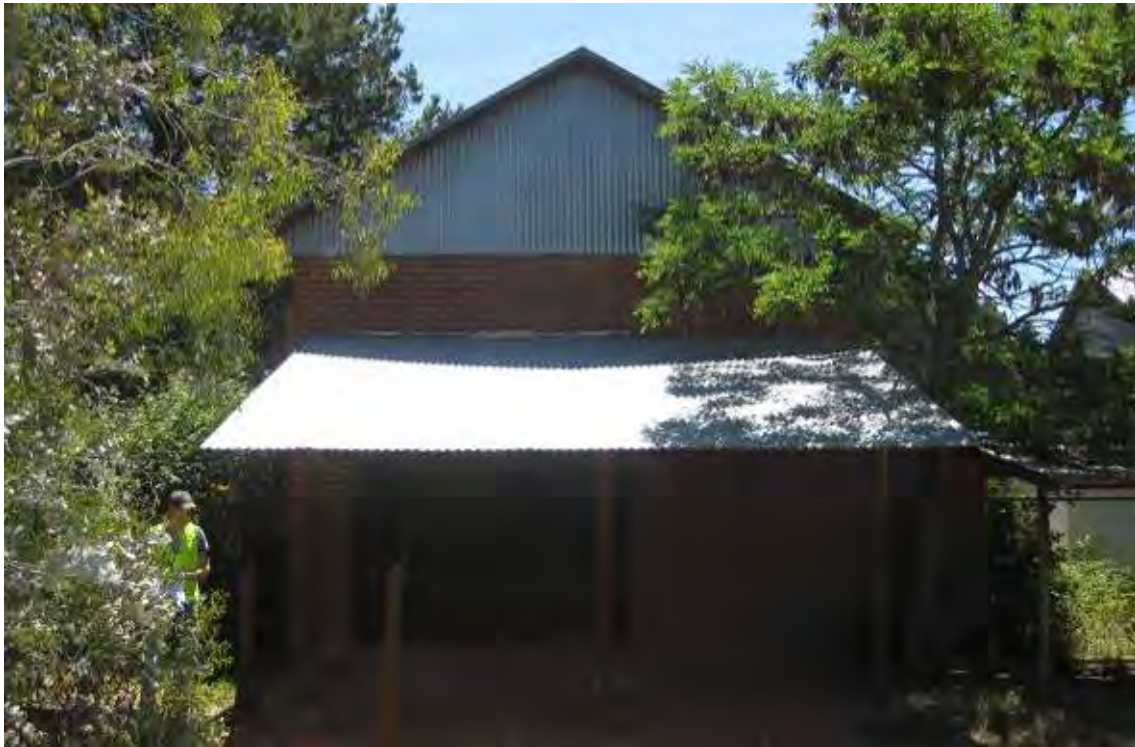
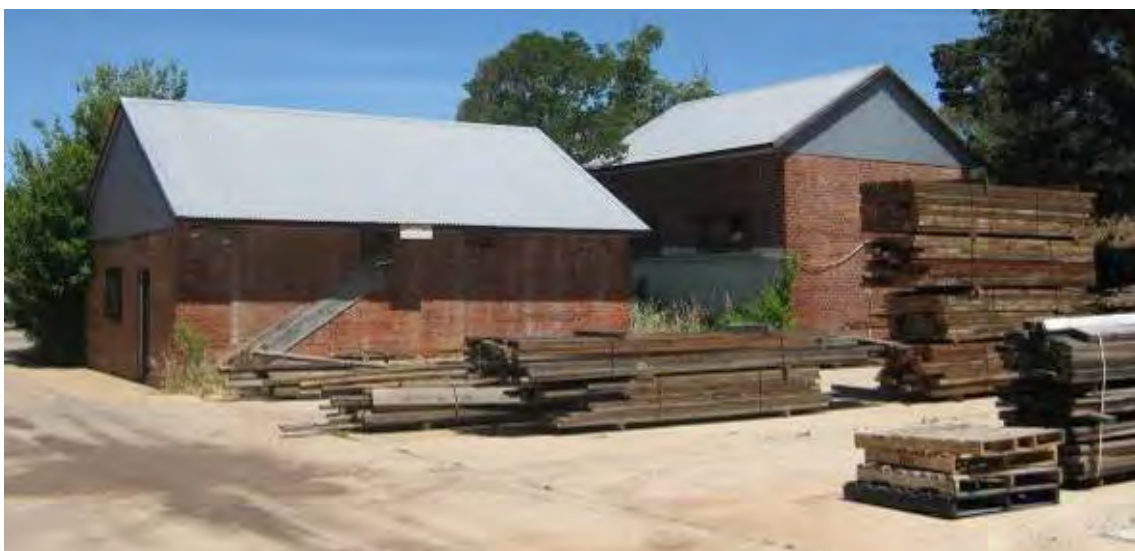
Figure 146 Former boiler house building showing east entry and later verandah addition.

Figure 147 The former boiler house and adjoining substation/control room, viewed from the site of the former extrusion plant. The boiler house is at right.

The building is in good condition, apart from the impacts of minor vandalism, including the breaking of windows.

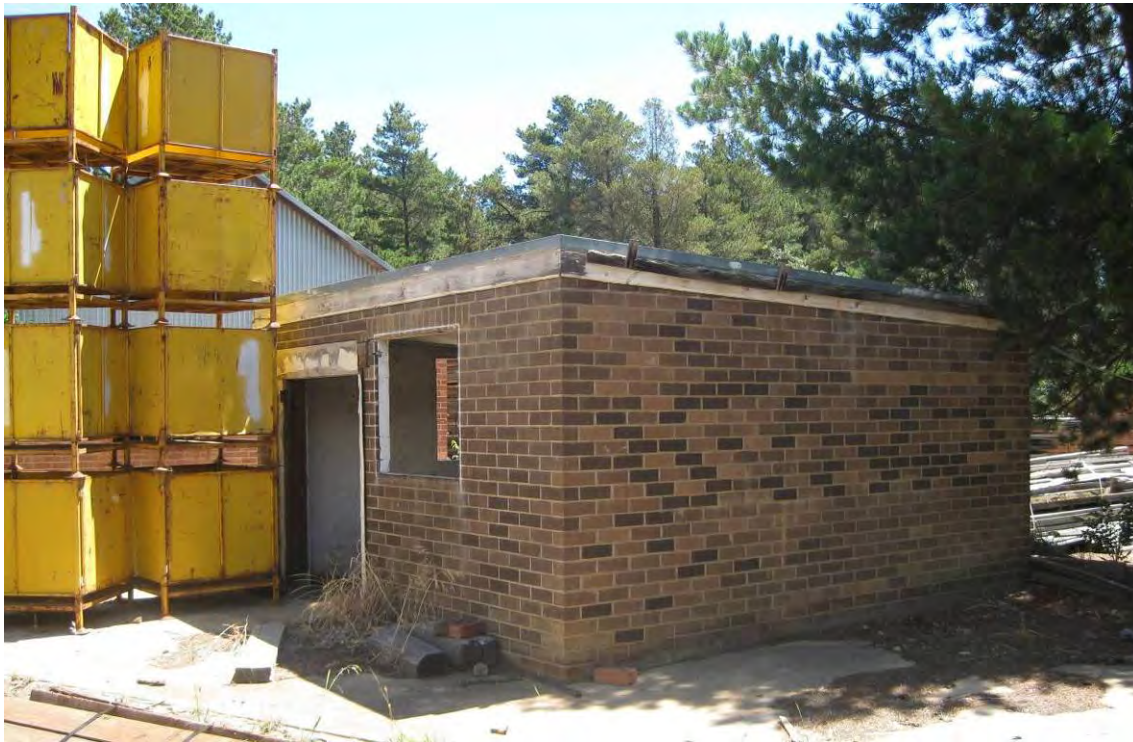
Figure 148 The storage building, adjoining the site of the brick extrusion plant site.

The building is vacant and in poor condition.

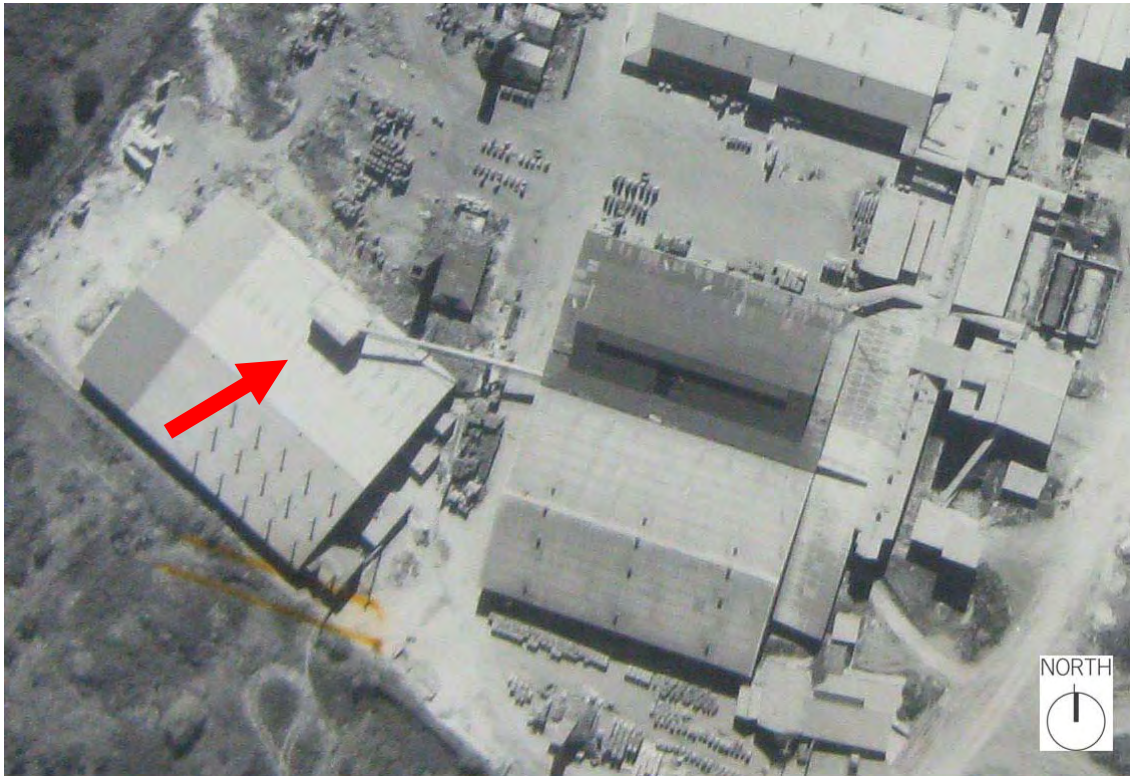
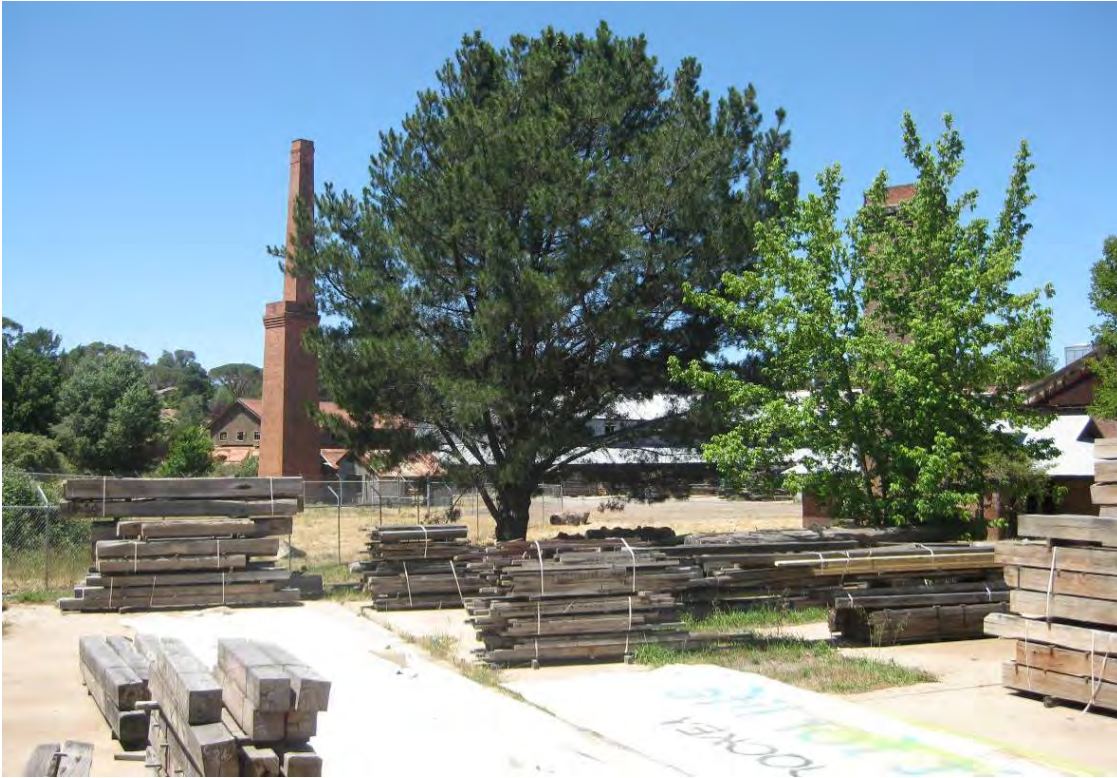
Figure 149 Detail of a 1976 aerial photograph showing the extrusion plant and overhead conveyor (indicated).  
Source: ACT Heritage Library, Woden ACT.

Figure 150 Brick extrusion plant site, looking north-east.

The concrete floor slab is the remaining element of the short-lived extrusion plant. Buildings 27 and 28 – the substation/control room and boiler house respectively which abut the site to the south-east - were constructed to service the extrusion plant.

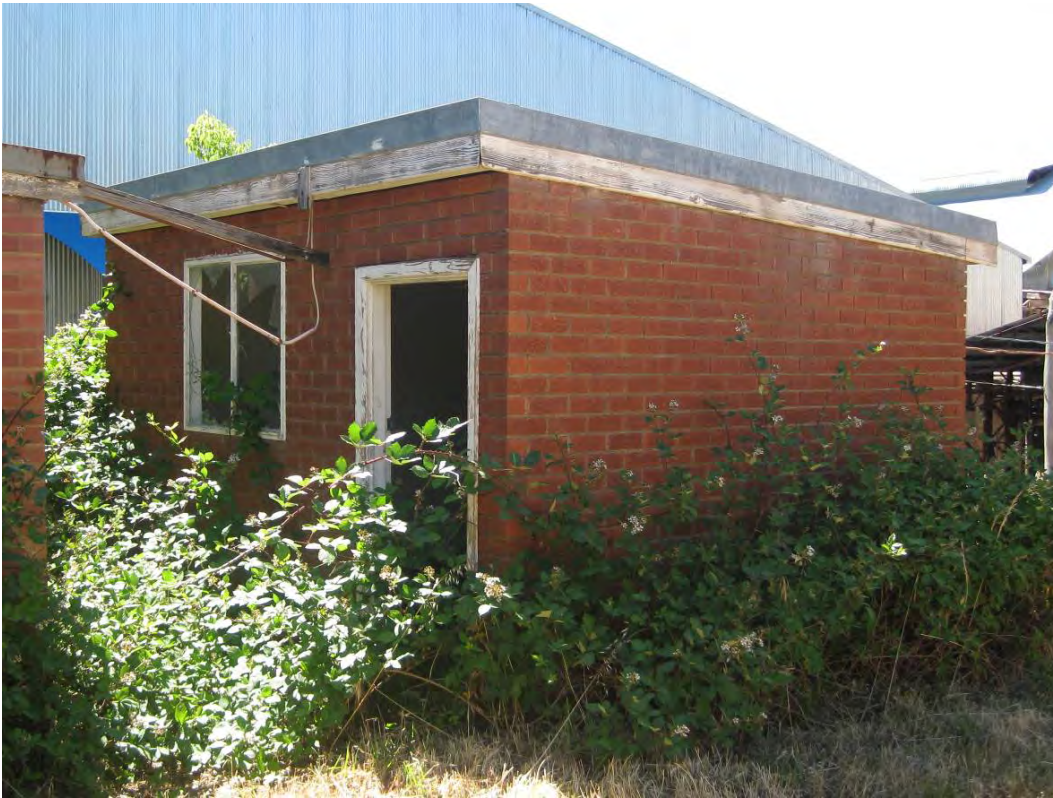
Figure 151 The ancillary storage building is sited behind the former offices (Building 7).

The structure is of orange face brick with a timber framed door and window to the south elevation. It has a skillion roof of metal roof decking. The interior walls are lined and part-fitted with shelving unit brackets. The building is unsecured, vandalized and in poor condition.

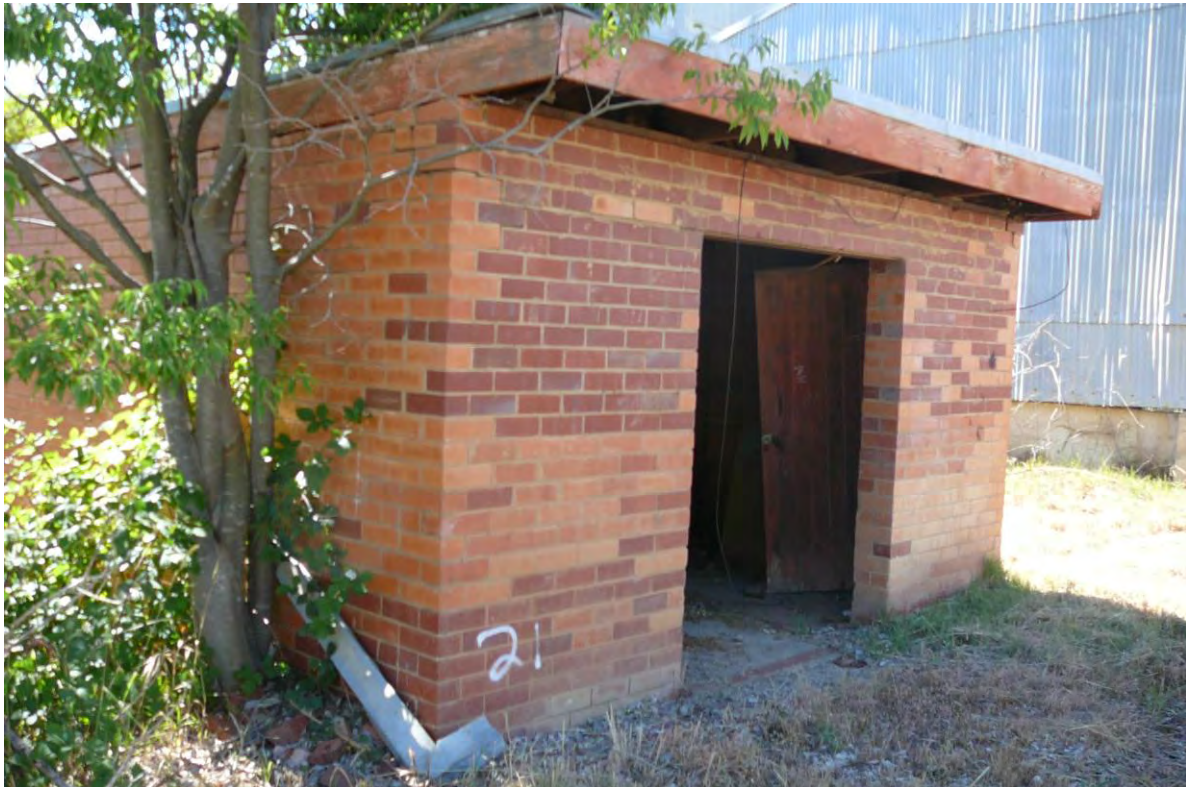
Figure 152 Storage shed.

The shed is of vari-coloured brickwork, and has a skillion roof of metal roof decking. Internally it has a concrete floor and the timber door to the large opening on its north face is stored within the building. The walls are not lined internally and the reflective insulation has been damaged by vandals. The shed is vacant and in fair condition.

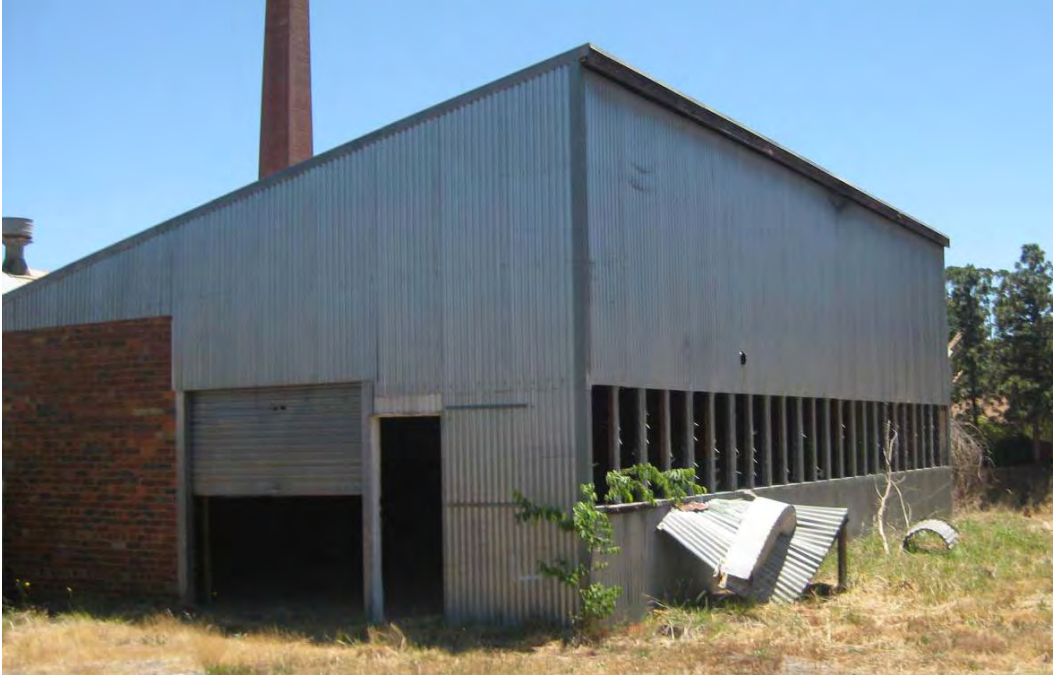
Figure 157 Exterior, showing the south and east elevations. The brick wall is an earlier element incorporated into the workshop building.

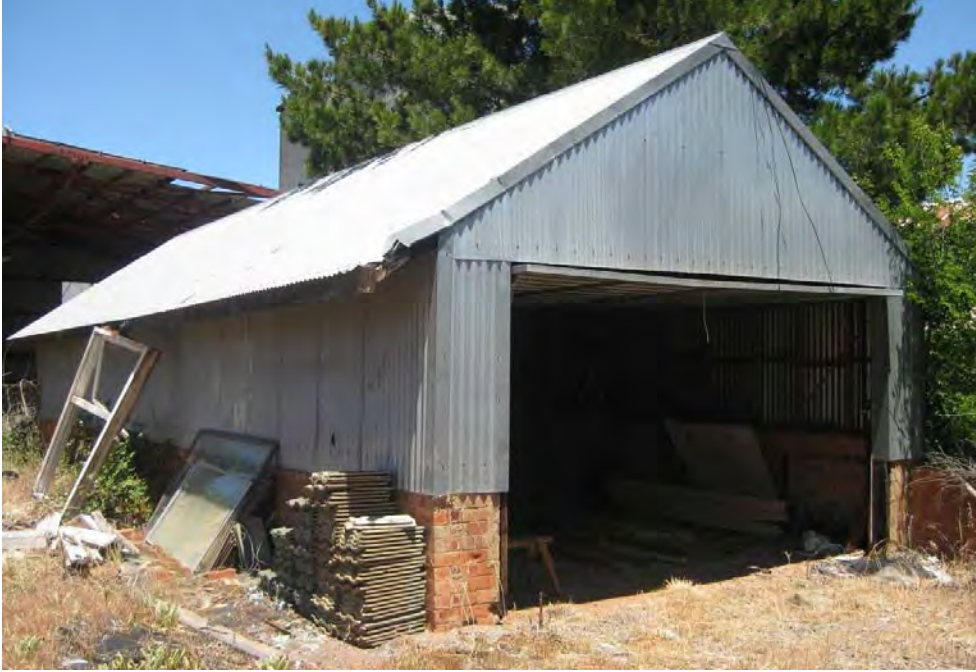
Figure 159 Exterior, showing east and north elevations.

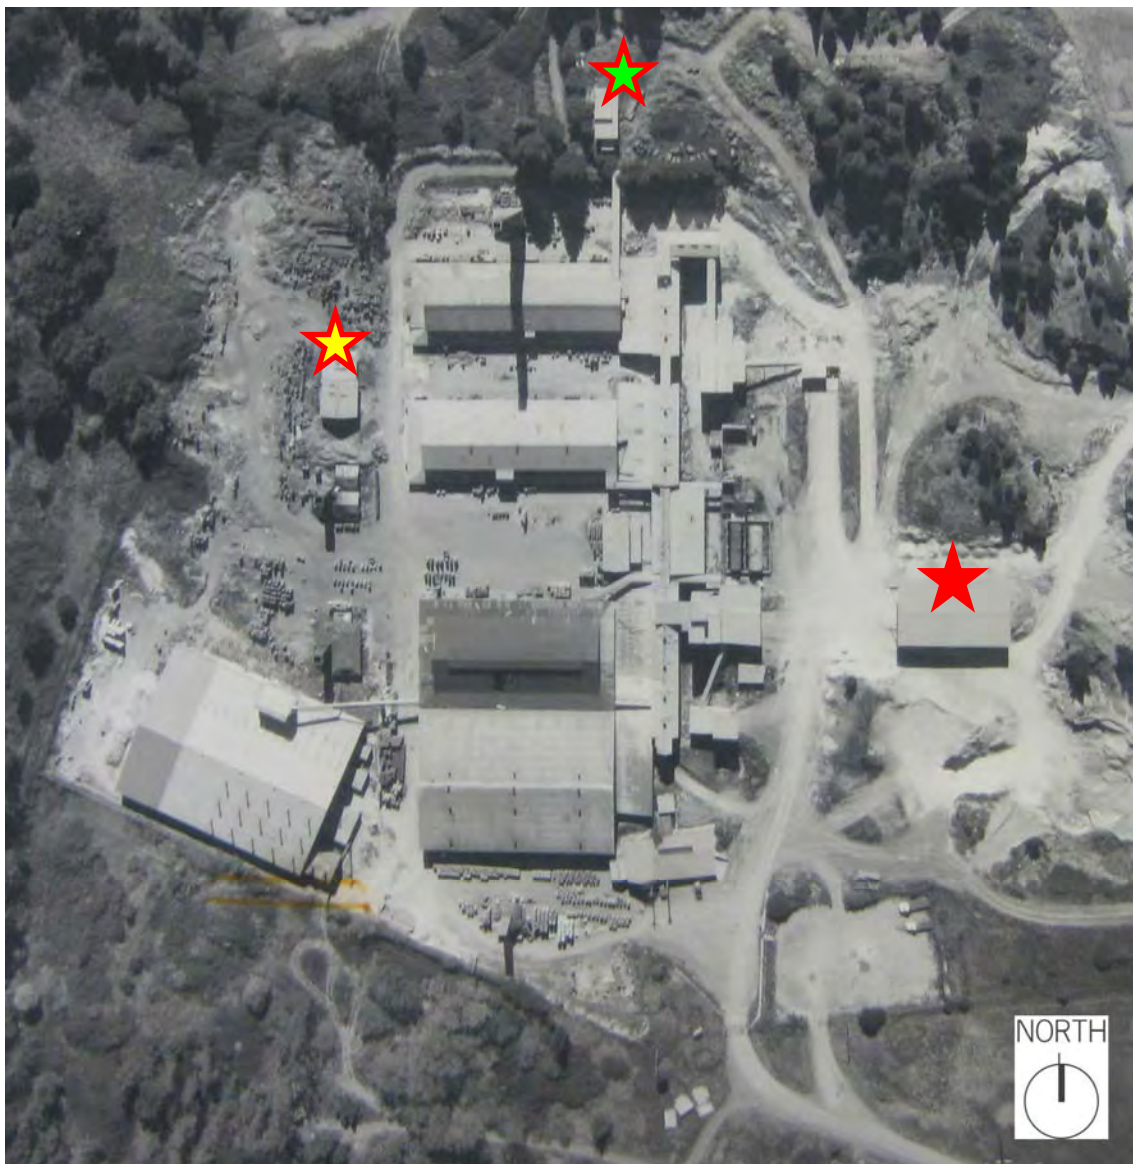
Figure 160 Aerial photograph, 1976, with the following later site elements indicated; clay storage shed (red star); coal storage bunker (red/green star) and former forklift shed (red/yellow star).

The storage shed was located within the quarry area to the immediate east of the brickworks. It stored clay, bought to the site by trucks prior to crushing. It is visible in 1976 aerial photograph of the site (see Figure 160).

The coal storage bunker was located on an elevated site to the north of the Hardy patent kiln II chimney stack (Building 13), as indicated at Figure 160. The site today forms part of the Lane Poole Place housing complex and is outside the study area.

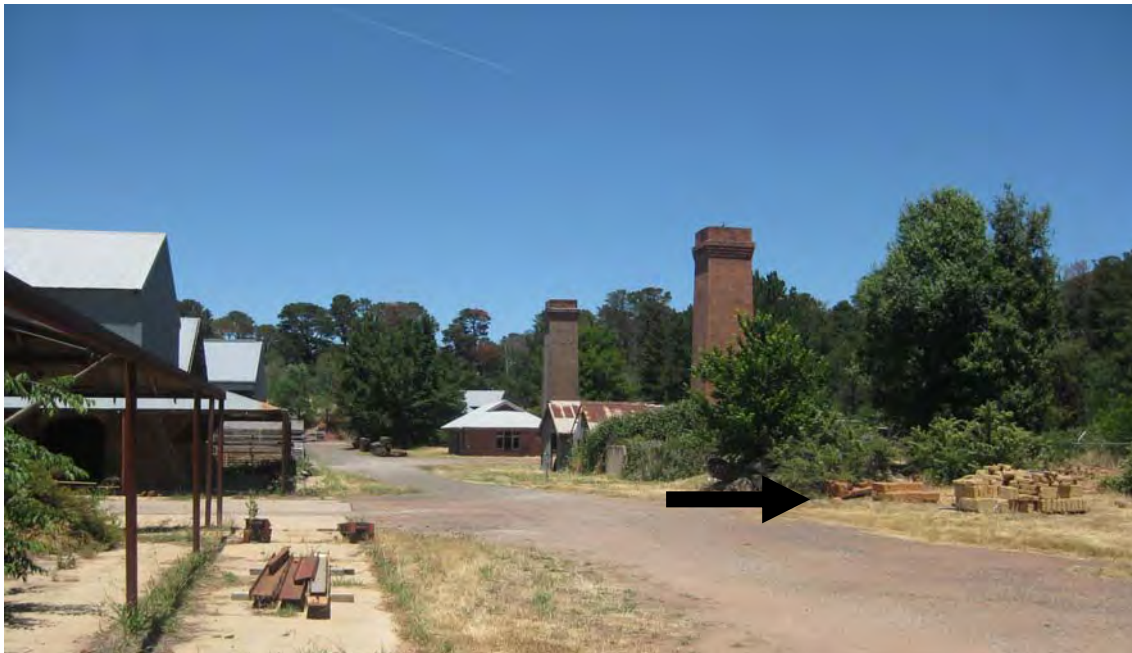
The forklift shed was extant at the time of the compilation of the 1986 *Conservation Plan*. The building was constructed in c. 1965 to house forklifts and replaced an earlier shed structure. The forklift shed was a brick structure with a corrugated galvanised steel roof. The structure contained a petrol bowser linked to a large underground tank sited between the shed and the fan house associated with the Hardy patent kiln I (Building 9). The description of the building provided in the 1986 *Conservation Plan* noted that it was in poor condition. The site of the building today is overgrown with little evidence of its form, apart from some remnant brickwork and rubble (Figure 161). As noted, the structure replaced an earlier shed building, the date or purpose of which is not known.

Figure 161 The approximate site of the former forklift shed indicated by the arrow.

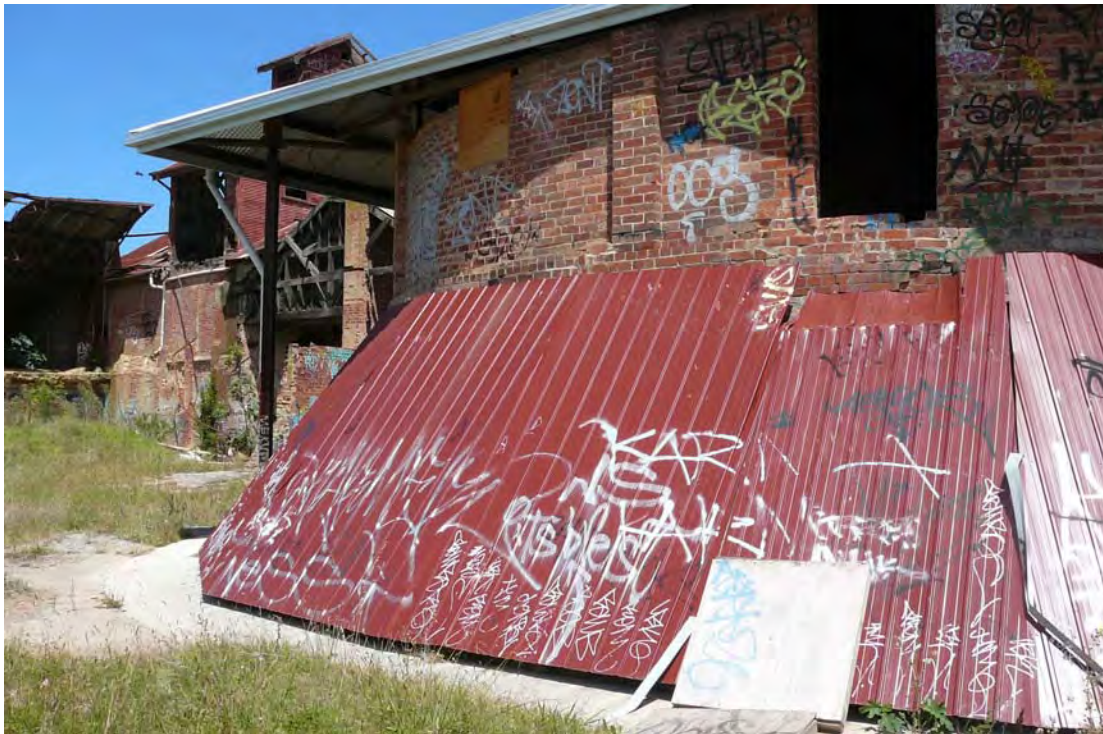
Figure 181 Hoffman kiln at the former Standard Brickworks, pictured in January 2010.  
Source: Lovell Chen.

An 18-chamber Hoffman kiln with a centralised integrated stack (circular) was built in c. 1913. Four brick presses were installed at the same time.<sup>169</sup> As existing, the site includes crusher houses, hoppers, storage facilities and bays, including some equipment. Despite a number of proposals for adaptive reuse/development, the site remains disused and the buildings are in poor condition, having been subject to extensive vandalism and graffiti. The ground level openings to the kiln have been boarded up.

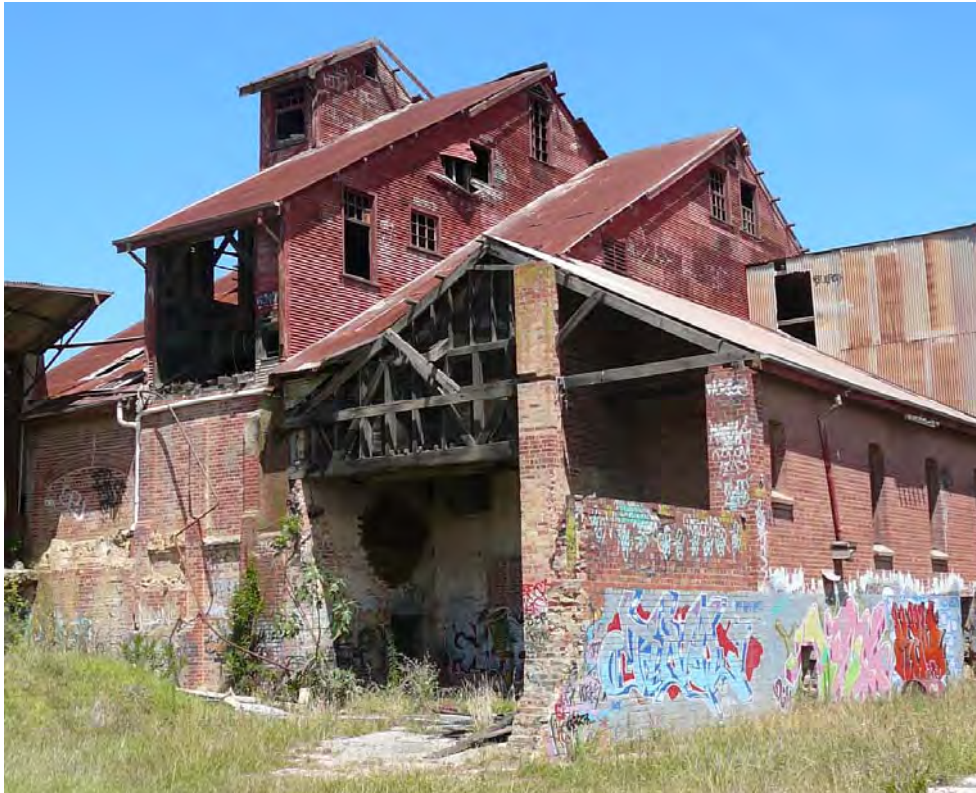
Figure 182 Former machinery sheds at the former Standard Brickworks, January 2010.  
Source: Lovell Chen.

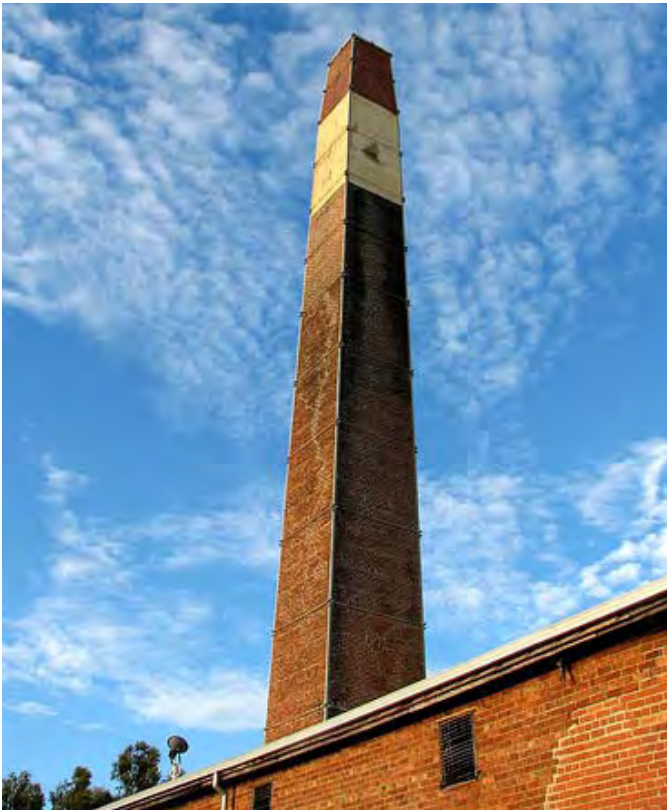
Figure 185 Recent shot of the Hoffman kiln and integrated stack at the former Maylands works.  
Source: Flickr

The first phase of development included a Hoffman kiln and drying sheds, pug mill and brick making extruder. The plant was expanded in 1936, with an additional Hoffman kiln, pug mill and drying sheds. As existing the site includes one Hoffman kiln with 18 chambers and centralised integrated stack (34m high). The second kiln was demolished following damage sustained during the 'Meckering' earthquake of 1968. Brick production ceased at the site in 1983.<sup>172</sup>

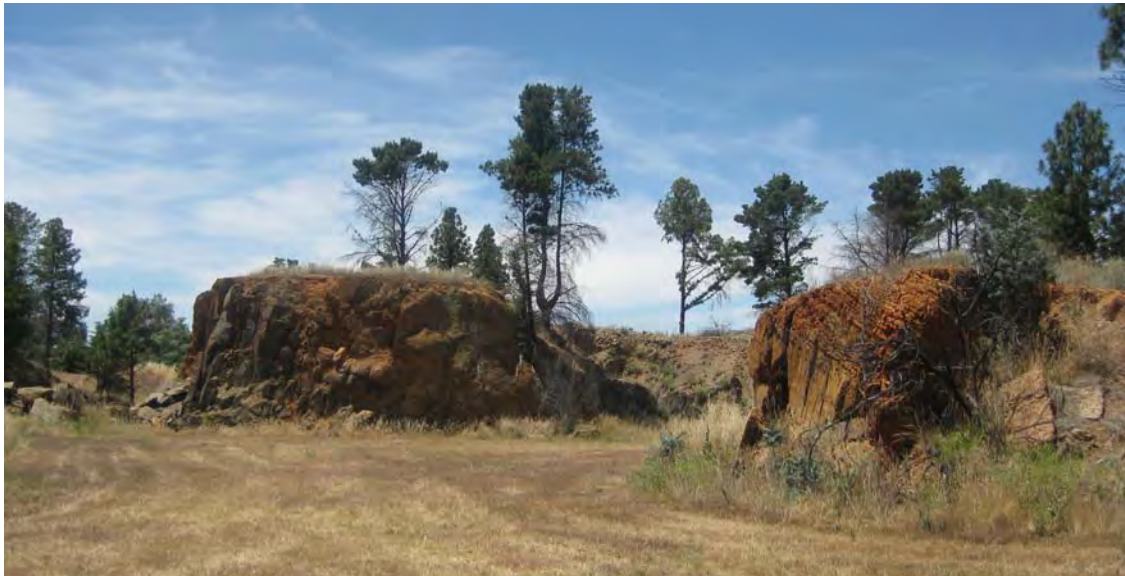
Figure 189 Formations A (left) and B (right).

Within the quarry, four specific locations (A, B, C D) have been identified which demonstrate particular aspects of the site and the Yarralumla formation (see Figure 189). These are mapped in Figure 188 as 12A, 12B, 12C and 12D. Of these, Sites A and D show excellent examples of anticline in calcareous siltstone and Site B shows a typical tuffaceous mudstone and siltstone of the Yarralumla Formation. Site C shows abundant fossils of mainly brachiopods [note, not *gracitopods*], trilobites and crinoids preserved in a bedding plane.<sup>184</sup>

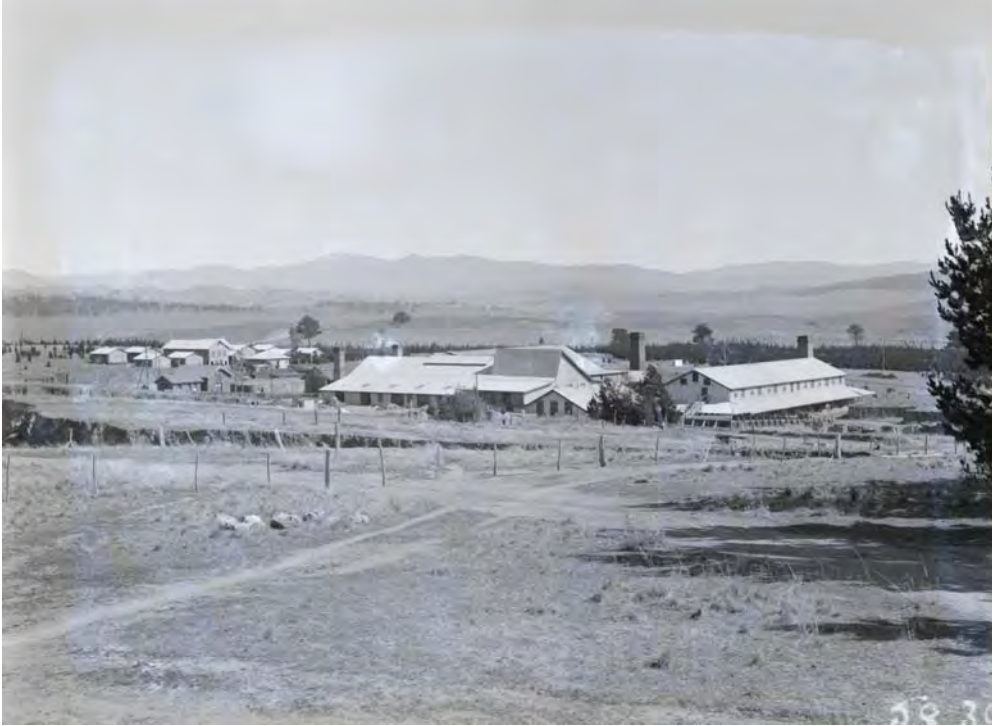
Figure 196 View west of the complex in 1929, including part of the quarry, the kilns and their stacks (albeit the Staffordshire kiln obscured), and the office and Power House (on left). The original crushing and pressing buildings (now demolished) are in the centre of this view, to the left of the Hardy patent kiln and in the background (far left) is the Brickworks Camp complex, now demolished. Source: National Library of Australia.
