Conservation Management Plan (2010)

Canberra Brickworks  
Denman Street, Yarralumla, Canberra

Conservation Management Plan

Prepared for  
Land Development Agency

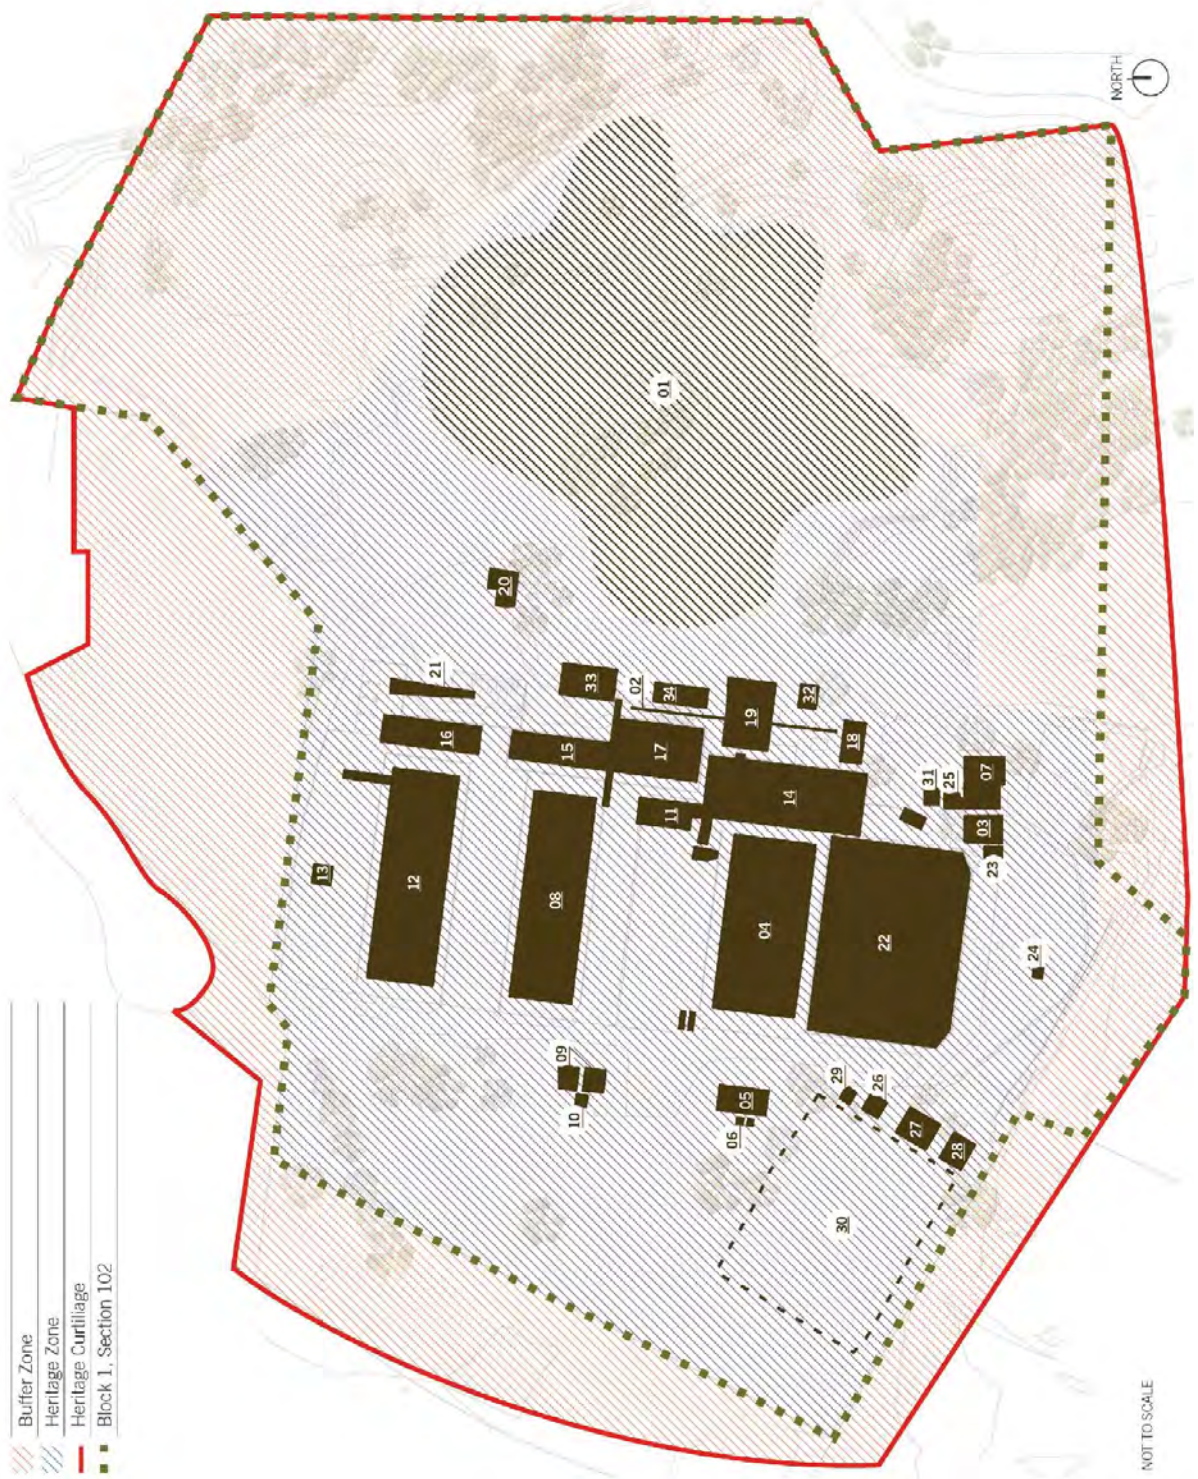
Figure 197 Heritage curtilage and management zones

Another key recommendation of the CMP is the establishment of Heritage Management Zones. These zones reflect the analysis of the key heritage issues of curtilage and setting as

they apply on this site and on land immediately abutting, and identify areas of greater or lesser significance and sensitivity. Explicit reference is made to these zones in the CMP policies for site development and new works, and it is recommended these are considered in any assessment of development proposals within or directly abutting the site.

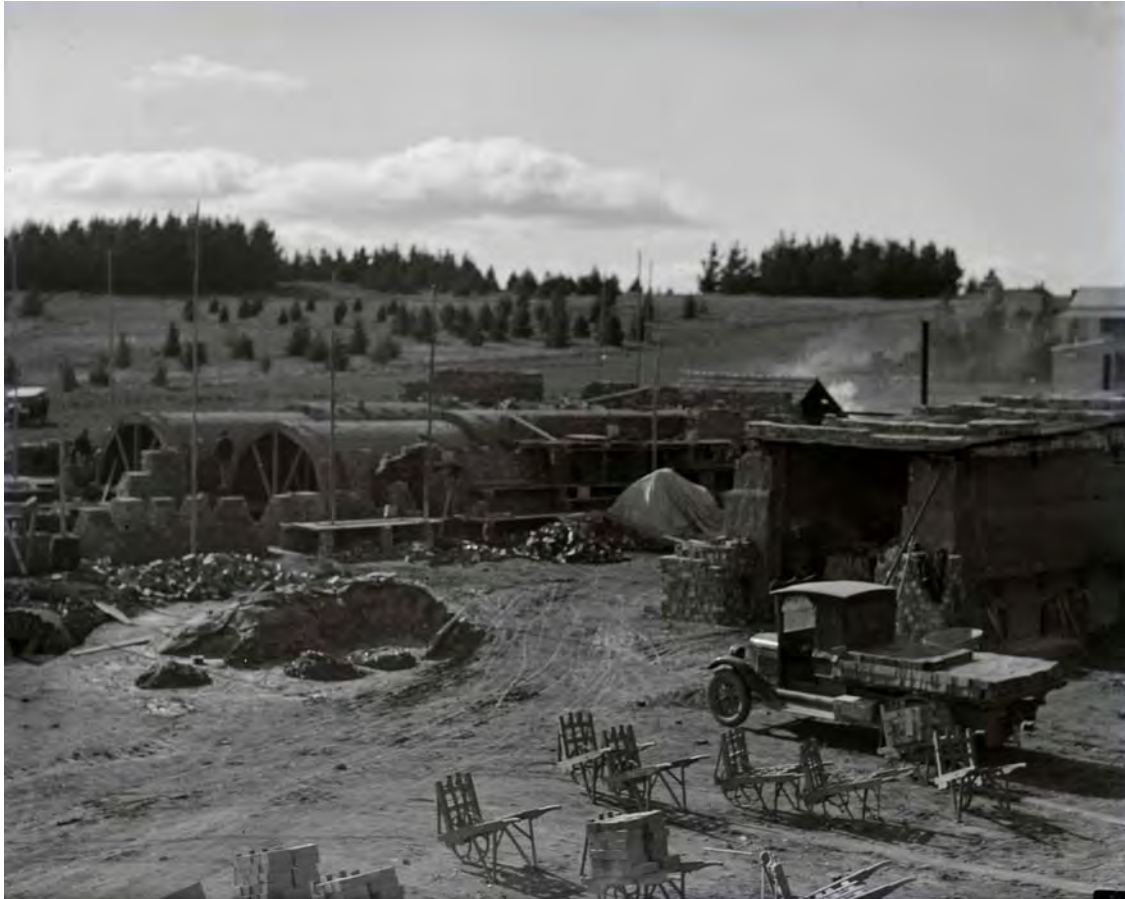
Figure 199 Hardy patent kiln under construction, looking north-east. Note the plantings on the ridge.

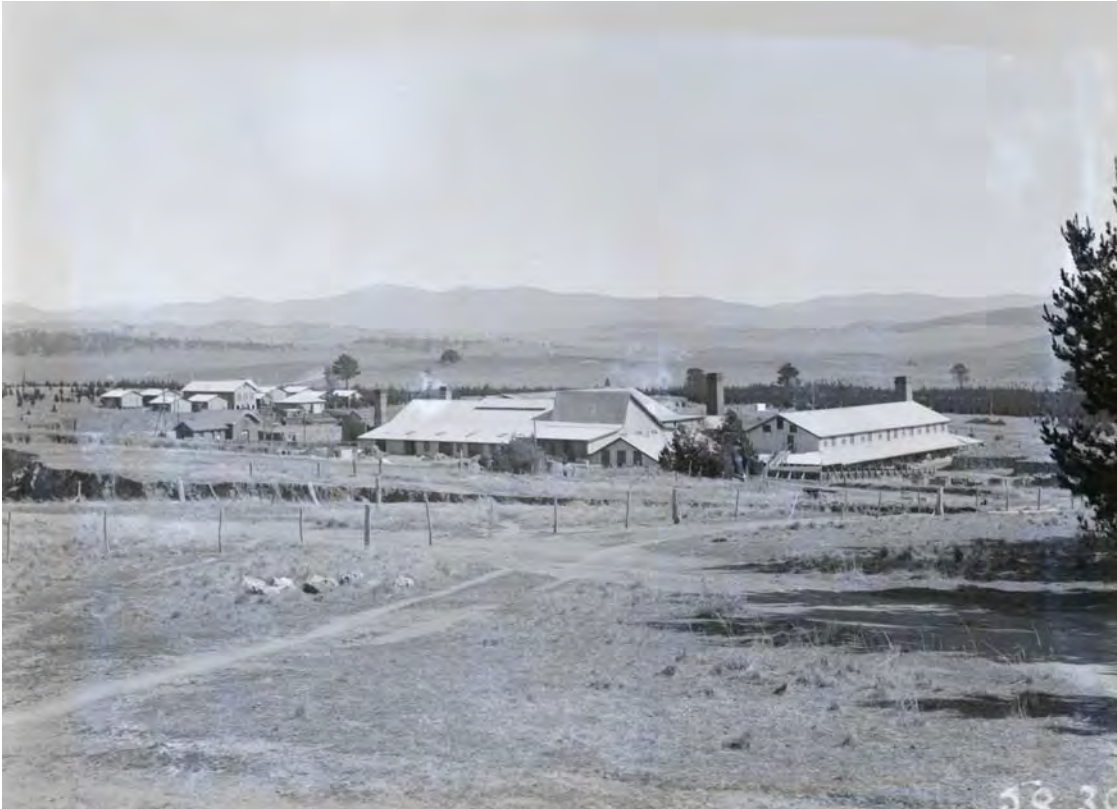
Figure 200 View westward from within the quarry, late 1920s, showing the earlier machine bays and the newly constructed Hardy patent kiln on the right.  
Source: National Archives of Australia

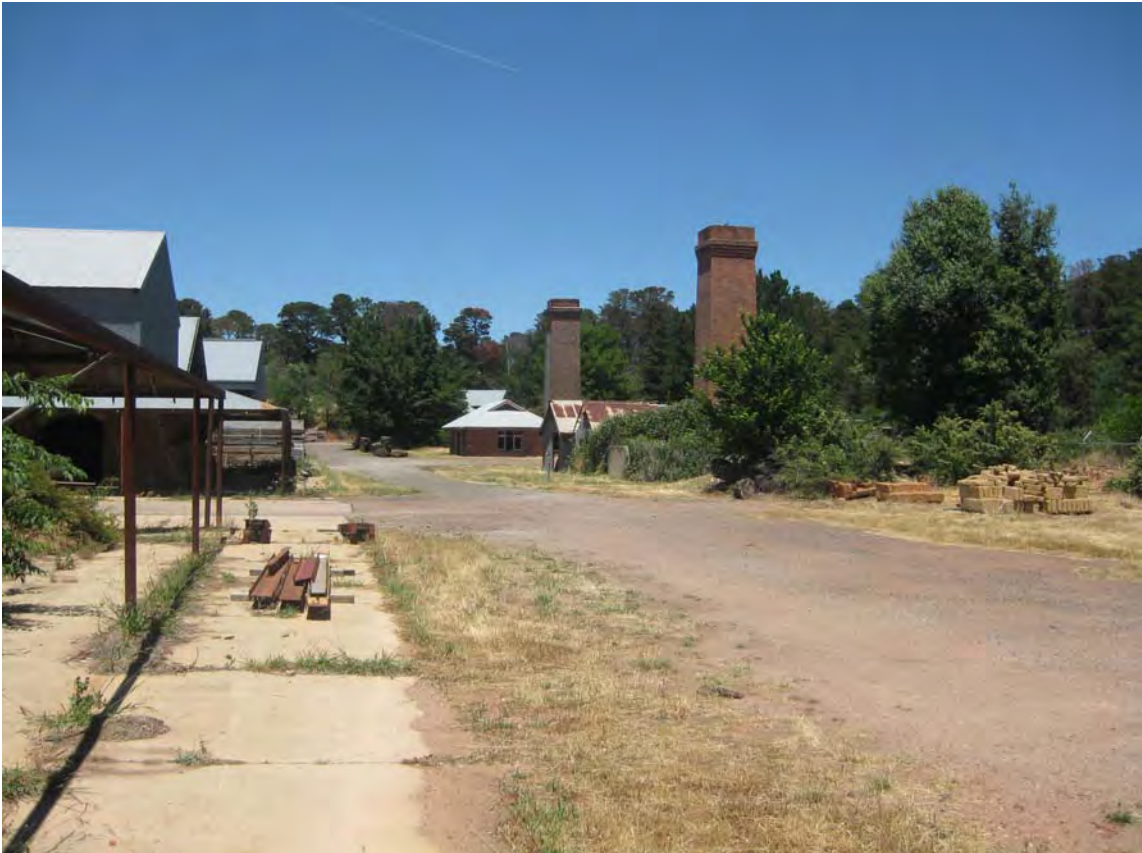
Figure 203 View southward between the kilns and their associated fan houses.

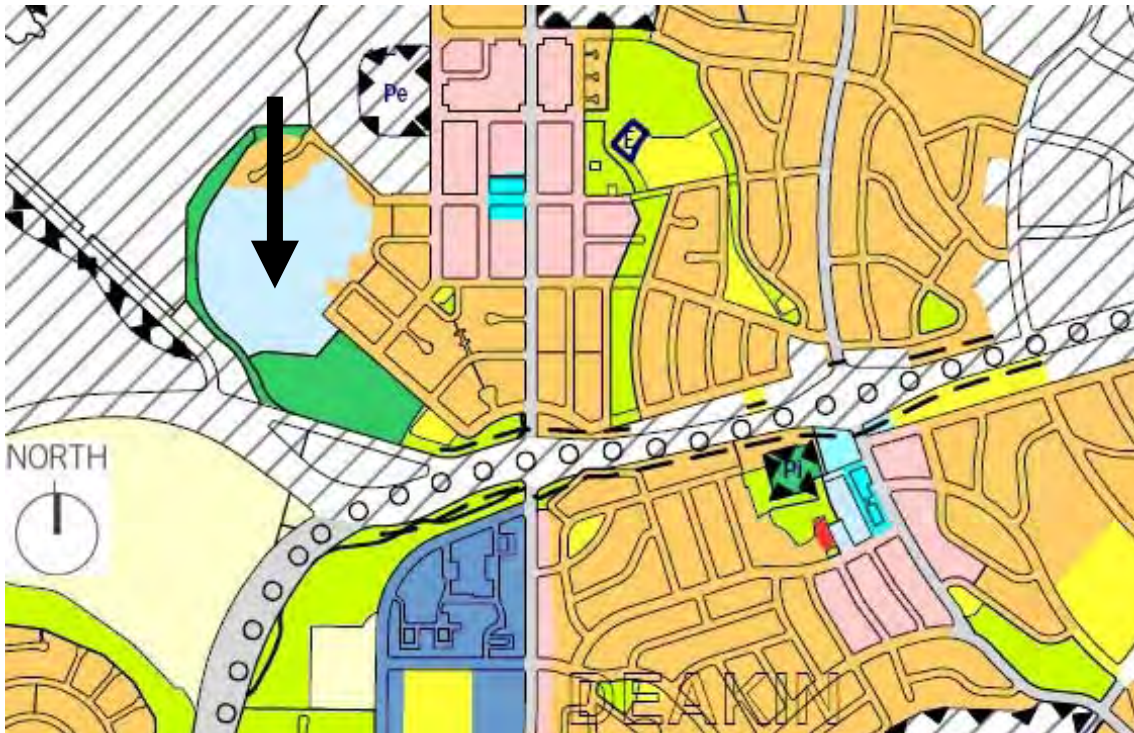
Figure 210 Land use plan (Territory Plan), with the Brickworks highlighted. Orange is Suburban (RZ1), dark green is Restricted Access Recreation (PRZ2) and blue is Leisure and Accommodation (CZ6).  
Source: Territory Plan online.

The Canberra Brickworks and land immediately to the south and west (Blocks 7 and 20) are zoned Leisure and Accommodation.

Residential areas to the north (Lane-Poole Place) and east are designated RZ1 (suburban). The land between Dudley Street and the ridgeline to the north, and the section of Westbourne Woods to the west of the site is designated 'Restricted Access Recreation' (PRZ2) (Figure 210).

The current zoning of the Brickworks (Leisure and Accommodation, CZ6) does not reflect the historic use of the site. While the zoning is wide-ranging in the uses that can be considered, it also does not necessarily capture all potential compatible uses. One or more alternative zonings could be considered to allow for an appropriate adaptive reuse and development on the site.
