Geological Fossil Study

5 March 2021

**CANBERRA BRICKWORKS REDEVELOPMENT - BLOCKS 1, 7, & 20, SECTION 102, YARRALUMLA  
BACKFILLING OF OLD QUARRY AREA**

**GEOLOGICAL FOSSIL STUDY**

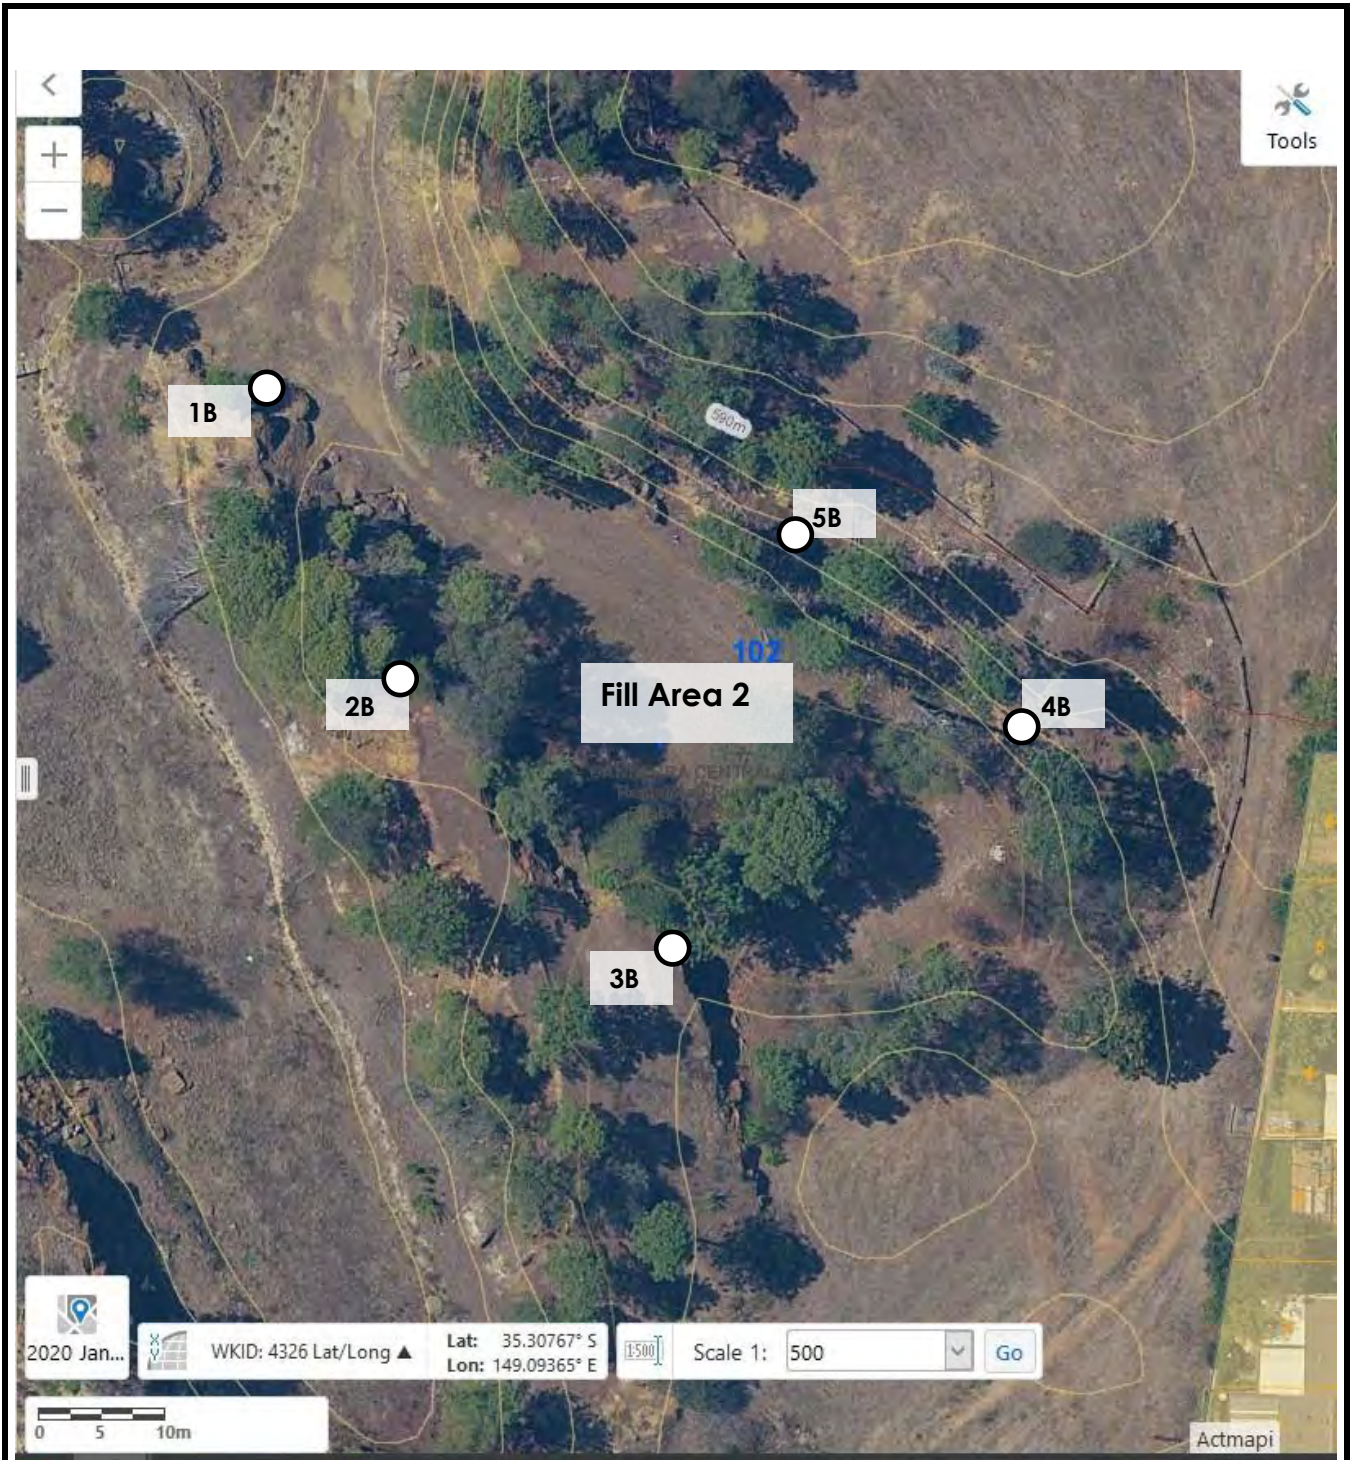
**DOMA GROUP  
CANBERRA BRICKWORKS – GEOLOGICAL FOSSIL STUDY  
AERIAL PHOTOGRAPH – FILL AREA 2**

- - Location of Geological & Fossil Mapping

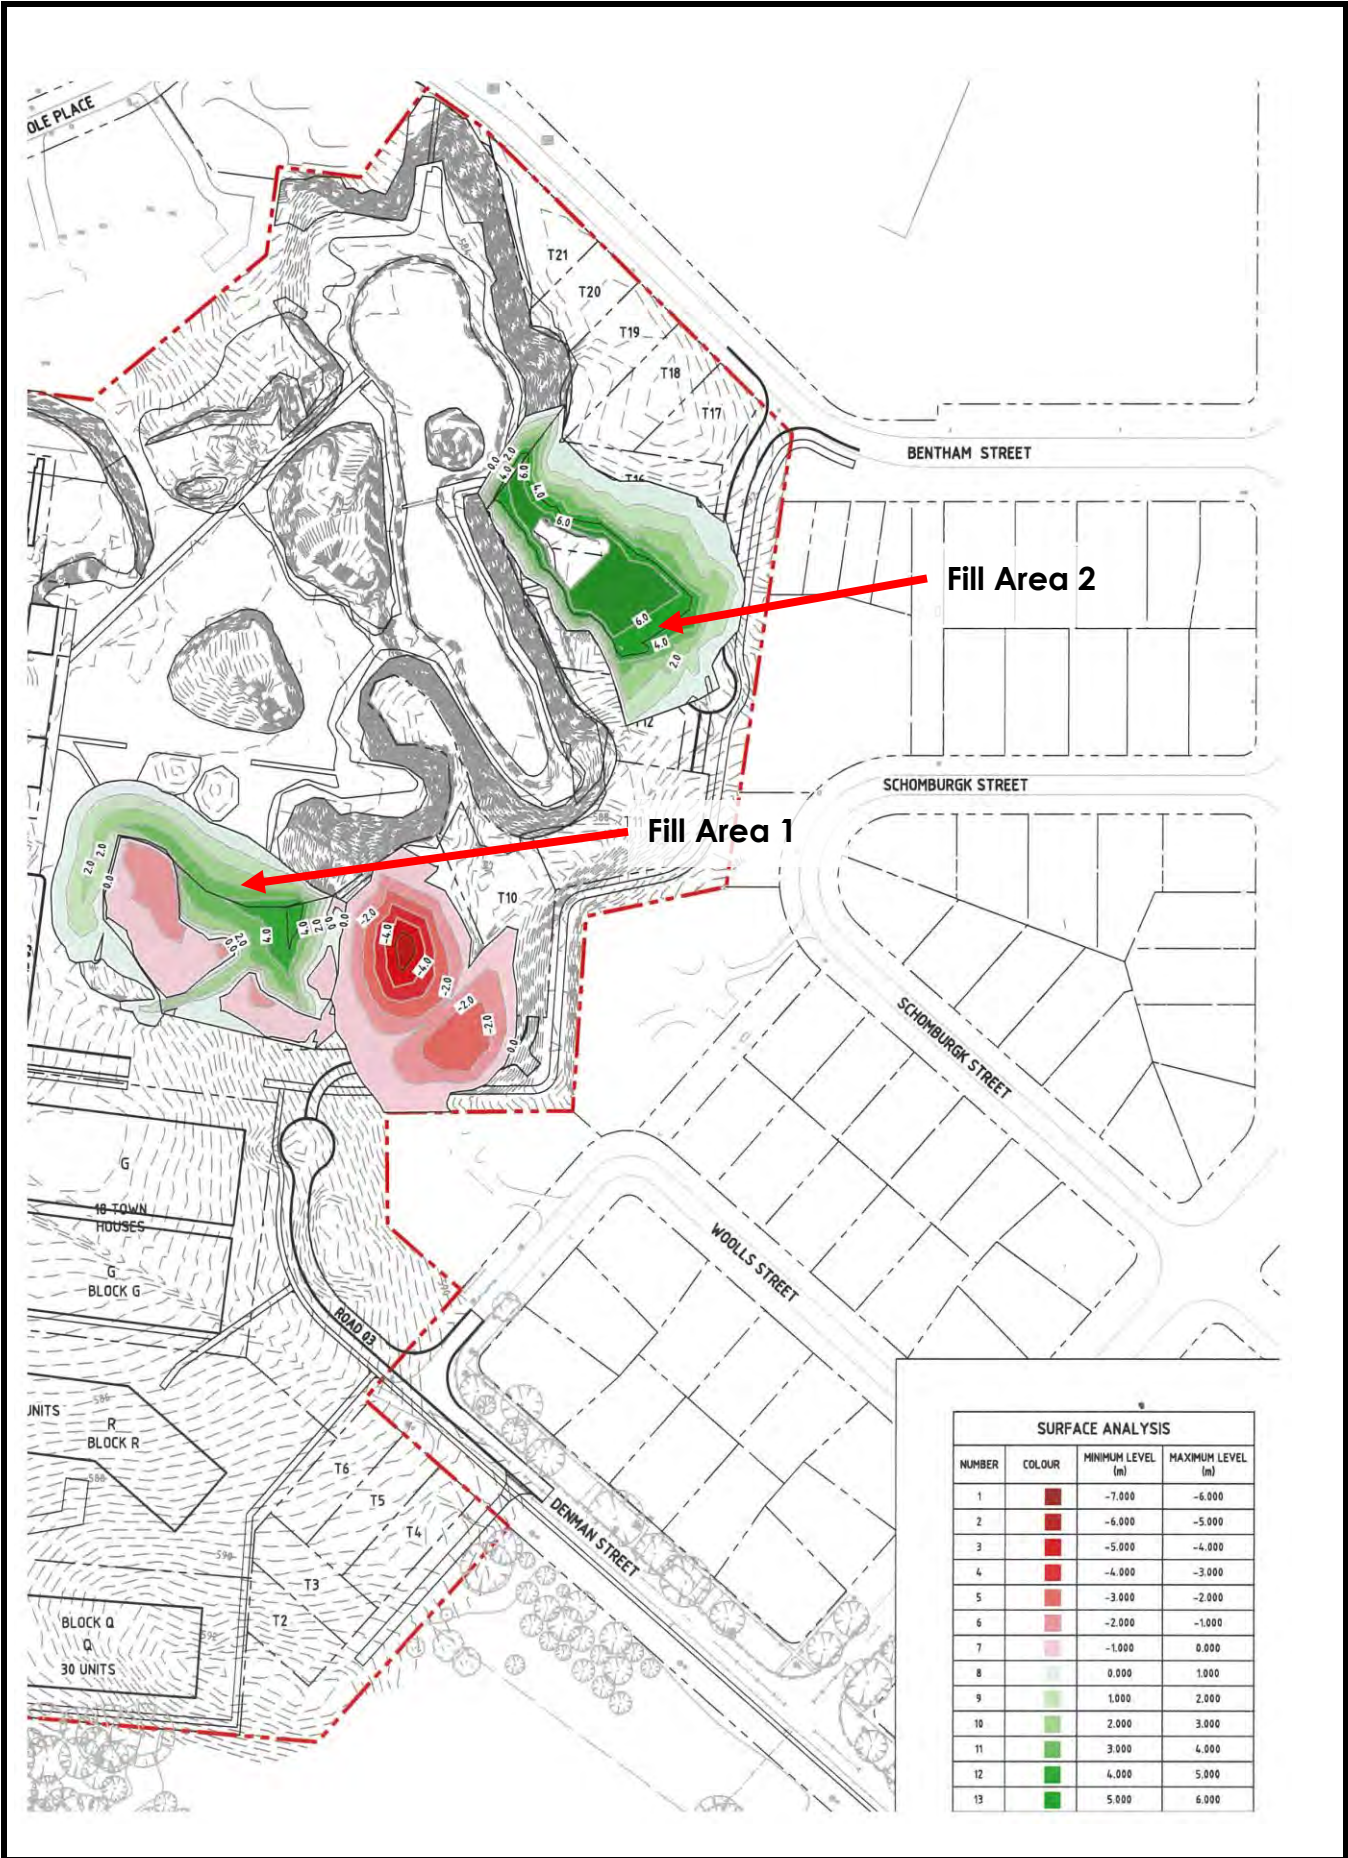
**DOMA GROUP  
CANBERRA BRICKWORKS – GEOLOGICAL FOSSIL STUDY  
EARTHWORKS PLAN**

Detailed geological mapping of the exposed quarry faces was conducted at approximately 20m spacing along the quarry faces, designated as 1A to 8A for Fill Area 1, and 1B to 5B for Fill Area 2. Detailed geological mapping was also conducted at Feature 12C, where the presence of fossils has previously been reported. The locations of Fill Area 1, Fill Area 2, and Feature 12C are shown in Figure 1, while Figures 2 and 3 show the locations of geological mappings 1A to 8A and 1B to 5B. A copy of the earthworks plan, showing the areas and depths of the proposed filling, is presented in Figure 4.

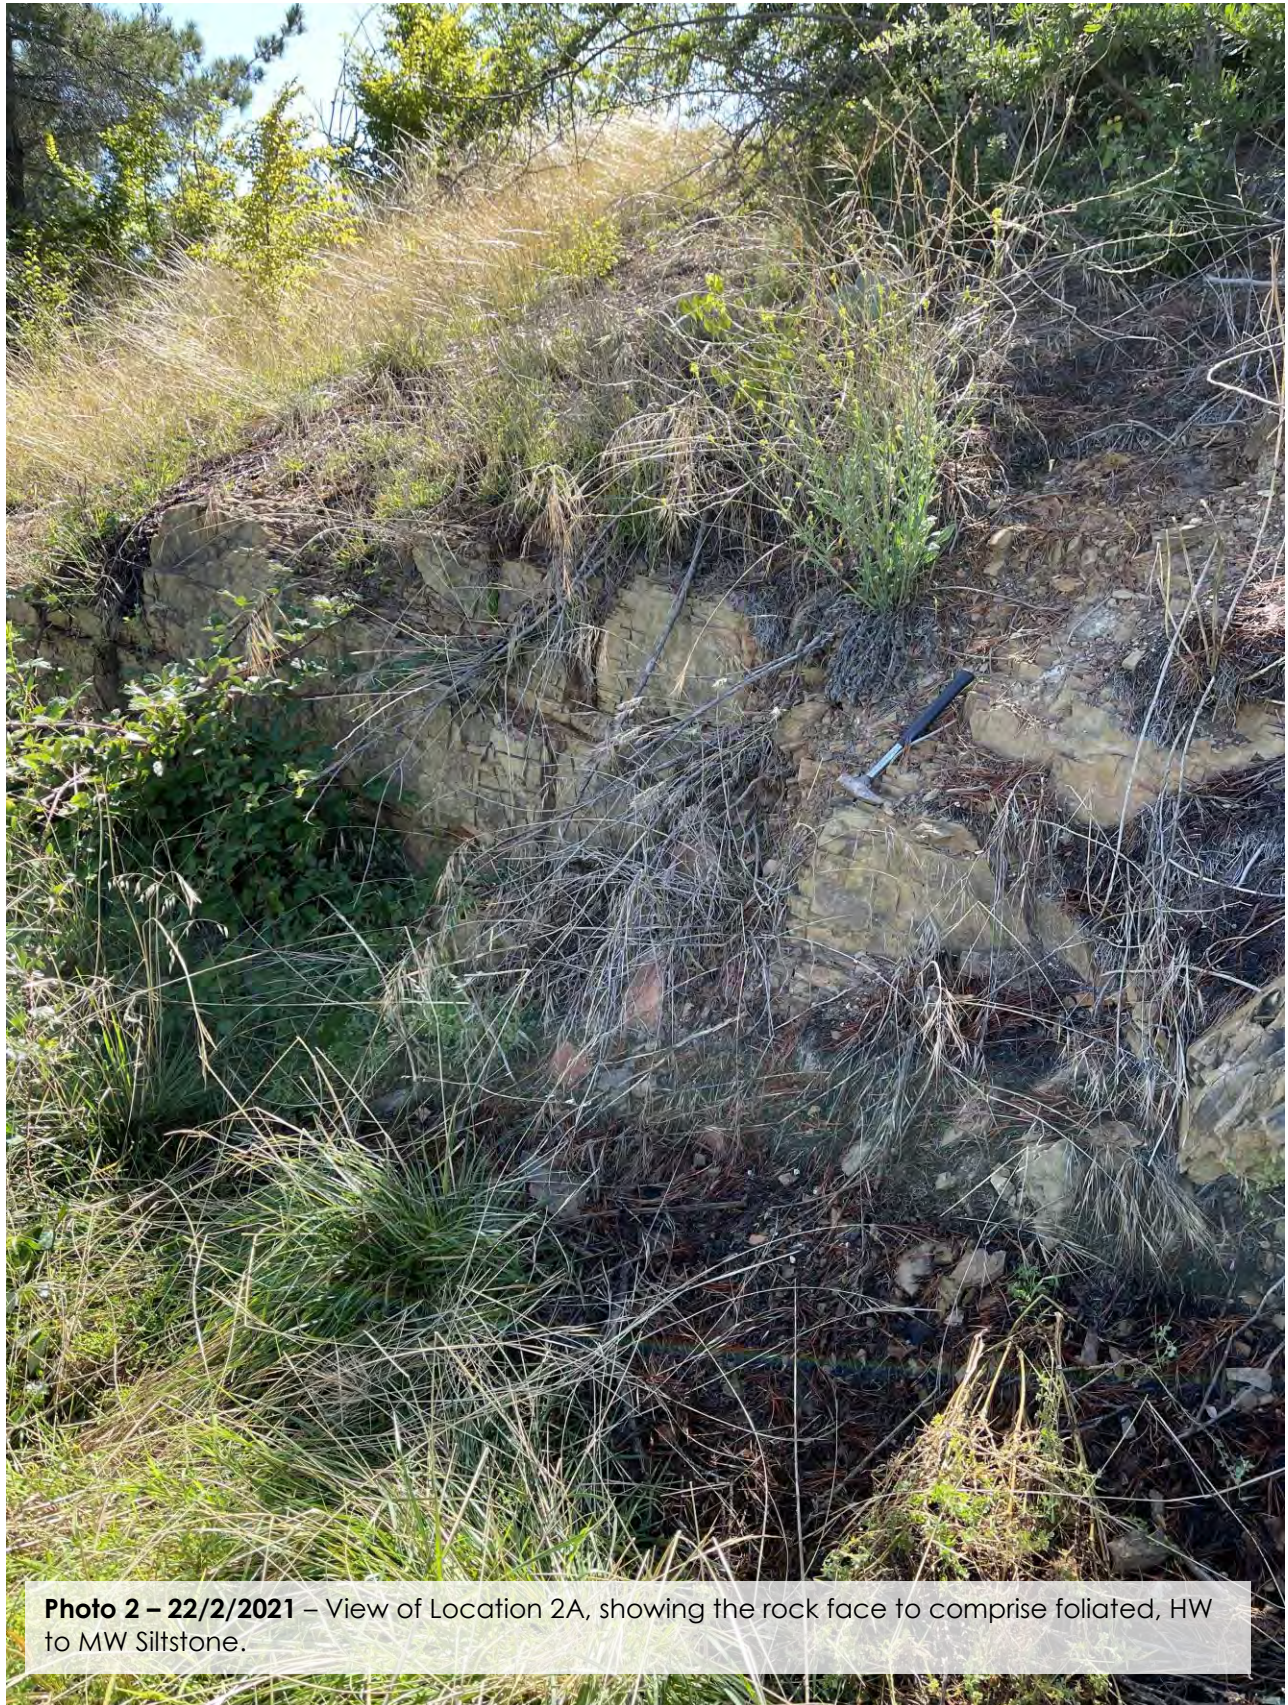
| Feature NO. | Description | Rock Profile | Defect Mapping | Presence of Fossils & Comments |
|--|---|---|---|--|
| 2A | ~1.5m high cut | HW to MW SLTSTONE, with some fine-grained SANDSTONE | Foliation - 63°/250° 5mm to 70mm spacing<br>Bedding - 11°/165° - 30mm to 70mm spacing<br>Joints - 90°/190° - 10mm to 20mm spacing | No fossils found. Photo 2 |

**Photo 2 – 22/2/2021** – View of Location 2A, showing the rock face to comprise foliated, HW to MW Siltstone.

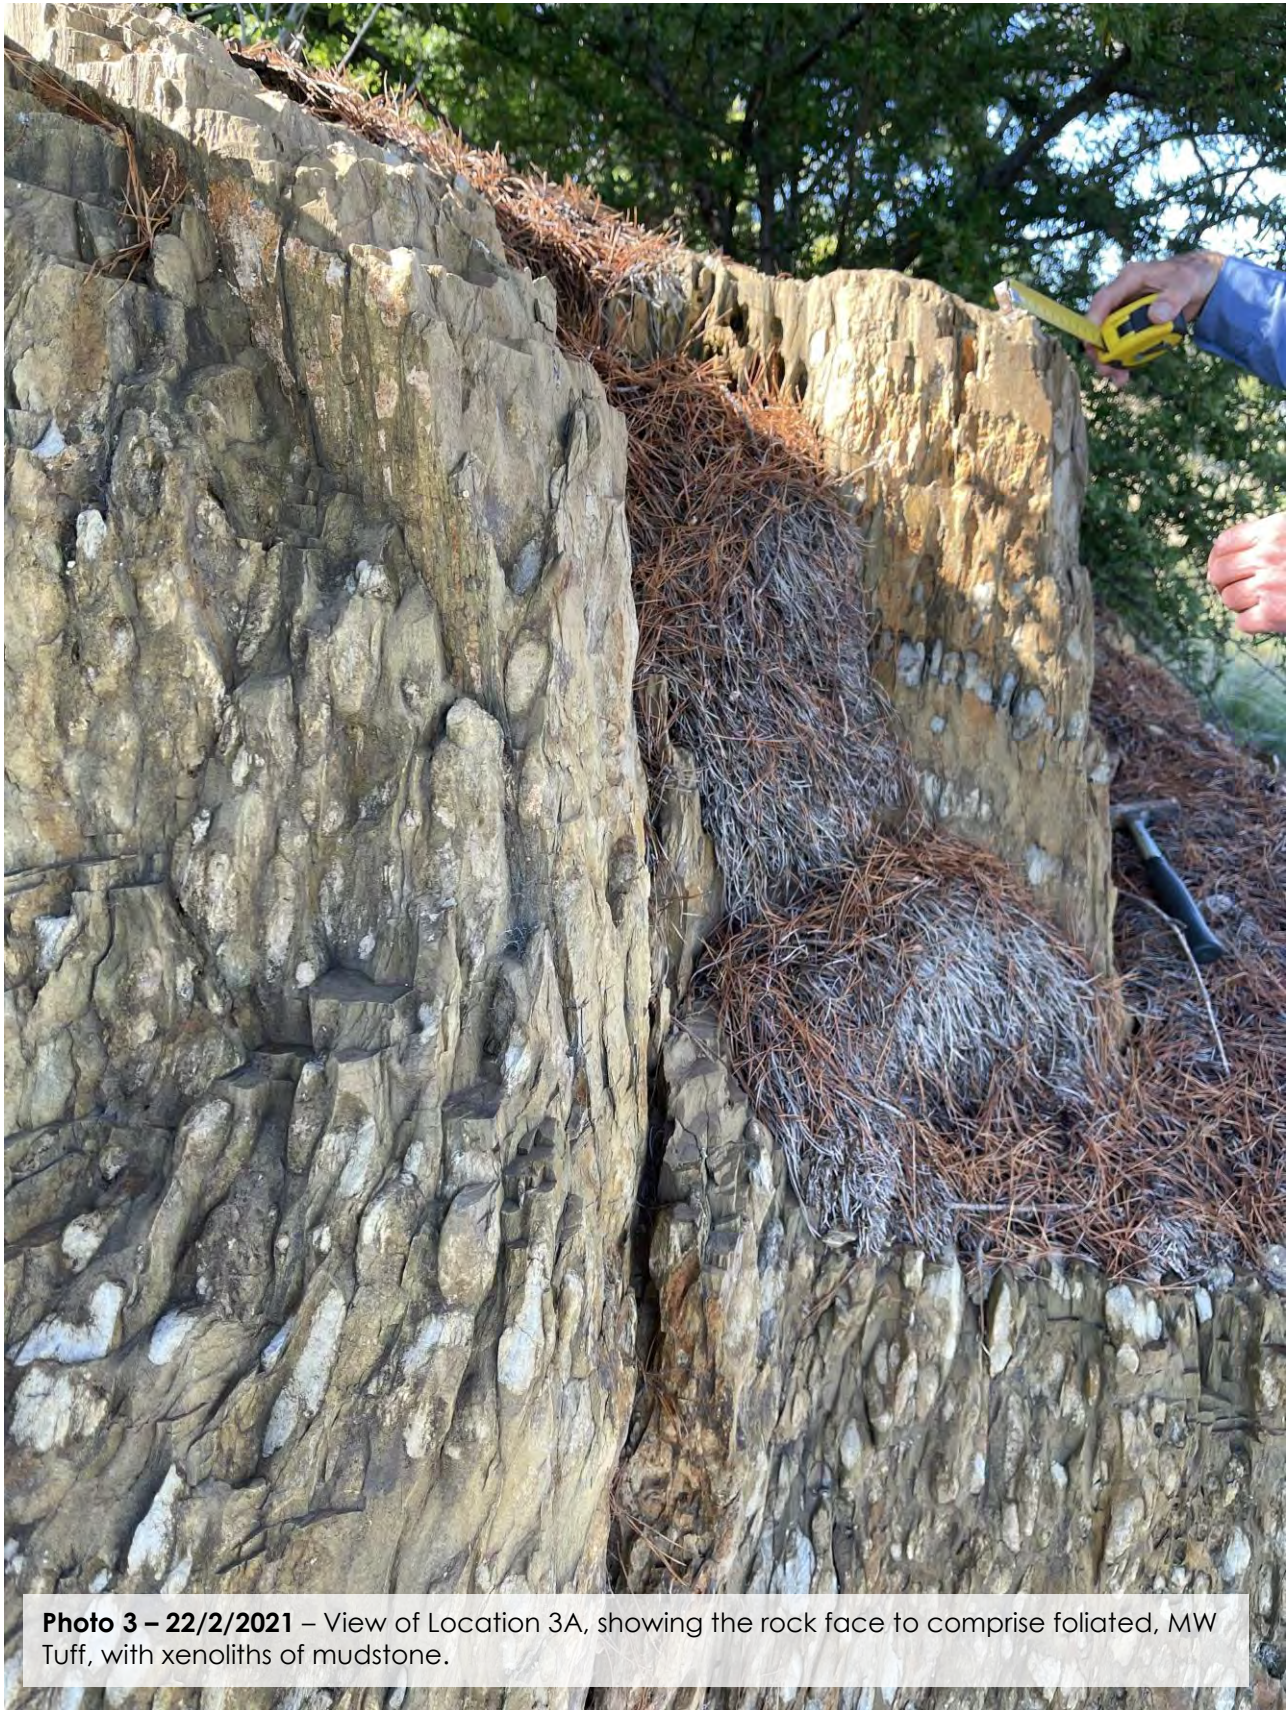
| Feature NO. | Description | Rock Profile | Defect Mapping | Presence of Fossils & Comments |
|--|---|---|---|--|
| 3A | ~1.5m high cut | MW TUFF, with 20mm/70mm mudstone xenoliths | Foliation - 81°/085° 20mm to 90mm spacing<br>Bedding - 16°/236° - 30mm to 300mm spacing<br>Joints - 88°/189° - 10mm to 20mm spacing | No fossils found. Possible fault, with fracturing and weathering of the rock. Photo 3. |

**Photo 3 – 22/2/2021** – View of Location 3A, showing the rock face to comprise foliated, MW Tuff, with xenoliths of mudstone.

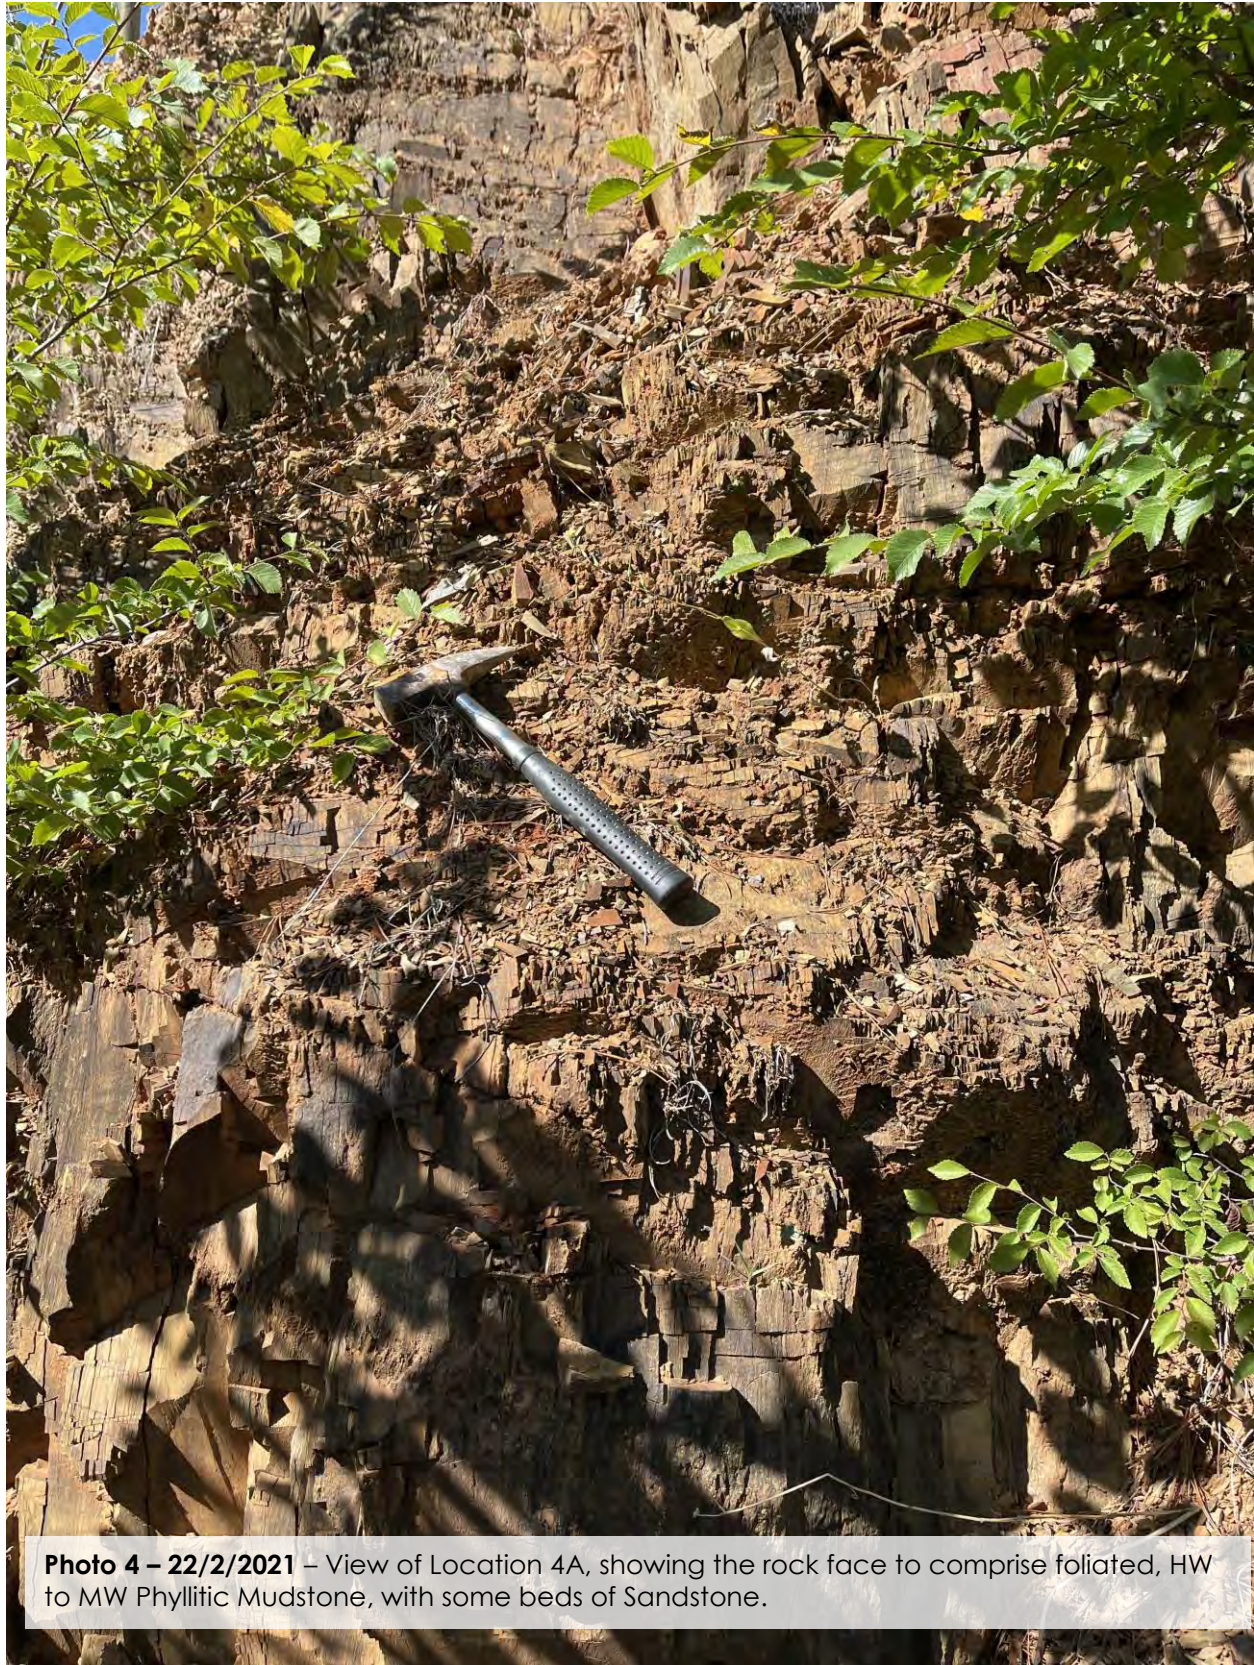
| Feature NO. | Description | Rock Profile | Defect Mapping | Presence of Fossils & Comments |
|--|---|---|---|--|
| 4A | ~4m high cut | HW/MW PHYLLITIC MUDSTONE, with MW SANDSTONE seam from ~0.5m to 2m depth | Foliation - 87°/085° 50mm to 100mm spacing<br>Bedding - 30°/180° - 40mm to 300mm spacing<br>Joints - 60°/350° - ~100mm spacing | No fossils found. Photo 4. |

**Photo 4 – 22/2/2021** – View of Location 4A, showing the rock face to comprise foliated, HW to MW Phyllitic Mudstone, with some beds of Sandstone.

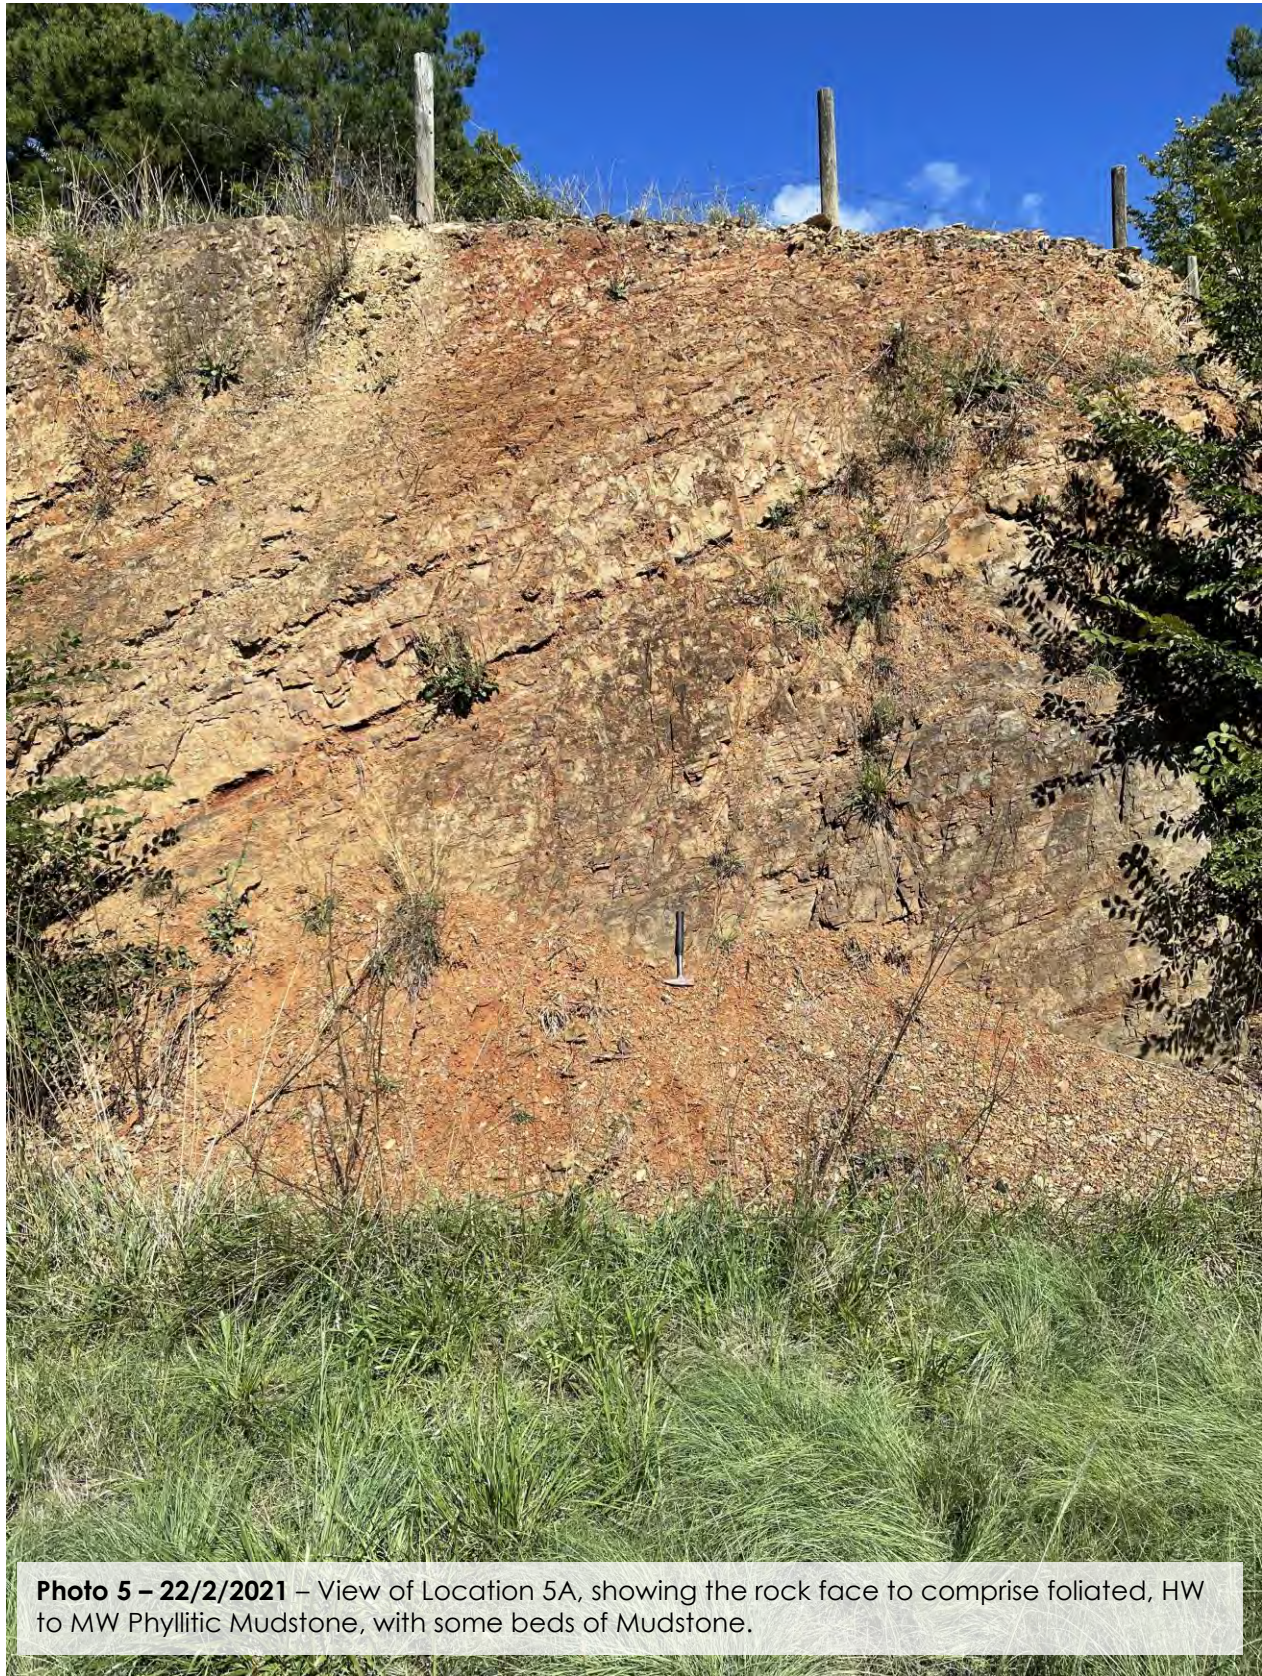
| Feature NO. | Description | Rock Profile | Defect Mapping | Presence of Fossils & Comments |
|--|---|---|---|--|
| 5A | ~4.5m high cut | HW to MW PHYLLITIC MUDSTONE, with thin beds of EW MUDSTONE | Foliation - 75°/080° 50mm to 100mm spacing<br>Bedding - 20°/100° - 70mm to 300mm spacing<br>Joints - 76°/163° - ~100mm spacing | No fossils found. Some evidence of normal faulting - ~100mm of displacement. Photo 5. |

**Photo 5 – 22/2/2021** – View of Location 5A, showing the rock face to comprise foliated, HW to MW Phyllitic Mudstone, with some beds of Mudstone.

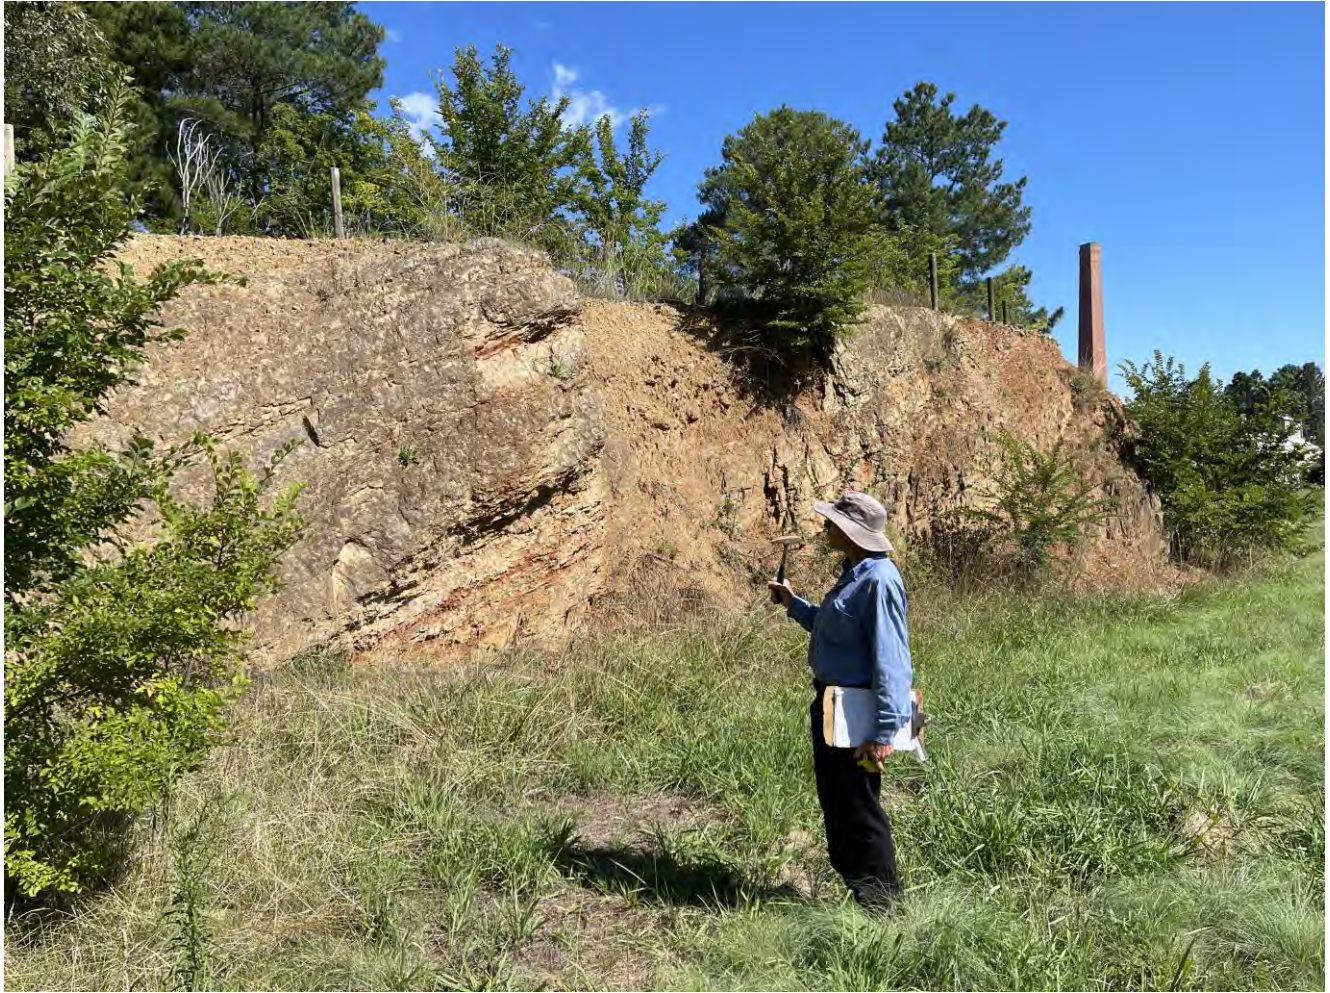
**Photo 6 – 22/2/2021** – View of Locations 4A and 5A, showing the rock face to comprise foliated, HW to MW Phyllitic Mudstone, with some beds of Sandstone & Mudstone.

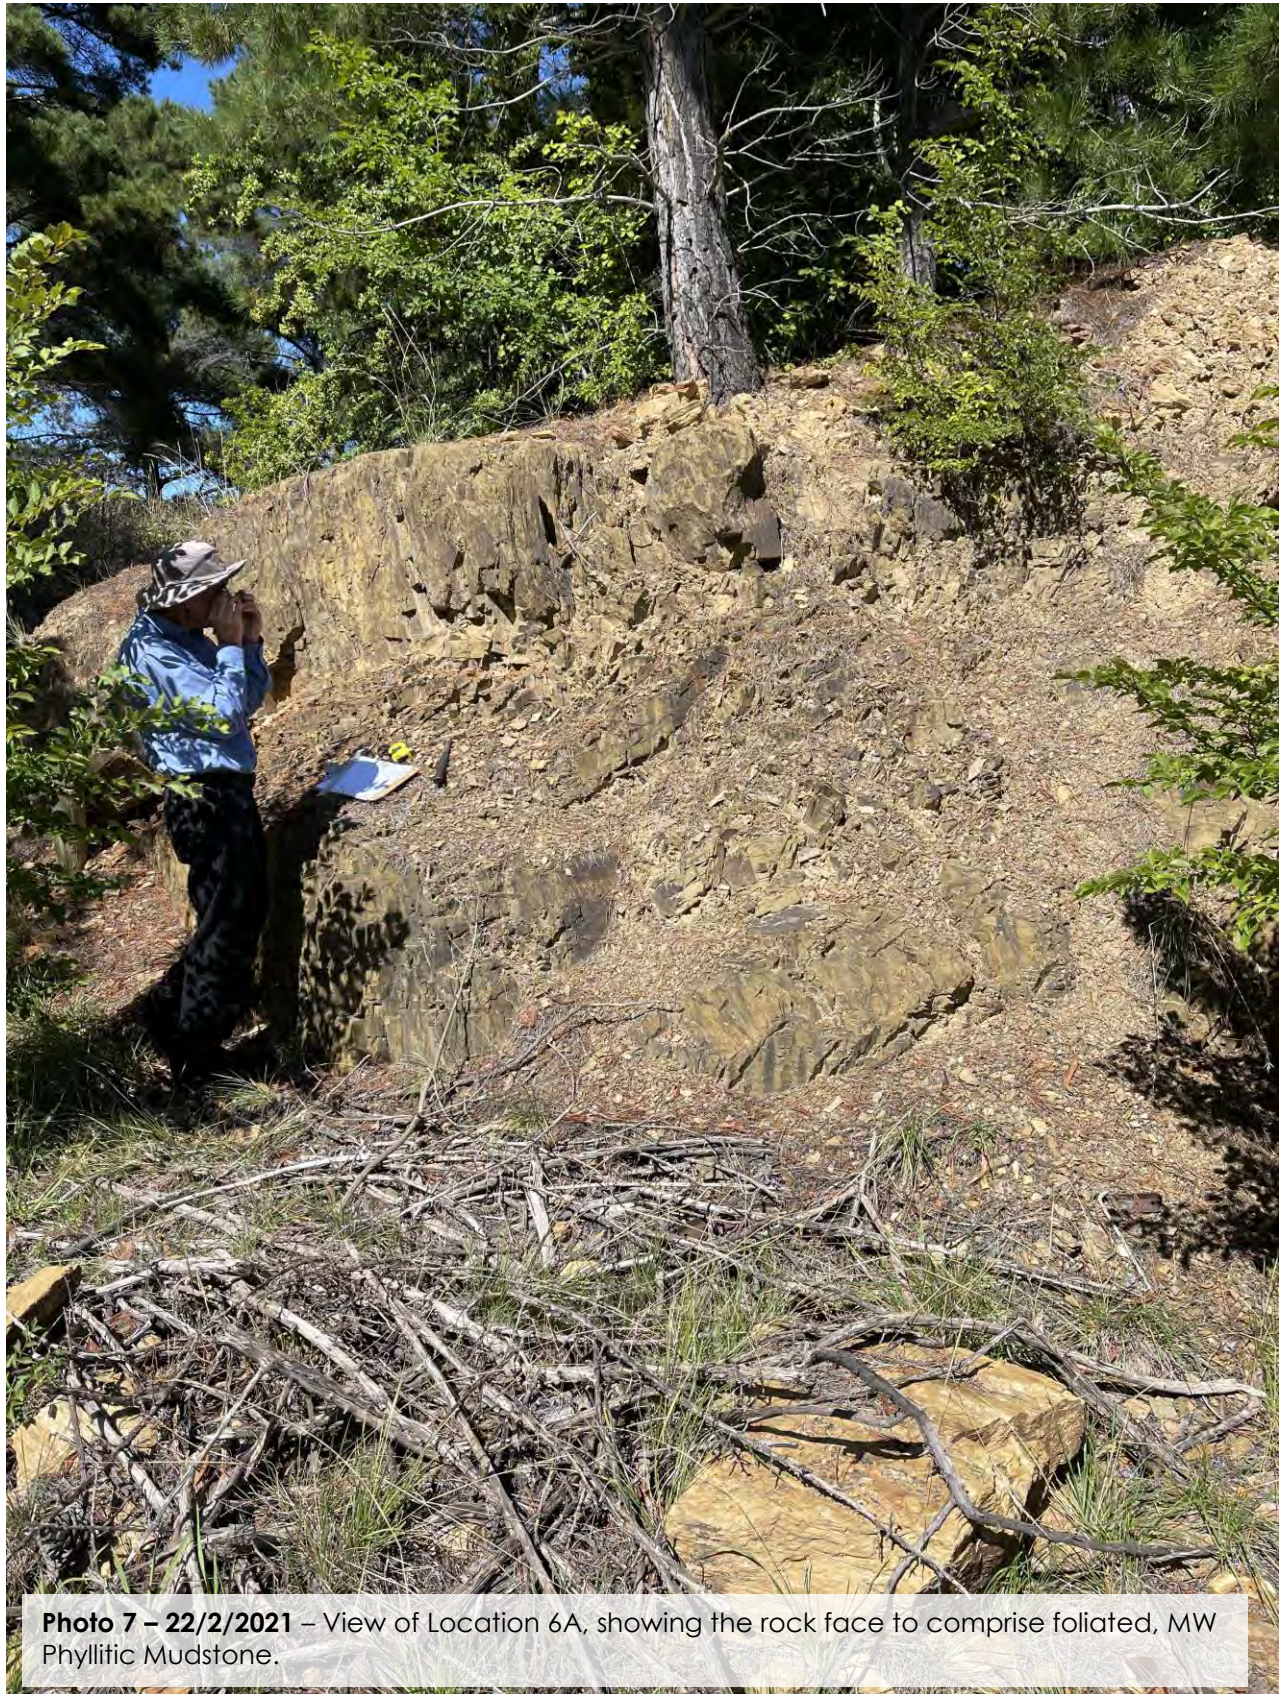
| Feature NO. | Description | Rock Profile | Defect Mapping | Presence of Fossils & Comments |
|--|---|---|---|--|
| 6A | ~2.5m high cut | MW PHYLLITIC MUDSTONE | Foliation - 79°/069° 80mm to 500mm spacing<br>Bedding - 09°/229° - 30mm to 300mm spacing<br>Joints - 81°/355° - 70mm to 150mm spacing | No fossils found. Photo 7. |

**Photo 7 – 22/2/2021** – View of Location 6A, showing the rock face to comprise foliated, MW Phyllitic Mudstone.

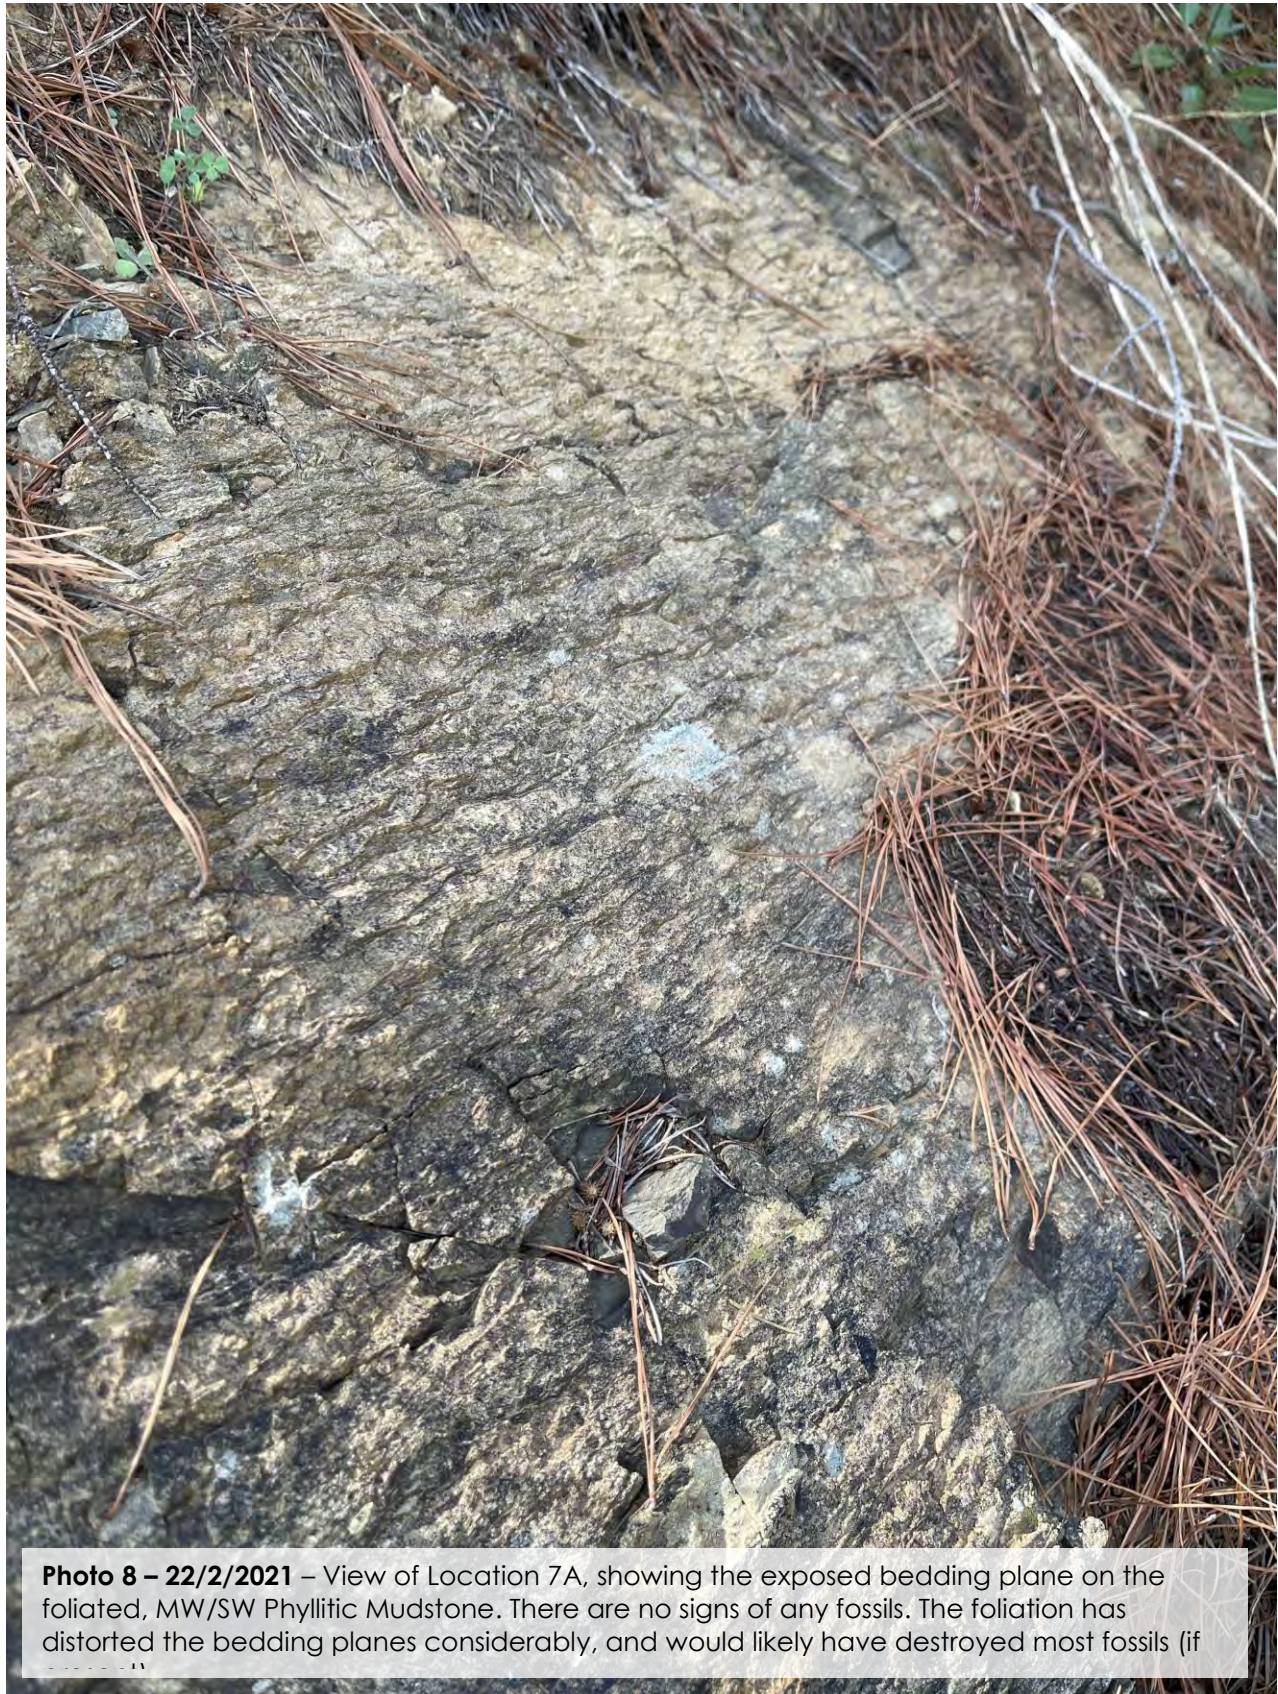
| Feature NO. | Description | Rock Profile | Defect Mapping | Presence of Fossils & Comments |
|--|---|---|---|--|
| 7A | ~4m high cut | ~3m of overburden fill, then MW/SW PHYLLITIC MUDSTONE | Foliation - 73°/260° 80mm to 500mm spacing<br>Bedding - 38°/235° - 30mm to 300mm spacing | No fossils found. The exposed bedding planes are masked by the foliation. Photo 8. |

**Photo 8 – 22/2/2021** – View of Location 7A, showing the exposed bedding plane on the foliated, MW/SW Phyllitic Mudstone. There are no signs of any fossils. The foliation has distorted the bedding planes considerably, and would likely have destroyed most fossils (if present).

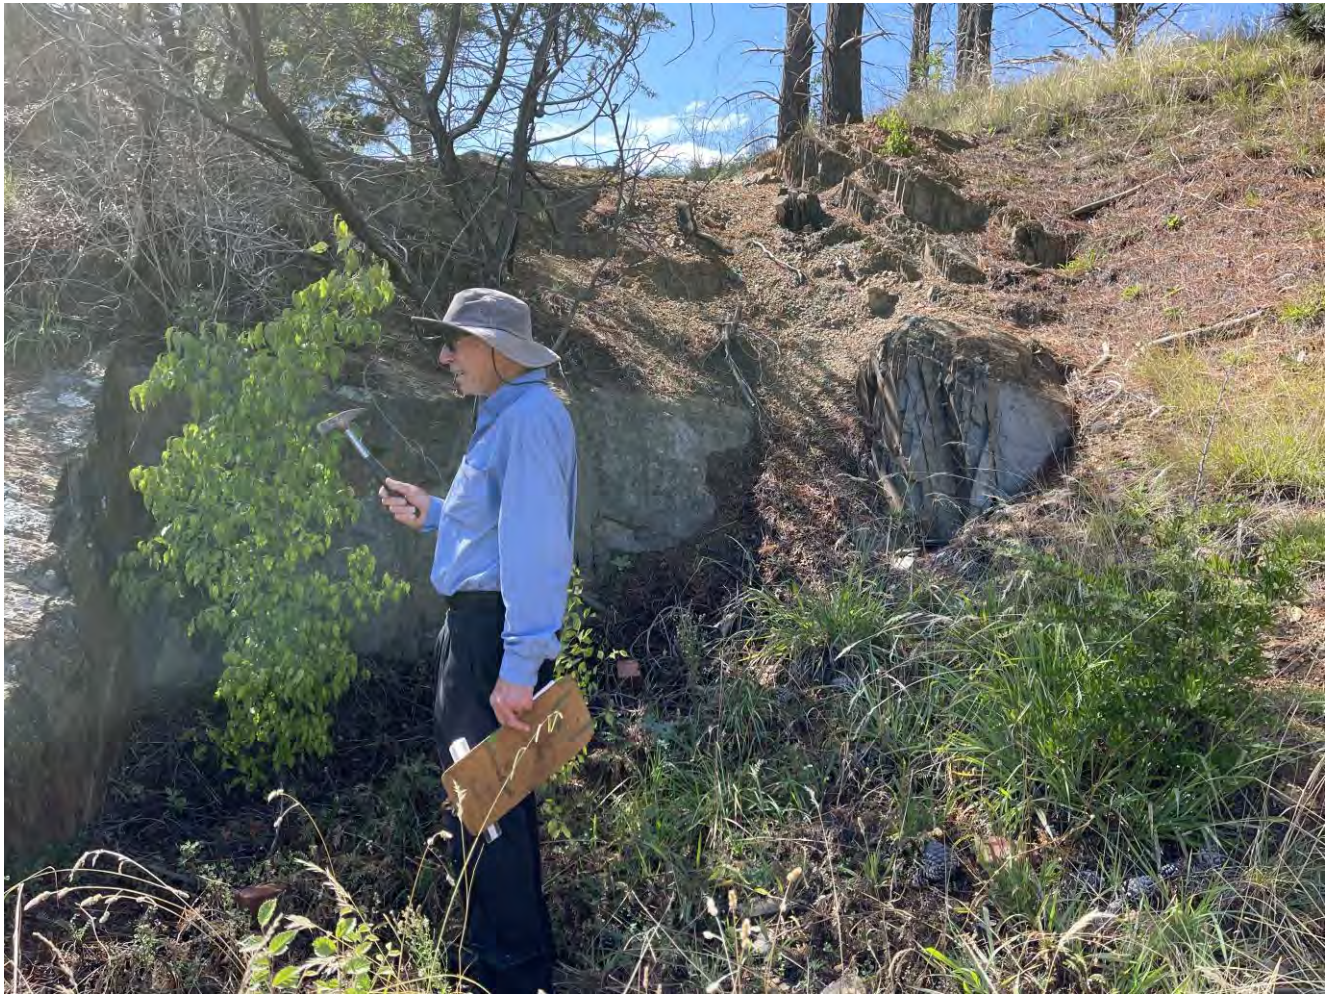
| Feature NO. | Description | Rock Profile | Defect Mapping | Presence of Fossils & Comments |
|--|---|---|---|--|
| 8A | ~2.5m high cut | MW/SW PHYLLITIC MUDSTONE | Foliation - 88°/260° 80mm to 500mm spacing<br>Bedding - 39°/247° - 30mm to 300mm spacing | No fossils found. The exposed bedding planes are masked by the foliation. Photos 9 and 10. |

**Photo 9 – 22/2/2021** – View of Location 8A, showing the rock face to comprise foliated, MW/SW Phyllitic Mudstone.
