Geological Fossil Study

5 March 2021

**CANBERRA BRICKWORKS REDEVELOPMENT - BLOCKS 1, 7, & 20, SECTION 102, YARRALUMLA  
BACKFILLING OF OLD QUARRY AREA**

**GEOLOGICAL FOSSIL STUDY**

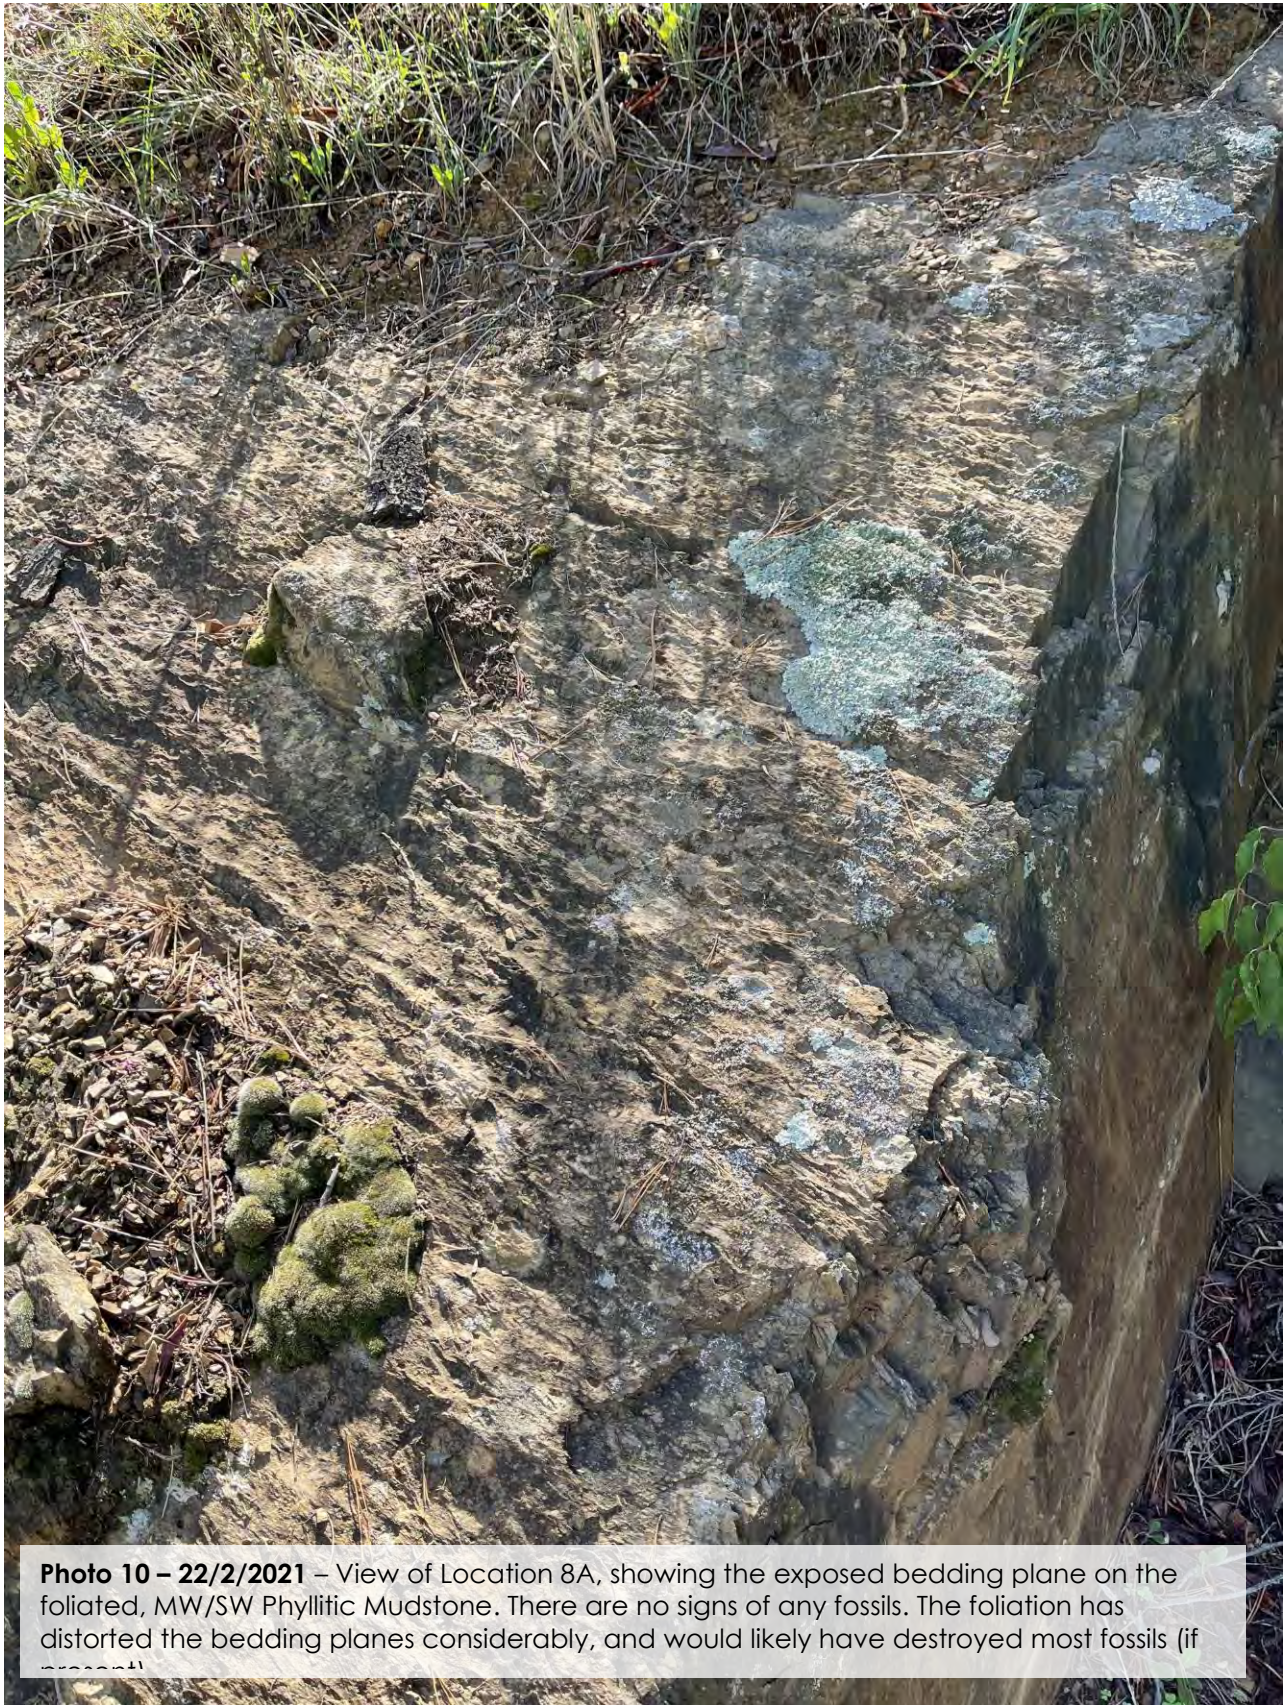
| Feature NO. | Description | Rock Profile | Defect Mapping | Presence of Fossils & Comments |
|--|---|---|---|--|
| 8A | ~2.5m high cut | MW/SW PHYLLITIC MUDSTONE | Foliation - 88°/260° 80mm to 500mm spacing<br>Bedding - 39°/247° - 30mm to 300mm spacing | No fossils found. The exposed bedding planes are masked by the foliation. Photos 9 and 10. |

**Photo 10 – 22/2/2021** – View of Location 8A, showing the exposed bedding plane on the foliated, MW/SW Phyllitic Mudstone. There are no signs of any fossils. The foliation has distorted the bedding planes considerably, and would likely have destroyed most fossils (if present).

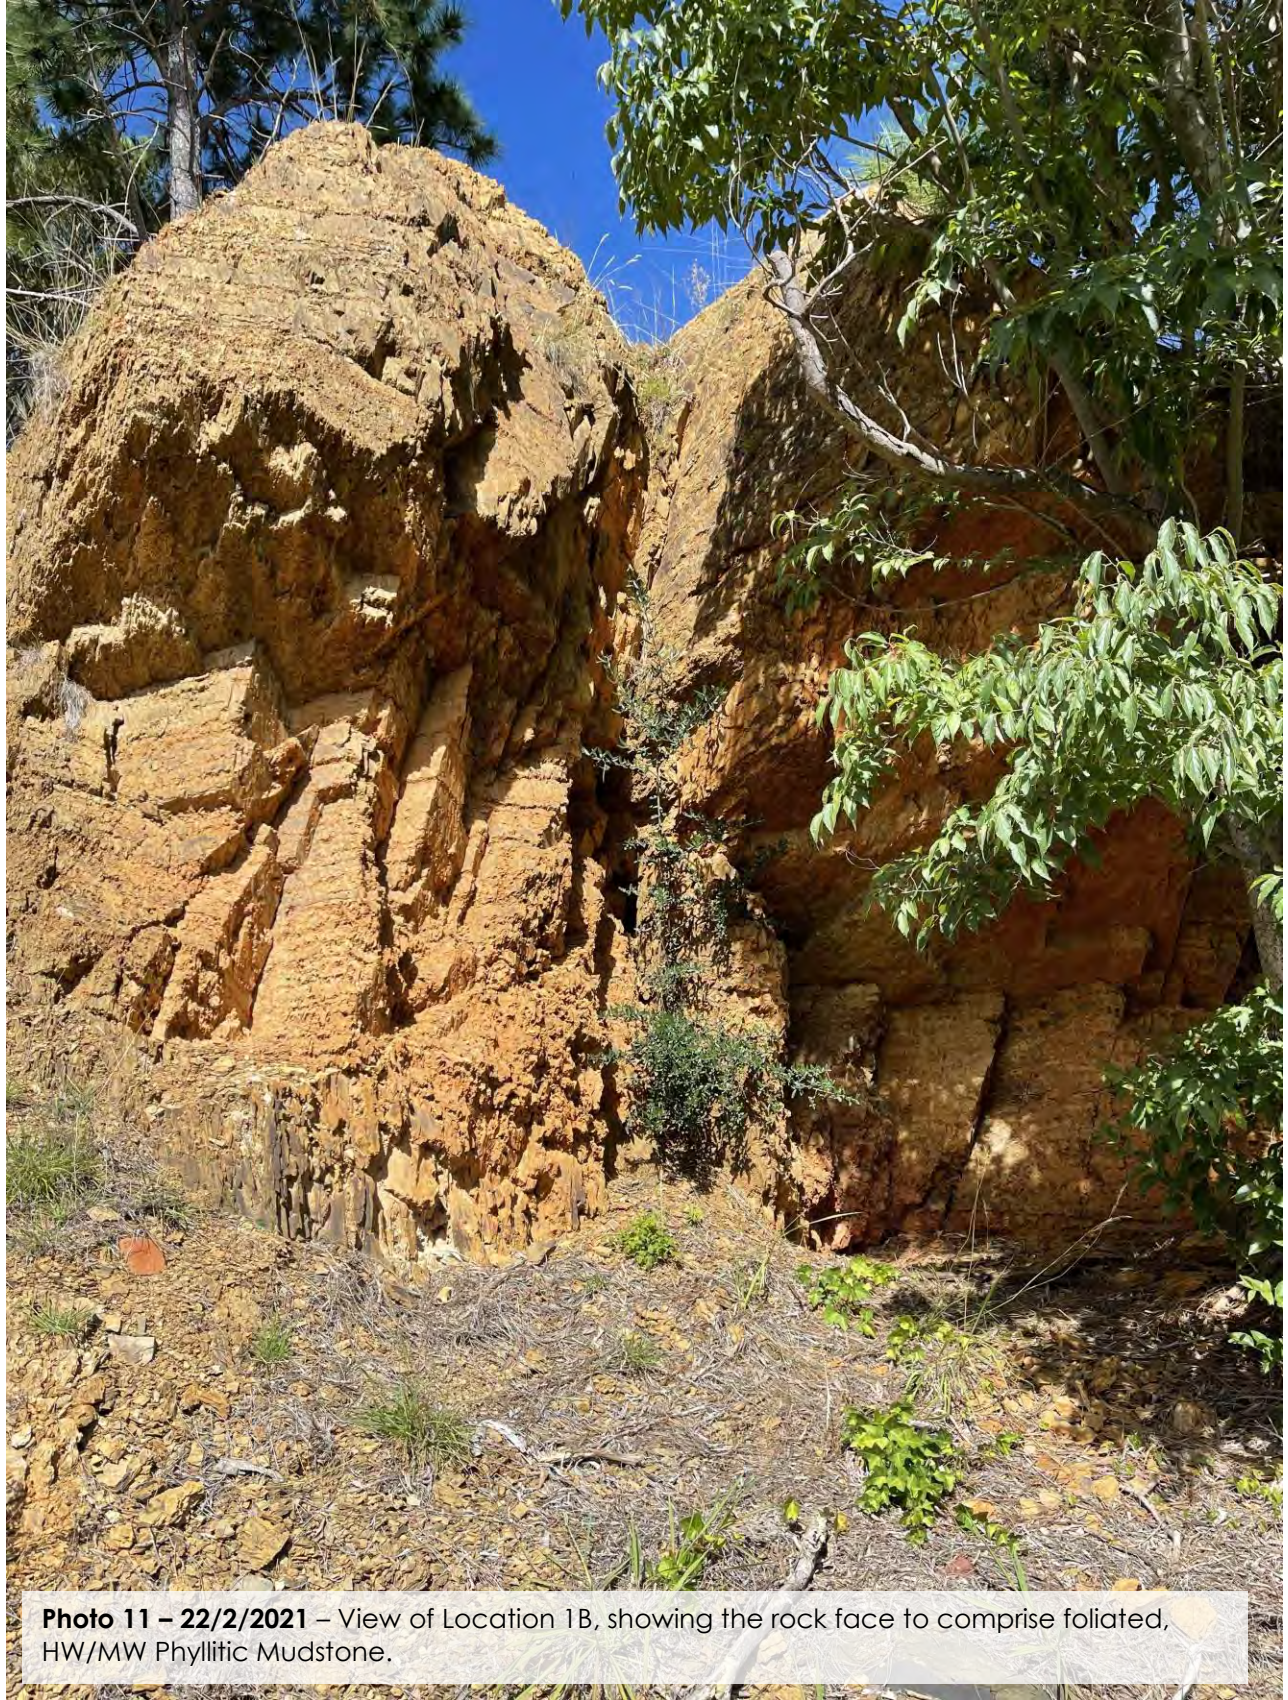
| Feature No. | Description | Rock Profile | Defect Mapping | Presence of Fossils & Comments |
|---|---|---|---|--|
| 1B | ~4m high cut | HW/MW<br>PHYLLITIC<br>MUDSTONE | Foliation - 81°/102° 5mm to 70mm spacing<br>Bedding - 42°/213° - 30mm to 70mm spacing<br>Joints - 68°/146° - 10mm to 20mm spacing | No fossils found. The exposed bedding planes are masked by the foliation. Photos 11 and 12. |

**Photo 11 – 22/2/2021** – View of Location 1B, showing the rock face to comprise foliated, HW/MW Phyllitic Mudstone.

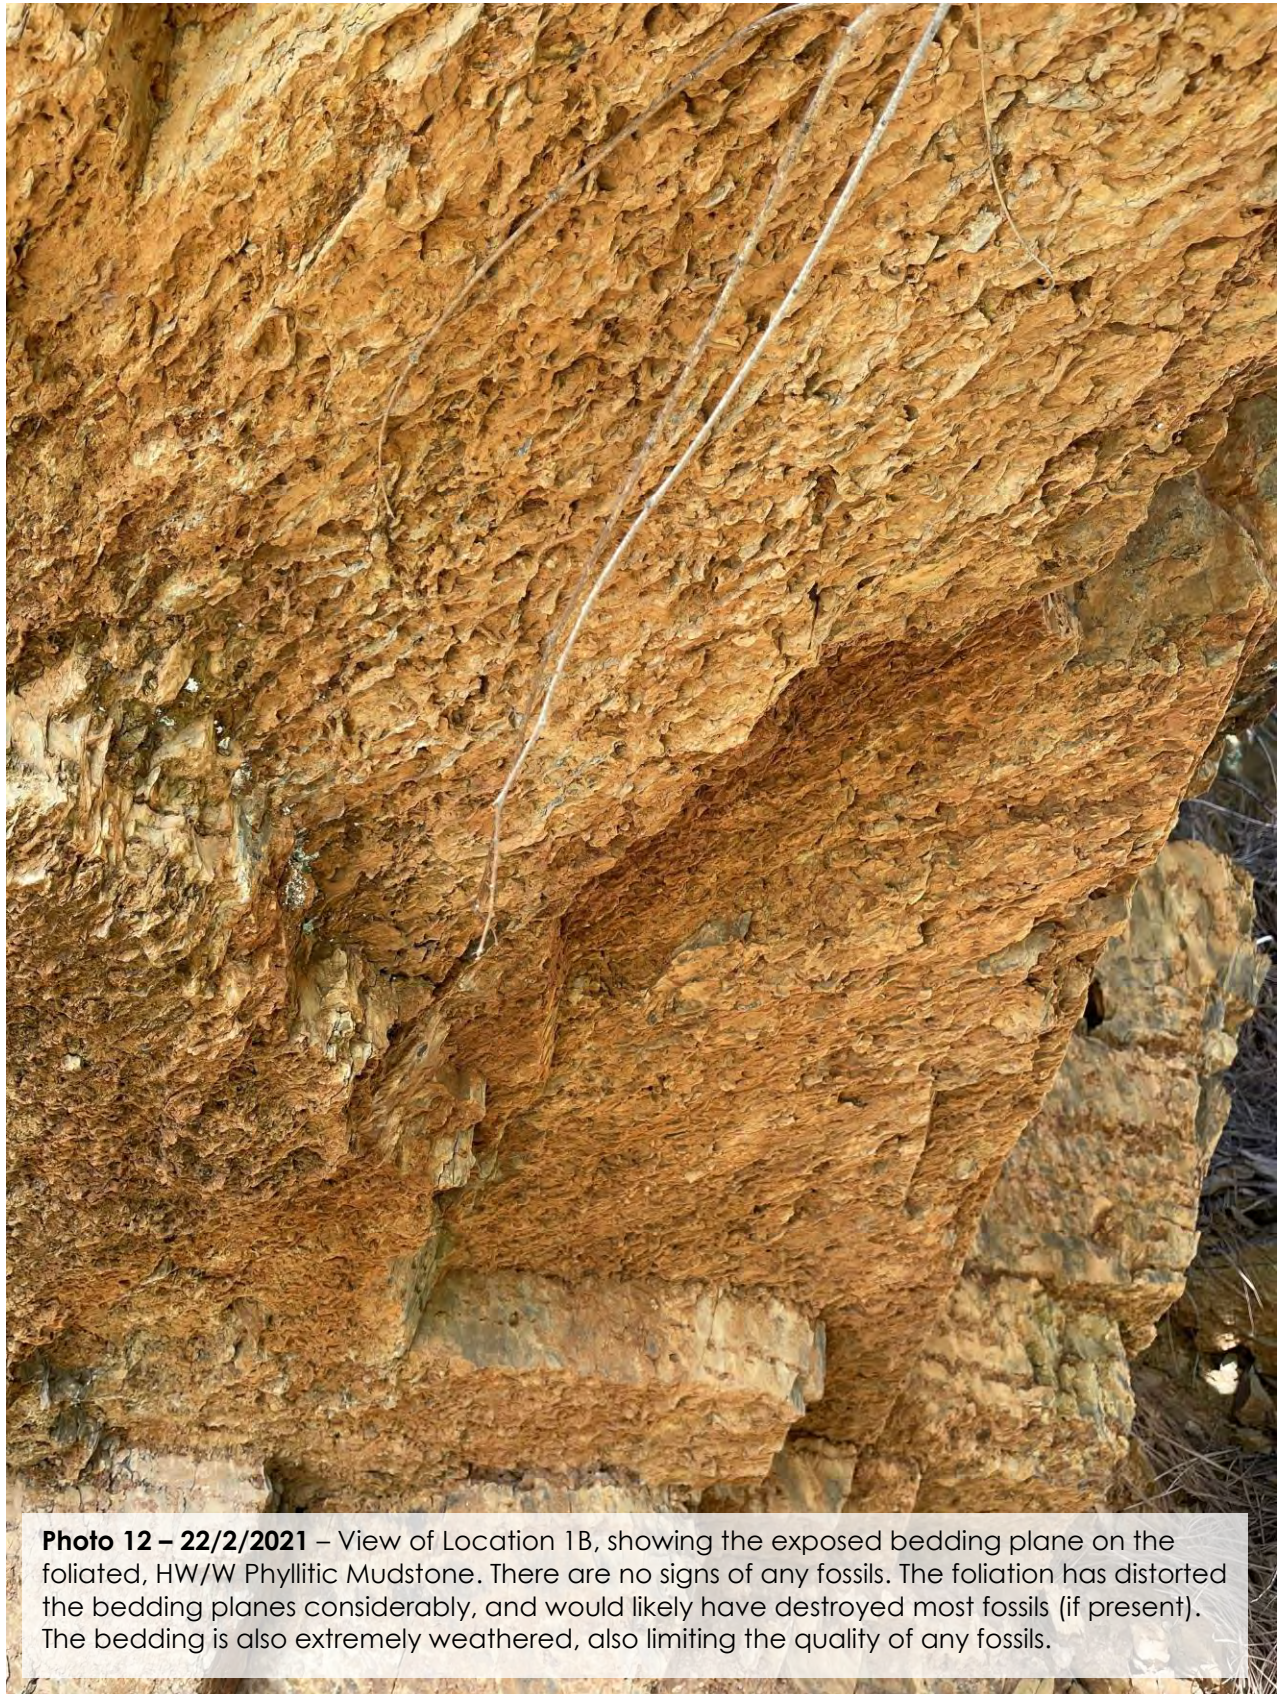
**Photo 12 – 22/2/2021** – View of Location 1B, showing the exposed bedding plane on the foliated, HW/W Phyllitic Mudstone. There are no signs of any fossils. The foliation has distorted the bedding planes considerably, and would likely have destroyed most fossils (if present). The bedding is also extremely weathered, also limiting the quality of any fossils.

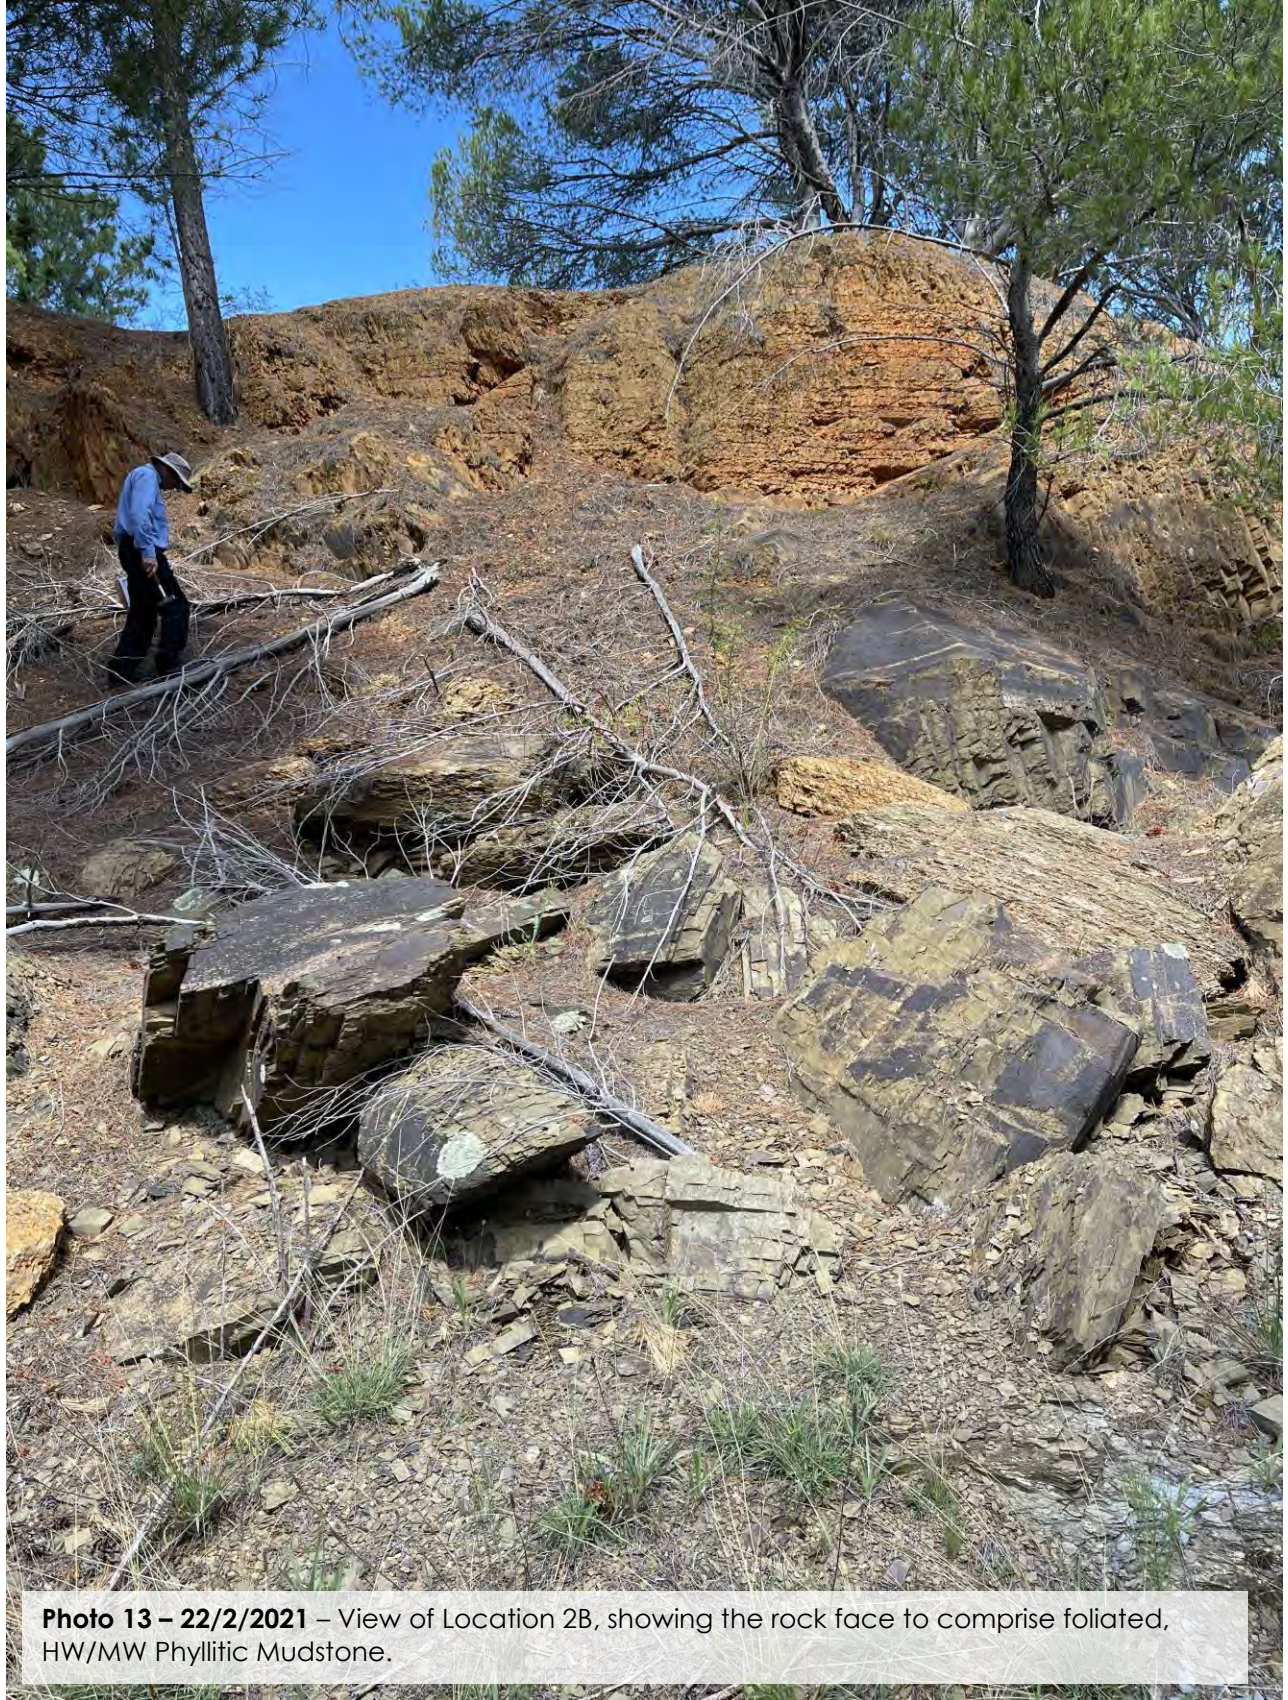
| Feature No. | Description | Rock Profile | Defect Mapping | Presence of Fossils & Comments |
|---|---|---|---|--|
| 2B | ~6m high cut | HW to HW/MW<br>PHYLLITIC<br>MUDSTONE | Foliation - 88°/062° 5mm to 70mm spacing<br>Bedding - 42°/260° - 30mm to 70mm spacing | No fossils found. The exposed bedding planes are masked by the foliation. Bedding also infilled with clay. Photos 13, 14 and 15. |

**Photo 13 – 22/2/2021** – View of Location 2B, showing the rock face to comprise foliated, HW/MW Phyllitic Mudstone.

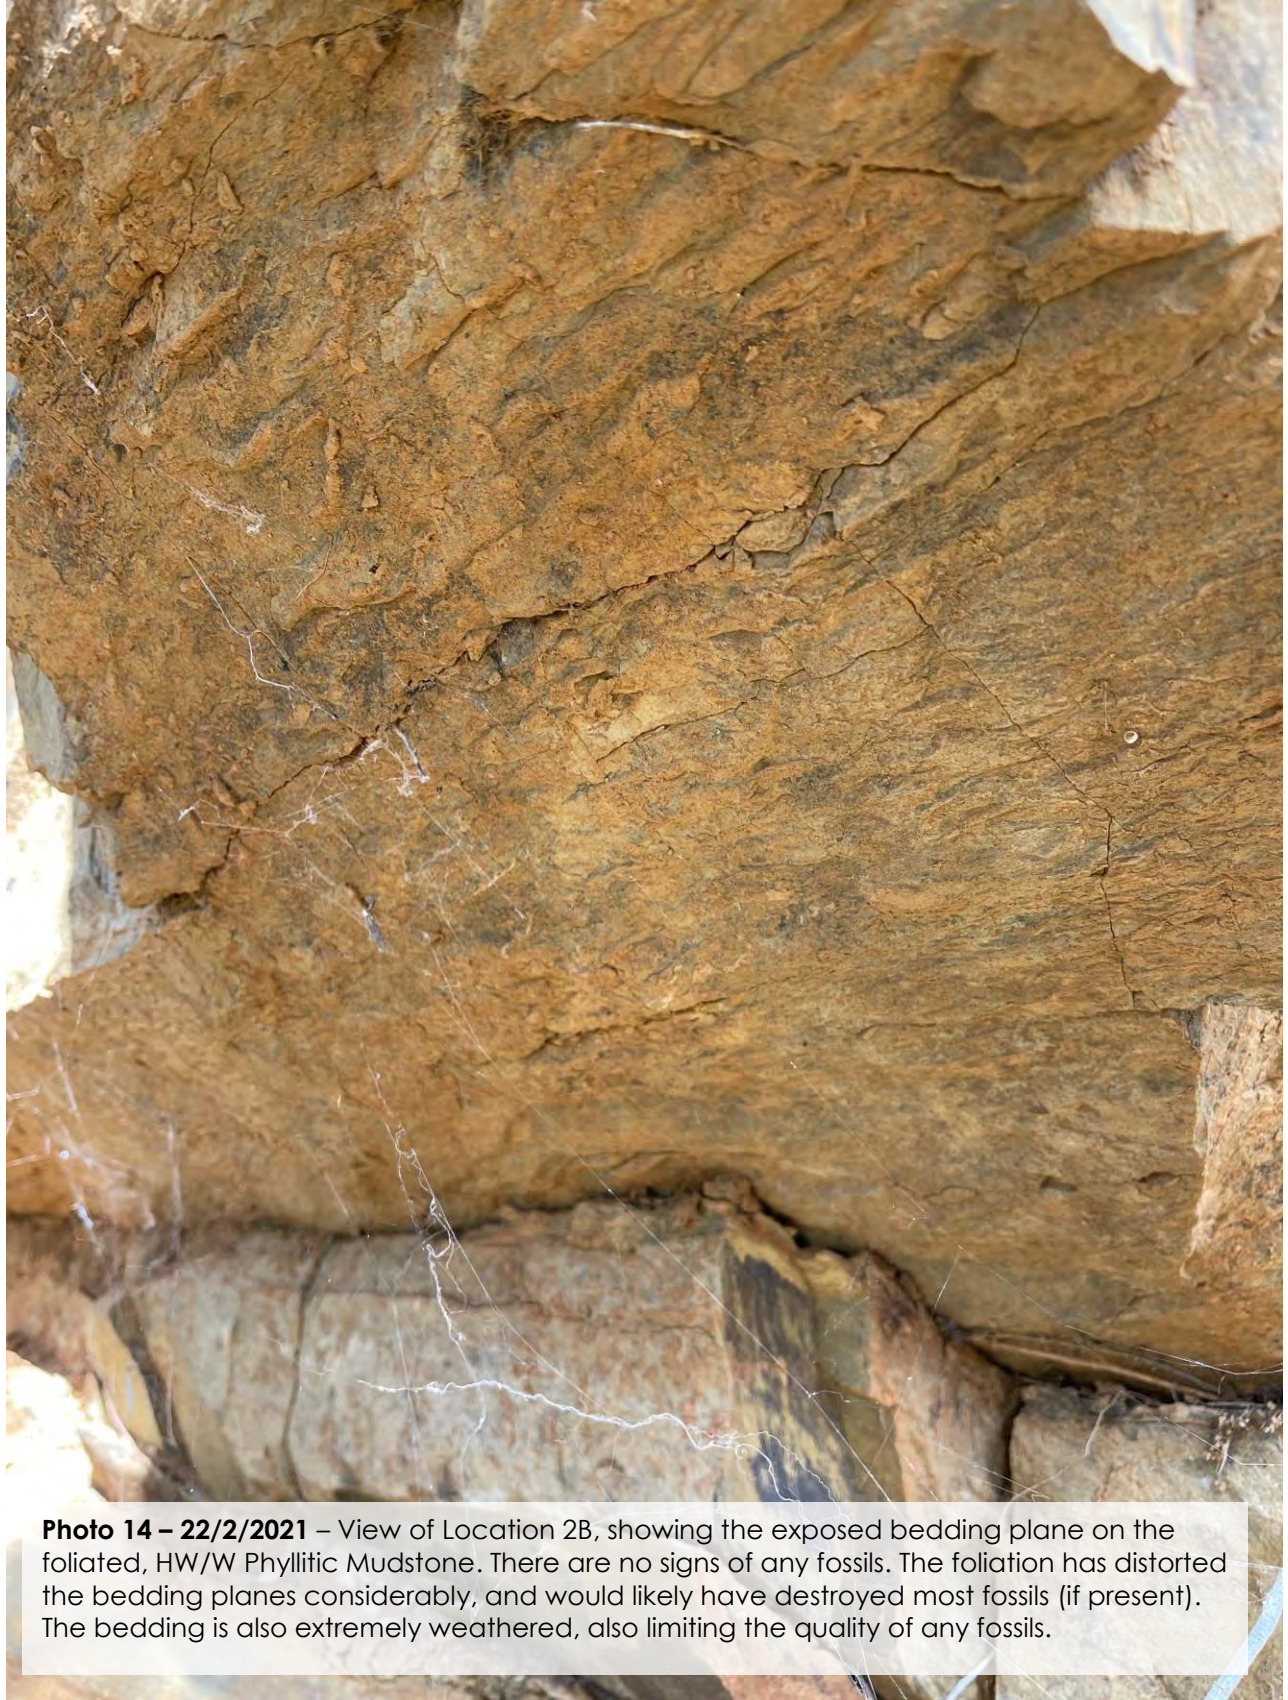
**Photo 14 – 22/2/2021** – View of Location 2B, showing the exposed bedding plane on the foliated, HW/W Phyllitic Mudstone. There are no signs of any fossils. The foliation has distorted the bedding planes considerably, and would likely have destroyed most fossils (if present). The bedding is also extremely weathered, also limiting the quality of any fossils.

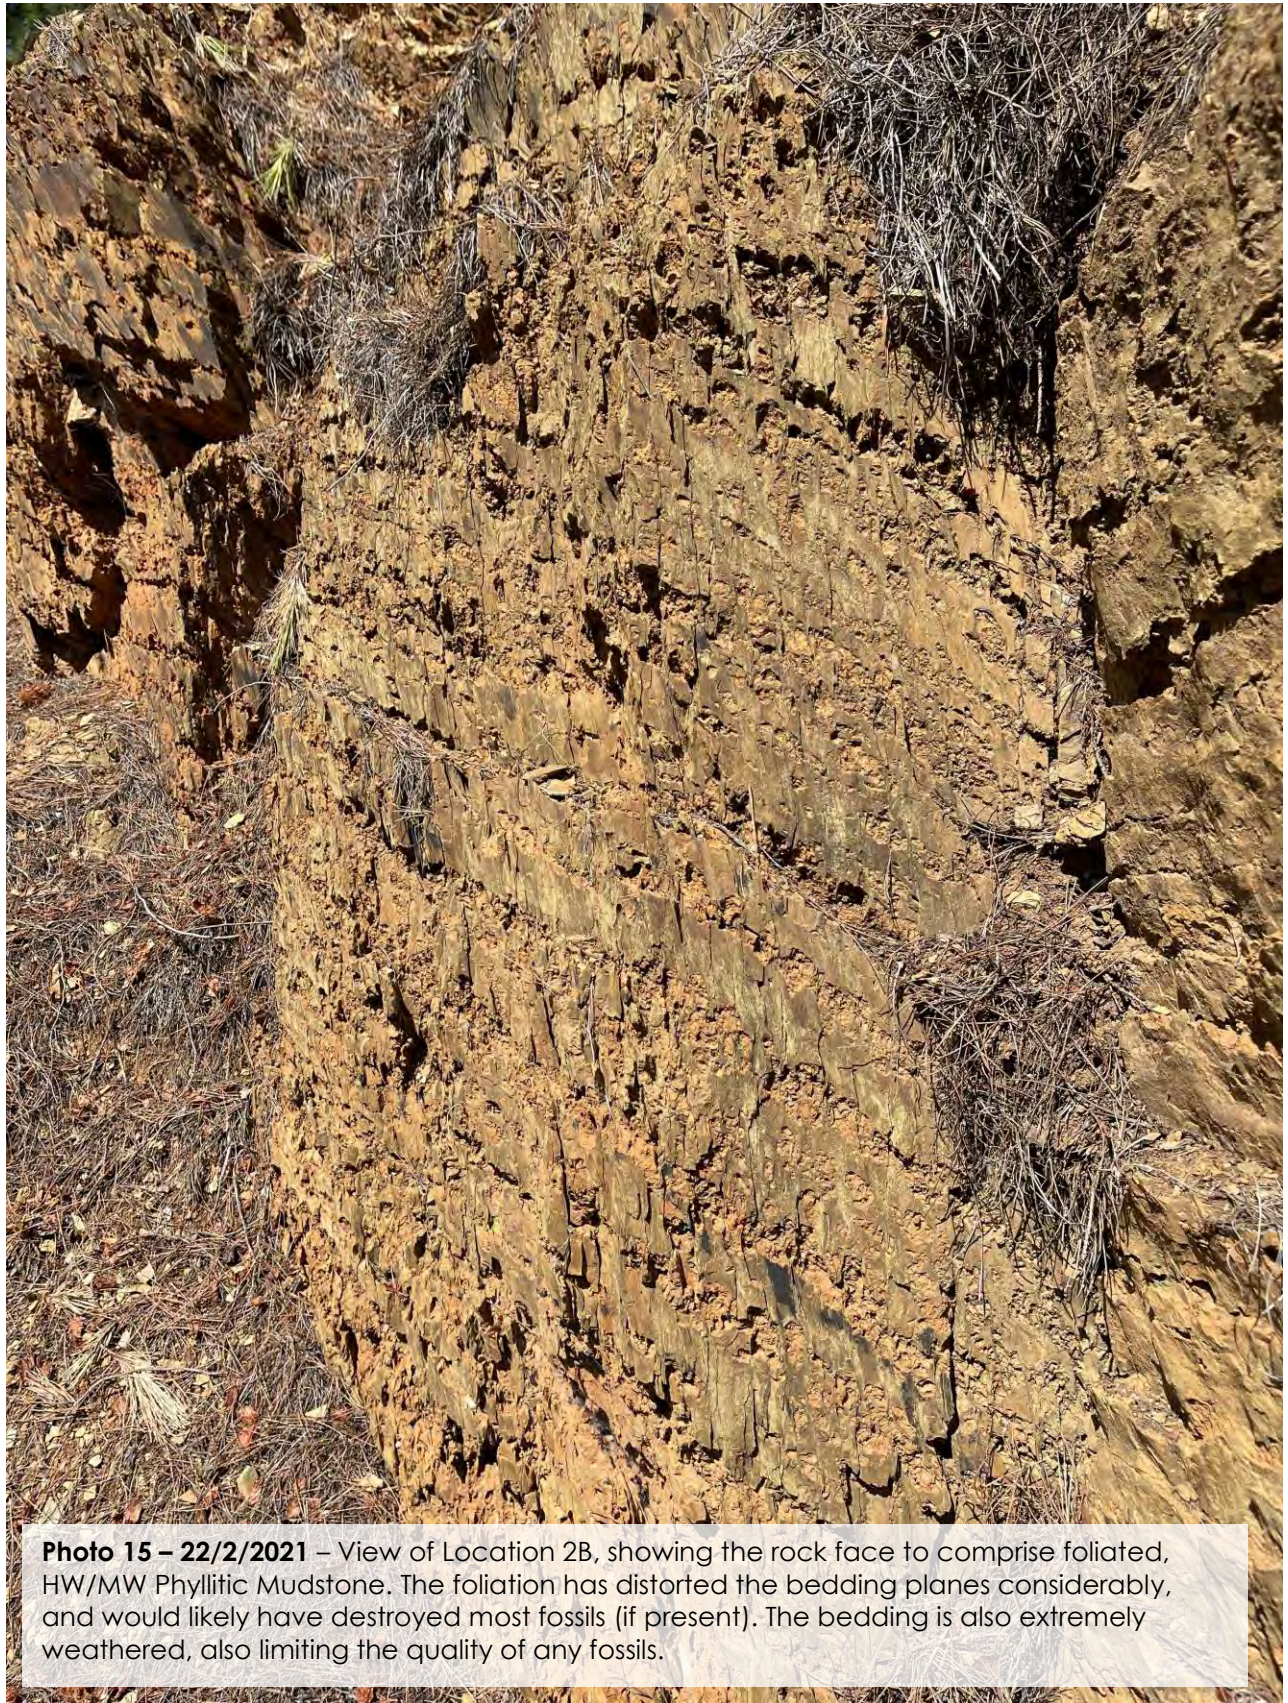
**Photo 15 – 22/2/2021** – View of Location 2B, showing the rock face to comprise foliated, HW/MW Phyllitic Mudstone. The foliation has distorted the bedding planes considerably, and would likely have destroyed most fossils (if present). The bedding is also extremely weathered, also limiting the quality of any fossils.

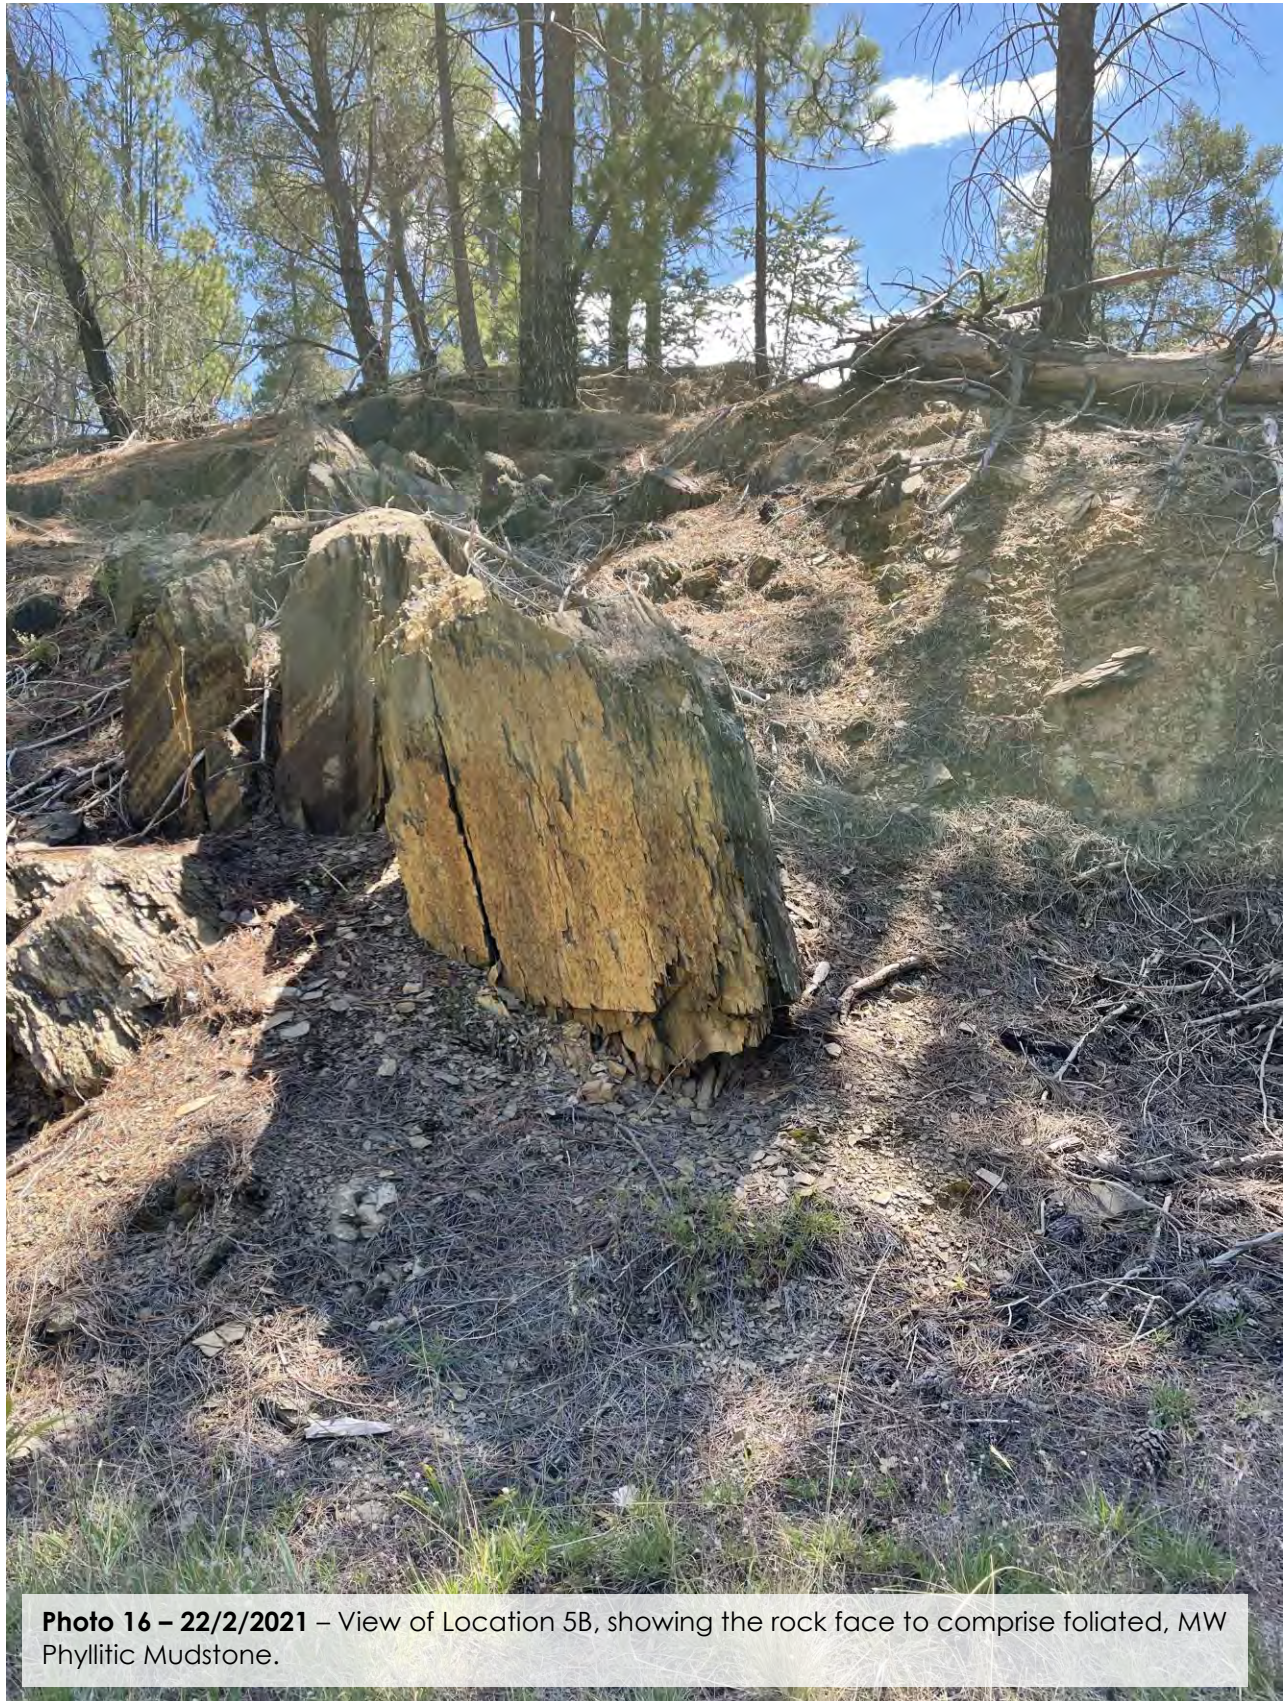
| Feature No. | Description | Rock Profile | Defect Mapping | Presence of Fossils & Comments |
|---|---|---|---|--|
| 5B | ~3m high cut | HW/MW<br>PHYLLITIC<br>MUDSTONE | Very disturbed and weathered face. Several large boulders on face (from quarrying or wedge failures) | No fossils found. Photo 16. |

**Photo 16 – 22/2/2021** – View of Location 5B, showing the rock face to comprise foliated, MW Phyllitic Mudstone.
