YARRALUMLA BRICKWORKS, ACT

Data Review and Gap Analysis and Sampling, Analysis and Quality Plan (SAQP)

26 JUNE 2017

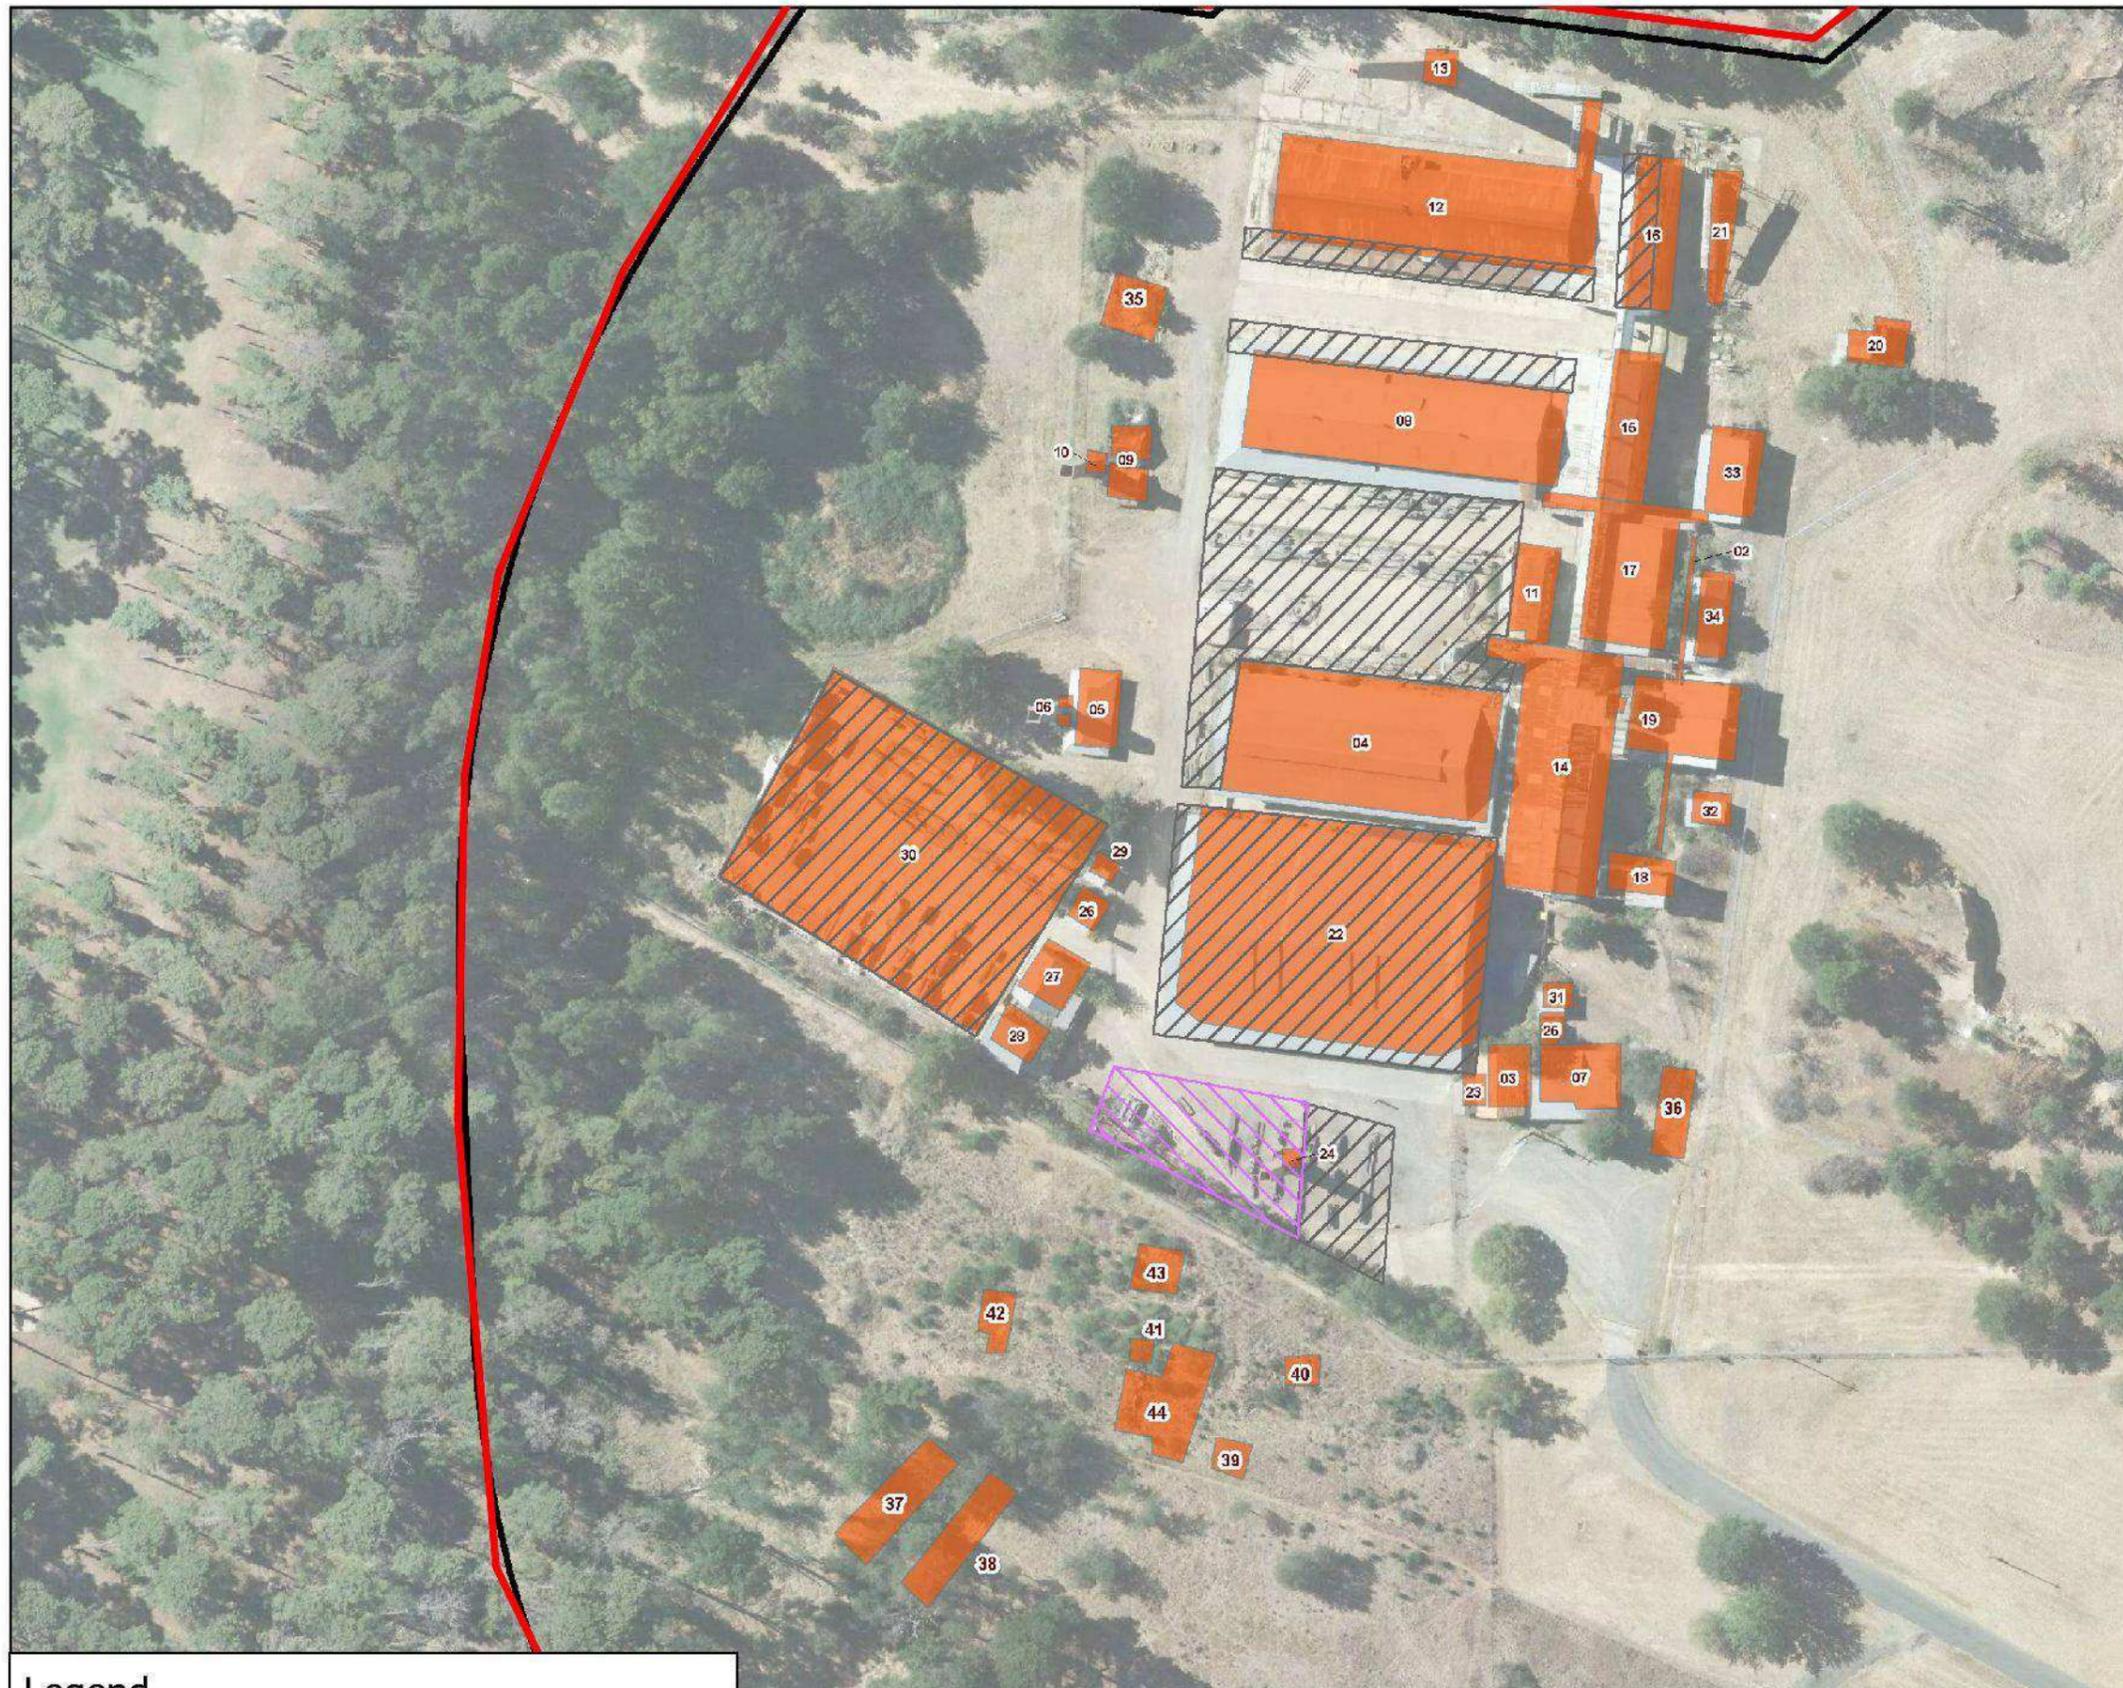
Figure 2:
Site Description

ID	Description
2	Concrete Retaining Wall
3	Power House
4	Staffordshire Kiln (Kiln 1)
5	Fan House for Kiln 1 (Fanhouse 1)
6	Chimney Stack for Kiln 1 (Stackhouse 2)
7	Offices
8	Hardy patent Kiln (Kiln 2)
9	Fan House for Kiln 2 (Fanhouse 2)
10	Chimney Stack for Kiln 2 (Stackhouse 3)
11	Amenities Block
12	Hardy Patent Kiln (Kiln 3)
13	Chimney Stack for Kiln 3 (Stackhouse 4)
14	Machine Bay I for Kiln 1
15	Machine Bay II for Kiln 2
16	Machine Bay III for Kiln 3
17	Workshop
18	Small Crusher House (Crusher House 1)
19	Larger Crusher House (White Pan Room / Crusher House II)
20	Primary Crusher House (Crusher House III)
21	Elevator / Conveyor
22	Downdraft Kilns (Kiln 4 - 6)
23	Downdraft Kiln Control Room
24	Chimney Stack for Kilns 4 - 6 (Stackhouse 1)
25	Toilet Block
26	Amenities Block
27	Substation / Control Room
28	Boiler House
29	Andillary Storage Building
30	Remnant of Extrusion Plant (Concrete Pad)
31	Andillary Storage Building

32	Storage Shed
33	Model Railway Workshop
34	Model Railway Storage Shed
35	Forklight Shed (Former)
36	Weighbridge (Former)
37	Sleeping Quarters 2
38	Sleeping Quarters 2
39	Hut
40	Hut
41	Hut
42	Hut
43	Latrine
44	Kitchen and Mess Hall

- Site Boundary
- Former Brickwork
- Timber Storage
- Unsealed Ground Surface
- Sealed Ground Surface

The general location is provided in Figure 1, Appendix A, while the current site boundary is shown in Figure 2, Appendix A. A figure with a surveyed site boundary will be provided within future works.

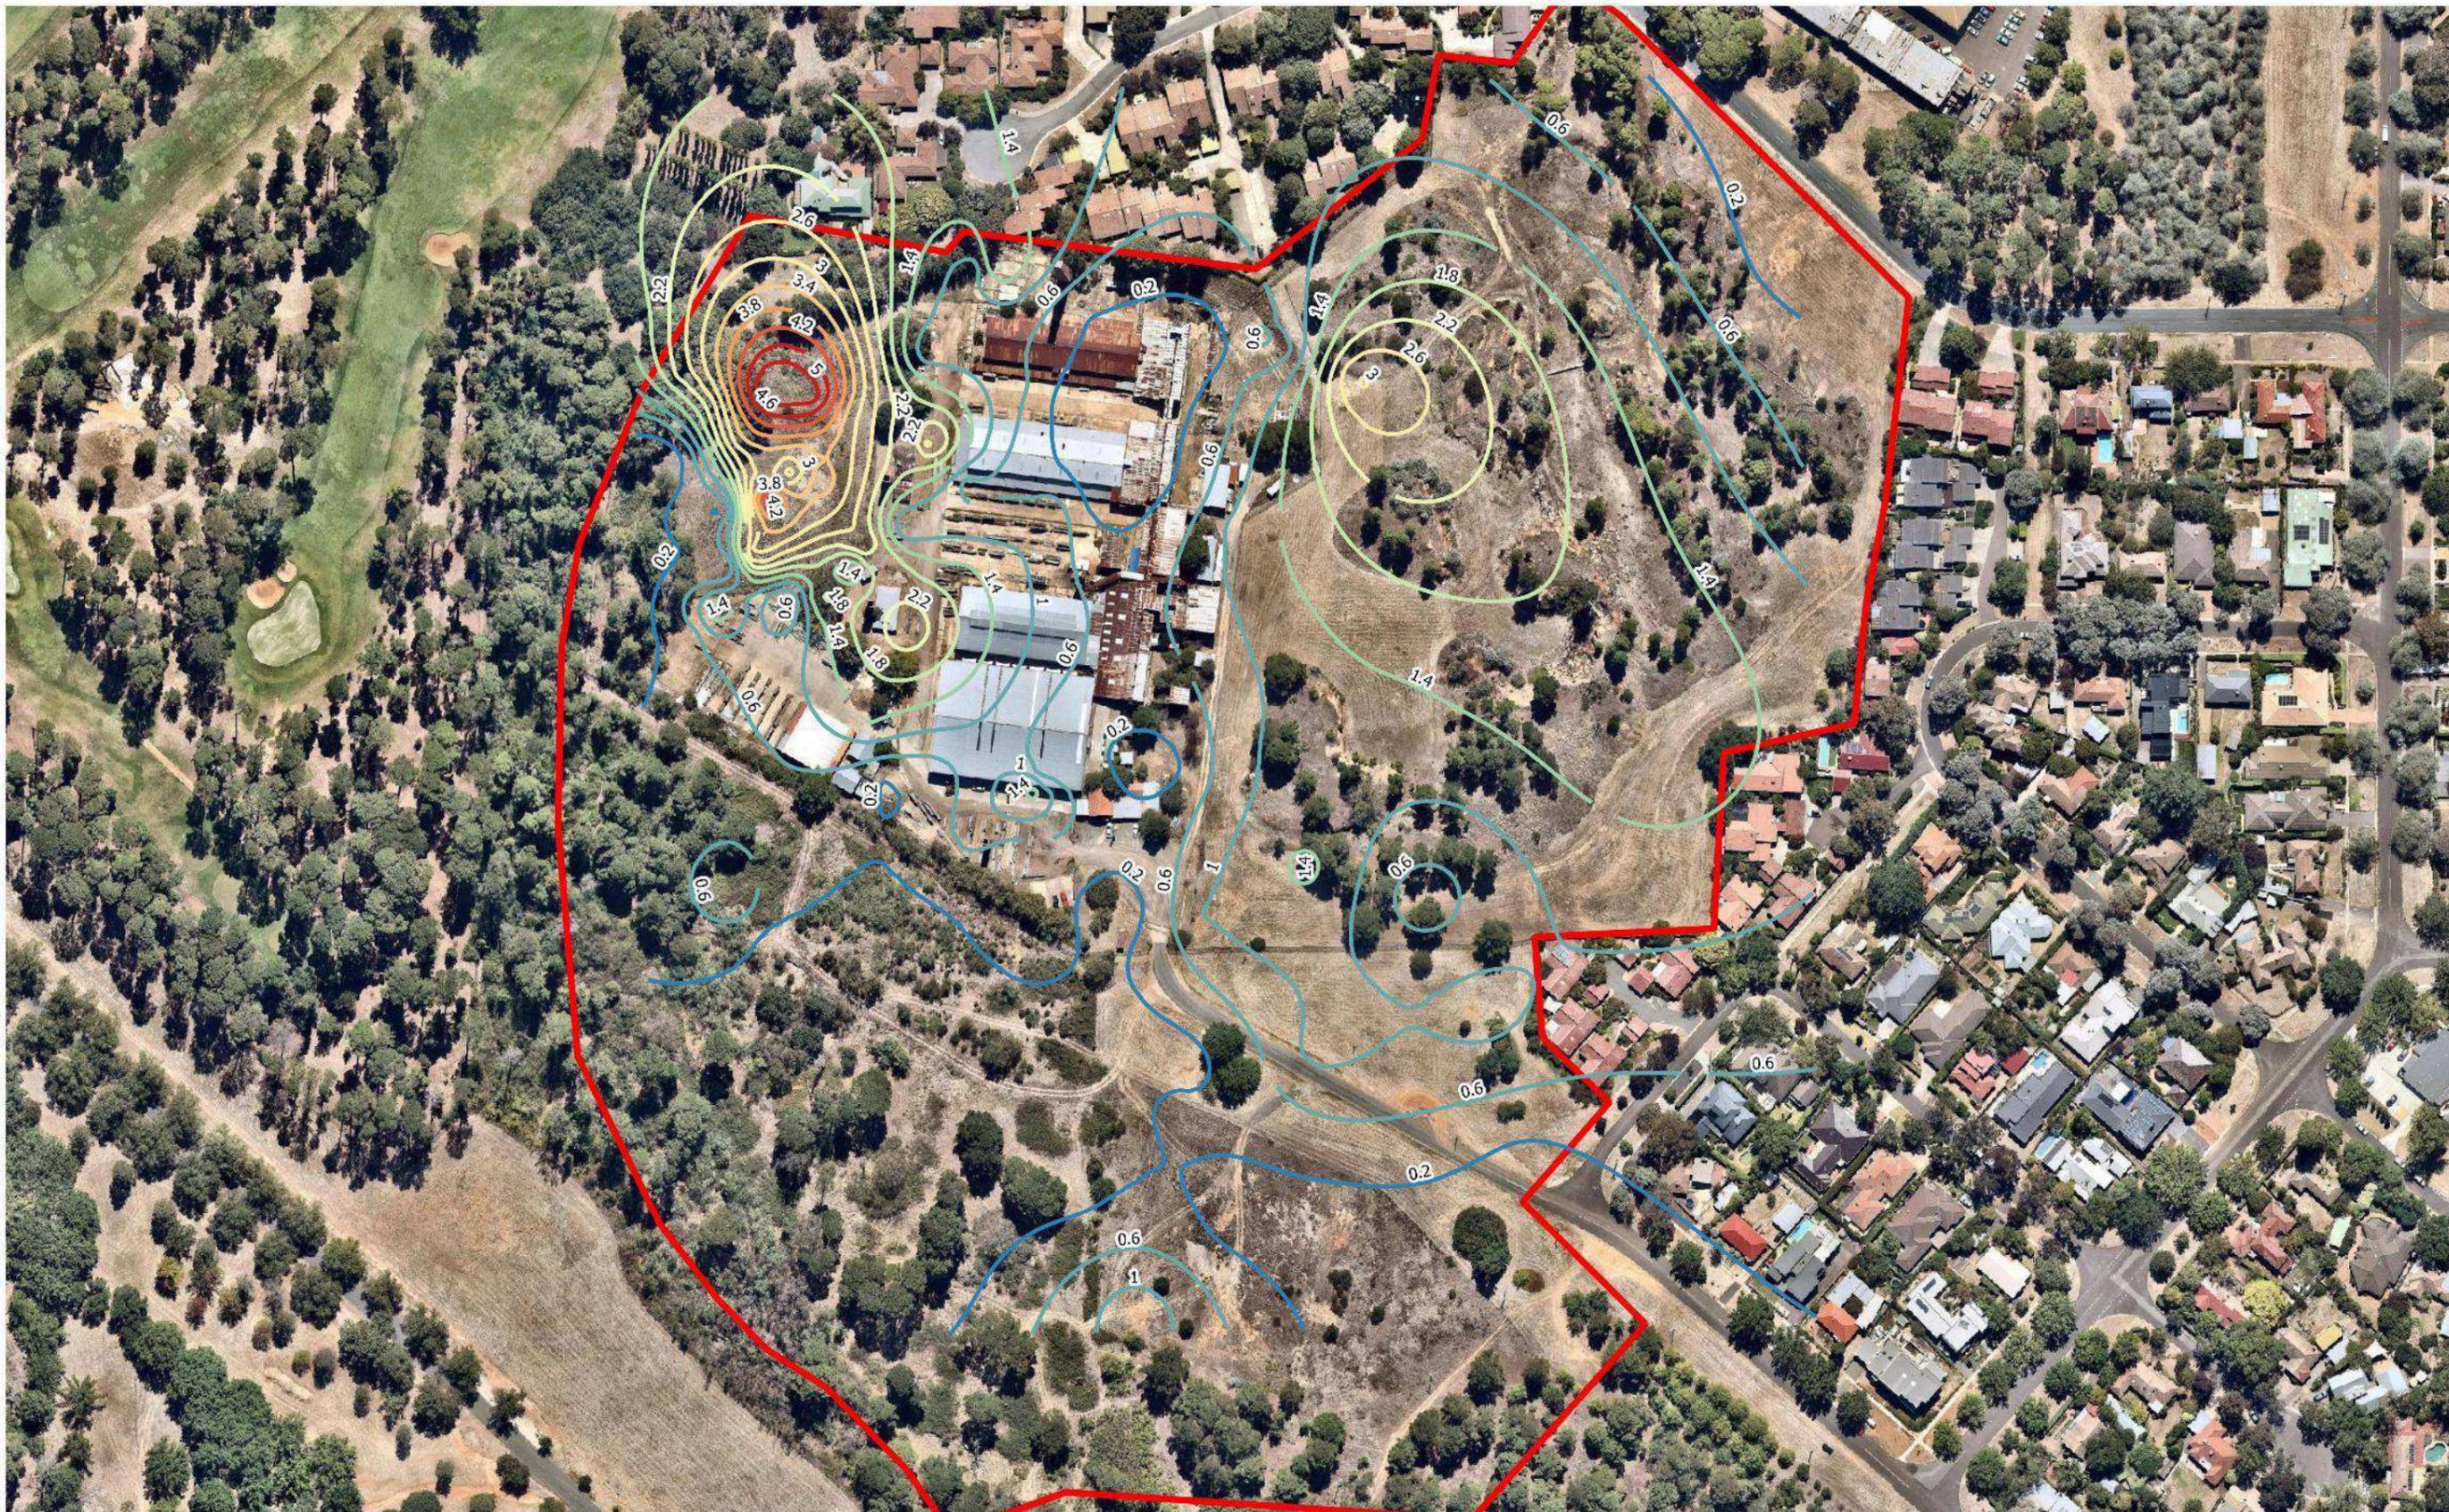
Legend
 Site Boundary
 Fill Contours (0.4m interval)

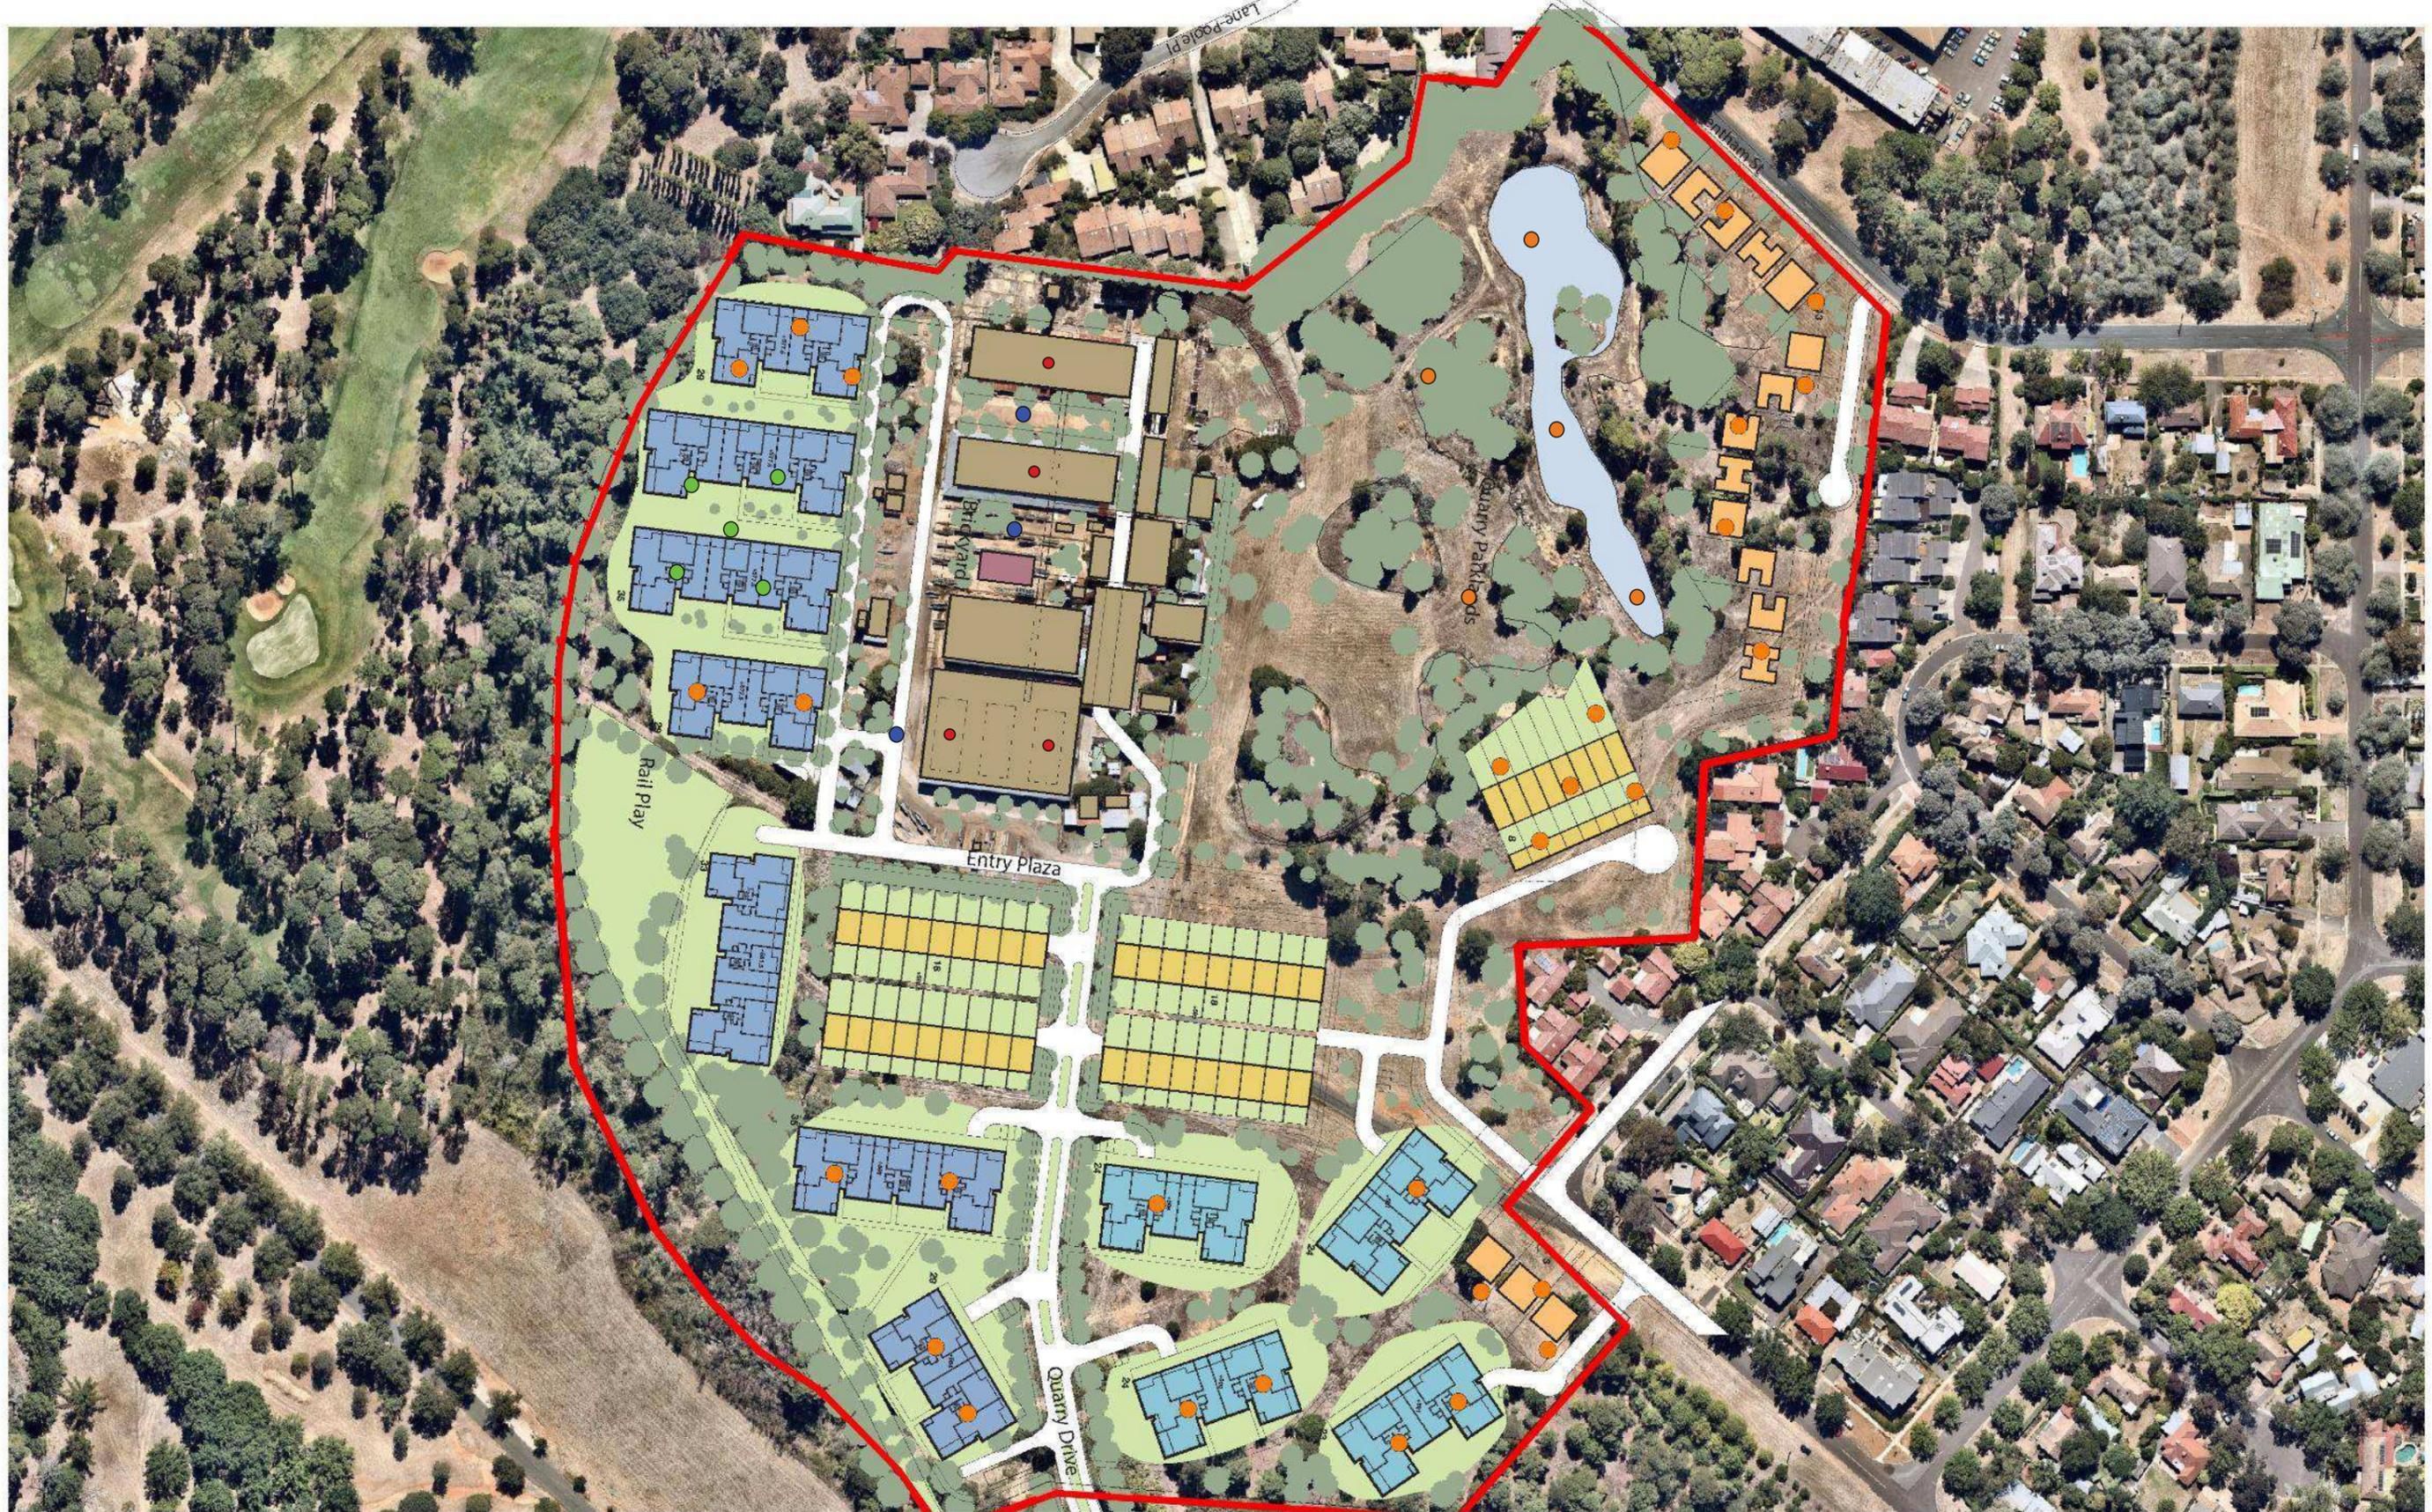
- Site Boundary
- Proposed GW Well
- Proposed Asbestos Dump Test Pit
- Proposed Sampling Locations
- Proposed Kiln Sample

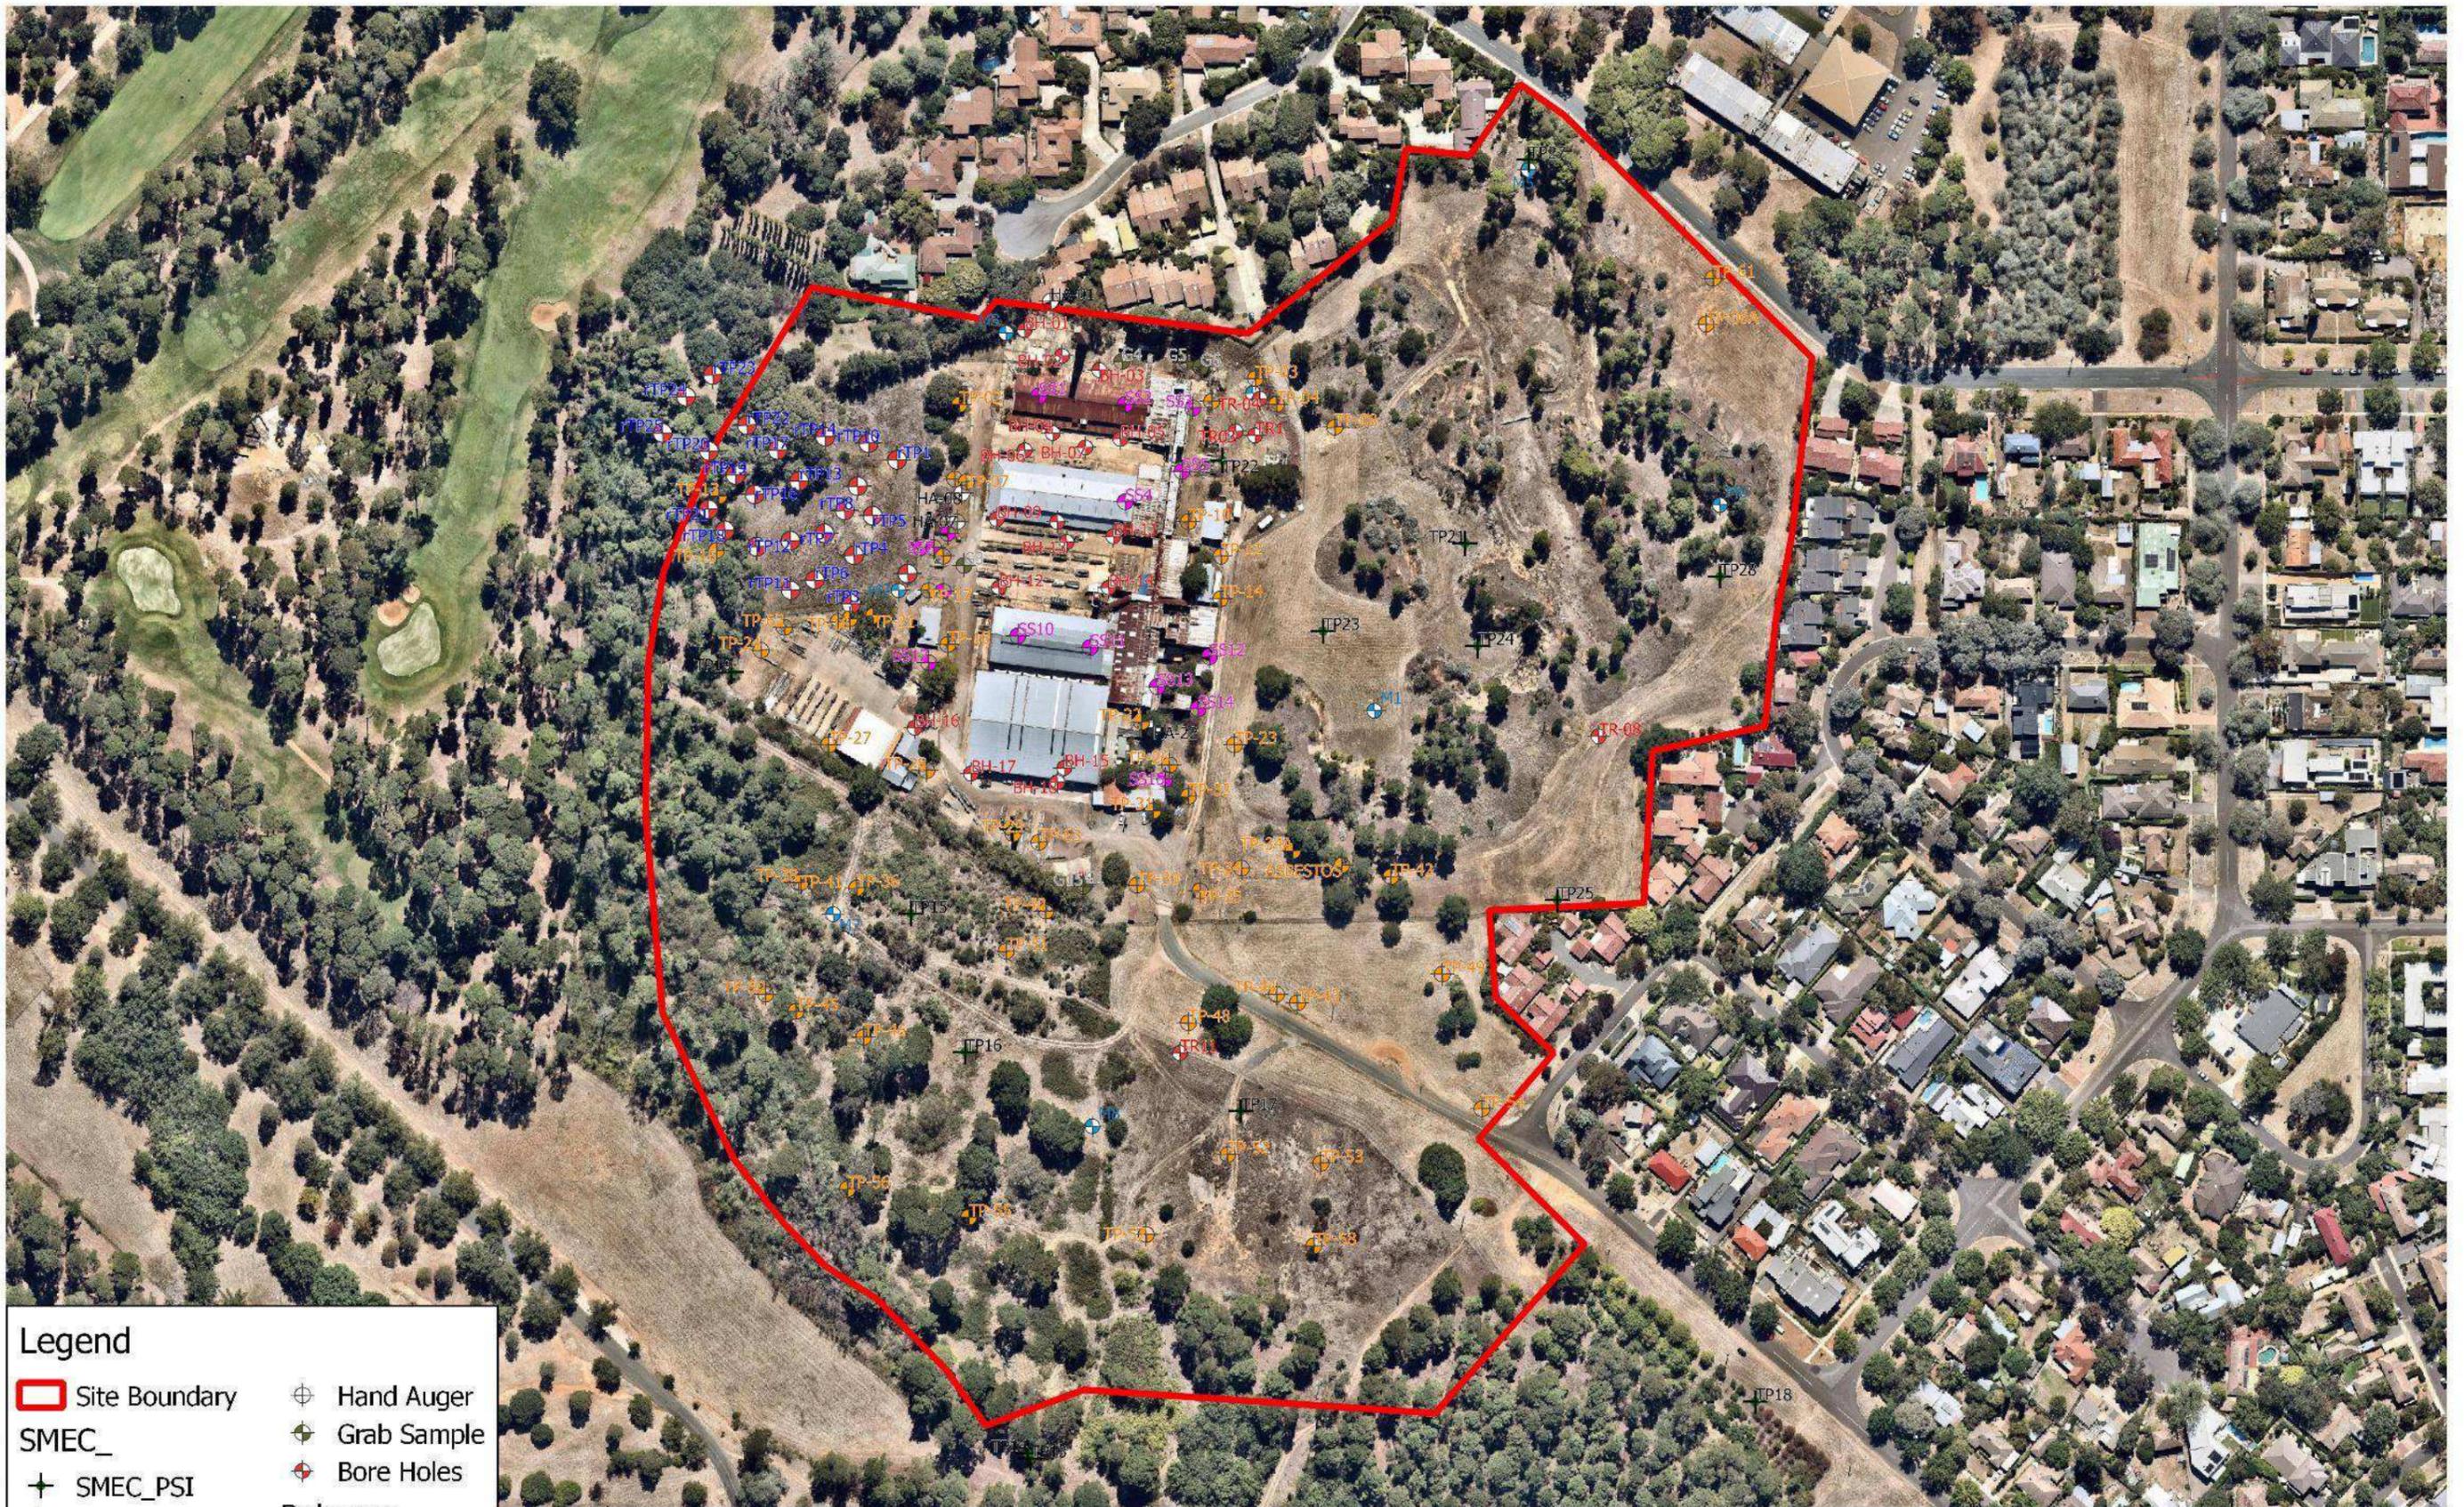
Site Boundary	Hand Auger
SMEC_	Grab Sample
SMEC_PSI	Bore Holes
Trench	Robsons_
Test Pits	Test Pits
Surface Sample	Transect
Monitoring Wells
