| Sheet Title: | Tree Assessment Plan | Date: | 3/11/2025 |
| Address: | 721 University Avenue, Canberra, ACT | Page Size: | A1 |
| | | Page: | TP-10.02 |

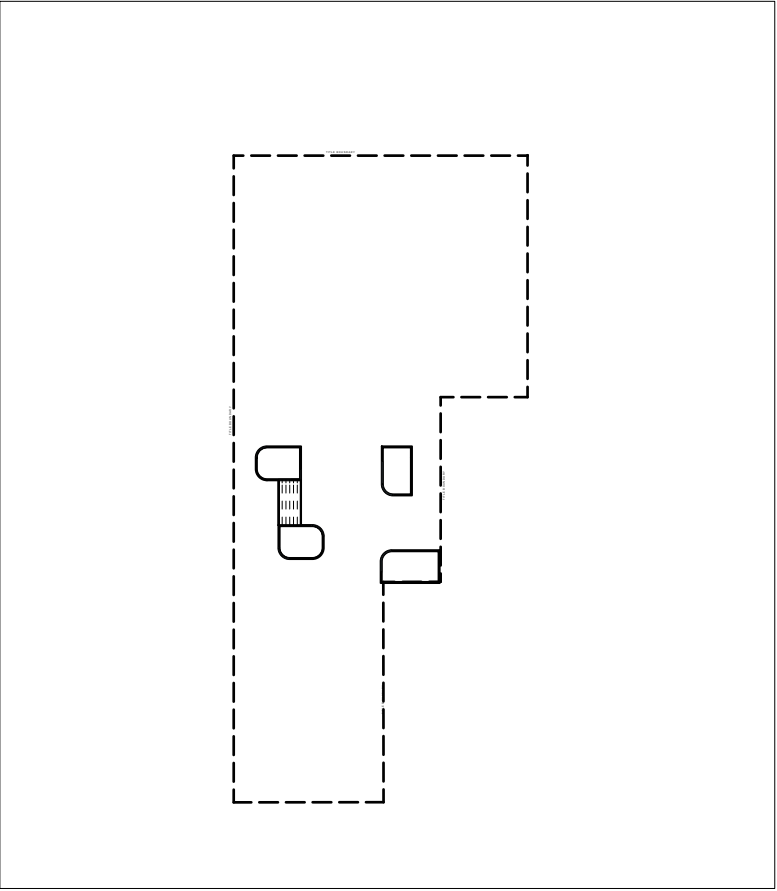
1 Landscape Tree Assessment Plan  
Scale: 1:150

\*All existing tree evaluations to be confirmed by arborist

- Existing trees to be removed
- Existing trees to be retained
- P - Poor Condition
- A - Average Condition
- G - Good Condition
