DATE: 8th of December 2021
REVISED 4th of February 2022

JOB REF: 8661

Preliminary Arboricultural Report 149 Canberra Avenue Fyshwick ACT 2609

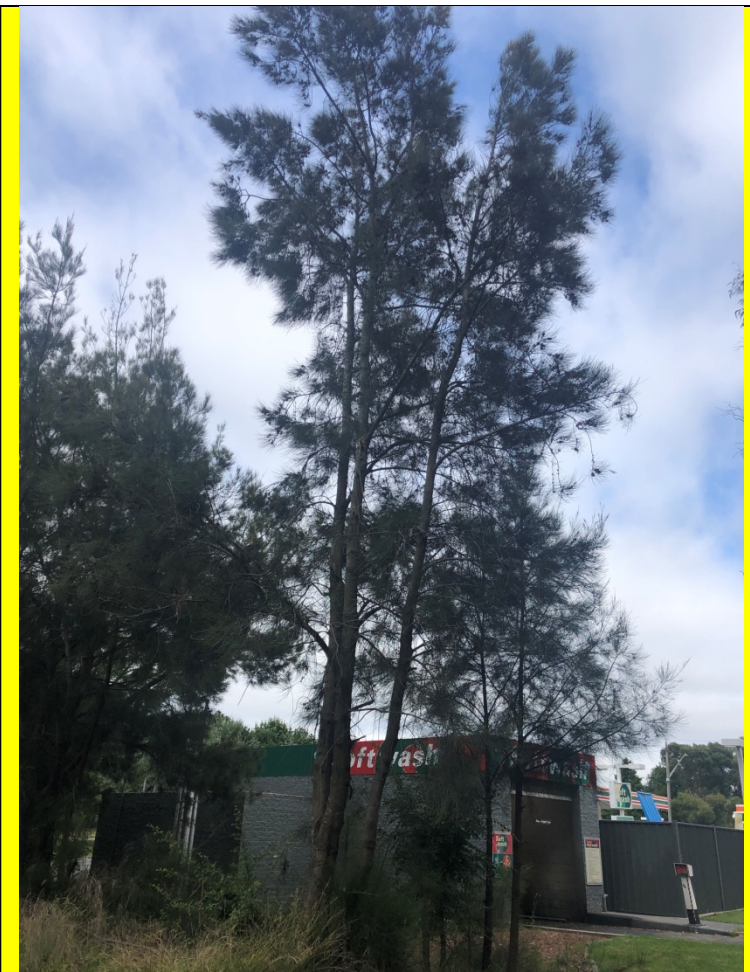
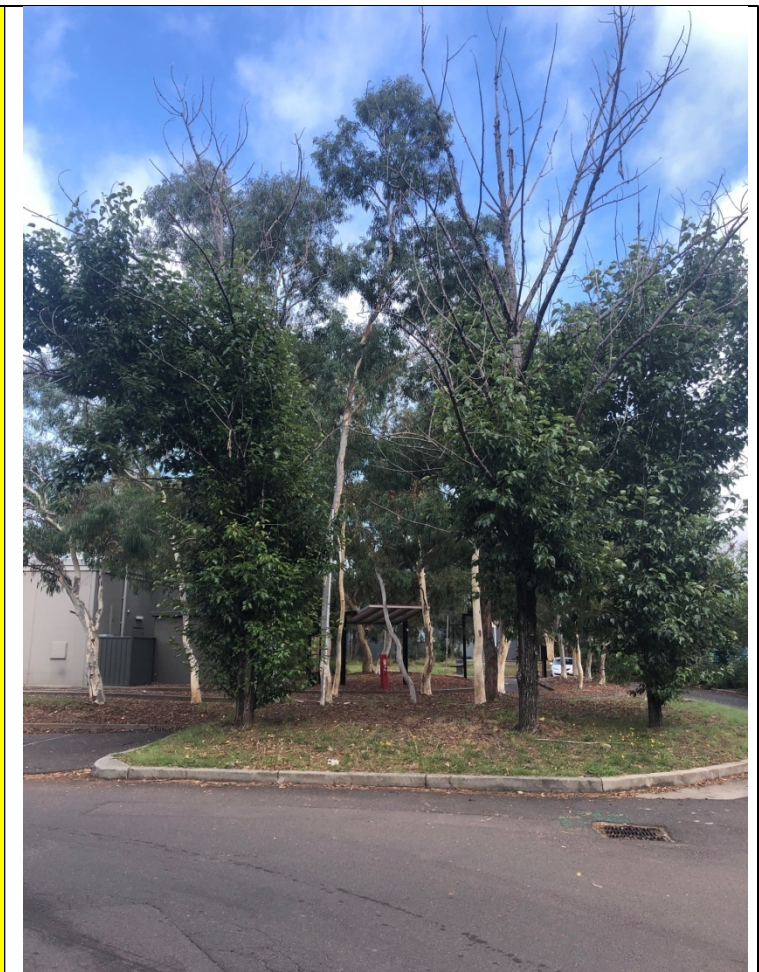
<p>Tree 37, 39 and 40 are Regulated and located within the raised medium strip</p>		<p>Tree 30 - Regulated</p>	<p>Trees not regulated because dieback in canopy top has reduced canopy height.</p>

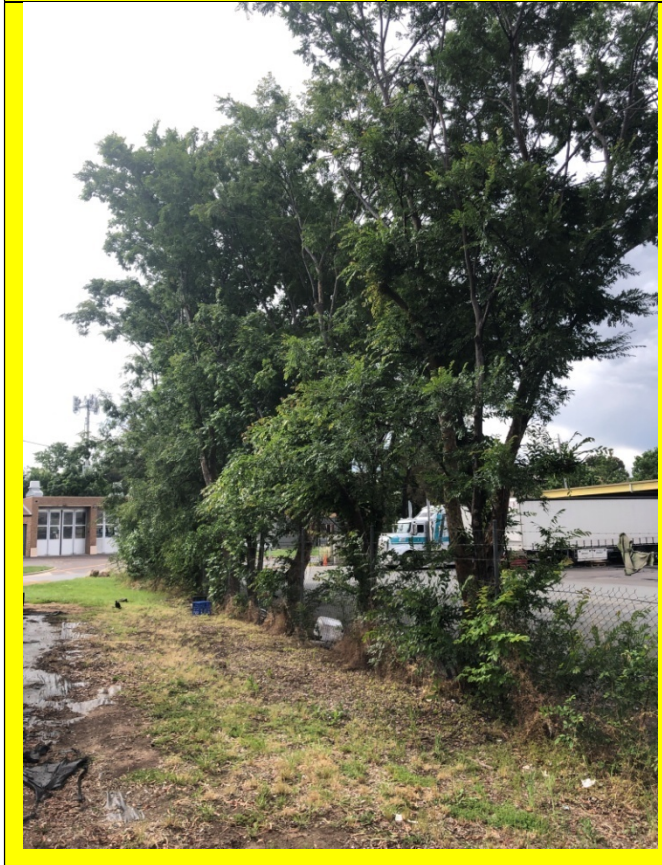
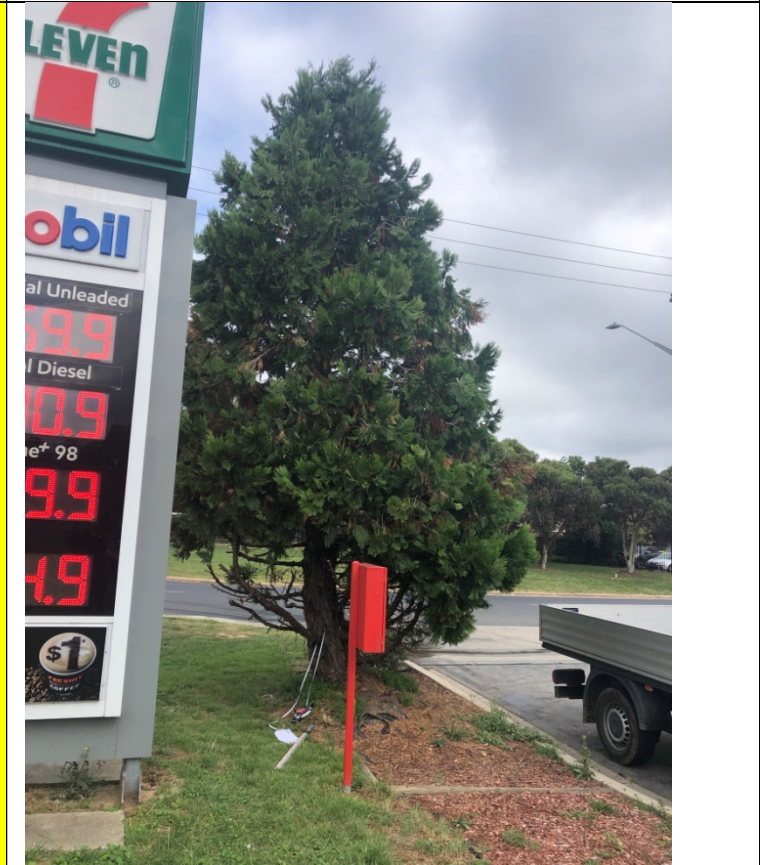
<p>Regulated ulmus parvifolia on boundary</p>	<p>Tree 81 Not Regulated</p>
