## HAZARDOUS MATERIALS SURVEY REPORT & MANAGEMENT PLAN

17-21 University Avenue,  
Canberra ACT 2601

Survey Completion Date: 9 August 2024

Job reference: LDJ3334

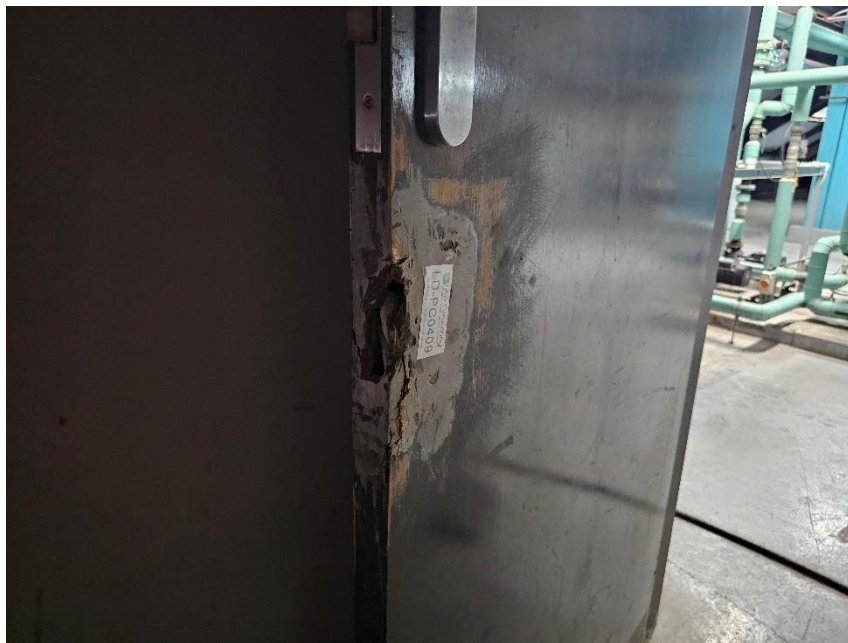
**Photo Number:** ACM17

**Material:** Membrane

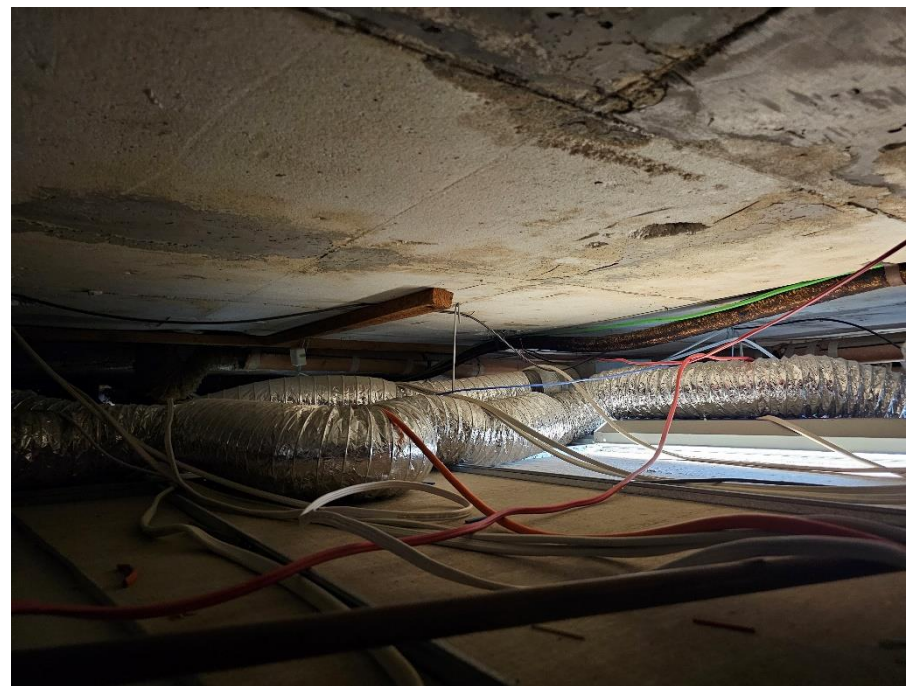
**Photo Number:** SMF2

**Location description:** Foil backed insulation to pipework

**Material description:** Fibreglass

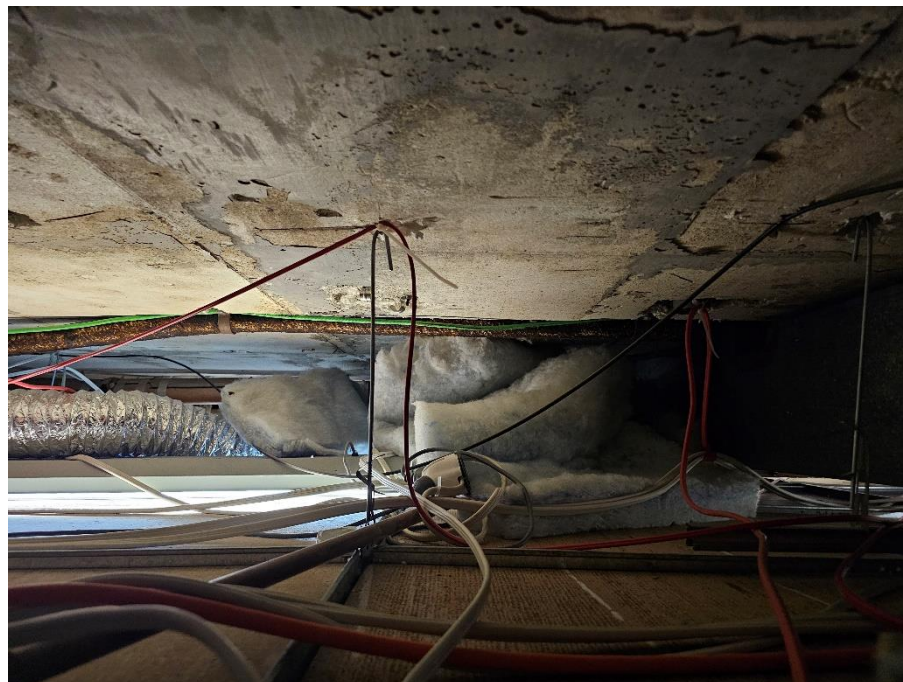
**Photo Number:** SMF5

**Material description:** Fibreglass
