## HAZARDOUS MATERIALS SURVEY REPORT & MANAGEMENT PLAN

24 Marcus Clarke Street,  
Canberra  
ACT 2601

Survey Completion Date: 31 July 2024

Job reference: LDJ03333

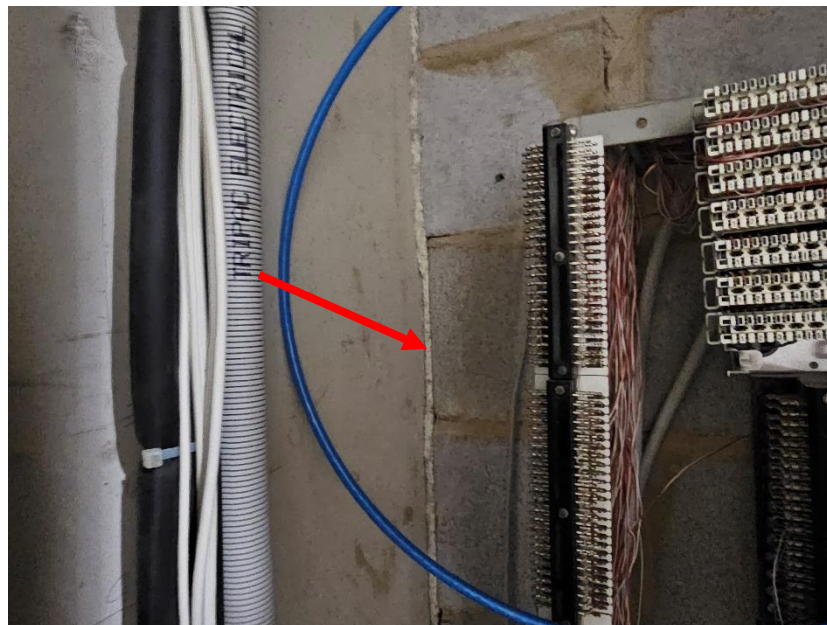
**Photo Number:** ACM13

**Material:** Rope

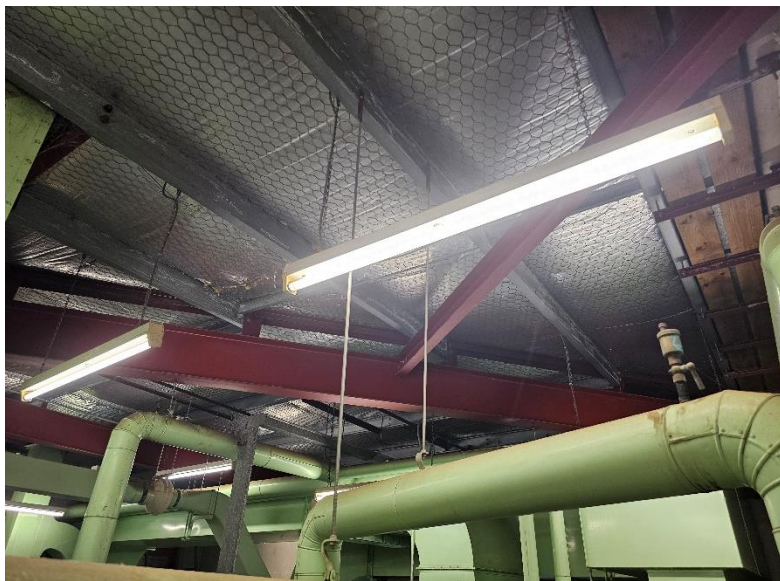
**Photo Number:** PCB1

Fluorescent lights were not inspected due to being electrically live at the time of the survey. They should be presumed to contain PCB containing capacitors unless further inspection proves otherwise. No evidence of deterioration or leaking of capacitors was identified during the survey.
