CANBERRA
BRICKWORKS

**CONSERVATION
DEVELOPMENT
STRATEGY**

February 2015

STAGE 1
PUBLIC AND PEDESTRIAN ACCESS
BUILDING WORKS

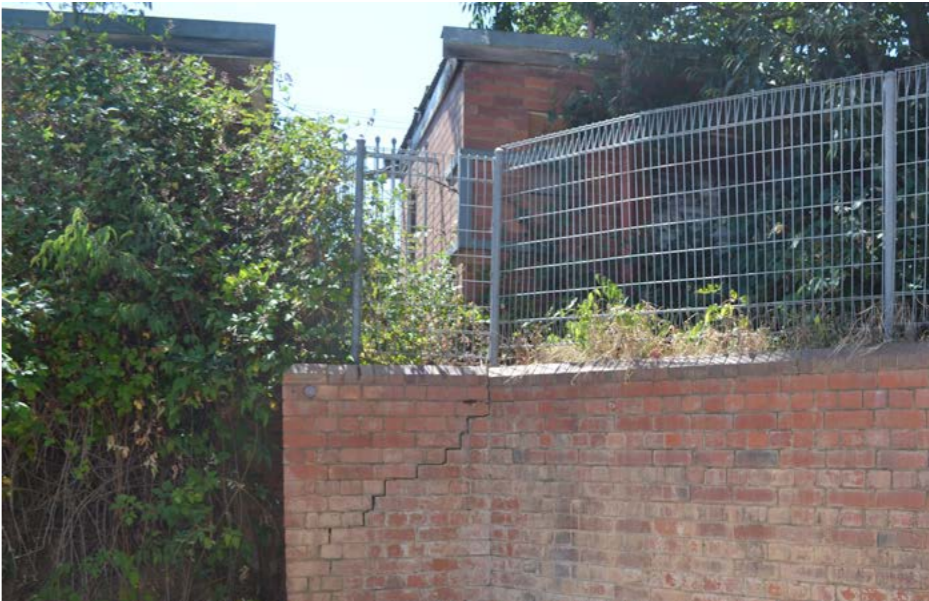
Building #	Building Name	Significance as identified in the 2010 CMP review	Make Safe - architectural	Make Safe - structural	Photo
24	Chimney stack for Kilns 4-	Supporting element	<p>Check lightning protection and rectify/replace if required.</p> <p>Cap top of chimney to make weather tight.</p> <p>Cracked brickwork to top courses (outward leaning).</p> <p>Secure all openings in face of chimney with CGI Steel sheet or mesh gates.</p> <p>Remove invasive vegetation.</p>		 
25	Toilet block	Incidental element	Demolish and clear site.
