# Canberra Brickworks Precinct

## Conservation Management Plan

### Volume Two—Appendices

September 2021

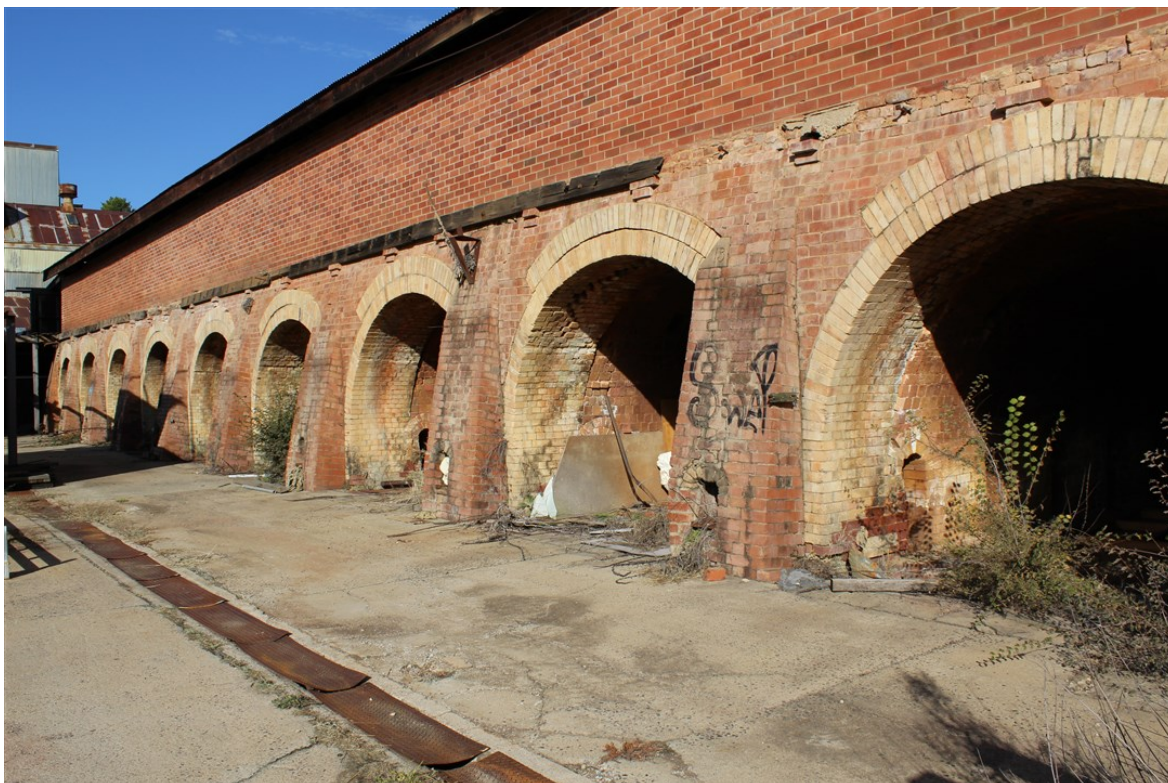
Internally, there are a number of 'trace-holes' which could be closed by dampers and were raised and lowered from the firing floor above. Within the kiln arches the feedholes and hot air off-takes are still apparent. Some kilns have been paved internally with cement tiles, a modification which occurred after the closure of the plant. The majority of the entry archways have loose bricks and voids in the brickwork bedding, resulting in displacement of some arches. The entry arches have displaced laterally in areas, which

is likely due to swelling of the bricks. The internal areas of the kilns are generally in sound structural condition, with some loose bricks.

**Figure 7** North elevation showing modified kiln entrances. (Source: GML, 2017)

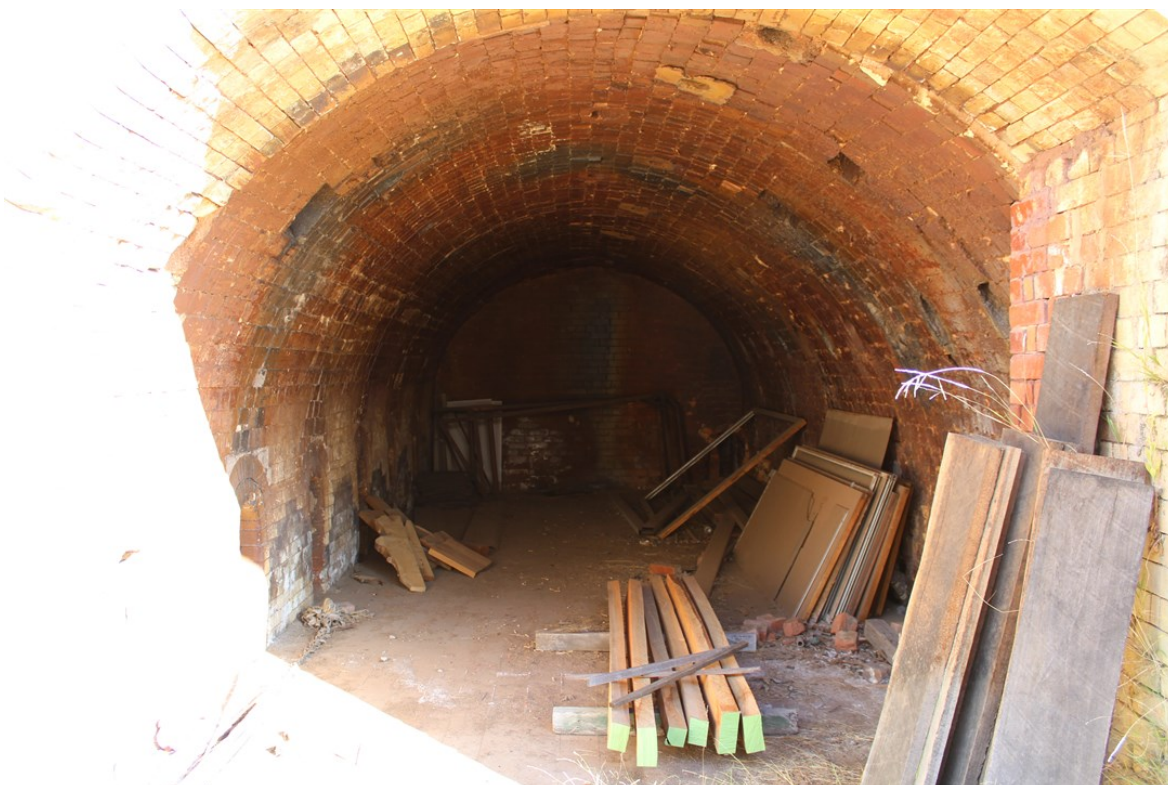
The inspection report for the building identified that the brick veneer is in reasonable condition for its age, however there is some cracking and loose brickwork throughout the arches of the kilns, and the entries to some have deteriorated. The wall sheeting has severe deterioration in places and the timber lean-to is significantly weathered. The sheet fixings are noted to be loose in some areas. The steel trussed roof is in a reasonable condition and roof sheeting appears to have been replaced more recently. The steel brace at the south elevation has buckled. There are 'chimney' holes from the kilns below throughout the floor.

**Figure 8** Interior of kiln at north elevation. (Source: GML, 2017)

Structural Advice as at 2021	Immediate rectification works required, with access to some floor areas to be restricted—refer to Appendix G for detail.
Conservation Policy and Adaptation Guidelines	Core elements must be retained and conserved
<ul style="list-style-type: none"> <li>The Staffordshire Kiln must be retained and conserved.</li> <li>The brickwork veneer should be restored and ensured that it is weatherproof.</li> <li>External fabric of the building should generally be retained, noting that non-original brickwork on the upper level could be removed/replaced.</li> <li>Locally displaced bricks should be reinstated.</li> <li>An area of the firing floor of either this kiln or one of the Hardy patent kilns should be retained intact as a single volume, allowing the nature and operations of the firing floors to be clearly understood.</li> <li>Minor changes to the exterior, such as new openings, would be acceptable.</li> <li>A limited number of roof lights would be acceptable to improve light and amenity to the upper floor.</li> <li>Installing solar panels on the roof and exploring other ESD opportunities would be acceptable.</li> <li>The remnant verandah could be removed and replaced. Any new structure (ie verandah and/or upper level walkway) should reference the industrial character.</li> <li>The current form of the entries to the kiln chambers should be retained. Chambers could be enclosed with recessed doors if needed.</li> <li>Retain kiln chambers as open space where possible in an adaptive reuse project, to provide a representative example of a kiln space for the interpretation of the historical use, rather than subdividing all of them.</li> <li>The building could be adapted internally for new use or uses, including subdivision and new fitout, provided an area of firing floor is retained for this kiln or one of the Hardy patent kilns. The kiln chambers could be linked (ie north-south or east-west connections) to extend the space, if necessary to support a new use.</li> <li>Within the interior upper level, the existing dirt floor can be excavated and replaced with a new floor, covering up the firing holes and ensuring the floor is free of trip hazards. This will lower the floor level and permit a sufficient truss clearance to allow an adaptive reuse of the space.</li> <li>Window fenestration to the upper floor should mimic the rhythm of historic openings but allow for appropriate daylight and ventilation access for an adaptive reuse.</li> <li>Restore all or part of a chamber, including the vents to show the original kiln operation, and the corresponding upper floor space sufficient so that the method of firing and controlling the kilns can be seen in future adaptive reuse.</li> <li>Bracing of the upper level should be further assessed by a structural engineer.</li> <li>Steel roof structure needs to be further assessed by a structural engineer and fixed where required.</li> </ul>

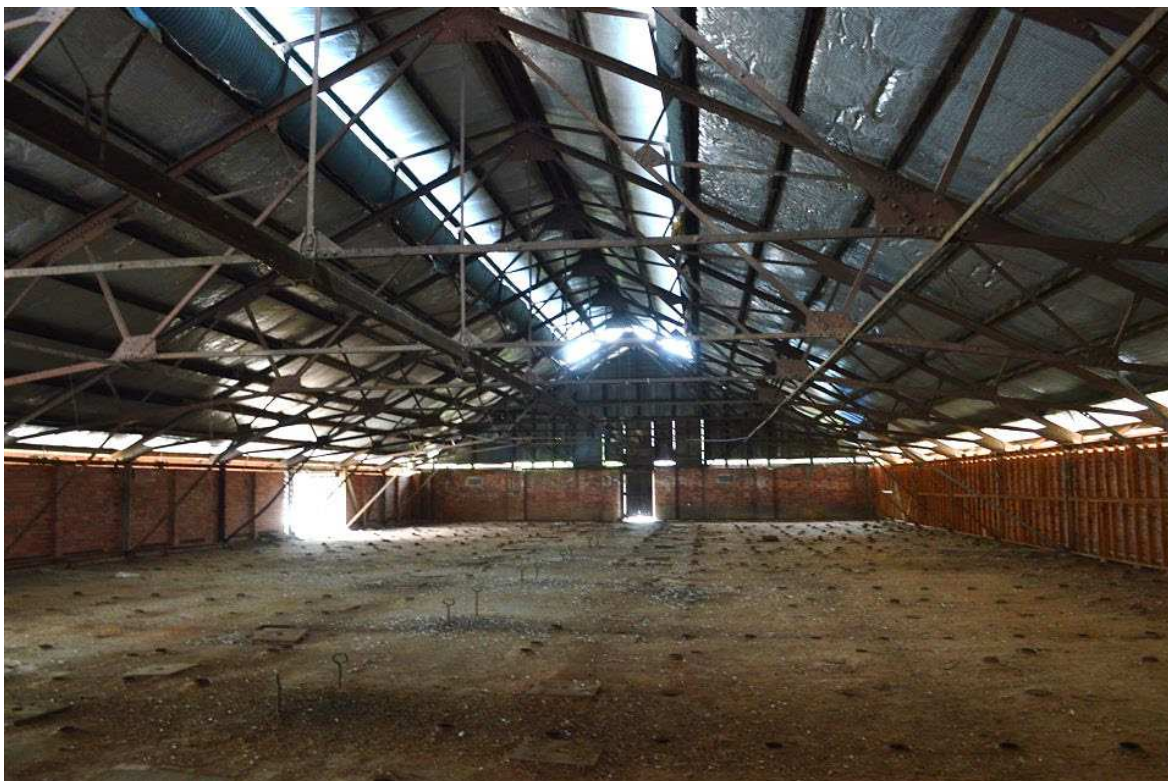
The upper floor and verandah of the Staffordshire Kiln has also been modified a number of times including the enclosing of the verandah with corrugated iron, bringing the line of the upper floor out to the edge of the original verandah. This modification was later reversed by A R Marr Pty Ltd when new brick walls were constructed on the line of the original building wall, with the intention of refitting the space as a commercial facility. The roofing was also replaced at this time. The glazed louvre vents are also broken and not weatherproof.

**Figure 9** Interior of upper level. (Source: GML, 2016)

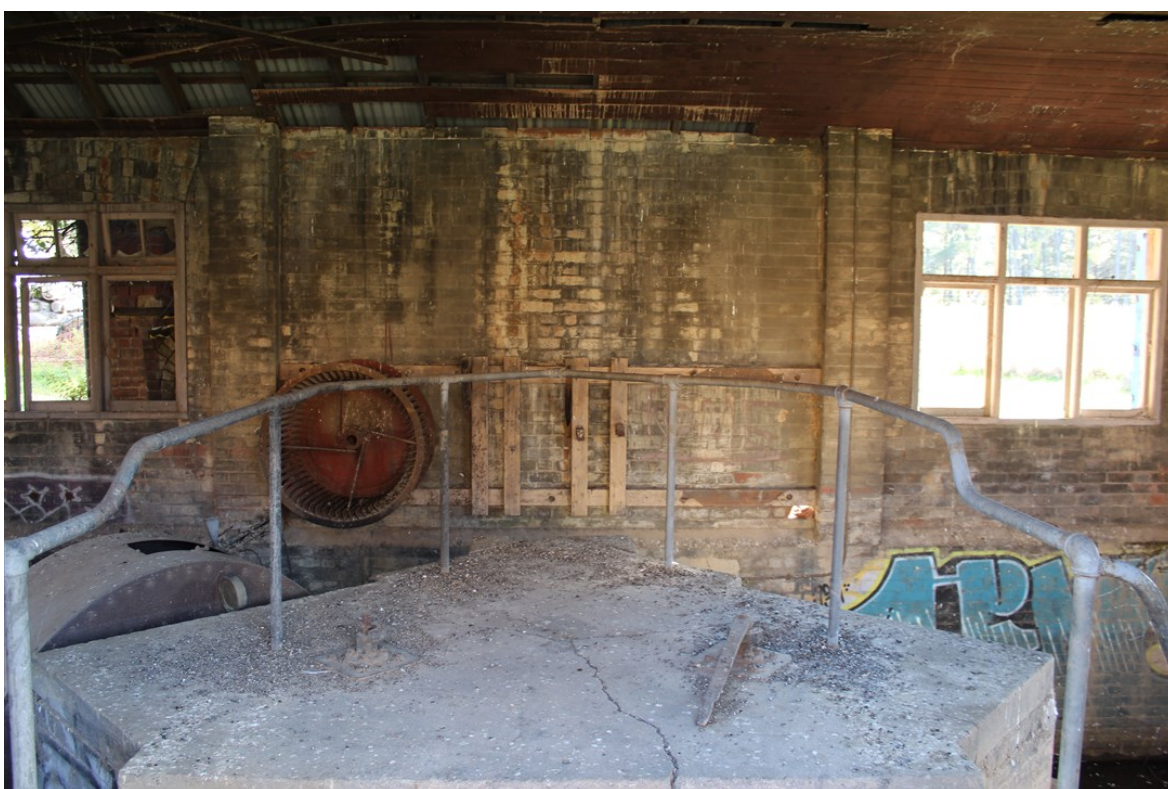
The inspection report for the building identified that the ceiling boards are in poor condition and partially collapsed and the concrete basement is filled with debris. The front doors have been removed, the windows are broken and the glass panes are missing. The internal brickwork is graffitied and heavily stained by soot. The handrails do not fully extend around the ground floor platform, with one handrail loose. There is moderate cracking of the brick lintels above the windows. The remaining fan motor is in a dilapidated state. Sinkholes have been observed around the building due to settlement of basement backfill. The brick 'oven' structure next to the chimney stack is severely cracked. Little to no mortar remains in the joints, leaving bricks loose and unstable. The rainwater goods, soffits and fascias to the roof have all been removed. The condition of the roof, joinery and interior is poor. Brickwalls are in reasonable condition, with some cracking to lintels.

**Figure 3** Interior of the Fan House from entrance across ground level platform. Tangential fan mounted on rear wall. (Source: GML, 2017)

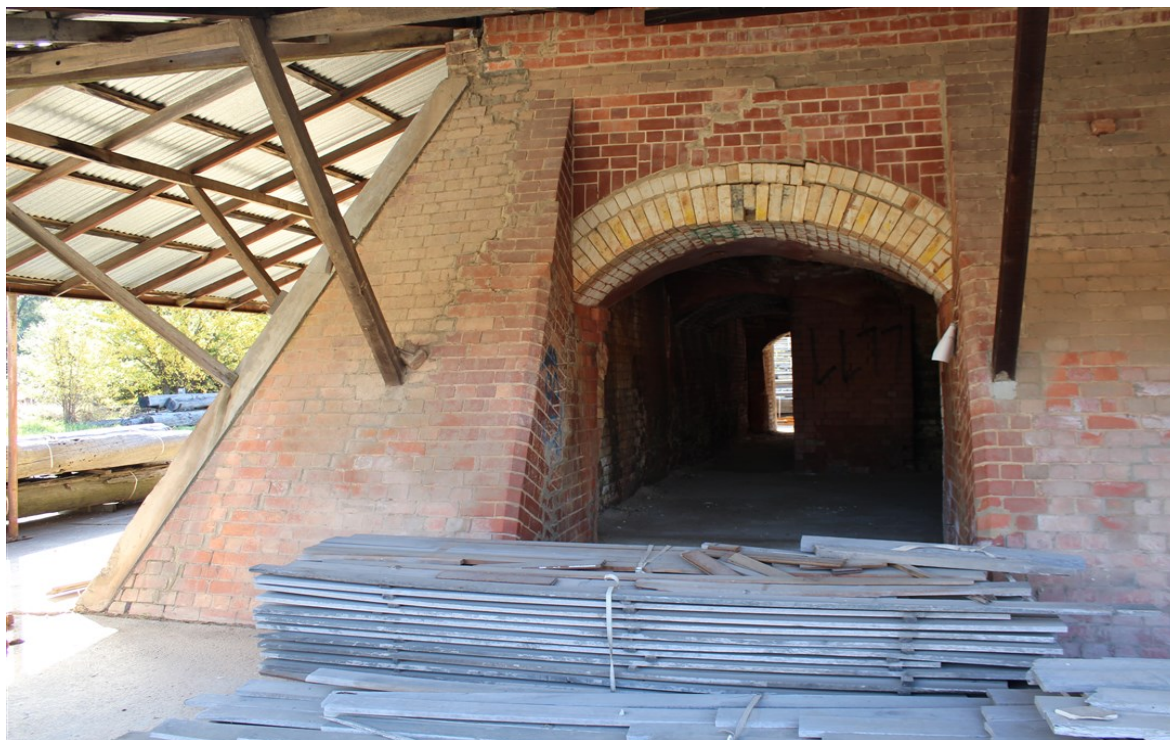
The inspection report for the building identified that the timber lean-to awning around the north and south elevations is in a reasonable condition with some weather damage to the rafters. The wall sheeting to exterior of structure is also in reasonable condition. Brickwork is loose throughout the wickets and some entry archways have been displaced from loose bricks and voids,

causing a displacement of the arch. The internal kiln area has loose bricks. Mass concrete has been used to augment some of the collapsed arches.

The east and west archways between kiln halls and the northeast entry have severe cracking and displacement. Both western entries are badly damaged and have suffered from structural movement. Ceiling battens line the underside of purlins on the first floor, several of which were loose. Windows throughout the first floor have been removed or damaged. The upper floor steel trusses are in reasonable condition. Within the interior upper floor, the chimney holes are a trip hazard. There are several battens loose where timber battens were installed to the underside of purlins that were potentially implemented to support ceiling lining. The roof sheeting appears to have been replaced more recently and is in reasonable condition.

**Figure 5** Southwest 'wicket' to Hardy Patent Kiln 1. (Source: GML, 2017)

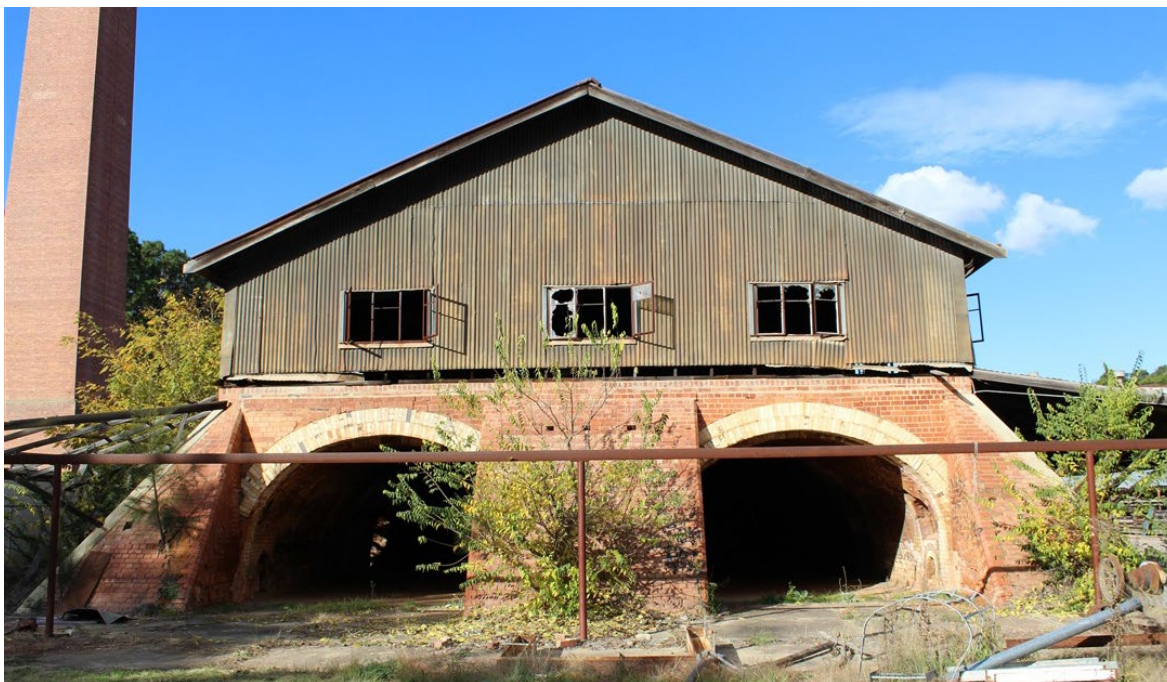
The inspection report for the building identified that the wall sheeting is in poor condition, with sheets loose in areas. Weather damage to the rafters and roof sheeting has deteriorated. Some fascia beams have weathered and weathering is significant in certain areas. The brickwork throughout the kiln arches and masonry arch entries is loose. The brickwork bedding of most of the entry archways has loose bricks and voids, causing a displacement of the arch. The southwest corner entrance has moved substantially with differential movement between the brickwork. Fire damage is evident to the first floor and has particularly affected one of the large roof trusses. Although roof trusses are in reasonable condition, lateral bracing of the roof structure may require upgrading. A trip hazard is also created by chimney holes throughout the dirt floor. Doors and windows are in poor condition or have been removed or damaged and there are some holes throughout the roof and wall sheeting. The timber ladder on the northeast corner of the building is severely weathered. Post connections loose in areas and connections between timber fascia and posts has failed in certain areas. There is severe weathering in the timber framed flooring and is thus not suitable for use. Mass concrete has been used to augment some of the collapsed arches.

**Figure 2** Front (west) elevation of Hardy Patent Kiln 2. Verandah framing evident. (Source: GML, 2017)

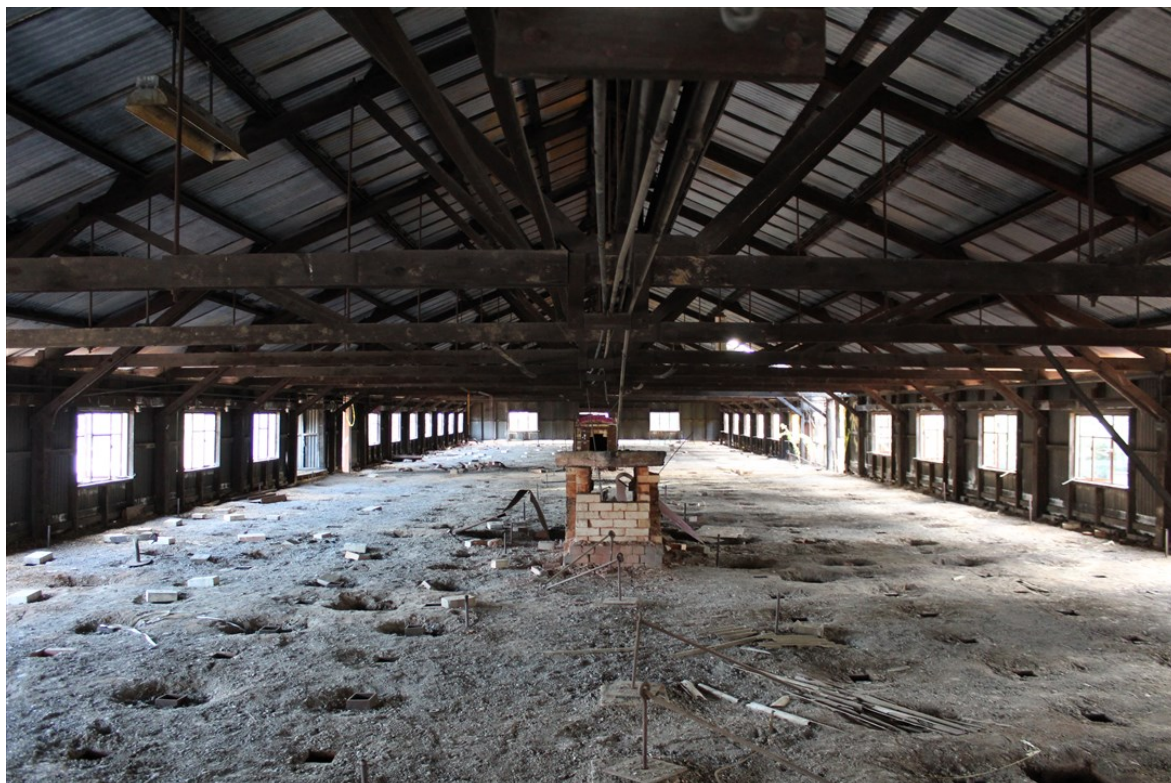
**Figure 6** View of first floor from the rear (east) of the building. Firing' holes evident in the floor. (Source: GML, 2017)

- Within the interior upper level, the existing dirt floor can be excavated and replaced with a new floor, covering up the firing holes and ensuring the floor is free of trip hazards. This will also lower the floor level and permit a sufficient truss clearance to allow an adaptive reuse of the space.

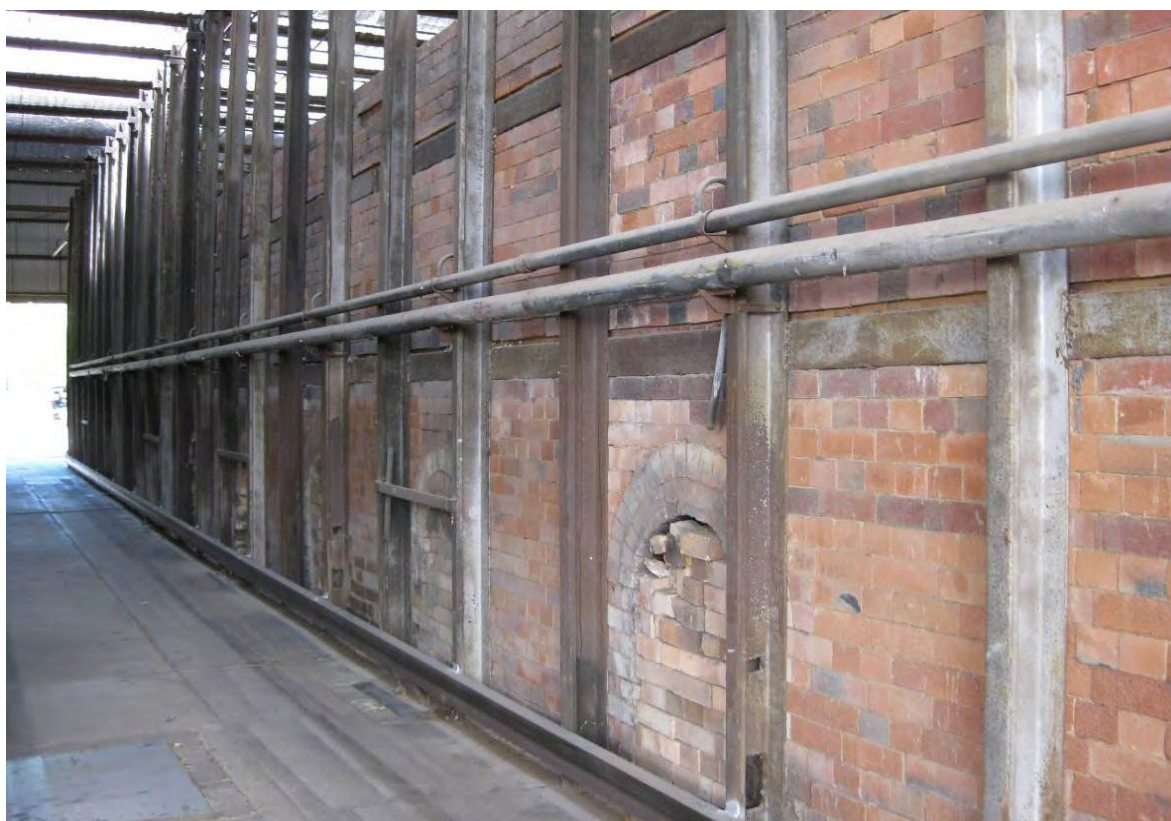
The kilns are in poor condition braced with steel posts and cables, which appear to be in reasonable condition. Internally, the brickwork is in a reasonable condition with isolated loose bricks.

**Figure 6** Side elevation showing steel framing and fire holes. (Source: Lovell Chen, 2010)

<b>Structural Advice as at 2021</b>	Reinstatement required for safe public access during construction works. Kilns require stabilisation and water proofing—refer to Appendix G for detail.
<b>Conservation Policy and Adaptation Guidelines</b>	Core elements must be retained and conserved.
<ul style="list-style-type: none"> <li>The Downdraught Kilns should be retained and conserved.</li> <li>The kilns require further structural assessment to inform remediation works. While thought to be broadly contemporary with the kilns, the enclosing shed roof structure could be retained or demolished as required.</li> <li>The internal adaptation is possible and alternatives for reuse should be explored. The kiln chambers could be subdivided if required.</li> <li>Assess all proposed actions, including conservation works or adaptation, for potential adverse impacts on the heritage significance, through the preparation of a Statement of Heritage Effects (SHE) in accordance with the ACT guidelines.</li> </ul>

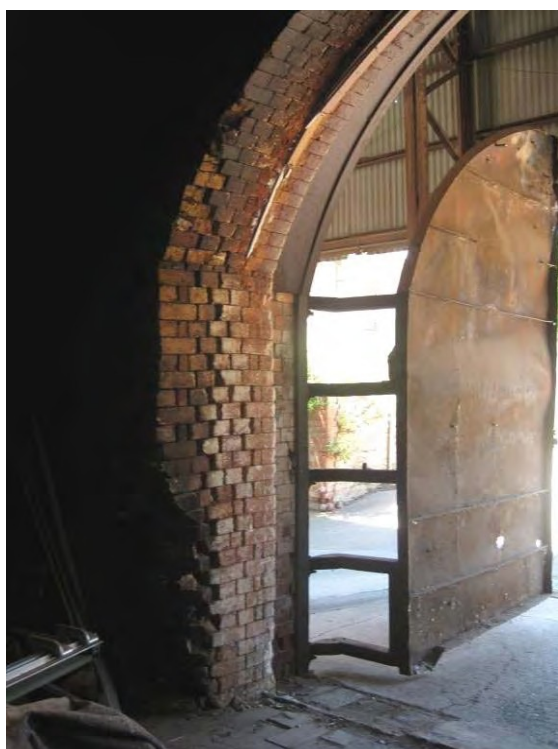
**Figure 7** Interior of kiln showing entry and deteriorating fire bricks. (Source: Lovell Chen, 2010)

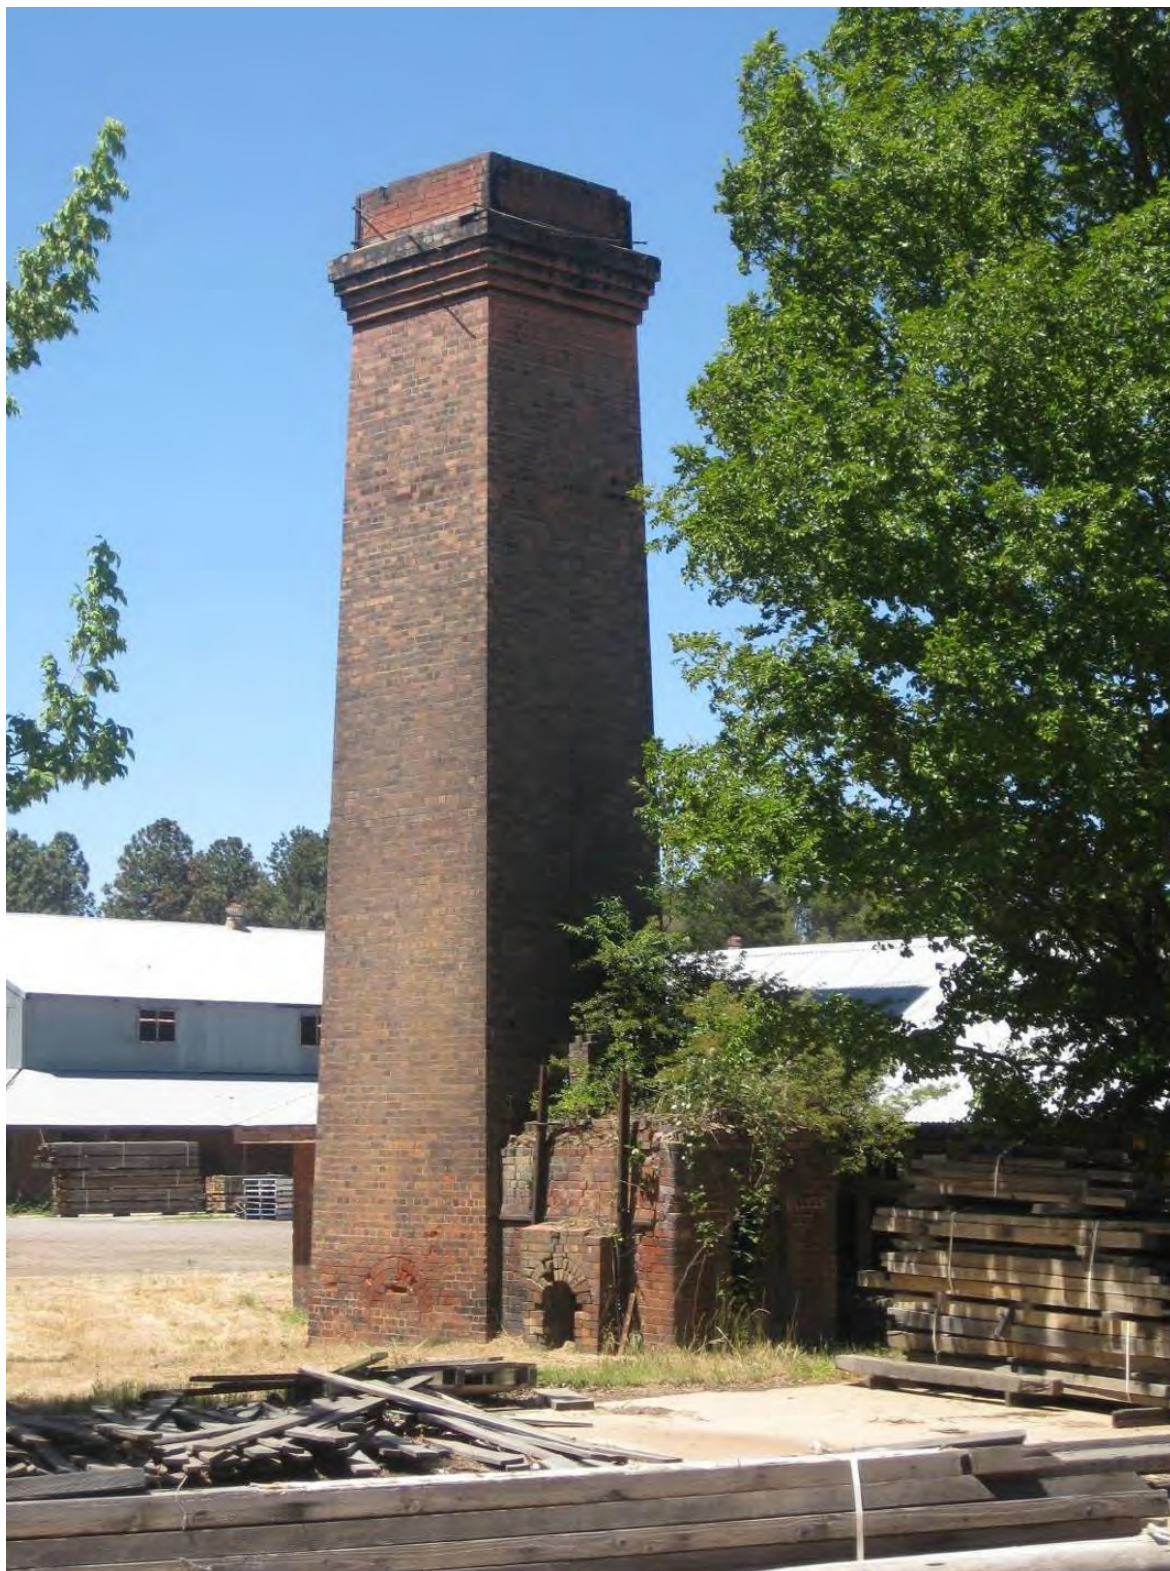
The inspection report for the building identified that the stack has cracking at the base, however it appears to be stable. Bricks are loose at the top and some have fallen. There is also some visible cracking at the top. The brick kiln is in a partially ruinous state. It is severely cracked with little to no mortar remaining in the joints, leaving the bricks loose and unstable. There is vegetative overgrowth impacting the structure.

**Figure 1** The full extent of the stack with a smaller, near-contemporary kiln adjoining to the right. (Source: Lovell Chen, 2010, Canberra Brickworks CMP, p 68)

- The Chimney Stack and attached kiln must be retained and conserved.
- Closer inspection of upper areas of chimney recommended.
- Additional structural support may be required. The loose bricks at top of chimney should be secured/reinstated. Assess all proposed actions, including conservation works or adaptation, for potential adverse impacts on the heritage significance, through the preparation of a Statement of Heritage Effects (SHE) in accordance with the ACT guidelines.

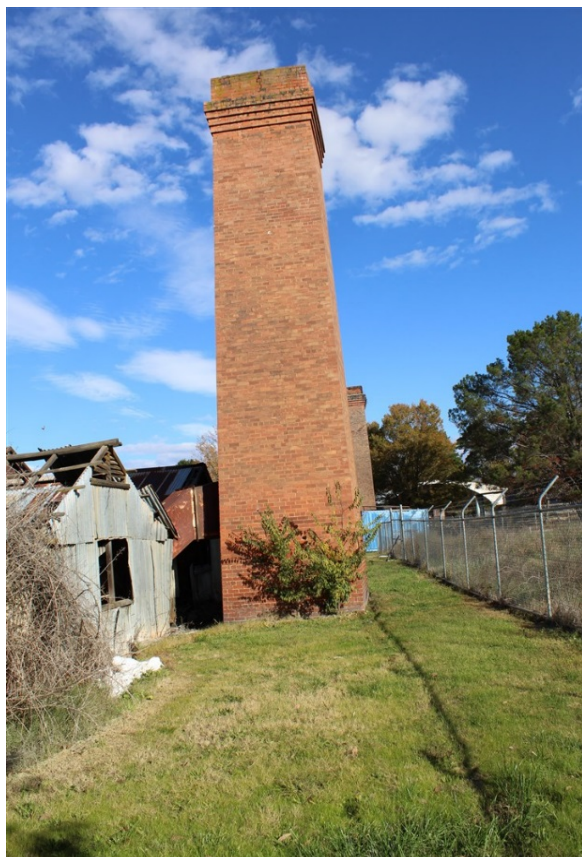
The inspection report identified cracking at the base of the chimney but overall appears stable. More severe cracking was observed at the top of the stack and bricks are loose and some have fallen. The arched opening in the south face of the stack is infilled with brickwork. The condition is good —reasonable.

**Figure 1** Chimney Stack north elevation. (Source: GML, 2017)

<ul style="list-style-type: none"> <li>The Chimney Stack must be retained and conserved.</li> <li>Closer inspection of upper areas of chimney recommended. Additional structural support may be required. The loose bricks at top of chimney should be secured/ reinstated.</li> <li>Assess all proposed actions, including conservation works or adaptation, for potential adverse impacts on the heritage significance, through the preparation of a Statement of Heritage Effects (SHE) in accordance with the ACT guidelines.</li> </ul>

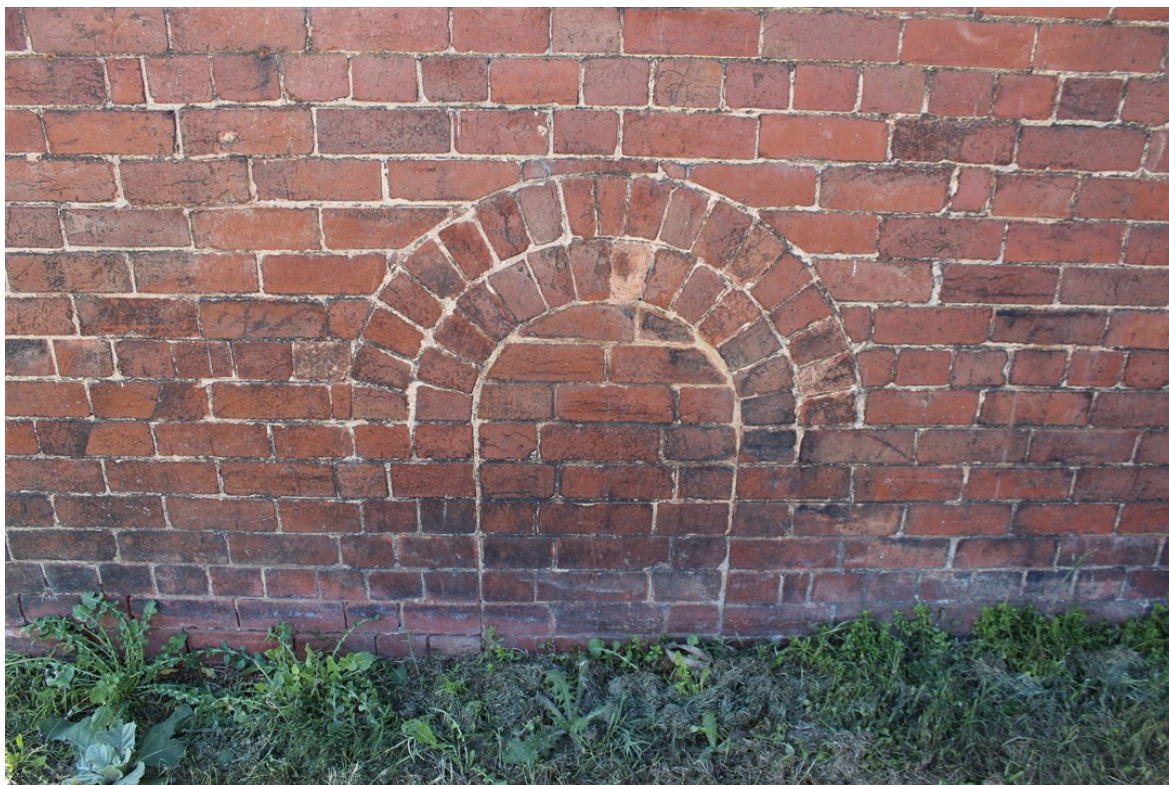
**Figure 3** Infilled archway at south elevation. (Source: GML, 2017)

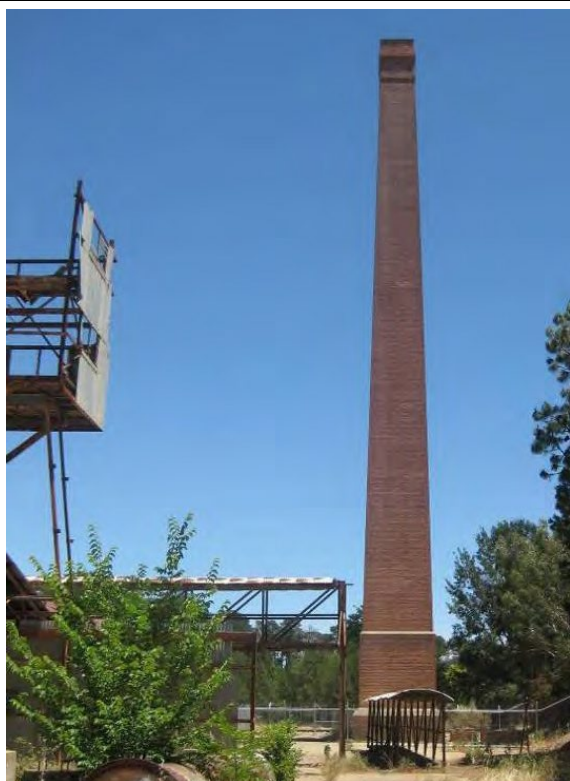
The top of the chimney has more severe cracking and loose bricks. Although the chimney appears to be stable overall, some observations of cracking were made at the base.

**Figure 1** View of the chimney stack from the east. (Source: Lovell Chen, 2010)

<b>Structural Advice as at 2021</b>	No structural concern, as viewed from ground level. Closer inspection of the upper chimney required. Rectification may be required as part of the construction works—refer to Appendix G for detail.
<b>Conservation Policy and Adaptation Guidelines</b>	Core elements must be retained and conserved
<ul style="list-style-type: none"> <li>• The Chimney Stack must be retained and conserved.</li> <li>• Loose bricks should be reinstated and secured at the top of the chimney.</li> <li>• Additional structural support may be required.</li> <li>• Assess all proposed actions, including conservation works or adaptation, for potential adverse impacts on the heritage significance, through the preparation of a Statement of Heritage Effects (SHE) in accordance with the ACT guidelines.</li> </ul>

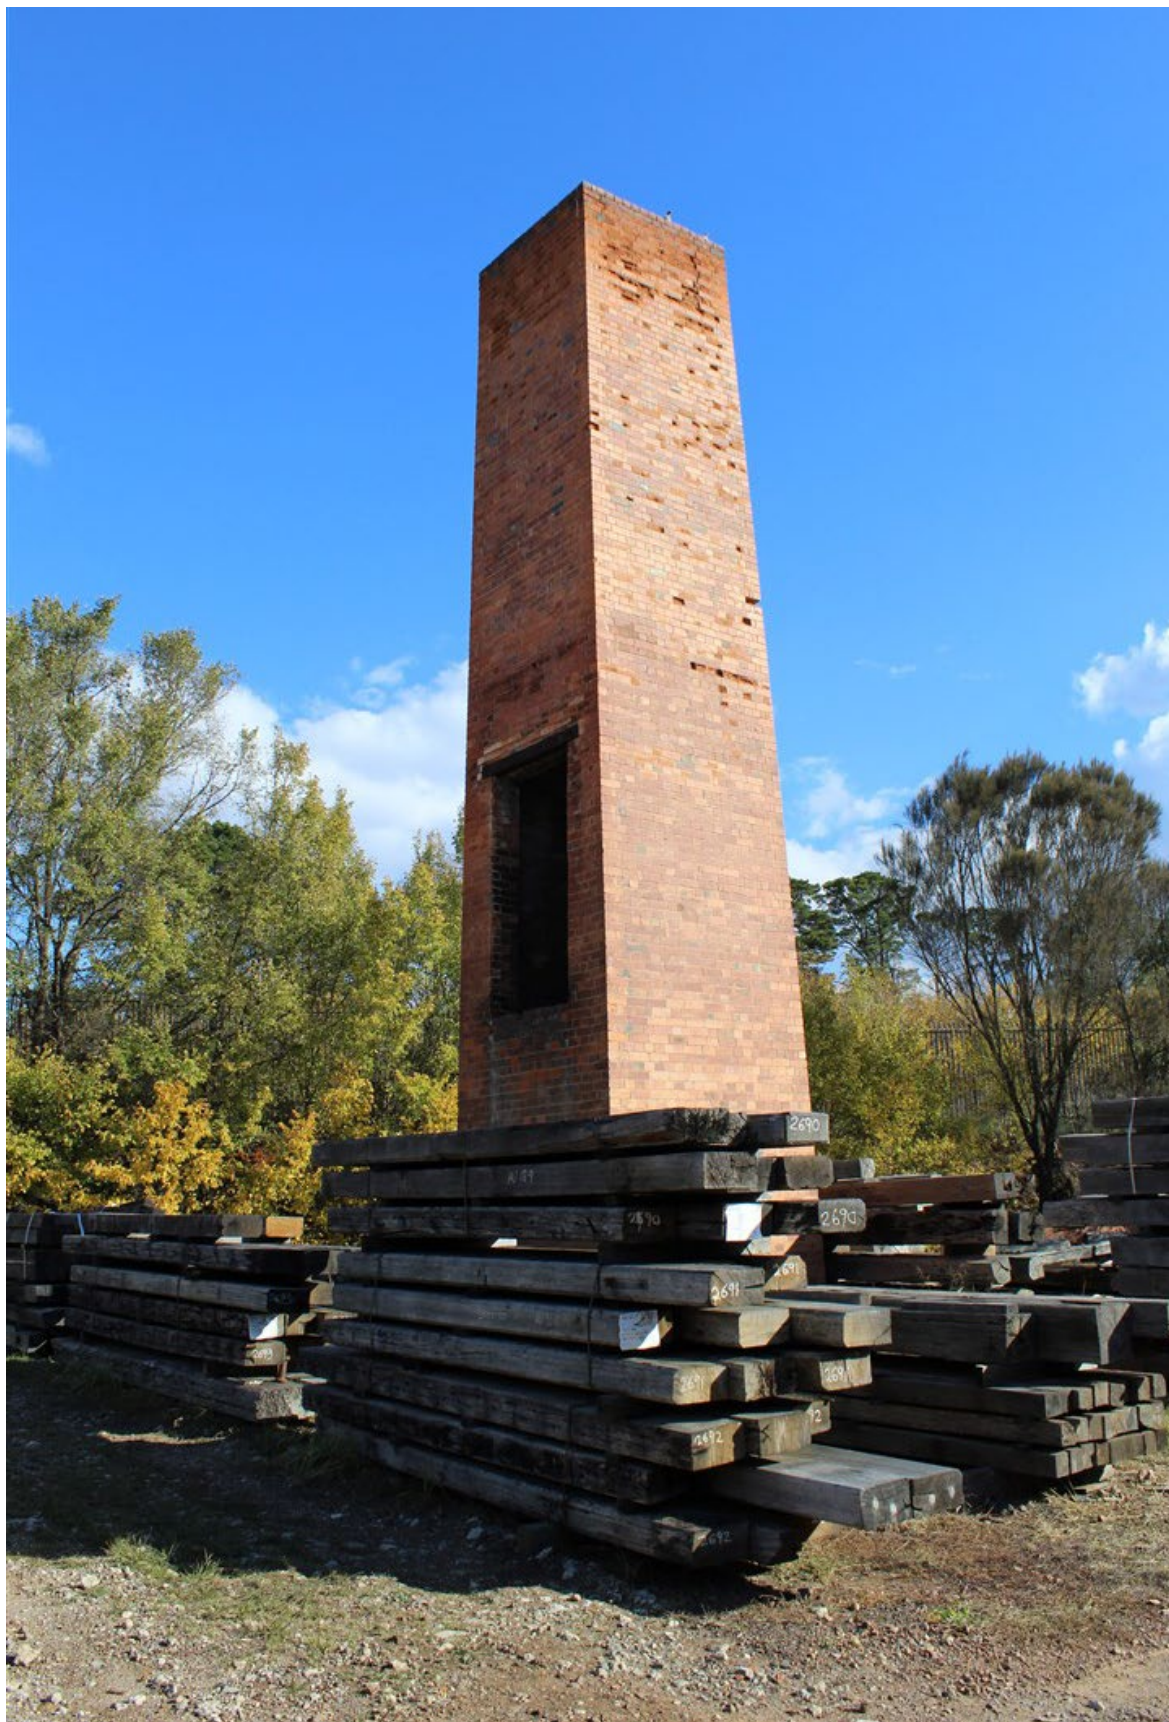
The Chimney Stack is in reasonable condition and appears to be stable. No significant cracking was observed (from ground level), but the upper section is in poorer condition, with loose and deteriorated bricks. There is evidence of brickwork spalling, particularly to the west and north faces.

**Figure 1** East and north elevation of the Chimney Stack for the Downdraught Kilns. (Source: GML, 2017)

- The Chimney Stack for Downdraught Kilns must be retained and conserved.
  - A structural assessment is required, and structural reinforcement may be needed.
  - Assess all proposed actions, including conservation works or adaptation, for potential adverse impacts on the heritage significance, through the preparation of a Statement of Heritage Effects (SHE) in accordance with the ACT guidelines.
-

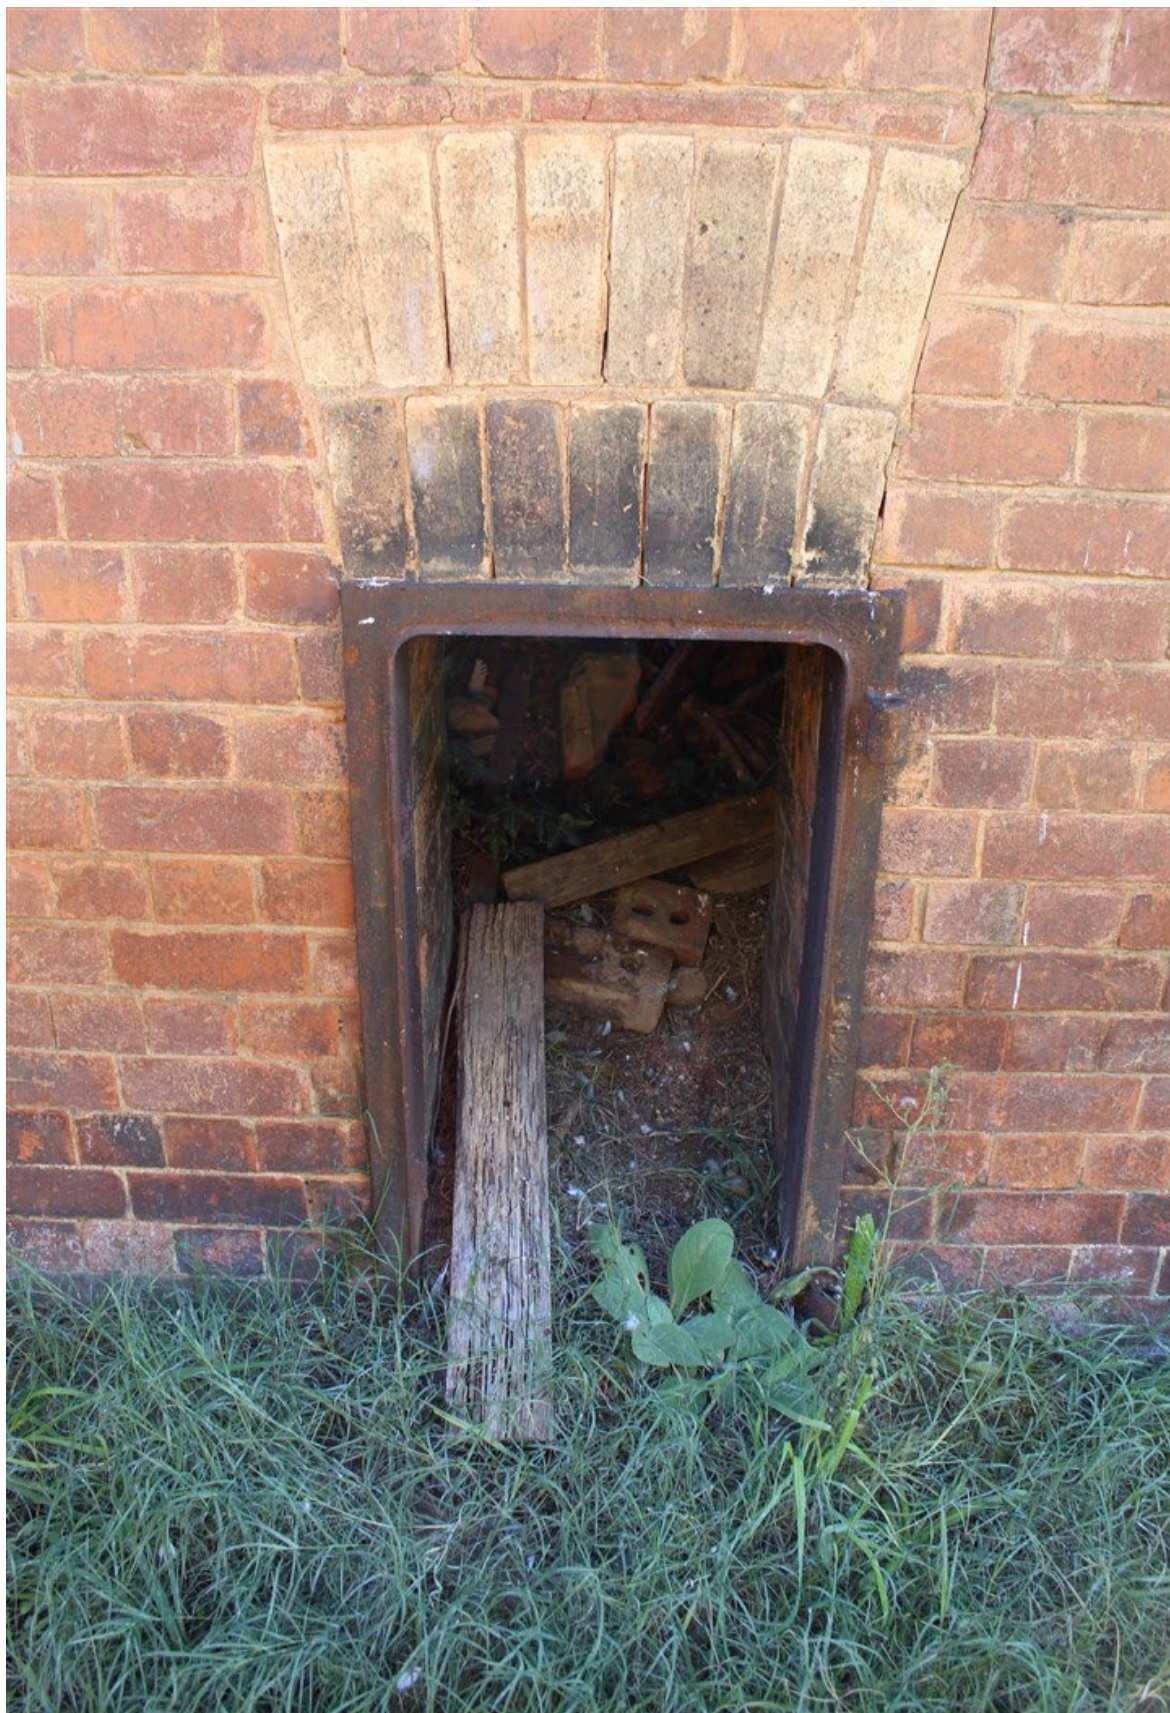
There is a large oblong opening approximately three metres above the ground in the north face, indicating where a duct channelled spent fuel and heat to the stack for dispersal. There is an opening at low level in the south face, set within a steel door surround. The door is missing.

**Figure 2** Opening at base of southern facade. (Source: GML, 2017)

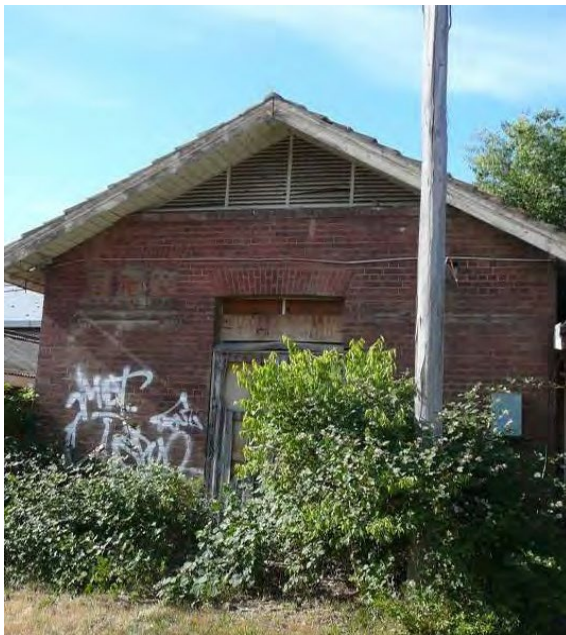
The inspection report for the building identified that the roof tiles are in a sound condition, the roof sheets and brickwork in general are in a reasonable condition, and the doors and windows are damaged but are boarded up. The timber fascia is weathered in some areas. The extension of the adjoining office block to the east and the siting of the small service building to the immediate west are intrusive elements to the Power House building. Comparing photographs from 2010, it appears some works have been undertaken to the roof, gable and brickwork.

**Figure 3** South elevation and entry, showing bricked up openings. (Source: Lovell Chen, 2010, Canberra Brickworks CMP, p 56)

- Consideration could be given to the reinstatement of infilled openings to the exterior. Original windows and doorways could be re-opened and repaired.

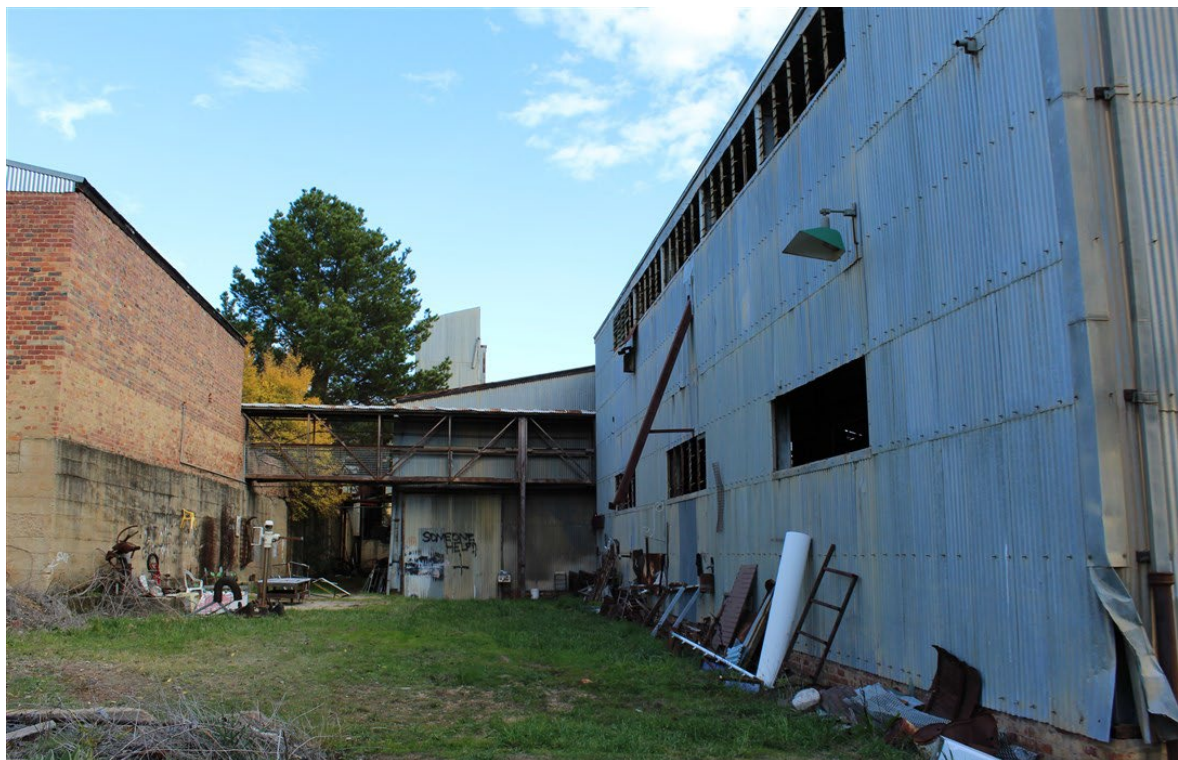
The inspection report for the building identified that the suspended concrete slabs to the upper floor appear to be in a reasonable condition with some minor spalling to the underside near a drilled penetration, which has exposed reinforcement. The raised timber deck walkway is weather damaged. Windows are weathered and have been broken or removed throughout the upper floors exposing the building's interior to weather and some roof sheeting has also been removed, which has caused rot to the timber purlins. Some steel truss bottom chords to the walkway extending from the machine bays to Hardy Patent Kiln 1 and the Staffordshire Kiln are significantly distorted.

**Figure 3** The rear (east) elevation of Machine Bay 2. (Source: GML, 2017)

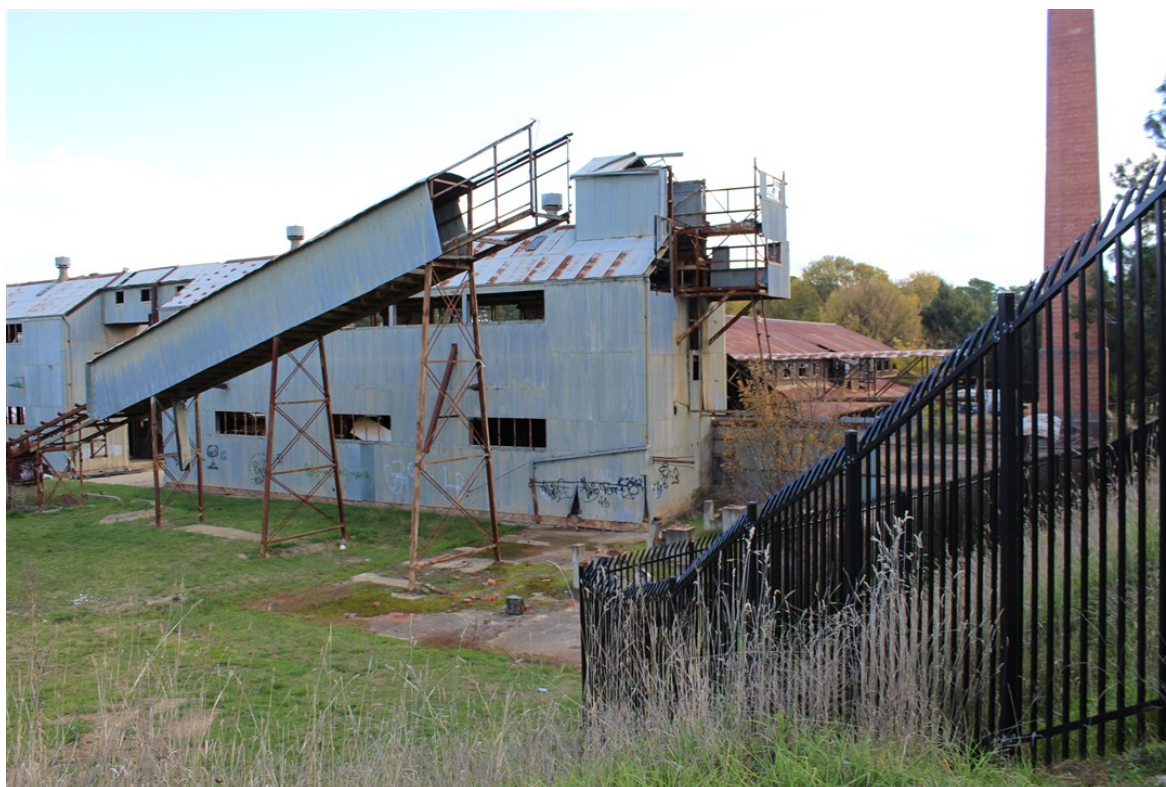
Poor condition: This structure is in worse condition than Machine Bay 2 to its south, with the upper level missing most of the cladding.

**Figure 4** Machine Bay 3 behind the Elevator/Conveyor. Chimney Stack for Hardy Patent Kiln 2 to the right. (Source: GML, 2017)

Immediate rectification works required. Loose roof sheets are a hazard, with access to some areas to be restricted—refer to Appendix G for detail.

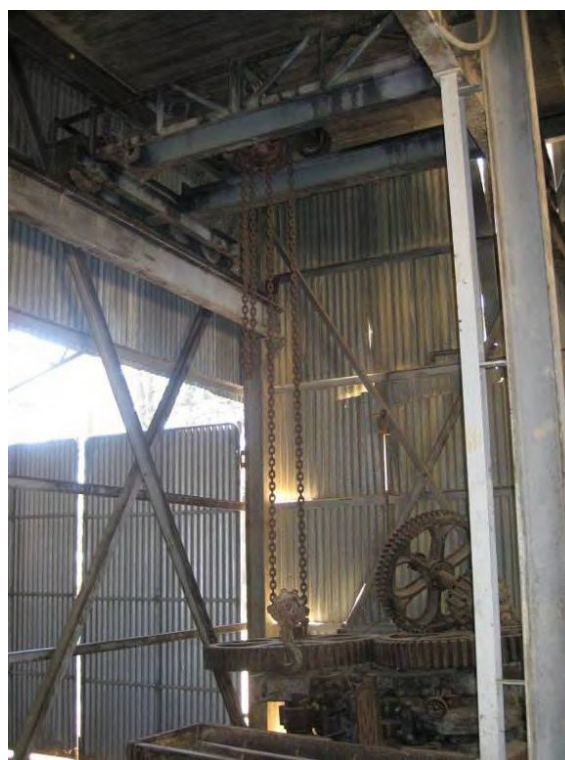
**Figure 7** Interior with remnants of the Anderson brick machinery at the north end. (Source: Lovell Chen, 2010)
