# Canberra Brickworks Precinct

## Conservation Management Plan

### Volume Two—Appendices

September 2021

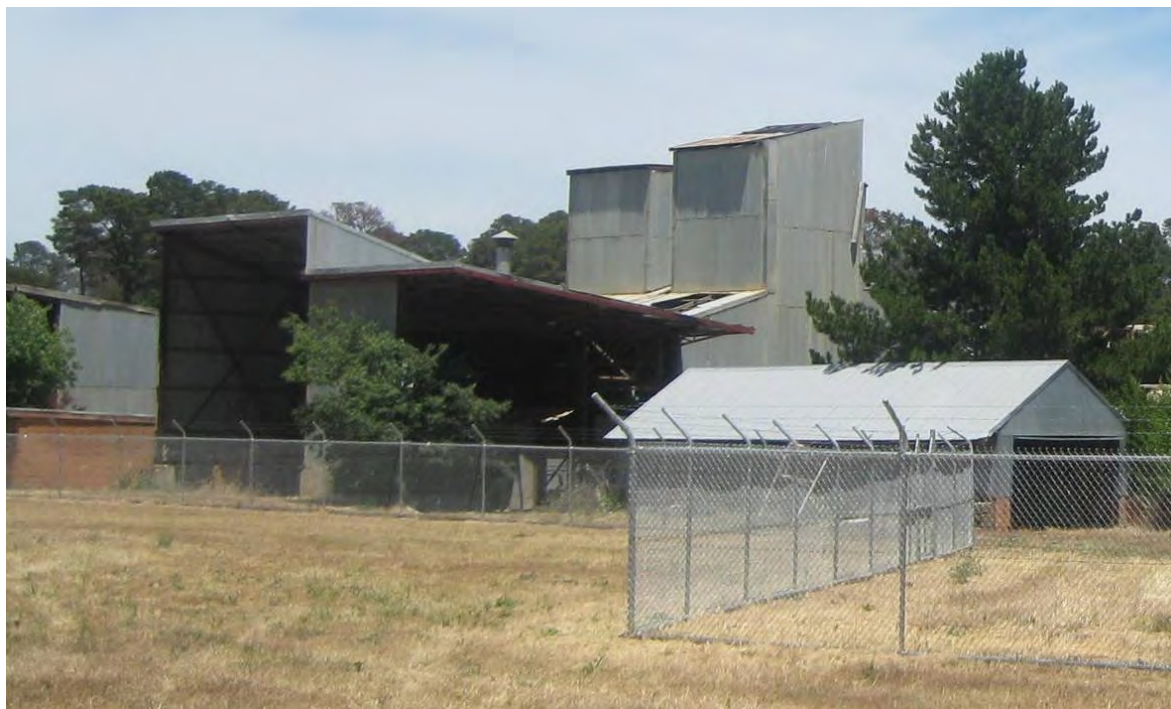
The inspection report for the building identified that several bracing members have been removed from the structure and that the wall sheeting is weathered and loose in some areas. There is debris scattered throughout the building and areas of the suspended slab have collapsed.

**Figure 2** The Large Crusher House viewed from the east. The shed in the foreground is Element 36—Model Railway Storage Shed. (Source: Lovell Chen, 2010)

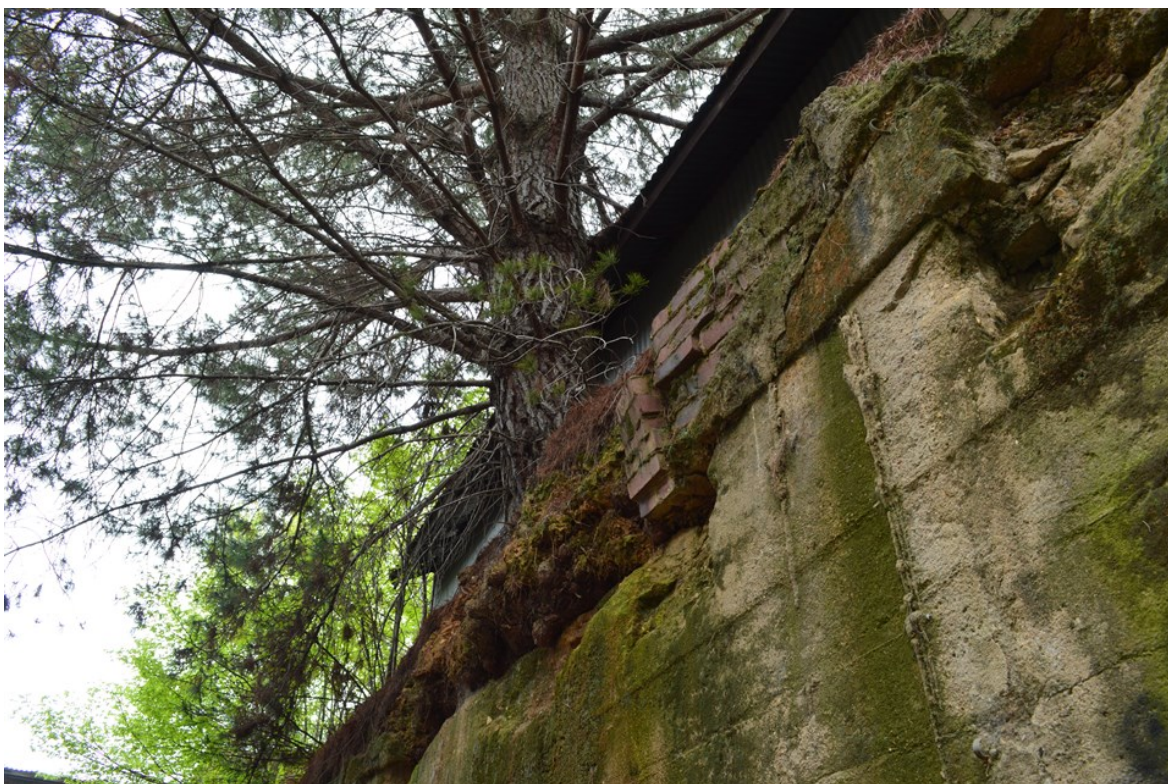
The inspection report notes that the brickwork part of the retaining wall appears to be sliding off the concrete retaining wall, and the wall has partially collapsed with loose bricks. There is also a large tree that has become unstable due to the collapse of the wall. The condition is reasonable.

Figure 4 Top of retaining wall showing unstable tree. (Source: GML, 2016)

- The retaining wall continues to operate to mediate the levels between the quarry and the brickworks. Although it is not required to be retained, it is likely to be largely retained as it interacts with many supporting heritage elements. Where retained, it should be stabilised as required.
- The Model Railway Workshop (Element 35), and non-original brickwork atop the wall could be retained or demolished as required.
- Assess all proposed actions, including conservation works or adaptation, for potential adverse impacts on the heritage significance, through the preparation of a Statement of Heritage Effects (SHE) in accordance with the ACT guidelines.

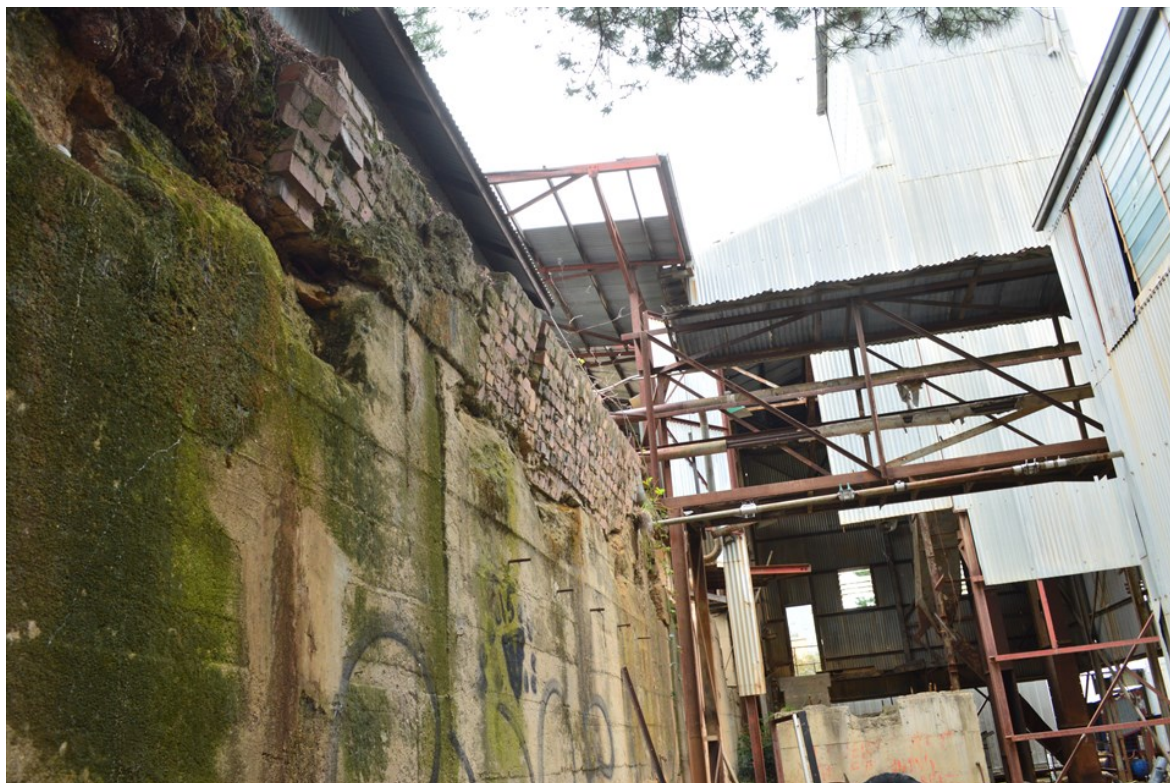
**Figure 5** Concrete top and upper masonry work to the retaining wall partially collapsed. (Source: GML, 2016)

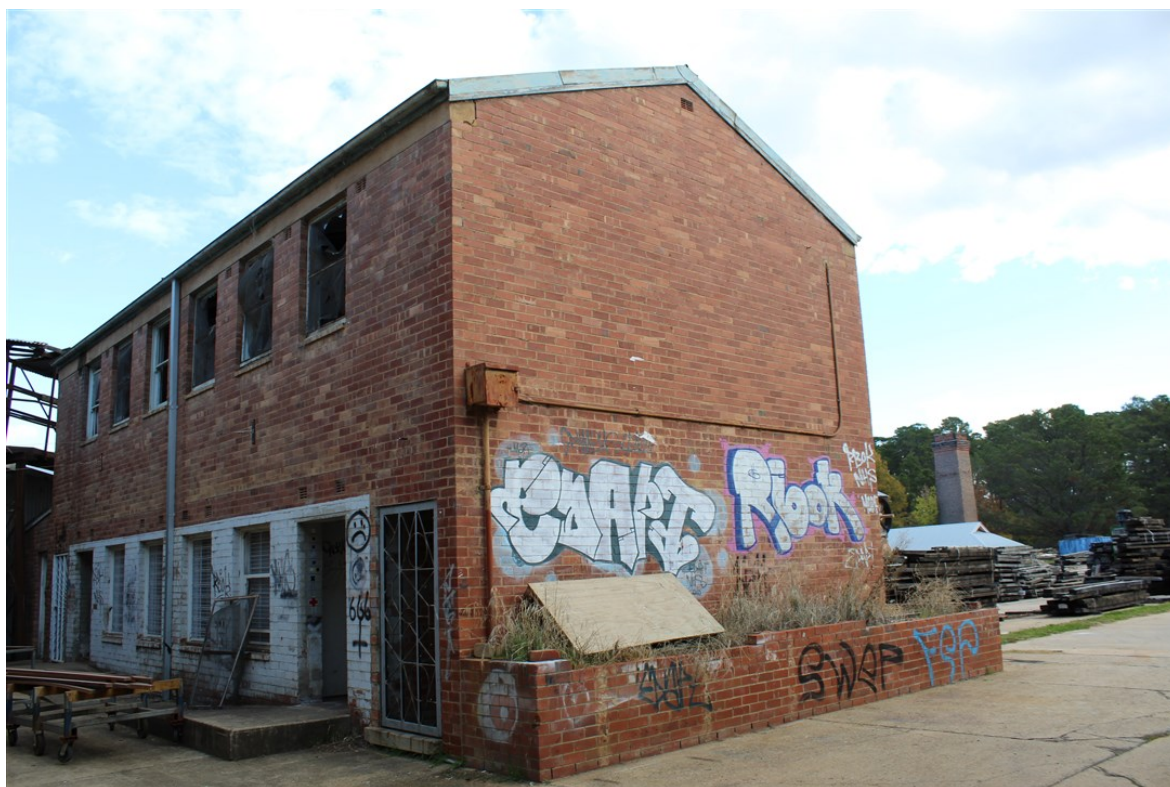
The inspection report for the building identified that the brickwork is in a reasonable condition, with the roof sheets, fascia boards and window frames weathered. There are signs of vandalism including graffiti, broken glass, and debris on the floor. As there was restricted access to the interior, from the external inspection the internal structure appears in sound condition.

Figure 2 The Amenities Block. The Chimney Stack for the Staffordshire Kiln is visible in the background. (Source: GML, 2017)

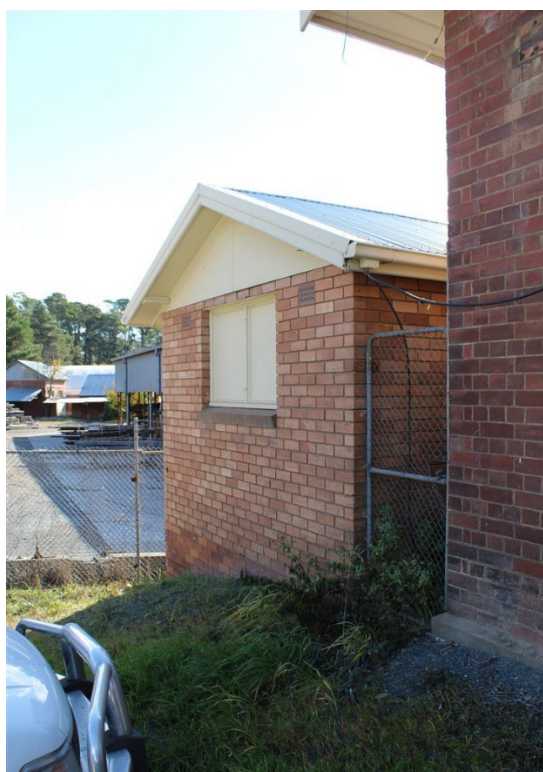
The inspection report for the structure notes the external brickwork is in a generally reasonable condition. The roof and gable ends have been updated and repainted. The windows and doors have been boarded up and are damaged in places.

**Figure 2** South elevation of the Control Room. (Source: GML, 2017)

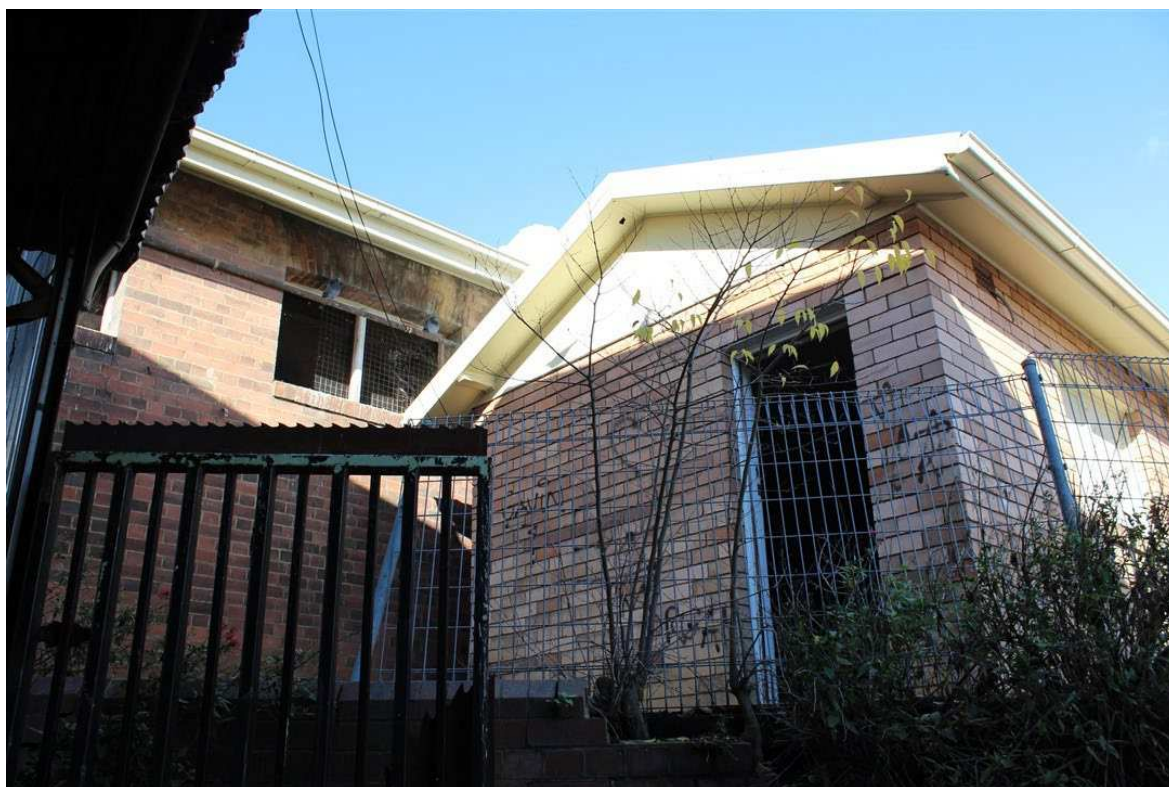
**Figure 3** North and partial west facade of the Control Room. (Source: GML, 2017)

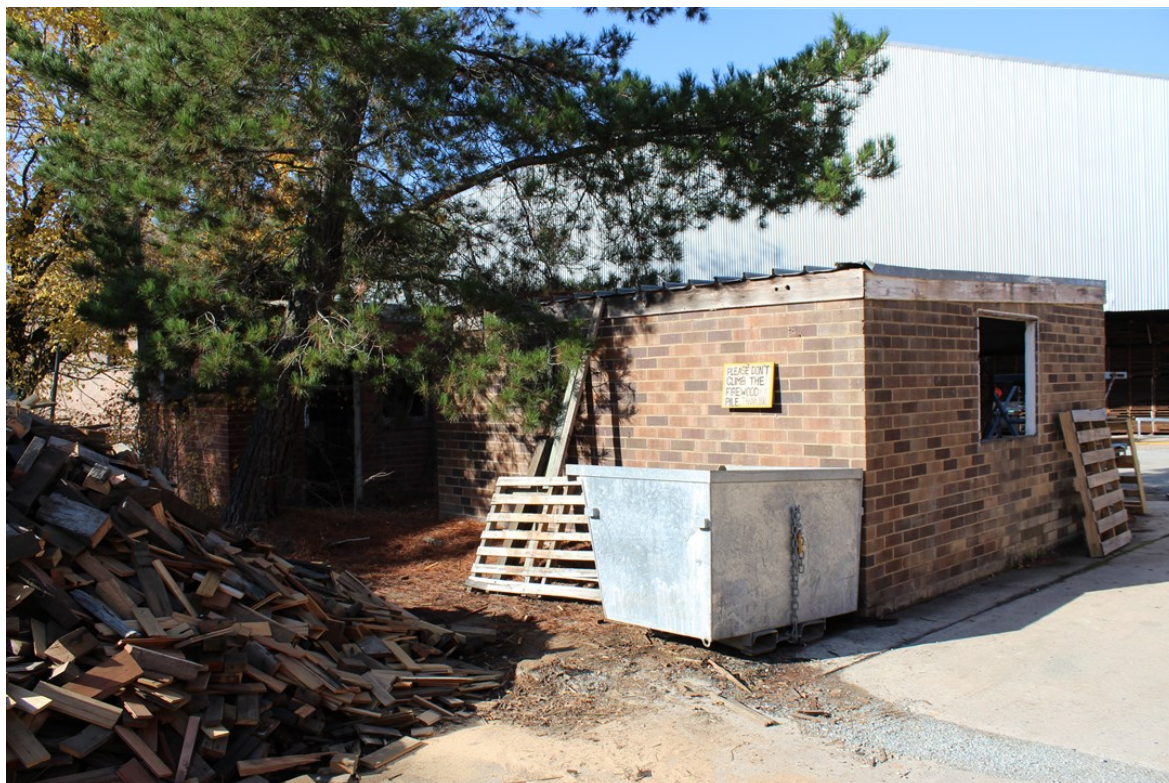
The building is vacant and in poor condition.

**Figure 1** The rear (west) elevation of the Ancillary Storage Building. The Downdraught Kilns storage shed is in the background. (Source: GML, 2017)

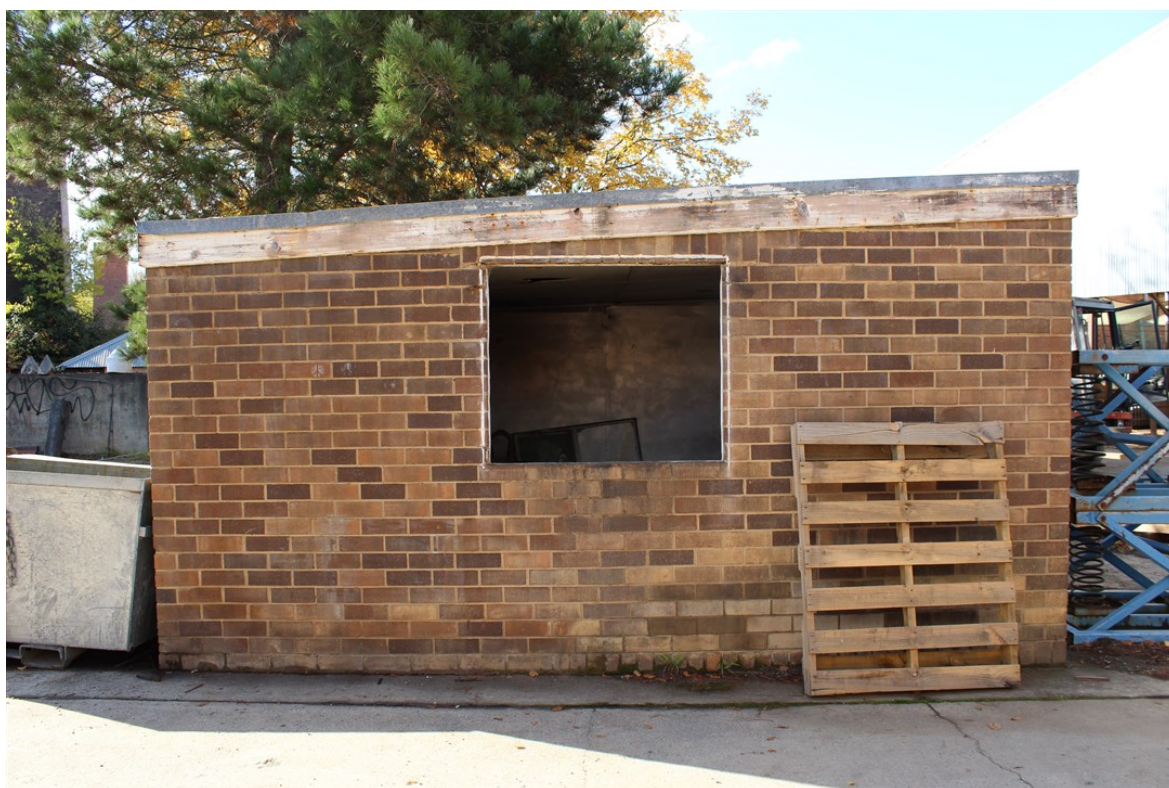
**Figure 2** South elevation of the Ancillary Storage Building. (Source: GML, 2017)

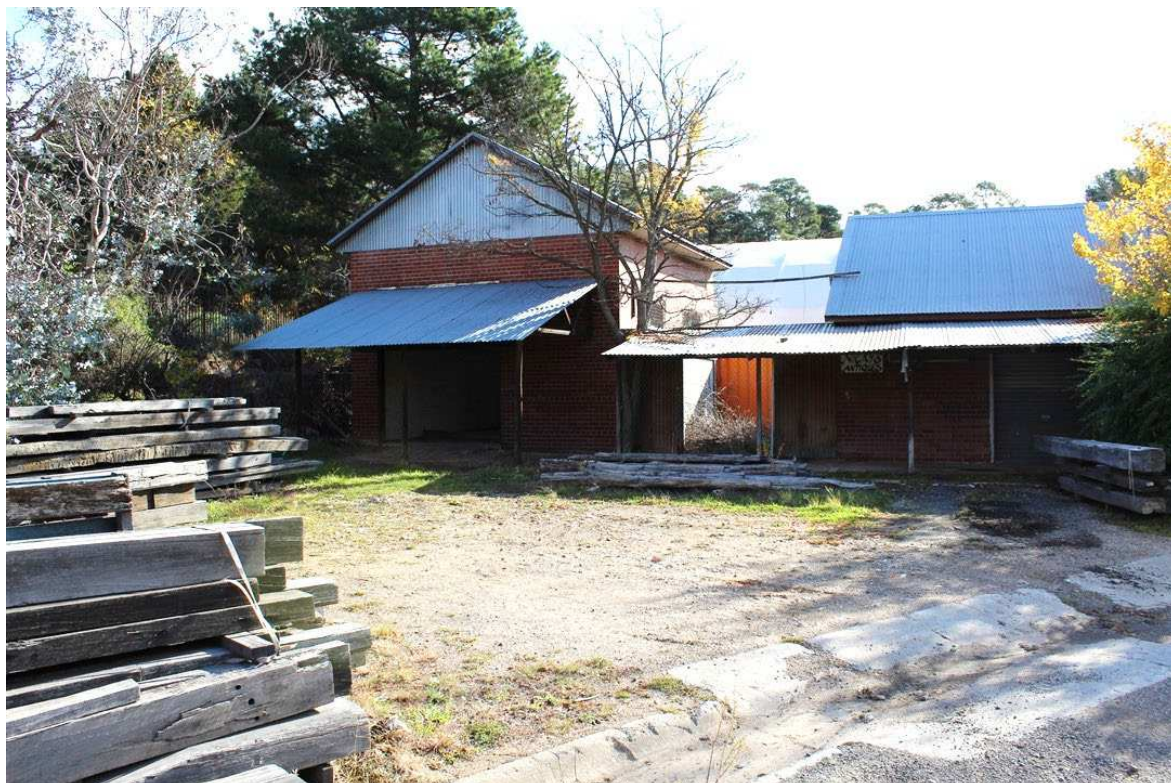
The building is in a reasonable condition. It has been impacted by minor vandalism, including broken windows, graffiti and smoke damage. The corrugated galvanised steel roofing appears recent and is in very good condition. The verandah and sign date from the post-closure phase and are related to its subsequent use as an antique stall.

**Figure 1** Front of Substation/Control Room with the Boiler House (Element 30) to the left. (Source; GML, 2017)

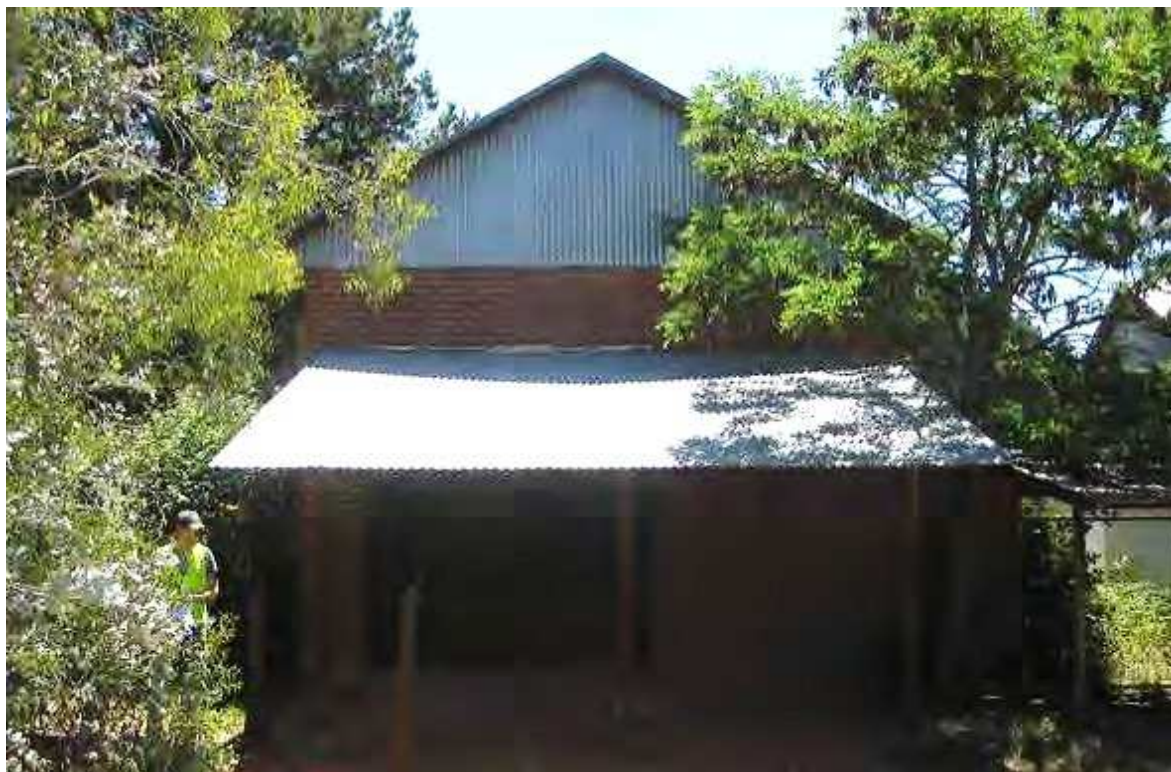
The building is in good condition apart from the impacts of minor vandalism, including the broken windows.

**Figure 1** Former boiler house building showing east entry and later verandah addition. (Source: Lovell Chen, 2010)

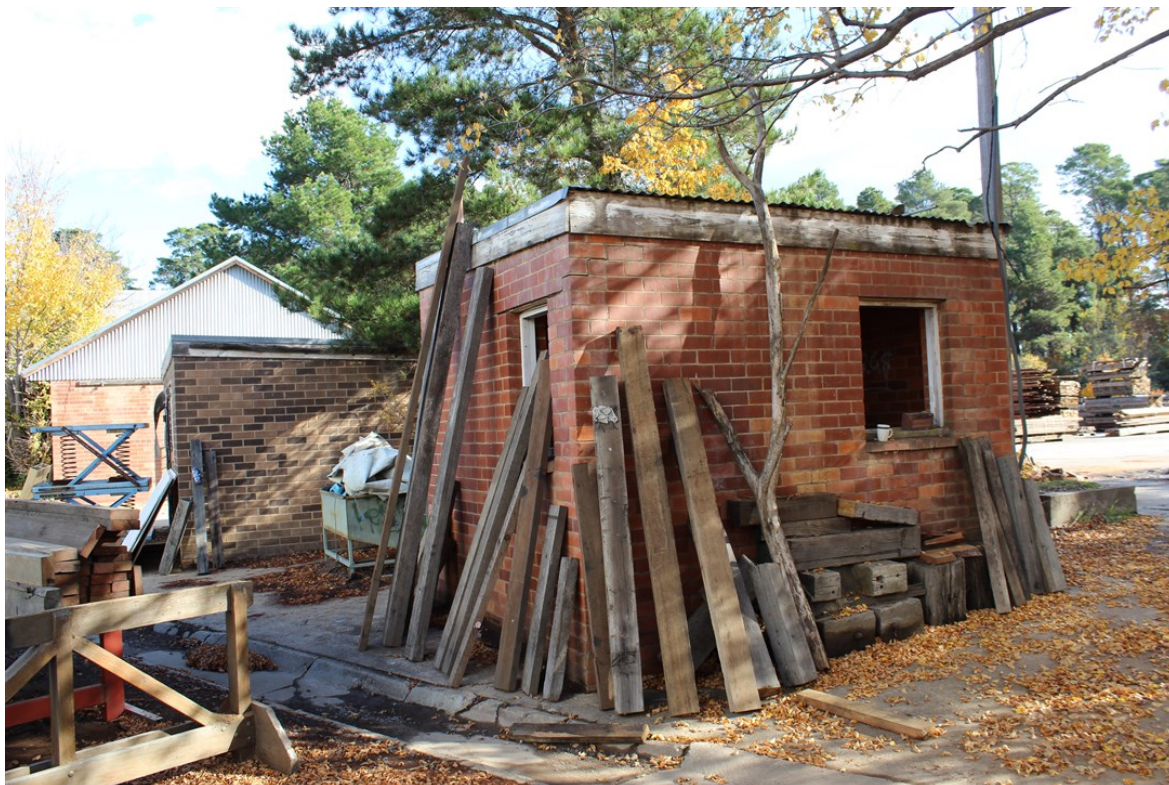
Amenities Block 2 is of vari-coloured brickwork and has a skillion roof of metal roof decking. Internally, it has a concrete floor and there are window openings to the north, east and south. Entry is from the south. The interior has been heavily vandalised with all fittings and finishes in poor condition.

**Figure 1** East and north elevation of the Amenities Block. (Source: GML, 2017)

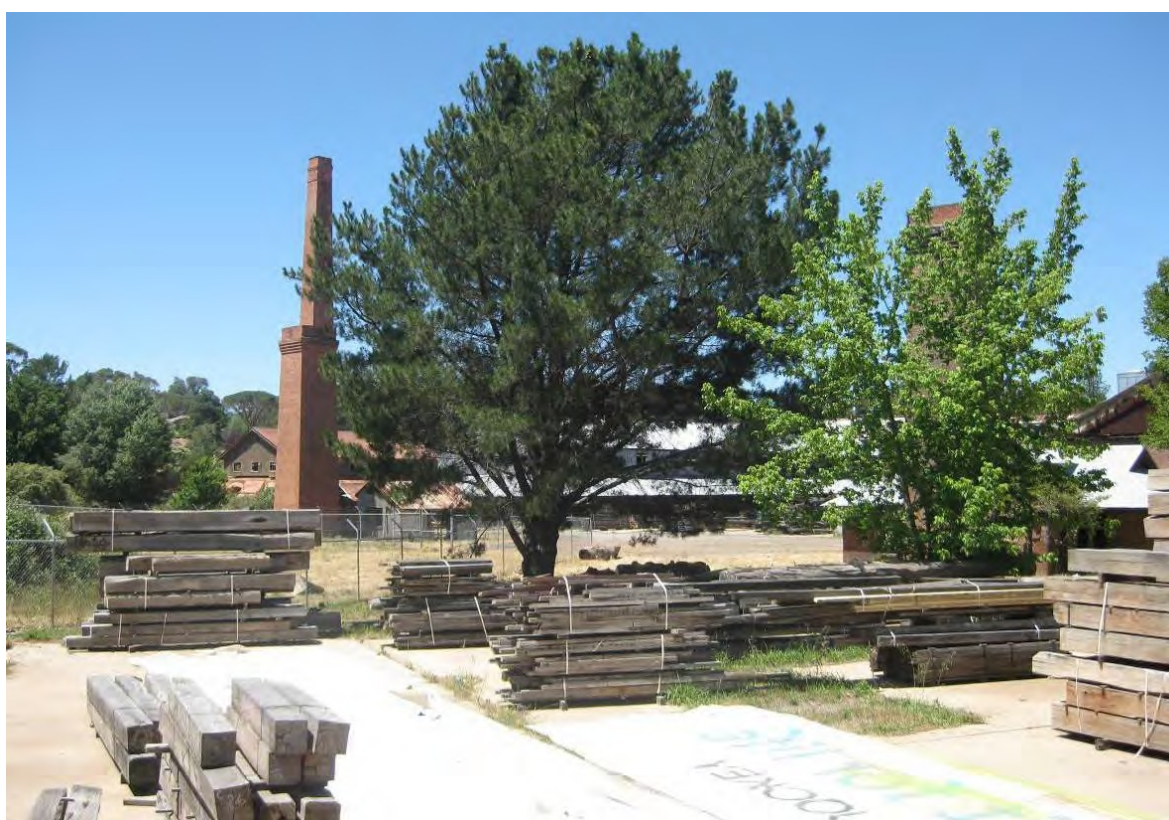
The concrete slab is in poor condition.

**Figure 2** Site of the Brick Extrusion Plant, looking northeast. (Source: Lovell Chen, 2010)

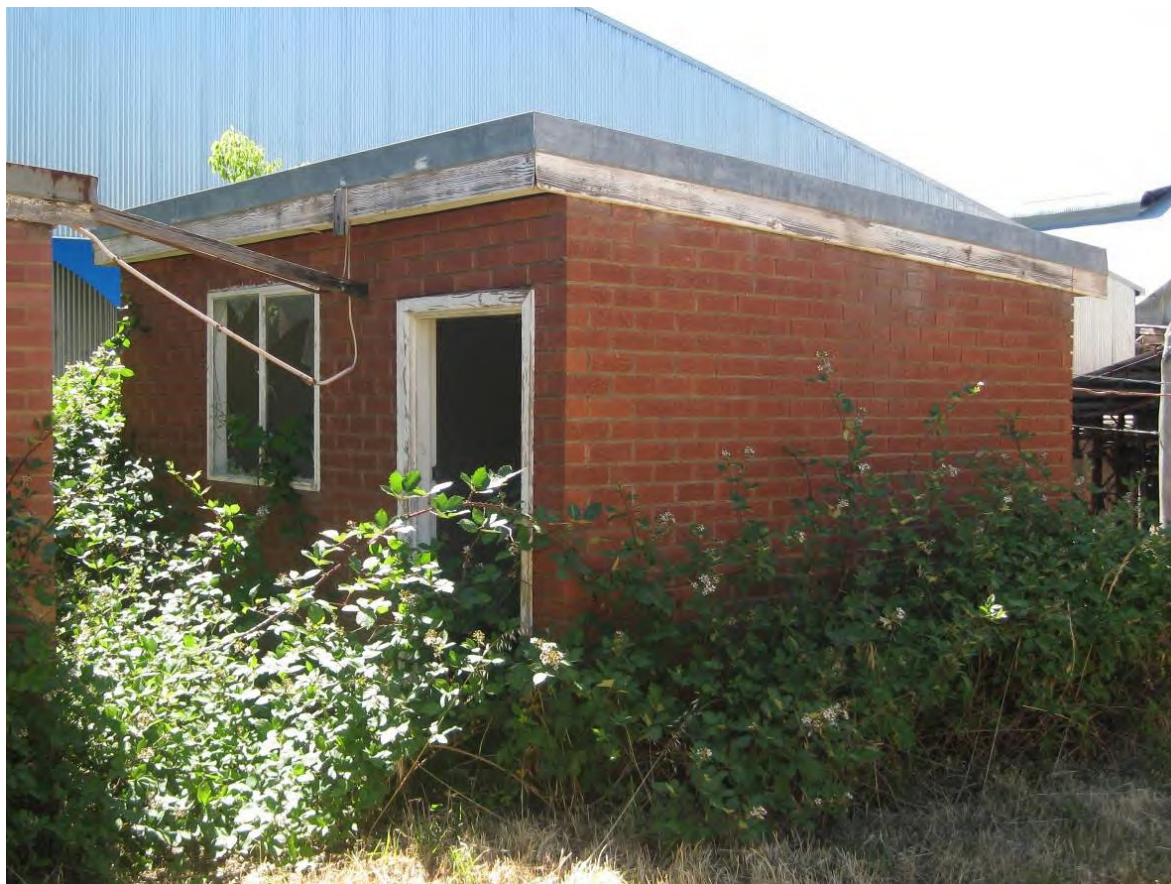
The building is unsecured, impacted by vandalism and in poor condition.

**Figure 1** Ancillary Storage Building 2 is sited behind the Office (Element 13). (Source: Lovell Chen, 2010)

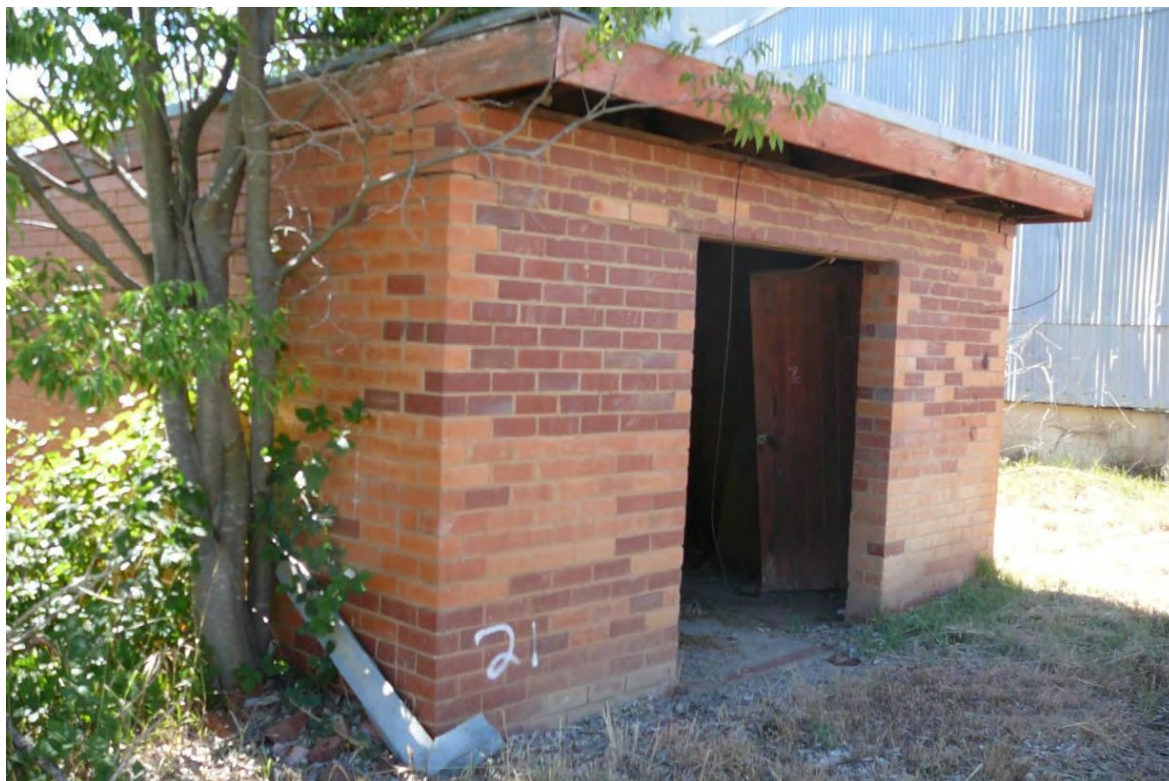
The shed is of vari-coloured brickwork and has a skillion roof of metal roof decking. Internally, it has a concrete floor and the timber door to the large opening at its north elevation is stored within the building. The walls are not lined, and the reflective insulation has been damaged by vandals. The shed is vacant and in reasonable condition.

**Figure 1** The storage shed. (Source: Lovell Chen, 2010)

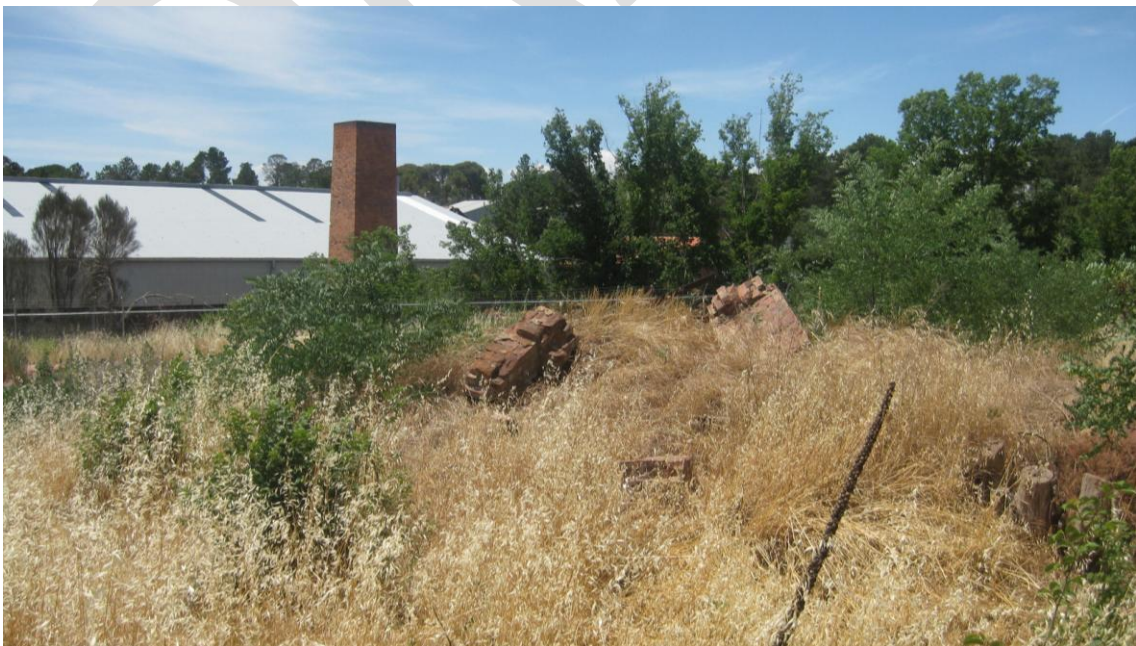
Figure 13 Walls/footings of the former Brickworks Hostel, 2010

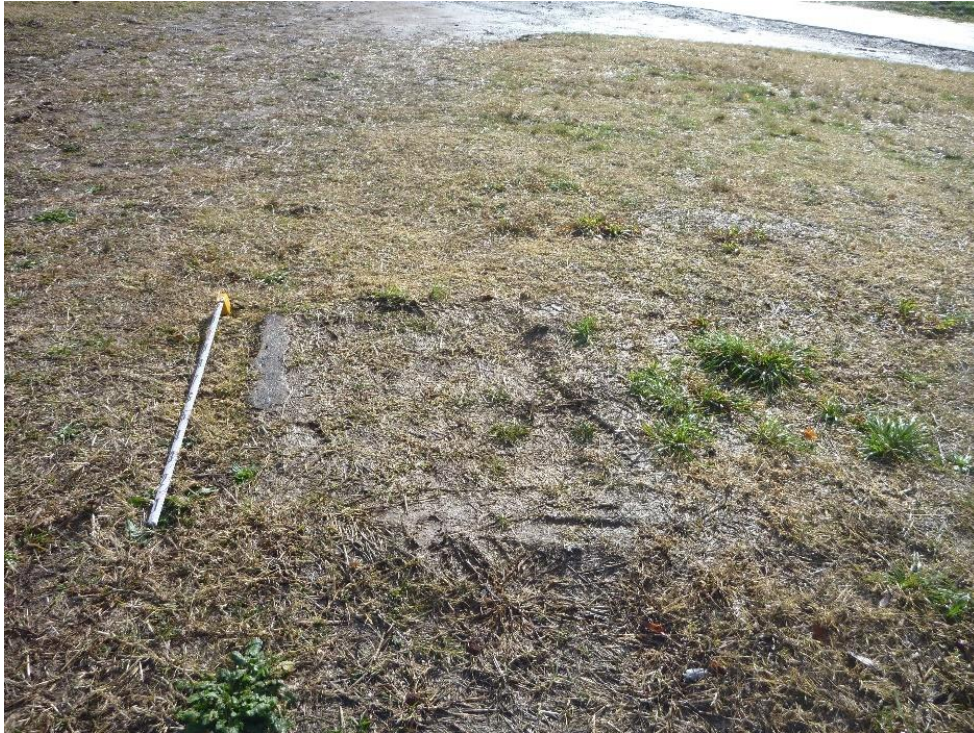
At the western end of the site there is a square concrete feature, approximately 1m x 1m, with an exposed top (Figure 17). This feature suggests a function associated with water, either for storage or drainage. Approximately 5m to the east of this square concrete feature is a visible line of grass die back, which suggests the presence of subsurface features. This line extends from north to south across the building platform that comprises the bulk of this site (Figure 18).

Site conditions are poor to fair. Two depressions identified within the platform suggest erosion or disturbance has occurred, while the in situ concrete features suggest a level of intactness. Visibility of this area was good, with only some low grass.

Figure 17 View of BRW1 concrete feature, looking north  
Source: NOHC

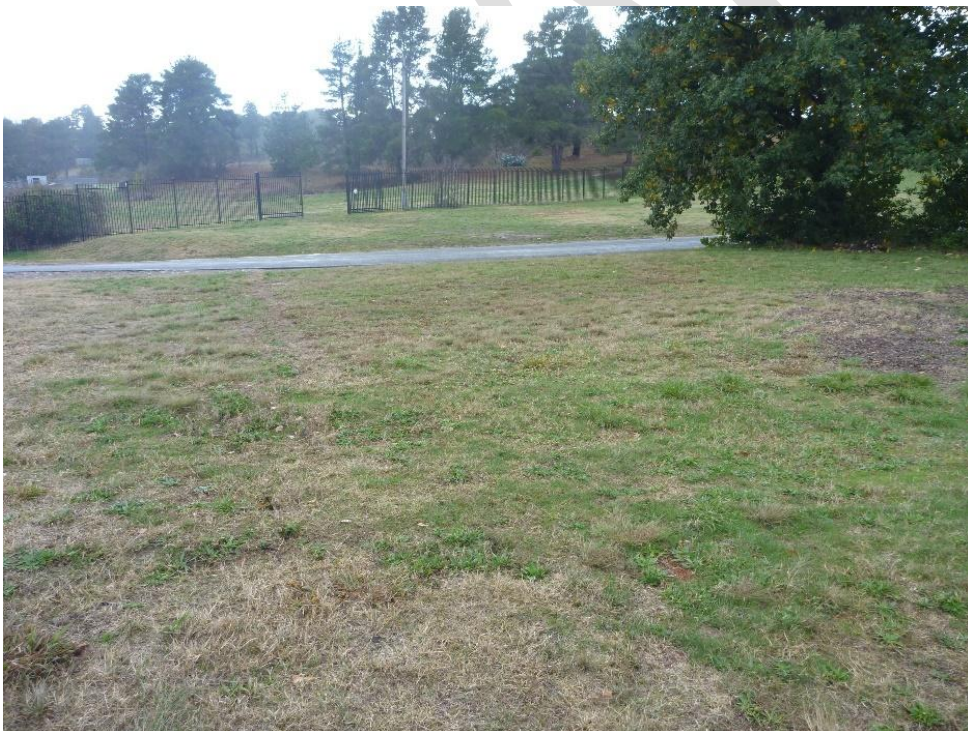
Figure 18 View looking north across BRW1, showing line of grass die off (centre left)  
Source: NOHC

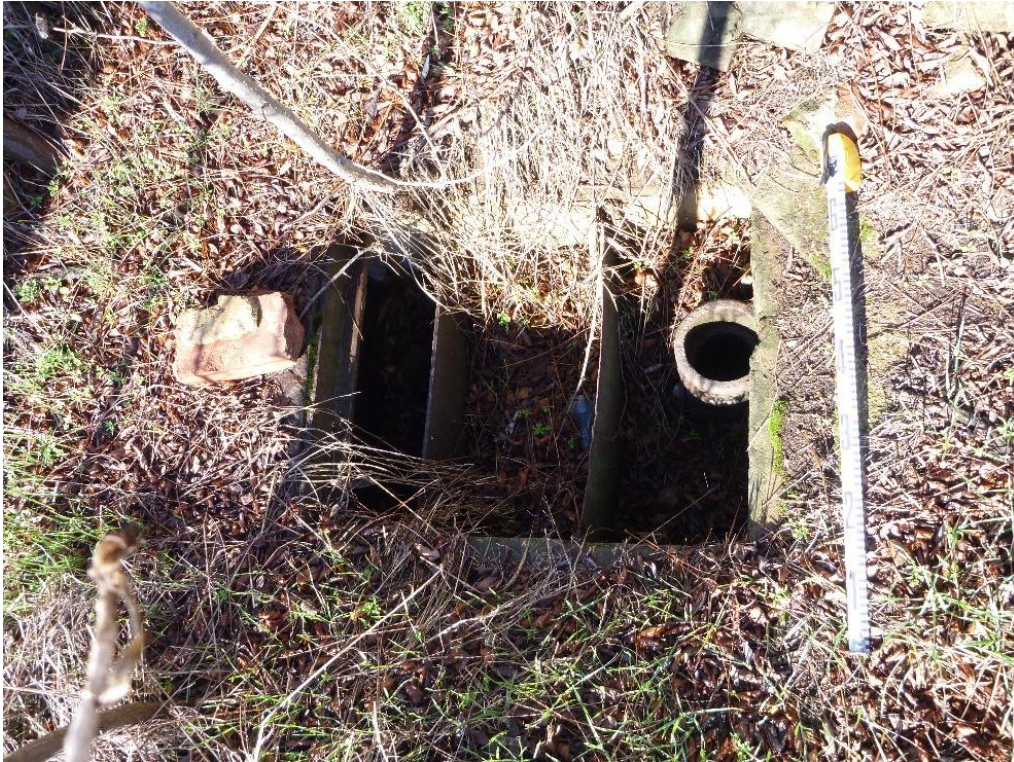
This brick feature is a substantial structural element of a former building and remains in situ unlike many of the other elements at this site. At the northern end of this structural feature is a large concrete lined drain or water trap, with remains of an iron grate (Figure 19). Brickwork around this feature, particularly the southern portion, shows signs of having been covered in tar or bitumen. Along the western side of the feature is a rectangular stall that is reminiscent of a fireplace or hearth recess (Figure 19). A piece of iron flue or furnace was identified as part of the spoil on this site, along with what appears to be a crumpled washtub (Figure 21). The bricks show a combination of different stamps and frog marks on their surface, including the early "CANBERRA C'WEALTH" stamp.

Figure 19 Detail of drain at northern end of BRW2-A  
Source: NOHC

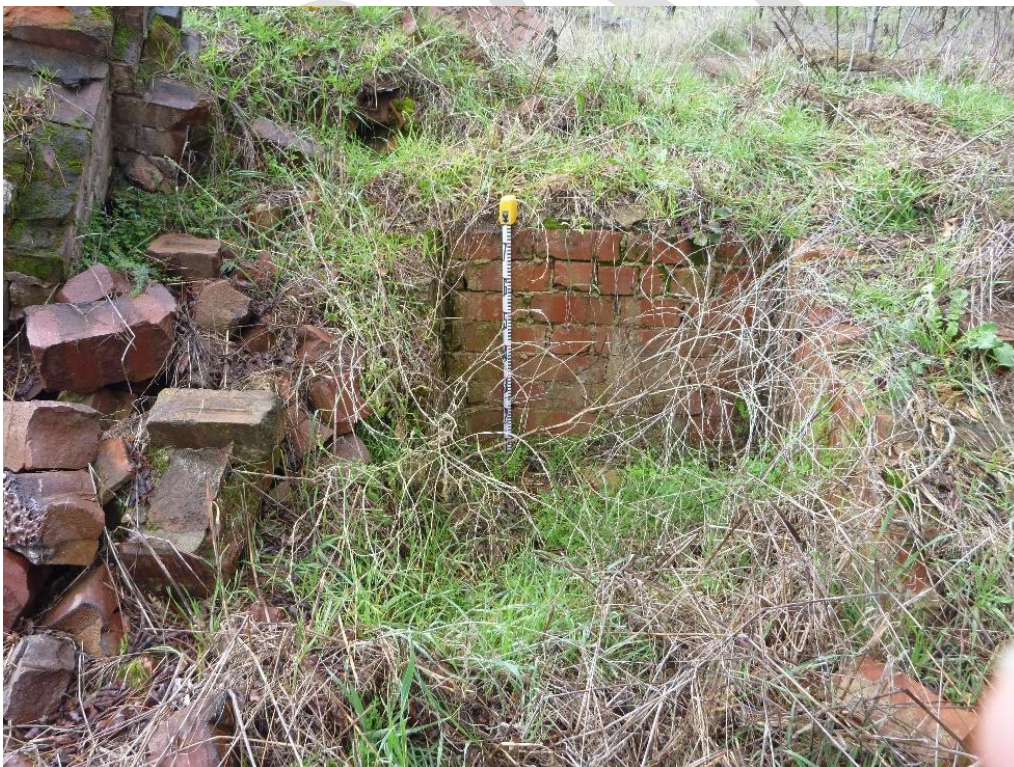
Figure 20 Detail of brick stall at BRW2-A  
Source: NOHC

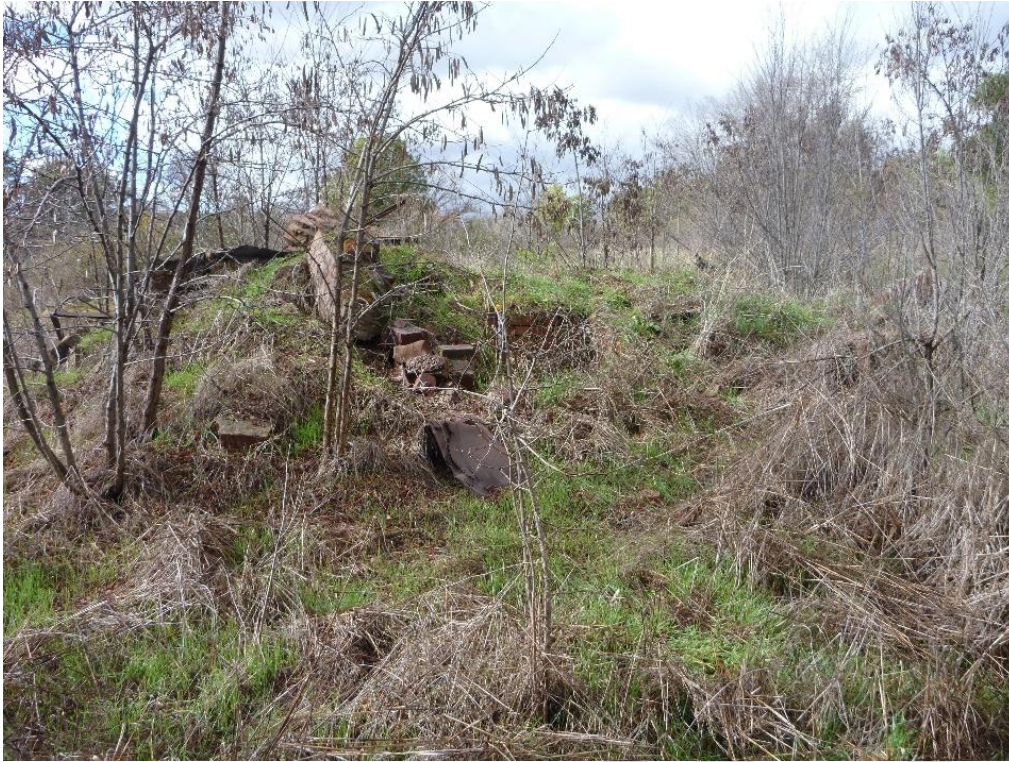
The site is defined by a number of highly visible mounds of spoil and a platform. These mounds of spoil, if related to former structures on the site, suggest heavy disturbance and a poor to fair condition across the site generally. Various items of artefactual material are scattered throughout the area, such as sheets of tin, brick and tile fragments, concrete and bottle fragments. Some of the material is relatively modern, including old car parts and even a bicycle frame, suggesting dumping of rubbish not necessarily associated with the site.

Figure 21 View looking west across BRW2; note the washtub and brick stall to the west and rubble to the north  
Source: NOHC

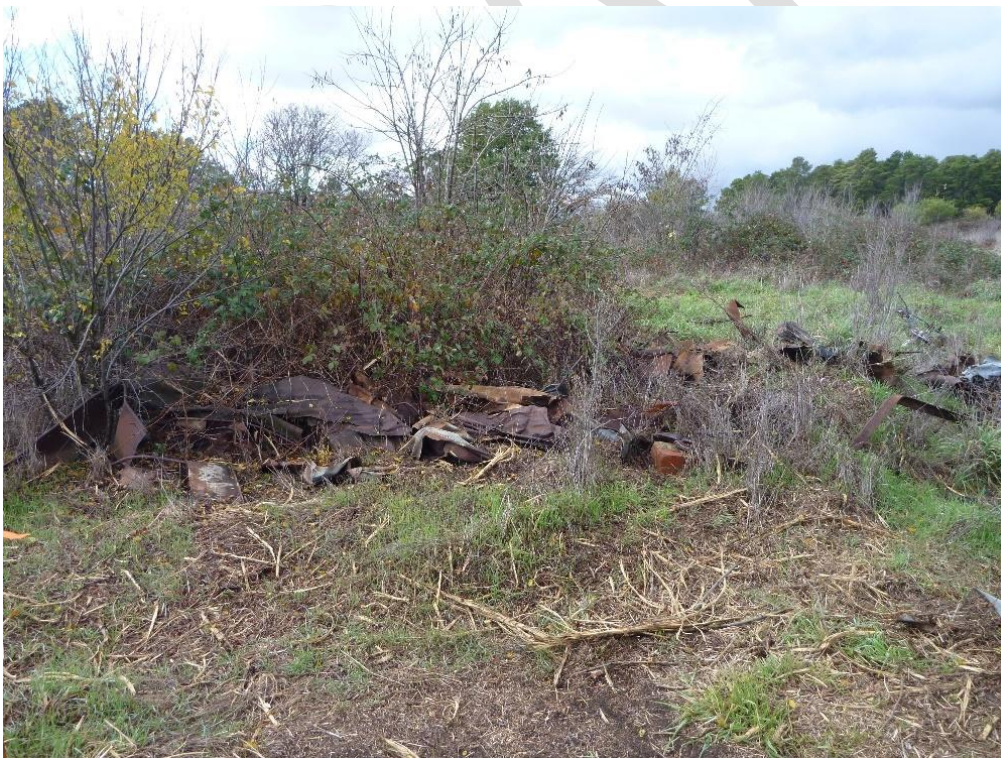
A spoil made up largely of metal remains including tin, iron girders and rods, galvanized and non-galvanized pipes is situated approximately 15m east of BRW2-A (Figure 22). There is some brick material within this spoil, including what appears to be an in situ brick footing. There is also the occasional plank of milled timber. The northern side of this mound is bordered by a blackberry bush cluster.

Figure 22 View looking east across BRW2-B  
Source: NOHC

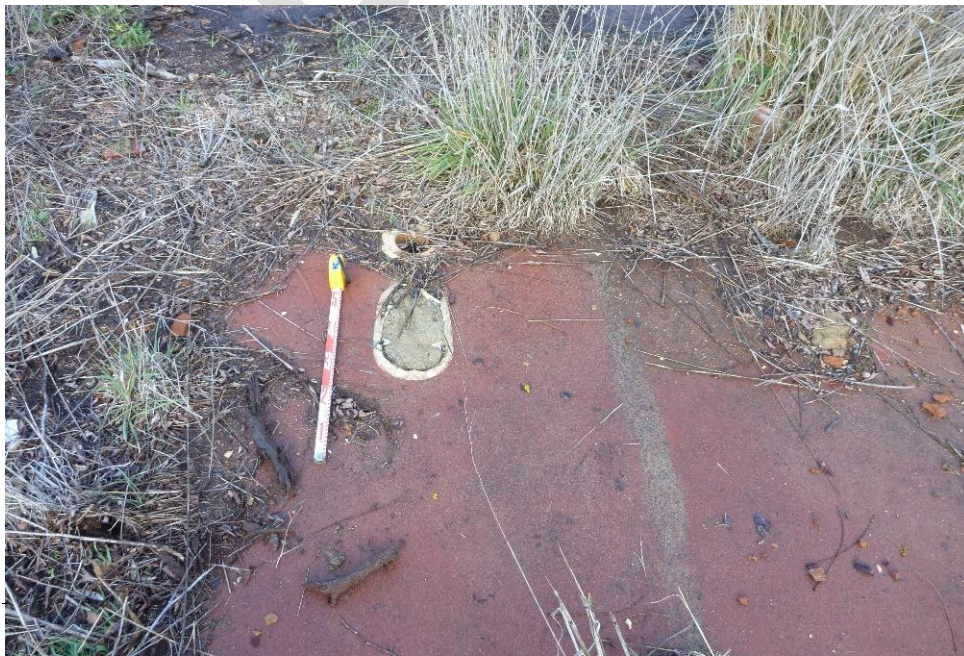
A concrete slab approximately 4m x 6m is located just south of the southern fence line of the brickworks at the western end of the site (Figure 23). The rendering is coloured red and has the remains of four toilet fittings running down the centre of the slab. The toilet bowls have been removed from the platform, although fragments of broken bowl and earthenware plumbing pipe exist around the slab (Figure 24). The alignment of the toilets suggest that the stalls were accessible from the northern side of the slab. A possible step or entrance way extends from the northern part of the slab in the centre. A stamped feature is evident in the north east corner of the slab suggesting a small closet, room or feature for what appears to be an ablutions block. The slab appears to be on the same alignment as BRW2-A, which is just further south. This structural feature appears to correspond with the brickworks ablution block which is depicted in images of this area from at least 1929. The ablution block suggests that it was more to do with the brickworks than it was to do with the accommodation of employees.

Figure 24 Remnant of one of the toilet fitting  
Source: NOHC

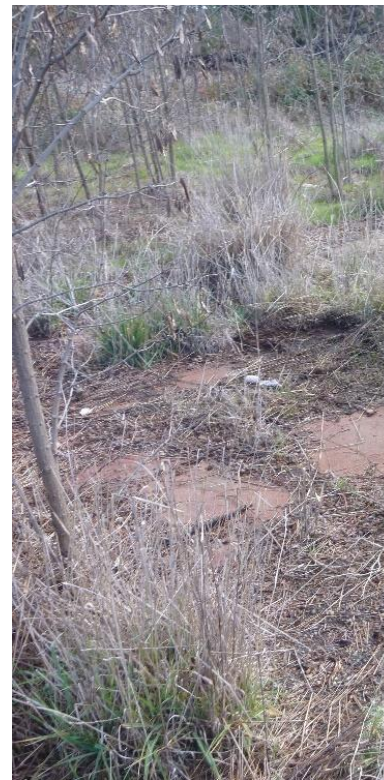
Figure 23 The concrete slab at  
Source:  
NOHC

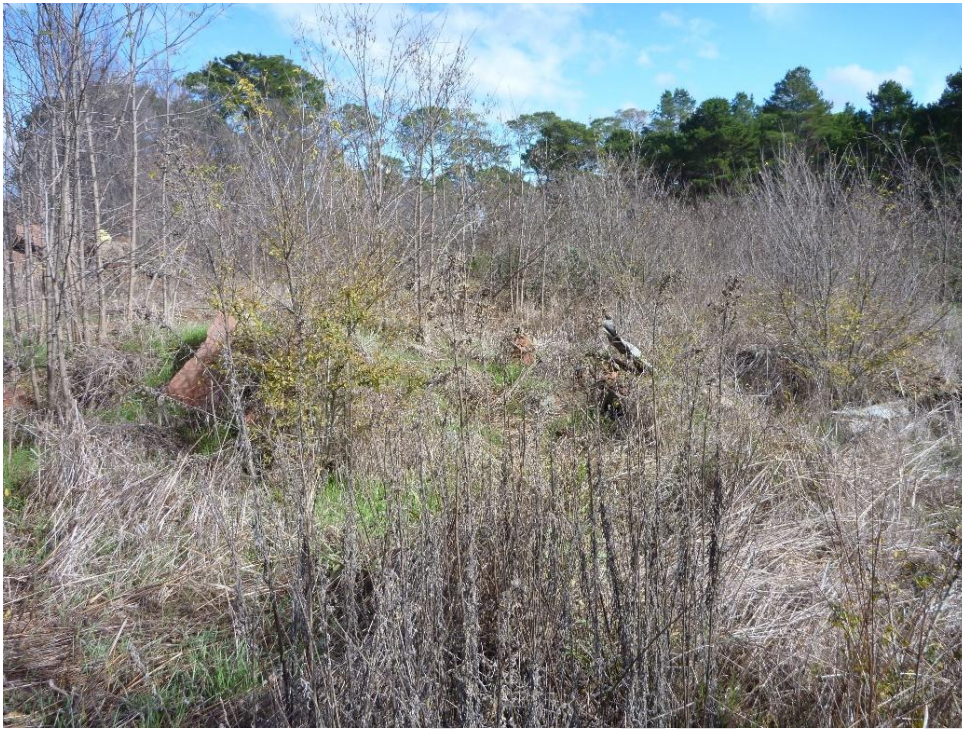
Positioned just east of BRW2-C is a small mound made up largely of brick and brick fragments, along with rendered red brick (Figure 25). There are also segments or clusters of concrete blocks with broken red tile as aggregate. There is also the occasional piece of tin sheeting. It is possible, due to the red rendered brick, that this mound is a spoil heap for structural remains from BRW2-C.

Figure 25 Looking south-west towards BRW2-D  
Source: NOHC

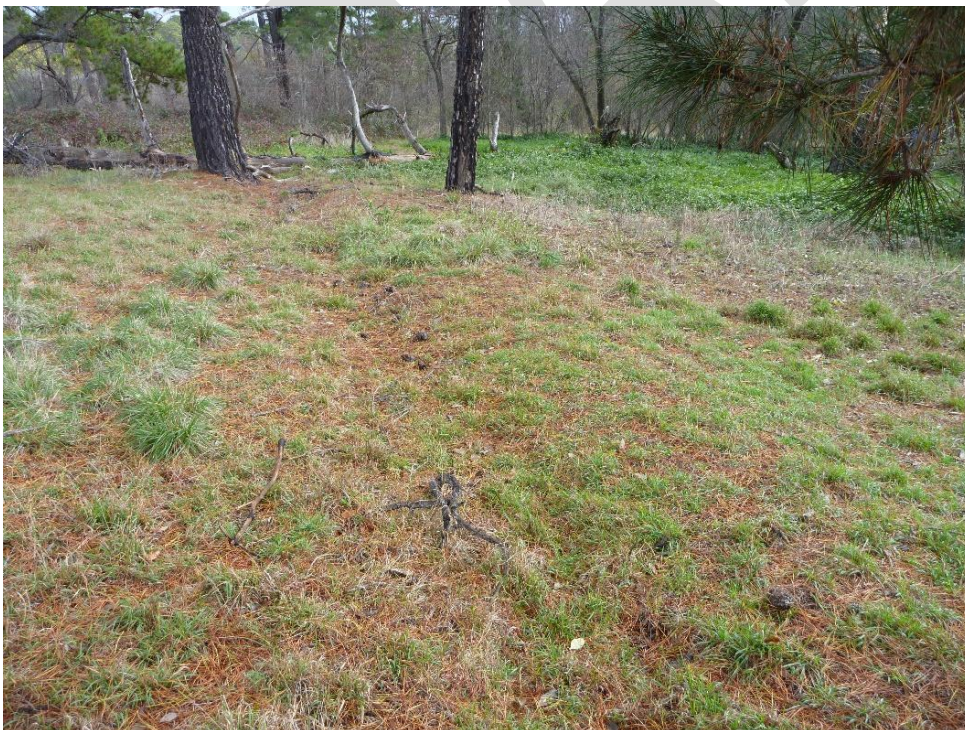
Figure 27 Drainage line at BRW3, looking west  
Source: NOHC
