# Canberra Brickworks Precinct

## Conservation Management Plan

### Volume Two—Appendices

September 2021

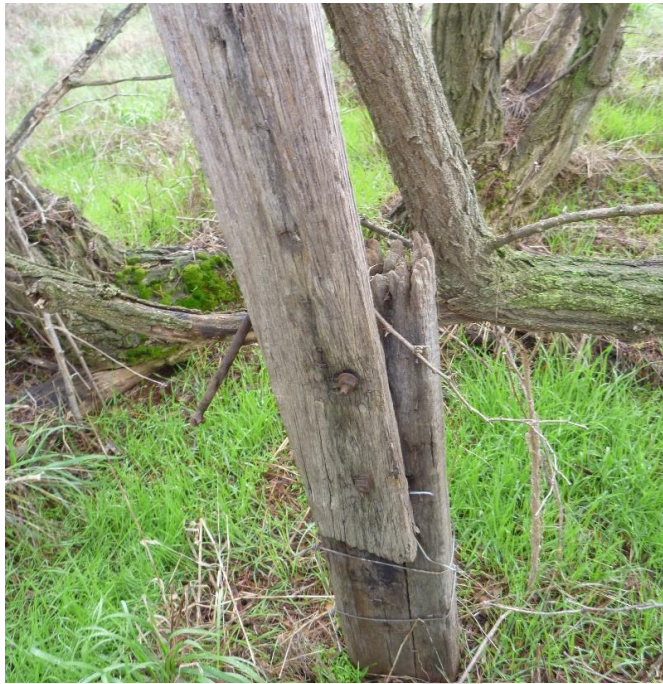
In proximity to the hearth and camp are mounds of structural spoil, consisting of brick and concrete, iron rods and metal sheeting, bottles and tin cans. To the east of the modern camp, and almost directly south from BRW2, a rectangular clearing was encountered. At the top of the slope to the south of the clearing a drainage line has been excavated, which runs approximately on an east-west alignment (Figure 27). No other structural features or remains were identified within this clearing between the drainage line and the northern border of the site. However, a slab timber fence or yard post is located at the northern end. The post itself appears to be early in origin, but has had modifications made to it by the addition of another slab bolted to the upright, and use of galvanized wire and nails, as opposed to non-galvanized iron nuts and bolts for other modifications (Figure 28). No other posts or holes were

Figure 28 Detail of slab post at BRW3  
Source: NOHC

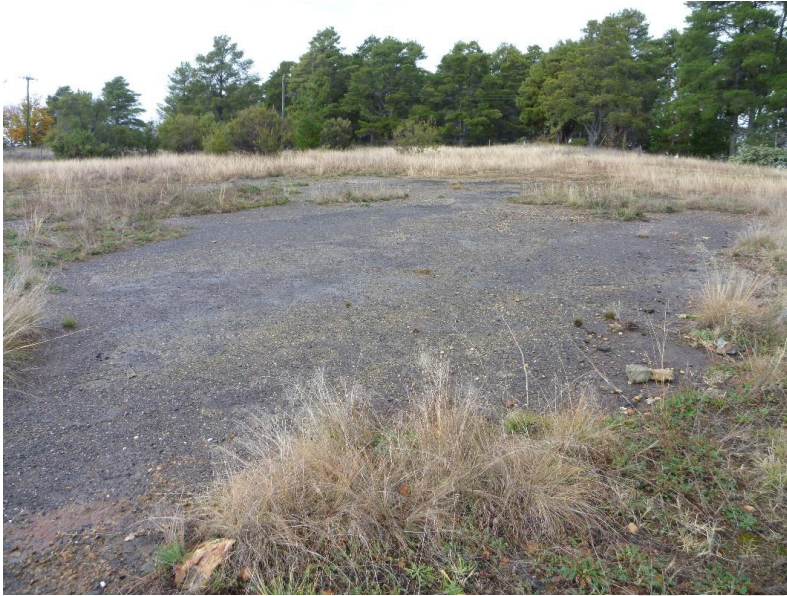
A fenced yard area measuring approximately 80m x 80m is located to the south of BRW1. Defined by a star picket fence line with wire netting along the bottom portion and barbed wire on the upper portion, the yard is accessed by gates at the northern end from Denman Street and a gate in the south-west corner. Visibility was very good as the area is relatively clear of vegetation, with the exception of a light covering of low growing grass across parts, and the occasional low growing shrub and small tree. The yard rises up a gentle slope to the south. A layer of bitumen such as that used for road surfaces covers a good portion of the site (Figure 29) and this sits directly above a layer of bedrock, with only a thin layer of topsoil present in patches throughout the yard. No structural features were identified, although fragments of window glass were found near the northern entrance to the site (Figure 30). The condition of this area is good.

Figure 29 Asphalted area at BRW4, looking east  
Source: NOHC

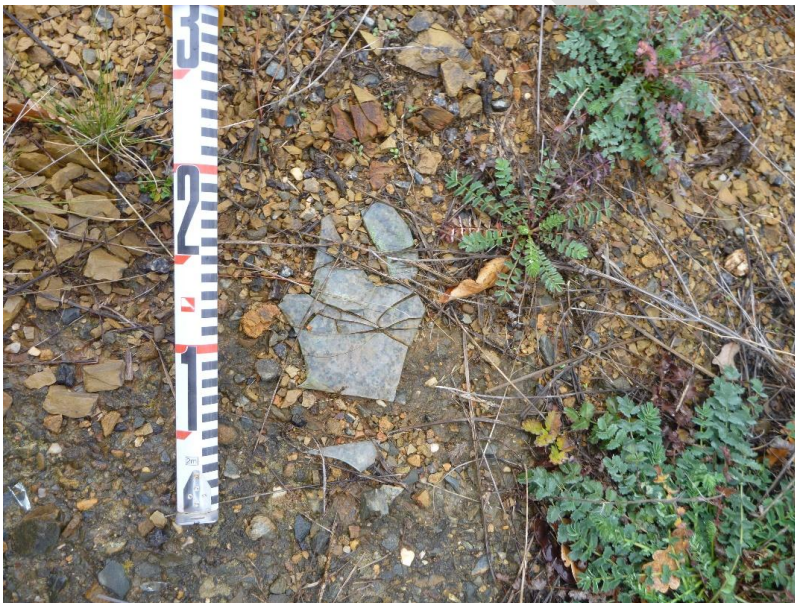
Figure 30 Window glass at BRW4  
Source: NOHC

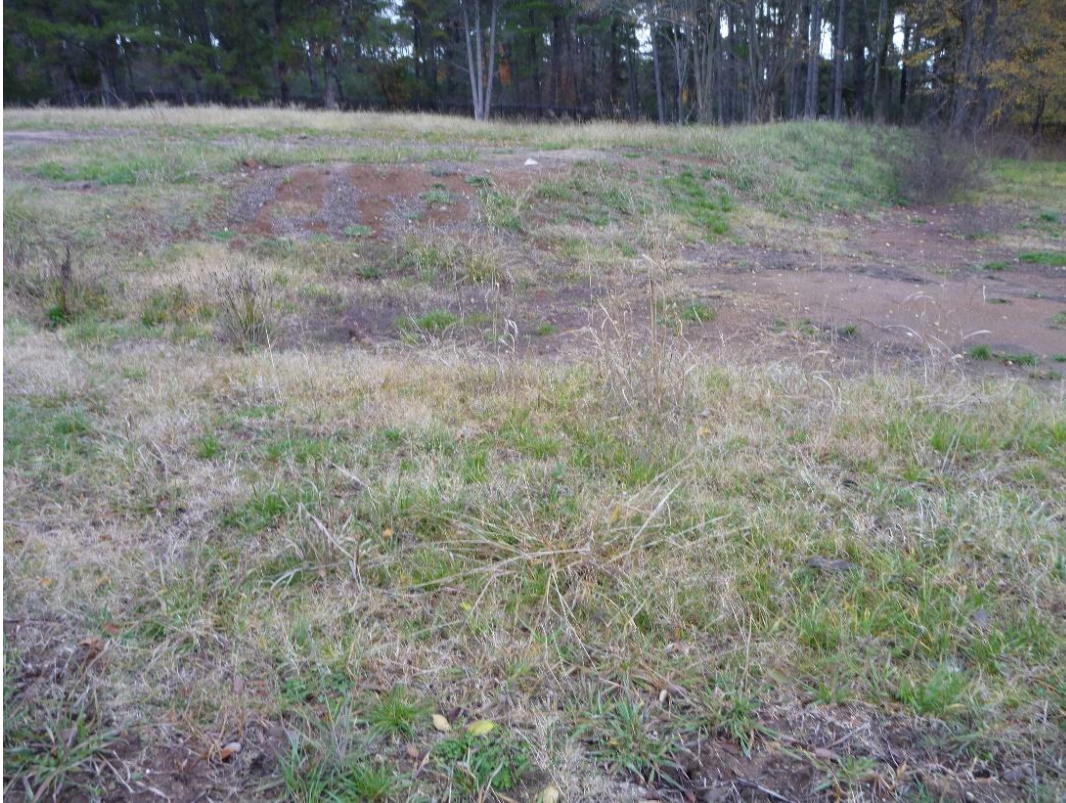
To the immediate west of the brickworks kilns is a silty clay feature up to 50m in diameter and 1 to 2m high, which appears to be a flat topped mound or stockpile of this resource (Figure 31). It is possible that it is a feature that has been created from earthworks in this area, however it does not sit on the same horizon as other surrounding features, such as the brickworks kilns. The location of this site is close to the former creek that fed into the precinct from its north-west corner. The silty clay material is different to any of the top soils and sediments around the rest of the precinct. Visibility of this area was good and the condition of this feature is good.

Figure 31 Clay mound feature at BRW5, looking west  
Source: NOHC

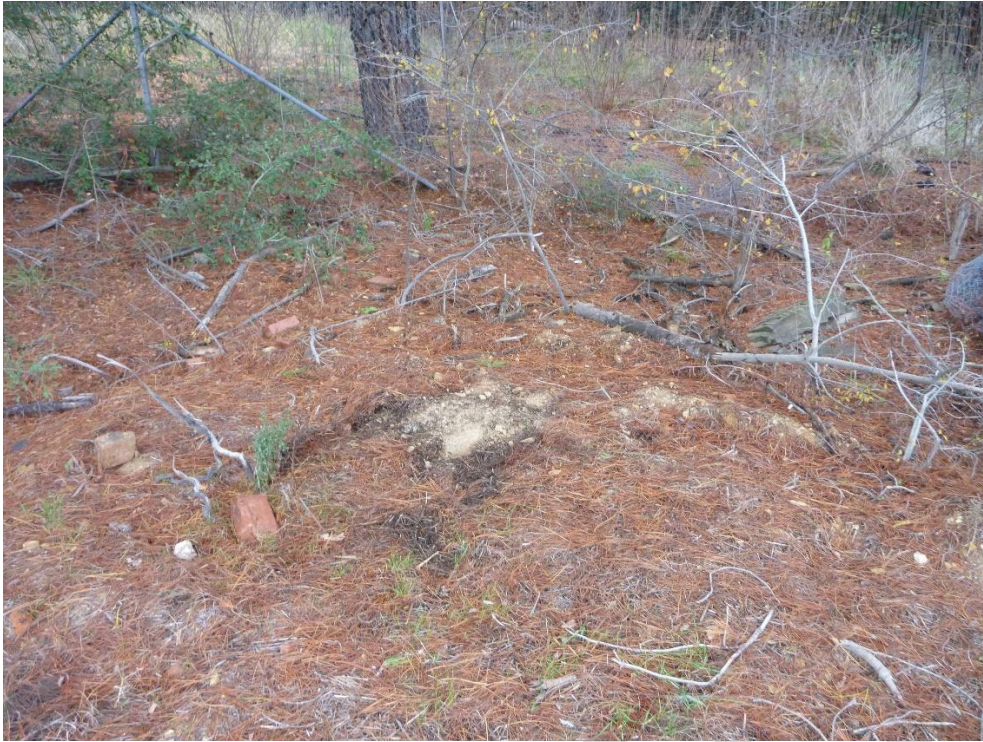
To the west of the mound is a series of depressions scattered throughout with brick and concrete rubble (Figure 32). These depressions are located between the mound to the east, and the railway remnants to the west. They could be associated with a former structure in the vicinity or rubble that has been

Figure 32 Rubble and depressions at BRW5  
Source: NOHC

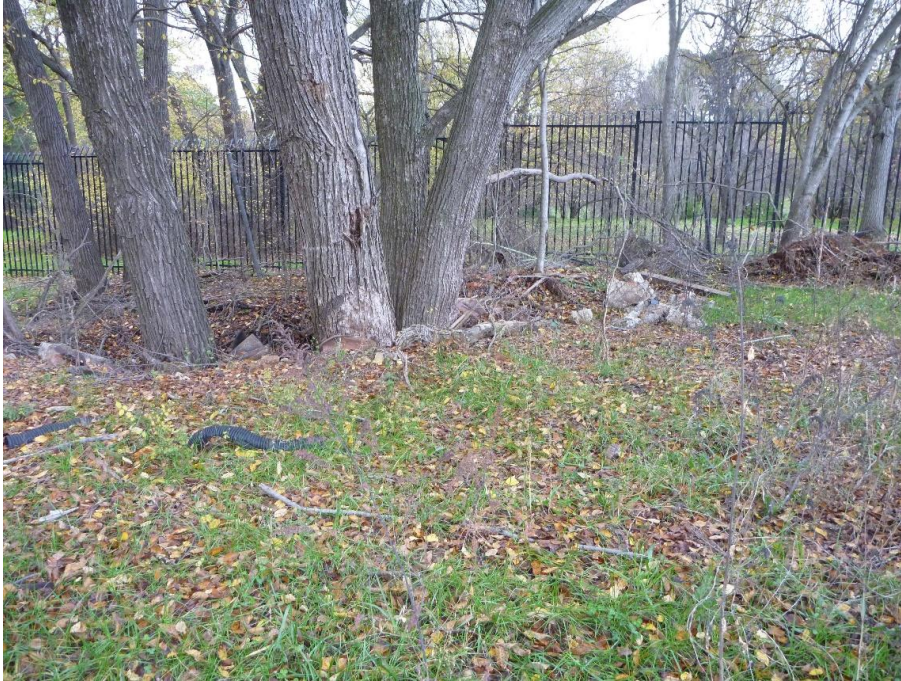
This site is located at the north-west section of the precinct and consists of a mix of brick and concrete rubble located within a depression at the base of trees (Figure 34). The remains could be associated with a former structure in the vicinity or rubble that has been dumped from another location. An aerial photograph from the 1960s shows that a rectangular structure was once located in this vicinity. Visibility was poor in this area due to high growing vegetation in the form of grasses and weeds. Condition is fair.

Figure 34 Brick and concrete rubble surrounding trees at BRW6, looking north  
Source: NOHC

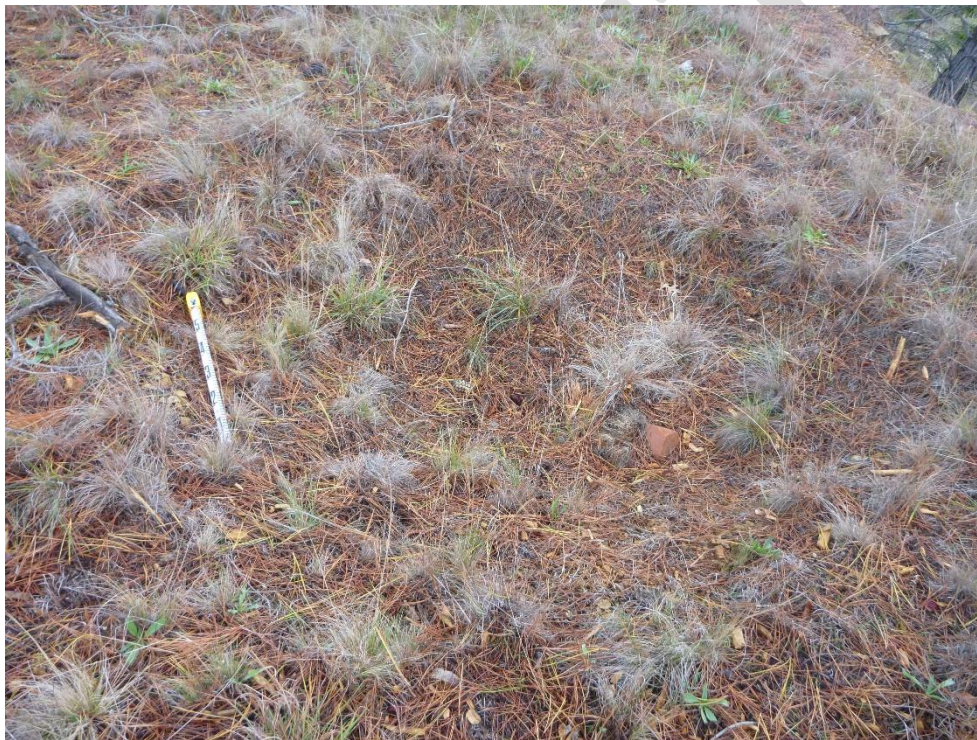
Further east and up an incline, there are a number of depressions amongst a grove of pines along the edge of the quarry cliff (Figure 35). These depressions are uniform in size, approximately 1m in diameter and appear to be in a sequence. The historic aerial dating to 1950 (Figure 33) shows a series of circular features similar to these depressions extending west to east up the slope in a double row. The function or purpose of these depressions is unknown. On the eastern side of the quarry zone to the north is an example of an in ground circular tank that has been back filled with brick rubble, approximately 3 metres in diameter (Figure 36). This tank does not resemble the depressions in the south of the quarry in scale and known purpose.

Figure 35      Depression on south side of quarry edge  
Source: NOHC

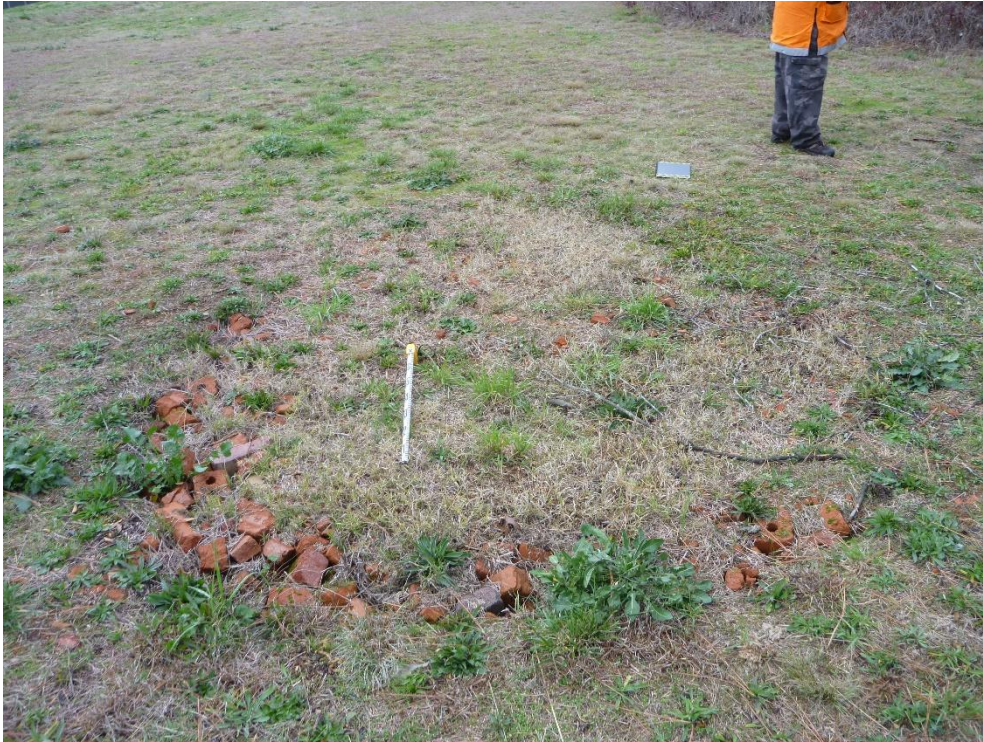
Figure 36 Tank at north-eastern edge of quarry, looking south  
Source: NOHC

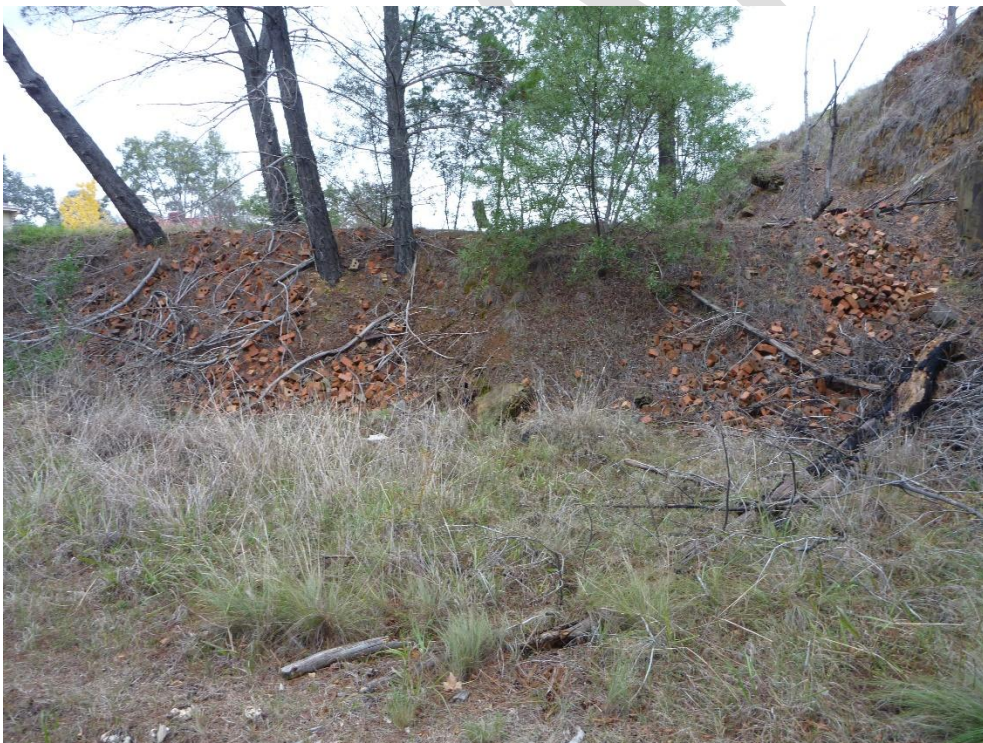
At various locations along the quarry wall, particularly the eastern side, brick rubble has been back-filled against the face (Figure 37). This is either an example of disposing of seconds and damaged bricks, or to provide something of a retaining wall for the cliff face. The exactness of the placement suggests the latter.

Figure 37 Rubble backfill along north-eastern edge of quarry face, looking east  
Source: NOHC

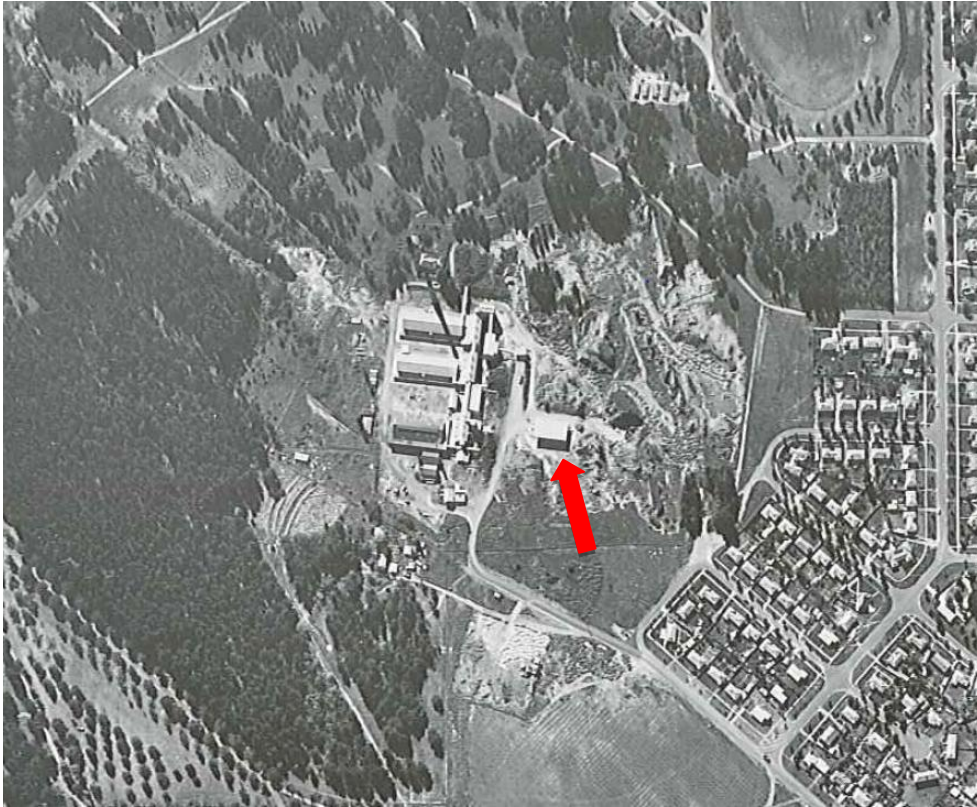
In the middle of the quarry floor are two mounds that have been covered with topsoil and grassy vegetation. Aerial imagery from the 1960s (Figure 38) shows a structure in the form of a large shelter or shed in the same location. These mounds could be evidence of this structure and its contents. This also confirms that there is likely to be intact subsurface material beneath these mounds dating to the original quarrying.

Figure 38 Aerial photograph of the Brickworks, 1961; the shelter is indicated  
Source: ACTPLA

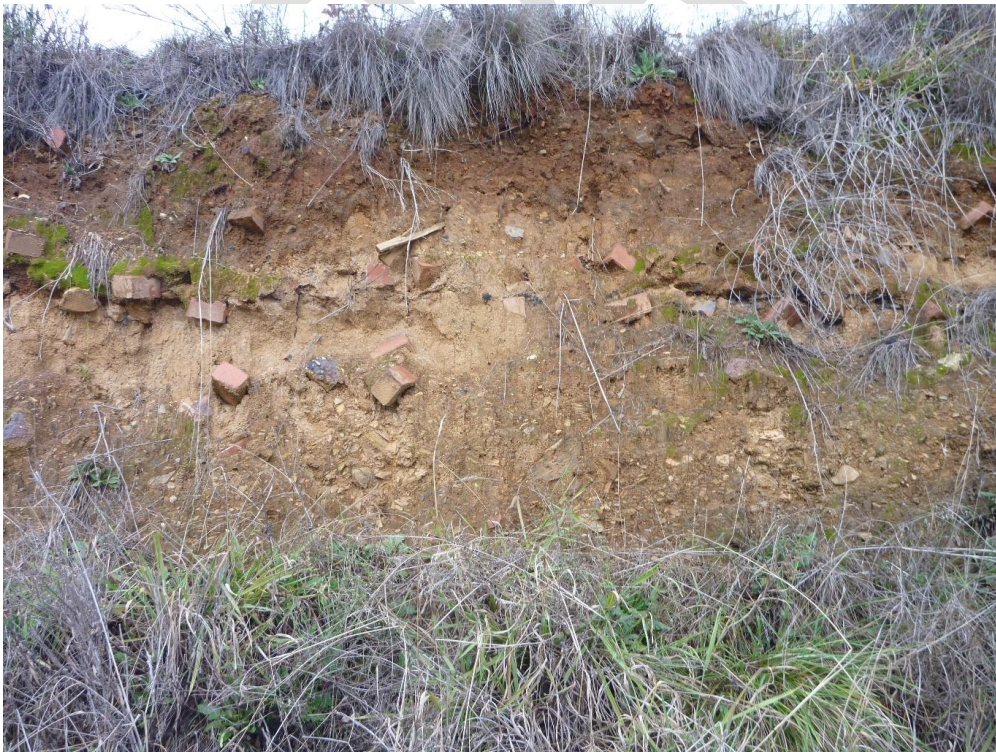
Along the north eastern edge of the quarry, the floor has been further excavated to create a pond or lake. This excavation dates to the time the brickworks precinct was a tourism facility. The quarry face to the west of this pond or lake in the north, shows stratigraphy that depicts a disposal event that has subsequently been capped by spoil from either the excavation of the pond/lake or from other areas. A layer of brick, concrete, glass, and iron exists along with a line of charcoal and burnt material approximately a metre below the surface (Figure 39).

Figure 39 Quarry face showing layer of rubble and charcoal at northern end of quarry  
Source: NOHC

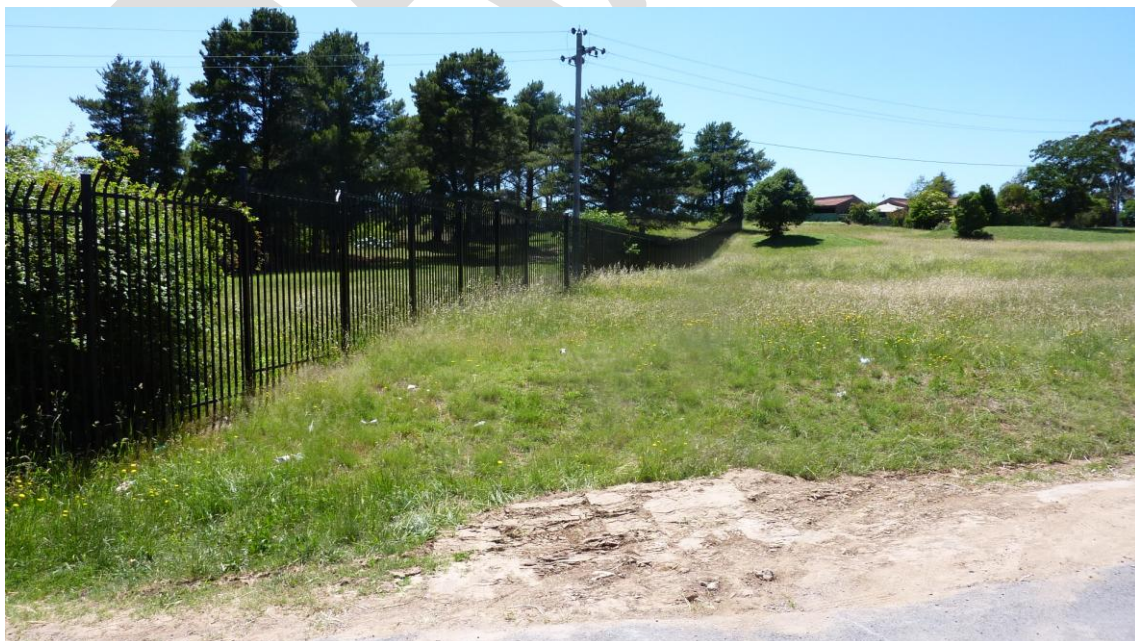
Archaeological deposits pertaining to built form from this era would be expected to comprise footings and machinery remnants. Material discard would be expected to be items of an industrial nature with the potential for some domestic material related to the dormitories (Figure 40).

Figure 40 Location of the old kiln and dormitories looking east  
Source: Lovell Chen

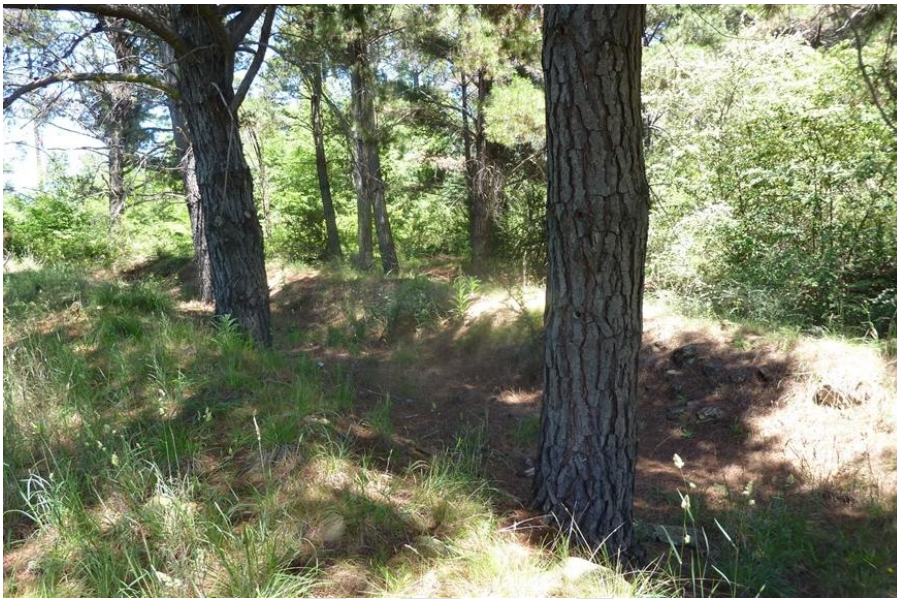
The brickworks railway operated between 1923 and 1927, and all tracks had been removed by 1929. Evidence of the railway siding, in the form of cuttings in the landscape located to the south-west of the brickworks, could be seen in aerial views of the site well into the 1970s and are still evident (Figure 41 and Figure 42). Self-seeded vegetation has since reclaimed much of the area. Although all remnants of the track were removed in the 1920s, and a period of 90 years has elapsed since then, there is some limited potential for archaeological evidence that would enhance an understanding of the railway and its operation.

Figure 41 Cutting in landscape showing the original alignment of the brickworks railway  
Source: Lovell Chen

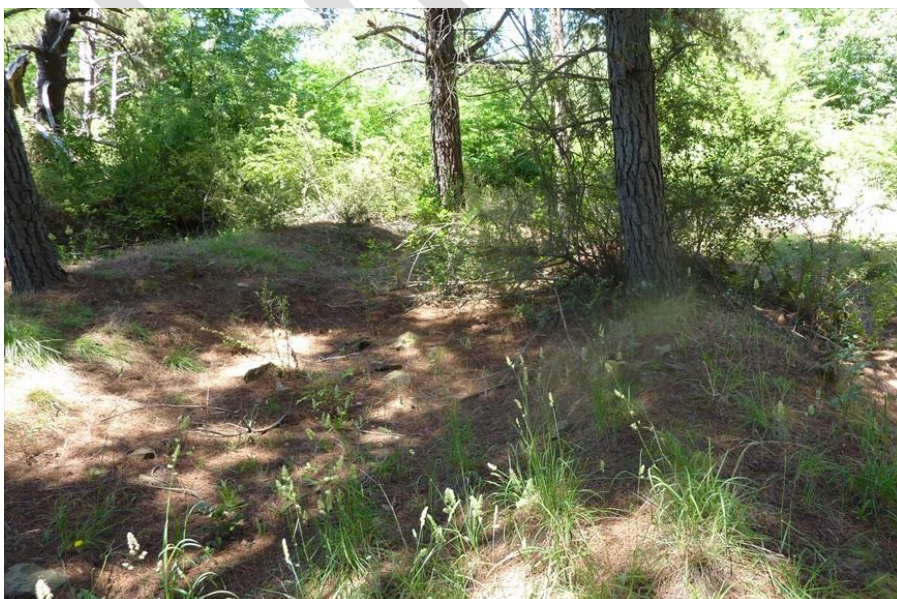
Figure 42 Cutting in landscape showing the original alignment of the brickworks railway  
Source: Lovell Chen

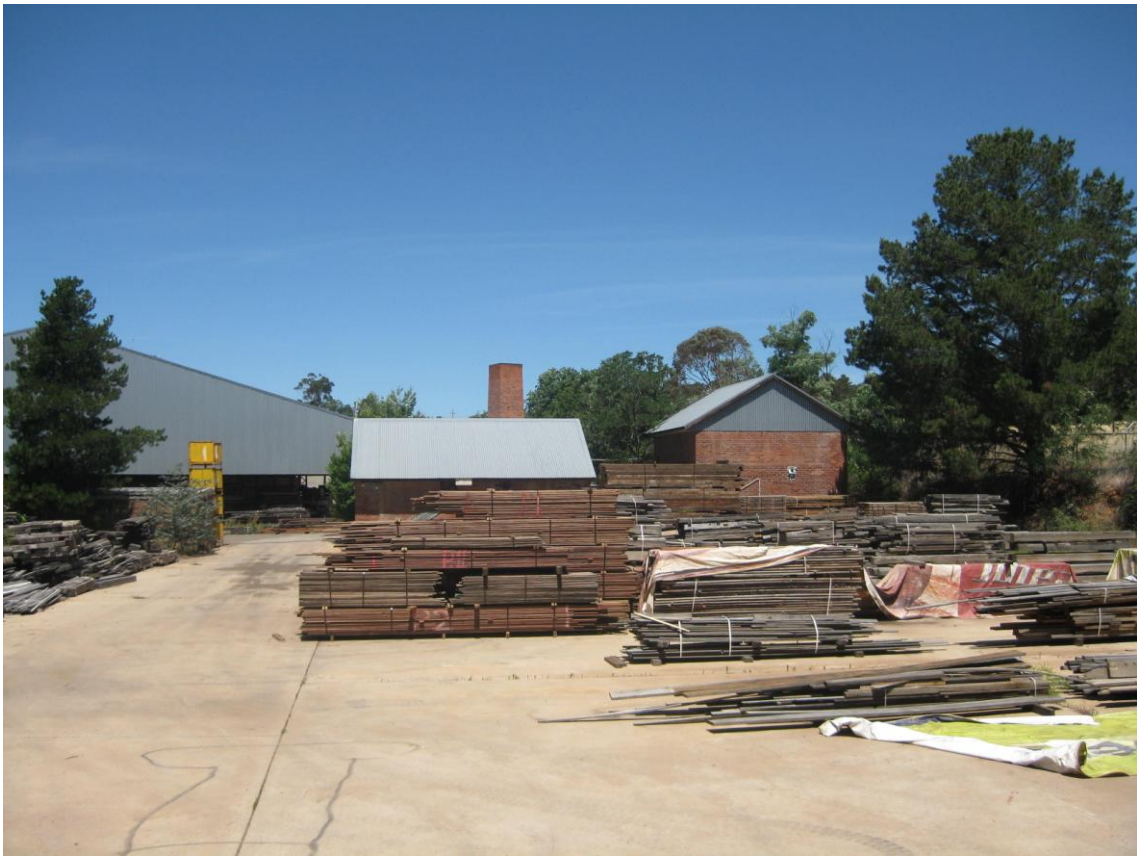
Figure 43 View looking east over the extrusion plant, part of the northern extension to the railway reserve  
Source: Lovell Chen

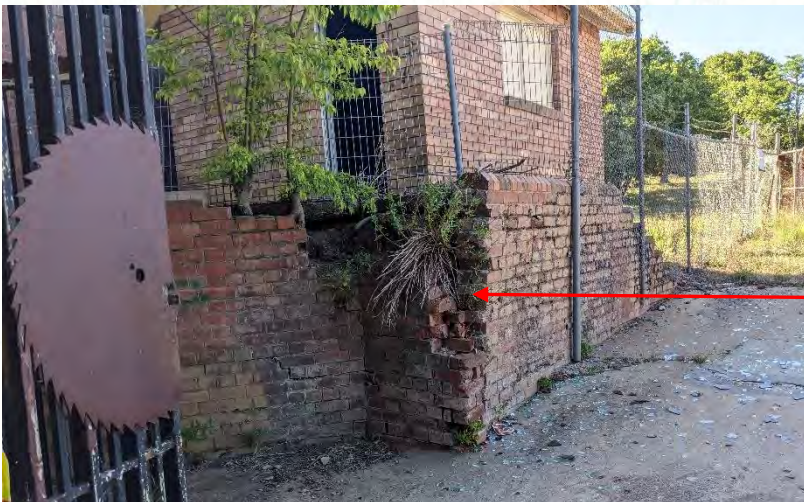
Compromised retaining wall

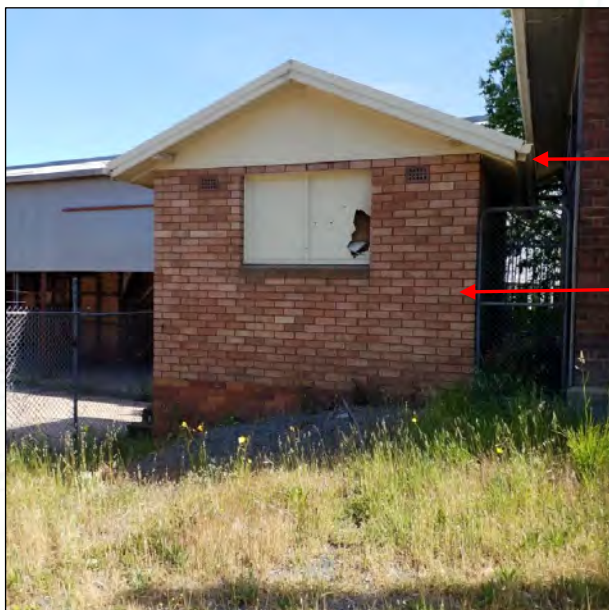
Downpipes not connected

Damaged boarded up window

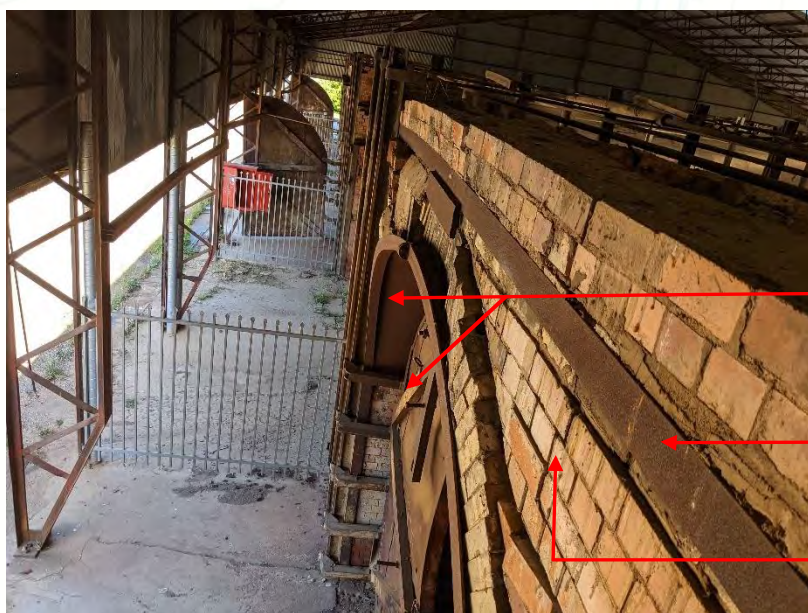
Distortion of steel  
framing

Temporary  
stripping

Partial failure of  
masonry façade

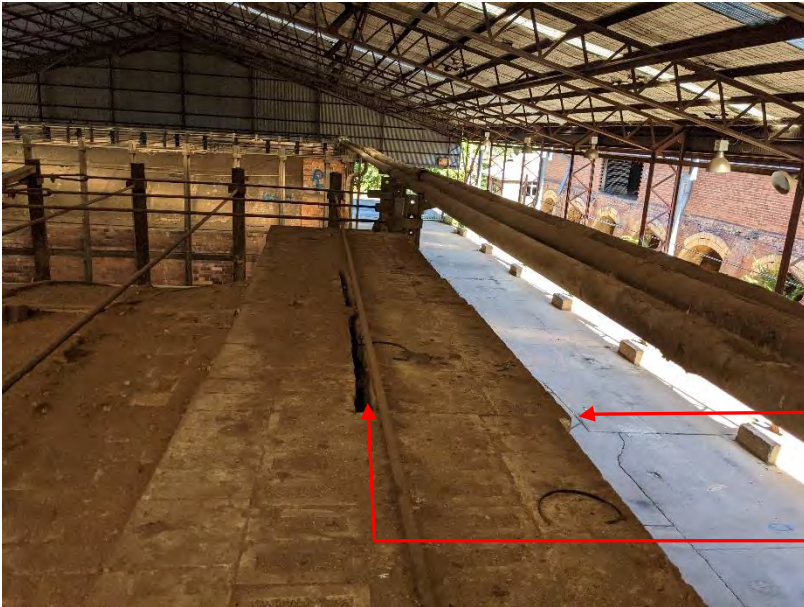
Entry

Development of  
severe crack to  
roof of kiln

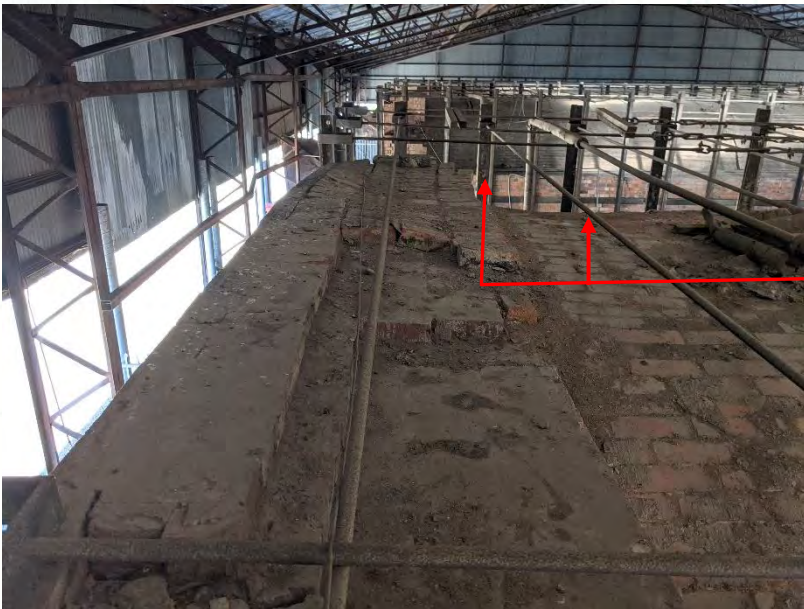
Wall ties in fair  
condition

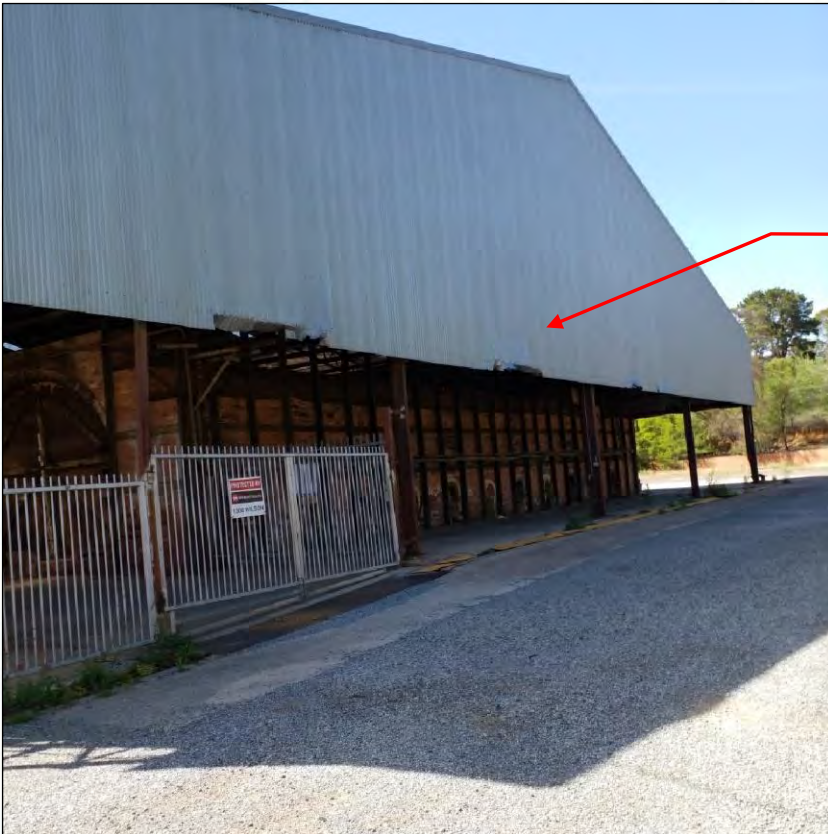
Damaged wall sheeting

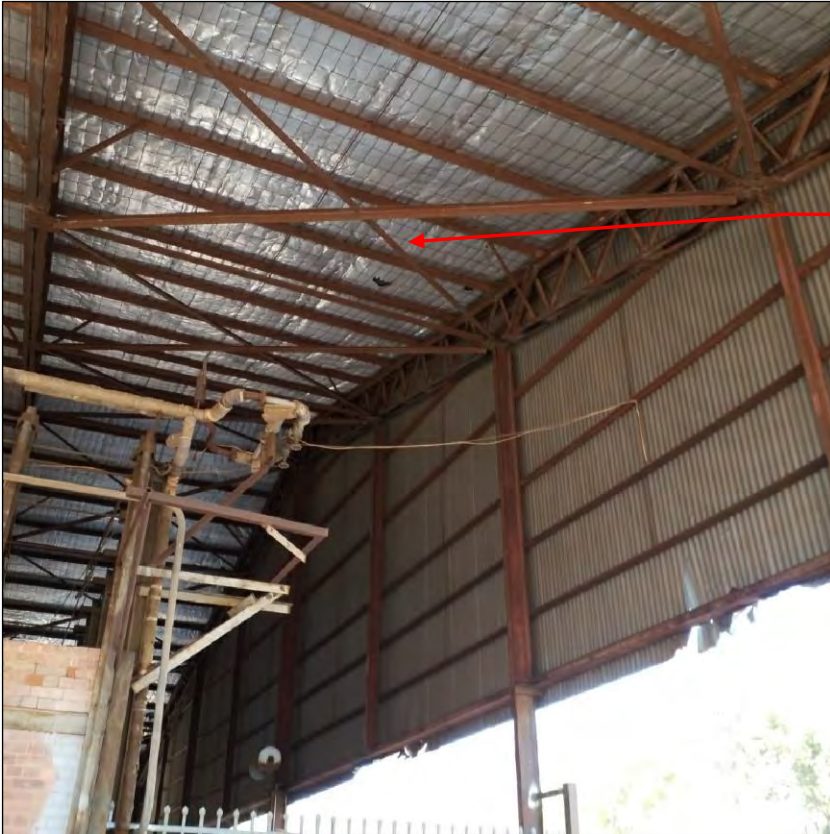
Deteriorated sarking

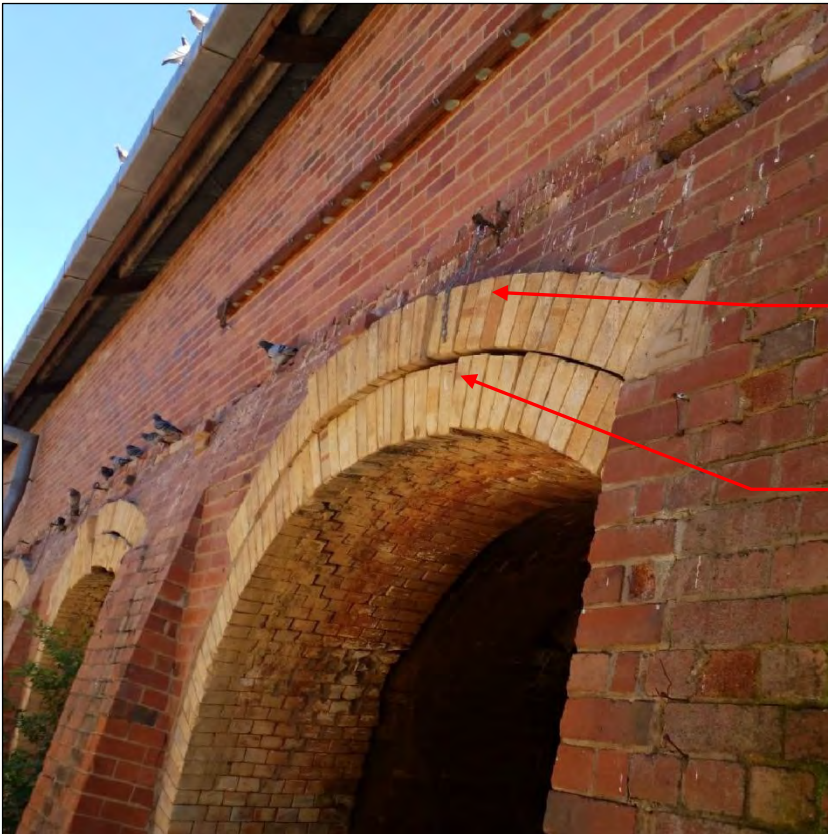
Displacement of arch

Voids in brickwork bedding

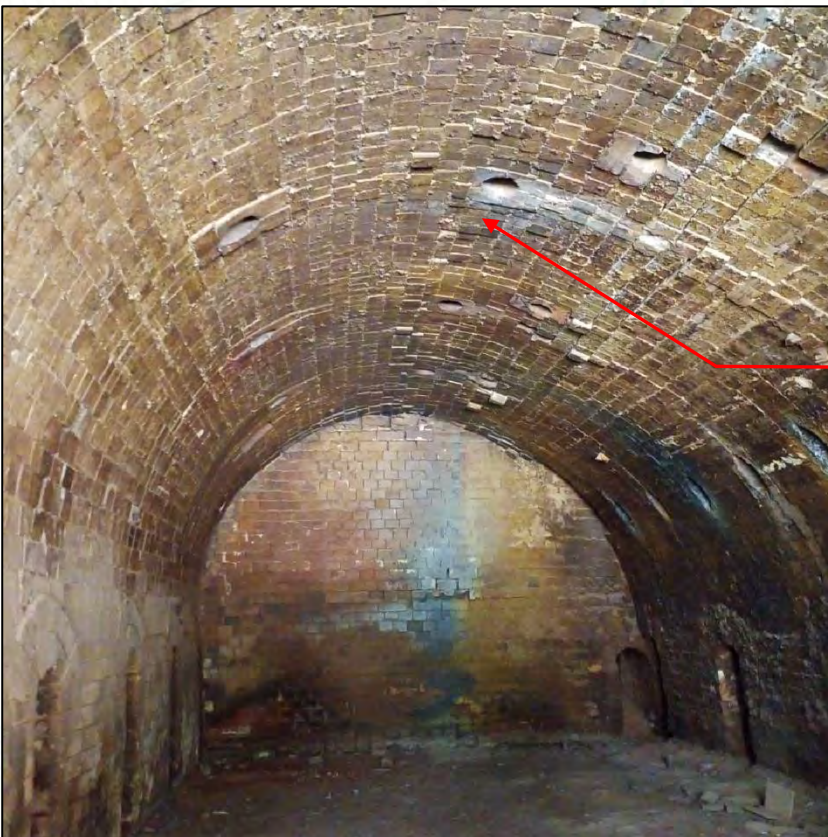
Arch generally in sound condition  
Loose bricks in areas

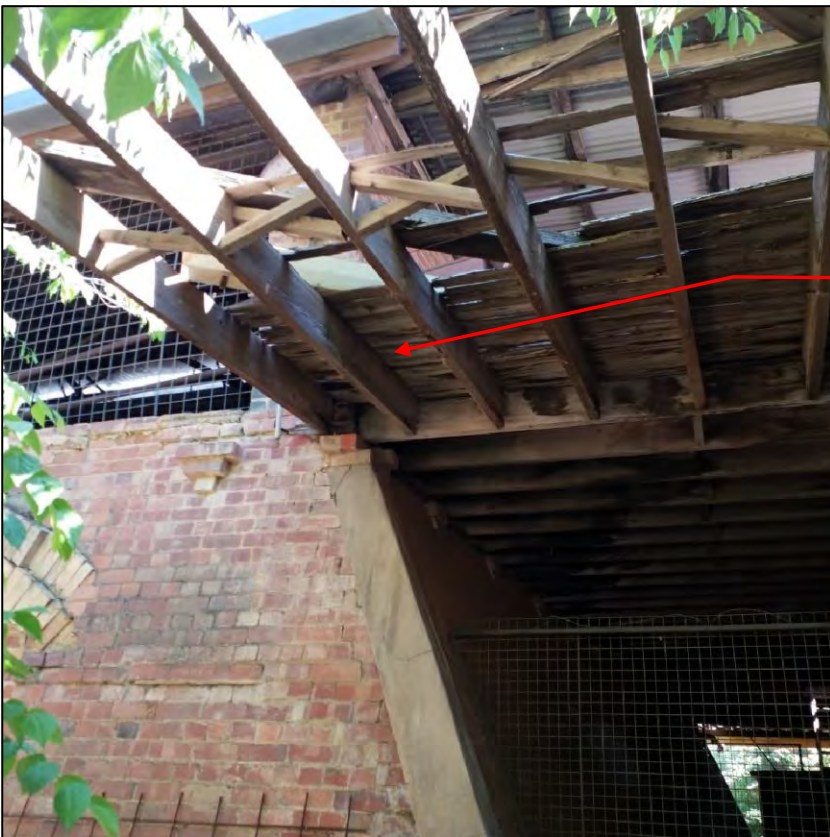
Joist and floorboards to be demolished

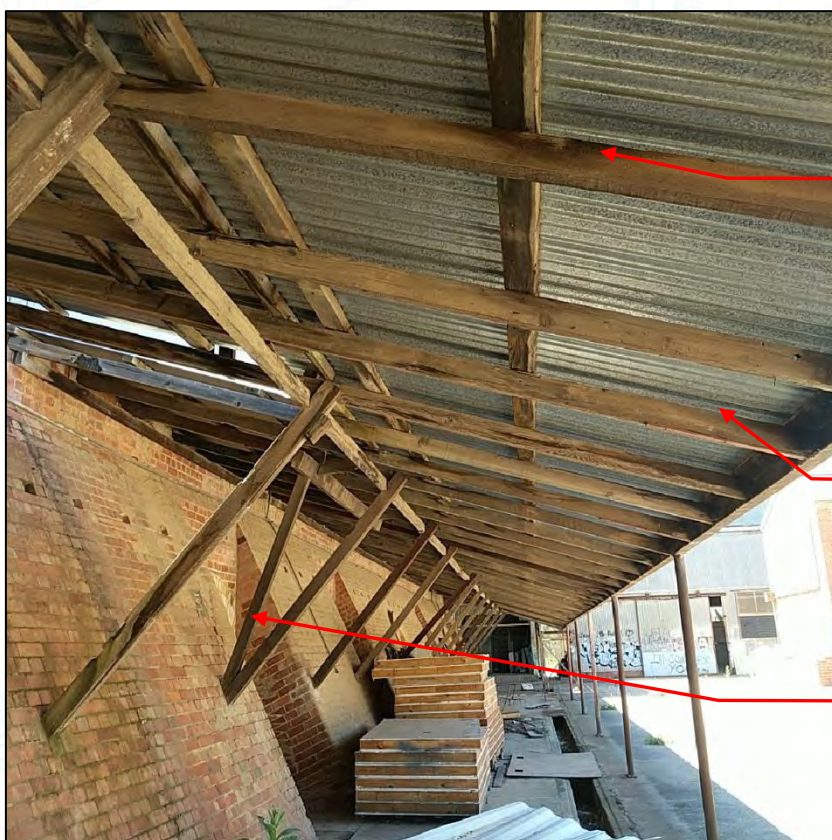
Timber rafters

Rafter to fascia connection  
weather damaged

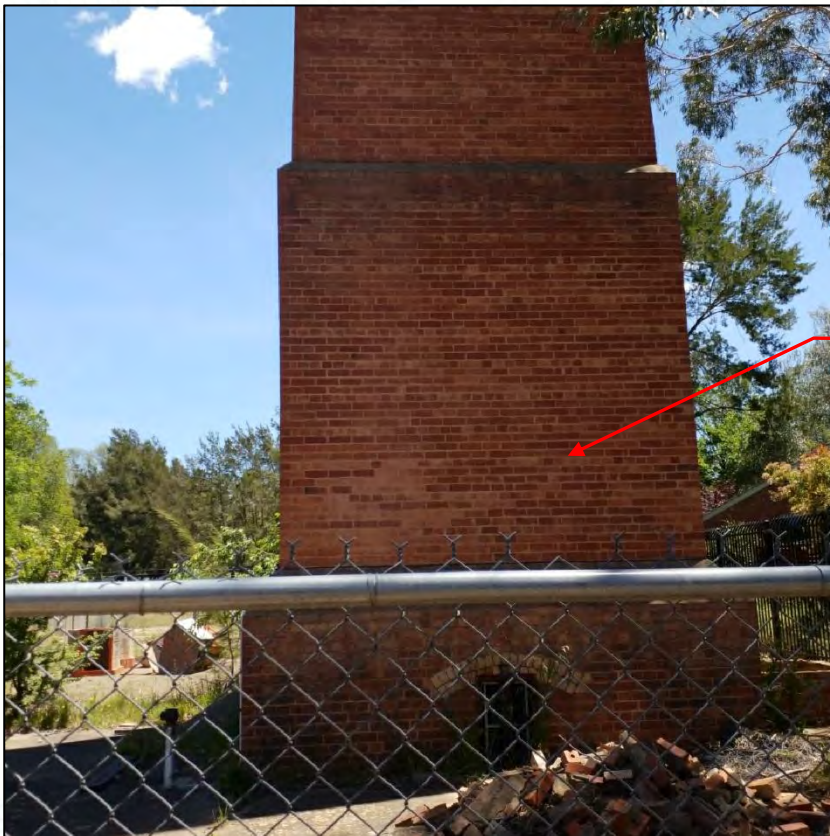
Base brickwork in good condition

Element	Condition	Remediation Requirement
Base of chimney	<ul style="list-style-type: none"><li>• Base of chimney was in good condition for the age of the structure. No notable cracking was observed.</li></ul>	Base of structure to be monitored and any loose bricks reinstated as required.
Upper areas of chimney	<ul style="list-style-type: none"><li>• Note - Access limited to ground floor.</li><li>• Brickwork appears to be in reasonable condition for age of structure.</li></ul>	<p>Closer inspection of upper chimney areas recommended due to limited access.</p> <p><b>Option 1:</b> Local areas of loose bricks, but not displacement of chimney – Reinstatement of loose bricks.</p> <p><b>Option 2:</b> Large areas of loose bricks and chimney displaced in areas – Additional structural support may be required.</p>

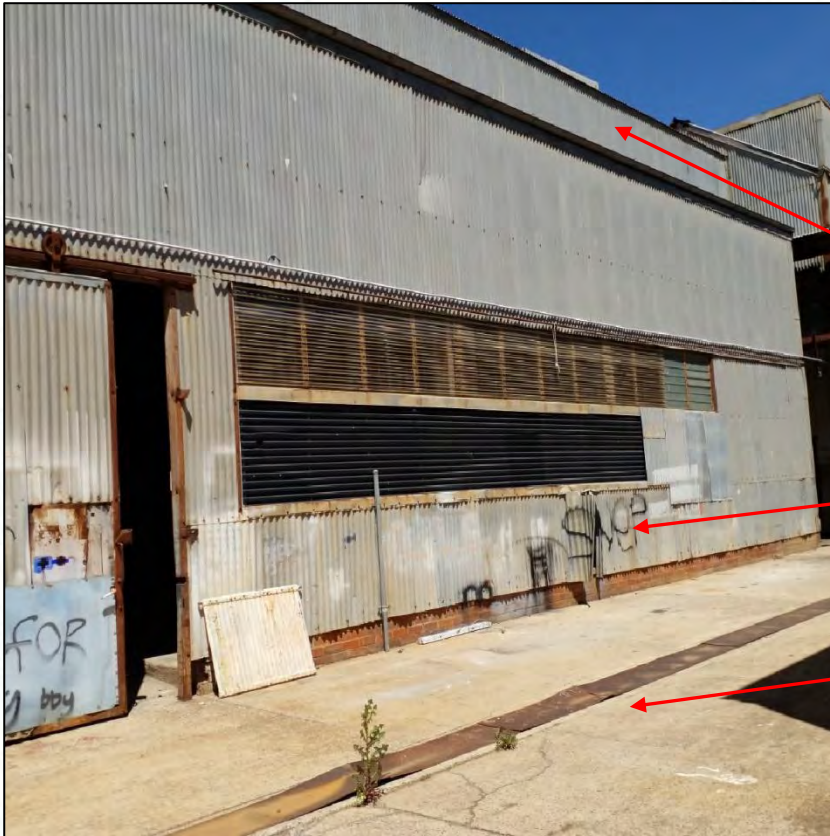
Upper level  
(No access)

Damaged sheeting

Trench grate is a  
trip hazard

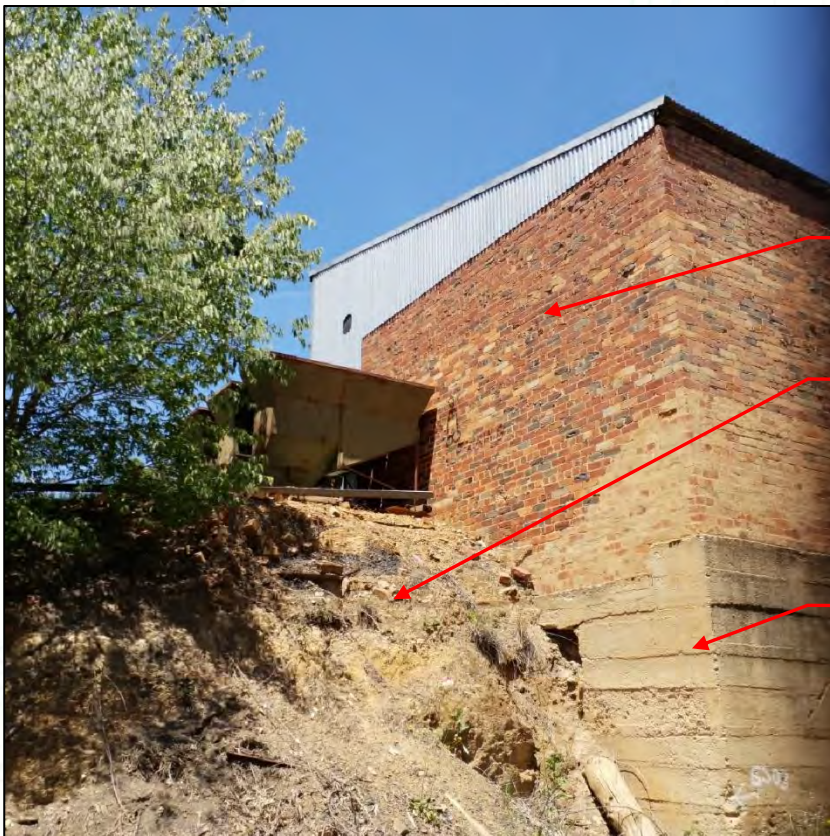
Double skin brickwork

Unstable embankment

Concrete retaining wall

Element	Condition	Remediation Requirement
Foundations	<ul style="list-style-type: none"><li>• Slab on grade was in reasonable condition.</li><li>• Concrete retaining wall was in reasonable condition.</li><li>• Embankment on side of structure is unstable and has eroded.</li></ul>	Stabilise embankment on side of structure.
Structure	<ul style="list-style-type: none"><li>• Double skin brickwork was in reasonable condition.</li><li>• Localised areas of brickwork were loose but appears stable overall.</li><li>• Timber wall framing, roof framing and sheeting appears to be in sound condition.</li></ul>	Reinstate areas of loose brickwork Seal windows and holes to weatherproof building.
Brickwork retaining wall	<ul style="list-style-type: none"><li>• Brickwork retaining wall appears to be sliding off concrete retaining wall.</li><li>• The end of the wall has partially collapsed, bricks have come loose.</li></ul>	Reinstate brickwork retaining wall. Engaged pier or reinforced concrete retaining wall may be required.

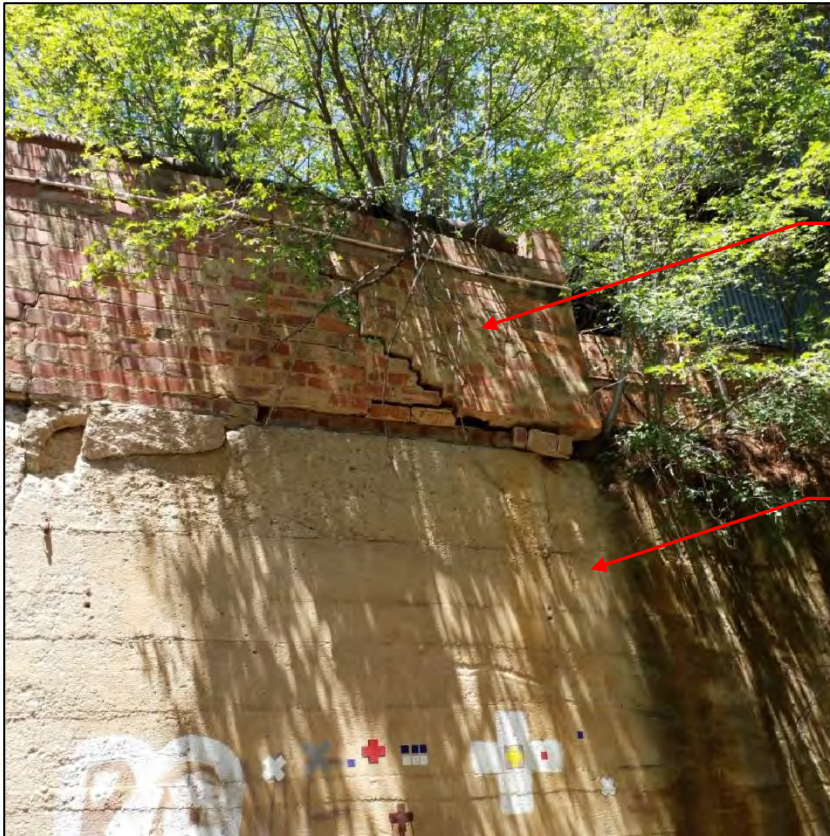
Brickwork retaining wall  
Partially collapsed

Concrete retaining wall
