# Canberra Brickworks Precinct

## Conservation Management Plan

### Volume Two—Appendices

September 2021

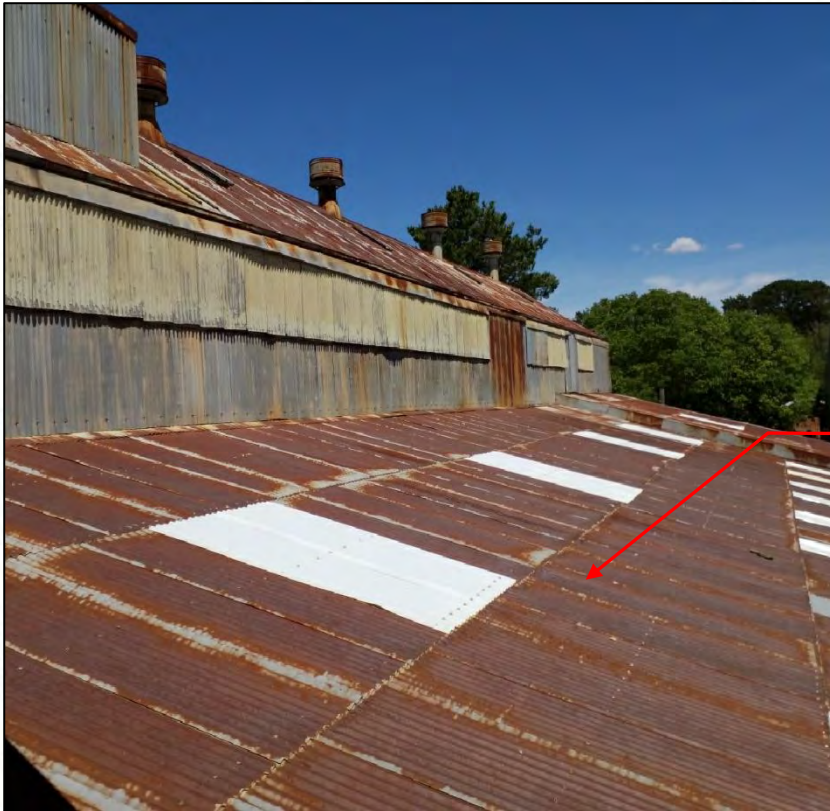
Weathered roof sheeting

Element	Condition	Remediation Requirement
Cladding	<ul style="list-style-type: none"> <li>• Steel roof and wall sheeting was weathered. Some sheets are loose and missing.</li> </ul>	<p>The loose roof/wall sheeting presents a safety risk in high winds.</p> <p>Loose sheets to be secured or removed and stored for re-fitting</p>
Slab on grade	<ul style="list-style-type: none"> <li>• The slab on grade is considered to be non-structural and was in reasonable condition.</li> </ul>	Any trip hazards across the slab should be rectified.
Steel columns	<ul style="list-style-type: none"> <li>• Steel columns were generally in sound condition.</li> </ul>	Treat surface corrosion if required.
Suspended slab	<ul style="list-style-type: none"> <li>• Note - Access was limited to underside of slab only.</li> <li>• Overall, slab appeared to be in reasonable condition.</li> <li>• Some local areas of spalling were noted, which do not present an overall structural concern.</li> </ul>	<p>Break away any areas of spalling concrete to remove hazard. Reinststate concrete with cementitious repair mortar.</p> <p>Structural assessment of upper floor recommended prior to opening to public.</p>

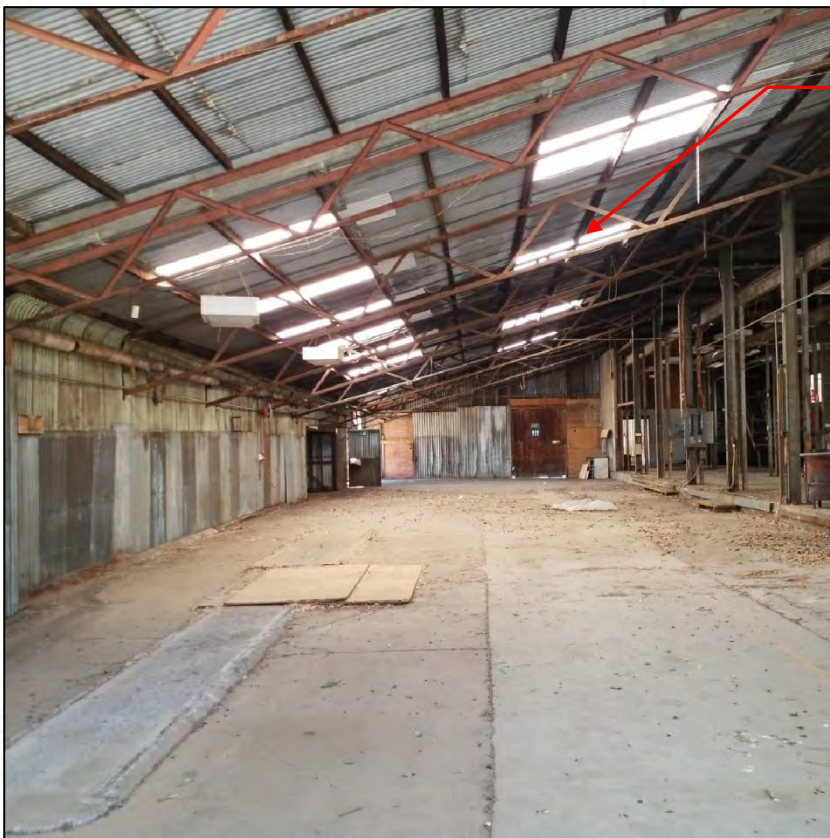
Steel framed trusses

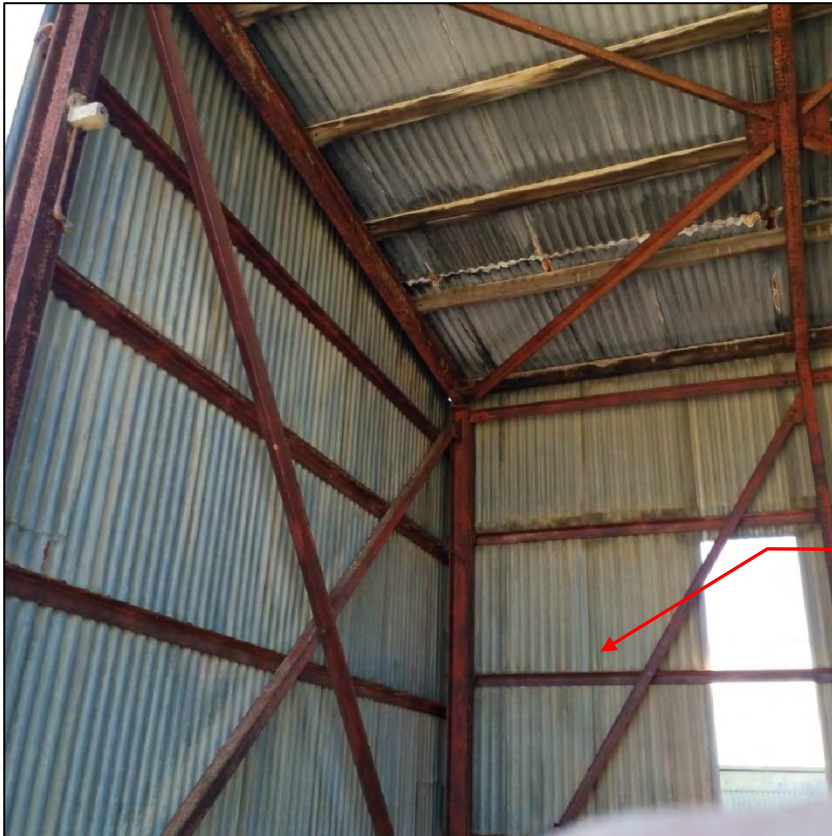
Braced steel structure

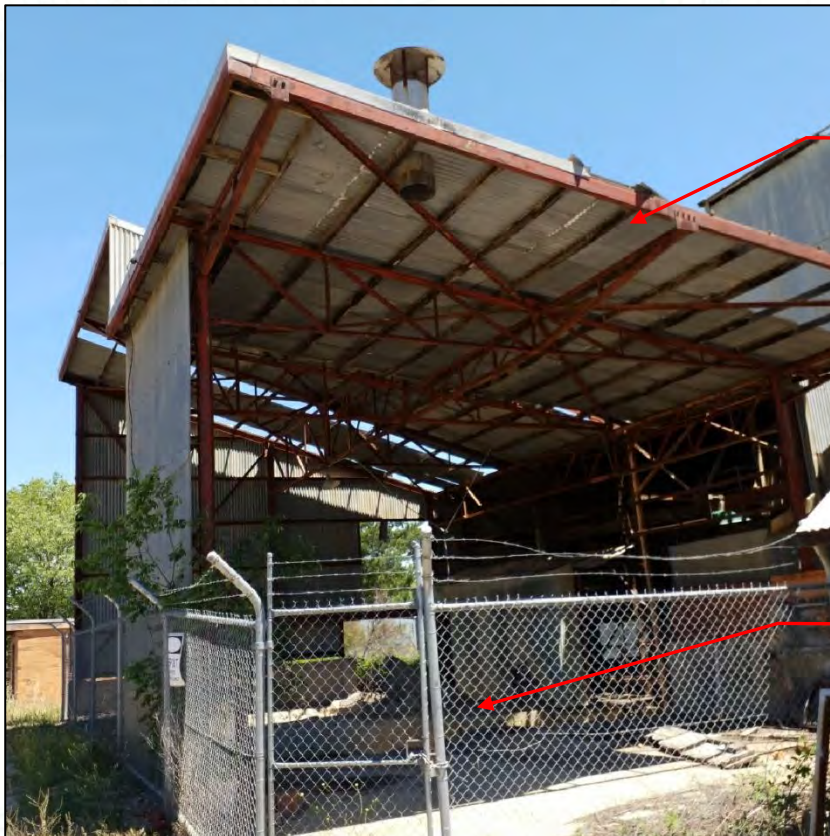
Steel framed roof

Areas of slab collapsed

Element	Condition	Remediation Requirement
Steel structure	<ul style="list-style-type: none"><li>• Some bracing members appear to be missing</li><li>• Some steelwork connections may require rectification.</li></ul>	Reinstate bracing members to match existing.  Detailed structural assessment required prior to opening to public.
Cladding	<ul style="list-style-type: none"><li>• Sheeting is weathered but in serviceable condition. Some loose sheets were noted.</li></ul>	Secure any loose sheeting prior to providing public access.
Ground floor slab	<ul style="list-style-type: none"><li>• Areas of suspended slab on grade have collapsed.</li><li>• Debris is scattered throughout ground floor.</li></ul>	Restrict public access.  Reinstate slab if required.  Clean up debris.

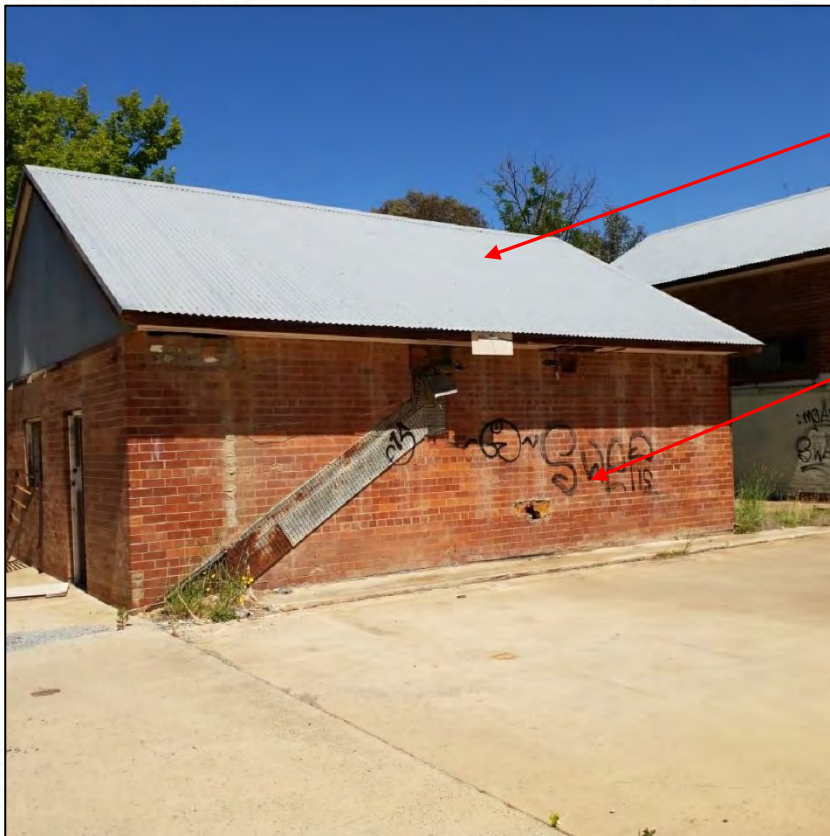
Timber framed roof

Brickwork walls

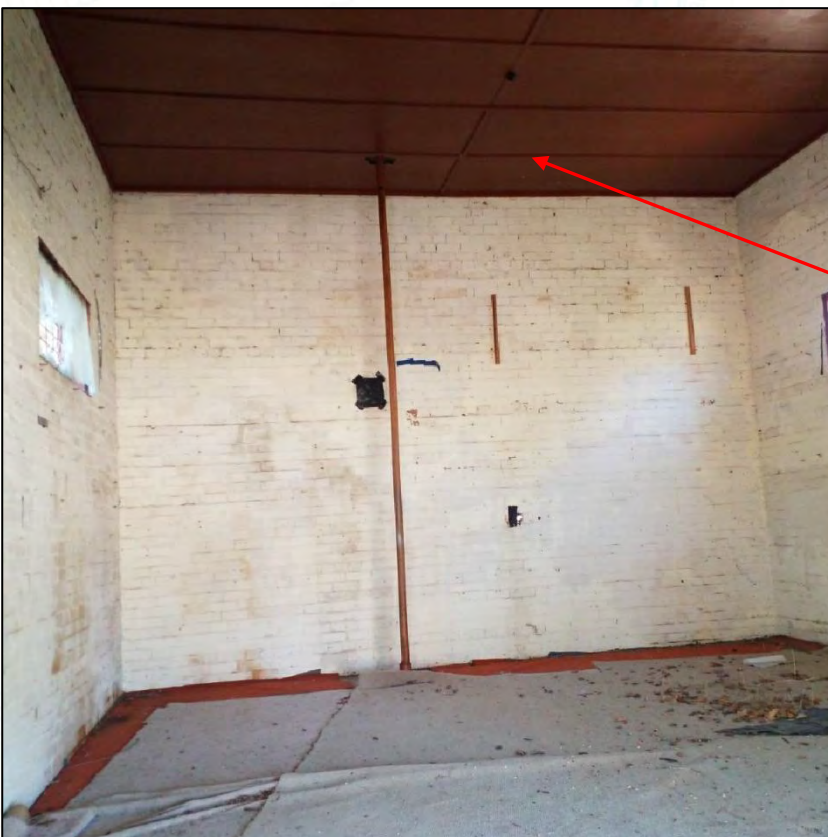
Ceiling  
Could not inspect roof

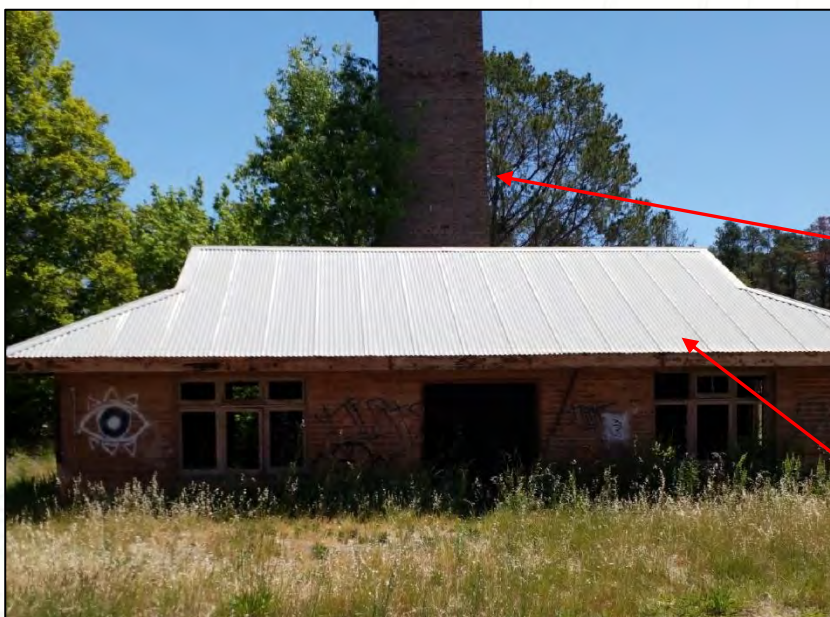
Brickwork chimney

Timber framed hip roof

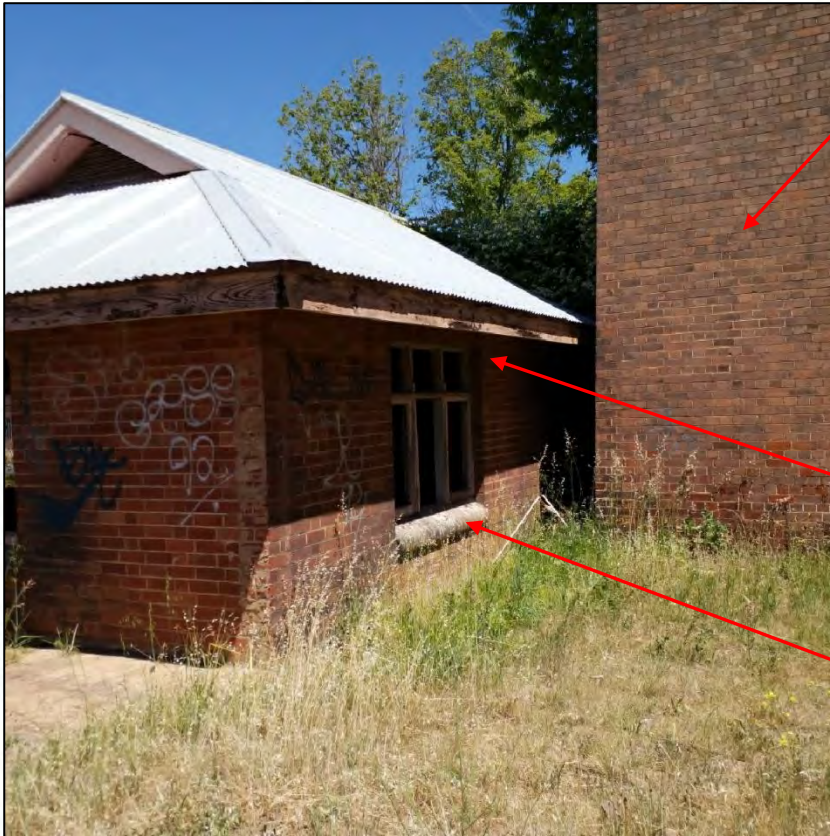
Base of chimney in reasonable condition

Weathered fascia beams

Broken windows

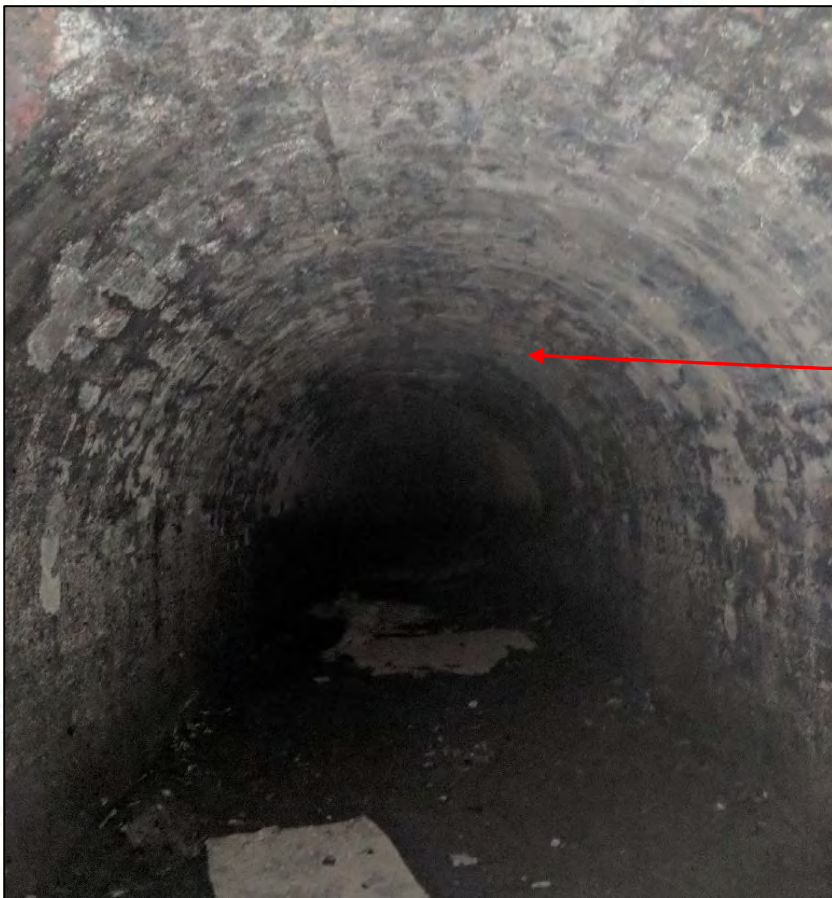
Tunnel under road  
Brickwork in sound condition

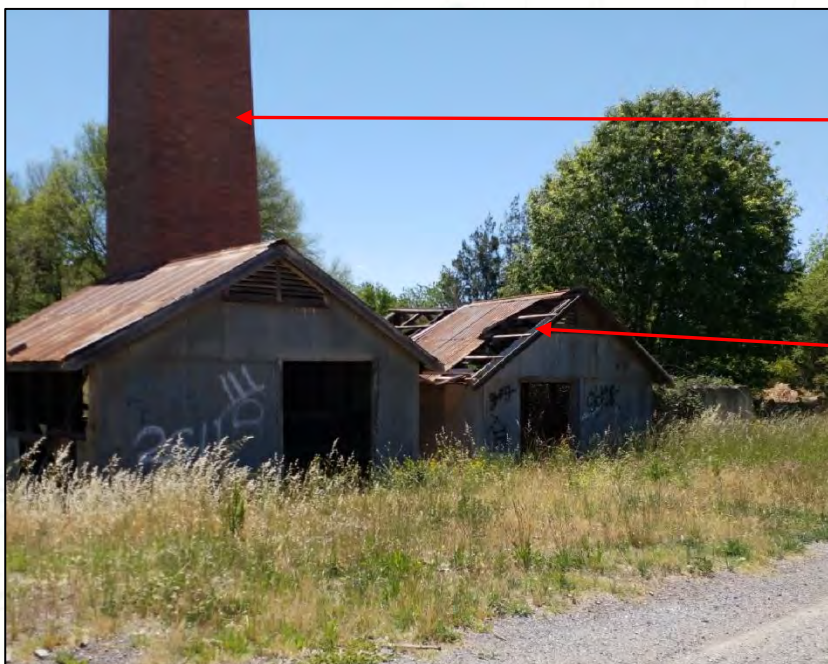
Brickwork chimney

Northern building in worse condition

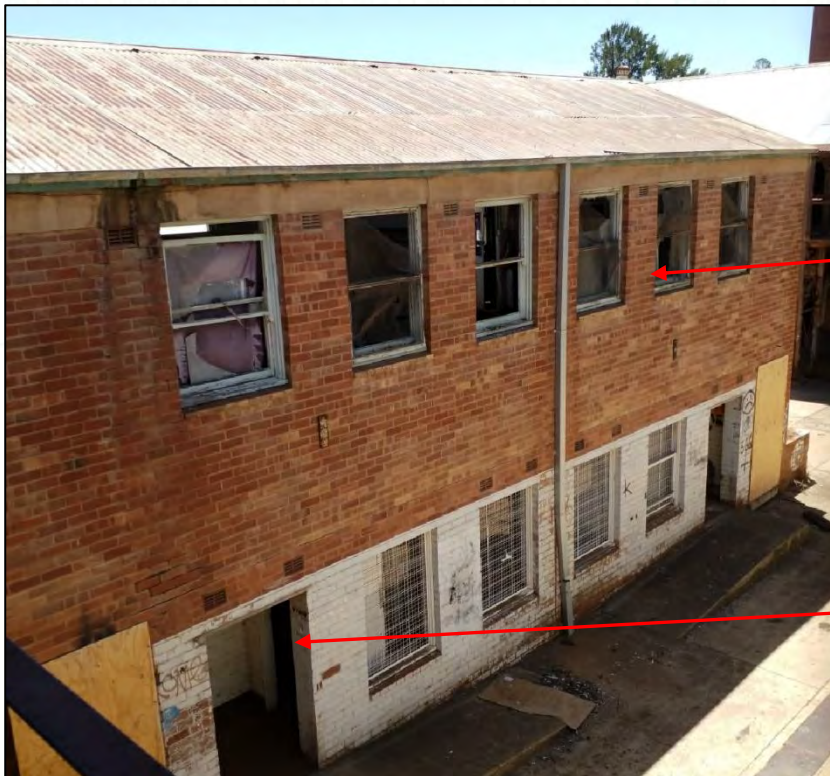
Broken windows

Double skin brickwork

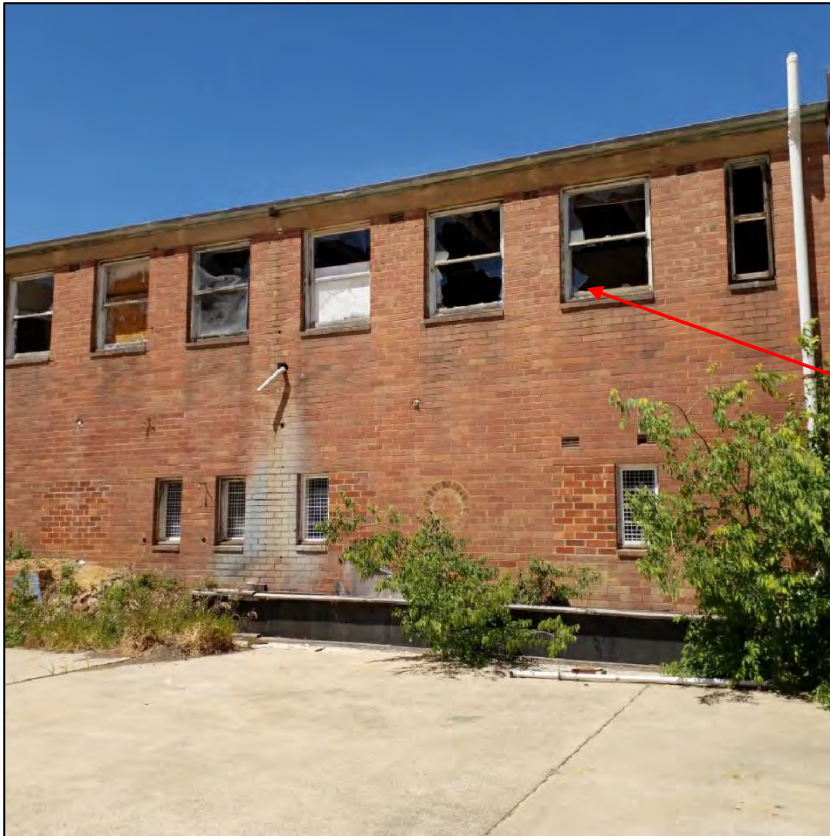
Broken windows

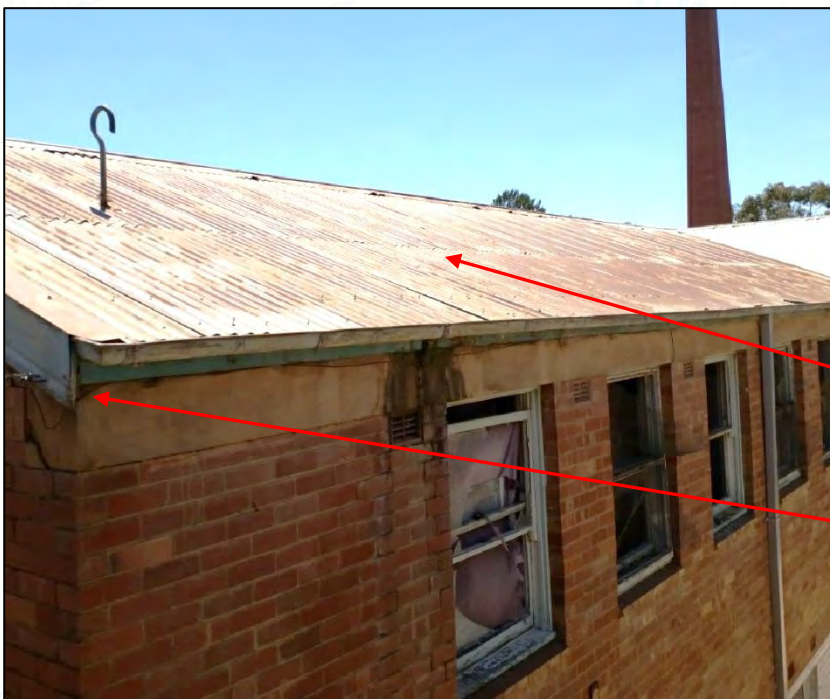
Weathered sheeting  
Loose nailed fixings

Weathered fascia boards

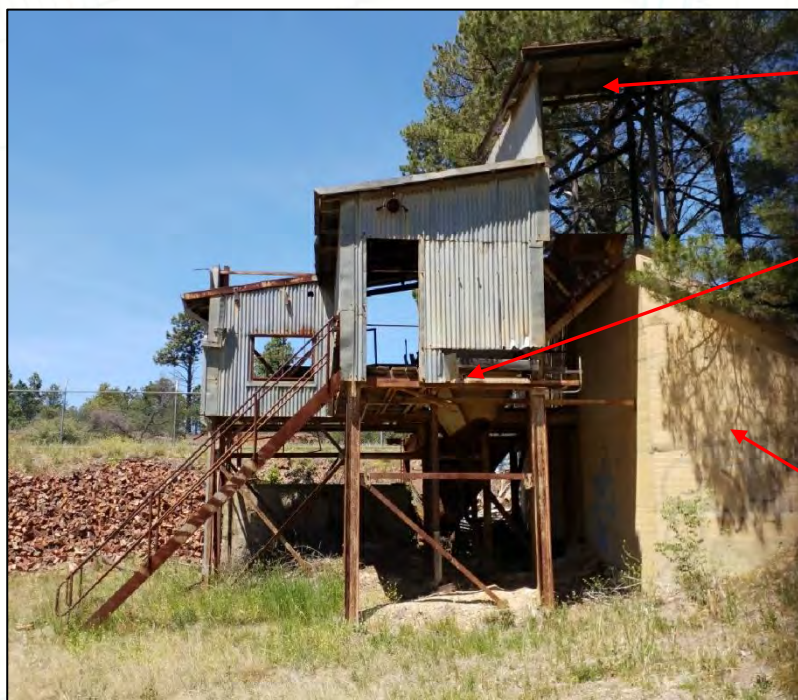
Missing sheets

Floor in poor condition

Element	Condition	Remediation Requirement
Cladding	<ul style="list-style-type: none"><li>• Steel roof and wall sheeting was highly weathered, loose and missing in areas.</li></ul>	The loose roof/wall sheeting presents a safety risk, sheets may become airborne in high winds. Loose sheets to be secured prior to public access. Roof areas not recommended for roof traffic in current condition.
Windows and Doors	<ul style="list-style-type: none"><li>• Windows and doors missing/broken.</li></ul>	Replace windows/doors if required.
Steel framing	<ul style="list-style-type: none"><li>• Steel framing was generally in reasonable condition. Surface rust was present but is not a structural concern.</li></ul>	Treat surface corrosion if required.  Further inspection required prior to providing public access.
Timber framing	<ul style="list-style-type: none"><li>• Floor and roof framing were in poor condition.</li></ul>	Areas of floor structure not safe for access. Access should be restricted until rectified.

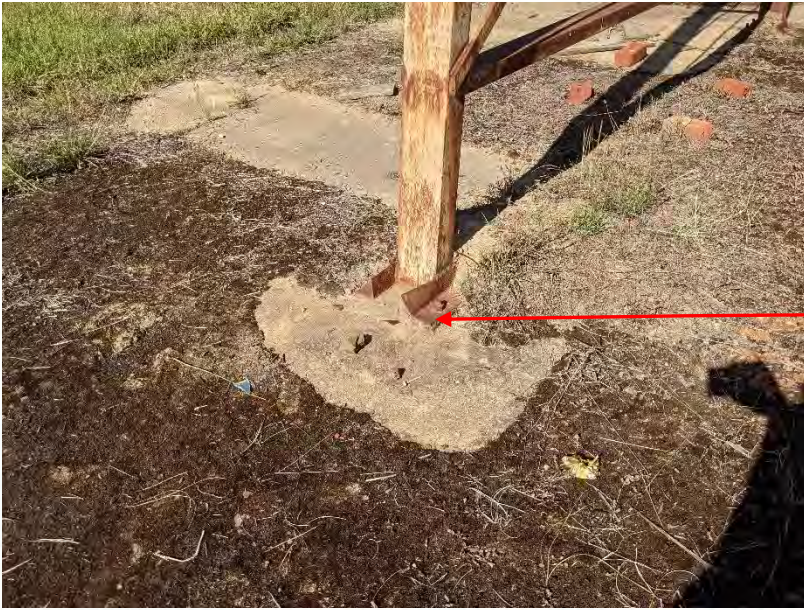
Typical base fixing

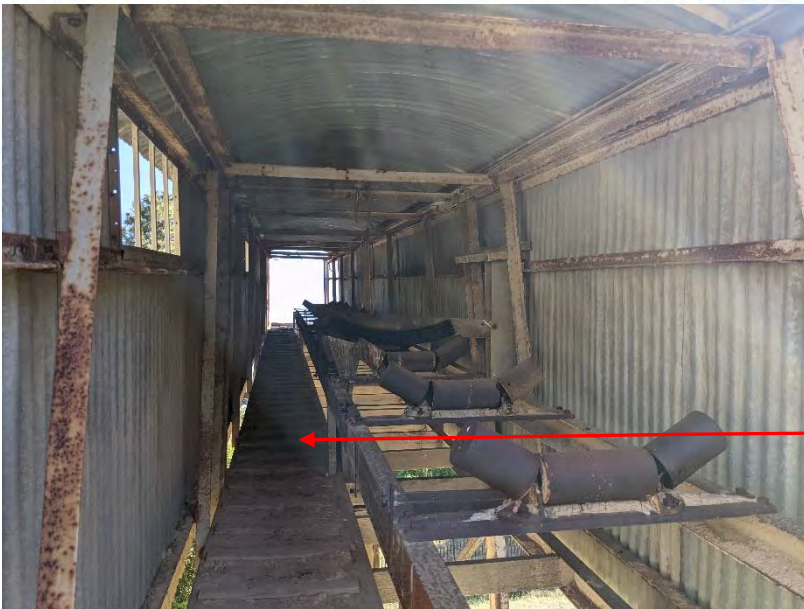
Walkway  
hazardous

Element	Condition	Remediation Requirement
Steel framing	<ul style="list-style-type: none"><li>• Fair condition with no evidence of concerning damage</li></ul>	Abrasive blast steelwork and paint.
Roof and Wall sheeting	<ul style="list-style-type: none"><li>• Fair condition with isolated loose fixings</li></ul>	Refixing of all connections.
Walkway	<ul style="list-style-type: none"><li>• Fair condition and hazardous for use</li></ul>	Replacement required.

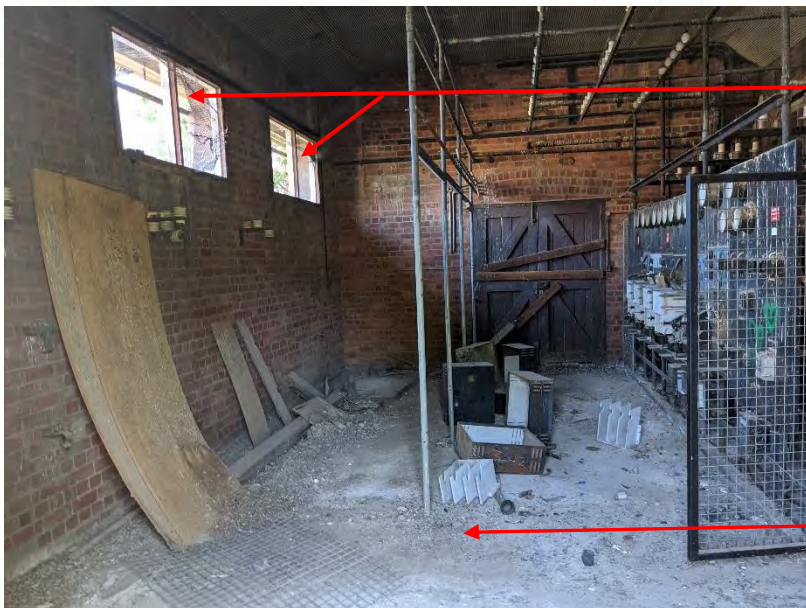
Broken windows  
to western side

Slab in good  
condition

Element	Condition	Remediation Requirement
Brickwork	<ul style="list-style-type: none"> <li>• Good to fair condition</li> </ul>	Ensure weatherproofing
Roof	<ul style="list-style-type: none"> <li>• Fair condition with weathering to eaves and fascia boards</li> </ul>	Replacement of eave boarding and fascia boards required.
Slab	<ul style="list-style-type: none"> <li>• Good condition</li> </ul>	Minor clean up and application of a sealer or covering.
External	<ul style="list-style-type: none"> <li>• Downpipes and gutters in poor condition</li> </ul>	Replacement and connection will be required.
	<ul style="list-style-type: none"> <li>• Doors and louvers in fair condition</li> </ul>	Replacement required.
	<ul style="list-style-type: none"> <li>• Windows broken and flyscreens damaged</li> </ul>	Replacement required to western windows.

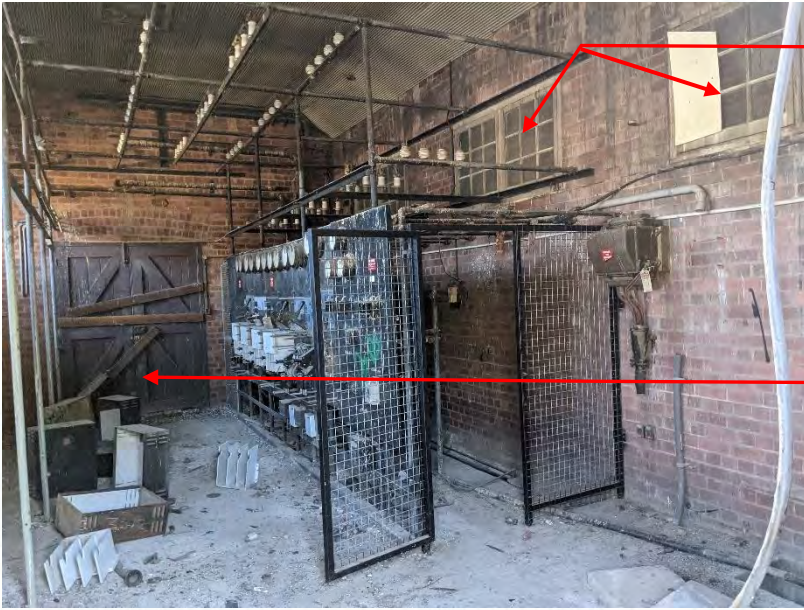
Eastern windows in place

Doors require replacement

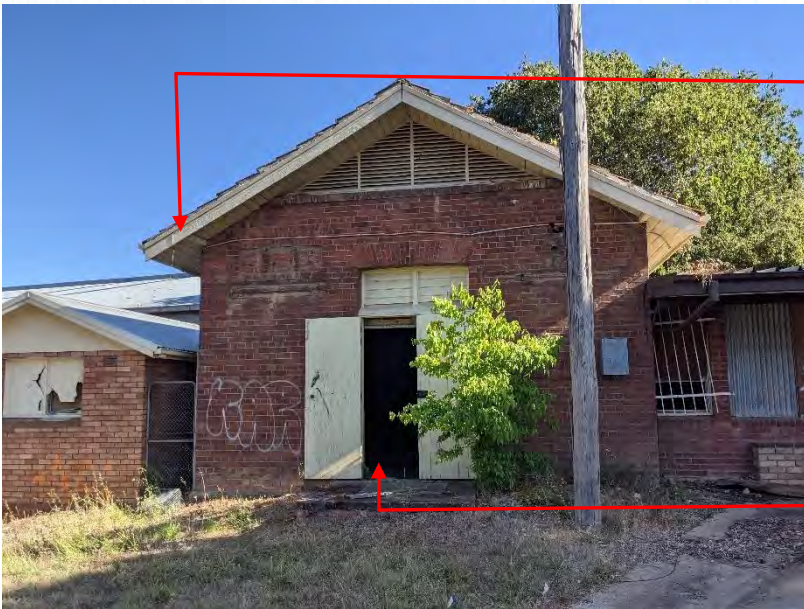
Weathered fascia boards and eave linings

Doors requiring replacement

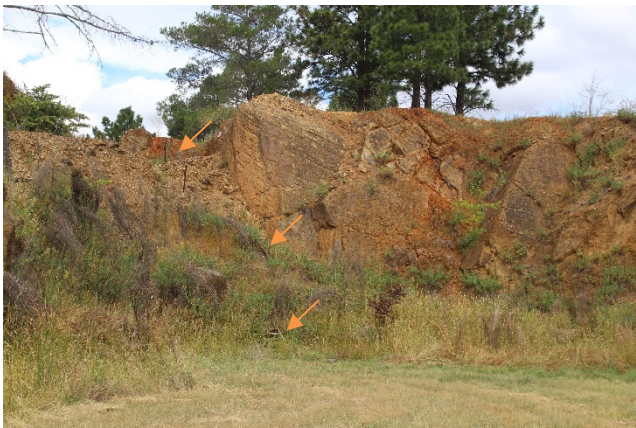
Element 11+12: Quarry and Geological features		
11+12-01	<p><i>Description:</i> Timber steps and ferrous handrails</p> <p><i>Location:</i> Central southern extent of Quarry (Element 11)</p> <p><i>Condition:</i> Poor</p> <p><i>Comments:</i> Affected by soil erosion and slip, rust activity on handrails</p> <p><i>Recommendation:</i> Further research required to determine provenance</p>

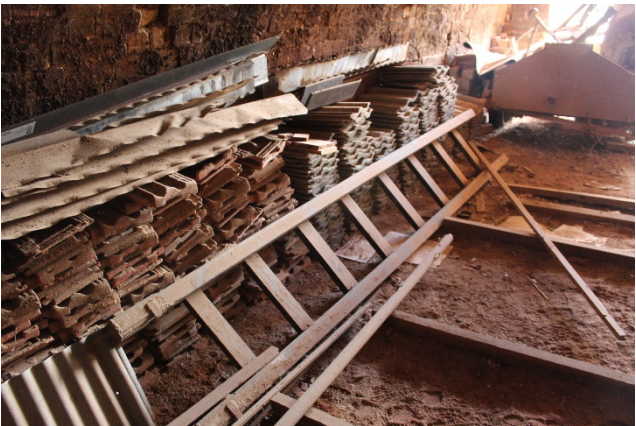
1-02	<p><i>Description:</i> Timber ladder with metal fixtures</p> <p><i>Location:</i> In north-facing kiln of Staffordshire Kiln (Element 1)</p> <p><i>Condition:</i> Fair</p> <p><i>Comments:</i> Little apparent fabric or structural damage</p> <p><i>Recommendation:</i> Salvage and store on site. Appropriately label with a catalogue number and provenance</p> <p>Possible conservation and reuse for on site interpretation</p>

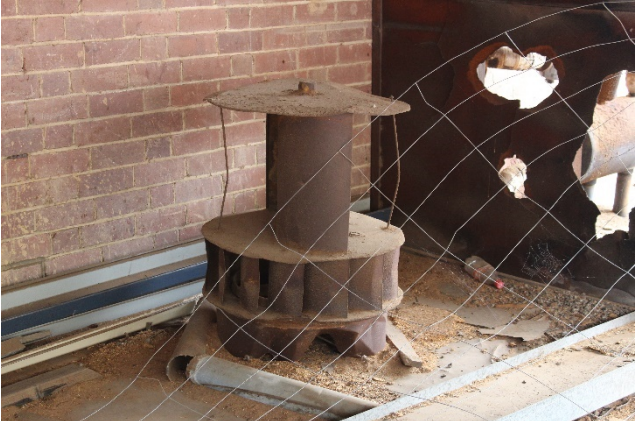
1-03	<p><i>Description:</i> Extractor fan</p> <p><i>Location:</i> Landing of upper level of Staffordshire Kiln (Element 1)</p> <p><i>Condition:</i> Poor</p> <p><i>Comments:</i> Not in situ, some fabric damage, advanced rust activity</p> <p><i>Recommendation:</i> Retain for interpretation on site</p> <p>Seek the advice of a conservator for conservation and interpretation on site</p>

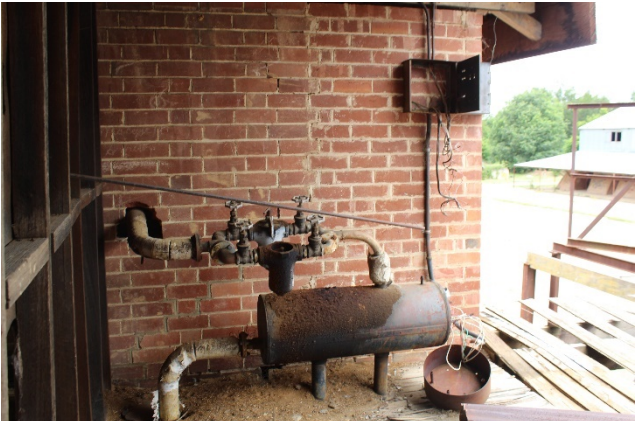
1-04	<p><i>Description:</i> Boiler</p> <p><i>Location:</i> Landing of upper level of Staffordshire Kiln (Element 1)</p> <p><i>Condition:</i> Poor</p> <p><i>Comments:</i> Advanced rust activity, exposed asbestos insulation</p> <p><i>Recommendation:</i> Retain and conserve in situ</p> <p>Seek the advice of a conservator for conservation and interpretation on site</p>

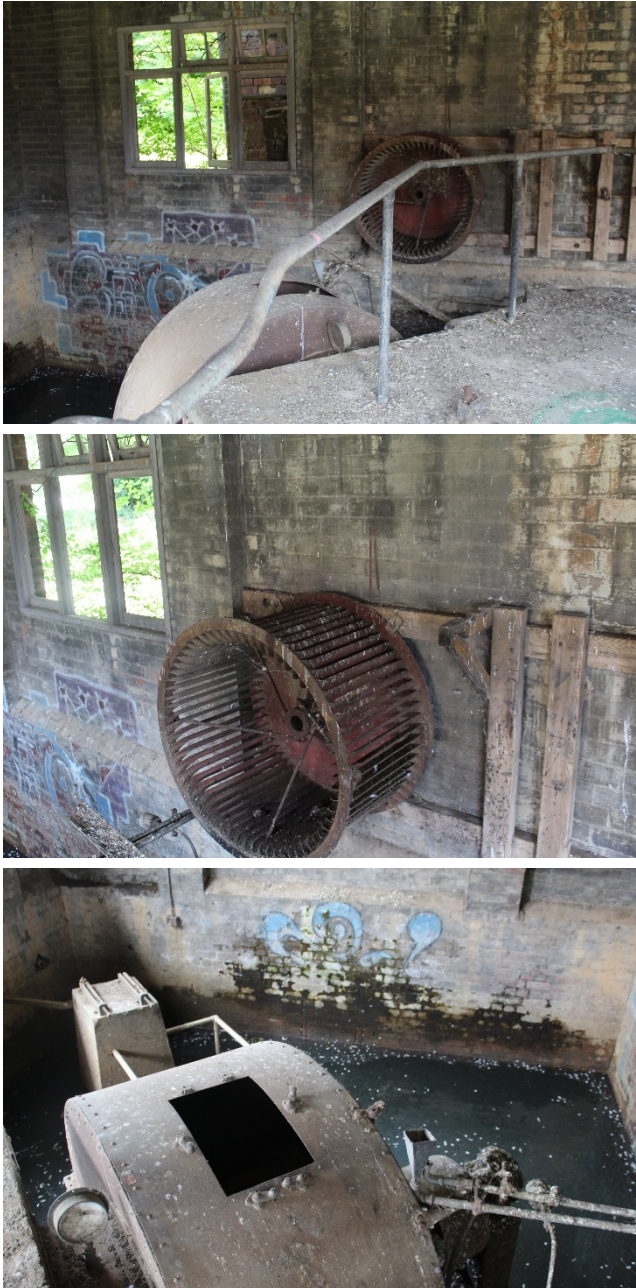
ID	Description	Photograph
Element 2: Fan House for Staffordshire Kiln		
2-01	<p><i>Description:</i> Fan equipment</p> <p><i>Location:</i> Centre of Fan House (Element 2)</p> <p><i>Condition:</i> Very poor</p> <p><i>Comments:</i> Considerable fabric damage, graffiti damage, pigeon activity damage, flooding, and advanced rust activity</p> <p><i>Recommendation:</i> Retain and conserve fan equipment in situ. Implement interpretation opportunities</p> <p>Seek the advice of a conservator for conservation and interpretation on site</p>

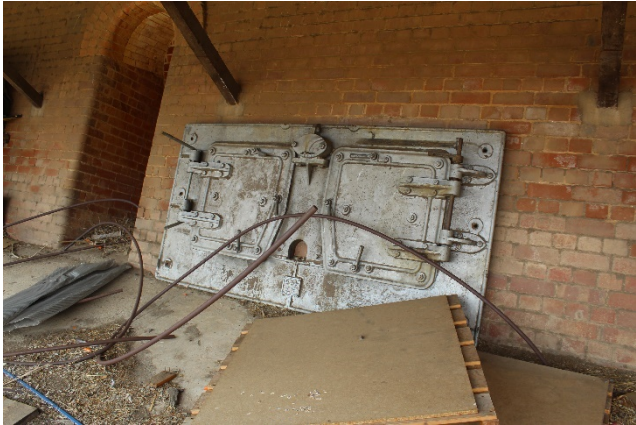
ID	Description	Photograph
3-01	<p><i>Description:</i> Kiln doors</p> <p><i>Location:</i> Adjacent to southern external wall of Hardy Patent Kiln 1 (Element 3)</p> <p><i>Condition:</i> Fair</p> <p><i>Comments:</i> Little apparent fabric damage, some rust activity</p> <p><i>Recommendations:</i> Salvage and store on site. Label with an inventory catalogue number and provenance</p> <p>Seek the advice of a conservator for conservation and on site interpretation</p>

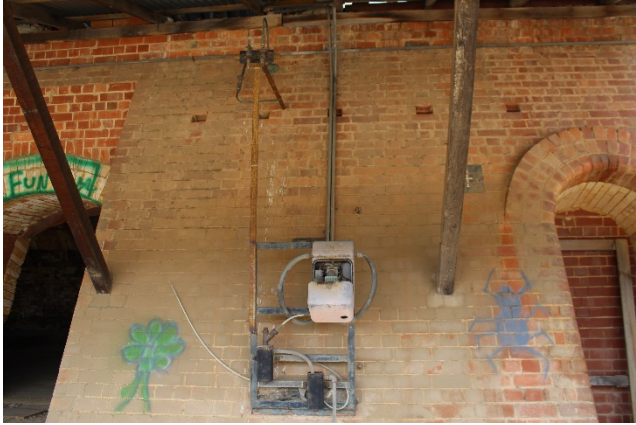
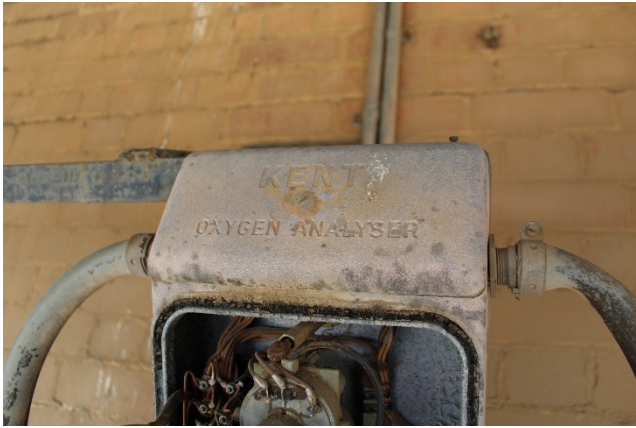
3-02	<p><i>Description:</i> 'Kent' oxygen analyser</p> <p><i>Location:</i> Southern external wall of Hardy Patent Kiln 1 (Element 3)</p> <p><i>Condition:</i> Poor</p> <p><i>Comments:</i> Fabric damage, some rust activity</p> <p><i>Recommendations:</i> Retain and conserve in situ</p> <p>Seek the advice of a conservator for conservation and interpretation on site</p>

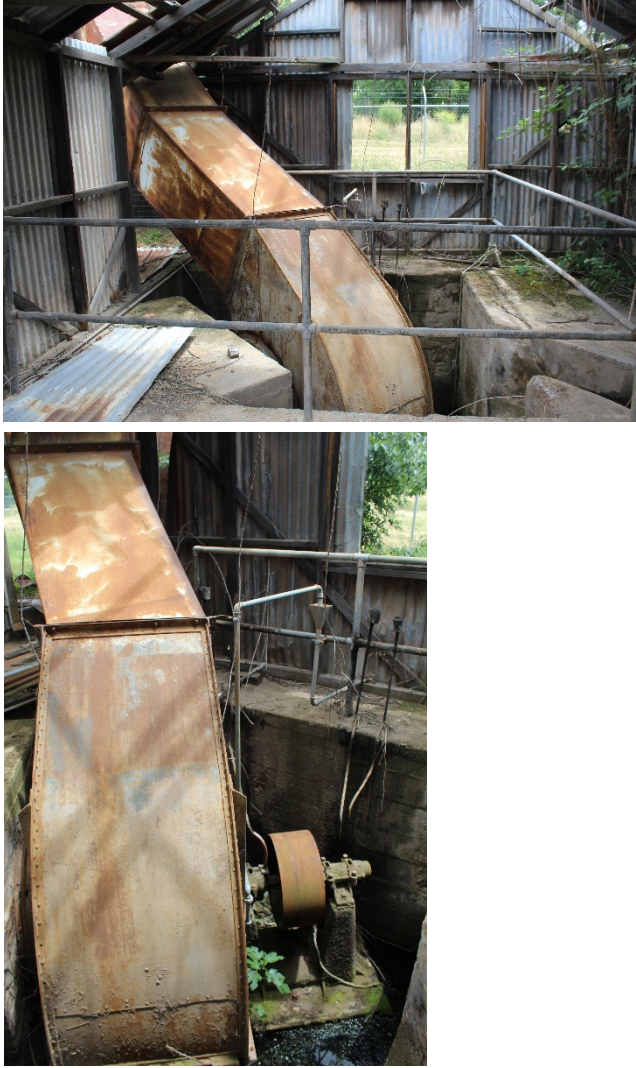
ID	Description	Photograph
4-01	<p><i>Description:</i> Fan equipment</p> <p><i>Location:</i> Centre of each Fan House (Element 4)</p> <p><i>Condition:</i> Very poor</p> <p><i>Comments:</i> Considerable fabric damage, graffiti damage, pigeon activity damage, flooding, and advanced rust activity</p> <p><i>Recommendation:</i> Retain and conserve fan equipment in situ. Implement interpretation opportunities</p> <p>Seek the advice of a conservator for conservation and interpretation on site</p>	  <p>The photographs show the interior of a fan house. The top photo shows a wide view of the space with rusted metal beams and a concrete floor. The second photo shows a close-up of a large, rusted metal structure, possibly a fan housing. The third photo shows a view through a window, looking out onto a green area. The bottom photo shows a close-up of a rusted metal structure on the floor, with some debris and a pipe visible.</p>

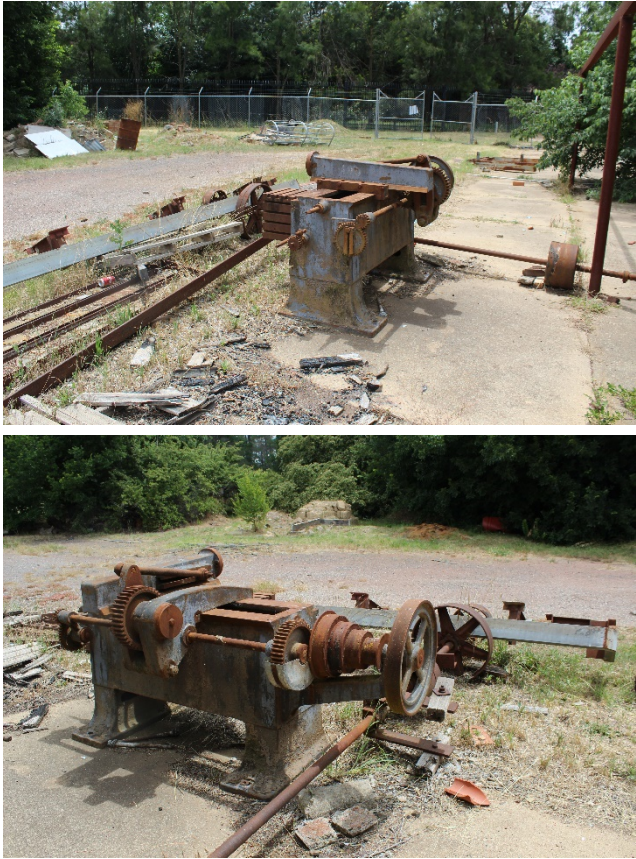
ID	Description	Photograph
5A-01	<p><i>Description:</i> Brick press machine base</p> <p><i>Location:</i> West of Hardy Patent Kiln 2 (Element 5)</p> <p><i>Condition:</i> Fair</p> <p><i>Comments:</i> Not in situ, little apparent fabric damage, advanced rust activity</p> <p><i>Recommendations:</i> Salvage and store on site. Label with an inventory catalogue number and provenance</p> <p>Seek the advice of a conservator for conservation and on site interpretation</p>

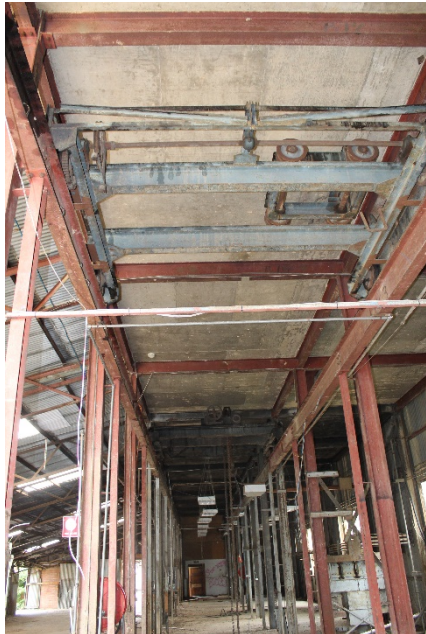
15-01	<p><i>Description:</i> Two bridge cranes</p> <p><i>Location:</i> Centre of Machine Bay 1 (Element 15)</p> <p><i>Condition:</i> Fair</p> <p><i>Comments:</i> Appears to be little fabric or structural damage, some rust activity</p> <p><i>Recommendations:</i> Conserve and retain representative example/s in situ. Implement interpretation opportunities</p> <p>Seek the advice of a conservator for conservation and on site interpretation</p> <p>Salvage and store other examples on or off site (see also 16A-03, 16701, 18-01)</p>

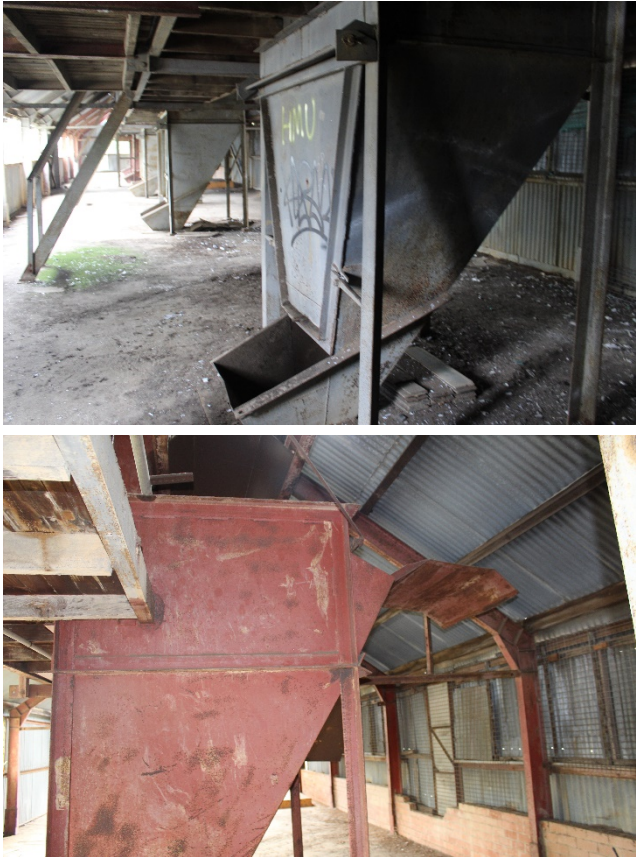
15-02	<p><i>Description:</i> Five chutes</p> <p><i>Location:</i> Across first floor of Machine Bay 1 (Element 15)</p> <p><i>Condition:</i> Fair</p> <p><i>Comments:</i> Little apparent structural damage, graffiti damage, some rust activity</p> <p><i>Recommendations:</i> Retain and conserve in situ. Implement interpretation opportunities</p> <p>Seek the advice of a conservator for conservation and on site interpretation</p>

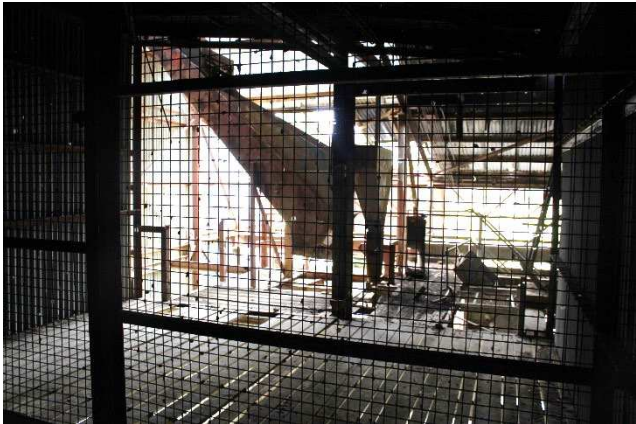
15-05	<p><i>Description:</i> Chute</p> <p><i>Location:</i> Second floor of Machine Bay 1 (Element 15) at northern end</p> <p><i>Condition:</i> Poor–fair</p> <p><i>Comments:</i> Could not inspect closely</p> <p><i>Recommendations:</i> Retain and conserve in situ. Implement interpretation opportunities</p> <p>Seek the advice of a conservator for conservation and interpretation on site</p>

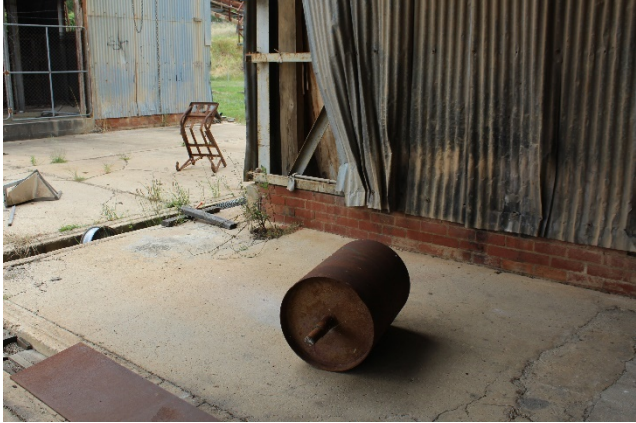
Element 16: Machine Bay 2 for Hardy Patent Kiln 1		
16-01	<p><i>Description:</i> Conveyor piece</p> <p><i>Location:</i> Floor of Machine Bay 2 (Element 16) at northern end</p> <p><i>Condition:</i> Poor</p> <p><i>Comments:</i> Not in situ, advanced rust activity</p> <p><i>Recommendations:</i> Salvage and restore to 15-03</p>

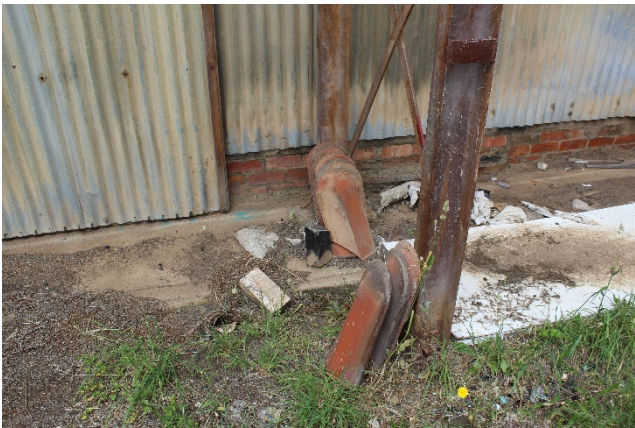
ID	Description	Photograph
16A-01	<p><i>Description:</i> Stack of 'Canberra' terracotta tiles</p> <p><i>Location:</i> Adjacent to external rear wall of Machine Bay 2 (Element 16) and external northern wall of Workshop (Element 18)</p> <p><i>Condition:</i> Poor–fair</p> <p><i>Comments:</i> Some fabric damage</p> <p><i>Recommendations:</i> Undertake additional research to determine provenance. Establish if they are from buildings on site and can be used for restoration of buildings on site (see also 18-02)</p>

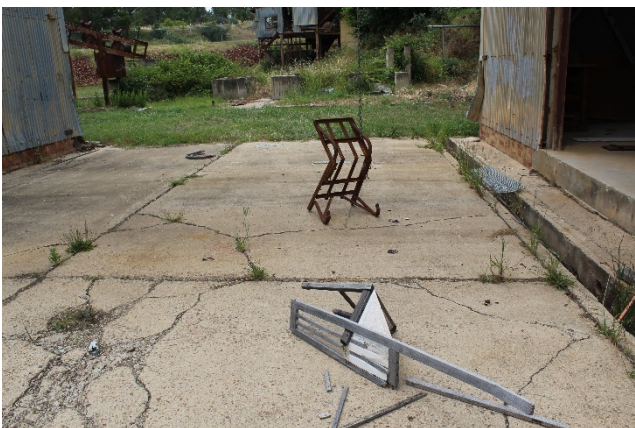
16A-02	<p><i>Description:</i> Dismantled brick barrow</p> <p><i>Location:</i> Space between Machine Bay 2 (Element 16) and Machine Bay 3 (Element 17)</p> <p><i>Condition:</i> Poor</p> <p><i>Comments:</i> Advanced rust, missing timber lining and wheels</p> <p><i>Recommendations:</i> Salvage and store on site. Label with an inventory catalogue number and provenance, likely as part of 27-01 'job lot'</p> <p>Seek the advice of a conservator for conservation and on site interpretation</p>

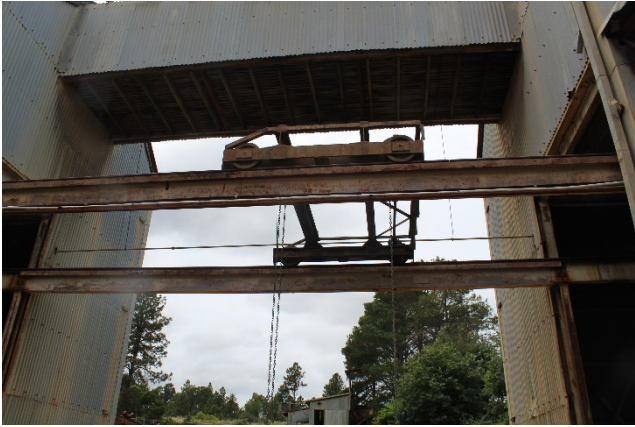
16A-03	<p><i>Description:</i> Bridge crane</p> <p><i>Location:</i> Space between Machine Bay 2 (Element 16) and Machine Bay 3 (Element 17)</p> <p><i>Condition:</i> Poor</p> <p><i>Comments:</i> Appears to be little fabric or structural damage, advanced rust activity</p> <p><i>Recommendations:</i> Conserve and retain representative example/s in situ. Implement interpretation opportunities</p> <p>Seek the advice of a conservator for conservation and interpretation on site</p> <p>Salvage and store other examples on or off site (see also 15-01, 17-01, 18-01)</p>

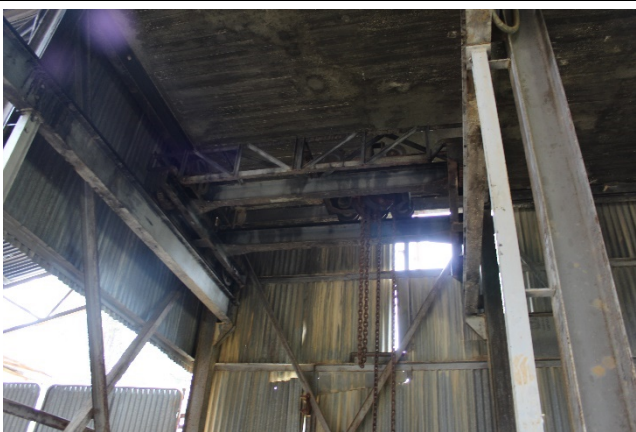
Element 17: Machine Bay 3 for Hardy Patent Kiln 3		
17-01	<p><i>Description:</i> Bridge crane</p> <p><i>Location:</i> Northern end of Machine Bay 3 (Element 17)</p> <p><i>Condition:</i> Fair</p> <p><i>Comments:</i> No apparent fabric damage, some rust activity</p> <p><i>Recommendations:</i> Conserve and retain representative example/s in situ. Implement interpretation opportunities</p> <p>Seek the advice of a conservator for conservation and interpretation on site</p> <p>Salvage and store other examples on or off site (see also 15-01, 16A-03, 18-01).</p>

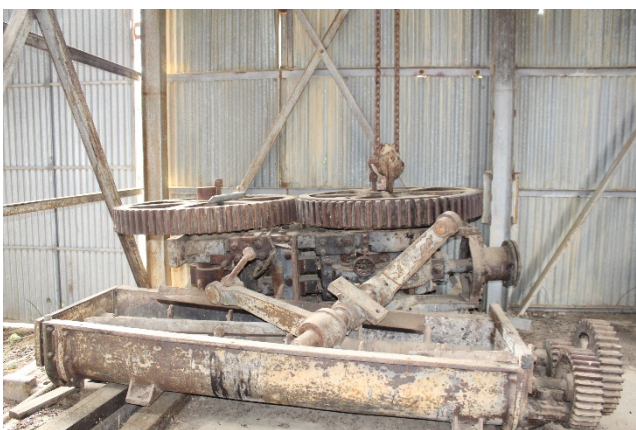
17-02	<p><i>Description:</i> Crusher and puddler machines</p> <p><i>Location:</i> Northern end of Machine Bay 3 (Element 17)</p> <p><i>Condition:</i> Poor</p> <p><i>Comments:</i> Not in situ, fabric damage, advanced rust activity</p> <p><i>Recommendations:</i> Salvage and store on site. Label with an inventory catalogue number and provenance.</p> <p>Seek the advice of a conservator for conservation and interpretation on site</p>

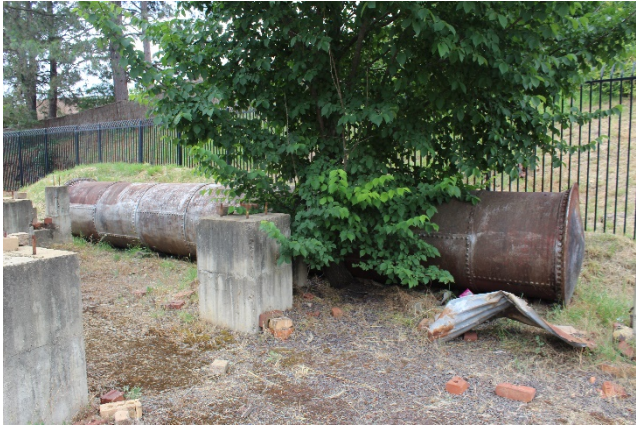
ID	Description	Photograph
17A-01	<p><i>Description:</i> Boiler or exhaust vent</p> <p><i>Location:</i> North of Machine Bay 3 (Element 17)</p> <p><i>Condition:</i> Poor</p> <p><i>Comments:</i> Not in situ, some fabric damage, advanced rust activity</p> <p><i>Recommendations:</i> Salvage and store on site. Label with an inventory catalogue number and provenance</p> <p>Undertake further investigation to determine provenance and whether it can be restored to its original location</p> <p>Seek the advice of a conservator for conservation and interpretation on site</p>
