# Canberra Brickworks Precinct

## Conservation Management Plan

### Volume Two—Appendices

September 2021

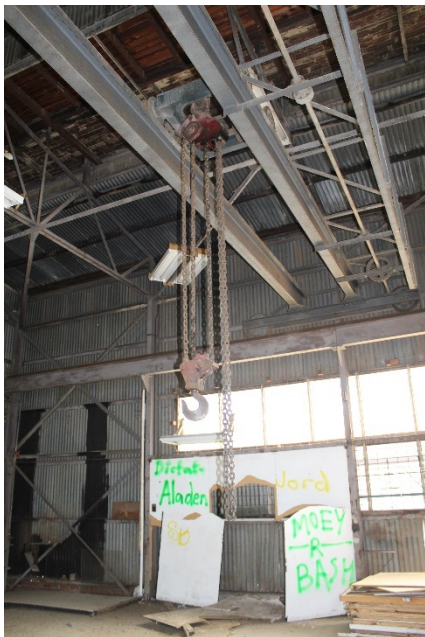
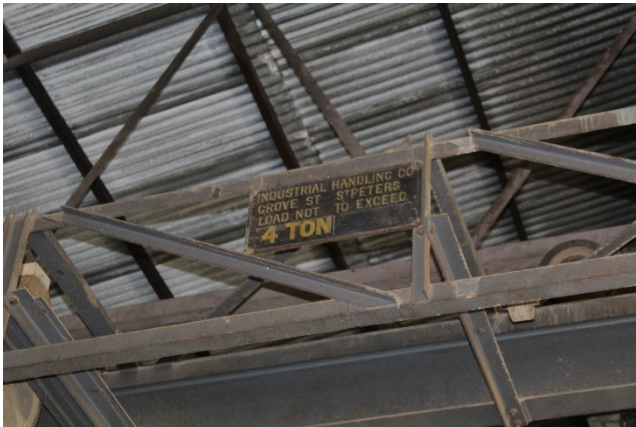
Element 18: Workshop		
18-01	<p><i>Description:</i> 'Industrial Handling Co' bridge crane</p> <p><i>Location:</i> Centre of Workshop (Element 18)</p> <p><i>Condition:</i> Fair</p> <p><i>Comments:</i> Appears to be little fabric or structural damage, some rust activity</p> <p><i>Recommendations:</i> Conserve and retain representative example/s in situ. Implement interpretation opportunities</p> <p>Seek the advice of a conservator for conservation and interpretation on site</p> <p>Salvage and store other examples on site (see also 15-01, 16A-03, 17-01)</p>

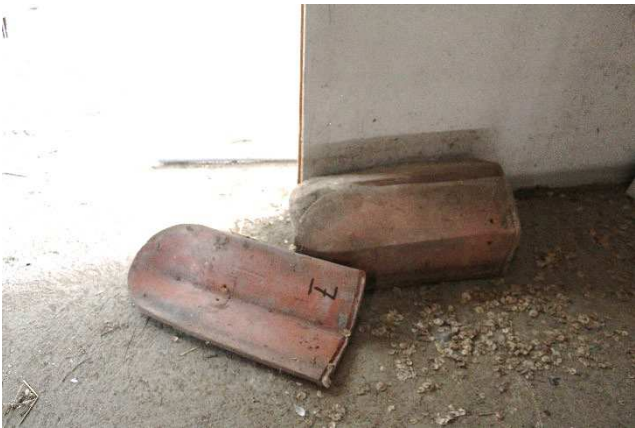
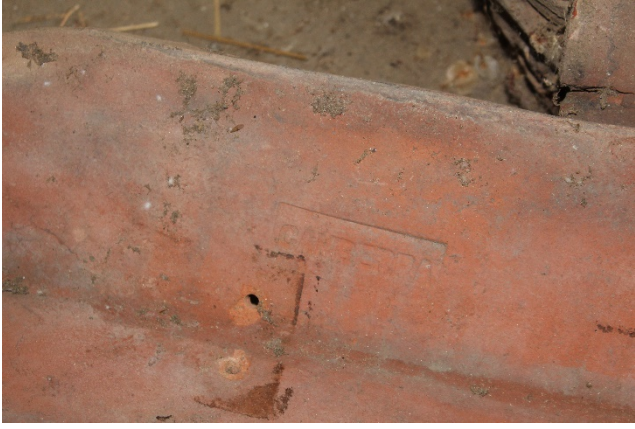
ID	Description	Photograph
18-02	<p><i>Description:</i> Stack of 'Canberra' terracotta tiles</p> <p><i>Location:</i> Behind partition wall at northern end of Workshop (Element 18)</p> <p><i>Condition:</i> Fair</p> <p><i>Comments:</i> Little apparent fabric damage</p> <p><i>Recommendations:</i> Undertake additional research to determine provenance. Establish if they are from buildings on site and can be used for restoration of buildings on site (see also 16A-01)</p>

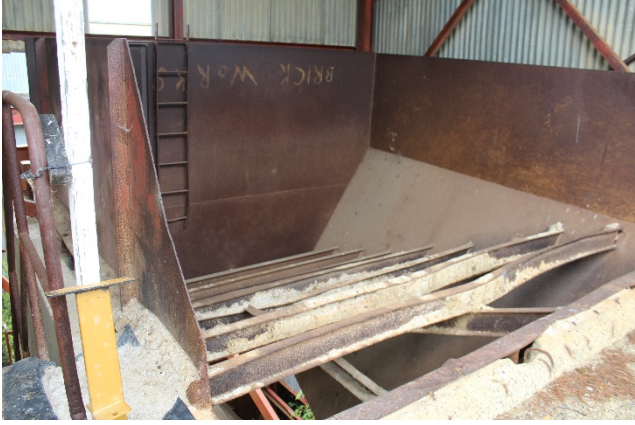
Element 21: Small Crusher House (Crusher House 1)		
21-01	<p><i>Description:</i> Chute</p> <p><i>Location:</i> Centre of Small Crusher House (Element 21)</p> <p><i>Condition:</i> Poor</p> <p><i>Comments:</i> Fabric damage, graffiti damage, advanced rust activity</p> <p><i>Recommendations:</i> Conserve and reuse in situ. Implement interpretation opportunities</p> <p>Seek the advice of a conservator for conservation and interpretation on site.</p>

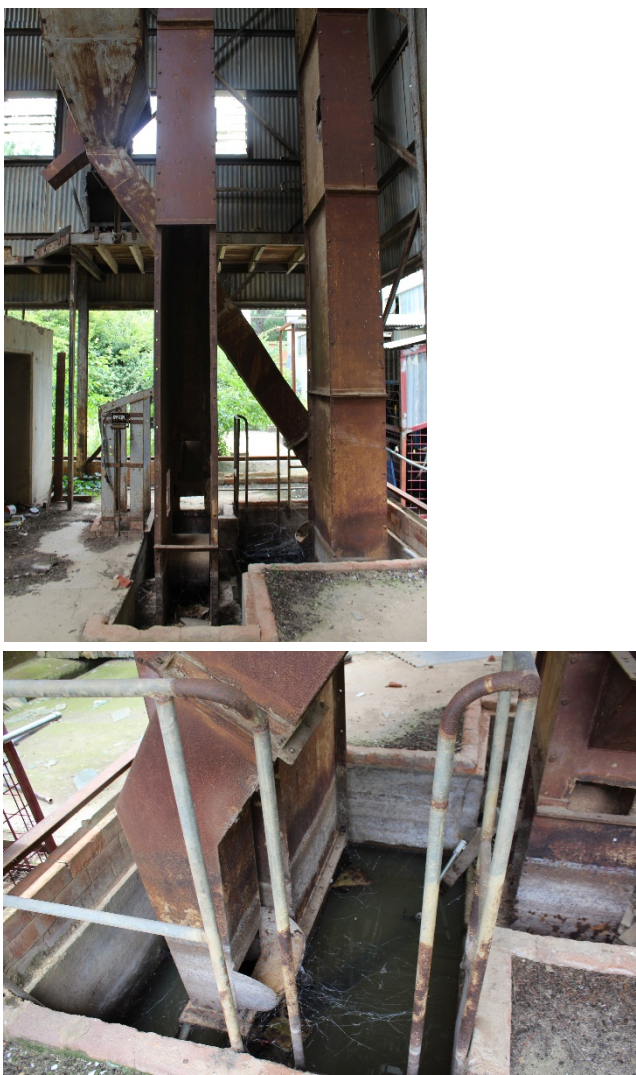
Element 19: White Pan Room (Large Crusher House/Crusher House II)		
19-01	<p><i>Description:</i> Miscellaneous chutes</p> <p><i>Location:</i> Lower level of White Pan Room (Element 19) at rear of Machine Bay 1 (Element 15)</p> <p><i>Condition:</i> Fair</p> <p><i>Comments:</i> Little apparent fabric damage, advanced rust activity</p> <p><i>Recommendations:</i> Retain and conserve in situ. Implement interpretation opportunities</p> <p>Seek the advice of a conservator for conservation and interpretation on site</p>

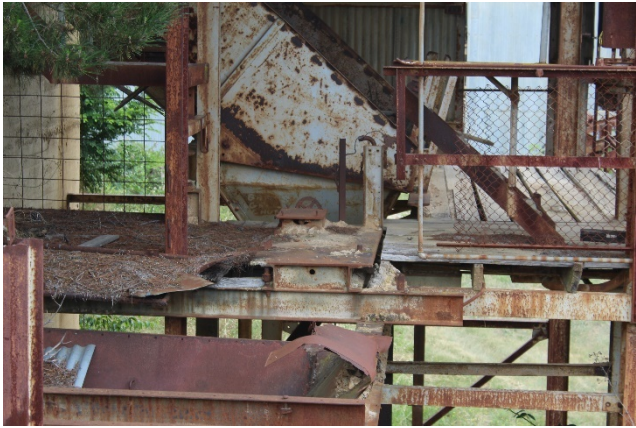
Element 20: Primary Crusher House (Crusher House III)		
20-01	<p><i>Description:</i> Crush machinery</p> <p><i>Location:</i> Centre of Primary Crusher House (Element 20)</p> <p><i>Condition:</i> Poor</p> <p><i>Comments:</i> Extensive fabric damage, extensive structural damage, advanced rust activity</p> <p><i>Recommendations:</i> Retain and conserve in situ. Implement interpretation opportunities</p> <p>Seek the advice of a conservator for conservation and interpretation on site</p>

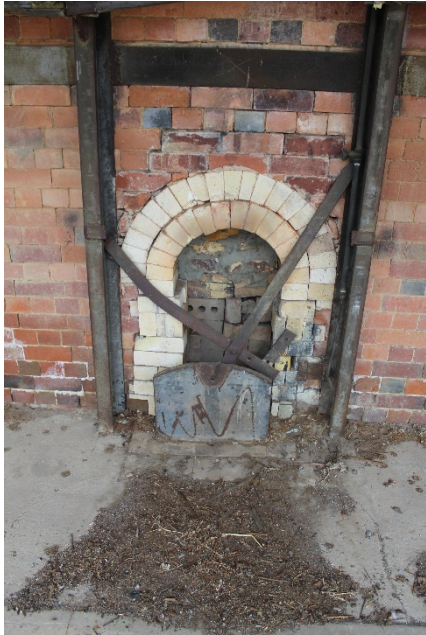
Element 22: Elevator/Conveyor		
No moveable relics associated with the primary function of the Brickworks were identified		
Element 6: Downdraught Kilns		
6-01	<p><i>Description:</i> Kiln fixings, including furnace doors and ladders</p> <p><i>Location:</i> Affixed to external walls of each kiln of Downdraught Kilns (Element 6)</p> <p><i>Condition:</i> Poor</p> <p><i>Comments:</i> Fabric damage, advanced rust damage, missing fixings</p> <p><i>Recommendations:</i> Retain and conserve in situ. Implement interpretation opportunities</p> <p>Seek the advice of a conservator for conservation and on site interpretation</p>

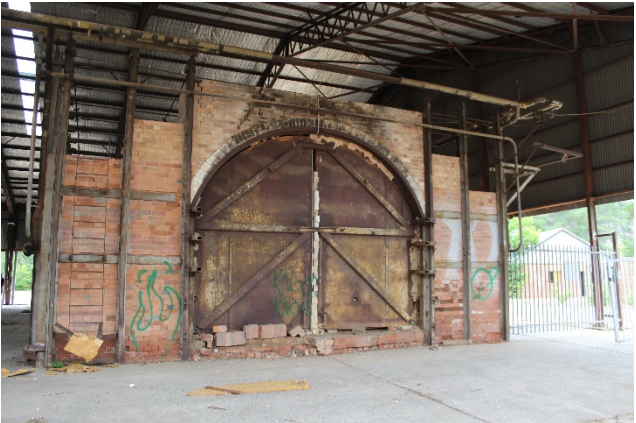
6-02	<p><i>Description:</i> Kiln doors</p> <p><i>Location:</i> At northern and southern ends of each kiln of Downdraught Kilns (Element 6)</p> <p><i>Condition:</i> Poor–fair</p> <p><i>Comments:</i> Fabric and structural damage, advanced rust activity, graffiti damage</p> <p><i>Recommendations:</i> Retain and conserve in situ. Implement interpretation opportunities</p> <p>Seek the advice of a conservator for conservation and on site interpretation</p>

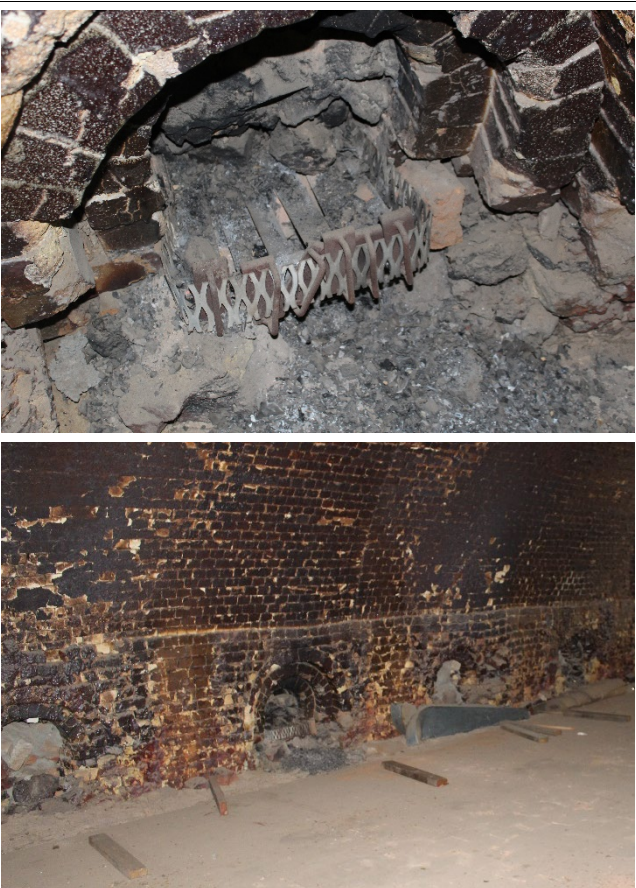
6-03	<p><i>Description:</i> Fire grate</p> <p><i>Location:</i> Central kiln of Downdraught Kilns (Element 6)</p> <p><i>Condition:</i> Fair</p> <p><i>Comments:</i> Little apparent fabric damage, some rust activity</p> <p><i>Recommendations:</i> Retain and conserve in situ. Implement interpretation opportunities</p> <p>Seek the advice of a conservator for conservation and interpretation on site</p>

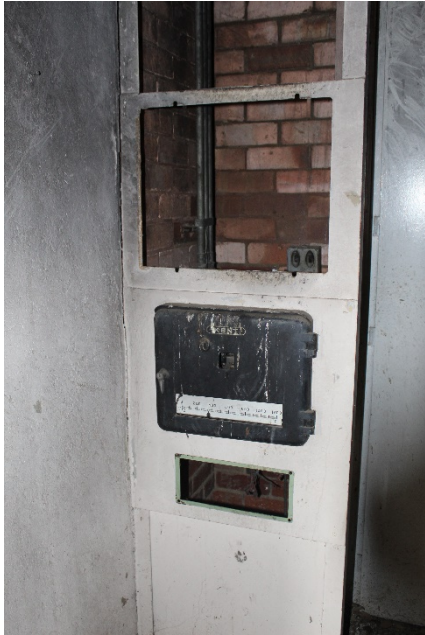
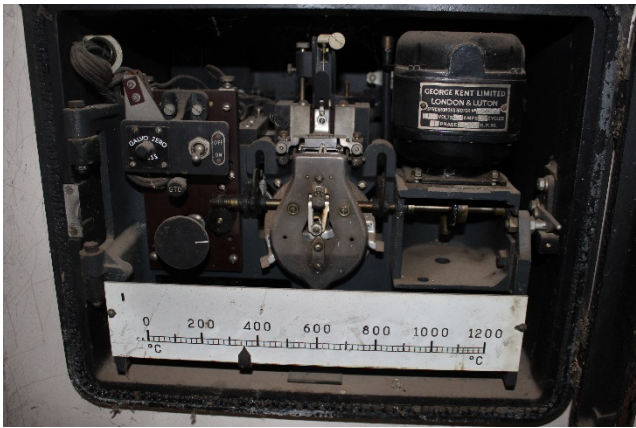
ID	Description	Photograph
Element 26: Downdraught Kilns Control Room		
26-01	<p><i>Description:</i> 'George Kent Limited London &amp; Luton' temperature control panel</p> <p><i>Location:</i> Adjacent to doorway of Downdraught Kilns—Control Room (Element 26)</p> <p><i>Condition:</i> Good</p> <p><i>Comments:</i> Non-operational, some external fabric damage, no damage to internal mechanism</p> <p><i>Recommendations:</i> Retain and conserve in situ. Implement interpretation opportunities</p> <p>Seek the advice of a conservator for conservation and interpretation on site</p>

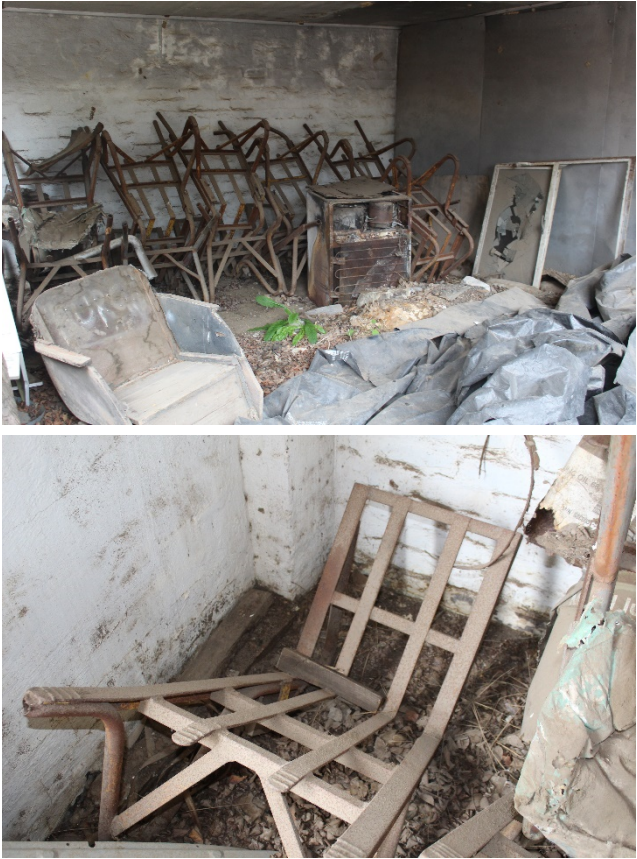
ID	Description	Photograph
28-01	<p><i>Description:</i> Approximately 11 dismantled brick barrows</p> <p><i>Location:</i> Rear of Ancillary Storage Building 1 (Element 28)</p> <p><i>Condition:</i> Poor</p> <p><i>Comments:</i> Advanced rust activity, missing timber lining and wheels</p> <p><i>Recommendations:</i> Salvage and store on site. Appropriately label as a 'job lot', with a catalogue number and provenance, likely will include 16A-02</p> <p>Seek the advice of a conservator for conservation and interpretation on site</p>

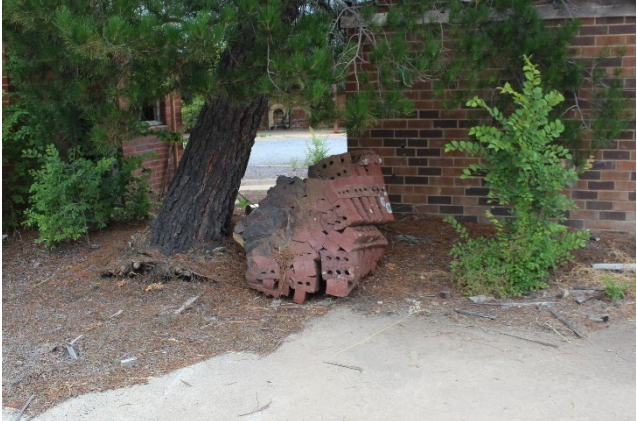
Element 32: Extrusion Plant (Remnants)		
32-01	<p><i>Description:</i> Stack of misfired red bricks, approximately 12 courses</p> <p><i>Location:</i> Northeastern end of concrete slab, adjacent to external rear wall of Ancillary Storage Building 1 (Element 28)</p> <p><i>Condition:</i> Good</p> <p><i>Comments:</i> Little apparent fabric damage, some minor lichen attachments</p> <p><i>Recommendations:</i> Retain for interpretation on site</p>

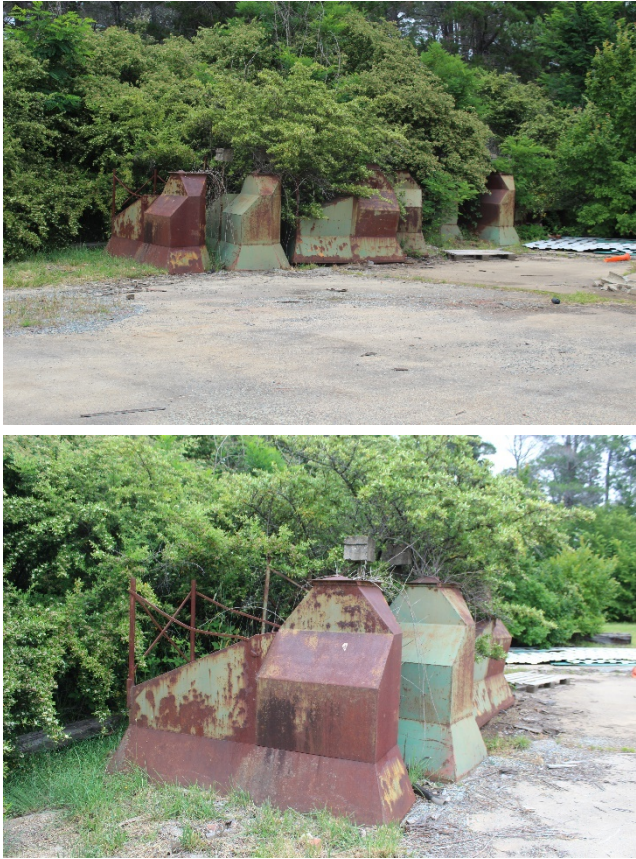
ID	Description	Photograph
32-02	<p><i>Description:</i> Approximately nine extrusion chutes</p> <p><i>Location:</i> Along southwestern edge of Extrusion Plant (Element 32)</p> <p><i>Condition:</i> Poor–fair</p> <p><i>Comments:</i> Some fabric damage, advanced rust activity on several examples, may be damage from encroaching foliage</p> <p><i>Recommendations:</i> Salvage and store on site. Appropriately label as a 'job lot', with a catalogue number and provenance, likely will include 34A-01</p> <p>Seek the advice of a conservator for conservation and interpretation on site</p>

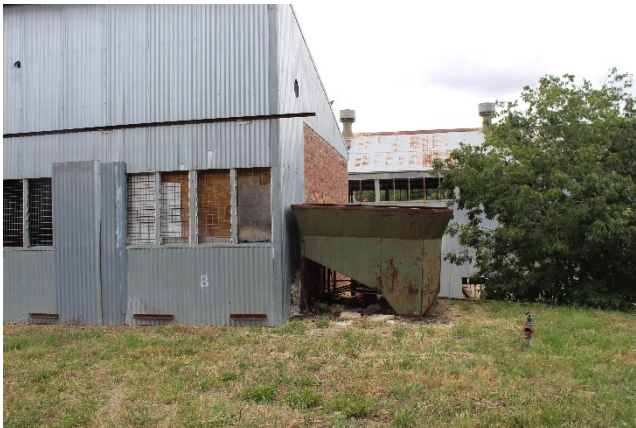
Model Railway Workshop Area		
35A-01	<p><i>Description:</i> Extrusion chute</p> <p><i>Location:</i> Adjacent to northern external wall of Model Railway Workshop Area (Element 35)</p> <p><i>Condition:</i> Fair</p> <p><i>Comments:</i> No apparent fabric damage, some rust activity</p> <p><i>Recommendations:</i> Salvage and store on site. Label with an inventory catalogue number and provenance, likely as part of 31-02 'job lot'</p> <p>Seek the advice of a conservator conservation and on site interpretation</p>

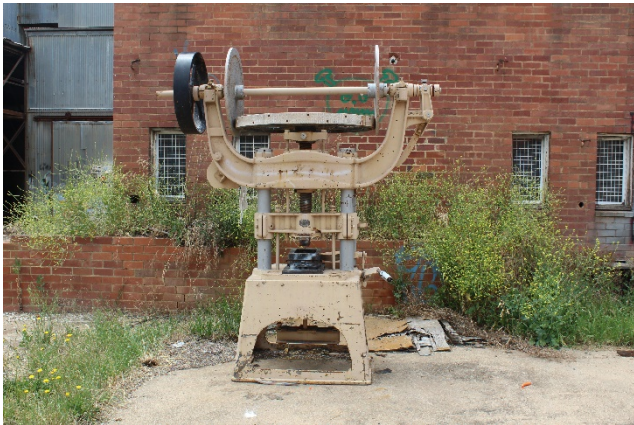
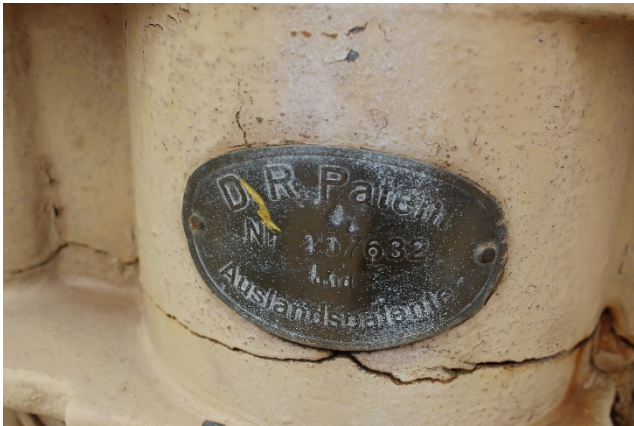
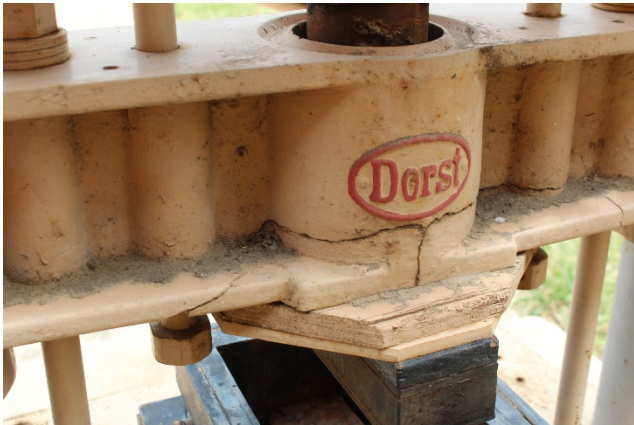
ID	Description	Photograph
Element 1A: Railway Remnants (Narrow-gauge Railway)		
No moveable relics were able to be checked in detail here.		
Element 37: Original Brickyard		
37-01	<p><i>Description:</i> 'DR Patent und Auslandspatente' brick press</p> <p><i>Location:</i> Eastern end of yard, adjacent to rear of Amenities Block 1 (Element 25)</p> <p><i>Condition:</i> Fair</p> <p><i>Comments:</i> Some fabric damage, graffiti damage, some rust activity</p> <p><i>Recommendations:</i> Salvage and store on site. Label with an inventory catalogue number and provenance</p> <p>Seek the advice of a conservator for conservation and interpretation on site</p>
