Canberra Brickworks Precinct

Archaeological Excavation Report and Statement of Heritage Effects

Volume 1—Report

Prepared for
Doma Group
April 2022

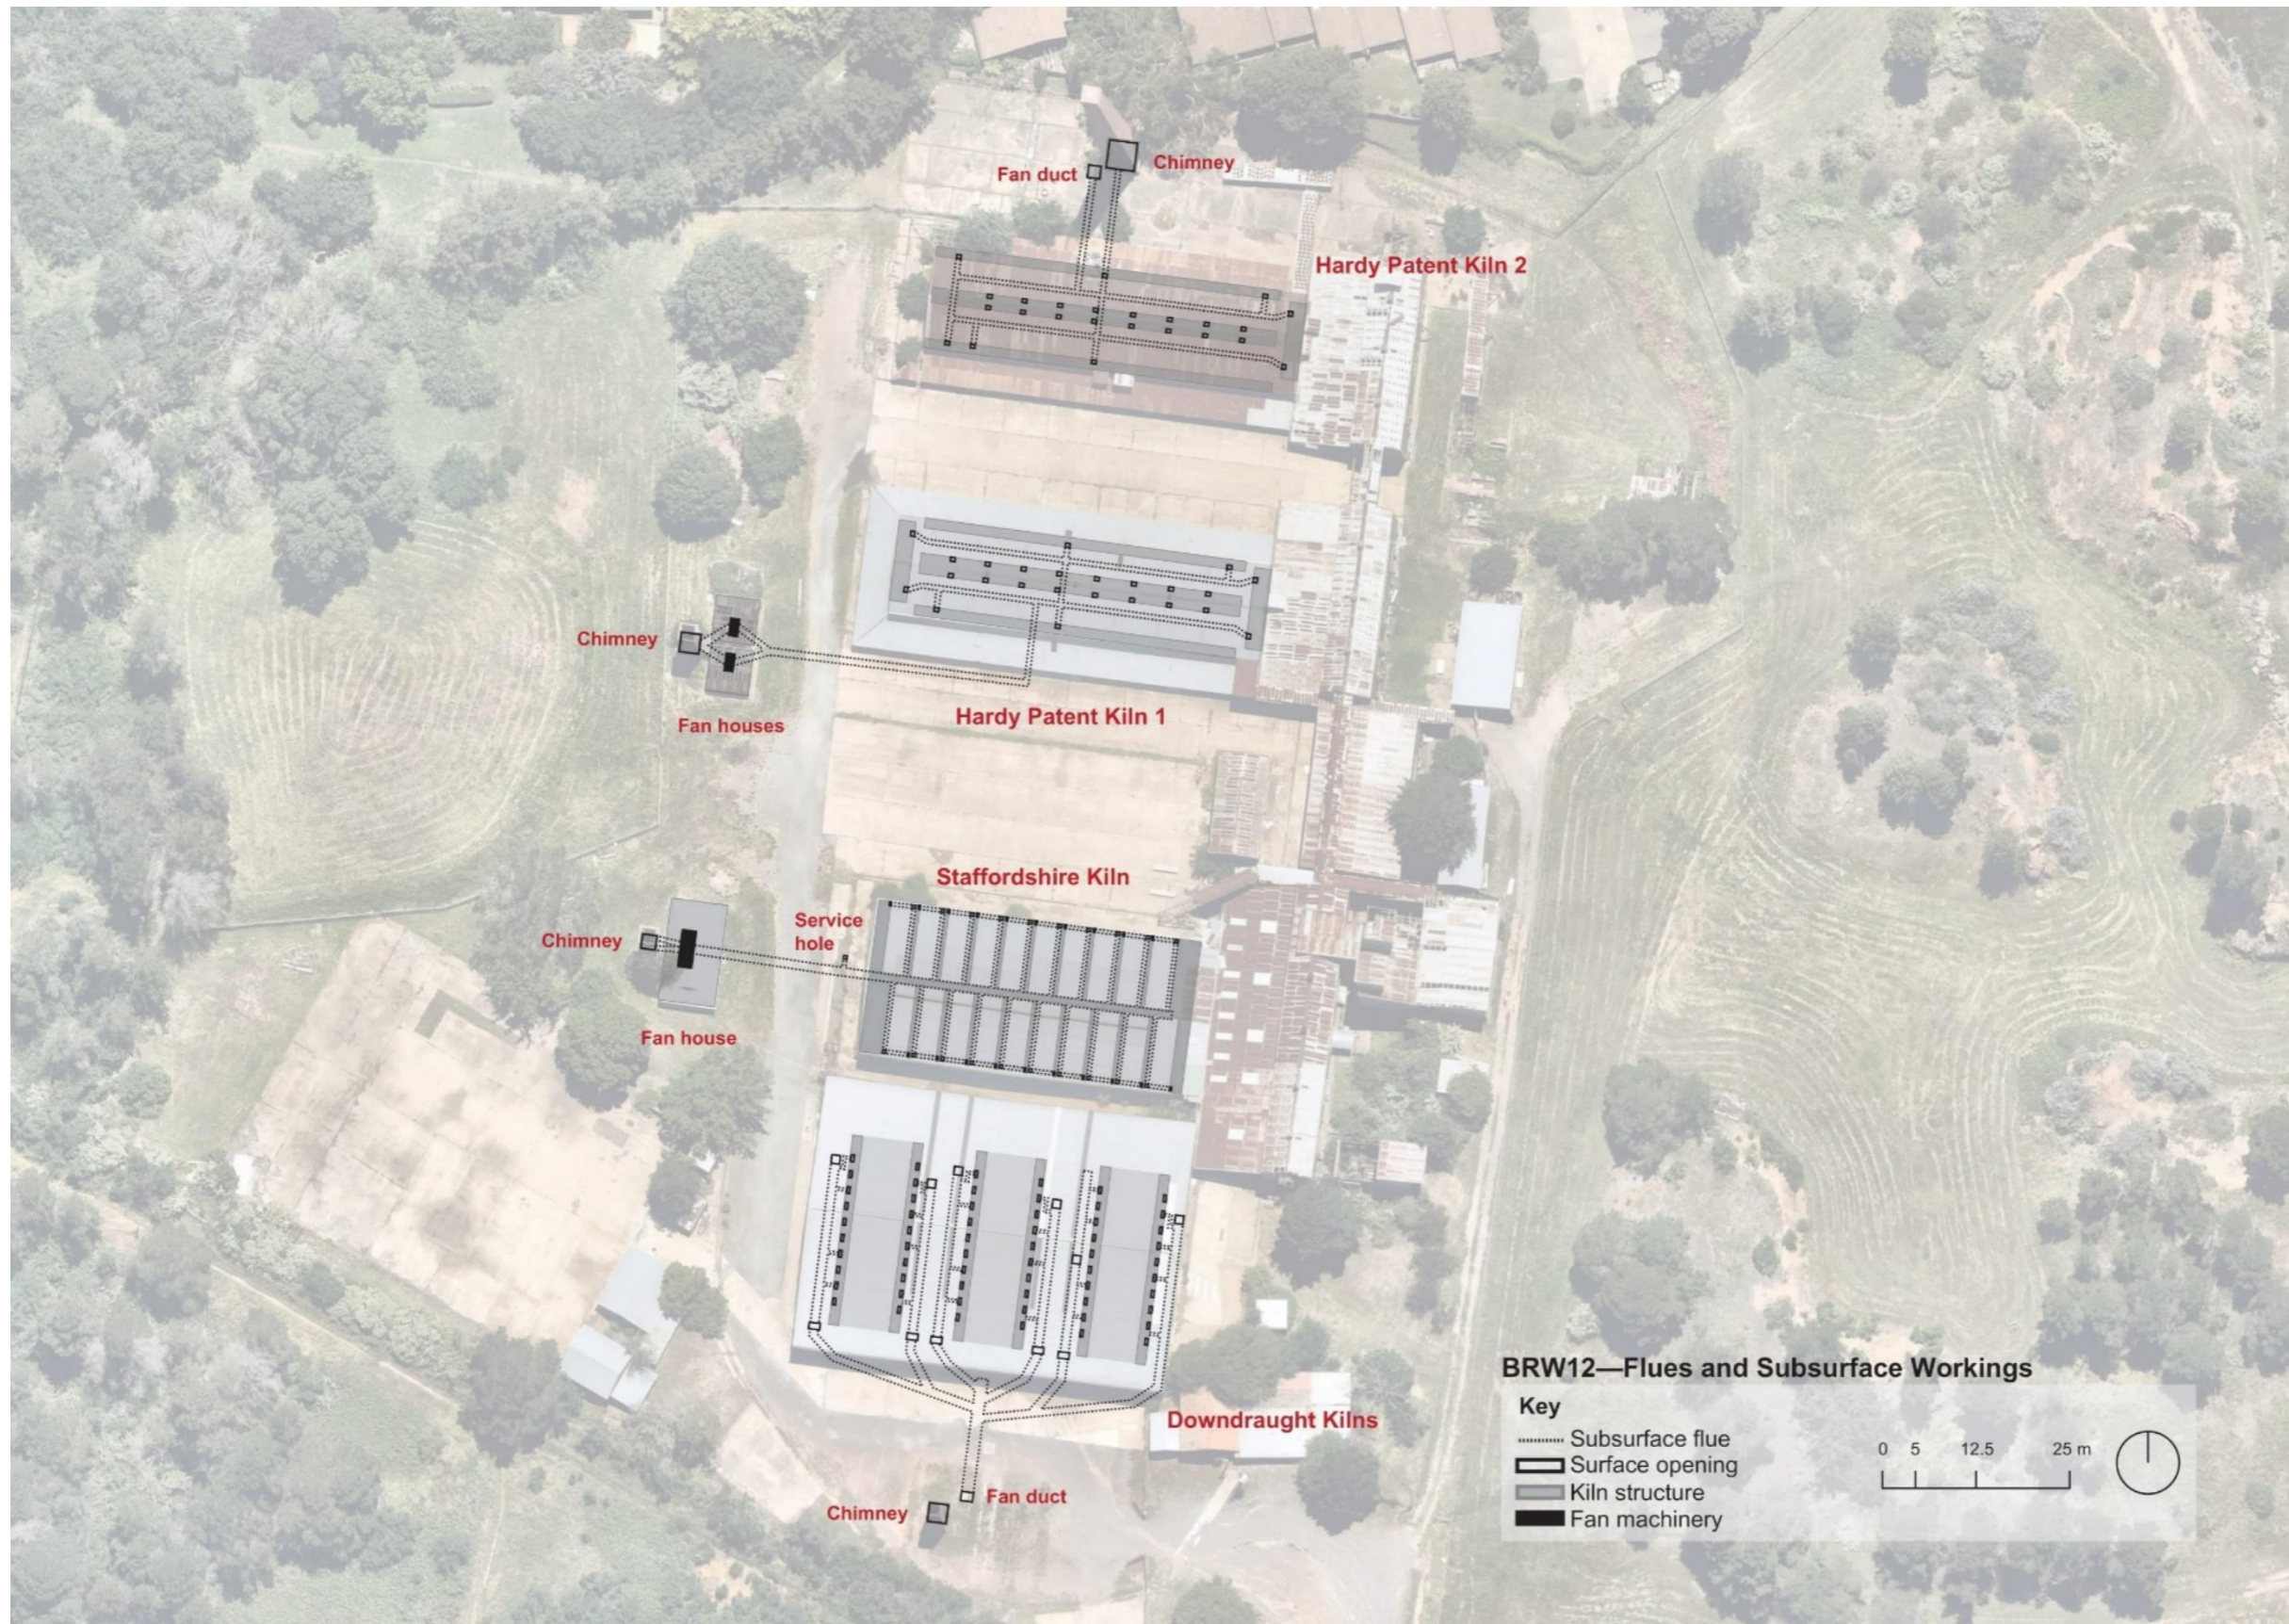
Figure 4.3 Layout of subsurface flues at the Canberra Brickworks Precinct. Note that the wickets in the long walls of both Hardy Patent Kilns have not been mapped due to successive alterations to the locations and use of the wickets. (Source: Near Map 2020 with GML additions)

Each of the kilns is serviced by an arrangement of subsurface flues (Figure 4.3). These flues assisted in drawing hot air out of the kiln spaces and allowed for better temperature control during the firing process.

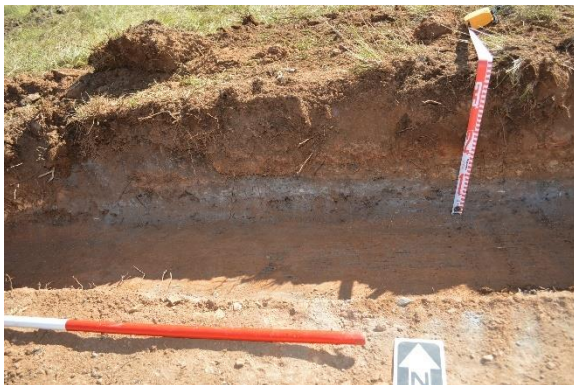
The identified surface features were ephemeral pre-cast concrete remnants and were not associated with any further subsurface features, such as water storage or drainage infrastructure, or other structural purposes. Removal of the topsoil in TT12 identified a very compact crushed yellow granite gravel layer (83, similar to 35 and 41), which is consistent with materials used in 1960s–1970s carparks in Canberra. Beneath the crushed gravel were several deposits (82, 85, and 87) containing ash, mixed shale, and brick rubble representative of background demolition and levelling events. These had been compacted into the natural soil surface. TT13 contained comparable deposits (84, 85, and 86). No artefacts were associated with any of these deposits.

Figure 4.4 TT12, ash (82) and crushed brick rubble (87) deposits, facing north.

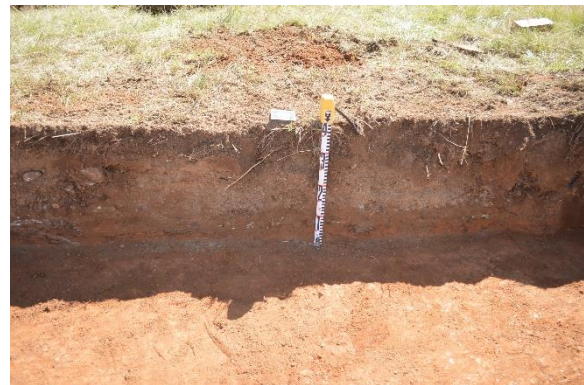
Figure 4.5 TT13, crushed brick rubble (85) and clay (86) deposits, facing north.

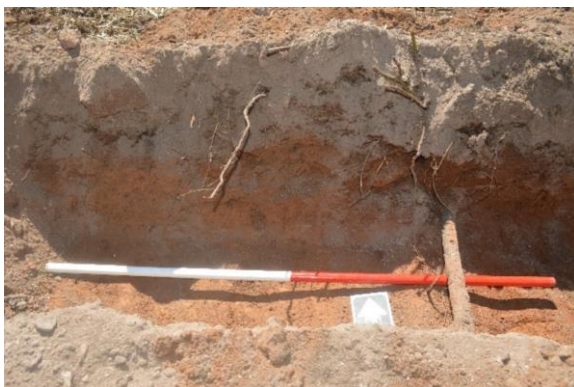
TT14 and 15 were on the eastern and northeastern extent of BRW2 within an area of dense shrubbery (refer to Figure 4.10 and Figure 4.11). Following the removal of the topsoil, ferrous waterpipes were identified in each TT. The pipe (88) in TT14 was aligned north-south, and was below a deposit of friable brownish grey sandy silt with brick rubble and charcoal inclusions (90) (Figure 4.8). This deposit was 0.25 metres deep and contained a considerable quantity of miscellaneous ferrous metal artefacts (Section 4.2). It had been deposited onto natural soil profiles. The water pipe (92) in TT15 was aligned northeast-southwest and was not associated with any further archaeological deposits, having been inserted through natural soil profiles (Figure 4.9).

Figure 4.8 The water pipe (88) and overlying rubble deposit (90) in TT14, looking north.

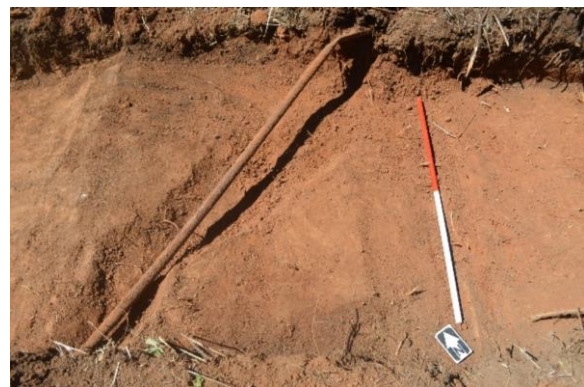
Figure 4.9 The water pipe (92) in TT15, looking northeast.

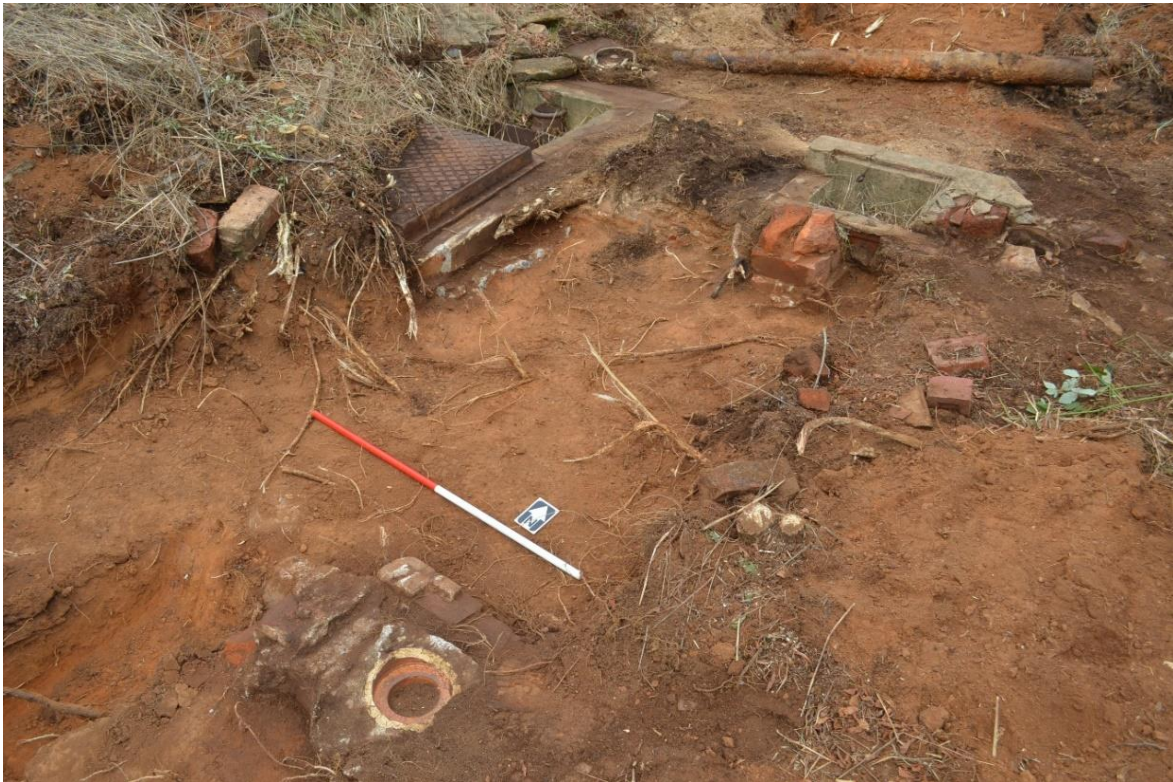
TT17 was in the centre of BRW2 (refer to Figure 4.13). It was characterised by several drainage and plumbing features (94), including drains, a ferrous water pipe, and a possible grease or debris trap (Figure 4.12). Artefacts recovered from this area primarily comprised c1960s glass beer and soft-drink bottles (Section 4.2). The whole area had been extensively disturbed, and a considerable quantity of demolition debris and other waste materials was contained within the topsoil.

Figure 4.12 TT17, plumbing features (94), facing northwest.

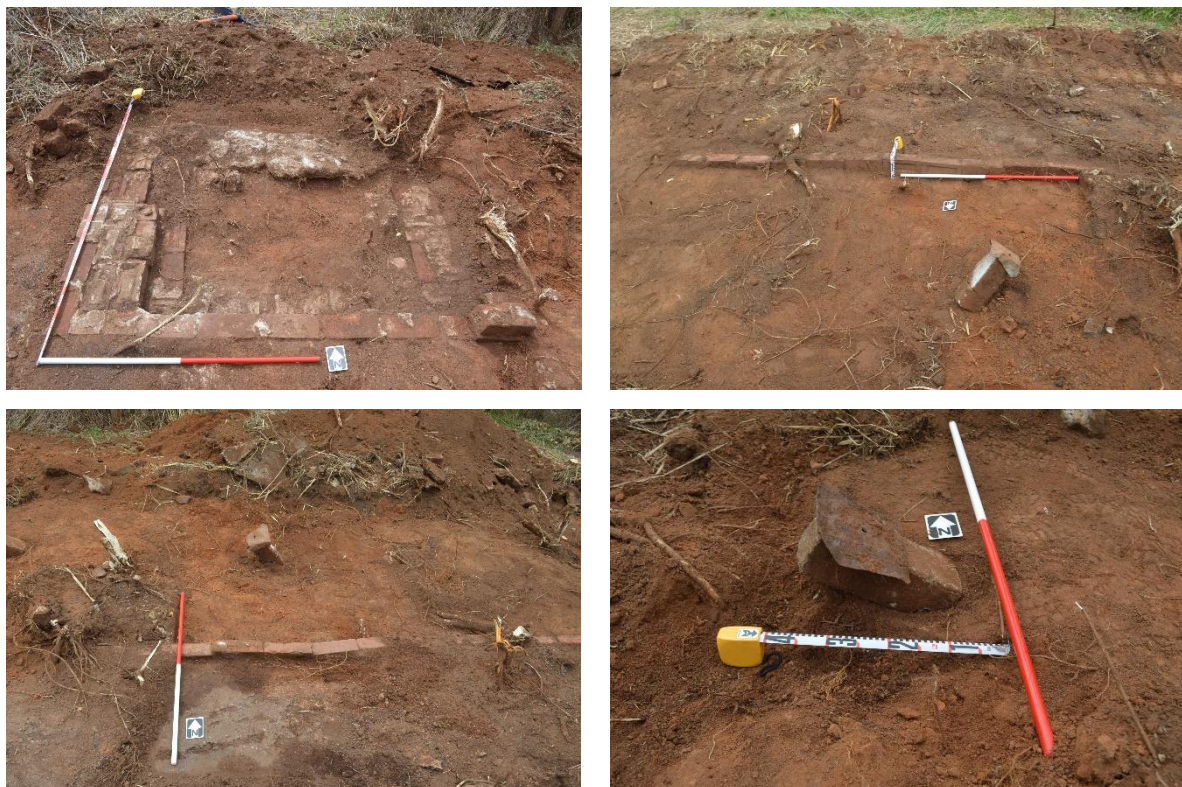
TT18 was on the southern boundary of BRW2, adjacent to an informal vehicle track that provides external access around the Brickworks (refer to Figure 4.15). Due to the presence of the vehicle track, the immediate location of TT18 was largely clear of vegetation. Following the removal of the topsoil, several brick strip footings (97 and 98) and (originally) upright concrete stumps (99) were identified in TT18. These features were adjacent to an asphalt surface (96), all aligned east–west (Figure 4.14). The western-most footings (97) were constructed from bricks laid in stretcher bond—forming three sides of a rectangle—with amorphous cast-in-place concrete completing the fourth side. The concrete obscured the brick frogs (brick frogs are discussed in Section 4.2.1). A single line of brick strip footings (98) extended from the southeast corner of the western-most footings (97). This line of brick strip footings (98) had been constructed from bricks with frogs marked either ‘CANBERRA C’WEALTH’ or with no mark (‘blank’), laid in shiner bond. The asphalt surface (96)—which had been significantly degraded—abutted both footings on the south. Five pre-cast concrete stumps with ferrous ant caps (99) were aligned linearly on the opposite side. Artefacts were predominantly collected from the topsoil in this area and reflected those found in TT17, with large quantities of glass beverage bottles, several tea cups and mugs, and animal (faunal) remains (Section 4.2).

Figure 4.14 TT18, brick strip footings (97 [top left] and 98 [top right and bottom left]), asphalt surface (96 [bottom left]), and (originally) upright concrete stumps (99 [top right and bottom right]), facing various.

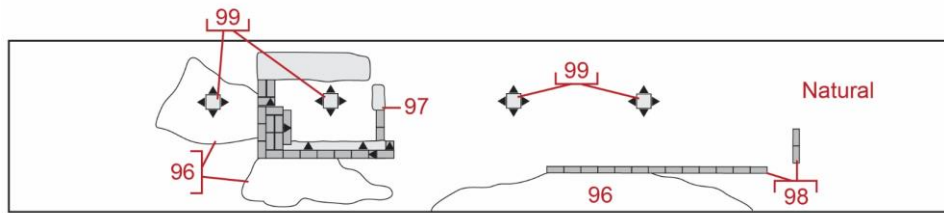
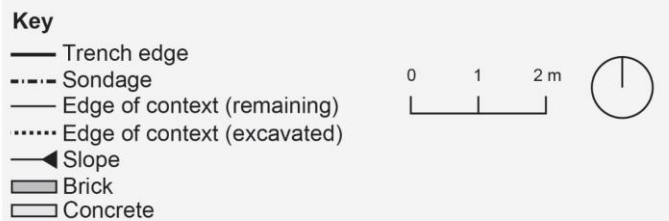
BRW2—Test Trench 18

The brick strip footings and concrete stumps in TT18 probably represent two structures. The more substantial brick and concrete footings in the western extent of the TT align with the remnant brick structure (95), indicating they probably supported the southeastern corner of the mess house (Figure 4.15). The brick strip footings adjacent to the asphalt surface, however, were too insubstantial to support a building the size of the mess house. Their location adjacent to this structure and the central road would suggest they formed part of the meat safe.

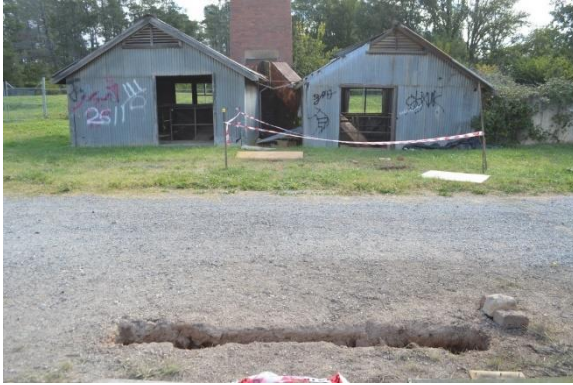
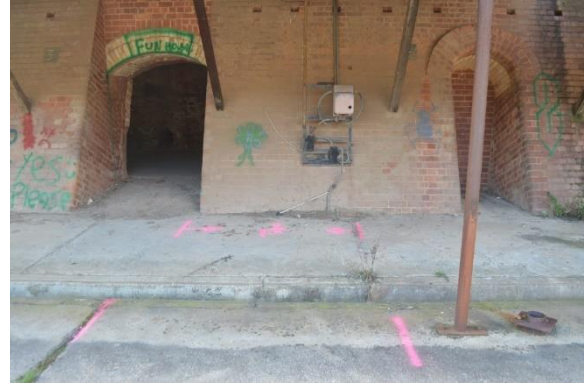
GPR identified a single tunnel leading east from the fan houses to the kiln, aligned along the southern wall of the kiln (Figure 4.125). This tunnel turns north to enter the kiln space approximately 45 metres from the fan houses, coinciding with the 'Kent' oxygen analyser mounted on the external wall (Figure 4.125). Readings from the internal space indicated that two flue tunnels are aligned through the centre of each chamber. These presumably connect to eight smaller flue channels (four in each chamber), identified by the downwards shaft in the firehole (Figure 4.130).

Externally, the single tunnel leading from the fan houses to the kiln was corroborated. However, this appeared in two different forms. Two hydro excavation potholes—1.8 metres and 11.2 metres west of the fan houses—revealed a rectangular cast concrete structure (Figure 4.126). Between these, a third pothole identified a partial brick arch and significant brick rubble collapse (Figure 4.127). This arch had been constructed predominantly from 'CANBERRA C'WEALTH' frog bricks, which included a single bullnose brick.

Figure 4.125 GPR identified a single tunnel leading from the fan houses to the kiln, which enters the kiln at the location of the 'Kent' oxygen analyser.

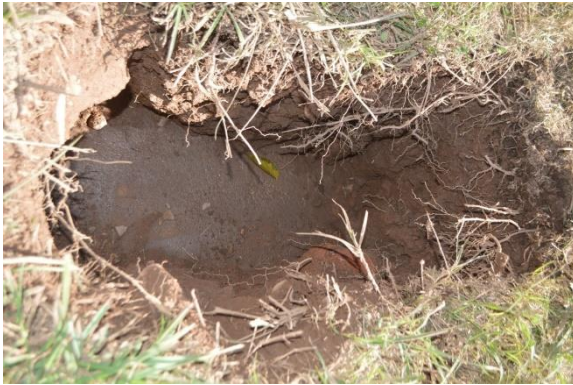
Figure 4.126 Part of the central concrete flue leading from the fan houses.

The archaeological investigations identified that extensive modifications had been made to the Hardy Patent Kiln 1 flues. The main tunnel leading from the fan houses to the kiln had been completely replaced with a new concrete structure. A large quantity of brick rubble was identified beneath the floor in the internal kiln space suggesting that at least some tunnels had been collapsed and replaced. If concrete was used to replace the main tunnel, it may have also been used to construct any new tunnels within the internal kiln space. This should not be assumed though, as one intact brick flue and no concrete flues were identified within the internal space.

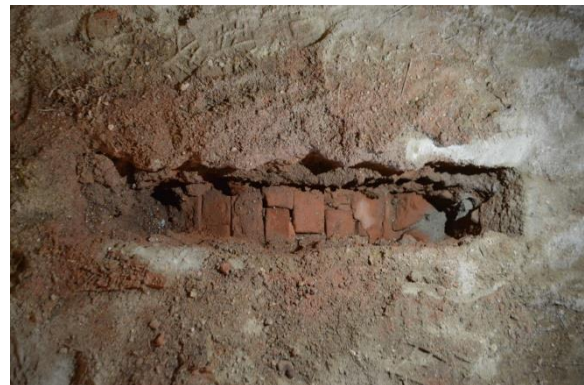
Within the internal space of the kiln, hydro excavation indicated that further alterations had been made to the original flue layout. A pothole excavated in the western passage between the two kiln chambers revealed a quantity of brick rubble embedded in the stratigraphy beneath the floor surface (Figure 4.128). No concrete flue channels were identified within the kilns—all other identified intact flues were constructed from brick (Figure 4.129).

Figure 4.128 Brick rubble embedded beneath the floor surface in the western passage between the two kiln chambers.

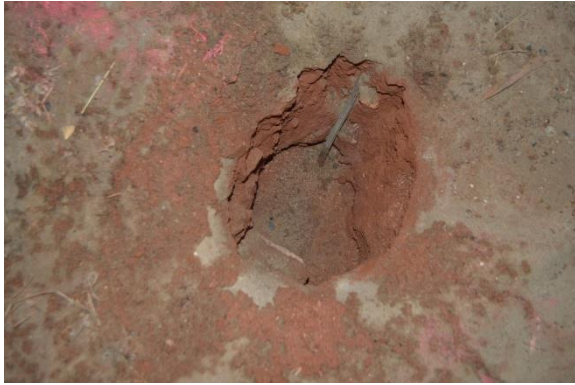
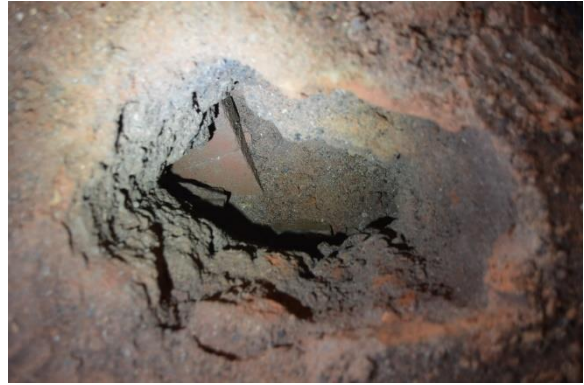
Hydro excavation in the southern kiln chamber indicated the Hardy Patent Kiln 2 flues had undergone a similar level of disturbance observed in Hardy Patent Kiln 1. The majority of the hydro excavation potholes revealed collapsed rubble, with only one intact brick arched tunnel located (Figure 4.132 and Figure 4.133). Brick rubble was also found in many of the flue channels within the internal walls of the kiln (Figure 4.134).

Figure 4.132 Brick rubble embedded beneath the floor surface in the southern kiln chamber.

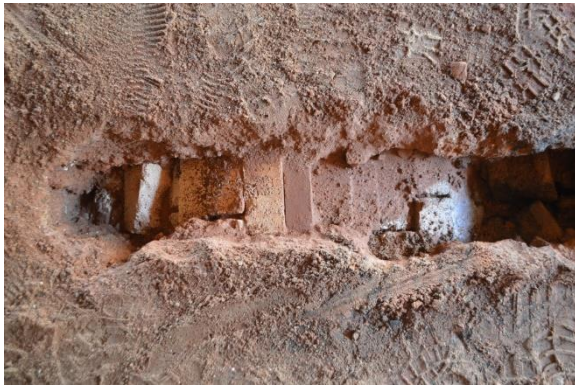
Figure 4.133 An intact brick flue.

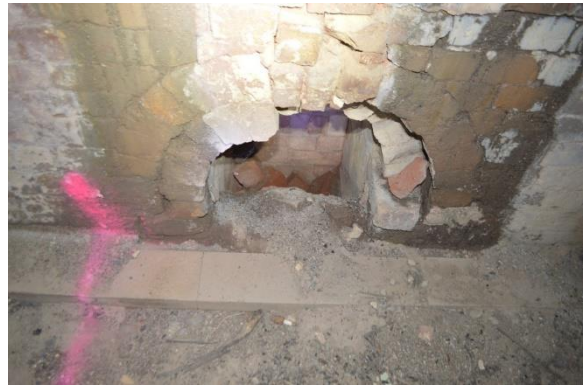
Figure 4.134 Brick rubble in the downwards shaft of a flue channel in the internal wall of the southern kiln chamber.

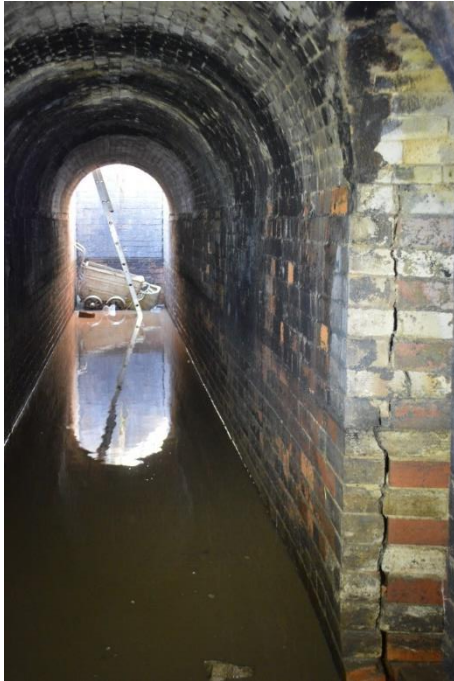
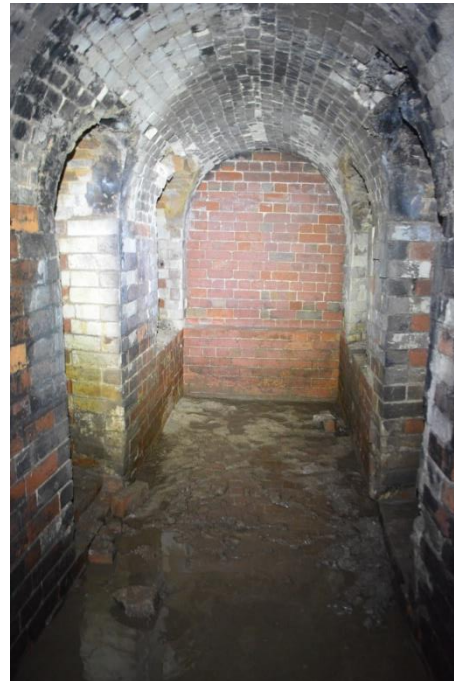
The overall condition of the flues is poor. The central tunnel is prone to flooding during rain events, which had led to the entire structure being subject to damp. This has resulted in extensive salt damage to the eastern tunnels and cracking in the brickwork throughout

Figure 4.136 Right: the central tunnel, aspect south towards the entrance of the fan duct. Left: the rear wall of the central tunnel, with the four branching side tunnels: A (left foreground), B (left background), C (right background), and D (right foreground).
