Yarralumla Brickworks Precinct Tree Assessment Update

Tree Assessment Update and Historical Tree
Assessment Package

Prepared by dsb Landscape Architects
5 March 2023

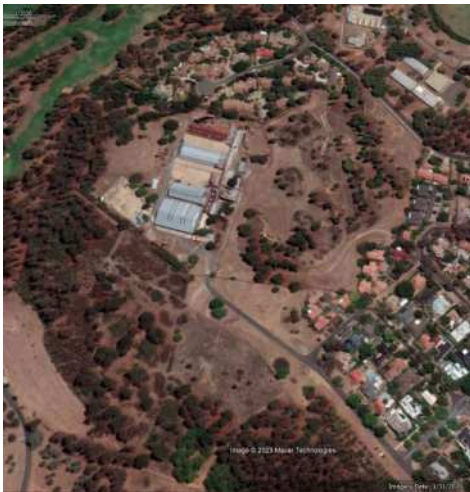
Google Earth Image January 2021

The reinspection of January 2020 was at the end of three successive dry years of 2017, 2018 and 2019. Rainfall in 2019 was 40% below the long-term average.

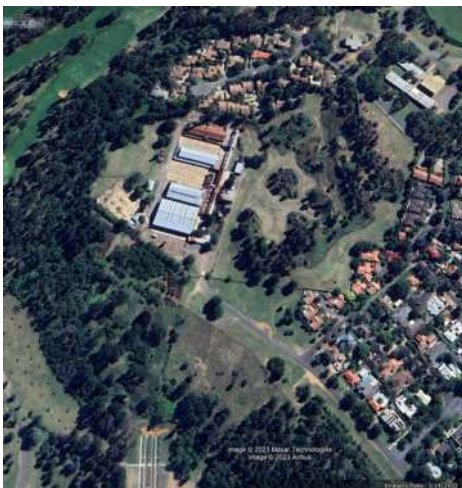
Google Earth Image March 2022

Reinspection of the Yarralumla Brickworks Precinct in February 2023 revealed that the trees generally have responded to the better climatic conditions of 2020 – 2023 with increased vigor and increased health and canopy density.
