# **BUSHFIRE RISK ASSESSMENT REPORT**

## **YARRALUMLA BRICKWORKS PRECINCT**

**BLOCK 1, BLOCK 7 & BLOCK 764,  
SECTION 102**

**UPDATED**

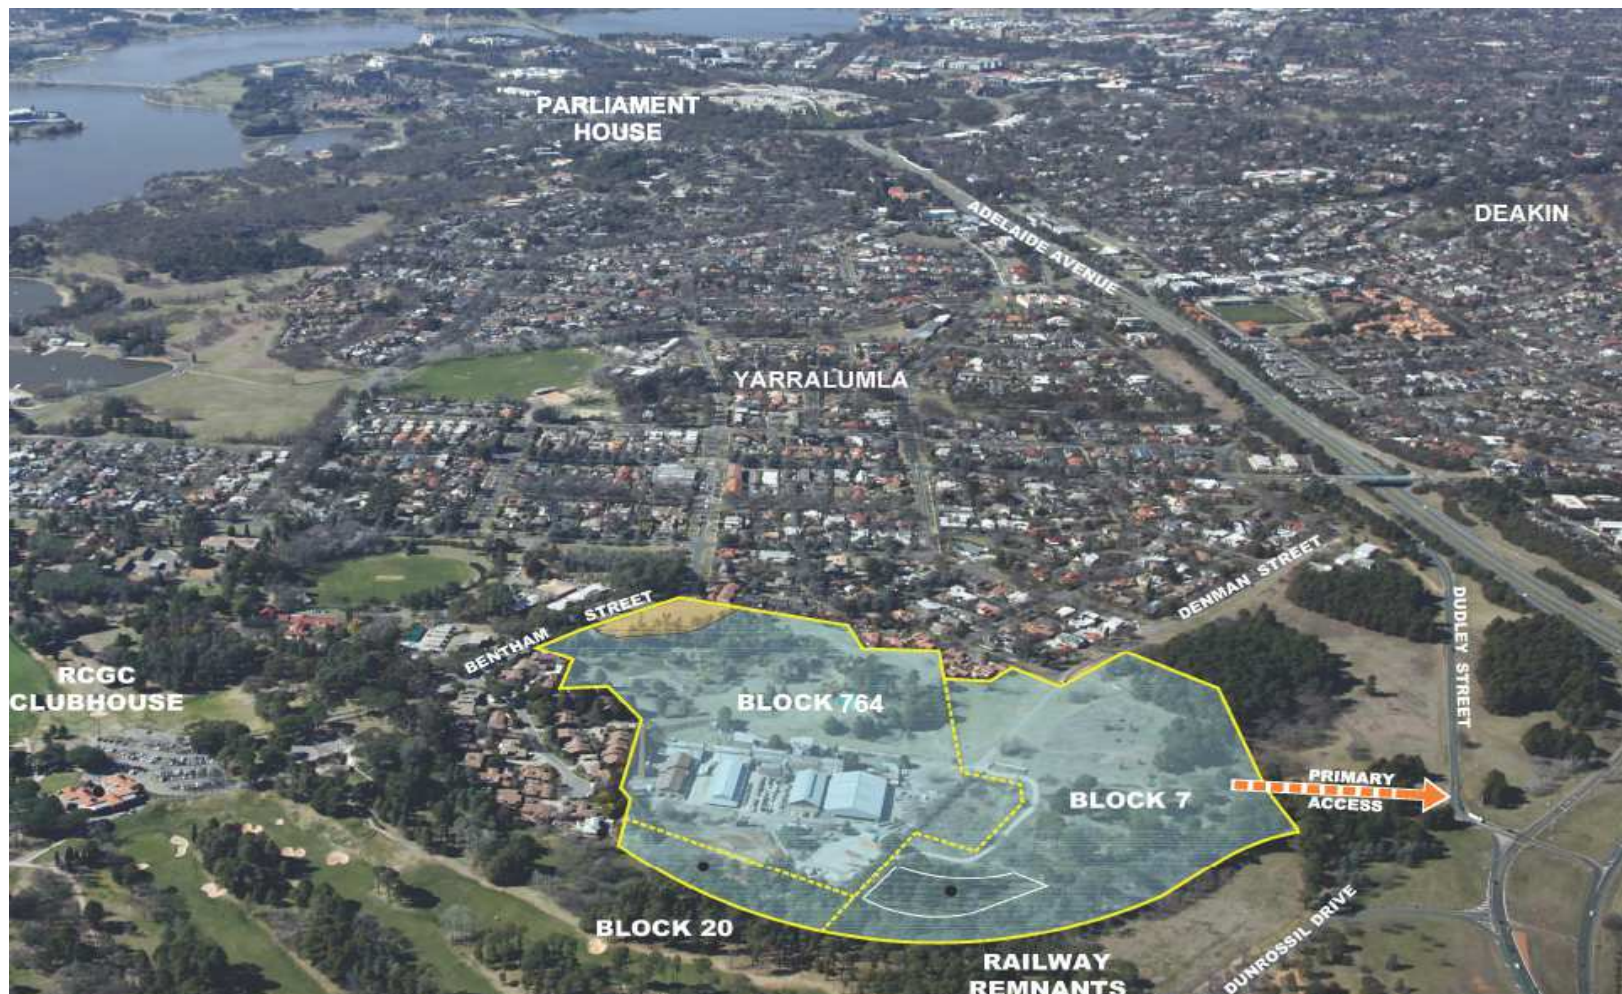
**Figure 2 – Aerial Photograph of the Yarralumla Brickworks Precinct and the surrounding landuse.**

Except for the former Yarralumla Brickworks complex on Block 764 Section 102 Yarralumla, the development precinct contains vacant land – refer to Figure 2 - Aerial Photograph of the Yarralumla Brickworks Precinct and the surrounding landuse on Page 11.

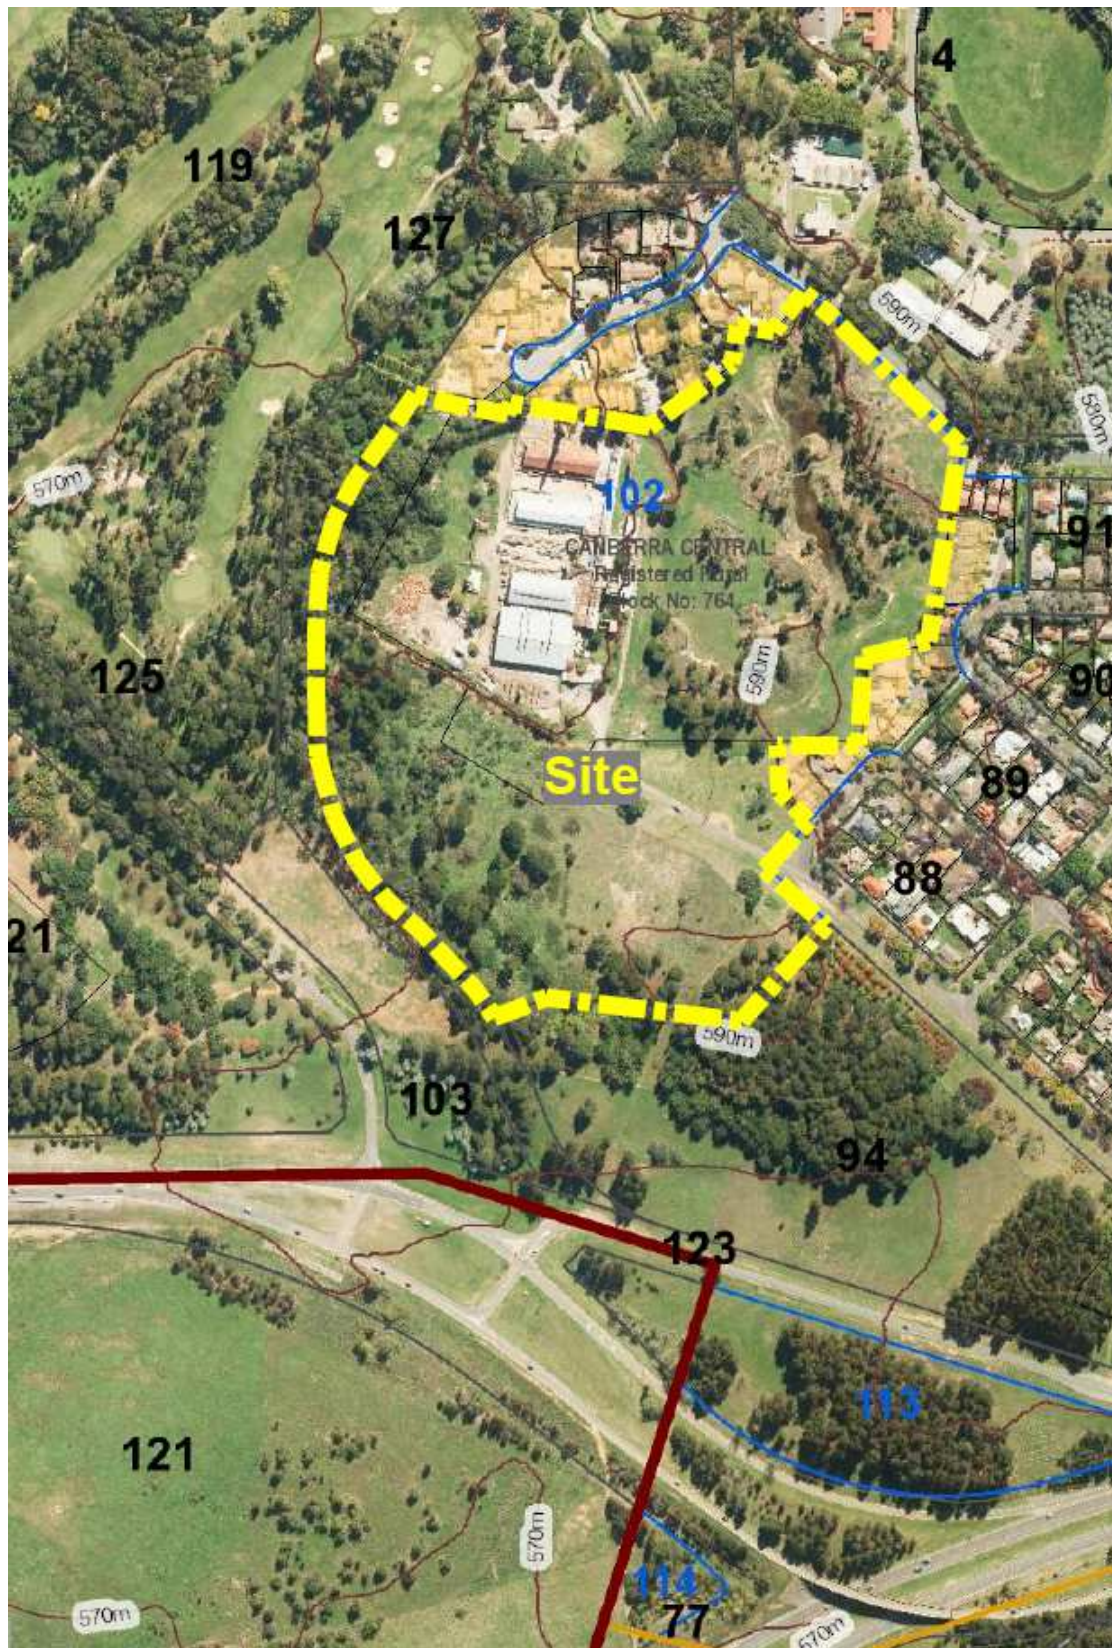
Figure 5 – Contour Plan.

The land beyond the precinct falls to the northwest at less than 10% across the Royal Canberra Golf Club and the Dunrossil Drive corridor, rising to the west beyond the Dunrossil Drive corridor. The land within the North Curtin Horse Paddock to the southwest of Cotter Road falls to the south and southwest at less than 10% into Yarralumla Creek – refer to Figure 5 – Contour Plan on Page 15.

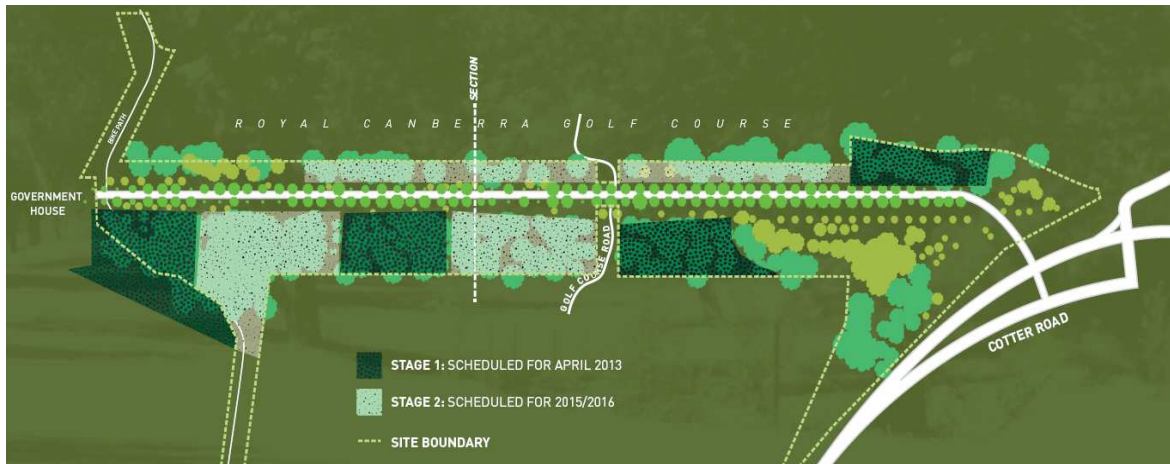
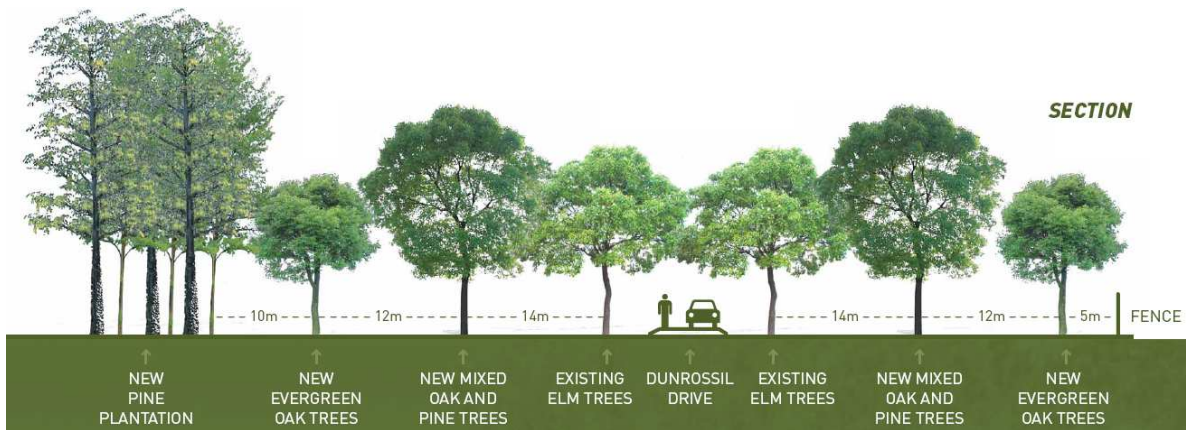
**Figure 6 – Plan and Section of the Dunrossil Drive planting**

The mature *Pinus Radiata* trees in the Dunrossil Drive corridor have been removed and tree replanting has commenced with the retention of the existing central avenue of Elm trees, surrounded by a second avenue of mixed trees [Pine & Oak], with an evergreen tree backdrop formed by creating a third outer avenue using an evergreen species of Oak and then replanting the Pine plantation on the outside of the avenue – refer to Figure 6 – Plan and Section of the Dunrossil Drive planting on Page 17.

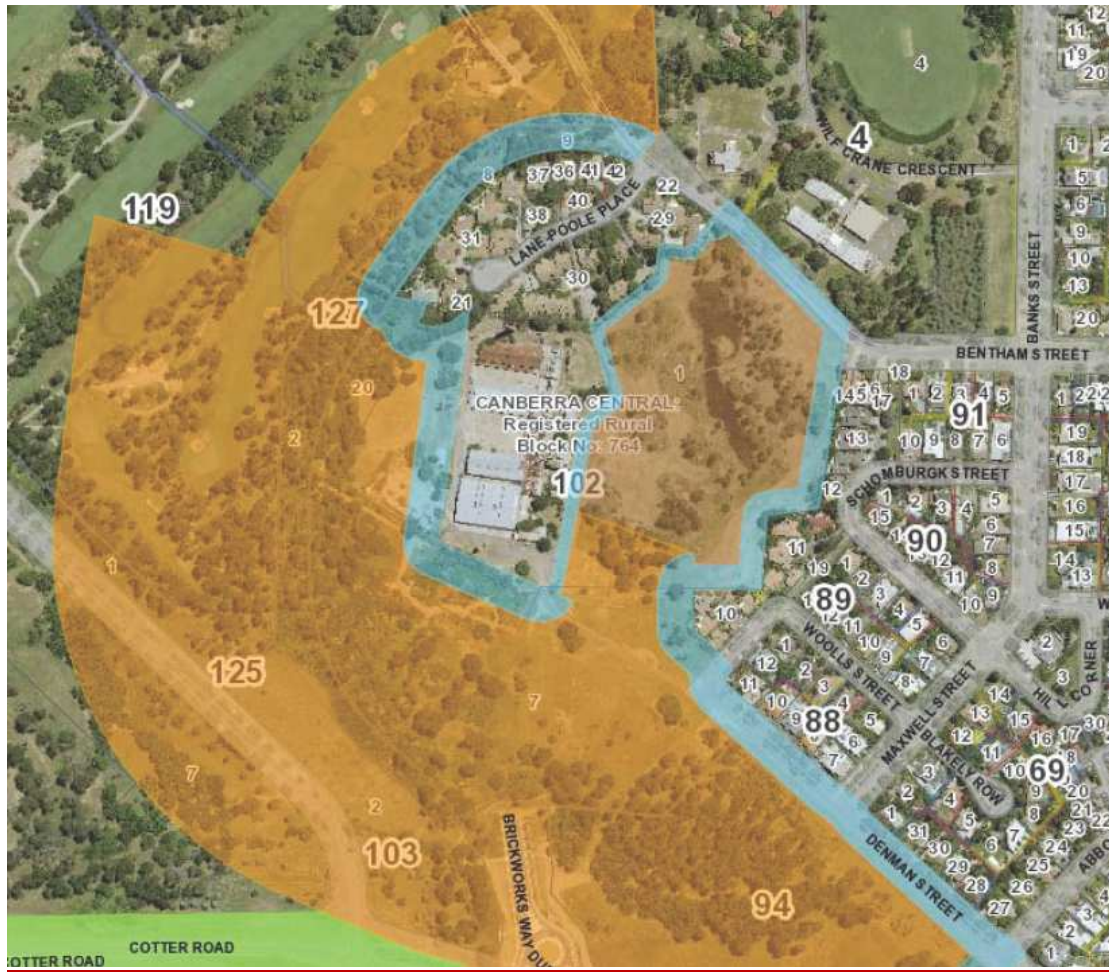
**Figure 9 – Extract ACTMapi Strategic Bushfire Management Plan.**

Figure 9 on Page 20 is an extract from the ACTMapi Strategic Bushfire Management Plan.

**Strategic Bushfire Management Zones**

- Inner Asset Protection Zone
- Outer Asset Protection Zone

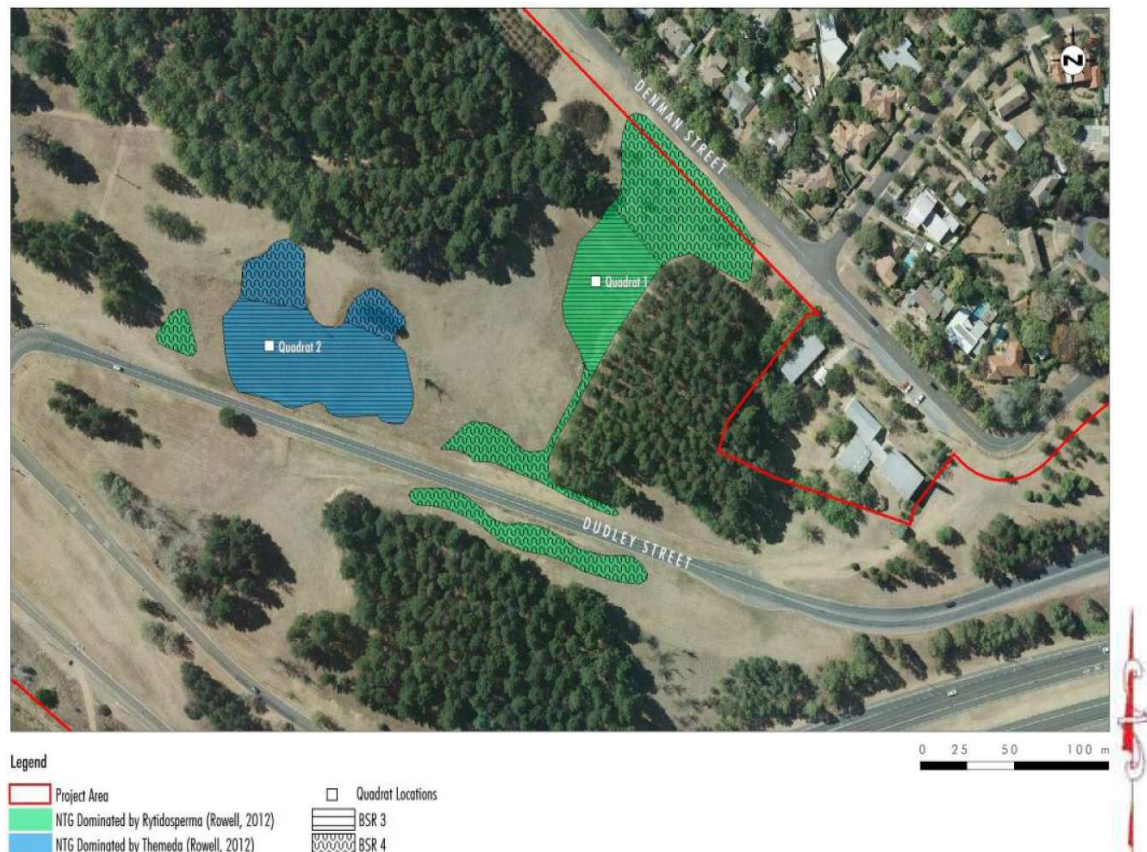
**Figure 11 – Ecological Constraints Plan – Natural Temperate Grassland.**

An ecological assessment was undertaken in late 2014 within the PRZ2 Area and adjoining land. Figure 10, below, provides the results of this study and identifies that the areas of grassland between the east and west bound lanes of Cotter Road and an area to the southwest and south of Denman Street contains Natural Temperate Grassland.
