Supplementary Environmental Site Assessment

Supplementary Environmental Site Assessment Canberra Brickworks Yarralumla ACT

Prepared for:	DOMA Group
Date:	3 July 2021
Reference No:	JC0546
Report Version:	JC0546_SESA.01

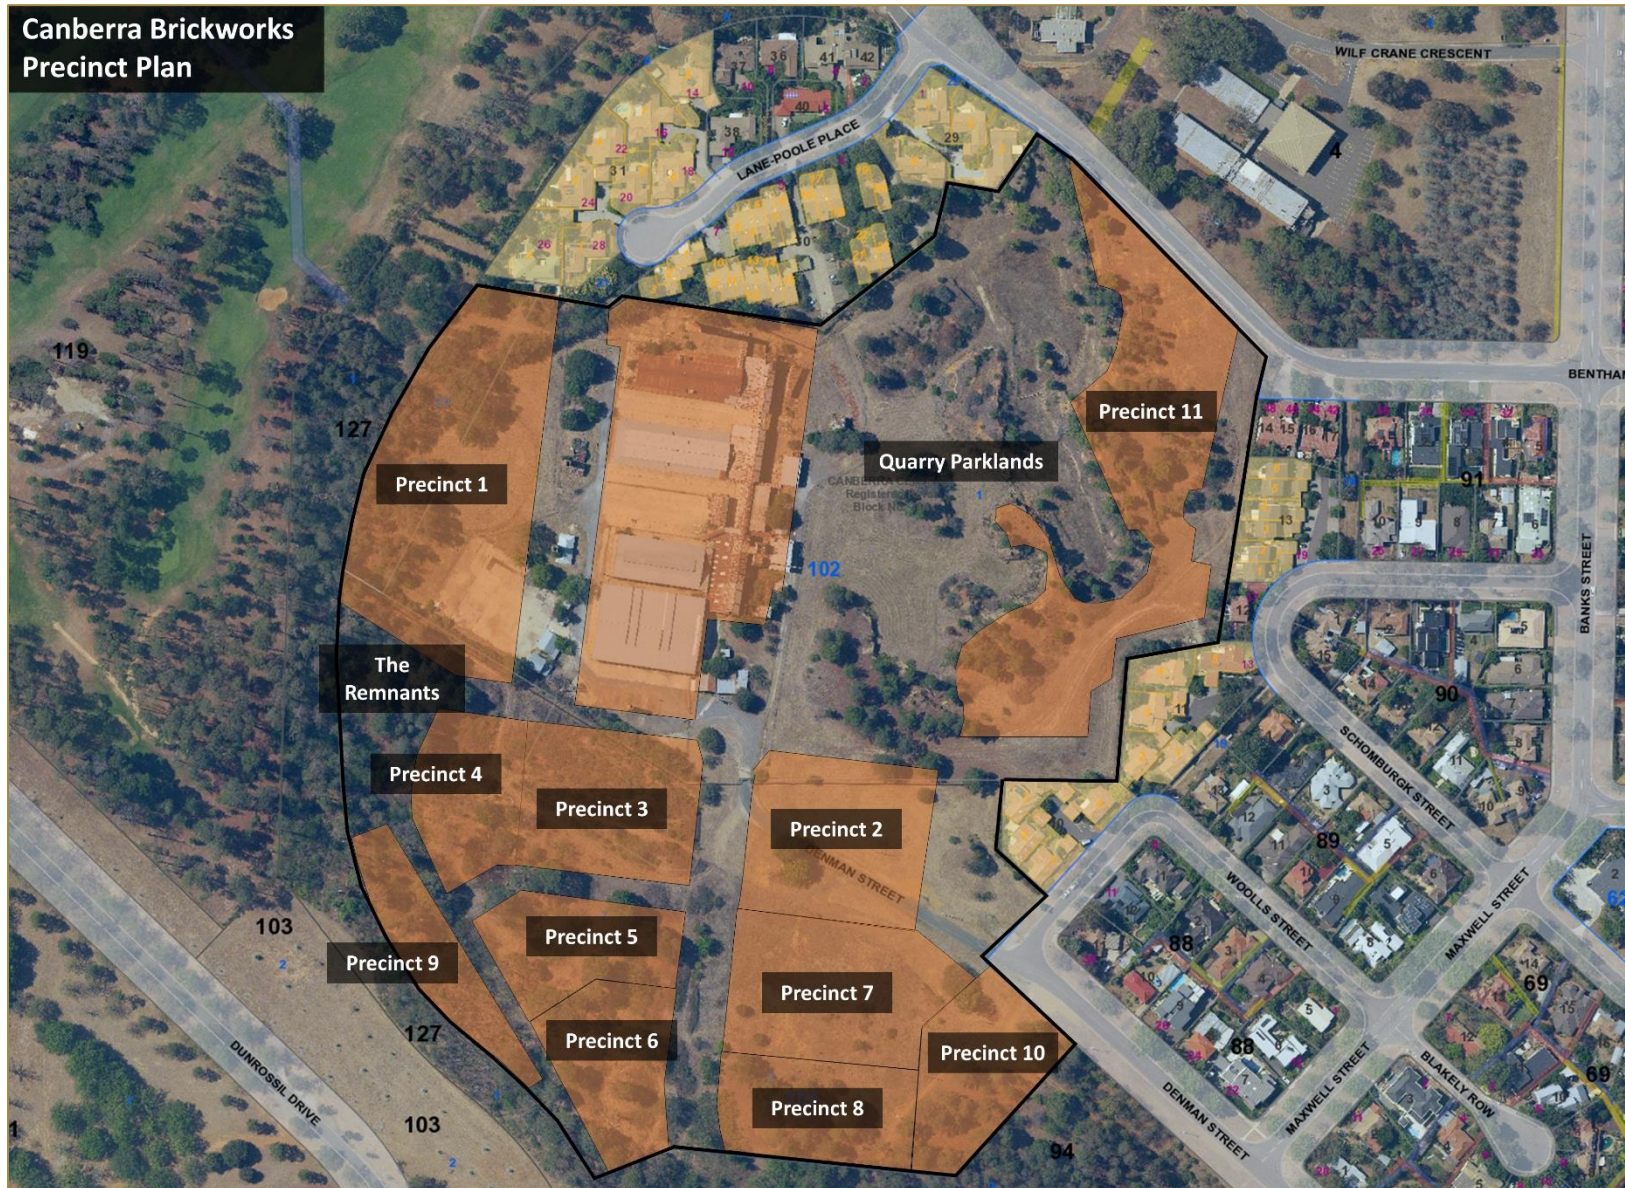
Figure 1: Site Location and Precinct Plan

Source: ACTmapi (2021)

DOMA Group (DOMA) engaged Agon Environmental Pty Ltd (Agon) to conduct a Supplementary Environmental Site Assessment (SESA) at the Canberra Brickworks defined as Block 764 Canberra Central and Block 7 Section 102 Yarralumla (the site, see Figure 1). It is understood that DOMA intend to the redevelop the site as a mixed-use development inclusive of residential, commercial and public space areas. Specific development Precincts are presented in **Section 2.1**.

Site Address	End of Denman Street, Yarralumla, ACT
Allotment Description	Block 7 Section 102, Yarralumla Block 764, Canberra Central and Block 1 Section 102 Yarralumla Blocks 11 & 12 Section 38, Fyshwick, Canberra ACT
Land Zoning	CZ6: Leisure and Accommodation RZ1: Suburban PRZ2: Restricted Access Recreation Zone
Current Land Use	Vacant
Proposed Land Use	Mixed use including residential, commercial and public space. Development Precincts are defined as follows: <ul style="list-style-type: none"> • Heritage Core – Commercial Land use. • Road and Open Space Network • Precincts 1, 2, 3, 4, 5, 6, 7, 8, 9 – Medium Density Residential. • Precinct 10 & 11 – Low Density Residential. The development Precincts are shown in Figure 1.
Total Area	16 Hectares or thereabouts
