**LINQ APARTMENTS SECTION 45
BELCONNEN EASTERN VALLEY WAY
DRIVEWAY**

DESIGN ROAD SAFETY AUDIT

EVRI GROUP

RG 25002 2 / 1

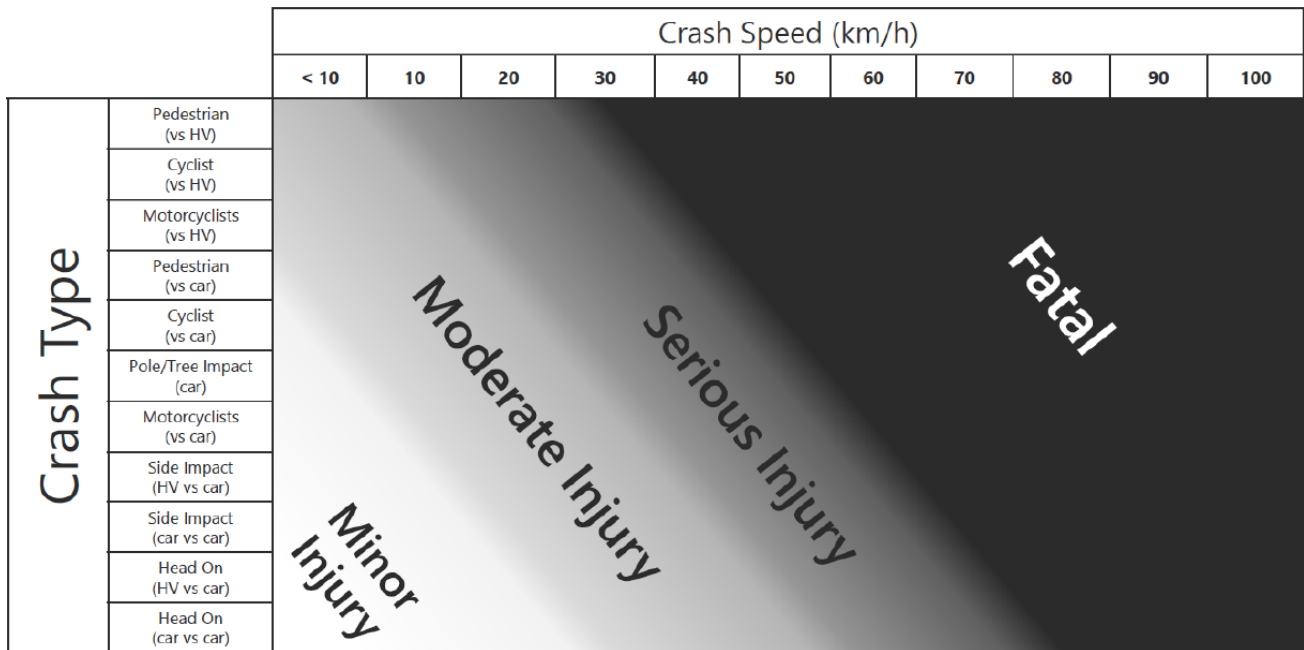
Figure 4-1 Severity guidance sheet – to be used with the risk matrix (Table 4-3)

The risk matrix is aligned with Safe System principles and was designed to be used with consideration of the severity guidance.
