Project Name
 YARRALUMLA BRICKWORKS
 Project No.
 0619SYD
 Address
 Yarralumla ACT 2600

Phase
 Schematic Design
 Sheet Title
 Materials Palette
 Sheet No.
 LD-DA-GEN-103

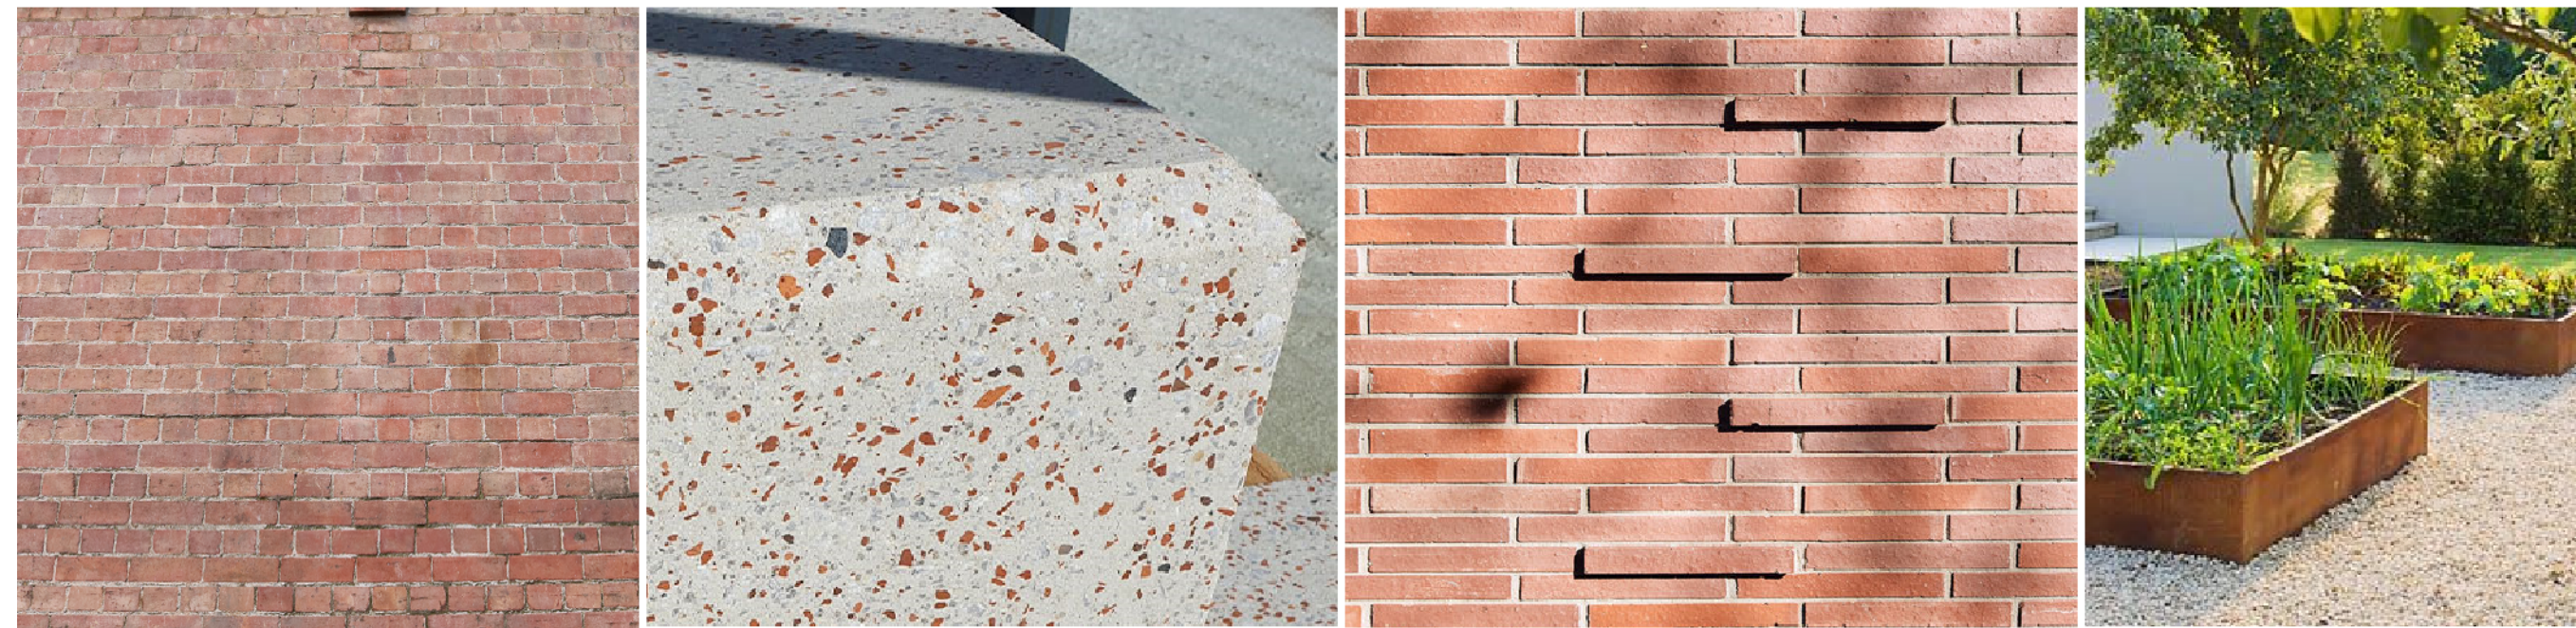
Heritage Core

Existing Red Brick Wall Exposed Red Aggregate Concrete Proposed Red Brick Wall Corten Steel Garden Edge / Planter Wall

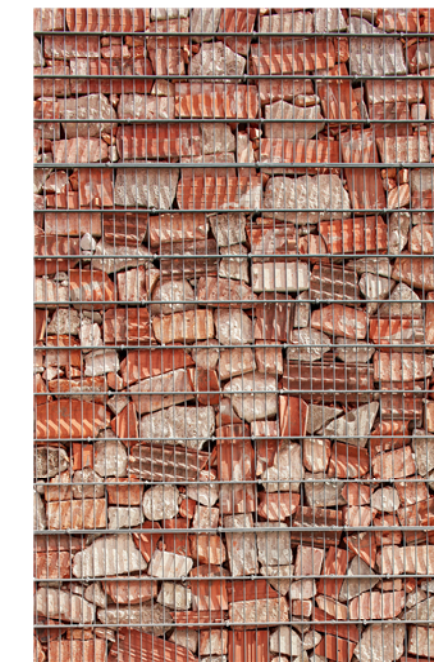
Quarry Parkland

Gabion Wall (mix of site-recycled red brick and stone)

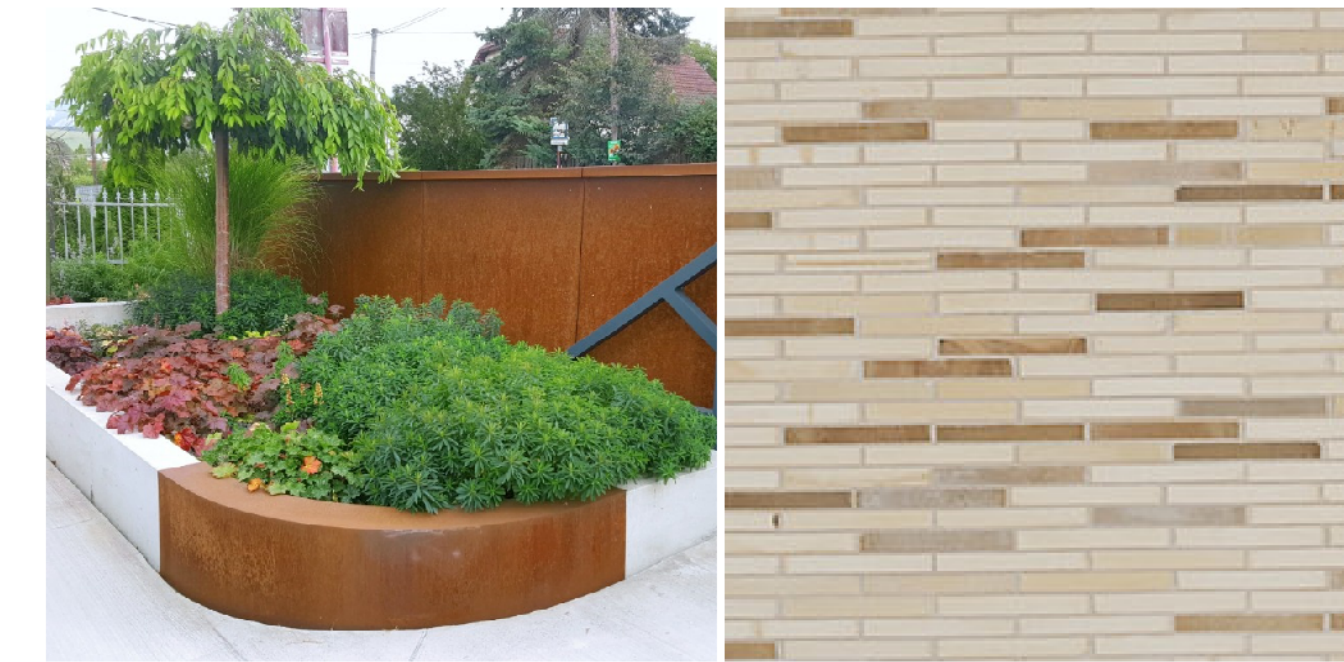
Precinct 1 & 3

Corten Steel Cladding Concrete Planter Wall Proposed Brown Brick Wall

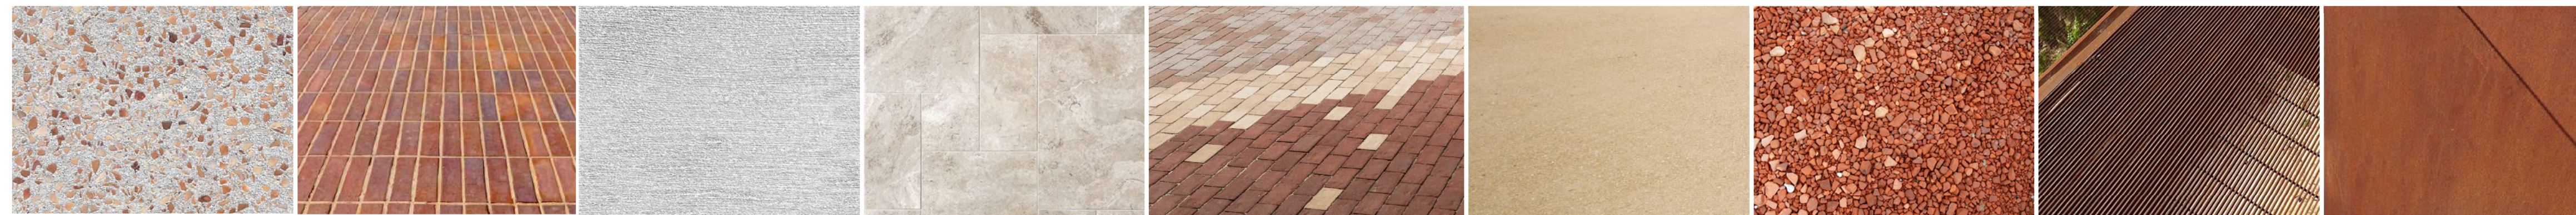
PAVING

Exposed Red Aggregate Concrete Red Brick (stack bond) Concrete In Situ (Broom Finish) Light Color Stone (Pool Area) Red Brick (stitch inlay) Decomposed Granite Crushed Bricks Corten Grating Corten Edge

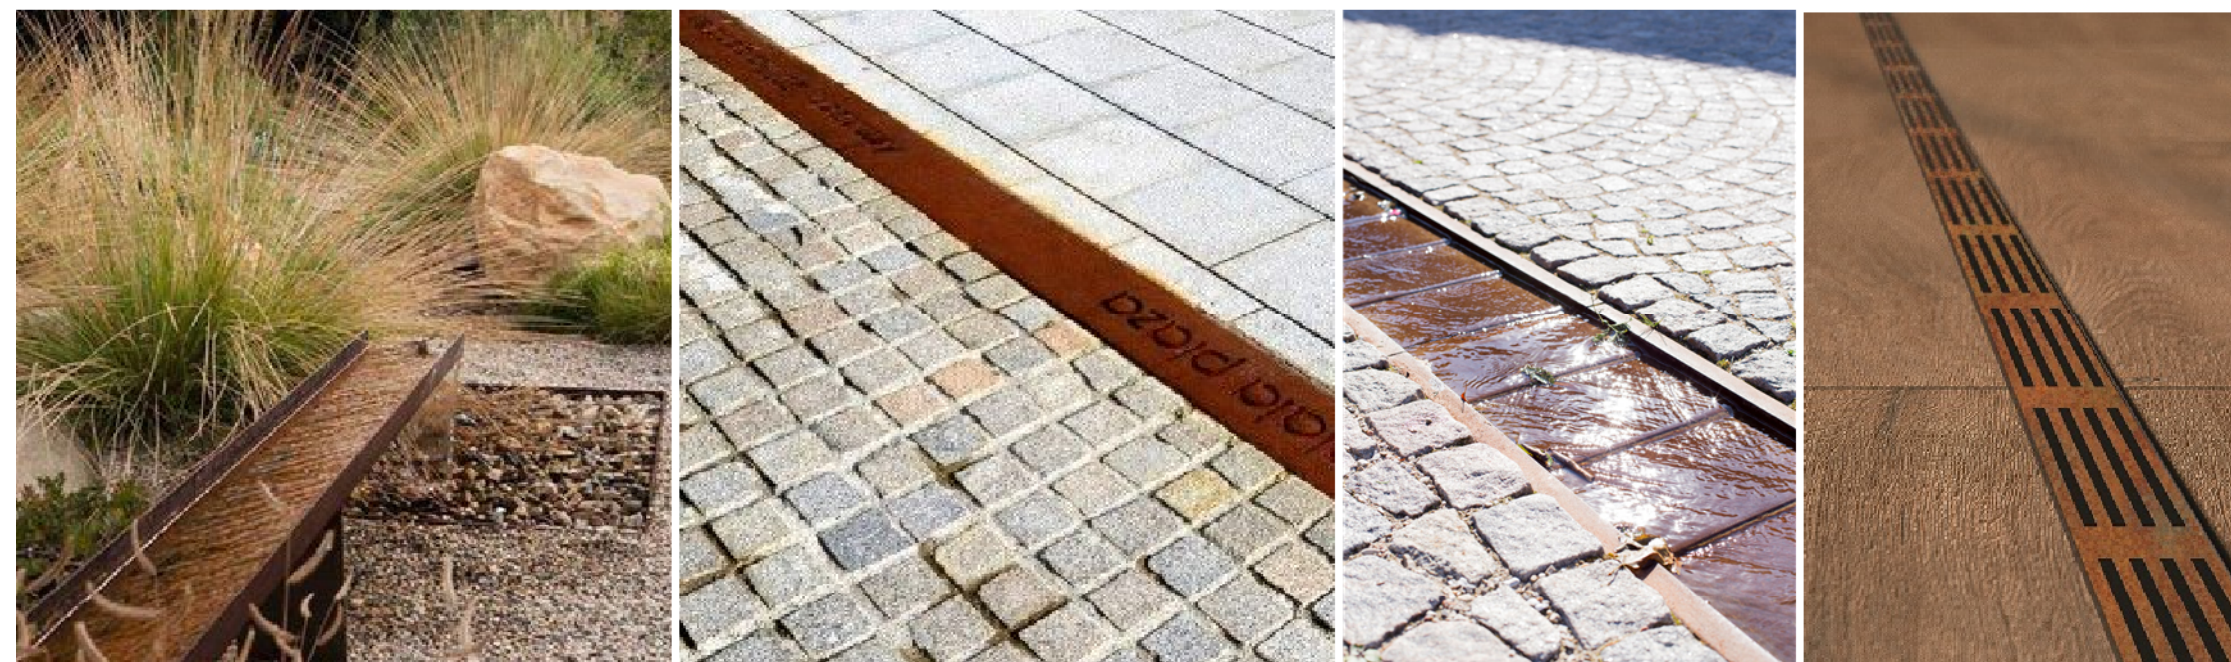
FURNITURE & FITTINGS

Quarry Park - Corten Water Concourse Feature Heritage Core - Corten Paving Inlay Heritage Core - Corten Water Feature Corten Steel Grated Drain

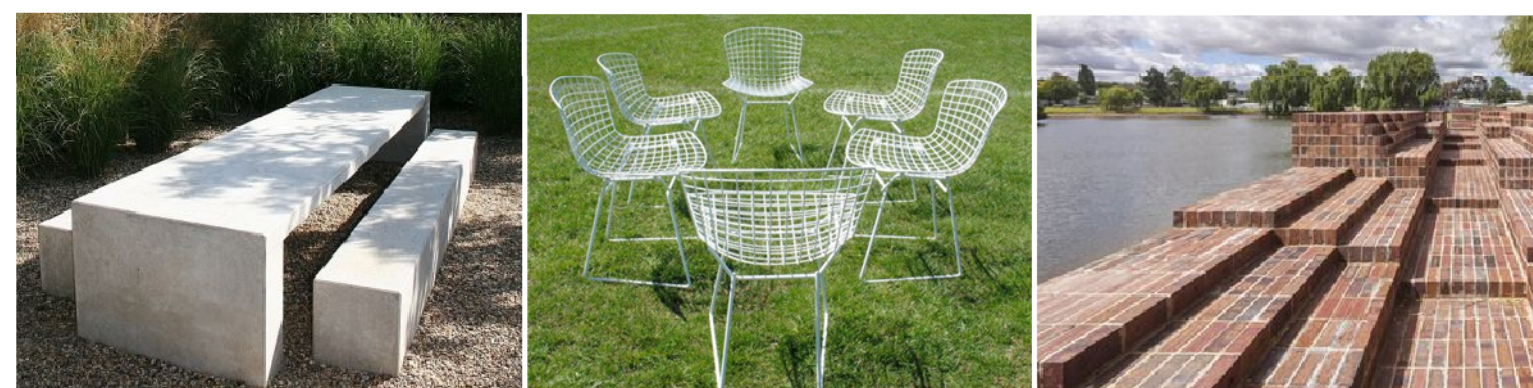
Long Table & Bench White colour loose furniture Red Brick Stacks
