Client
DOMA GROUP

Project Name
YARRALUMLA BRICKWORKS

Schematic Design
Sheet Title
Materials Palette
Sheet No.
LD-DA-GEN-103

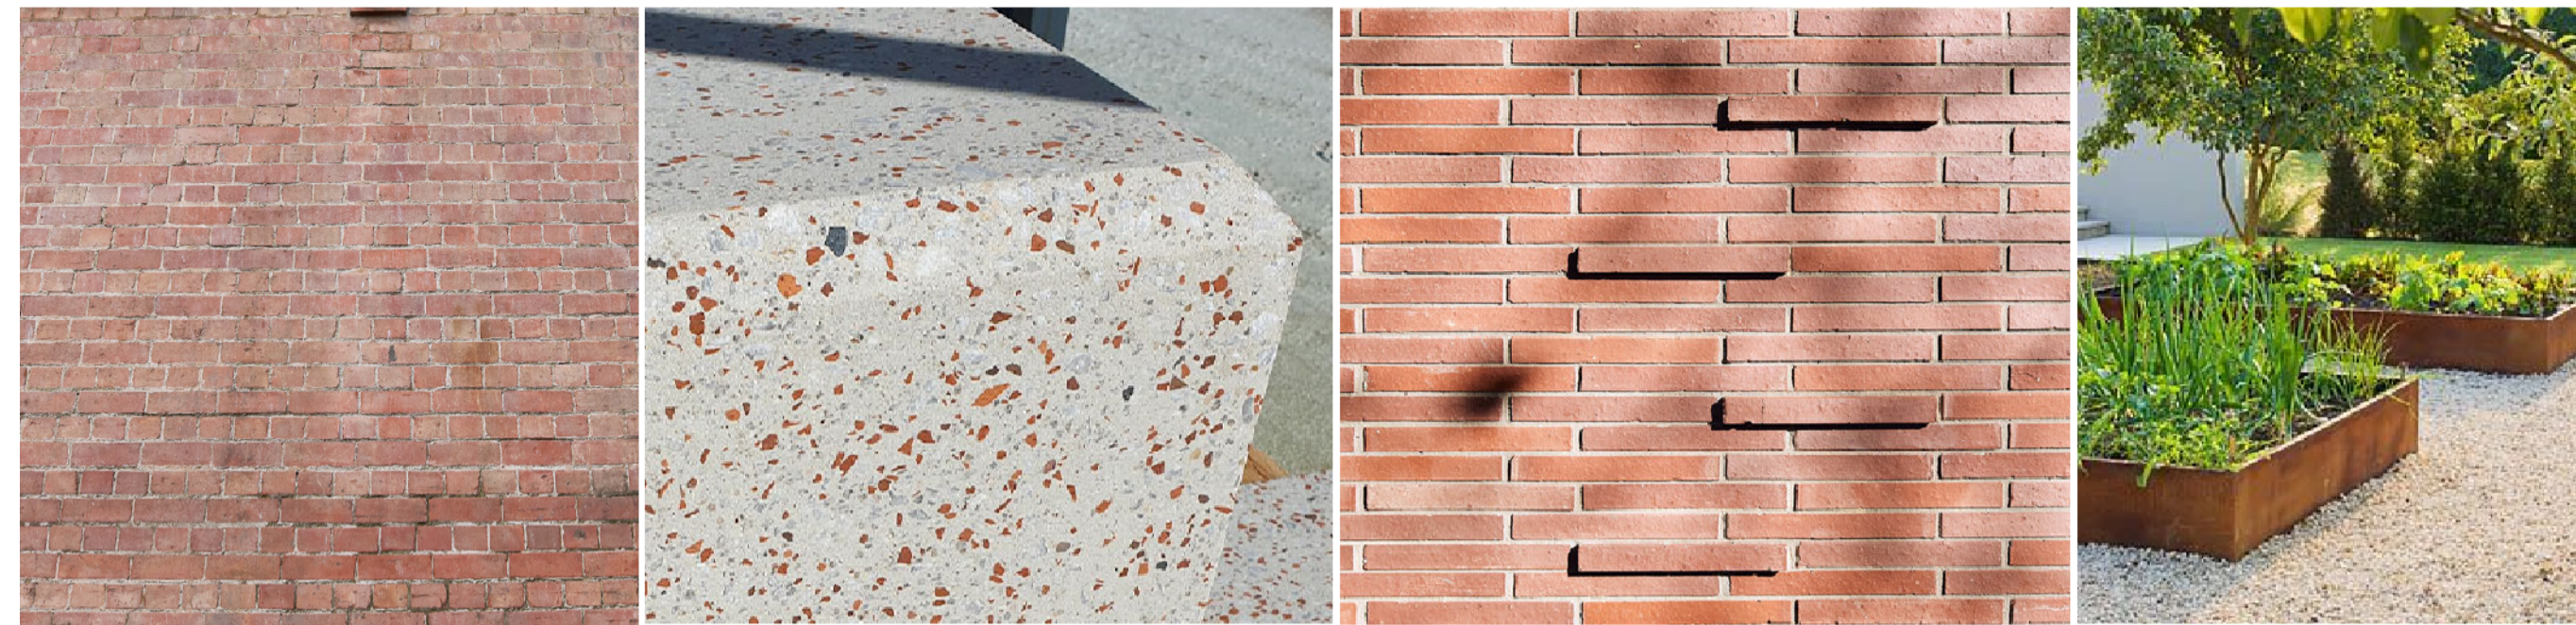
WALLS & EDGES

Existing Red Brick Wall Exposed Red Aggregate Concrete Proposed Red Brick Wall Corten Steel Garden Edge / Planter Wall

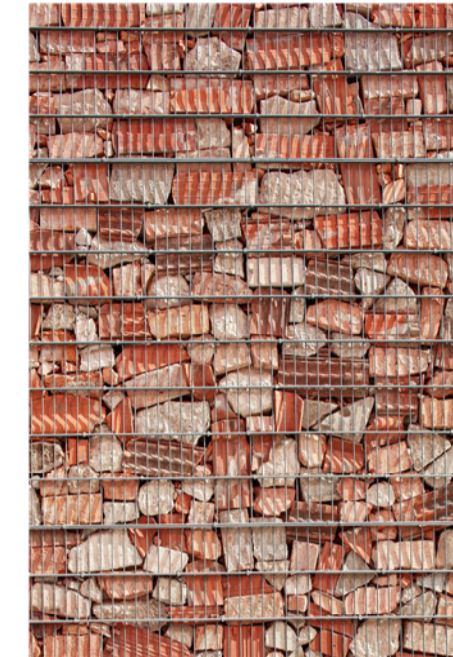
Quarry Parkland

Gabion Wall (mix of site-recycled red brick and stone)

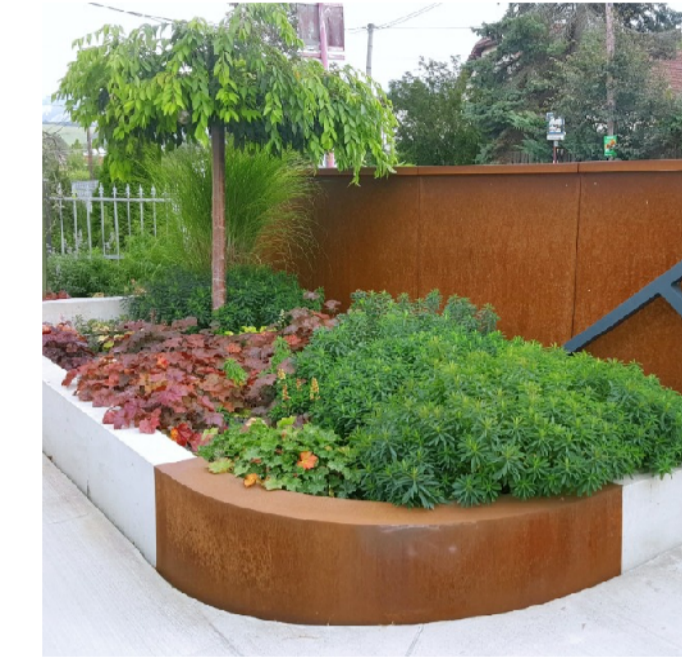
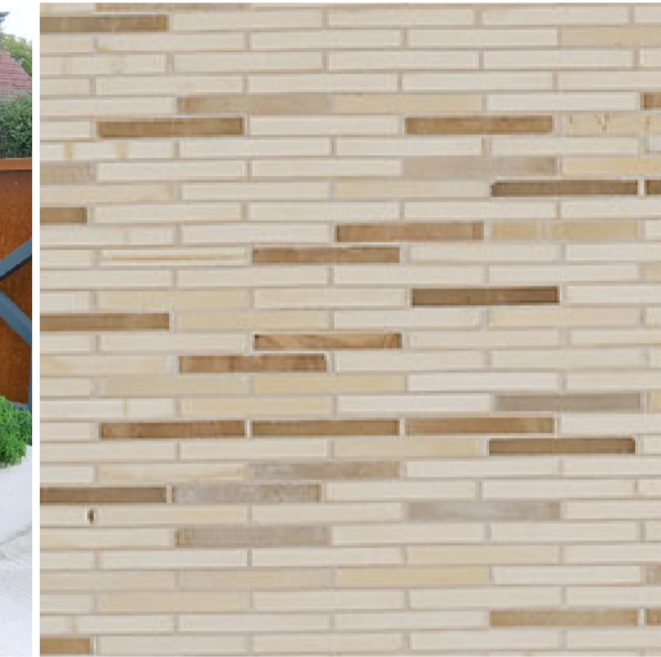
Precinct 1 & 3

Corten Steel Cladding Concrete Planter Wall

Proposed Brown Brick Wall

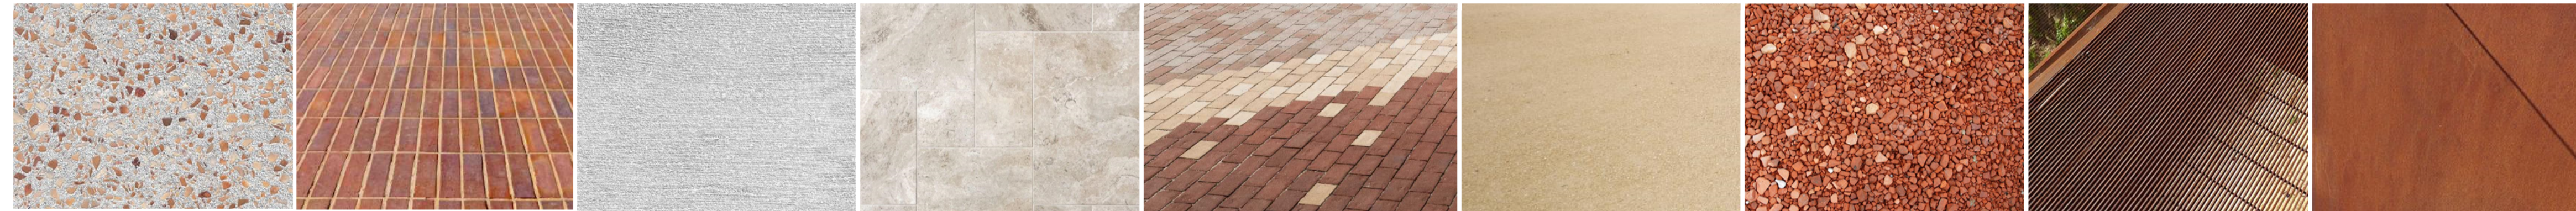
Heritage Core & Quarry Park

Exposed Red Aggregate Concrete Red Brick (stack bond) Concrete In Situ (Broom Finish) Light Color Stone (Pool Area) Red Brick (stitch inlay) Decomposed Granite Crushed Bricks Corten Grating Corten Edge

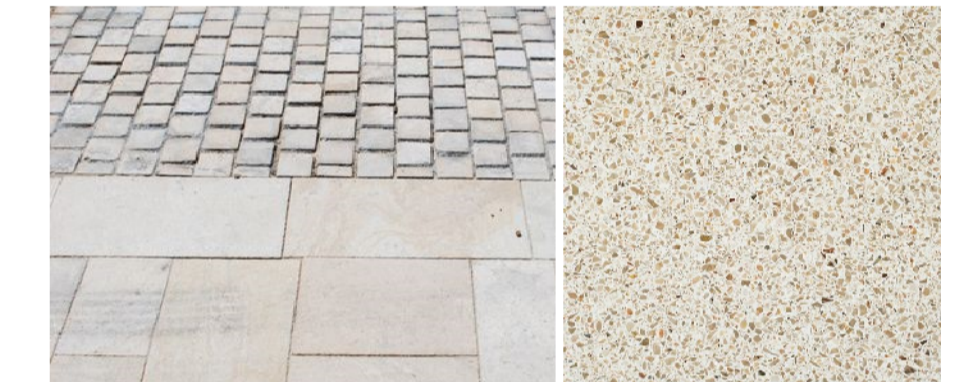
Precinct 1 & 3

Granite Stone Paving (Internal Courtyard) Exposed Aggregate Concrete (Internal Footpath)

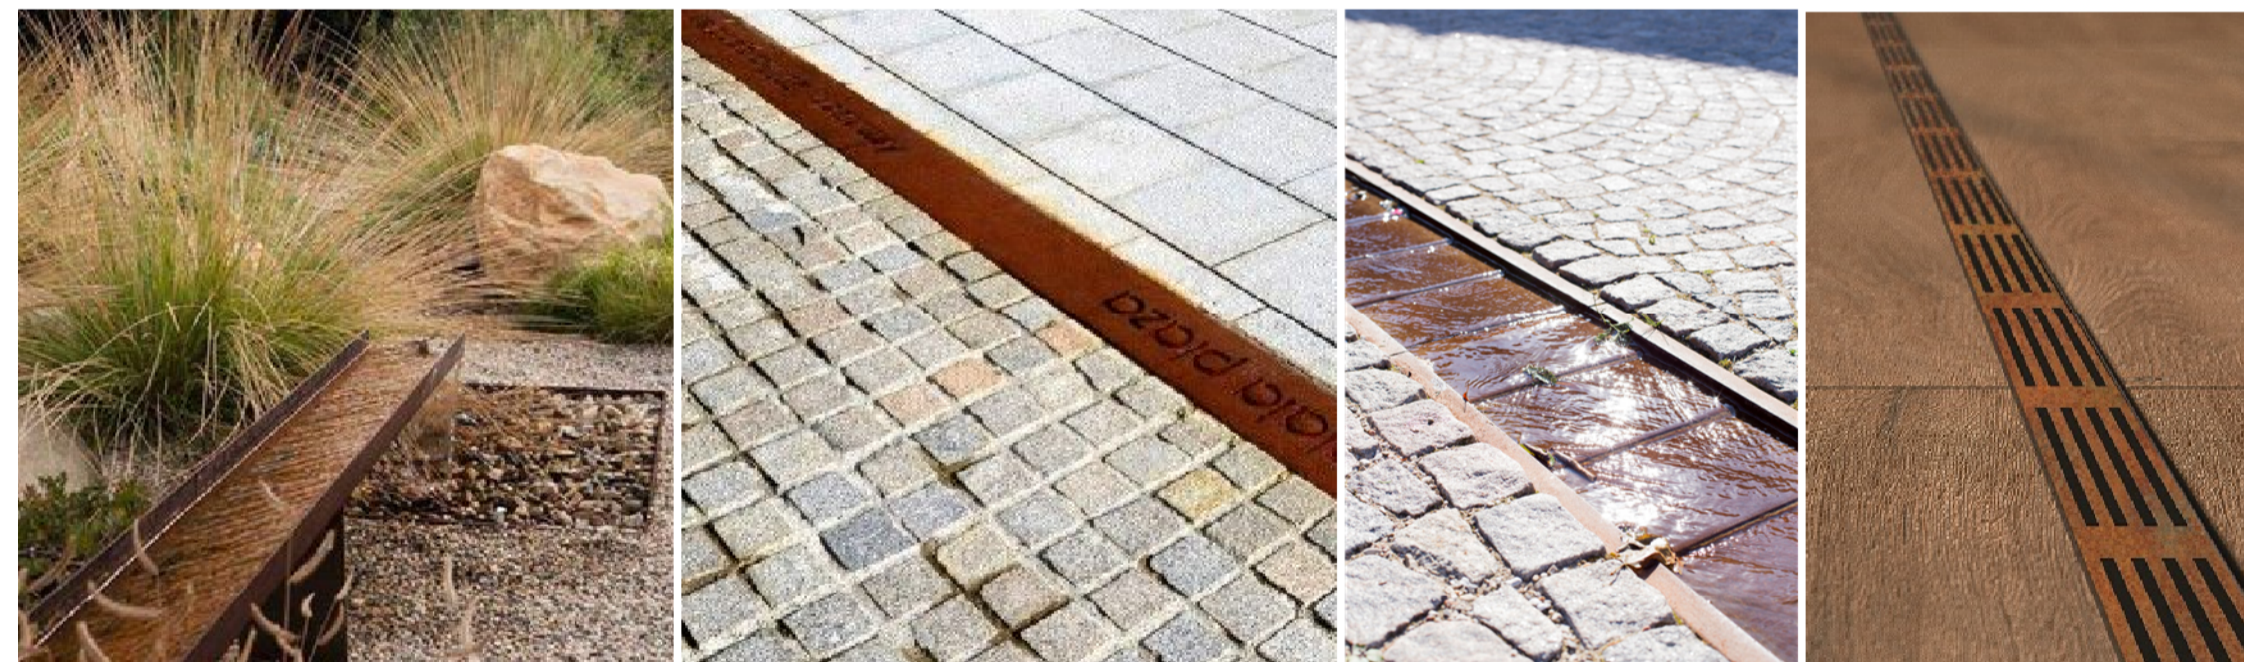
FURNITURE & FITTINGS

Quarry Park - Corten Water Concourse Feature Heritage Core - Corten Paving Inlay Heritage Core - Corten Water Feature Corten Steel Grated Drain

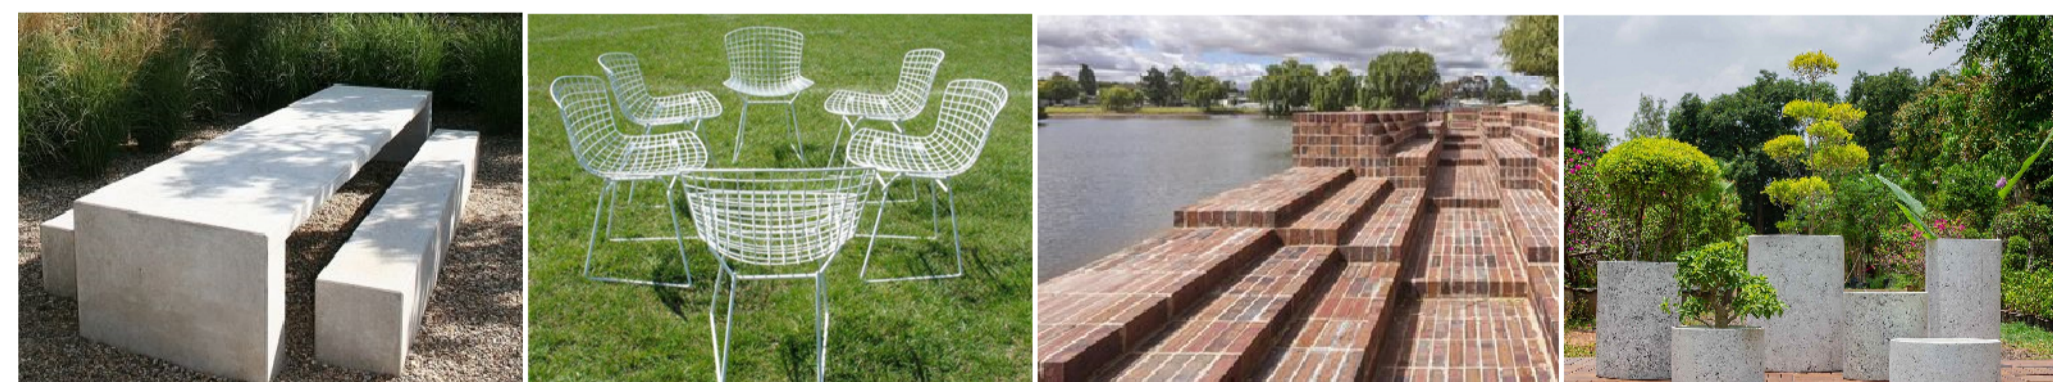
Long Table & Bench White colour loose furniture Red Brick Stacks Precinct 03 - Concrete Planter
