# Kingston Arts Precinct

1D: PRECINCT CONCEPT DESIGN REPORT

VOLUME 2 - APPENDICES

Stormwater & Sewer Hydraulics Investigation

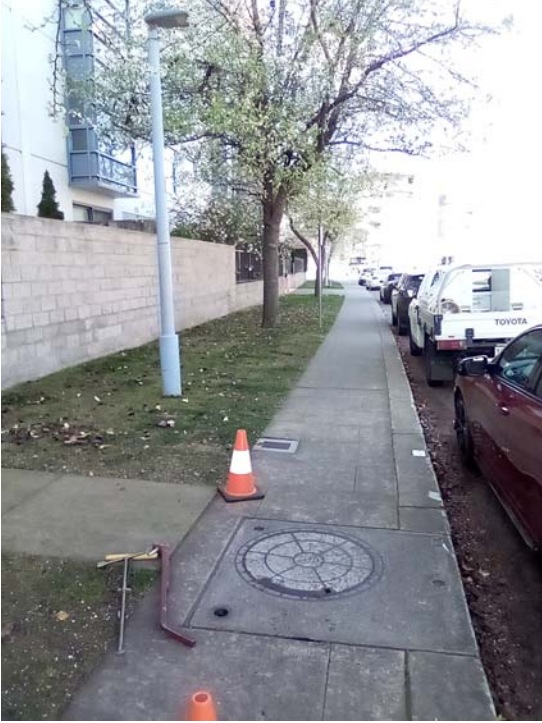
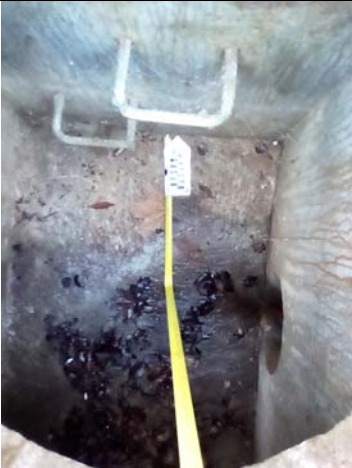
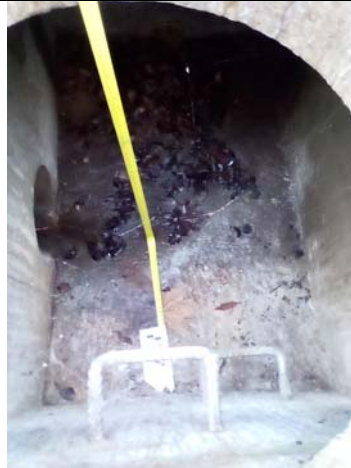
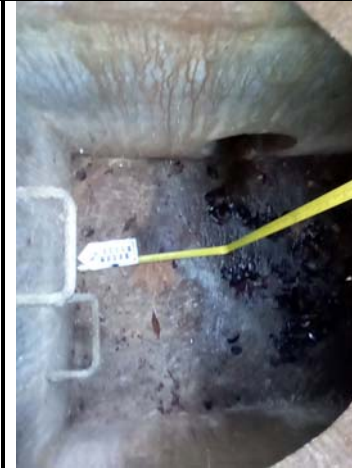
| | PIT DETAILS | | | | | |
|---|---|---|---|---|---|--|
| 1 | OUTLET | 1.18 | 0.3 | 80 | RL557.08 | |

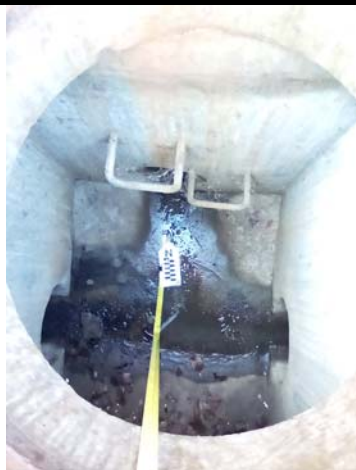
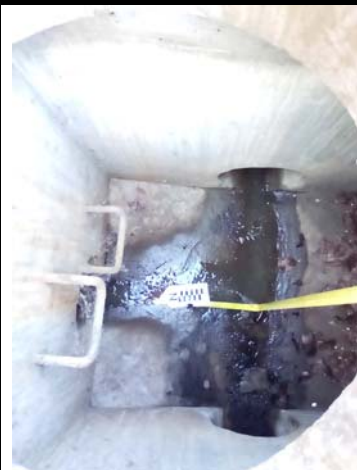
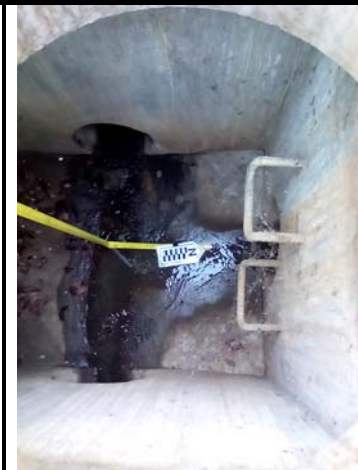
| PIT ID: | P35 |

| PIPE | FLOW | DEPTH | DIAMETER | DIR'N | INVERT |
|---|---|---|---|---|---|
| 1 | OUTLET | 1.3 | 0.3 | 80 | RL556.877 |
| 2 | INLET | 1.29 | 0.3 | 260 | RL556.887 |
| 3 | INLET | 1.28 | 0.3 | 0 | RL556.897 |

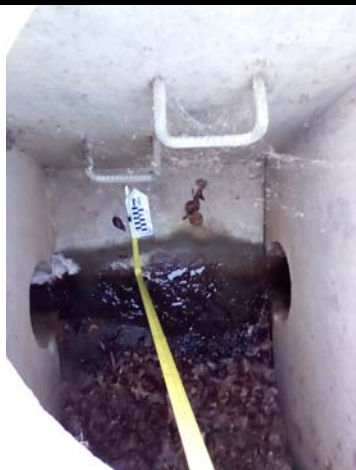
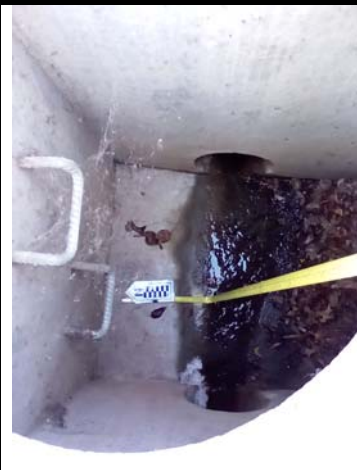
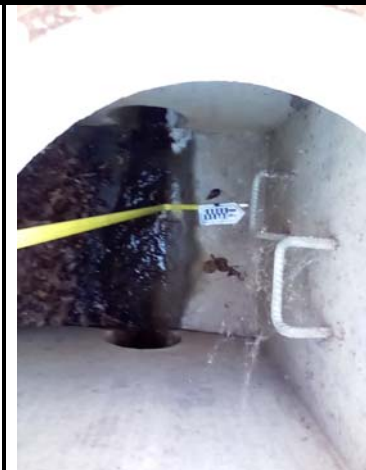
| PIT ID: | P36 |

| PIPE | FLOW | DEPTH | DIAMETER | DIR'N | INVERT |
|---|---|---|---|---|---|
| 1 | OUTLET | 1.39 | 0.3 | 80 | RL556.689 |
| 2 | INLET | 1.31 | 0.3 | 260 | RL556.769 |

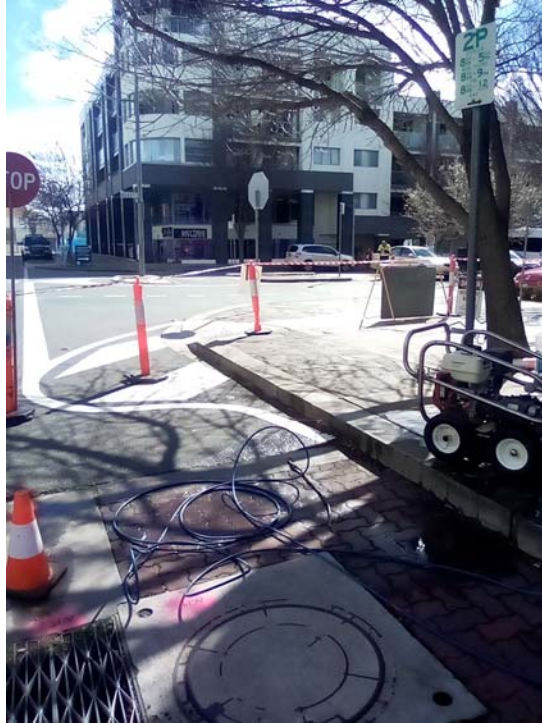
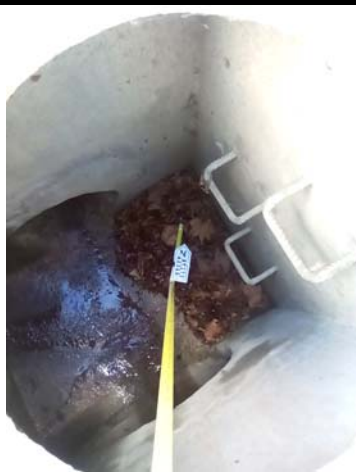
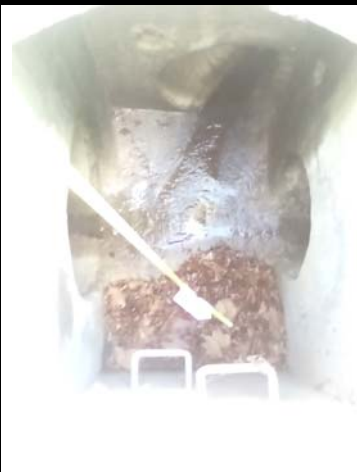
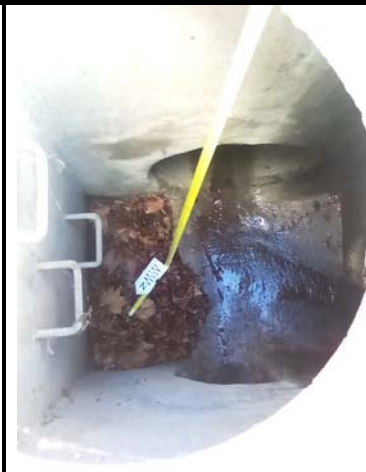
| PIT ID: | P37 |

| PIPE | FLOW | DEPTH | DIAMETER | DIR'N | INVERT |
|---|---|---|---|---|---|
| 1 | OUTLET | 1.86 | 0.75 | 140 | RL558.053 |
| 2 | INLET | 1.84 | 0.6 | 260 | RL558.073 |
| 3 | INLET | 1.85 | 0.6 | 320 | RL558.063 |

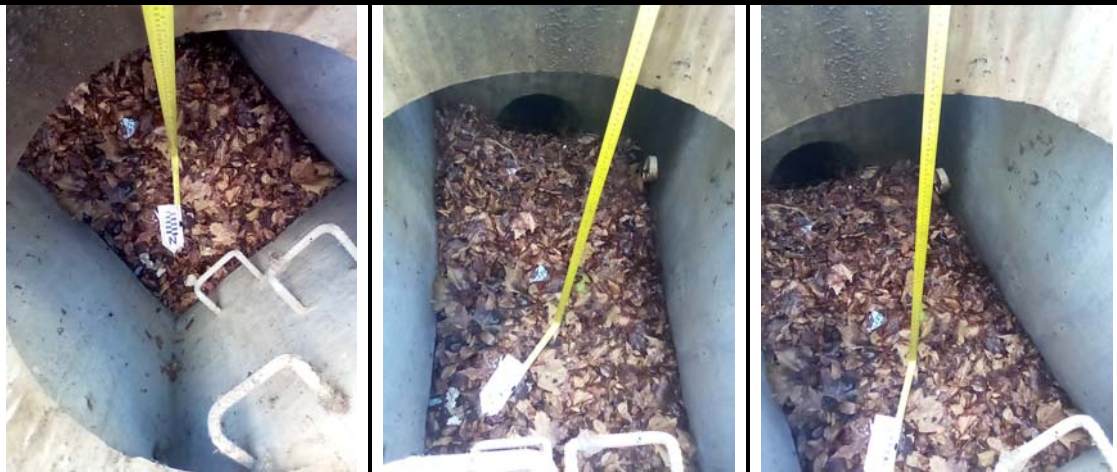
| | PIT DETAILS | | | | |
|---|---|---|---|---|---|
| | PIT ID: | P38 | | | |

| | PIT DETAILS | | | | |
|---|---|---|---|---|---|
| 1 | OUTLET | 1.36 | 0.3 | 150 | RL557.951 |

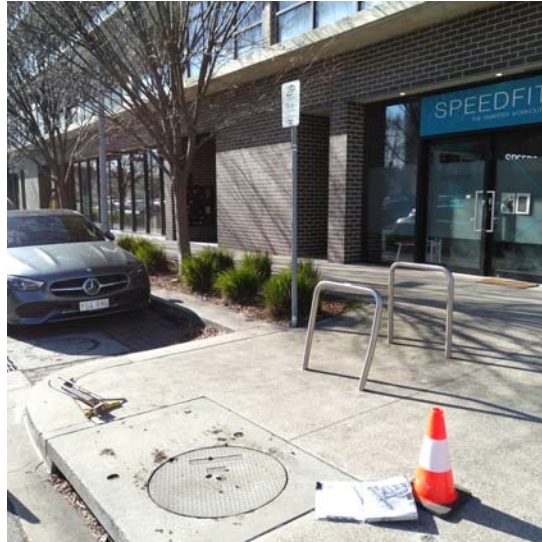
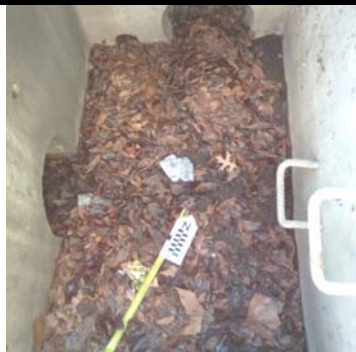
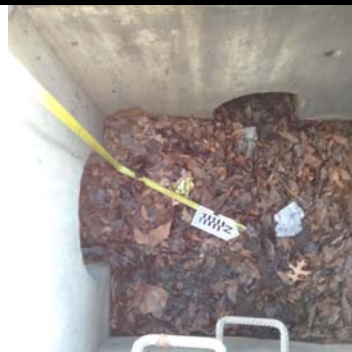
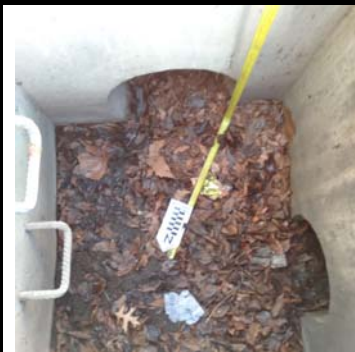
| PIT ID: | P58 |

| STRUCTURE: | SUMP (R) |

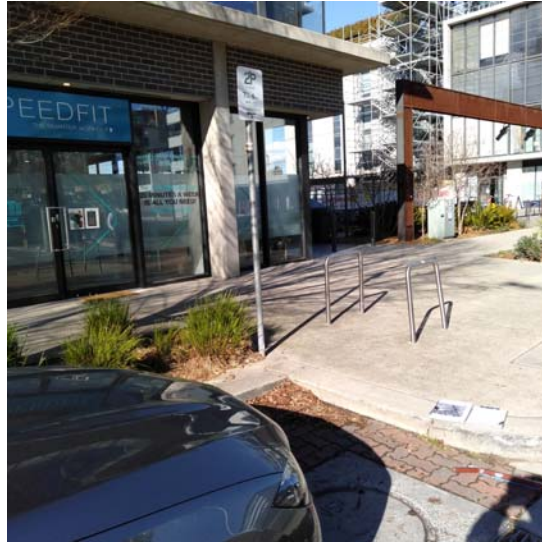
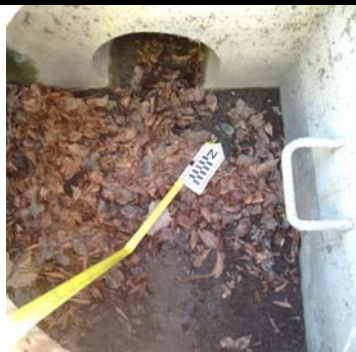
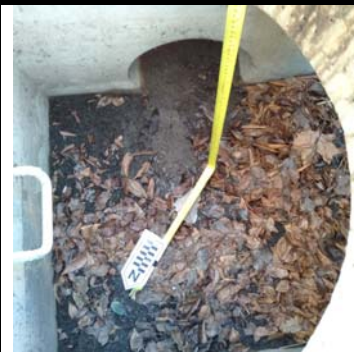
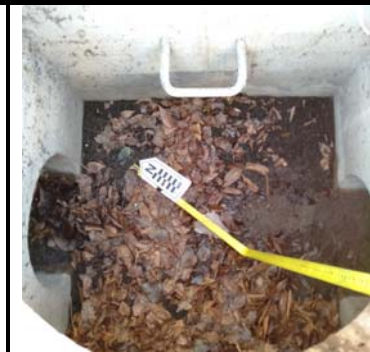
| PIT ID: | P59 |

| STRUCTURE: | SUMP (QS) |

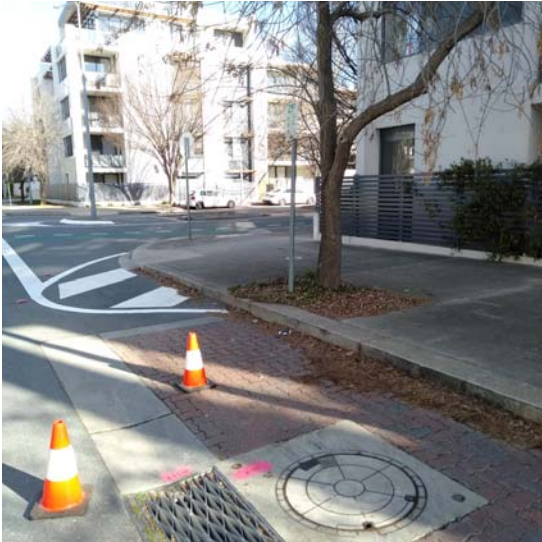
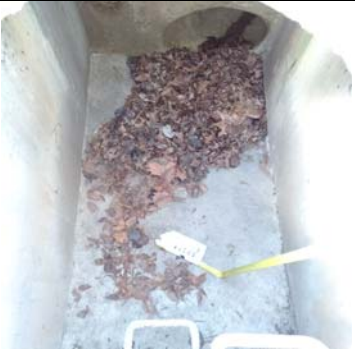
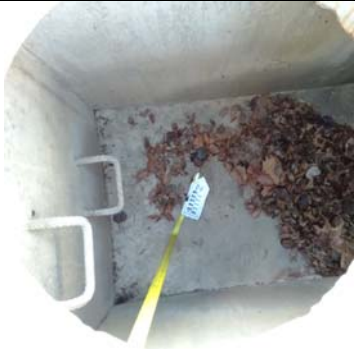
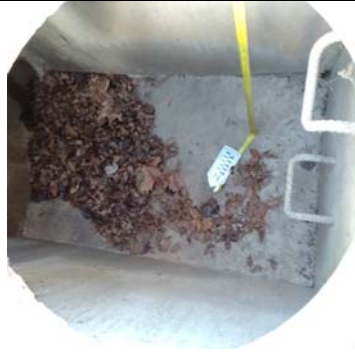
| | PIT DETAILS | | | | | | | | | | |
|---|---|---|---|---|---|---|--|--|--|--|--|
| | STRUCTURE: | | SUMP (QS) | | | | | | | | |

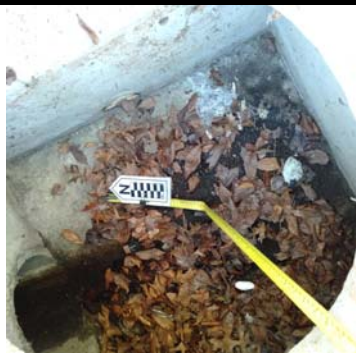
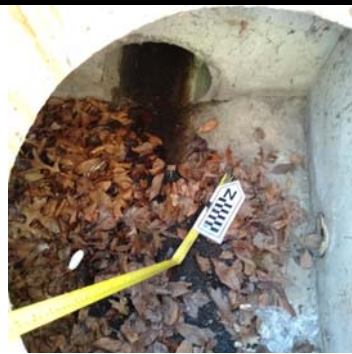
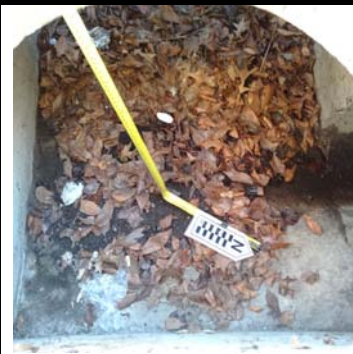
| PIT ID: | P61 |

| STRUCTURE: | SUMP (QS) |

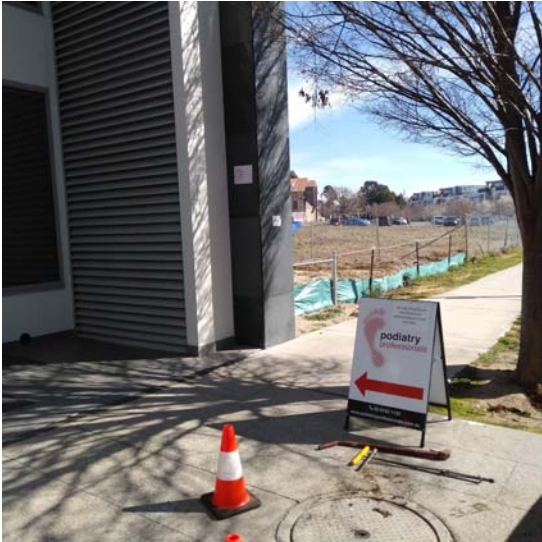
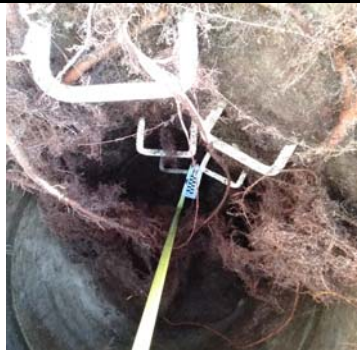
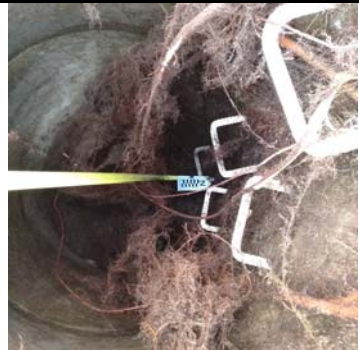
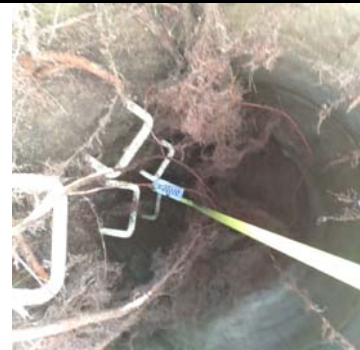
| | PIT DETAILS | | | | |
|---|---|---|---|---|---|
| | STRUCTURE: | SMH (Silted) | | | |

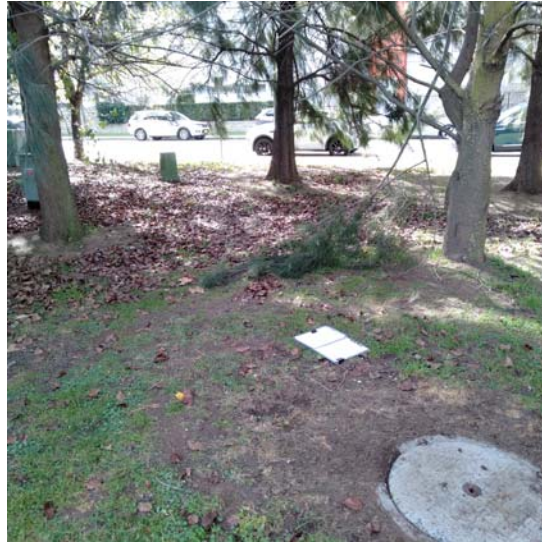
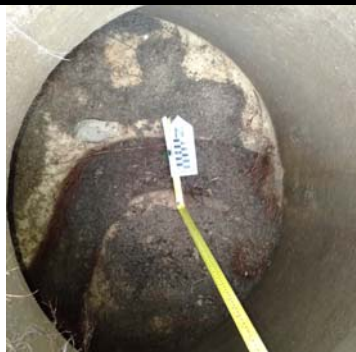
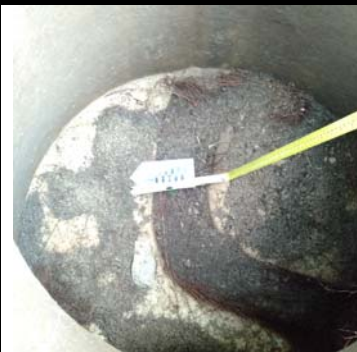
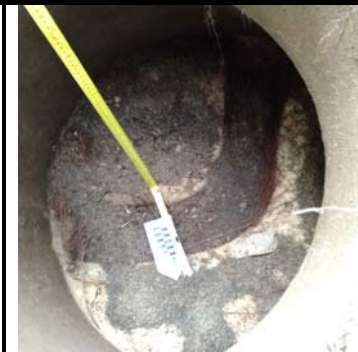
| PIT ID: | P68 |

| STRUCTURE: | SMH (Silted) |

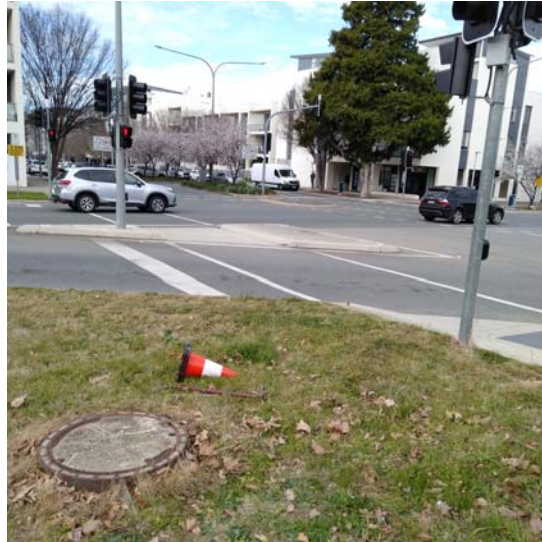
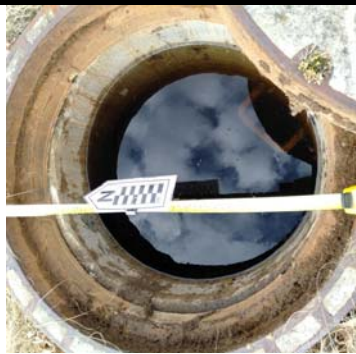
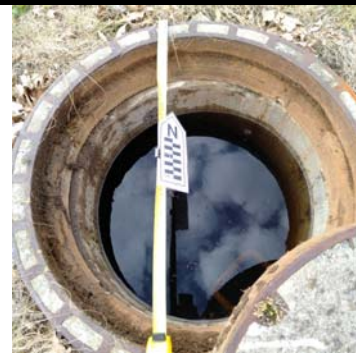
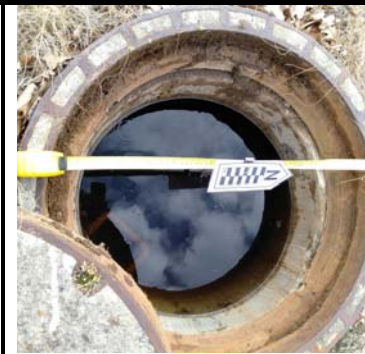
| PIT ID: | <b>P72</b> |

| STRUCTURE: | SMH (Flooded) |

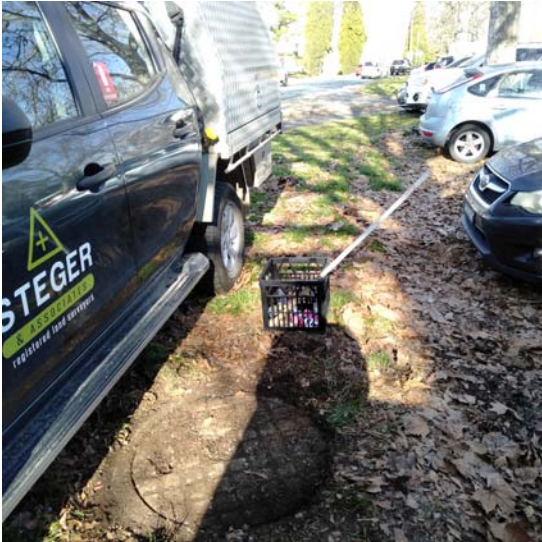
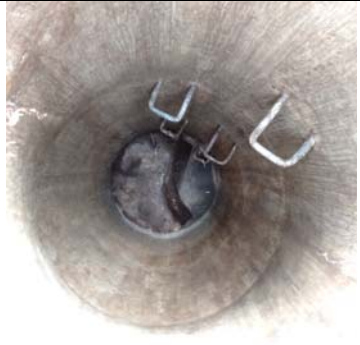
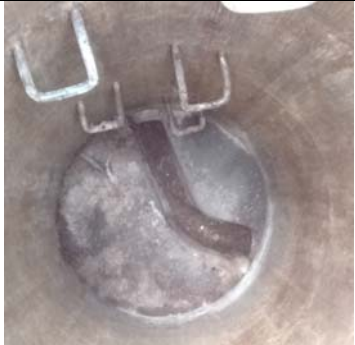
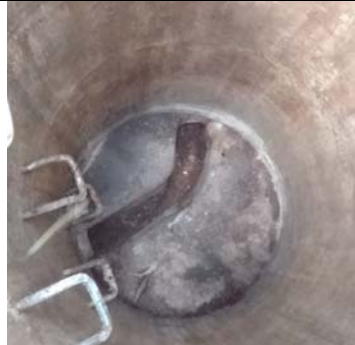
| | PIT DETAILS | | | | |
|---|---|---|---|---|---|
| | STRUCTURE: | SMH | | | |

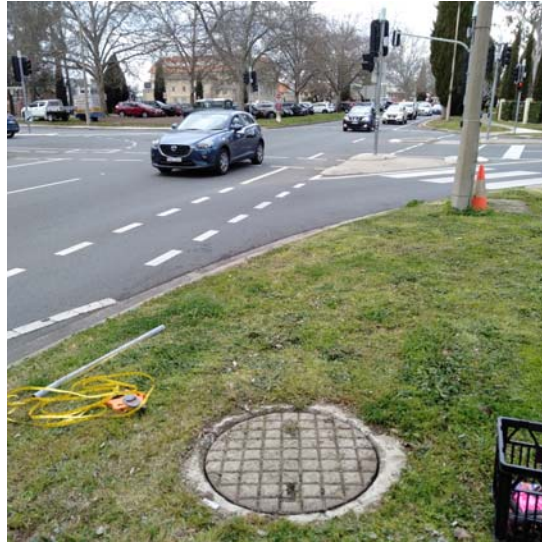
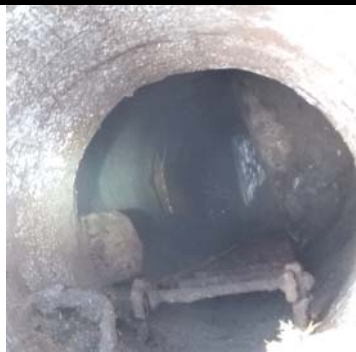
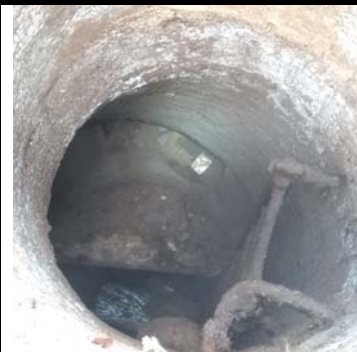
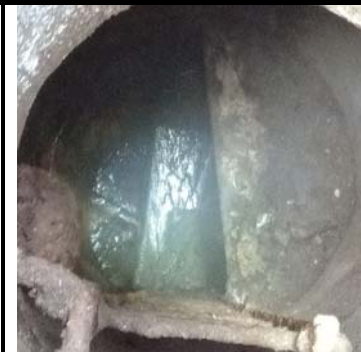
| PIT ID: | P95 |

| STRUCTURE: | SMH |

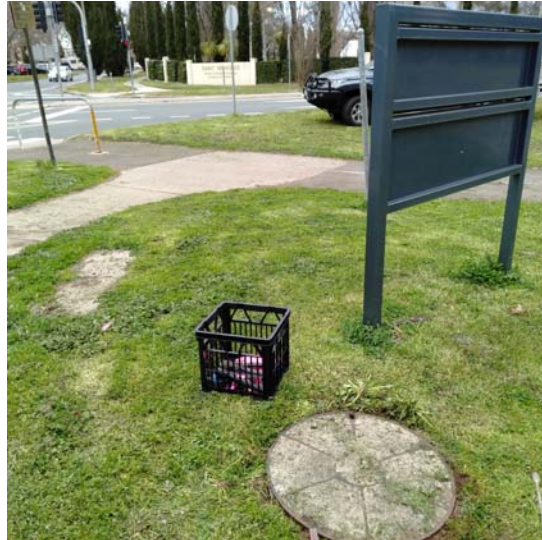
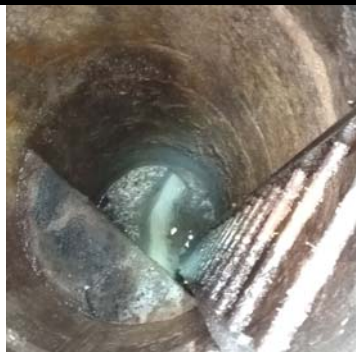
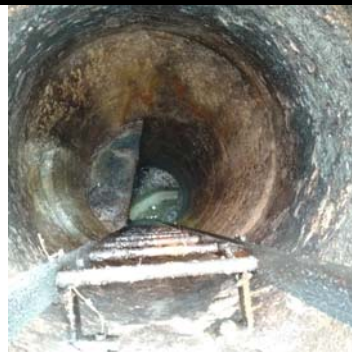
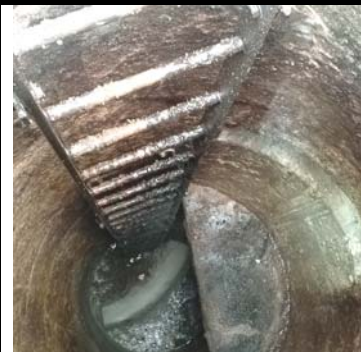
| PIT ID: | P96 |

| STRUCTURE: | SMH |

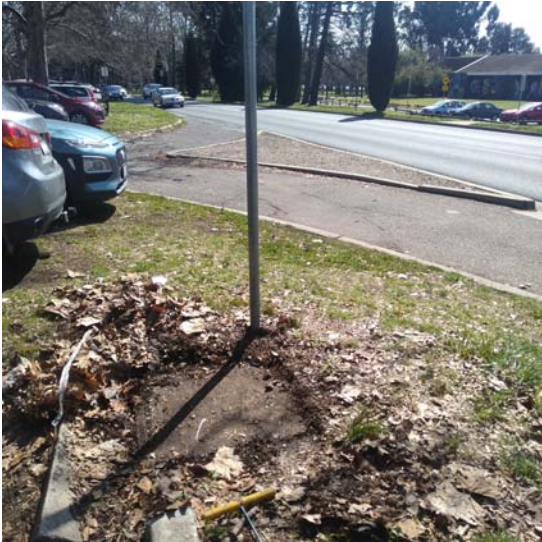
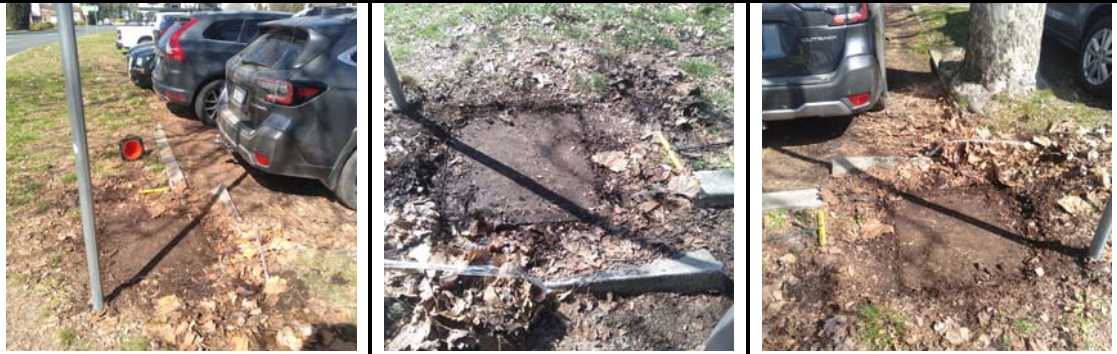
| | PIT DETAILS | | | | |
|---|---|---|---|---|---|
| | PIT ID: | P97 | | | |

| | PIT DETAILS | | | | |
|---|---|---|---|---|---|
| | STRUCTURE: | SUMP (QS) Inaccessible | | | |

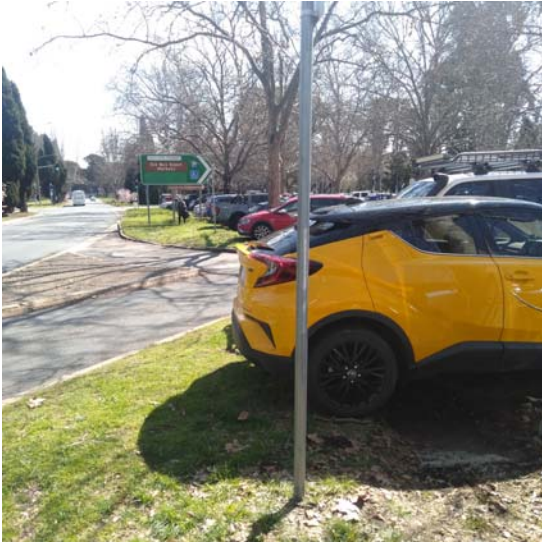
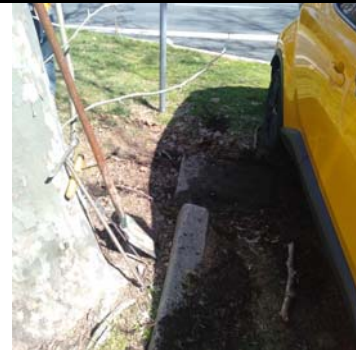
| | PIT DETAILS | | | | | |
|---|---|---|---|---|---|--|
| | STRUCTURE: | | SUMP (QS) Inaccessible | | | |

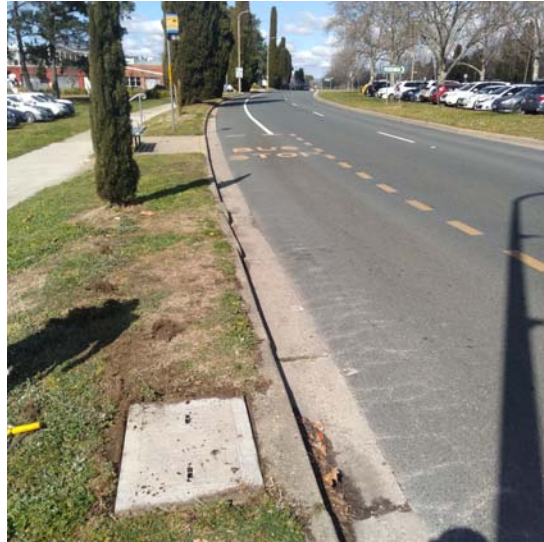
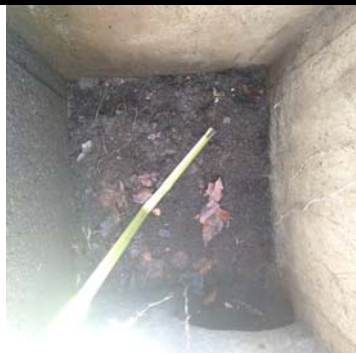
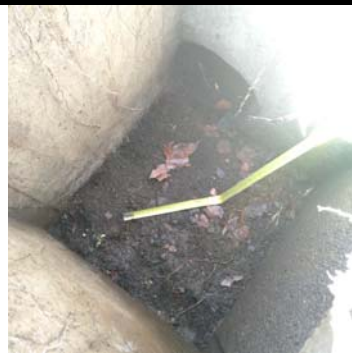
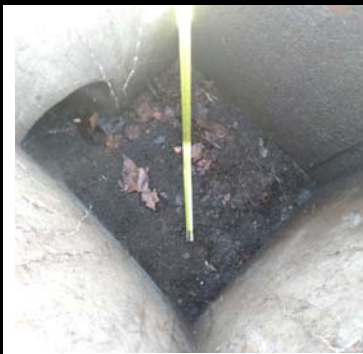
| <b>PIT ID:</b> | <b>P99</b> |

| <b>STRUCTURE:</b> | SUMP (QS) |
